Profile/Photo Observation Report

Street:	North Colorado Street	Flow Control:	Not Controlled
City:	Hobart, IN	Year Renewed:	
Location:	Alley	Tape/Media #:	
Purpose:	Routine Assessment	Dia/Height:	12"
Use:	Sanitary Sewage Pipe	Material:	CP
Drain Area:		Lining:	None
Category:	NA		
Comment:

Location Details:		Direction of Survey:	Downstream
US MH:	M-504-074	DS MH:	M-504-103
		Total Length Surveyed (ft):	110.5

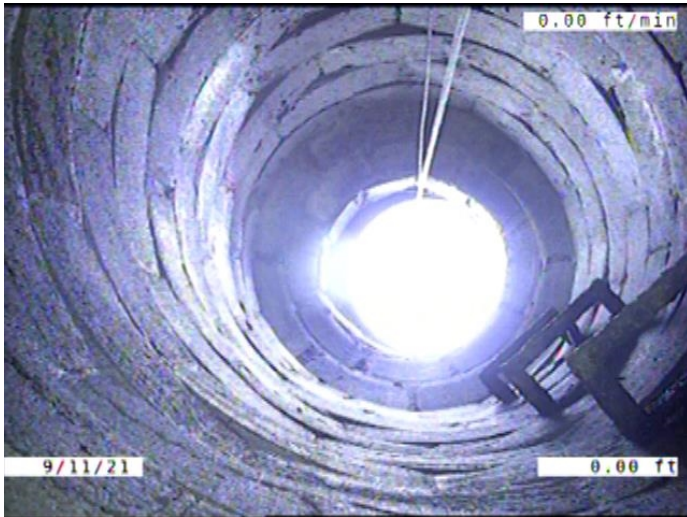
Code: **AMH**
 Description: **Manhole**

Distance (ft): **.0**
 Structural Grade: **0**
 O&M Grade: **0**
 Clock Start/From:
 Clock To:
 1st Value:
 2nd Value:
 Value Percent:
 Continuous Index:
 Within 8" of Joint: **NO**
 Remarks: **M-504-074**

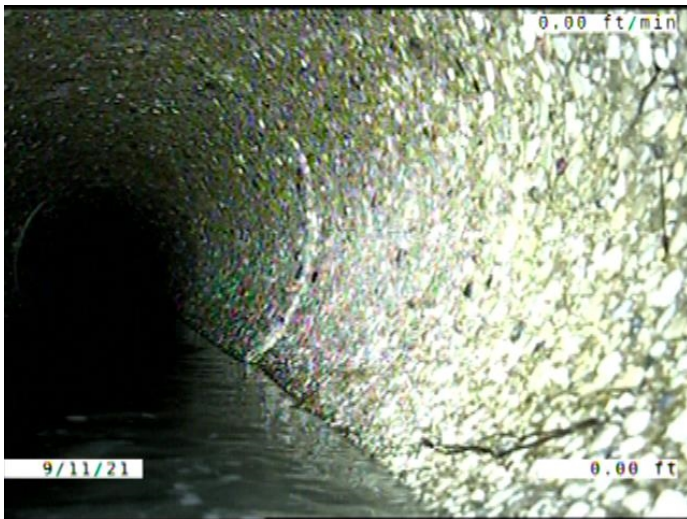
Code: **MWL**
 Description: **Miscellaneous Water Level**

Distance (ft): **.0**
 Structural Grade: **0**
 O&M Grade: **0**
 Clock Start/From:
 Clock To:
 1st Value:
 2nd Value:
 Value Percent: **10.000**
 Continuous Index:
 Within 8" of Joint: **NO**
 Remarks:

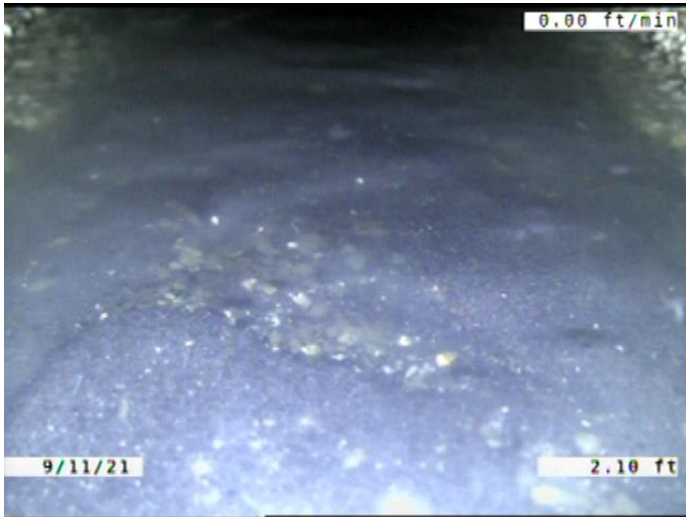
Code: **DSF**
 Description: **Deposits Settled Fine**

Distance (ft): **2.1**
 Structural Grade: **0**
 O&M Grade: **2**
 Clock Start/From: **5**
 Clock To: **7**
 1st Value:
 2nd Value:
 Value Percent: **5.000**
 Continuous Index: **S01**
 Within 8" of Joint: **YES**
 Remarks:

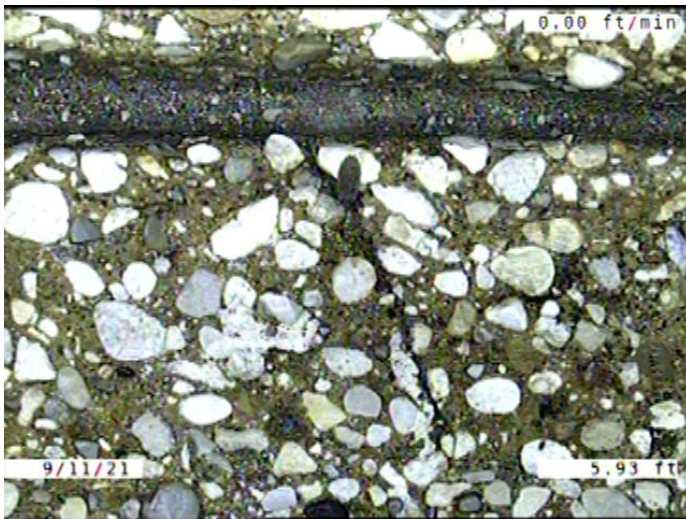
Code: **FM**
 Description: **Fracture Multiple**

Distance (ft): **5.9**
 Structural Grade: **4**
 O&M Grade: **0**
 Clock Start/From: **11**
 Clock To: **1**
 1st Value:
 2nd Value:
 Value Percent:
 Continuous Index:
 Within 8" of Joint: **YES**
 Remarks:

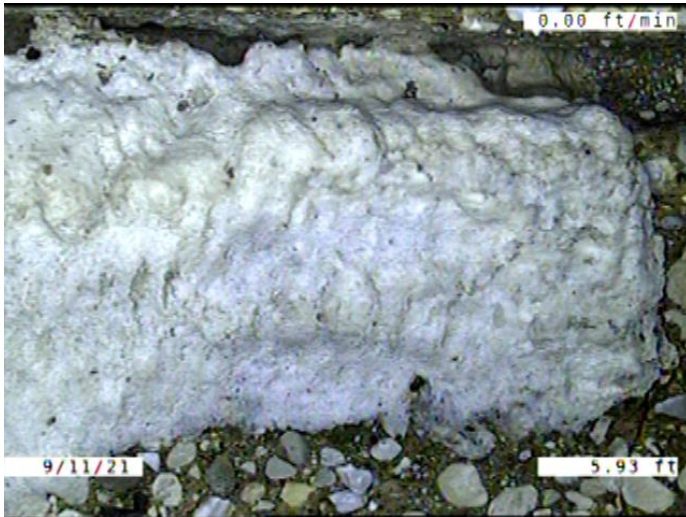
Code:	DAE
Description:	Deposits Attached Encrustation
Distance (ft):	5.9
Structural Grade:	0
O&M Grade:	2
Clock Start/From:	9
Clock To:	11
1st Value:	
2nd Value:	
Value Percent:	5.000
Continuous Index:	
Within 8" of Joint:	YES
Remarks:

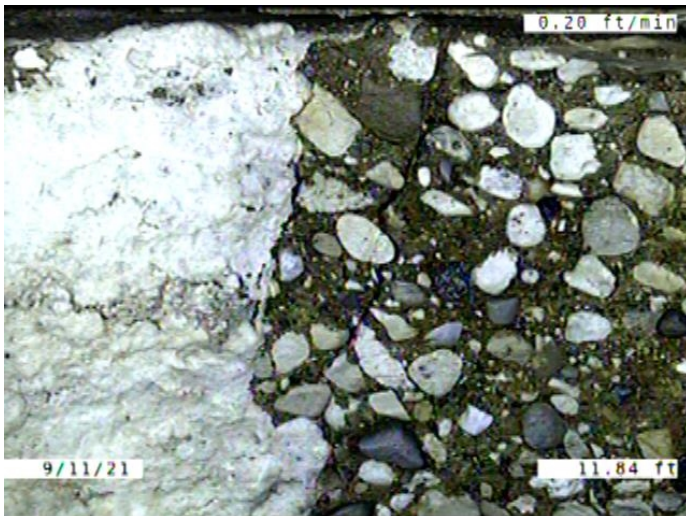
Code:	CM
Description:	Crack Multiple
Distance (ft):	11.8
Structural Grade:	3
O&M Grade:	0
Clock Start/From:	10
Clock To:	3
1st Value:	
2nd Value:	
Value Percent:	
Continuous Index:	
Within 8" of Joint:	YES
Remarks:

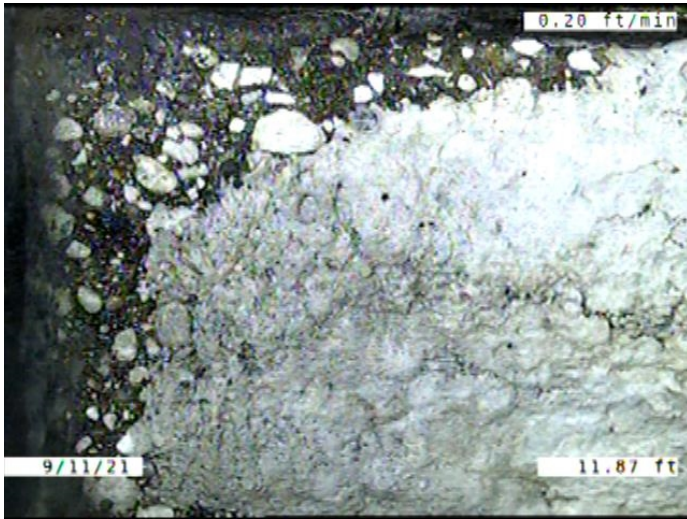
Code: **DAE**
 Description: **Deposits Attached Encrustation**

Distance (ft): **11.9**
 Structural Grade: **0**
 O&M Grade: **2**
 Clock Start/From: **8**
 Clock To: **11**
 1st Value:
 2nd Value:
 Value Percent: **5.000**
 Continuous Index:
 Within 8" of Joint: **YES**
 Remarks:

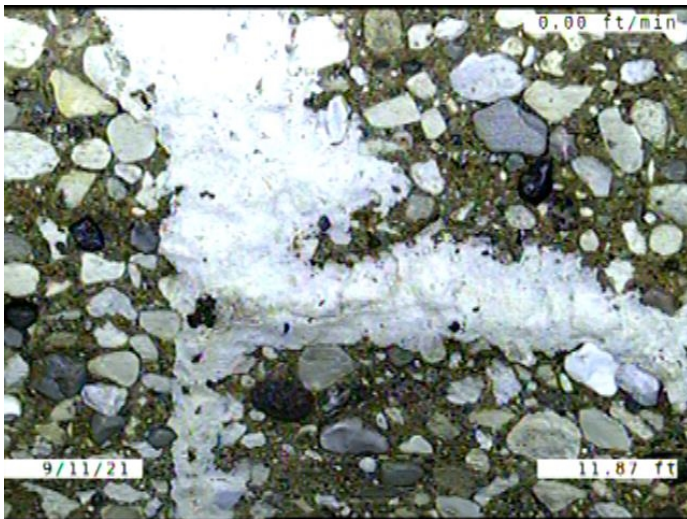
Code: **DAE**
 Description: **Deposits Attached Encrustation**

Distance (ft): **11.9**
 Structural Grade: **0**
 O&M Grade: **2**
 Clock Start/From: **1**
 Clock To: **4**
 1st Value:
 2nd Value:
 Value Percent: **5.000**
 Continuous Index:
 Within 8" of Joint: **YES**
 Remarks:

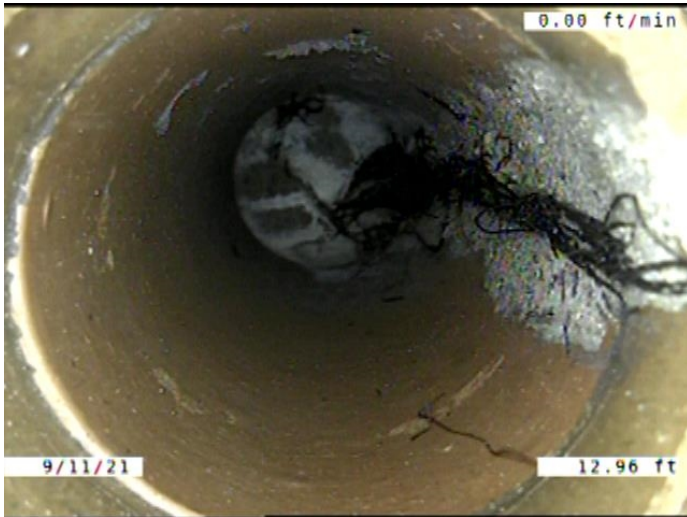
Code:	TBC
Description:	Tap Break-in Capped
Distance (ft):	13.0
Structural Grade:	0
O&M Grade:	0
Clock Start/From:	1
Clock To:	
1st Value:	4.000
2nd Value:	
Value Percent:	
Continuous Index:	
Within 8" of Joint:	YES
Remarks:	ROOTS GROWING AROUND THE CAP

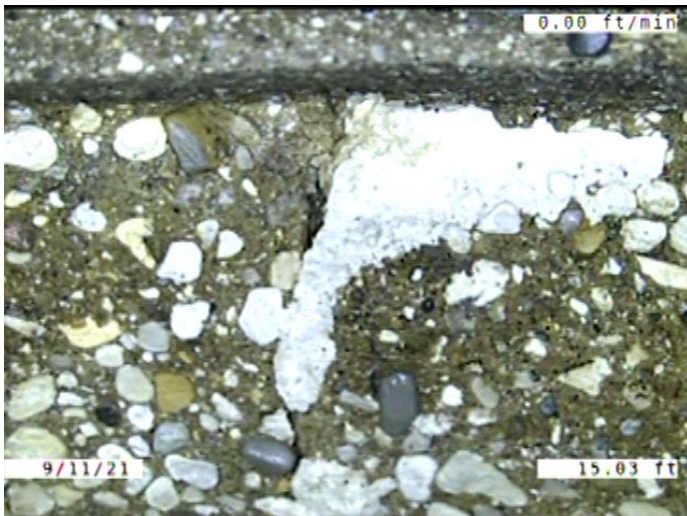
Code:	FM
Description:	Fracture Multiple
Distance (ft):	15.0
Structural Grade:	4
O&M Grade:	0
Clock Start/From:	10
Clock To:	1
1st Value:	
2nd Value:	
Value Percent:	
Continuous Index:	S02
Within 8" of Joint:	YES
Remarks:

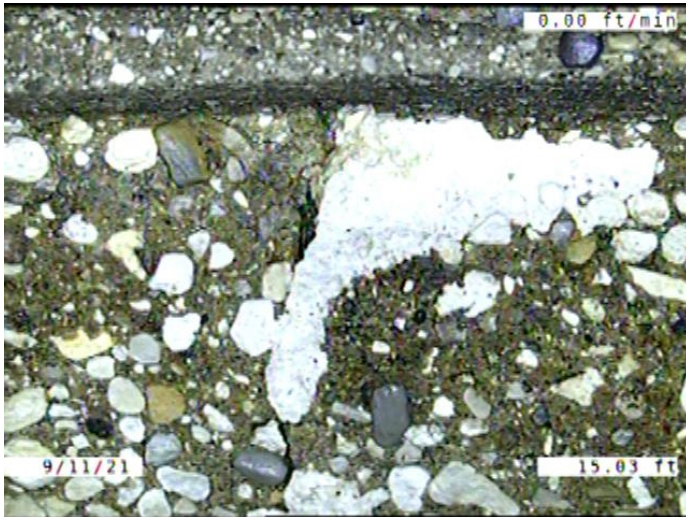
Code: **DAE**
 Description: **Deposits Attached Encrustation**

Distance (ft): **15.0**
 Structural Grade: **0**
 O&M Grade: **2**
 Clock Start/From: **8**
 Clock To: **4**
 1st Value:
 2nd Value:
 Value Percent: **5.000**
 Continuous Index: **S03**
 Within 8" of Joint: **YES**
 Remarks:

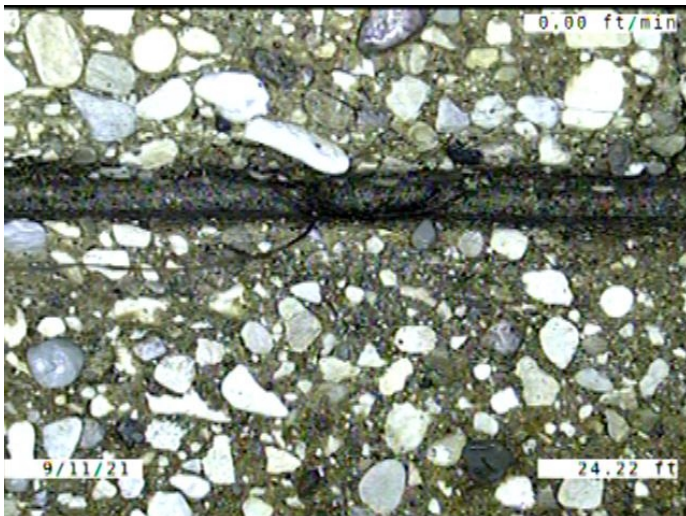
Code: **RFJ**
 Description: **Roots Fine Joint**

Distance (ft): **24.2**
 Structural Grade: **0**
 O&M Grade: **1**
 Clock Start/From: **11**
 Clock To:
 1st Value:
 2nd Value:
 Value Percent:
 Continuous Index:
 Within 8" of Joint: **YES**
 Remarks:

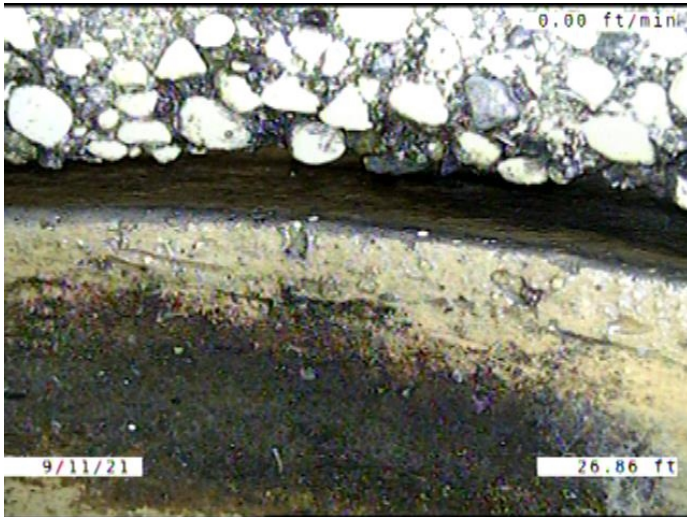
Code: **MMC**
 Description: **Miscellaneous Material Change**

Distance (ft): **26.9**
 Structural Grade: **0**
 O&M Grade: **0**
 Clock Start/From:
 Clock To:
 1st Value:
 2nd Value:
 Value Percent:
 Continuous Index:
 Within 8" of Joint: **NO**
 Remarks: **CONCRETE TO VCP**

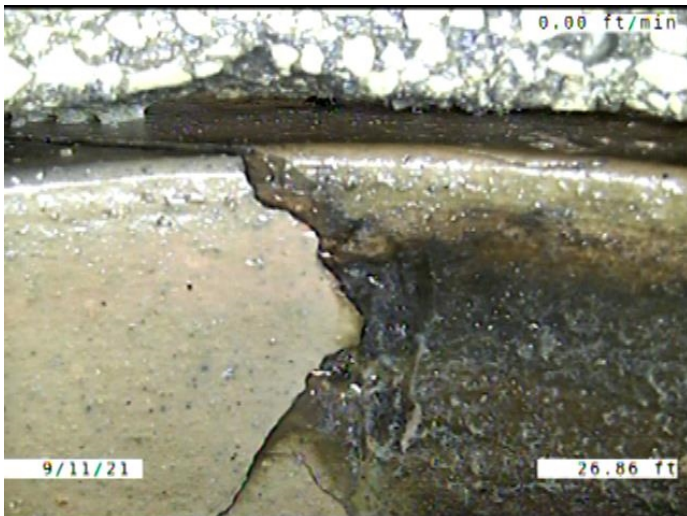
Code: **B**
 Description: **Broken**

Distance (ft): **26.9**
 Structural Grade: **4**
 O&M Grade: **0**
 Clock Start/From: **8**
 Clock To: **2**
 1st Value:
 2nd Value:
 Value Percent:
 Continuous Index:
 Within 8" of Joint: **YES**
 Remarks:

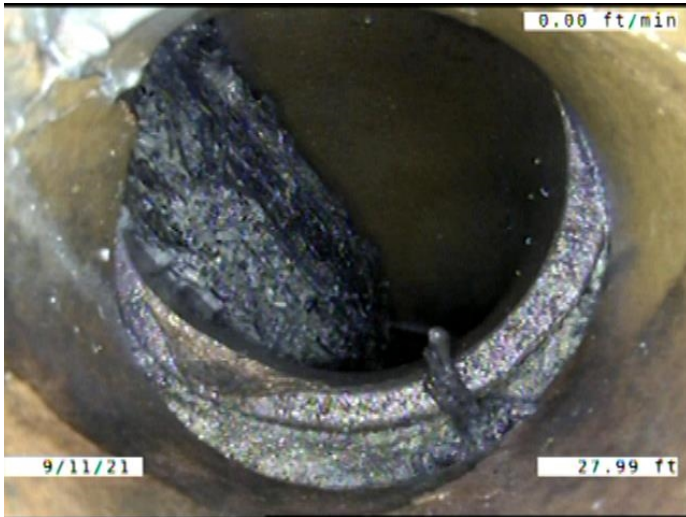
Code: **TFD**
 Description: **Tap Factory Defective**

Distance (ft): **28.0**
 Structural Grade: **0**
 O&M Grade: **3**
 Clock Start/From: **11**
 Clock To:
 1st Value: **4.000**
 2nd Value:
 Value Percent:
 Continuous Index:
 Within 8" of Joint: **YES**
 Remarks: **Defective**

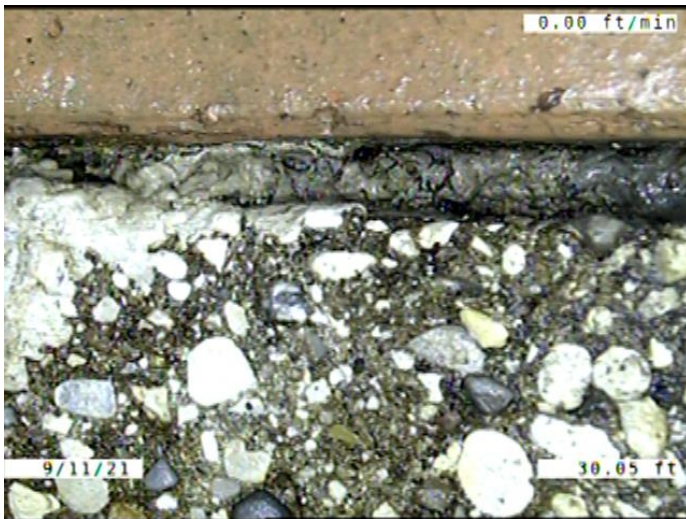
Code: **MMC**
 Description: **Miscellaneous Material Change**

Distance (ft): **30.0**
 Structural Grade: **0**
 O&M Grade: **0**
 Clock Start/From:
 Clock To:
 1st Value:
 2nd Value:
 Value Percent:
 Continuous Index:
 Within 8" of Joint: **NO**
 Remarks: **VCP TO CONCRETE**

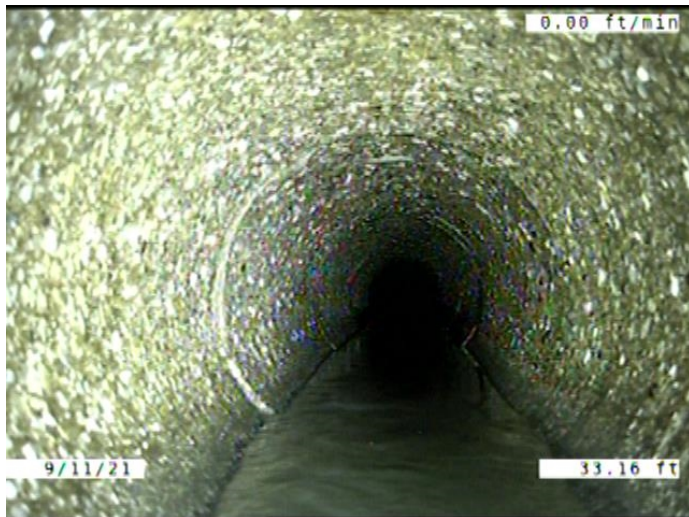
Code: **FM**
 Description: **Fracture Multiple**

Distance (ft): **33.2**
 Structural Grade: **4**
 O&M Grade: **0**
 Clock Start/From: **10**
 Clock To: **1**
 1st Value:
 2nd Value:
 Value Percent:
 Continuous Index: **F02**
 Within 8" of Joint: **YES**
 Remarks:

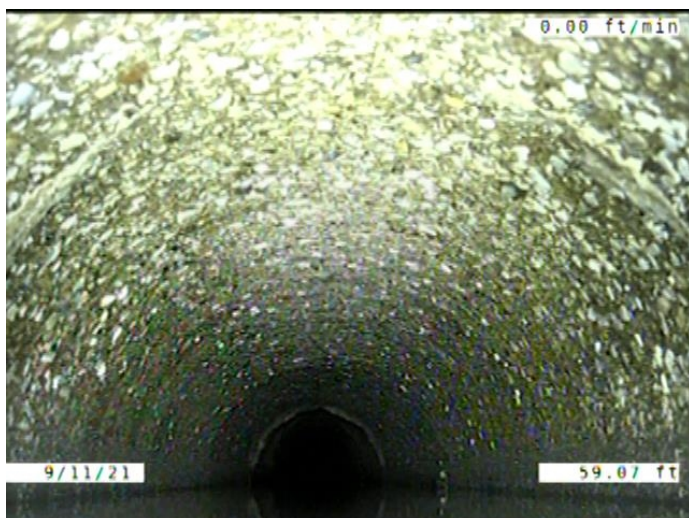
Code: **MWLS**
 Description: **Miscellaneous Water Level Sag**

Distance (ft): **59.1**
 Structural Grade: **2**
 O&M Grade: **0**
 Clock Start/From:
 Clock To:
 1st Value:
 2nd Value:
 Value Percent: **20.000**
 Continuous Index: **S04**
 Within 8" of Joint: **NO**
 Remarks:

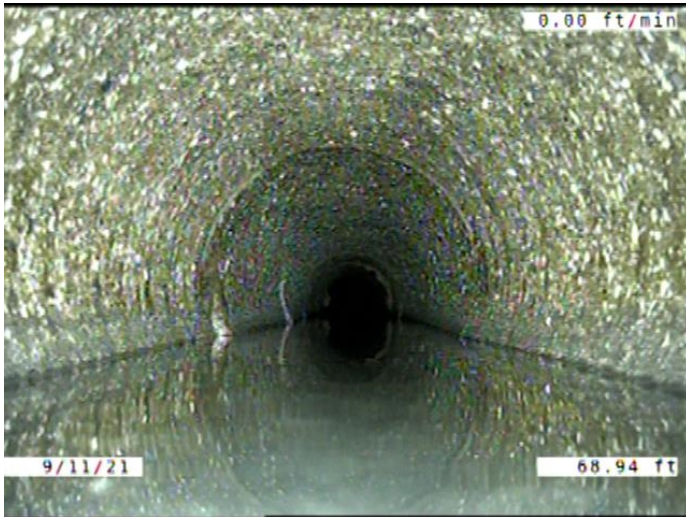
Code: **MWLS**
 Description: **Miscellaneous Water Level Sag**

Distance (ft): **68.9**
 Structural Grade: **2**
 O&M Grade: **0**
 Clock Start/From:
 Clock To:
 1st Value:
 2nd Value:
 Value Percent: **20.000**
 Continuous Index: **F04**
 Within 8" of Joint: **NO**
 Remarks:

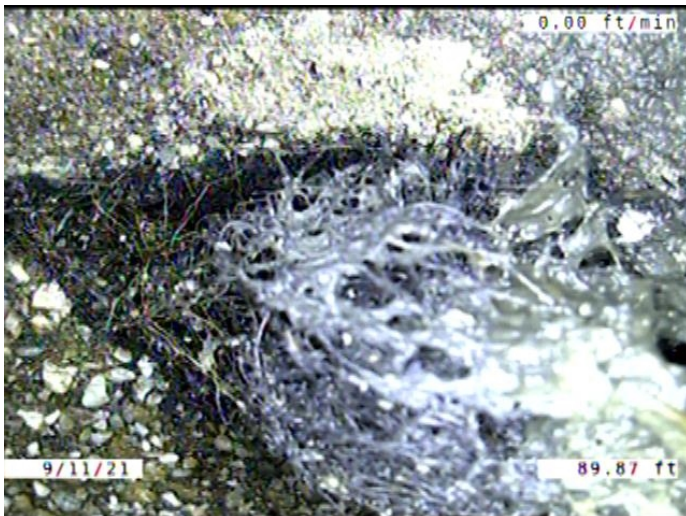
Code: **RMJ**
 Description: **Roots Medium Joint**

Distance (ft): **89.9**
 Structural Grade: **0**
 O&M Grade: **3**
 Clock Start/From: **1**
 Clock To: **4**
 1st Value:
 2nd Value:
 Value Percent: **5.000**
 Continuous Index:
 Within 8" of Joint: **YES**
 Remarks:

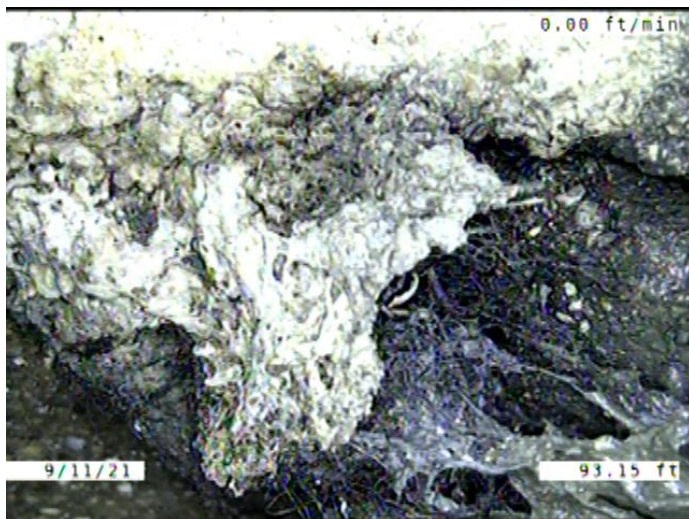
Code: **RMJ**
 Description: **Roots Medium Joint**

Distance (ft): **93.2**
 Structural Grade: **0**
 O&M Grade: **3**
 Clock Start/From: **12**
 Clock To: **4**
 1st Value:
 2nd Value:
 Value Percent: **5.000**
 Continuous Index:
 Within 8" of Joint: **YES**
 Remarks:

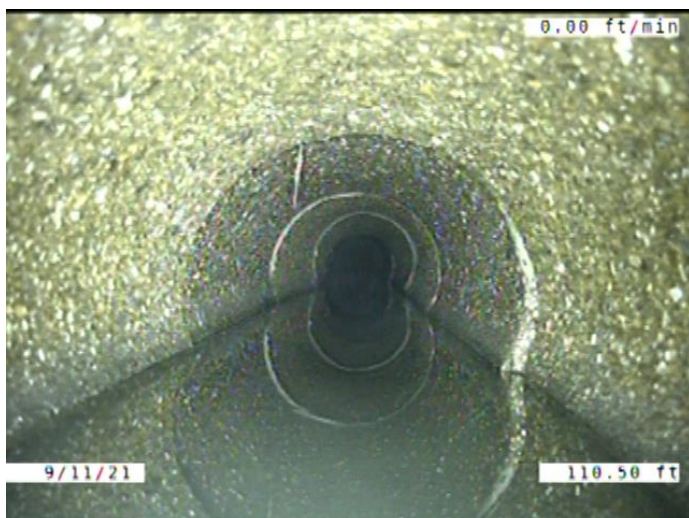
Code: **DSF**
 Description: **Deposits Settled Fine**

Distance (ft): **110.5**
 Structural Grade: **0**
 O&M Grade: **2**
 Clock Start/From: **5**
 Clock To: **7**
 1st Value:
 2nd Value:
 Value Percent: **5.000**
 Continuous Index: **F01**
 Within 8" of Joint: **YES**
 Remarks:

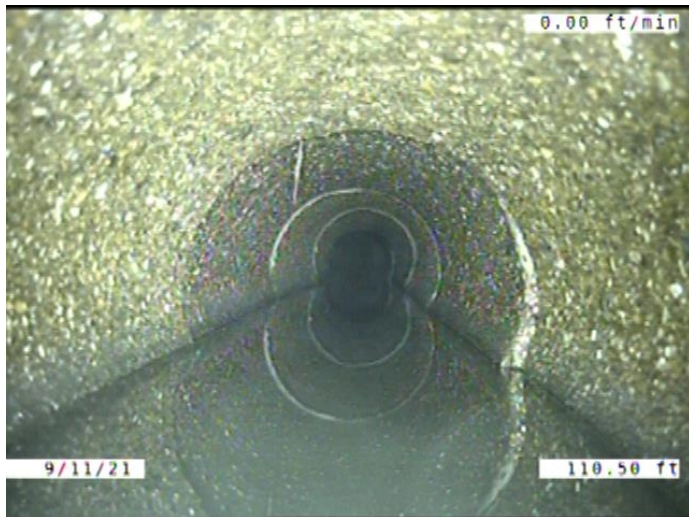
Code: **DAE**
 Description: **Deposits Attached Encrustation**

Distance (ft): **110.5**
 Structural Grade: **0**
 O&M Grade: **2**
 Clock Start/From: **8**
 Clock To: **4**
 1st Value:
 2nd Value:
 Value Percent: **5.000**
 Continuous Index: **F03**
 Within 8" of Joint: **YES**
 Remarks:

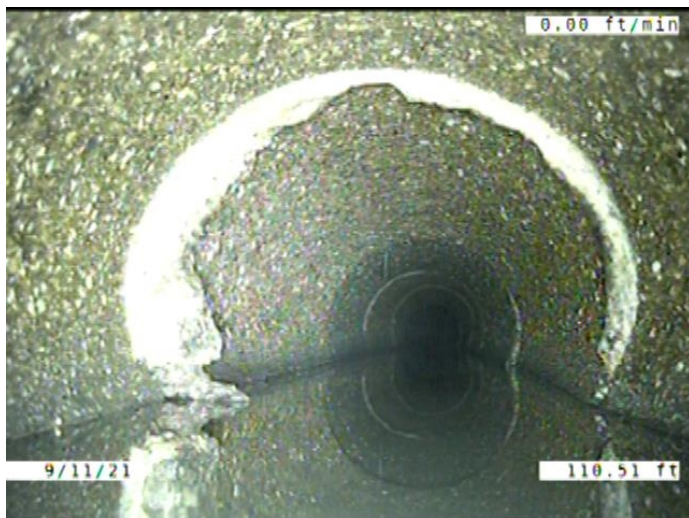
Code: **MSA**
 Description: **Miscellaneous Survey Abandoned**

Distance (ft): **110.5**
 Structural Grade: **0**
 O&M Grade: **0**
 Clock Start/From:
 Clock To:
 1st Value:
 2nd Value:
 Value Percent:
 Continuous Index:
 Within 8" of Joint: **NO**
 Remarks: **CAMERA CANT MAKE IT PAST ENCRUSTATION**
