## Profile/Photo Observation Report

Date:	<b>09/11/2021</b>	Weather:		Coding:	<b>PACP 7.0</b>
Pipe Length (ft):	<b>135.0</b>	Owner:	<b>City of Hobart</b>	Pre Clean:	<b>Heavy Cleaning</b>
P.O.#:	<b>YES502259</b>	Surveyor:	<b>S. Bucklin</b>	PSR:	<b>P-504-103-074</b>
Customer:	<b>City of Hobart</b>	Clean Date:	<b>08/27/2021</b>	Shape:	<b>C</b>

Location Details:		Direction of Survey:	<b>Upstream</b>
US MH:	<b>M-504-074</b>	DS MH:	<b>M-504-103</b>
		Total Length Surveyed (ft):	<b>35.8</b>

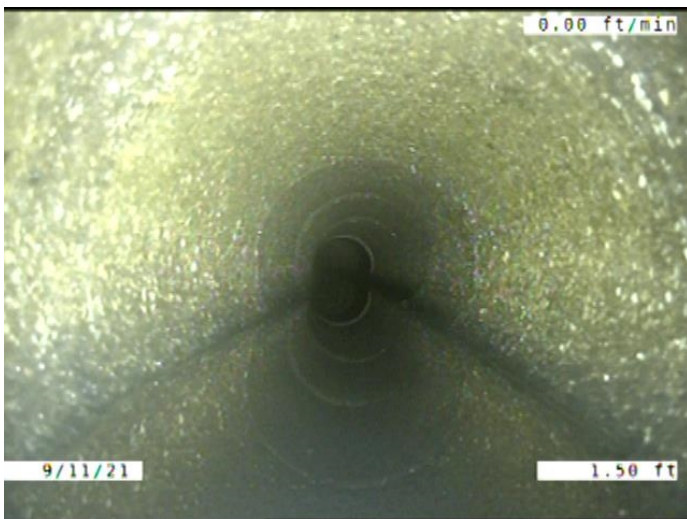
Code: **MGO**  
Description: **Miscellaneous General Observation**

Distance (ft): **1.5**  
Structural Grade: **0**  
O&M Grade: **0**  
Clock Start/From:  
Clock To:  
1st Value:  
2nd Value:  
Value Percent:  
Continuous Index:  
Within 8" of Joint: **NO**  
Remarks: **DROP INTO THE MANHOLE. HAD TO START IN THE PIPE.**

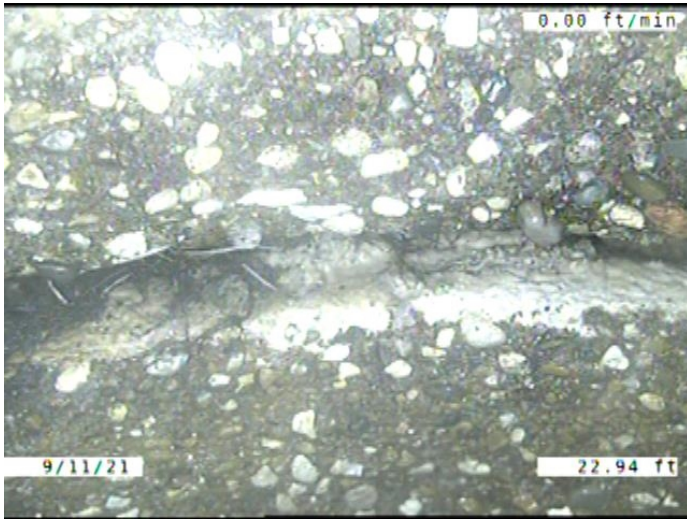
Code: **DAE**  
 Description: **Deposits Attached Encrustation**

Distance (ft): **22.9**  
 Structural Grade: **0**  
 O&M Grade: **2**  
 Clock Start/From: **9**  
 Clock To: **3**  
 1st Value:  
 2nd Value:  
 Value Percent: **5.000**  
 Continuous Index: **S01**  
 Within 8" of Joint: **YES**  
 Remarks:

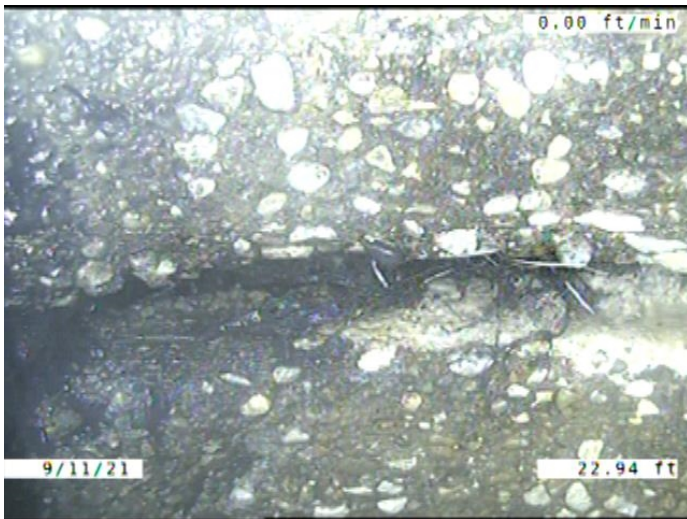
Code: **RFJ**  
 Description: **Roots Fine Joint**

Distance (ft): **22.9**  
 Structural Grade: **0**  
 O&M Grade: **1**  
 Clock Start/From: **9**  
 Clock To: **3**  
 1st Value:  
 2nd Value:  
 Value Percent:  
 Continuous Index:  
 Within 8" of Joint: **YES**  
 Remarks:

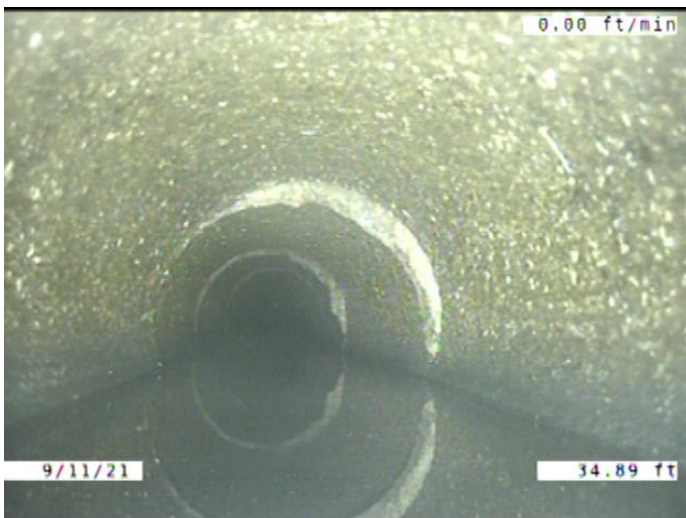
Code: **DAE**  
 Description: **Deposits Attached Encrustation**

Distance (ft): **34.9**  
 Structural Grade: **0**  
 O&M Grade: **2**  
 Clock Start/From: **9**  
 Clock To: **3**  
 1st Value:  
 2nd Value:  
 Value Percent: **5.000**  
 Continuous Index: **F01**  
 Within 8" of Joint: **YES**  
 Remarks:
