Profile/Photo Observation Report

Date:	09/11/2021	Weather:		Coding:	PACP 7.0
Pipe Length (ft):	135.0	Owner:	City of Hobart	Pre Clean:	Heavy Cleaning
P.O.#:	YES502259	Surveyor:	S. Bucklin	PSR:	P-504-103-074
Customer:	City of Hobart	Clean Date:	08/27/2021	Shape:	C

Street:	North Colorado Street	Flow Control:	Not Controlled
City:	Hobart, IN	Year Renewed:	
Location:	Alley	Tape/Media #:	
Purpose:	Routine Assessment	Dia/Height:	12"
Use:	Sanitary Sewage Pipe	Material:	CP
Drain Area:		Lining:	None
Category:	NA		
Comment:

Location Details:		Direction of Survey:	Upstream
US MH:	M-504-074	DS MH:	M-504-103
		Total Length Surveyed (ft):	35.8

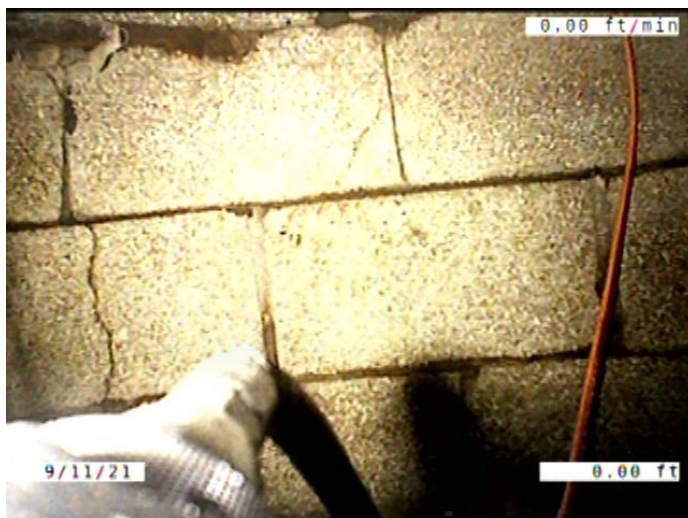
Code: **AMH**
 Description: **Manhole**

Distance (ft): **.0**
 Structural Grade: **0**
 O&M Grade: **0**
 Clock Start/From:
 Clock To:
 1st Value:
 2nd Value:
 Value Percent:
 Continuous Index:
 Within 8" of Joint: **NO**
 Remarks: **M-504-103**

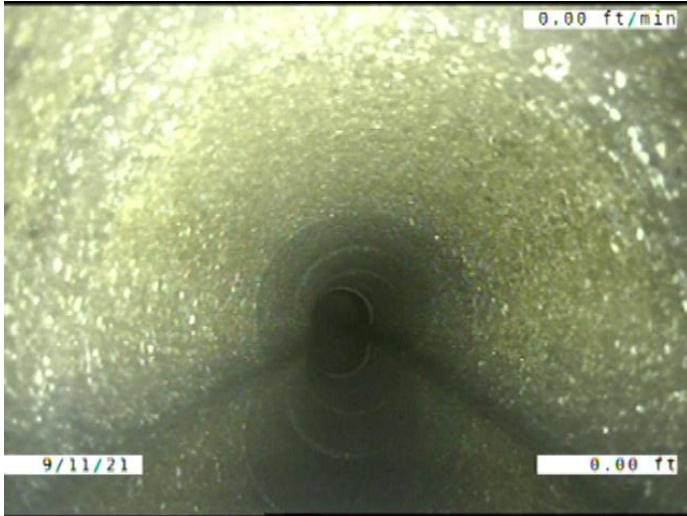
Code: **MWL**
Description: **Miscellaneous Water Level**

Distance (ft): **.0**
Structural Grade: **0**
O&M Grade: **0**
Clock Start/From:
Clock To:
1st Value:
2nd Value:
Value Percent: **10.000**
Continuous Index:
Within 8" of Joint: **NO**
Remarks:

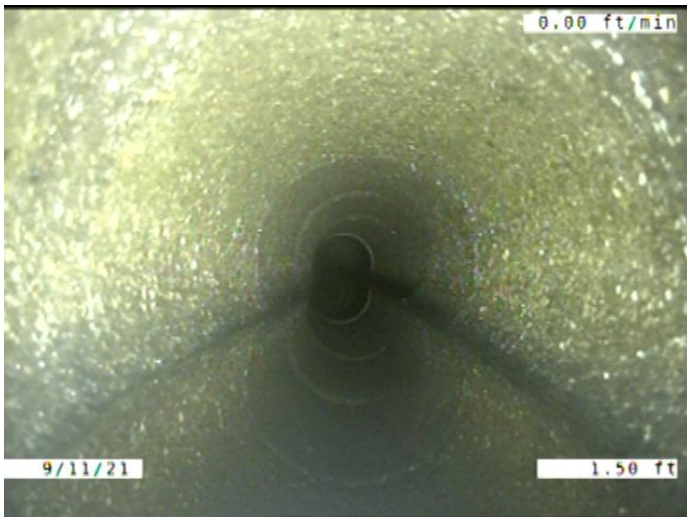
Code: **MGO**
Description: **Miscellaneous General Observation**

Distance (ft): **1.5**
Structural Grade: **0**
O&M Grade: **0**
Clock Start/From:
Clock To:
1st Value:
2nd Value:
Value Percent:
Continuous Index:
Within 8" of Joint: **NO**
Remarks: **DROP INTO THE MANHOLE. HAD TO START IN THE PIPE.**

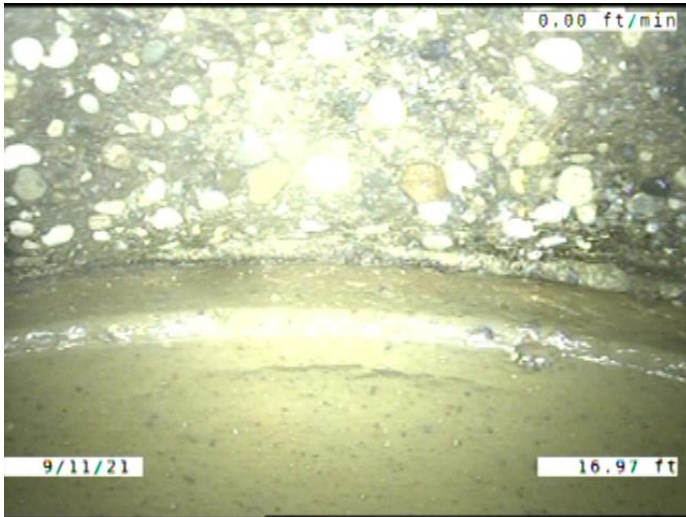
Code: **MMC**
 Description: **Miscellaneous Material Change**

Distance (ft): **17.0**
 Structural Grade: **0**
 O&M Grade: **0**
 Clock Start/From:
 Clock To:
 1st Value:
 2nd Value:
 Value Percent:
 Continuous Index:
 Within 8" of Joint: **NO**
 Remarks: **CONCRETE TO VCP**

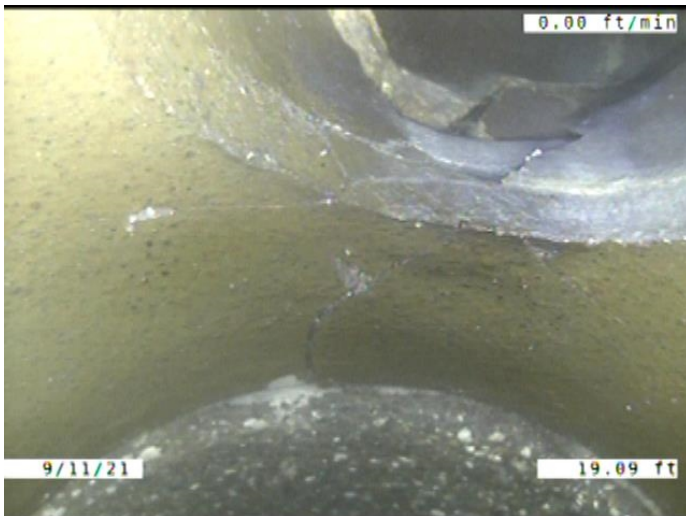
Code: **FM**
 Description: **Fracture Multiple**

Distance (ft): **19.1**
 Structural Grade: **4**
 O&M Grade: **0**
 Clock Start/From: **10**
 Clock To: **3**
 1st Value:
 2nd Value:
 Value Percent:
 Continuous Index:
 Within 8" of Joint: **YES**
 Remarks:

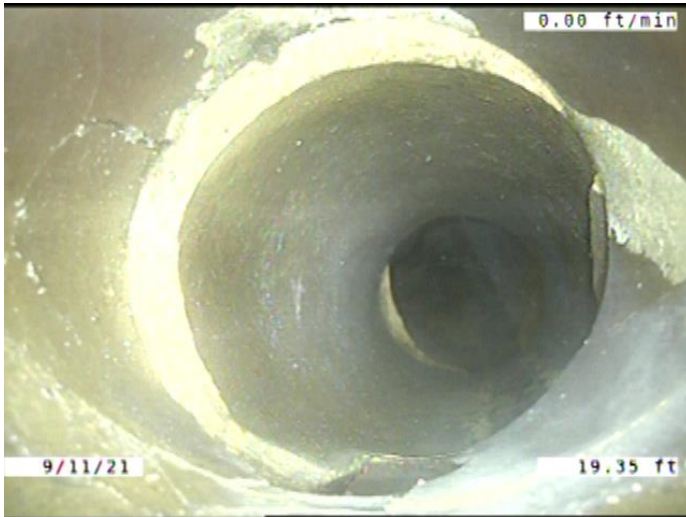
Code: **TFD**
 Description: **Tap Factory Defective**

Distance (ft): **19.4**
 Structural Grade: **0**
 O&M Grade: **3**
 Clock Start/From: **12**
 Clock To:
 1st Value: **4.000**
 2nd Value:
 Value Percent:
 Continuous Index:
 Within 8" of Joint: **YES**
 Remarks: **Defective**

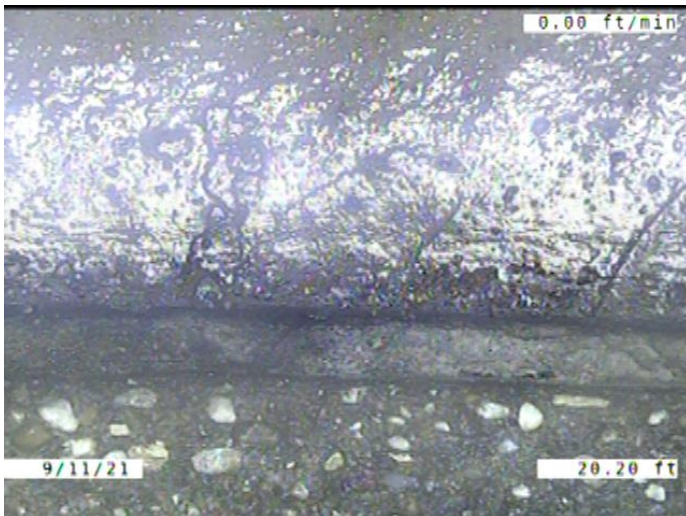
Code: **MMC**
 Description: **Miscellaneous Material Change**

Distance (ft): **20.2**
 Structural Grade: **0**
 O&M Grade: **0**
 Clock Start/From:
 Clock To:
 1st Value:
 2nd Value:
 Value Percent:
 Continuous Index:
 Within 8" of Joint: **NO**
 Remarks: **VCP TO CONCRETE**

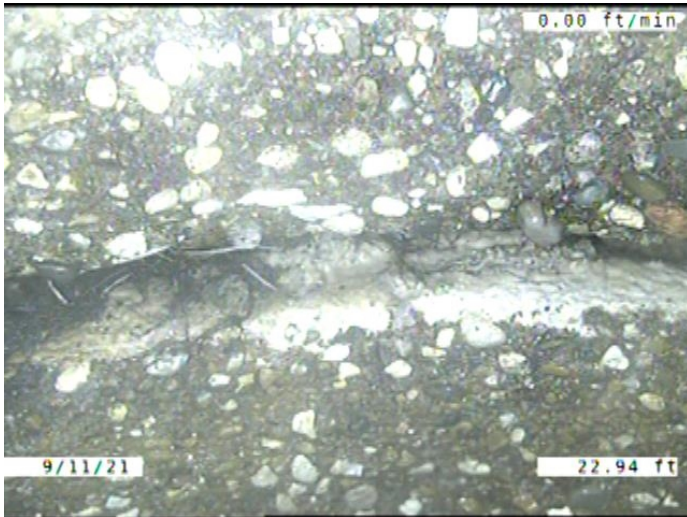
Code: **DAE**
 Description: **Deposits Attached Encrustation**

Distance (ft): **22.9**
 Structural Grade: **0**
 O&M Grade: **2**
 Clock Start/From: **9**
 Clock To: **3**
 1st Value:
 2nd Value:
 Value Percent: **5.000**
 Continuous Index: **S01**
 Within 8" of Joint: **YES**
 Remarks:

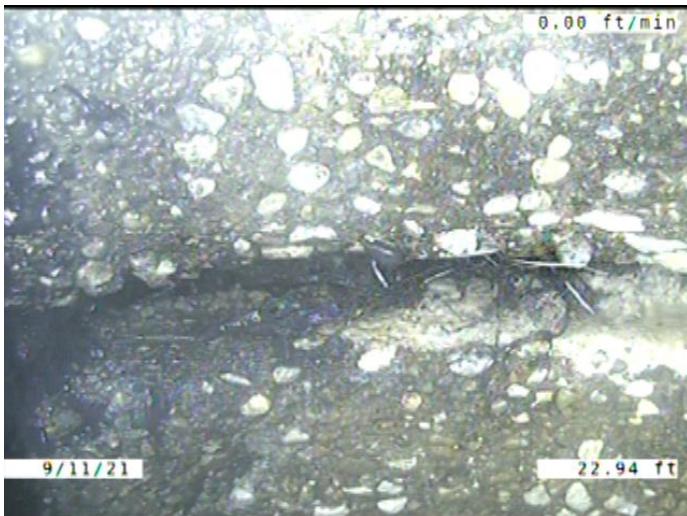
Code: **RFJ**
 Description: **Roots Fine Joint**

Distance (ft): **22.9**
 Structural Grade: **0**
 O&M Grade: **1**
 Clock Start/From: **9**
 Clock To: **3**
 1st Value:
 2nd Value:
 Value Percent:
 Continuous Index:
 Within 8" of Joint: **YES**
 Remarks:

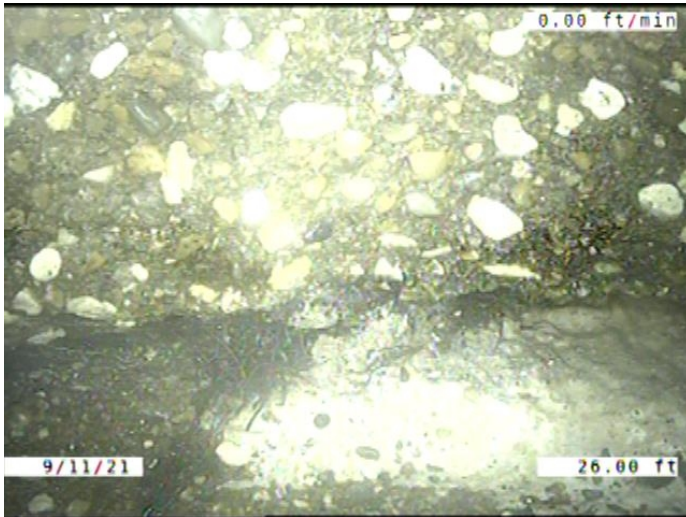
Code: **RFJ**
 Description: **Roots Fine Joint**

Distance (ft): **26.0**
 Structural Grade: **0**
 O&M Grade: **1**
 Clock Start/From: **9**
 Clock To: **10**
 1st Value:
 2nd Value:
 Value Percent:
 Continuous Index:
 Within 8" of Joint: **YES**
 Remarks:

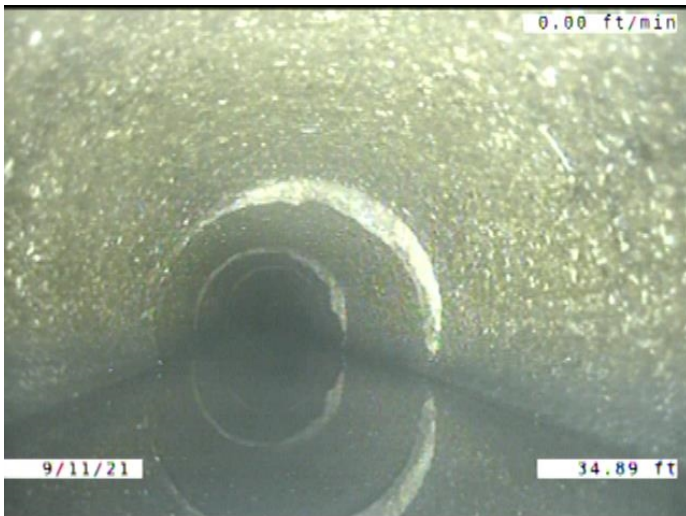
Code: **DAE**
 Description: **Deposits Attached Encrustation**

Distance (ft): **34.9**
 Structural Grade: **0**
 O&M Grade: **2**
 Clock Start/From: **9**
 Clock To: **3**
 1st Value:
 2nd Value:
 Value Percent: **5.000**
 Continuous Index: **F01**
 Within 8" of Joint: **YES**
 Remarks:

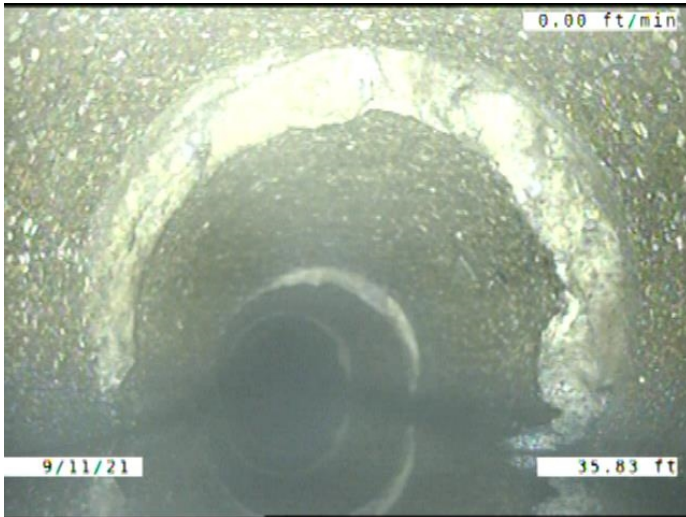
Code:	MSA
Description:	Miscellaneous Survey Abandoned
Distance (ft):	35.8
Structural Grade:	0
O&M Grade:	0
Clock Start/From:	
Clock To:	
1st Value:	
2nd Value:	
Value Percent:	
Continuous Index:	
Within 8" of Joint:	NO
Remarks:	CAMERA CANT MAKE IT PAST ENCUSTATION. MADE IT TO THE POI
