Profile/Photo Observation Report

Profile/Photo Observation Report								
Date: Pipe Length (ft P.O.#: Customer:	04/08/2018): 21-2 City of Hobart	Weather: Owner: Surveyor: Clean Date:	City of H M. Pielad		Pre Clean: PSR:	PACP 6.0 No Pre-Cleaning M-504-075-M-504-074 C		
Street: Off Colorado Street City: Hobart, IN Location: Light Highway Purpose: Routine Assessment		Flow Control: Year Renewed: Tape/Media #: Dia/Height:		Not Controlled DEP 21 18"	DEP 21			
Use: Drain Area: Category: Comment:	Sanitary NA		Material: Lining:		VCP			
Location Detail US MH:	ls: M-504-075	DS MH:	Direction 6 M-504-074	of Survey:	Downstream Total Length Surveyed (ft):	222.7		
O&M Index:	3.00	_O&M Quick:		3400	O&M Rating:	12.00		
Structural Index:		_Structural Qu	uick:	0000	Structural Rating:	0.00		
Overall Index:	3.00	Overall Quicl	k:	3400	Overall Rating:	12.00

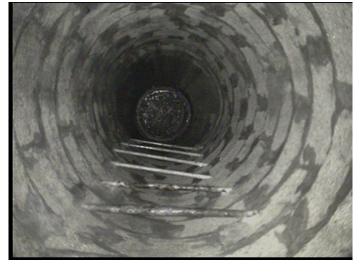
Code: Description:	AMH Manhole		
Distance (ft):	.0		
Structural Grade:	0		
O&M Grade:	0		
Clock Start/From:			
Clock To:			
1st Value:			
2nd Value:			
Value Percent:			
Continuous Index:			
Within 8" of Joint:	NO		
Remarks:	M-504-075

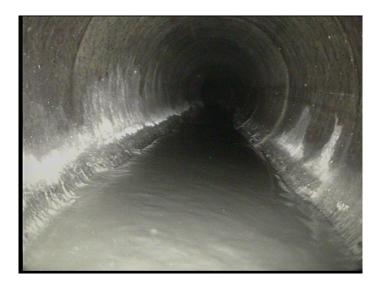
Code: MWL

Description: Water Level

Distance (ft): .0
Structural Grade: 0
O&M Grade: 0

Value Percent: 5.000

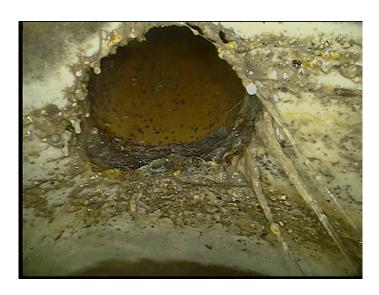
Code: TBA

Description: Tap Break-in Active

Distance (ft): 80.3
Structural Grade: 0

Clock Start/From: 12

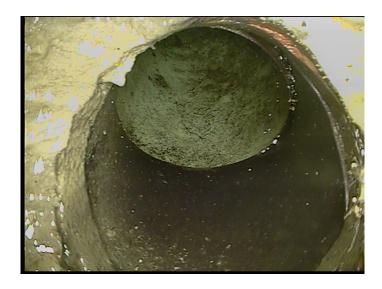
Code: TB

Description: Tap Break-in

Distance (ft): 122.1
Structural Grade: 0
O&M Grade: 0
Clock Start/From: 10

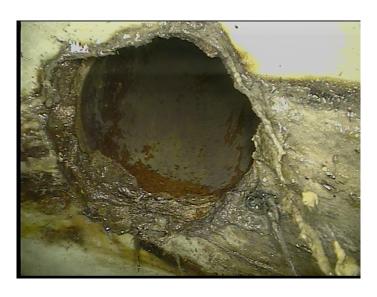
Code: TBA

Description: Tap Break-in Active

Distance (ft): 134.3
Structural Grade: 0
O&M Grade: 0
Clock Start/From: 2

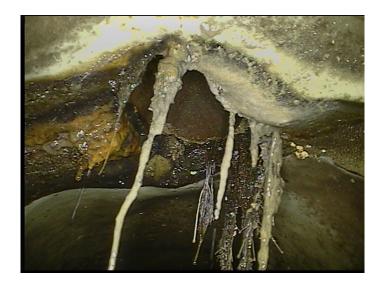
Code: TBD

Description: **Tap Break-in Defective**

Distance (ft): 166.1 Structural Grade: 0 3 O&M Grade: Clock Start/From: 12

Remarks: **Defective**

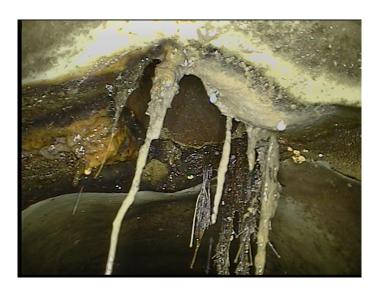
Code: **RML**

Description: **Roots Medium Lateral**

Distance (ft): 166.1 Structural Grade: 0 O&M Grade: 3 Clock Start/From: 12

Value Percent: 5.000

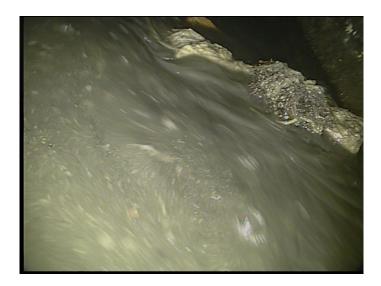
Code: OBZ

Description: Obstacle Other

Distance (ft): 208.7
Structural Grade: 0
O&M Grade: 3
Clock Start/From: 5
Clock To: 7

Value Percent: 15.000

Within 8" of Joint: NO
Remarks: Debris

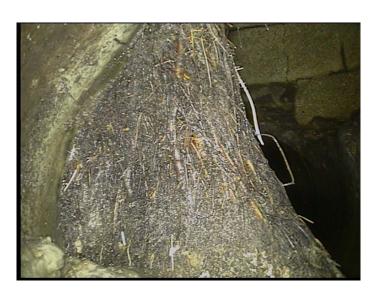
Code: RMJ

Description: Roots Medium Joint

Distance (ft): 221.0
Structural Grade: 0
O&M Grade: 3
Clock Start/From: 6
Clock To: 12
1st Value:

Value Percent: 25.000

Within 8" of Joint: YES

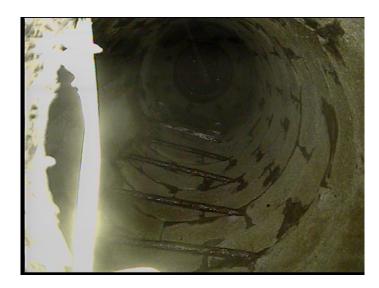
Code: AMH
Description: Manhole

Distance (ft): 222.7
Structural Grade: 0
O&M Grade: 0

Remarks: M-504-074
