Profile/Photo Observation Report

Date:	04/08/2018	Weather:		Coding:	PACP 6.0
Pipe Length (ft):		Owner:	City of Hobart	Pre Clean:	No Pre-Cleaning
P.O.#:	21-2	Surveyor:	M. Pielacha	PSR:	M-504-075-M-504-074
Customer:	City of Hobart	Clean Date:		Shape:	C

Street:	Off Colorado Street	Flow Control:	Not Controlled
City:	Hobart, IN	Year Renewed:	
Location:	Light Highway	Tape/Media #:	DEP 21
Purpose:	Routine Assessment	Dia/Height:	18"
Use:	Sanitary	Material:	VCP
Drain Area:		Lining:

US MH: **M-504-075** DS MH: **M-504-074** Total Length Surveyed (ft): **222.7**

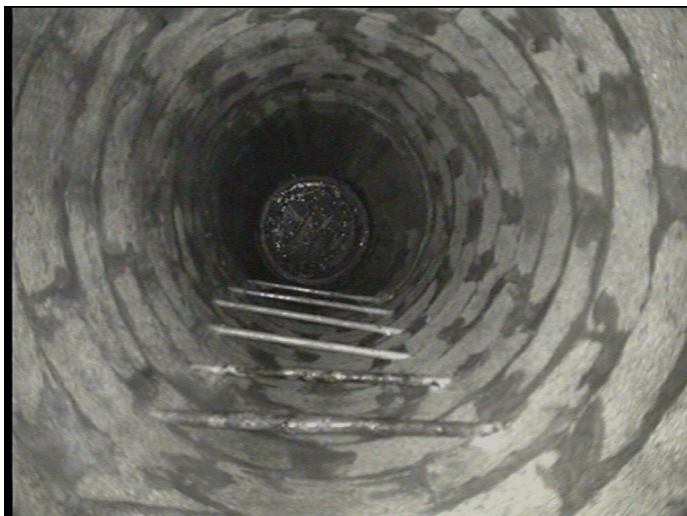
Code: **AMH**
 Description: **Manhole**

Distance (ft): **.0**
 Structural Grade: **0**
 O&M Grade: **0**
 Clock Start/From:
 Clock To:
 1st Value:
 2nd Value:
 Value Percent:
 Continuous Index:
 Within 8" of Joint: **NO**
 Remarks: **M-504-075**

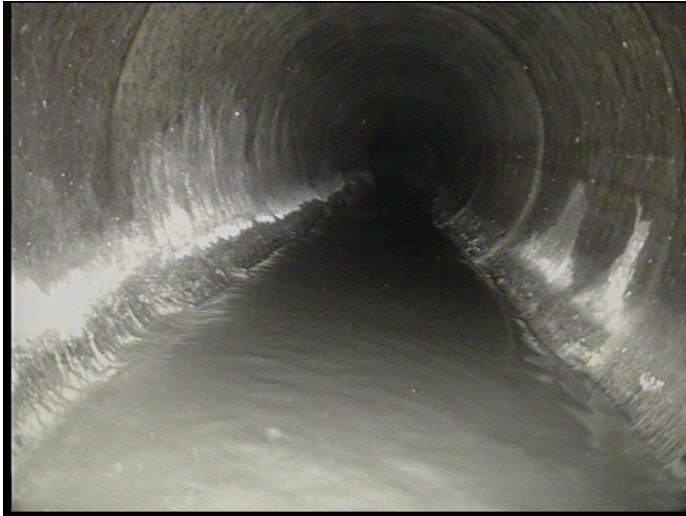
Code: **MWL**
Description: **Water Level**

Distance (ft): **.0**
Structural Grade: **0**
O&M Grade: **0**
Clock Start/From:
Clock To:
1st Value:
2nd Value:
Value Percent: **5.000**
Continuous Index:
Within 8" of Joint: **NO**
Remarks:

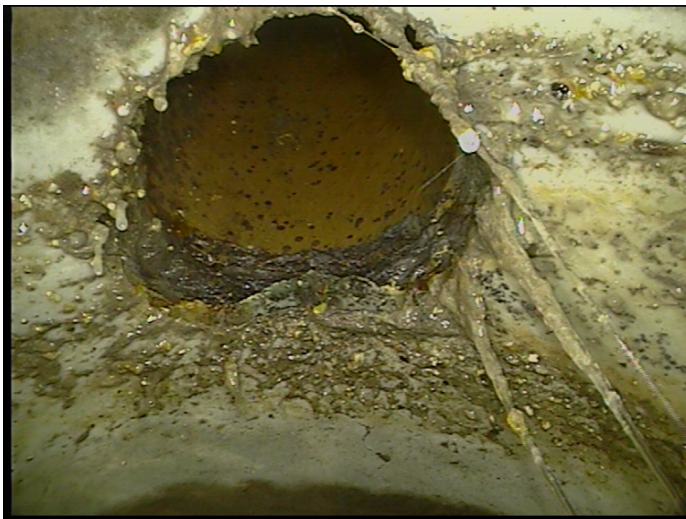
Code: **TBA**
Description: **Tap Break-in Active**

Distance (ft): **80.3**
Structural Grade: **0**
O&M Grade: **0**
Clock Start/From: **12**
Clock To:
1st Value: **4.000**
2nd Value:
Value Percent:
Continuous Index:
Within 8" of Joint: **NO**
Remarks:

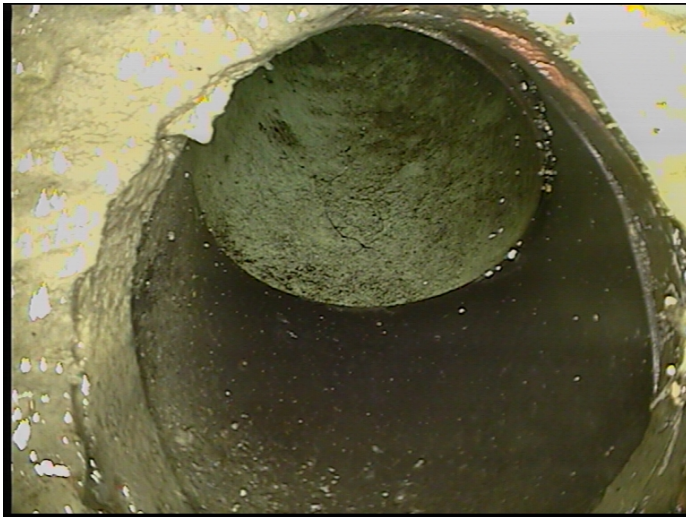
Code: **TB**
Description: **Tap Break-in**

Distance (ft): **122.1**
Structural Grade: **0**
O&M Grade: **0**
Clock Start/From: **10**
Clock To:
1st Value: **4.000**
2nd Value:
Value Percent:
Continuous Index:
Within 8" of Joint: **NO**
Remarks:

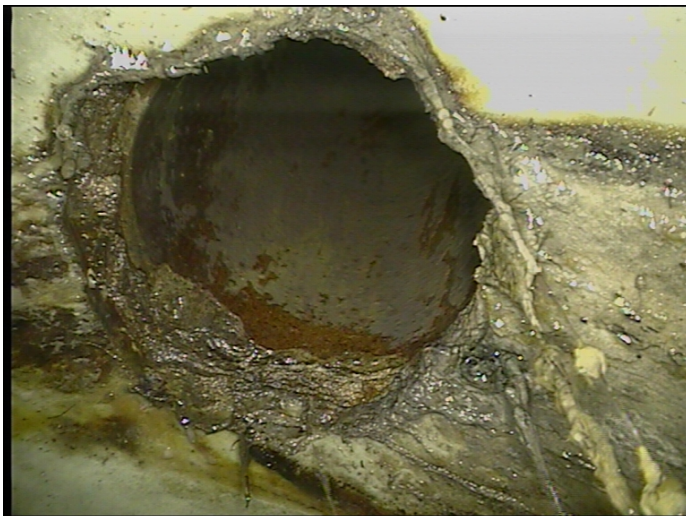
Code: **TBA**
Description: **Tap Break-in Active**

Distance (ft): **134.3**
Structural Grade: **0**
O&M Grade: **0**
Clock Start/From: **2**
Clock To:
1st Value: **4.000**
2nd Value:
Value Percent:
Continuous Index:
Within 8" of Joint: **NO**
Remarks:

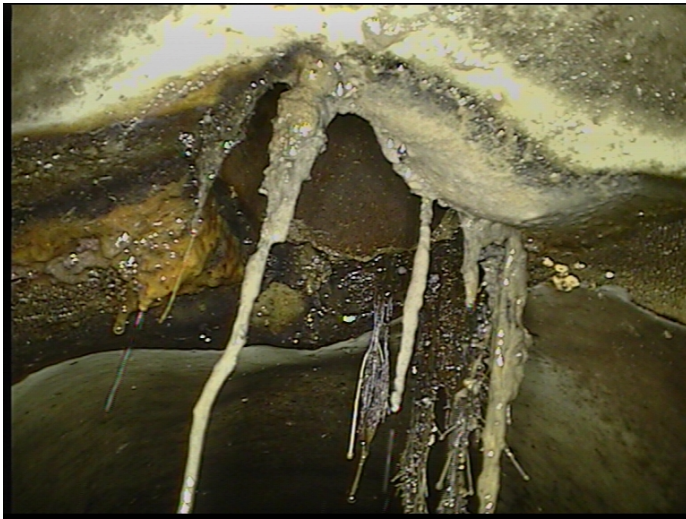
Code: **TBD**
Description: **Tap Break-in Defective**

Distance (ft): **166.1**
Structural Grade: **0**
O&M Grade: **3**
Clock Start/From: **12**
Clock To:
1st Value: **4.000**
2nd Value:
Value Percent:
Continuous Index:
Within 8" of Joint: **NO**
Remarks: **Defective**

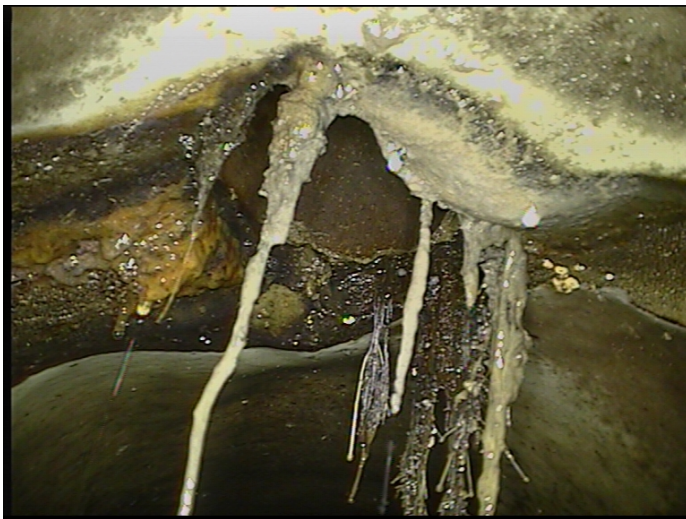
Code: **RML**
Description: **Roots Medium Lateral**

Distance (ft): **166.1**
Structural Grade: **0**
O&M Grade: **3**
Clock Start/From: **12**
Clock To:
1st Value:
2nd Value:
Value Percent: **5.000**
Continuous Index:
Within 8" of Joint: **NO**
Remarks:

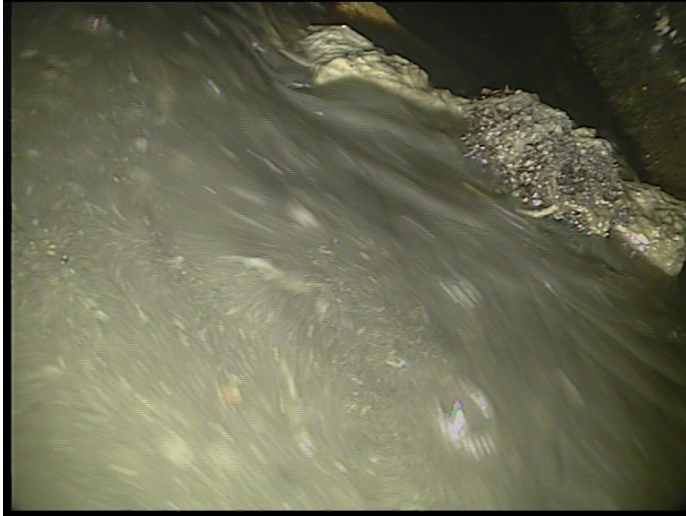
Code: **OBZ**
Description: **Obstacle Other**

Distance (ft): **208.7**
Structural Grade: **0**
O&M Grade: **3**
Clock Start/From: **5**
Clock To: **7**
1st Value:
2nd Value:
Value Percent: **15.000**
Continuous Index:
Within 8" of Joint: **NO**
Remarks: **Debris**

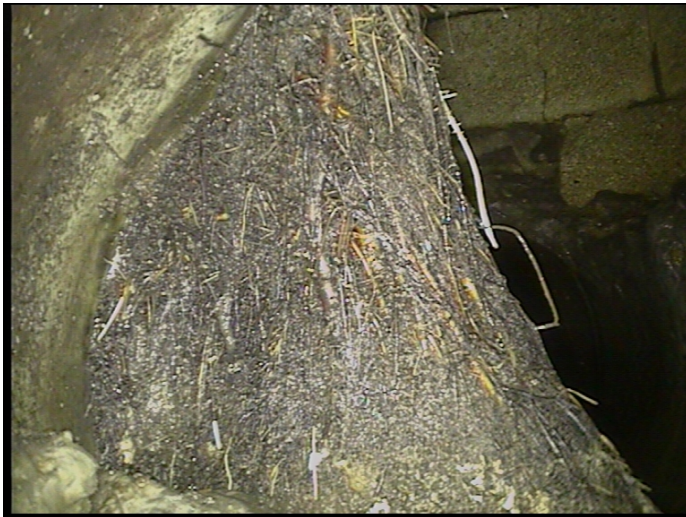
Code: **RMJ**
Description: **Roots Medium Joint**

Distance (ft): **221.0**
Structural Grade: **0**
O&M Grade: **3**
Clock Start/From: **6**
Clock To: **12**
1st Value:
2nd Value:
Value Percent: **25.000**
Continuous Index:
Within 8" of Joint: **YES**
Remarks:

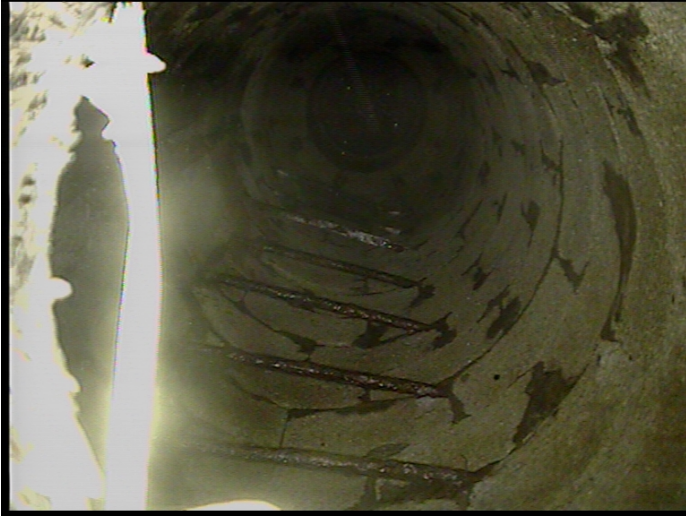
Code:	AMH
Description:	Manhole
Distance (ft):	222.7
Structural Grade:	0
O&M Grade:	0
Clock Start/From:	
Clock To:	
1st Value:	
2nd Value:	
Value Percent:	
Continuous Index:	
Within 8" of Joint:	NO
Remarks:	M-504-074
