Profile/Photo Observation Report

Date:	10/16/2021	Weather:		Coding:	PACP 6.0
Pipe Length (ft):		Owner:	Hobart, IN	Pre Clean:	Not Known
P.O.#:	843_1	Surveyor:	M. Pielacha	PSR:	P-504-116-076
Customer:	Hobart, IN	Clean Date:		Shape:	C

Street:	Off North Colorado Street	Flow Control:	
City:	Hobart, IN	Year Renewed:	
Location:	Alley	Tape/Media #:	843
Purpose:	Routine Assessment	Dia/Height:	12"
Use:	Sanitary	Material:	VCP
Drain Area:		Lining:

US MH: **M-504-76** DS MH: **M-504-116** Total Length Surveyed (ft): **3.0**

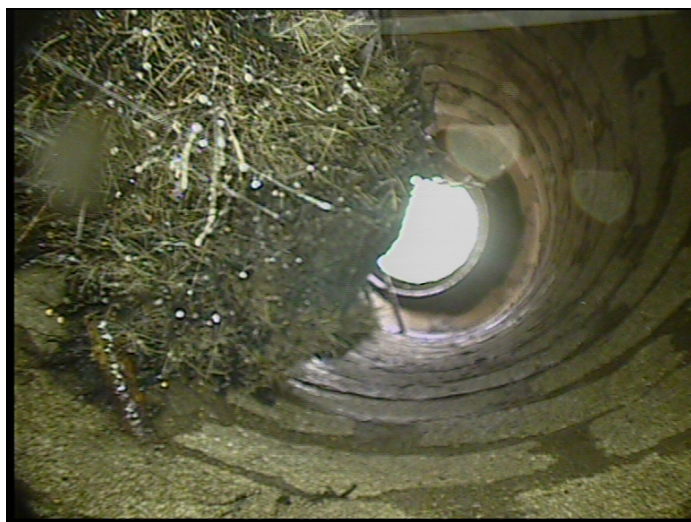
Code: **AMH**
Description: **Manhole**

Distance (ft): **.0**
Structural Grade: **0**
O&M Grade: **0**
Clock Start/From:
Clock To:
1st Value:
2nd Value:
Value Percent:
Continuous Index:
Within 8" of Joint: **NO**
Remarks: **M-504-76**

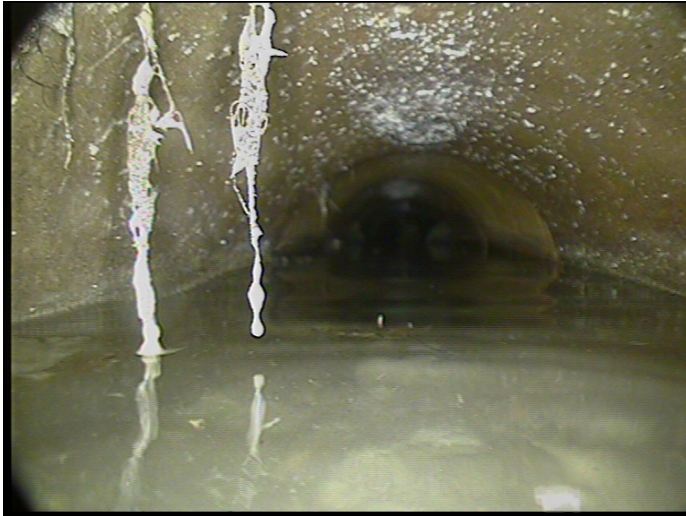
Code: **MWL**
Description: **Water Level**

Distance (ft): **.0**
Structural Grade: **0**
O&M Grade: **0**
Clock Start/From:
Clock To:
1st Value:
2nd Value:
Value Percent: **30.000**
Continuous Index:
Within 8" of Joint: **NO**
Remarks:

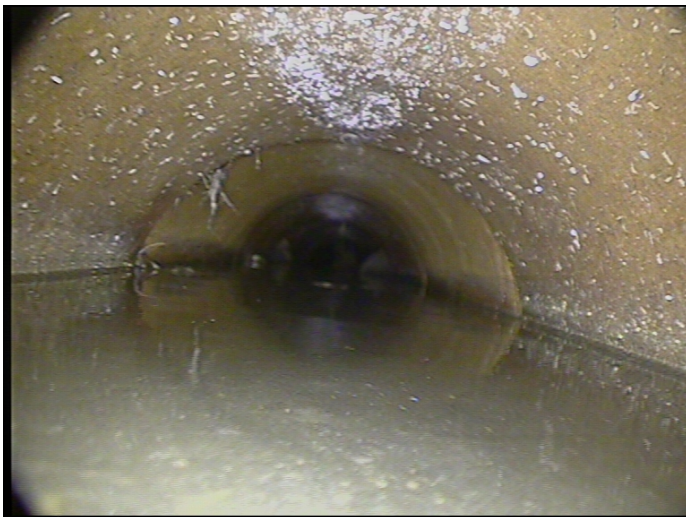
Code: **OBZ**
Description: **Obstacle Other**

Distance (ft): **3.0**
Structural Grade: **0**
O&M Grade: **2**
Clock Start/From: **6**
Clock To:
1st Value:
2nd Value:
Value Percent: **10.000**
Continuous Index:
Within 8" of Joint: **NO**
Remarks: **Under water debris**

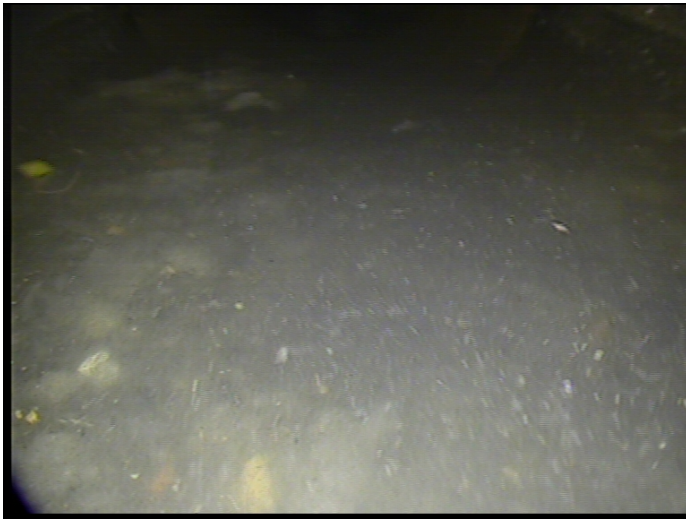
Code:	MSA
Description:	Abandoned Survey
Distance (ft):	3.0
Structural Grade:	0
O&M Grade:	0
Clock Start/From:	
Clock To:	
1st Value:	
2nd Value:	
Value Percent:	
Continuous Index:	
Within 8" of Joint:	NO
Remarks:	Under water debris
