# Profile/Photo Observation Report

Date:	<b>09/05/2021</b>	Weather:		Coding:	<b>PACP 7.0</b>
Pipe Length (ft):	<b>195.3</b>	Owner:	<b>City of Hobart</b>	Pre Clean:	<b>Heavy Cleaning</b>
P.O.#:	<b>YES502259</b>	Surveyor:	<b>S. Bucklin</b>	PSR:	<b>P-504-077-076</b>
Customer:	<b>City of Hobart</b>	Clean Date:	<b>09/02/2021</b>	Shape:	<b>C</b>

Street:	<b>North Cavender Street</b>	Flow Control:	<b>Not Controlled</b>
City:	<b>Hobart, IN</b>	Year Renewed:	
Location:	<b>Alley</b>	Tape/Media #:	
Purpose:	<b>Routine Assessment</b>	Dia/Height:	<b>12"</b>
Use:	<b>Sanitary Sewage Pipe</b>	Material:	<b>VCP</b>
Drain Area:		Lining:	
Category:	<b>NA</b>		
Comment:			
Location Details:		Direction of Survey:	<b>Downstream</b>
US MH:	<b>M-504-077</b>	DS MH:	<b>M-504-076</b>
		Total Length Surveyed (ft):	<b>195.3</b>

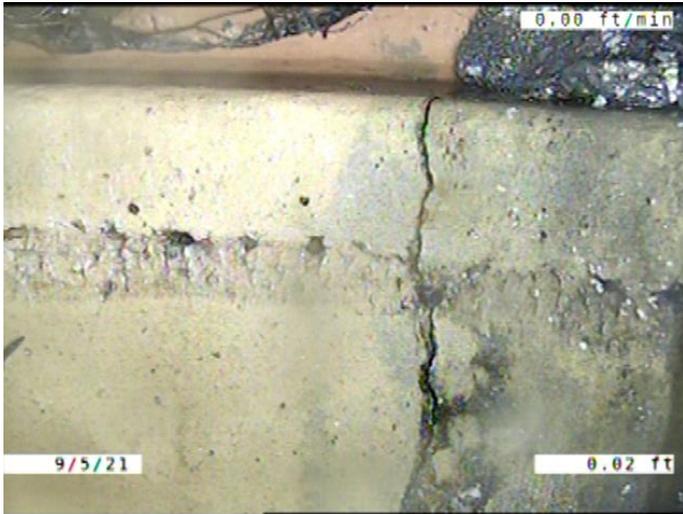
Code: **CM**  
Description: **Crack Multiple**

Distance (ft): **.0**  
Structural Grade: **3**  
O&M Grade: **0**  
Clock Start/From: **2**  
Clock To: **3**  
1st Value:  
2nd Value:  
Value Percent:  
Continuous Index:  
Within 8" of Joint: **YES**  
Remarks:

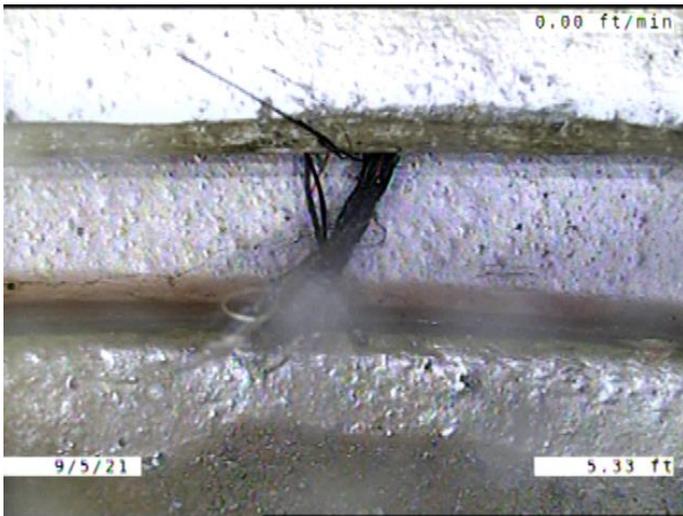
Code: **RFJ**  
Description: **Roots Fine Joint**

Distance (ft): **5.3**  
Structural Grade: **0**  
O&M Grade: **1**  
Clock Start/From: **9**  
Clock To: **11**  
1st Value:  
2nd Value:  
Value Percent:  
Continuous Index:  
Within 8" of Joint: **YES**  
Remarks:

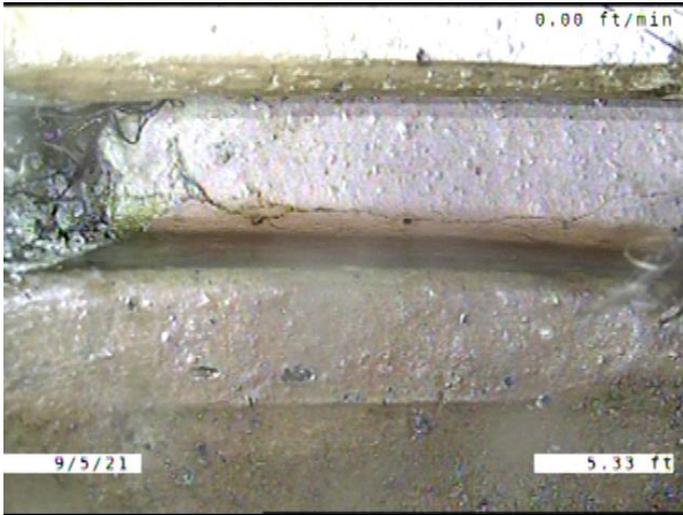
Code: **CM**  
 Description: **Crack Multiple**

Distance (ft): **5.3**  
 Structural Grade: **3**  
 O&M Grade: **0**  
 Clock Start/From: **9**  
 Clock To: **11**  
 1st Value:  
 2nd Value:  
 Value Percent:  
 Continuous Index:  
 Within 8" of Joint: **YES**  
 Remarks:

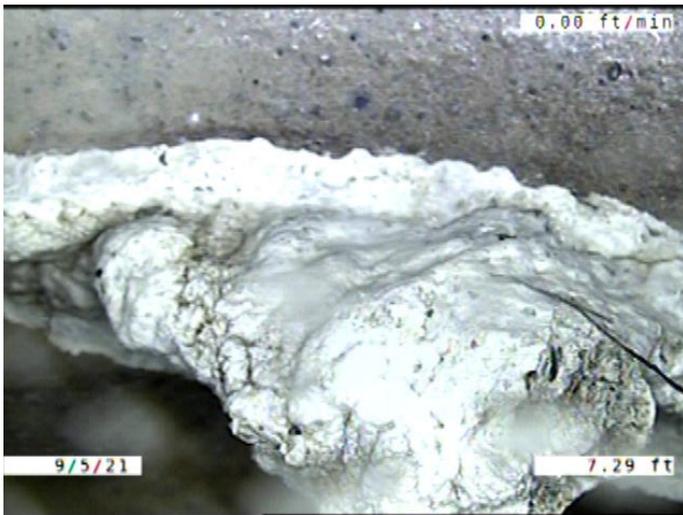
Code: **DAE**  
 Description: **Deposits Attached Encrustation**

Distance (ft): **7.3**  
 Structural Grade: **0**  
 O&M Grade: **2**  
 Clock Start/From: **9**  
 Clock To: **3**  
 1st Value:  
 2nd Value:  
 Value Percent: **5.000**  
 Continuous Index:  
 Within 8" of Joint: **YES**  
 Remarks:

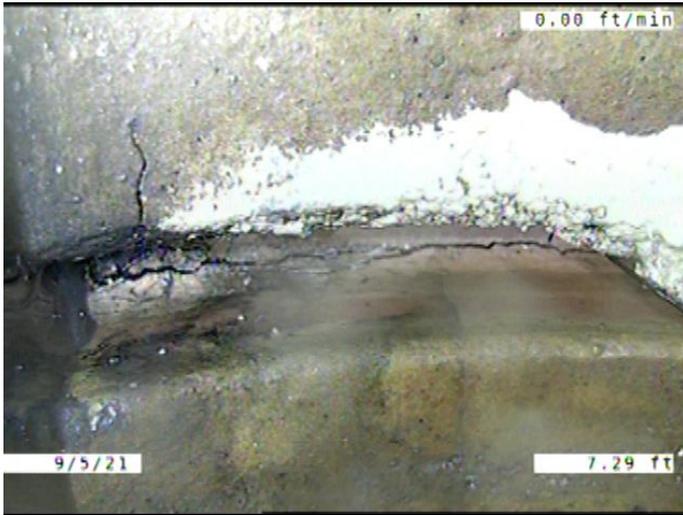
Code: **FM**  
Description: **Fracture Multiple**

Distance (ft): **7.3**  
Structural Grade: **4**  
O&M Grade: **0**  
Clock Start/From: **9**  
Clock To: **10**  
1st Value:  
2nd Value:  
Value Percent:  
Continuous Index:  
Within 8" of Joint: **YES**  
Remarks:

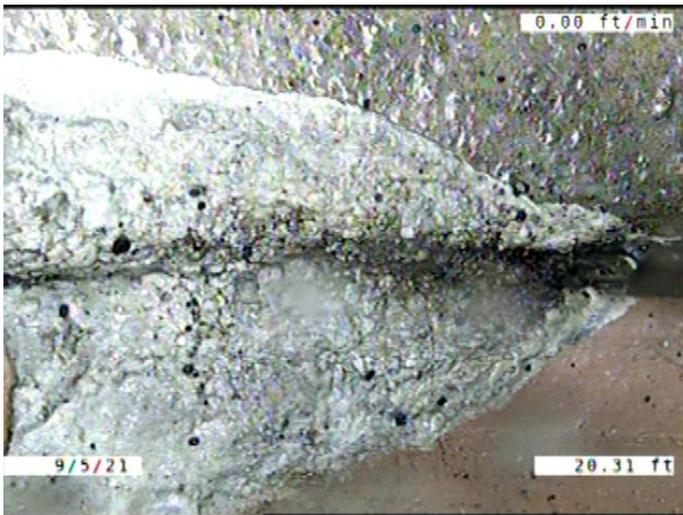
Code: **DAE**  
Description: **Deposits Attached Encrustation**

Distance (ft): **20.3**  
Structural Grade: **0**  
O&M Grade: **2**  
Clock Start/From: **9**  
Clock To: **10**  
1st Value:  
2nd Value:  
Value Percent: **5.000**  
Continuous Index:  
Within 8" of Joint: **YES**  
Remarks:

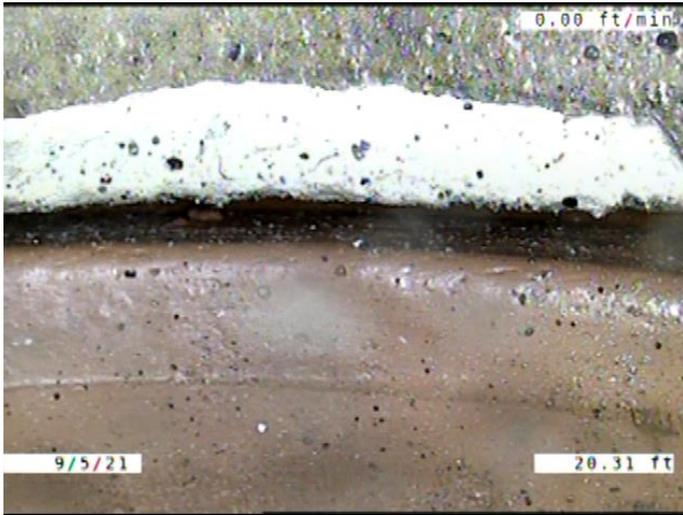
Code: **DAE**  
 Description: **Deposits Attached Encrustation**

Distance (ft): **20.3**  
 Structural Grade: **0**  
 O&M Grade: **2**  
 Clock Start/From: **12**  
 Clock To: **3**  
 1st Value:  
 2nd Value:  
 Value Percent: **5.000**  
 Continuous Index:  
 Within 8" of Joint: **YES**  
 Remarks:

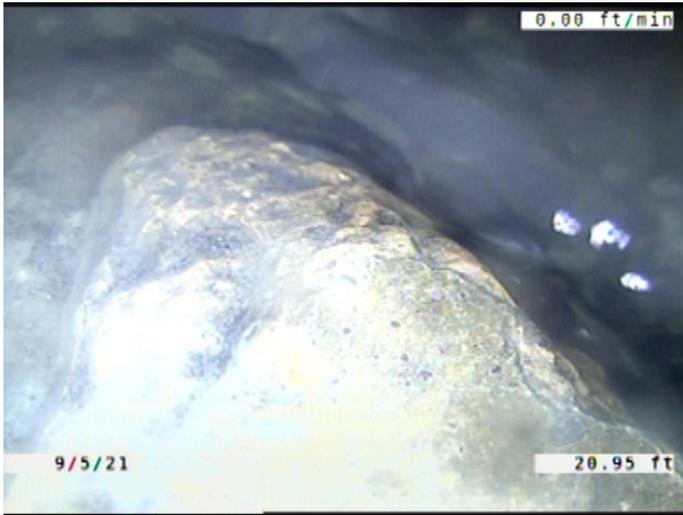
Code: **OBM**  
 Description: **Obstruction Pipe Material in Invert**

Distance (ft): **21.0**  
 Structural Grade: **0**  
 O&M Grade: **2**  
 Clock Start/From: **5**  
 Clock To: **6**  
 1st Value:  
 2nd Value:  
 Value Percent: **5.000**  
 Continuous Index:  
 Within 8" of Joint: **YES**  
 Remarks:

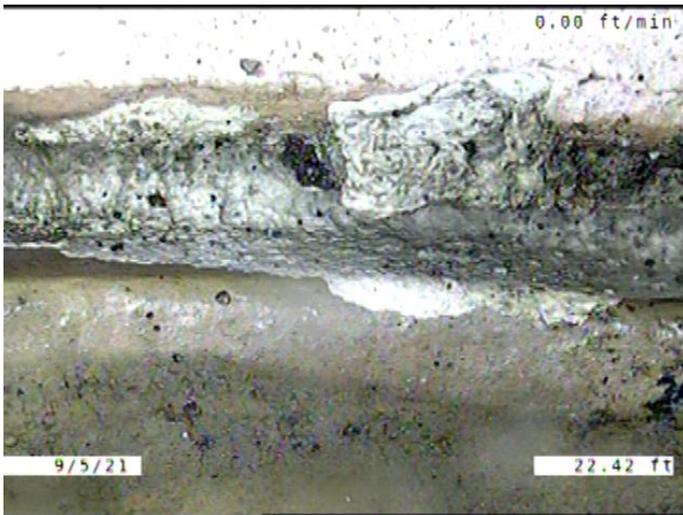
Code: **DAE**  
 Description: **Deposits Attached Encrustation**

Distance (ft): **22.4**  
 Structural Grade: **0**  
 O&M Grade: **2**  
 Clock Start/From: **8**  
 Clock To: **10**  
 1st Value:  
 2nd Value:  
 Value Percent: **5.000**  
 Continuous Index:  
 Within 8" of Joint: **YES**  
 Remarks:

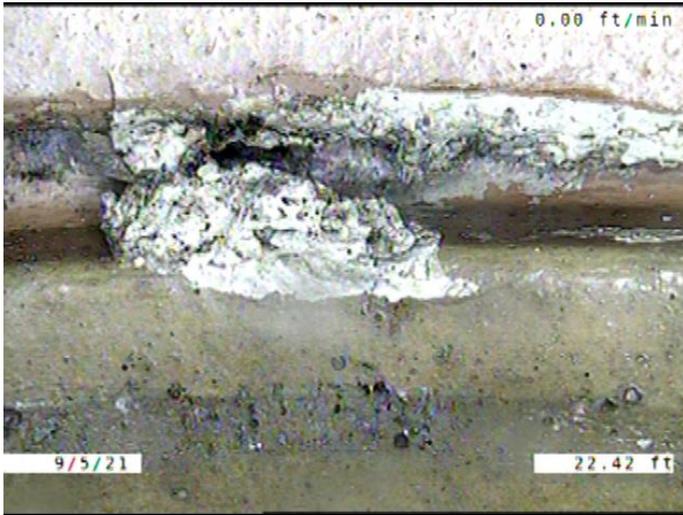
Code: **DAE**  
Description: **Deposits Attached Encrustation**

Distance (ft): **22.4**  
Structural Grade: **0**  
O&M Grade: **2**  
Clock Start/From: **2**  
Clock To: **4**  
1st Value:  
2nd Value:  
Value Percent: **5.000**  
Continuous Index:  
Within 8" of Joint: **YES**  
Remarks:

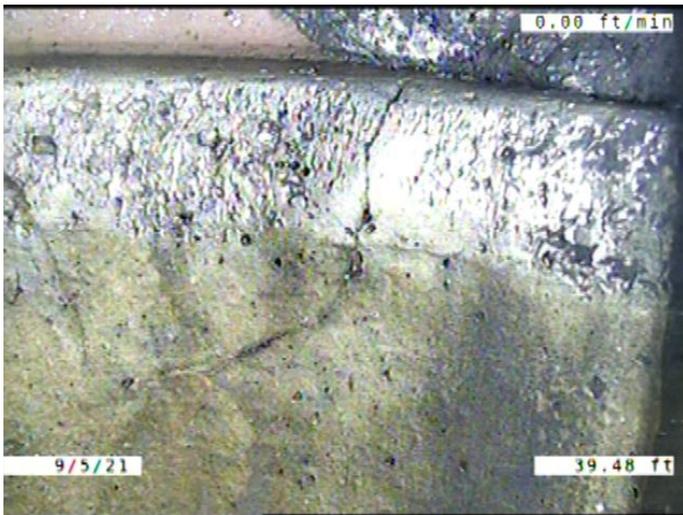
Code: **CL**  
Description: **Crack Longitudinal**

Distance (ft): **39.5**  
Structural Grade: **2**  
O&M Grade: **0**  
Clock Start/From: **3**  
Clock To:  
1st Value:  
2nd Value:  
Value Percent:  
Continuous Index:  
Within 8" of Joint: **YES**  
Remarks:

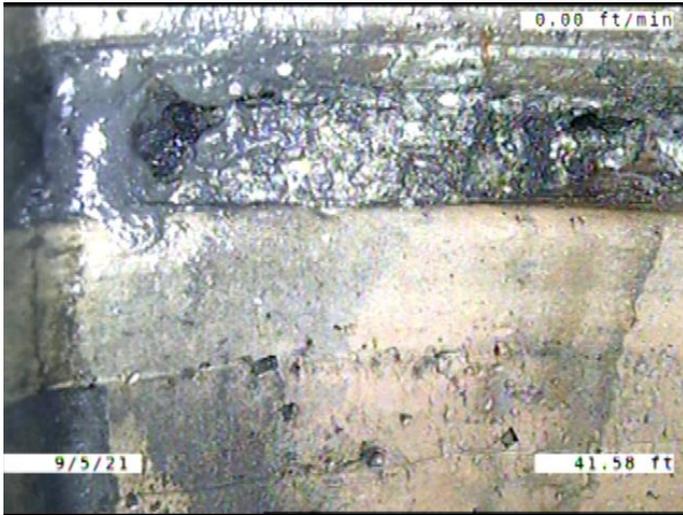
Code: **DAE**  
Description: **Deposits Attached Encrustation**

Distance (ft): **41.6**  
Structural Grade: **0**  
O&M Grade: **2**  
Clock Start/From: **9**  
Clock To:  
1st Value:  
2nd Value:  
Value Percent: **5.000**  
Continuous Index:  
Within 8" of Joint: **YES**  
Remarks:

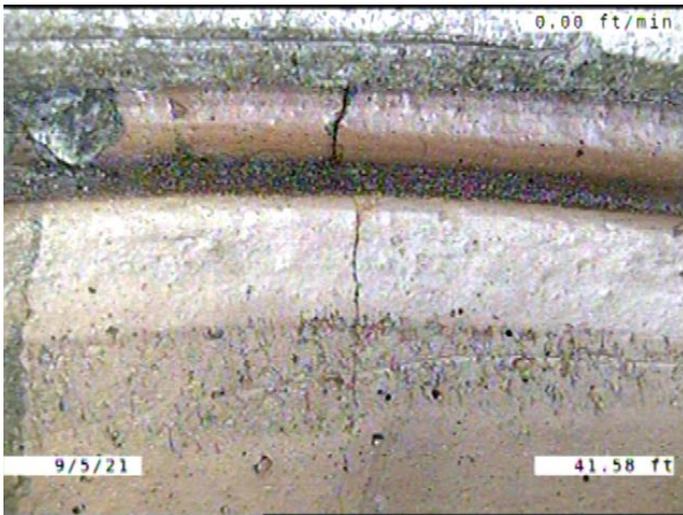
Code: **CL**  
Description: **Crack Longitudinal**

Distance (ft): **41.6**  
Structural Grade: **2**  
O&M Grade: **0**  
Clock Start/From: **10**  
Clock To:  
1st Value:  
2nd Value:  
Value Percent:  
Continuous Index:  
Within 8" of Joint: **YES**  
Remarks:

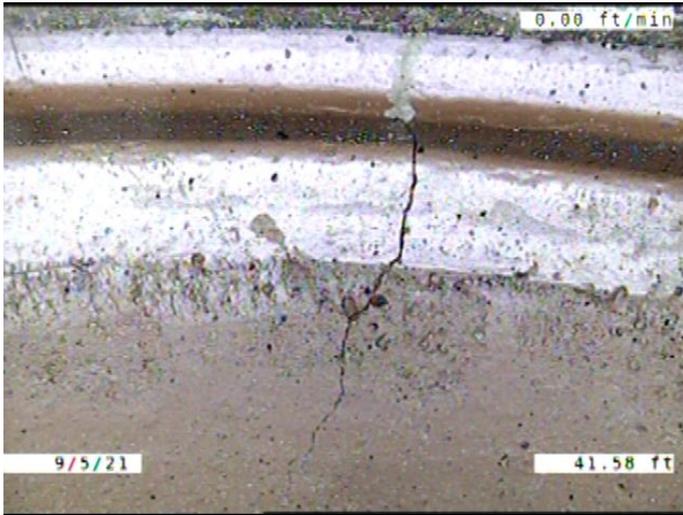
Code: **CL**  
 Description: **Crack Longitudinal**

Distance (ft): **41.6**  
 Structural Grade: **2**  
 O&M Grade: **0**  
 Clock Start/From: **12**  
 Clock To:  
 1st Value:  
 2nd Value:  
 Value Percent:  
 Continuous Index:  
 Within 8" of Joint: **YES**  
 Remarks:

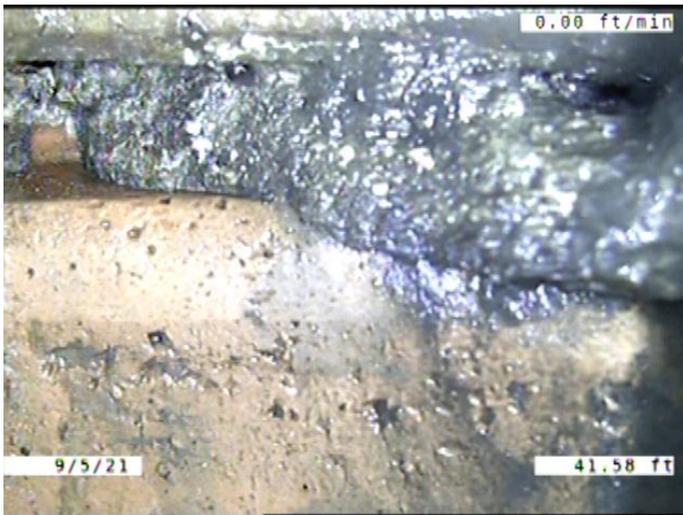
Code: **DAE**  
 Description: **Deposits Attached Encrustation**

Distance (ft): **41.6**  
 Structural Grade: **0**  
 O&M Grade: **2**  
 Clock Start/From: **3**  
 Clock To:  
 1st Value:  
 2nd Value:  
 Value Percent: **5.000**  
 Continuous Index:  
 Within 8" of Joint: **YES**  
 Remarks:

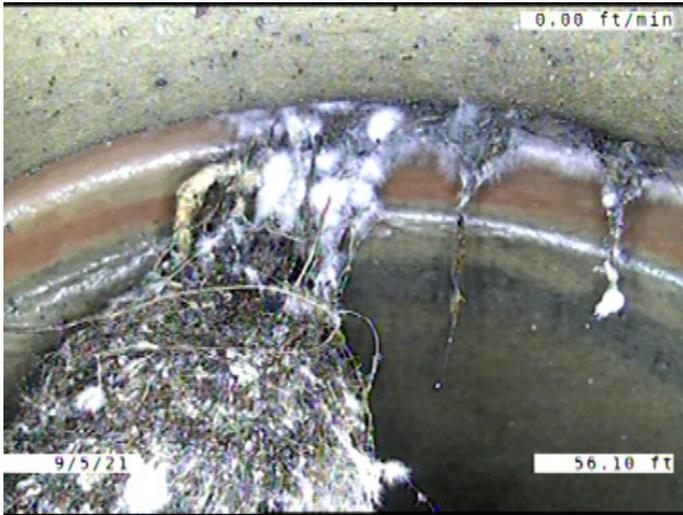
Code: **RMJ**  
 Description: **Roots Medium Joint**

Distance (ft): **56.1**  
 Structural Grade: **0**  
 O&M Grade: **3**  
 Clock Start/From: **11**  
 Clock To: **1**  
 1st Value:  
 2nd Value:  
 Value Percent: **10.000**  
 Continuous Index:  
 Within 8" of Joint: **YES**  
 Remarks:

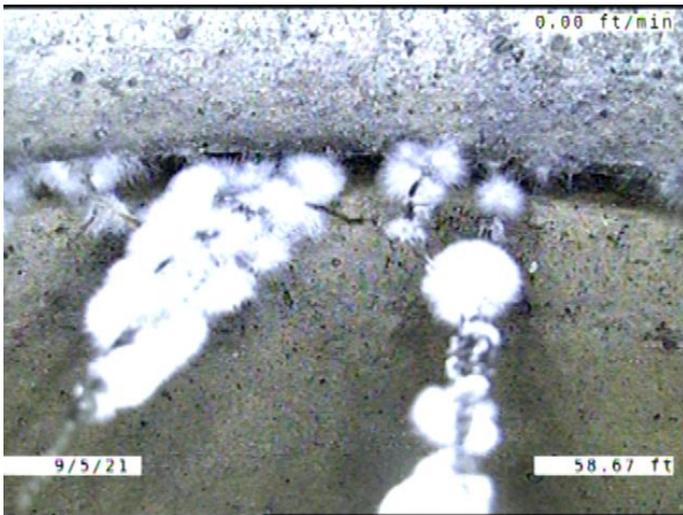
Code: **RFJ**  
 Description: **Roots Fine Joint**

Distance (ft): **58.7**  
 Structural Grade: **0**  
 O&M Grade: **1**  
 Clock Start/From: **11**  
 Clock To: **1**  
 1st Value:  
 2nd Value:  
 Value Percent:  
 Continuous Index:  
 Within 8" of Joint: **YES**  
 Remarks:

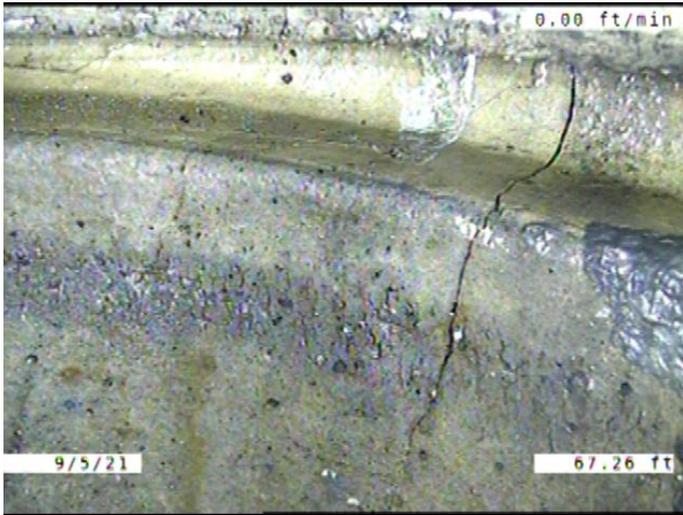
Code: **CL**  
 Description: **Crack Longitudinal**

Distance (ft): **67.3**  
 Structural Grade: **2**  
 O&M Grade: **0**  
 Clock Start/From: **2**  
 Clock To:  
 1st Value:  
 2nd Value:  
 Value Percent:  
 Continuous Index:  
 Within 8" of Joint: **YES**  
 Remarks:

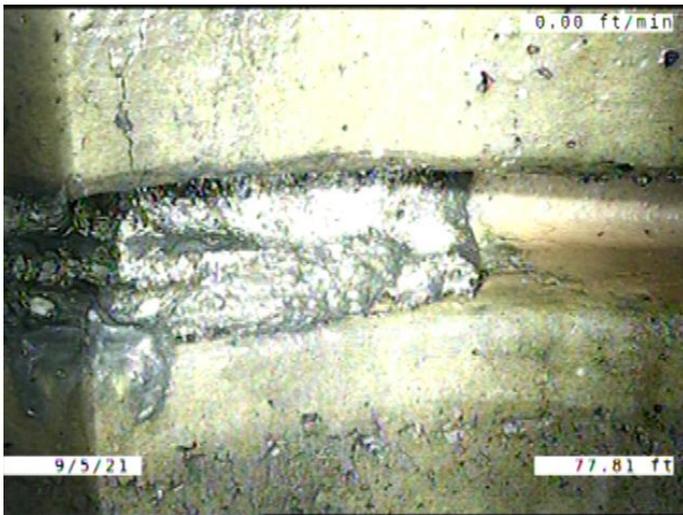
Code: **DAE**  
 Description: **Deposits Attached Encrustation**

Distance (ft): **77.8**  
 Structural Grade: **0**  
 O&M Grade: **2**  
 Clock Start/From: **9**  
 Clock To:  
 1st Value:  
 2nd Value:  
 Value Percent: **5.000**  
 Continuous Index:  
 Within 8" of Joint: **YES**  
 Remarks:

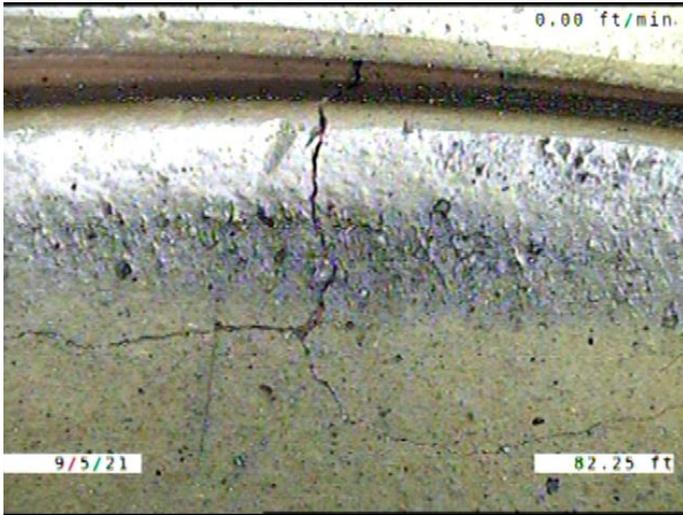
Code: **CM**  
 Description: **Crack Multiple**

Distance (ft): **82.2**  
 Structural Grade: **3**  
 O&M Grade: **0**  
 Clock Start/From: **11**  
 Clock To: **2**  
 1st Value:  
 2nd Value:  
 Value Percent:  
 Continuous Index:  
 Within 8" of Joint: **YES**  
 Remarks:

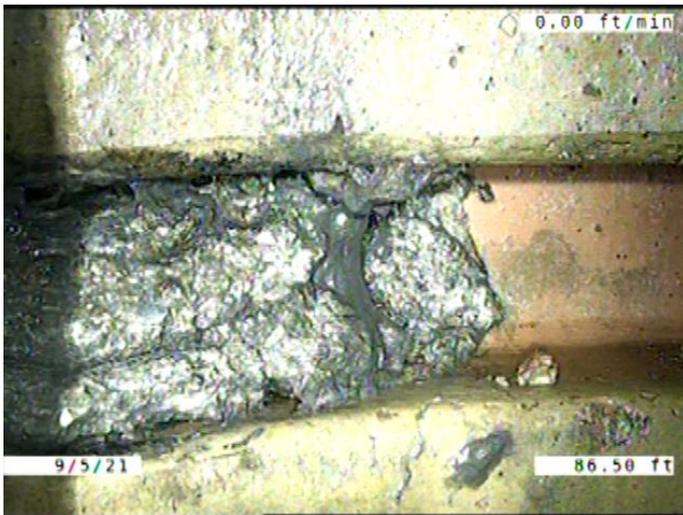
Code: **DAE**  
 Description: **Deposits Attached Encrustation**

Distance (ft): **86.5**  
 Structural Grade: **0**  
 O&M Grade: **2**  
 Clock Start/From: **9**  
 Clock To:  
 1st Value:  
 2nd Value:  
 Value Percent: **5.000**  
 Continuous Index:  
 Within 8" of Joint: **YES**  
 Remarks:

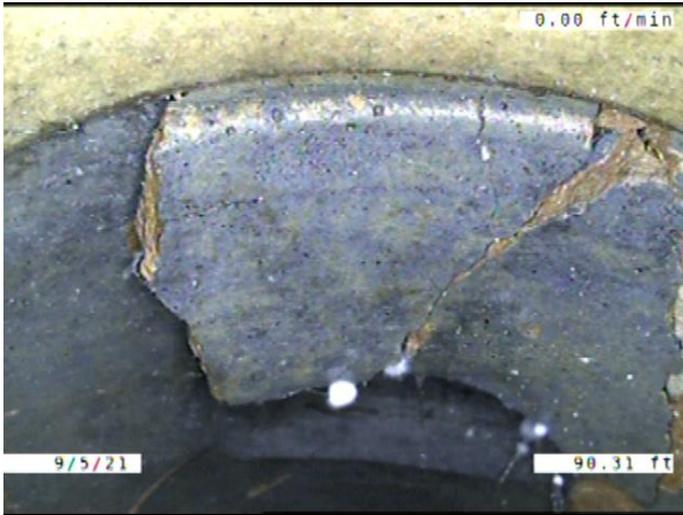
Code: **B**  
 Description: **Broken**

Distance (ft): **90.3**  
 Structural Grade: **4**  
 O&M Grade: **0**  
 Clock Start/From: **8**  
 Clock To: **4**  
 1st Value:  
 2nd Value:  
 Value Percent:  
 Continuous Index:  
 Within 8" of Joint: **YES**  
 Remarks:

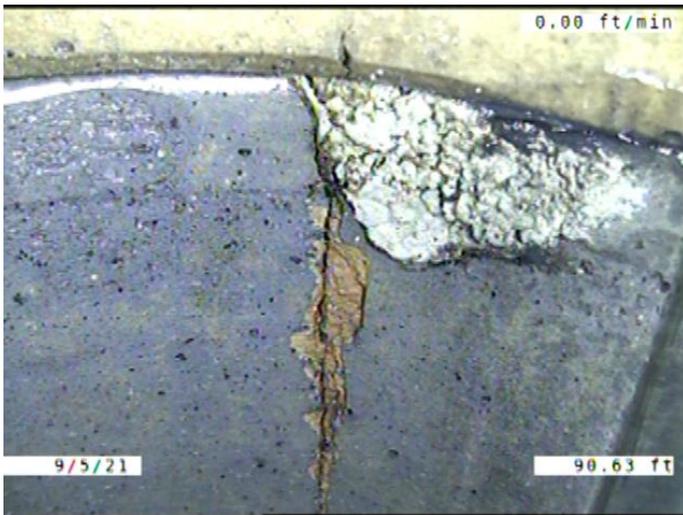
Code: **DAE**  
 Description: **Deposits Attached Encrustation**

Distance (ft): **90.6**  
 Structural Grade: **0**  
 O&M Grade: **2**  
 Clock Start/From: **1**  
 Clock To: **4**  
 1st Value:  
 2nd Value:  
 Value Percent: **5.000**  
 Continuous Index:  
 Within 8" of Joint: **YES**  
 Remarks:

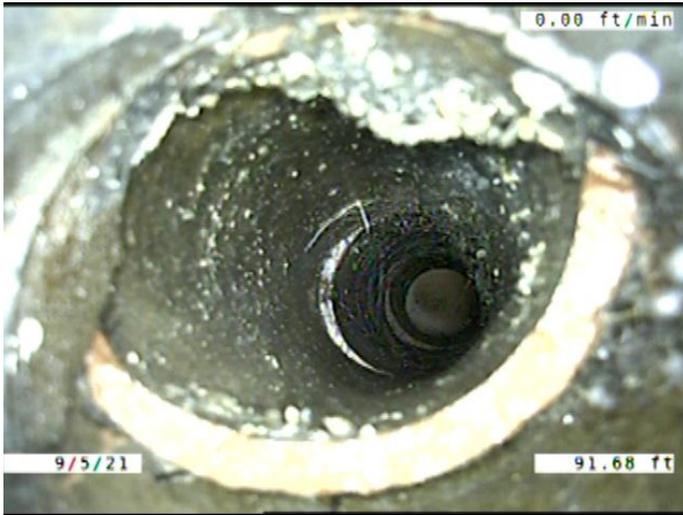
Code: **TFD**  
 Description: **Tap Factory Defective**

Distance (ft): **91.7**  
 Structural Grade: **0**  
 O&M Grade: **3**  
 Clock Start/From: **12**  
 Clock To:  
 1st Value: **6.000**  
 2nd Value:  
 Value Percent:  
 Continuous Index:  
 Within 8" of Joint: **YES**  
 Remarks: **LOOKS TO BE CAPPED**

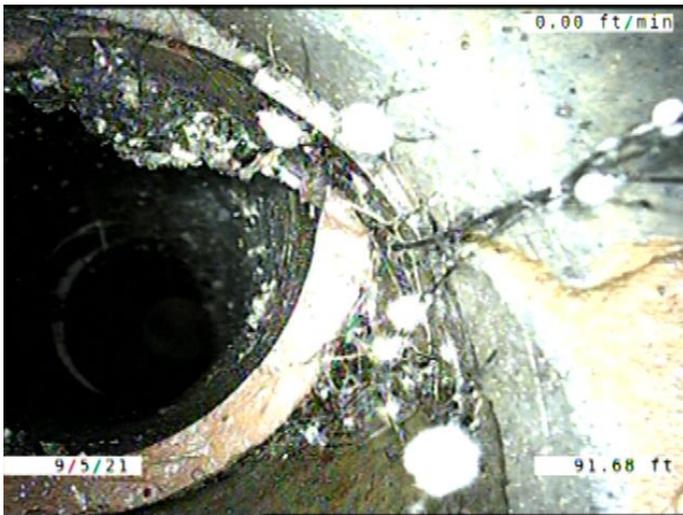
Code: **RFL**  
 Description: **Roots Fine Lateral**

Distance (ft): **91.7**  
 Structural Grade: **0**  
 O&M Grade: **1**  
 Clock Start/From: **11**  
 Clock To: **1**  
 1st Value:  
 2nd Value:  
 Value Percent:  
 Continuous Index:  
 Within 8" of Joint: **NO**  
 Remarks:

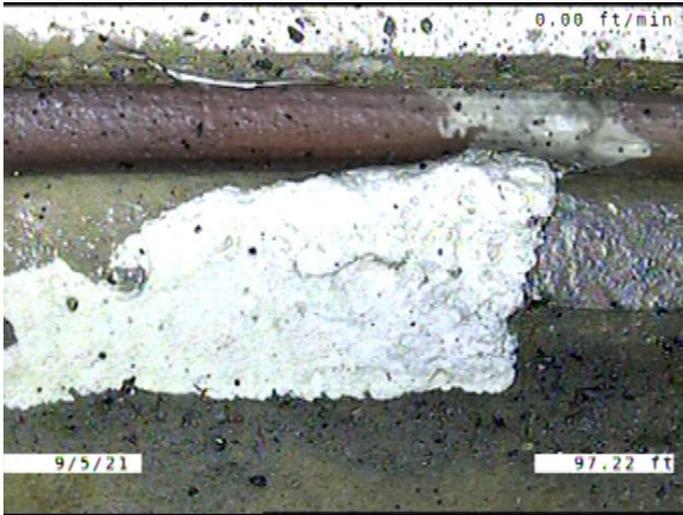
Code: **DAE**  
 Description: **Deposits Attached Encrustation**

Distance (ft): **97.2**  
 Structural Grade: **0**  
 O&M Grade: **2**  
 Clock Start/From: **10**  
 Clock To: **11**  
 1st Value:  
 2nd Value:  
 Value Percent: **5.000**  
 Continuous Index:  
 Within 8" of Joint: **YES**  
 Remarks:

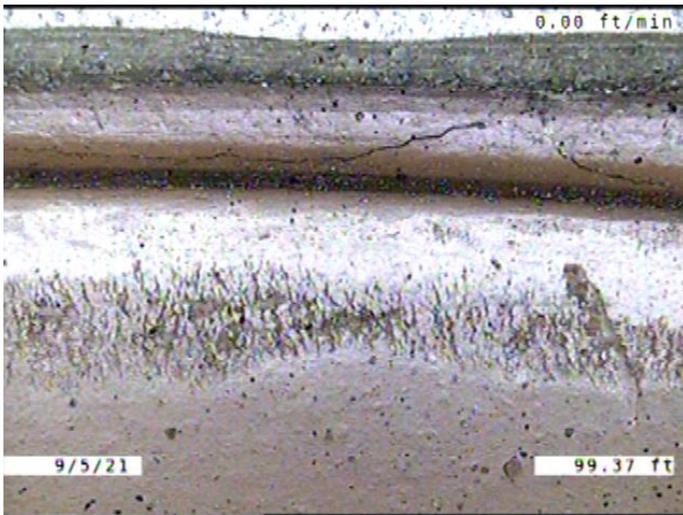
Code: **CM**  
 Description: **Crack Multiple**

Distance (ft): **99.4**  
 Structural Grade: **3**  
 O&M Grade: **0**  
 Clock Start/From: **10**  
 Clock To: **1**  
 1st Value:  
 2nd Value:  
 Value Percent:  
 Continuous Index:  
 Within 8" of Joint: **YES**  
 Remarks:

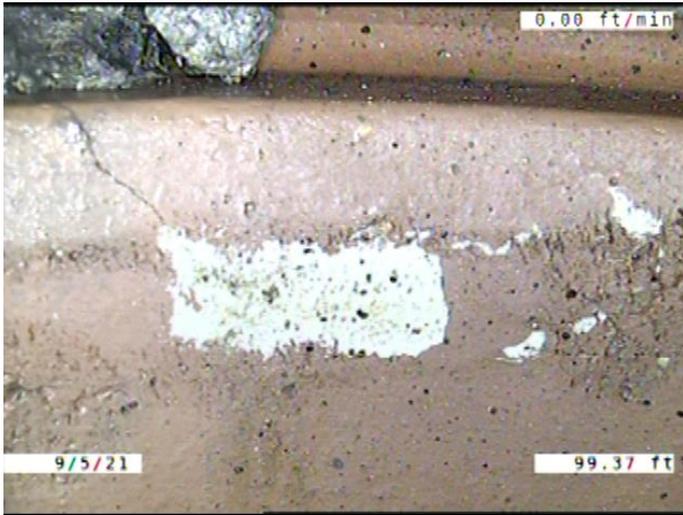
Code: **DAE**  
Description: **Deposits Attached Encrustation**

Distance (ft): **99.4**  
Structural Grade: **0**  
O&M Grade: **2**  
Clock Start/From: **10**  
Clock To:  
1st Value:  
2nd Value:  
Value Percent: **5.000**  
Continuous Index:  
Within 8" of Joint: **YES**  
Remarks:

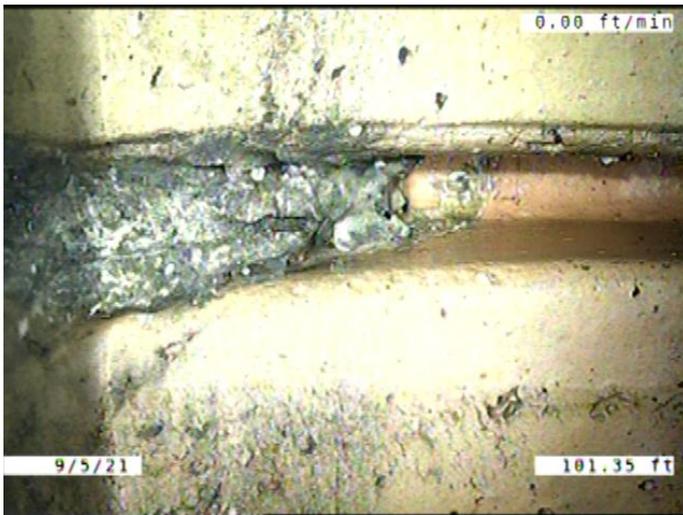
Code: **DAE**  
Description: **Deposits Attached Encrustation**

Distance (ft): **101.4**  
Structural Grade: **0**  
O&M Grade: **2**  
Clock Start/From: **9**  
Clock To:  
1st Value:  
2nd Value:  
Value Percent: **5.000**  
Continuous Index:  
Within 8" of Joint: **YES**  
Remarks:

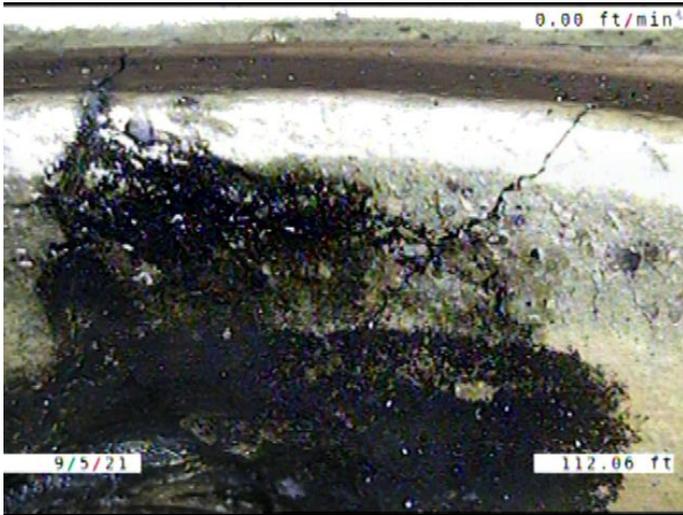
Code: **CM**  
Description: **Crack Multiple**

Distance (ft): **112.1**  
Structural Grade: **3**  
O&M Grade: **0**  
Clock Start/From: **11**  
Clock To: **1**  
1st Value:  
2nd Value:  
Value Percent:  
Continuous Index:  
Within 8" of Joint: **YES**  
Remarks:

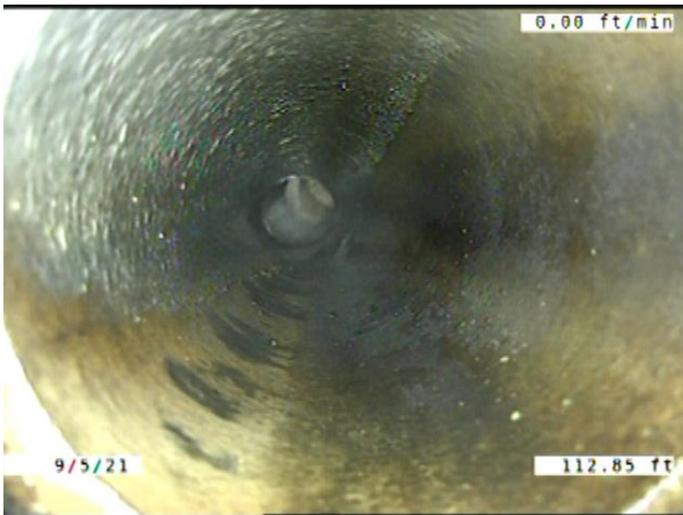
Code: **TBD**  
Description: **Tap Break-in/Hammer Defective**

Distance (ft): **112.9**  
Structural Grade: **0**  
O&M Grade: **3**  
Clock Start/From: **12**  
Clock To:  
1st Value: **6.000**  
2nd Value:  
Value Percent:  
Continuous Index:  
Within 8" of Joint: **YES**  
Remarks: **Defective**

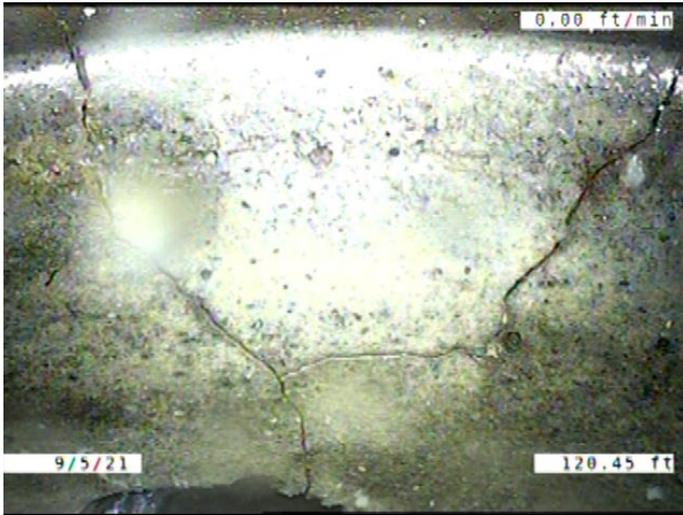
Code: **FM**  
Description: **Fracture Multiple**

Distance (ft): **120.5**  
Structural Grade: **4**  
O&M Grade: **0**  
Clock Start/From: **11**  
Clock To: **1**  
1st Value:  
2nd Value:  
Value Percent:  
Continuous Index:  
Within 8" of Joint: **YES**  
Remarks:

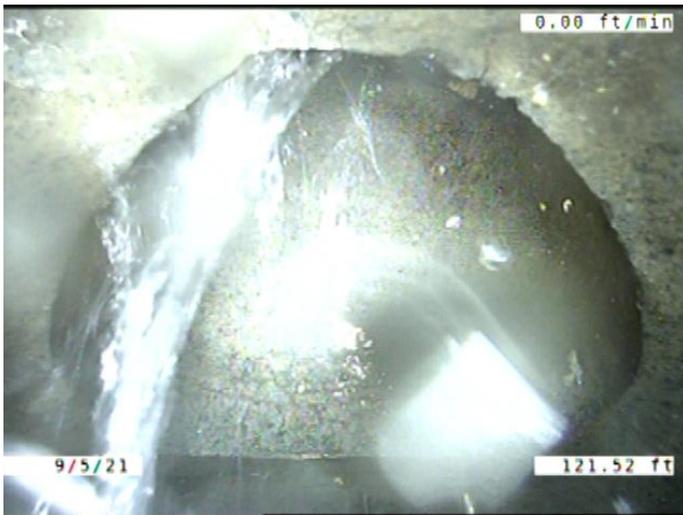
Code: **TFD**  
Description: **Tap Factory Defective**

Distance (ft): **121.5**  
Structural Grade: **0**  
O&M Grade: **3**  
Clock Start/From: **11**  
Clock To:  
1st Value: **6.000**  
2nd Value:  
Value Percent:  
Continuous Index:  
Within 8" of Joint: **YES**  
Remarks: **CONSTANTLY RUNNING WATER**

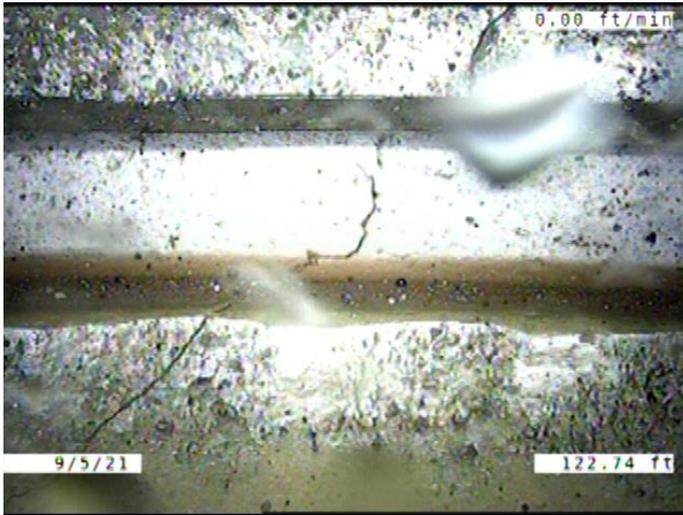
Code: **CM**  
Description: **Crack Multiple**

Distance (ft): **122.7**  
Structural Grade: **3**  
O&M Grade: **0**  
Clock Start/From: **9**  
Clock To: **12**  
1st Value:  
2nd Value:  
Value Percent:  
Continuous Index:  
Within 8" of Joint: **YES**  
Remarks:

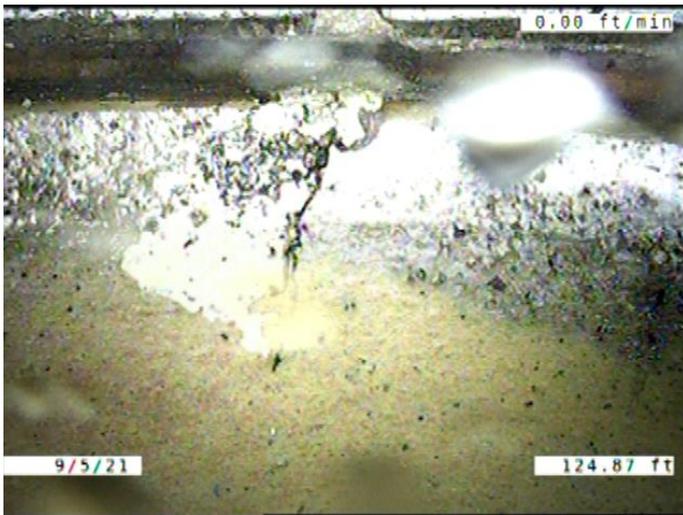
Code: **CL**  
Description: **Crack Longitudinal**

Distance (ft): **124.9**  
Structural Grade: **2**  
O&M Grade: **0**  
Clock Start/From: **12**  
Clock To:  
1st Value:  
2nd Value:  
Value Percent:  
Continuous Index:  
Within 8" of Joint: **YES**  
Remarks:

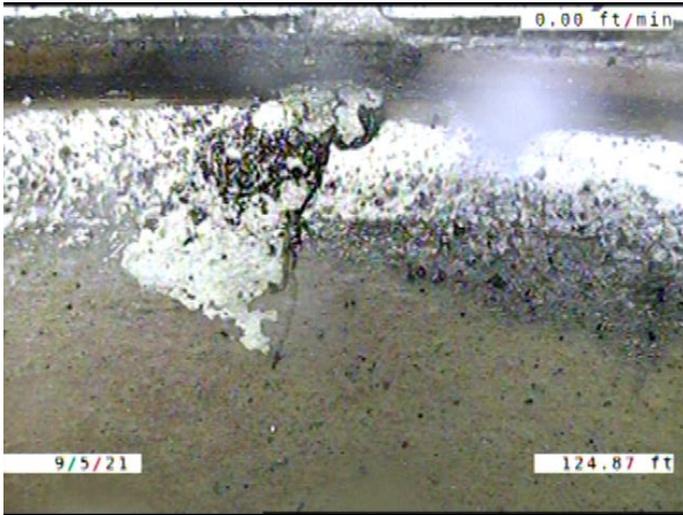
Code: **DAE**  
 Description: **Deposits Attached Encrustation**

Distance (ft): **124.9**  
 Structural Grade: **0**  
 O&M Grade: **2**  
 Clock Start/From: **12**  
 Clock To:  
 1st Value:  
 2nd Value:  
 Value Percent: **5.000**  
 Continuous Index:  
 Within 8" of Joint: **YES**  
 Remarks:

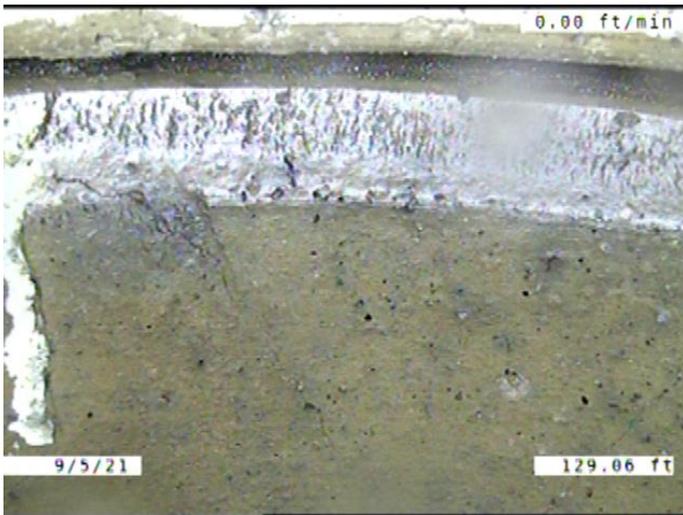
Code: **CM**  
 Description: **Crack Multiple**

Distance (ft): **129.1**  
 Structural Grade: **3**  
 O&M Grade: **0**  
 Clock Start/From: **11**  
 Clock To: **1**  
 1st Value:  
 2nd Value:  
 Value Percent:  
 Continuous Index:  
 Within 8" of Joint: **YES**  
 Remarks:

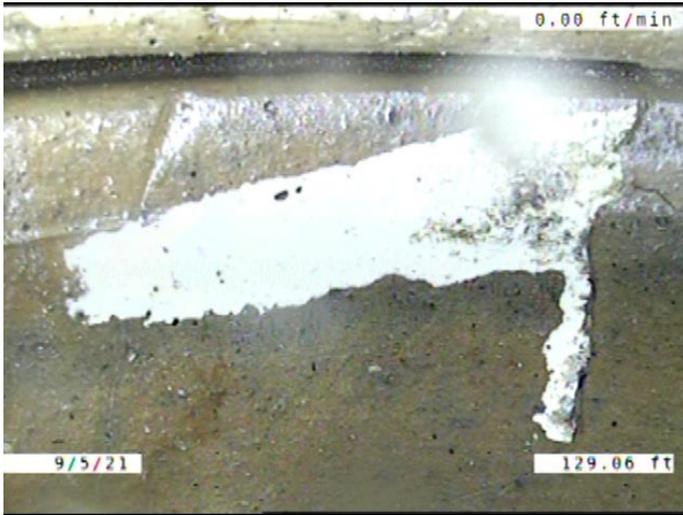
Code: **DAE**  
Description: **Deposits Attached Encrustation**

Distance (ft): **129.1**  
Structural Grade: **0**  
O&M Grade: **2**  
Clock Start/From: **10**  
Clock To: **11**  
1st Value:  
2nd Value:  
Value Percent: **5.000**  
Continuous Index:  
Within 8" of Joint: **YES**  
Remarks:

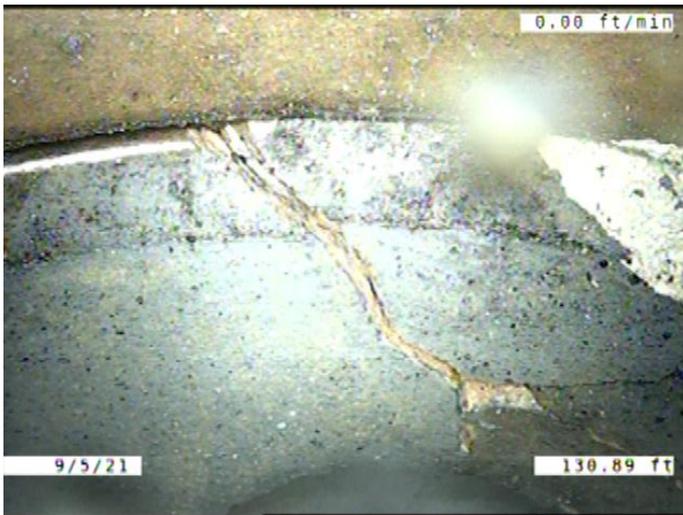
Code: **B**  
Description: **Broken**

Distance (ft): **130.9**  
Structural Grade: **4**  
O&M Grade: **0**  
Clock Start/From: **10**  
Clock To: **3**  
1st Value:  
2nd Value:  
Value Percent:  
Continuous Index:  
Within 8" of Joint: **YES**  
Remarks:

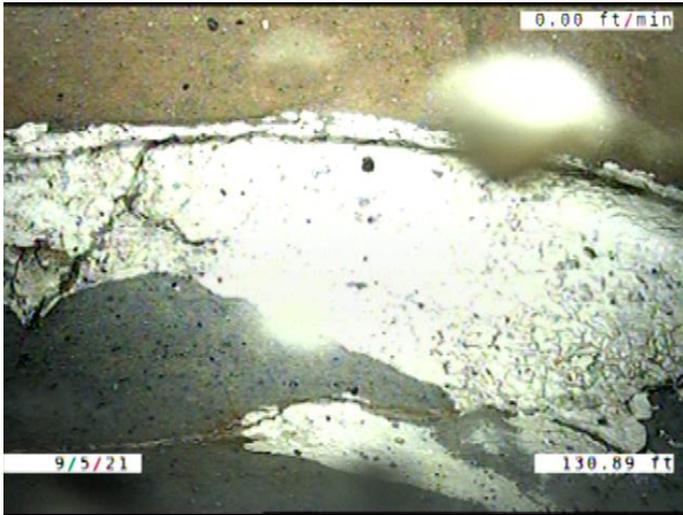
Code: **DAE**  
 Description: **Deposits Attached Encrustation**

Distance (ft): **130.9**  
 Structural Grade: **0**  
 O&M Grade: **2**  
 Clock Start/From: **12**  
 Clock To: **3**  
 1st Value:  
 2nd Value:  
 Value Percent: **5.000**  
 Continuous Index:  
 Within 8" of Joint: **YES**  
 Remarks:

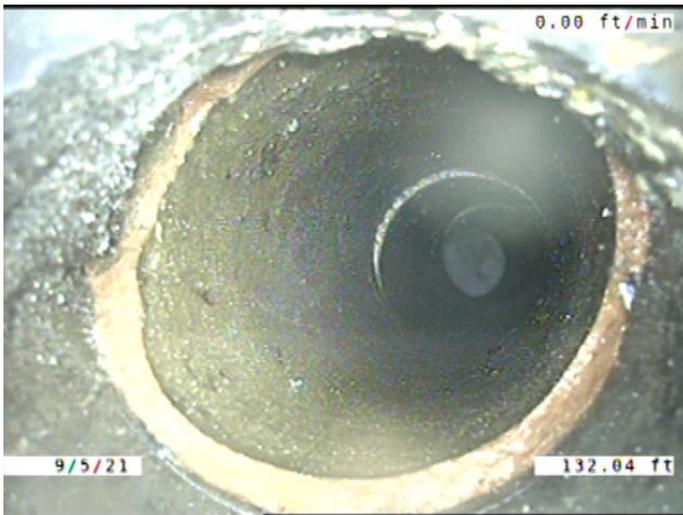
Code: **TFD**  
 Description: **Tap Factory Defective**

Distance (ft): **132.0**  
 Structural Grade: **0**  
 O&M Grade: **3**  
 Clock Start/From: **12**  
 Clock To:  
 1st Value: **6.000**  
 2nd Value:  
 Value Percent:  
 Continuous Index:  
 Within 8" of Joint: **YES**  
 Remarks: **LOOKS TO BE CAPPED**

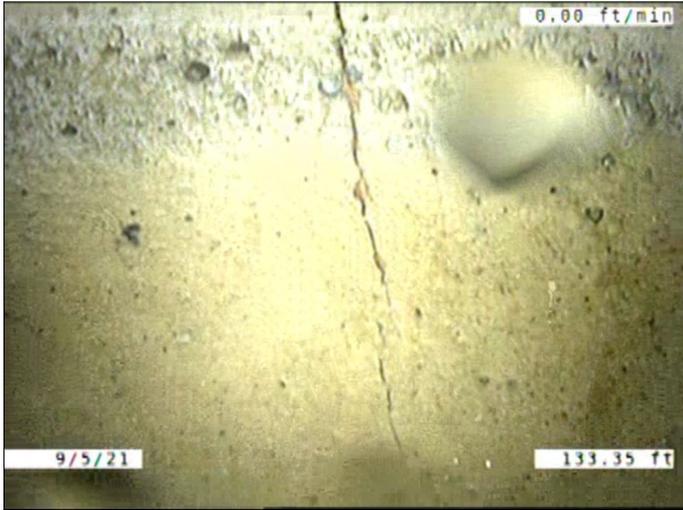
Code: **FM**  
Description: **Fracture Multiple**

Distance (ft): **133.4**  
Structural Grade: **4**  
O&M Grade: **0**  
Clock Start/From: **12**  
Clock To: **3**  
1st Value:  
2nd Value:  
Value Percent:  
Continuous Index:  
Within 8" of Joint: **YES**  
Remarks:

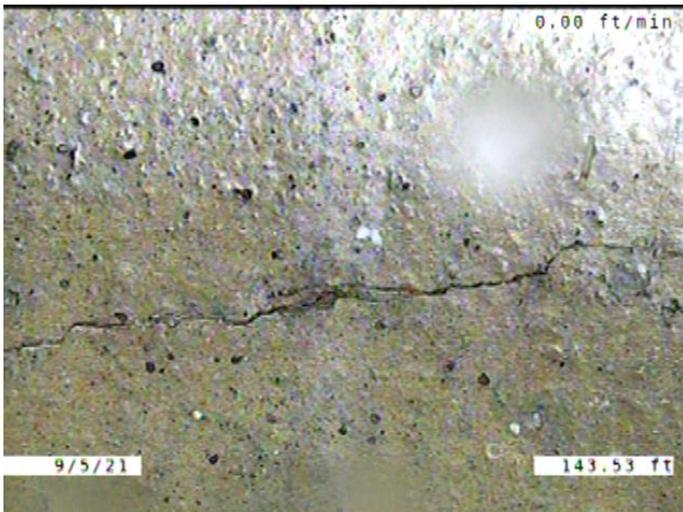
Code: **CM**  
Description: **Crack Multiple**

Distance (ft): **143.5**  
Structural Grade: **3**  
O&M Grade: **0**  
Clock Start/From: **9**  
Clock To: **3**  
1st Value:  
2nd Value:  
Value Percent:  
Continuous Index:  
Within 8" of Joint: **YES**  
Remarks:

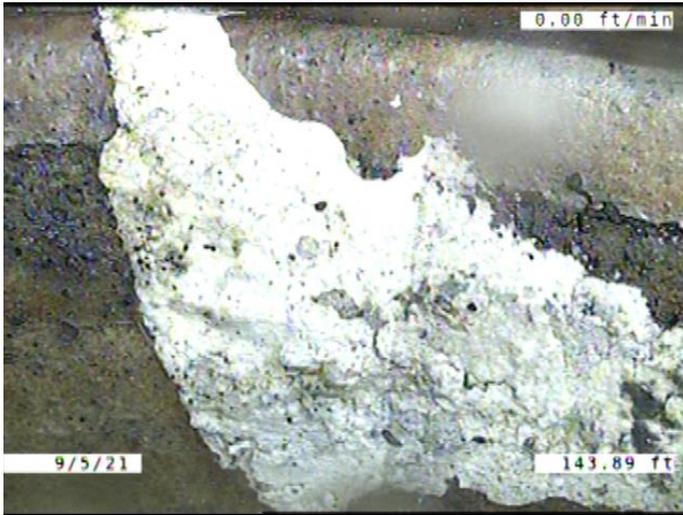
Code: **DAE**  
 Description: **Deposits Attached Encrustation**

Distance (ft): **143.9**  
 Structural Grade: **0**  
 O&M Grade: **2**  
 Clock Start/From: **1**  
 Clock To: **3**  
 1st Value:  
 2nd Value:  
 Value Percent: **5.000**  
 Continuous Index:  
 Within 8" of Joint: **YES**  
 Remarks:

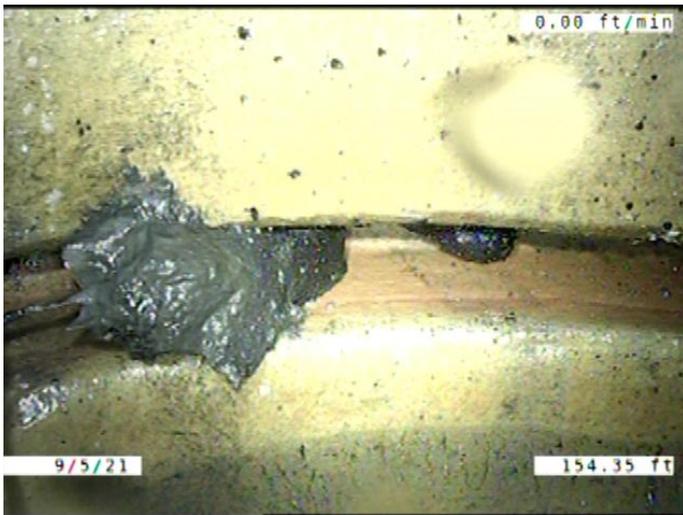
Code: **DAE**  
 Description: **Deposits Attached Encrustation**

Distance (ft): **154.4**  
 Structural Grade: **0**  
 O&M Grade: **2**  
 Clock Start/From: **9**  
 Clock To: **10**  
 1st Value:  
 2nd Value:  
 Value Percent: **5.000**  
 Continuous Index:  
 Within 8" of Joint: **YES**  
 Remarks:

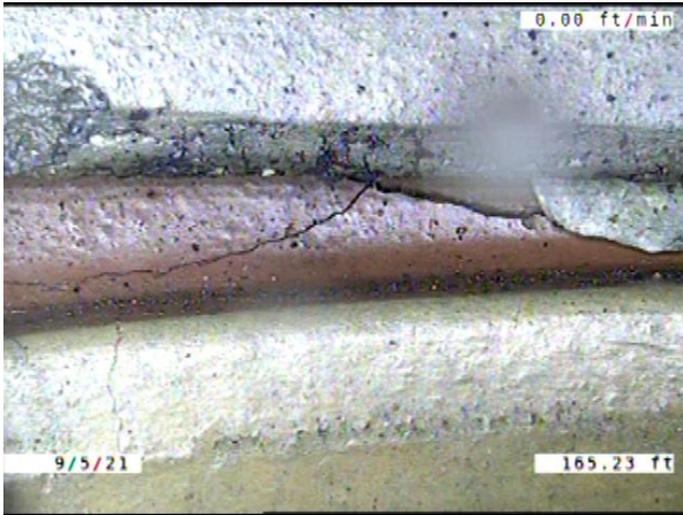
Code: **FM**  
Description: **Fracture Multiple**

Distance (ft): **165.2**  
Structural Grade: **4**  
O&M Grade: **0**  
Clock Start/From: **10**  
Clock To: **1**  
1st Value:  
2nd Value:  
Value Percent:  
Continuous Index:  
Within 8" of Joint: **YES**  
Remarks:

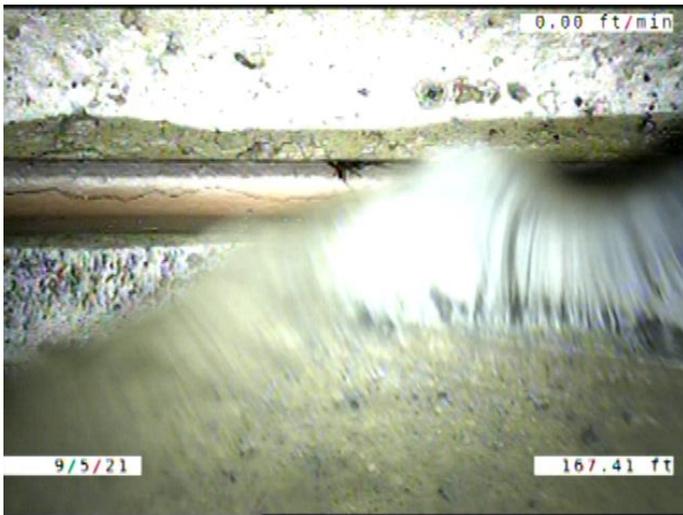
Code: **CM**  
Description: **Crack Multiple**

Distance (ft): **167.4**  
Structural Grade: **3**  
O&M Grade: **0**  
Clock Start/From: **11**  
Clock To: **1**  
1st Value:  
2nd Value:  
Value Percent:  
Continuous Index:  
Within 8" of Joint: **YES**  
Remarks:

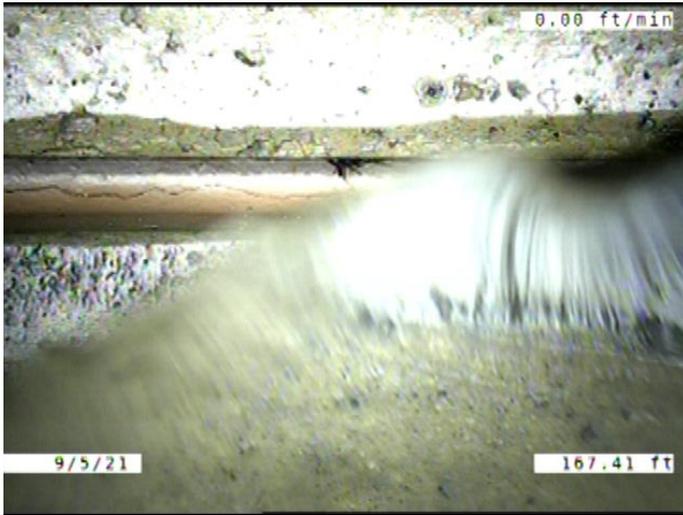
Code: **MCU**  
 Description: **Miscellaneous Camera Underwater**

Distance (ft): **167.4**  
 Structural Grade: **0**  
 O&M Grade: **4**  
 Clock Start/From:  
 Clock To:  
 1st Value:  
 2nd Value:  
 Value Percent:  
 Continuous Index:  
 Within 8" of Joint: **NO**  
 Remarks: **Out at 169.4**

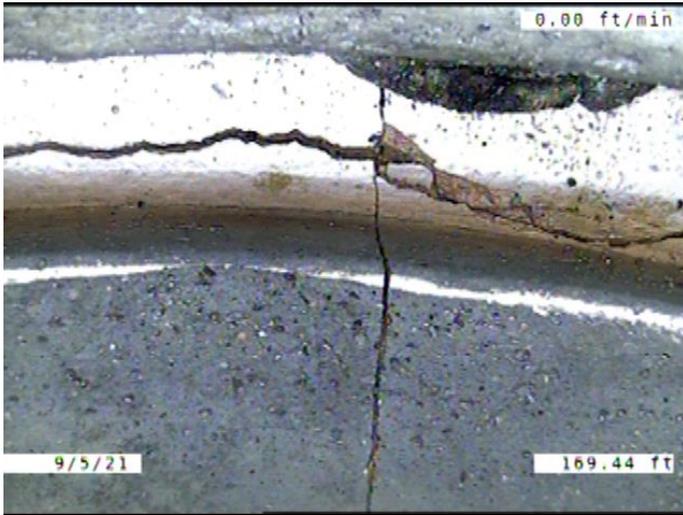
Code: **FM**  
 Description: **Fracture Multiple**

Distance (ft): **169.4**  
 Structural Grade: **4**  
 O&M Grade: **0**  
 Clock Start/From: **10**  
 Clock To: **3**  
 1st Value:  
 2nd Value:  
 Value Percent:  
 Continuous Index:  
 Within 8" of Joint: **YES**  
 Remarks:

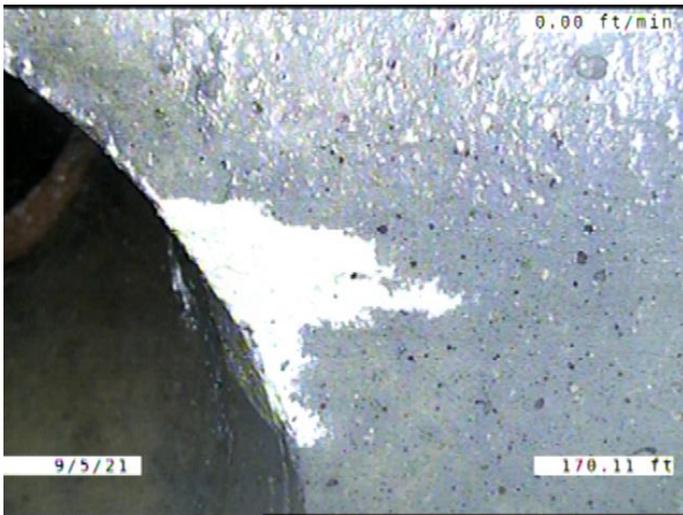
Code: **DAE**  
 Description: **Deposits Attached Encrustation**

Distance (ft): **170.1**  
 Structural Grade: **0**  
 O&M Grade: **2**  
 Clock Start/From: **1**  
 Clock To:  
 1st Value:  
 2nd Value:  
 Value Percent: **5.000**  
 Continuous Index:  
 Within 8" of Joint: **YES**  
 Remarks:

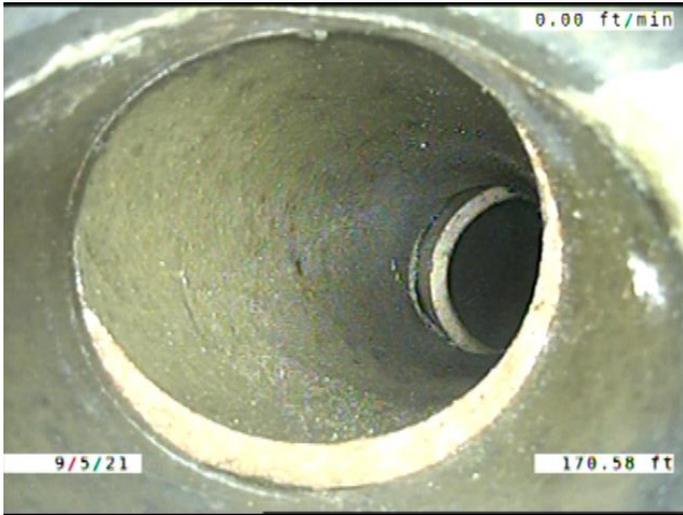
Code: **TFD**  
Description: **Tap Factory Defective**

Distance (ft): **170.6**  
Structural Grade: **0**  
O&M Grade: **3**  
Clock Start/From: **12**  
Clock To:  
1st Value: **6.000**  
2nd Value:  
Value Percent:  
Continuous Index:  
Within 8" of Joint: **YES**  
Remarks: **Defective**

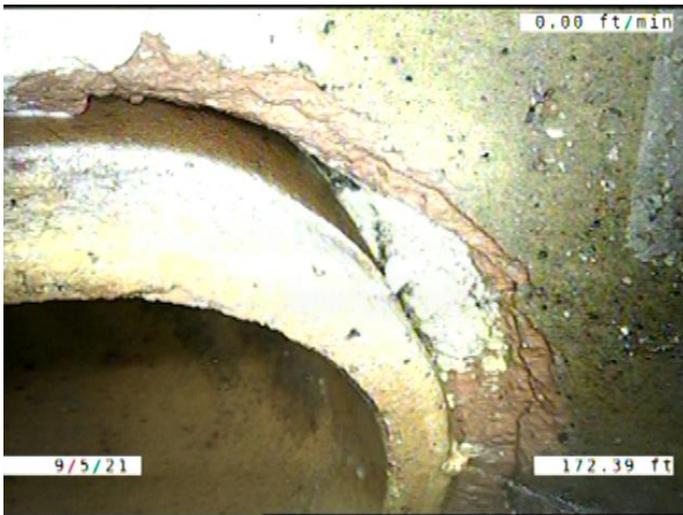
Code: **SSS**  
Description: **Surface Damage Surface Spalling**

Distance (ft): **172.4**  
Structural Grade: **2**  
O&M Grade: **0**  
Clock Start/From: **12**  
Clock To: **2**  
1st Value:  
2nd Value:  
Value Percent:  
Continuous Index:  
Within 8" of Joint: **NO**  
Remarks:
