# Profile/Photo Observation Report

Date:	<b>09/05/2021</b>	Weather:		Coding:	<b>PACP 7.0</b>
Pipe Length (ft):	<b>195.3</b>	Owner:	<b>City of Hobart</b>	Pre Clean:	<b>Heavy Cleaning</b>
P.O.#:	<b>YES502259</b>	Surveyor:	<b>S. Bucklin</b>	PSR:	<b>P-504-077-076</b>
Customer:	<b>City of Hobart</b>	Clean Date:	<b>09/02/2021</b>	Shape:	<b>C</b>

Street:	<b>North Cavender Street</b>	Flow Control:	<b>Not Controlled</b>
City:	<b>Hobart, IN</b>	Year Renewed:	
Location:	<b>Alley</b>	Tape/Media #:	
Purpose:	<b>Routine Assessment</b>	Dia/Height:	<b>12"</b>
Use:	<b>Sanitary Sewage Pipe</b>	Material:	<b>VCP</b>
Drain Area:		Lining:	
Category:	<b>NA</b>		
Comment:			
Location Details:		Direction of Survey:	<b>Downstream</b>
US MH:	<b>M-504-077</b>	DS MH:	<b>M-504-076</b>
		Total Length Surveyed (ft):	<b>195.3</b>

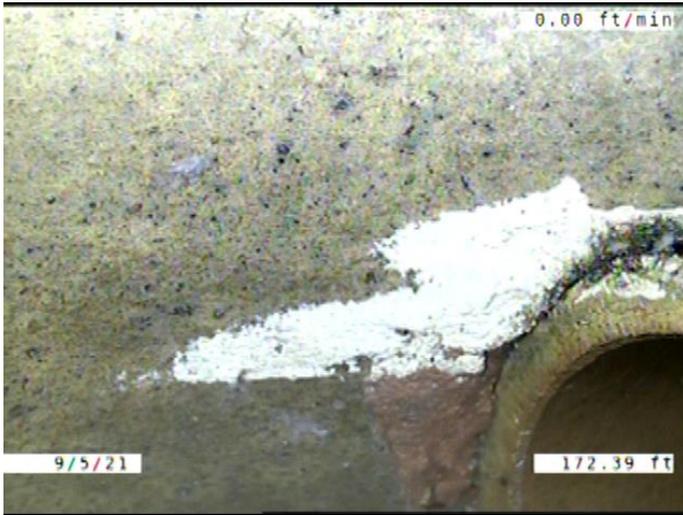
Code: **DAE**  
 Description: **Deposits Attached Encrustation**

Distance (ft): **172.4**  
 Structural Grade: **0**  
 O&M Grade: **2**  
 Clock Start/From: **11**  
 Clock To: **3**  
 1st Value:  
 2nd Value:  
 Value Percent: **5.000**  
 Continuous Index:  
 Within 8" of Joint: **YES**  
 Remarks:

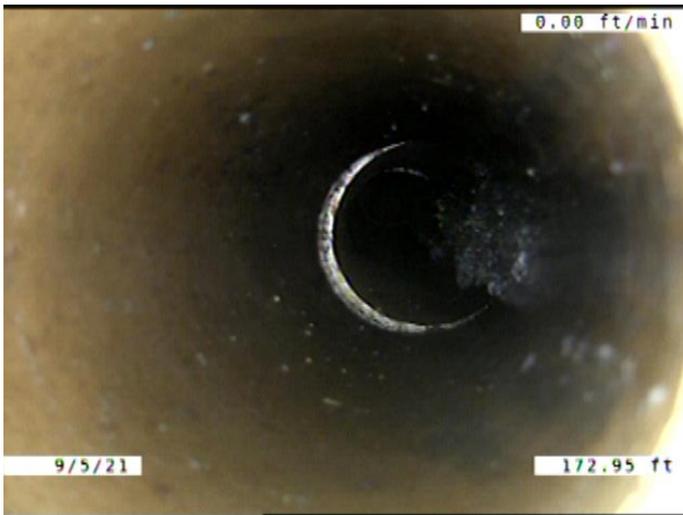
Code: **TBI**  
 Description: **Tap Break-in Intruding**

Distance (ft): **173.0**  
 Structural Grade: **0**  
 O&M Grade: **2**  
 Clock Start/From: **1**  
 Clock To:  
 1st Value: **6.000**  
 2nd Value: **1.000**  
 Value Percent:  
 Continuous Index:  
 Within 8" of Joint: **NO**  
 Remarks: **ROOTS GROWING IN THE TAP**

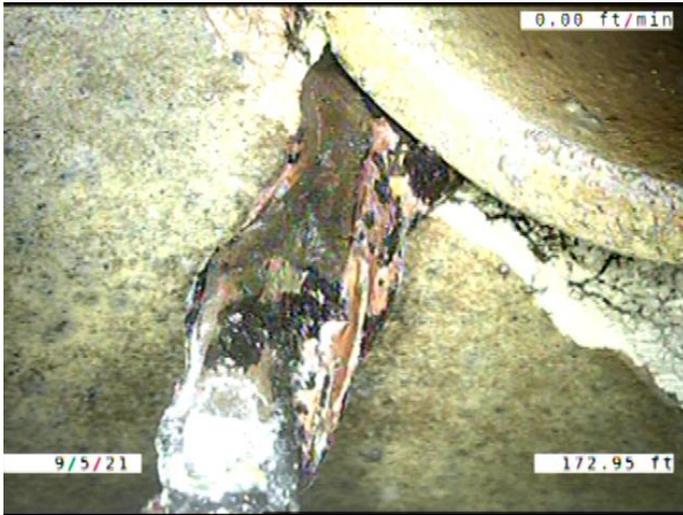
Code: **ISZ**  
 Description: **Intruding Sealing Material Other**

Distance (ft): **173.0**  
 Structural Grade: **0**  
 O&M Grade: **2**  
 Clock Start/From: **11**  
 Clock To: **12**  
 1st Value:  
 2nd Value:  
 Value Percent: **5.000**  
 Continuous Index:  
 Within 8" of Joint: **NO**  
 Remarks: **TAP SEAL HANGING INTO THE MAIN**

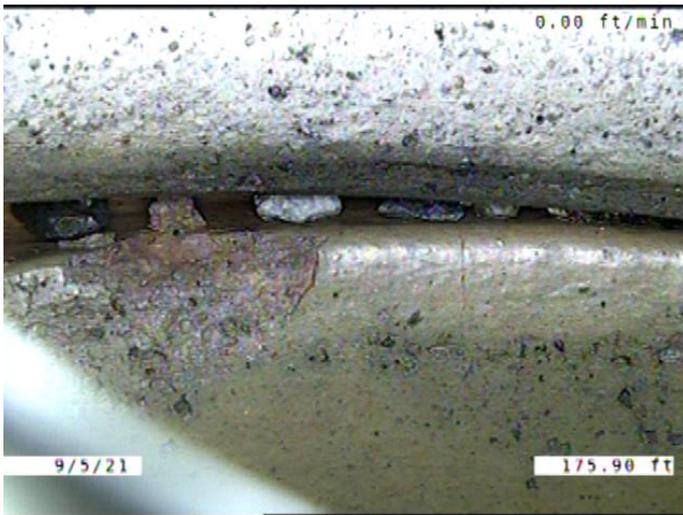
Code: **SSS**  
 Description: **Surface Damage Surface Spalling**

Distance (ft): **175.9**  
 Structural Grade: **2**  
 O&M Grade: **0**  
 Clock Start/From: **11**  
 Clock To:  
 1st Value:  
 2nd Value:  
 Value Percent:  
 Continuous Index:  
 Within 8" of Joint: **YES**  
 Remarks:

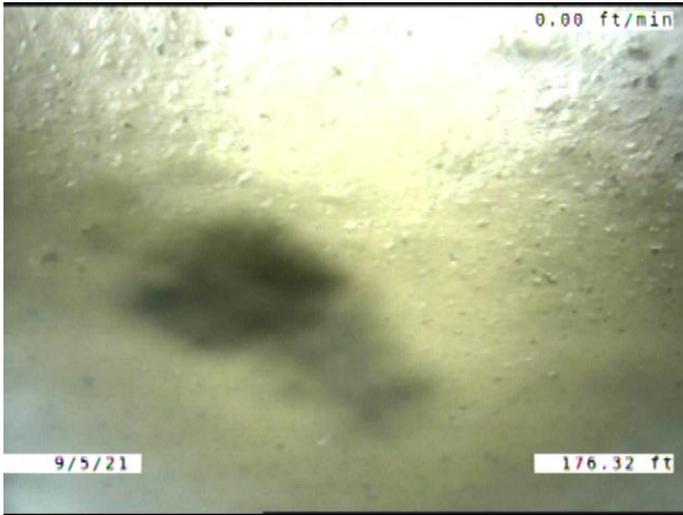
Code: **MCU**  
Description: **Miscellaneous Camera Underwater**

Distance (ft): **176.3**  
Structural Grade: **0**  
O&M Grade: **4**  
Clock Start/From:  
Clock To:  
1st Value:  
2nd Value:  
Value Percent:  
Continuous Index:  
Within 8" of Joint: **NO**  
Remarks: **Out at 176.9**

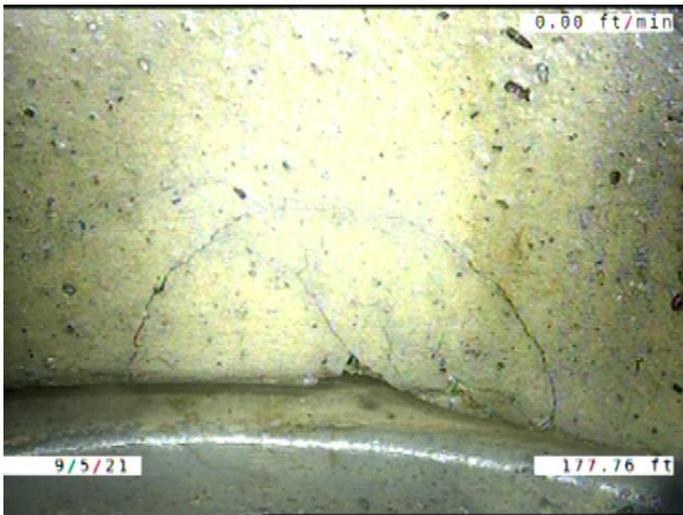
Code: **CM**  
Description: **Crack Multiple**

Distance (ft): **177.8**  
Structural Grade: **3**  
O&M Grade: **0**  
Clock Start/From: **12**  
Clock To: **1**  
1st Value:  
2nd Value:  
Value Percent:  
Continuous Index:  
Within 8" of Joint: **YES**  
Remarks:

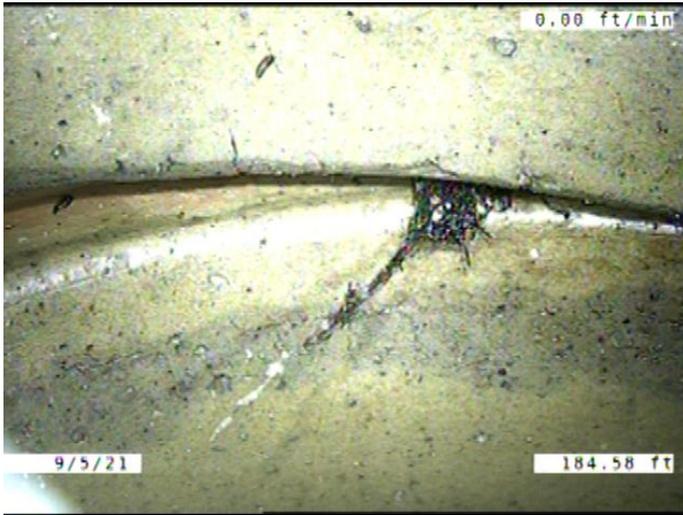
Code: **RFJ**  
 Description: **Roots Fine Joint**

Distance (ft): **184.6**  
 Structural Grade: **0**  
 O&M Grade: **1**  
 Clock Start/From: **11**  
 Clock To:  
 1st Value:  
 2nd Value:  
 Value Percent:  
 Continuous Index:  
 Within 8" of Joint: **YES**  
 Remarks:

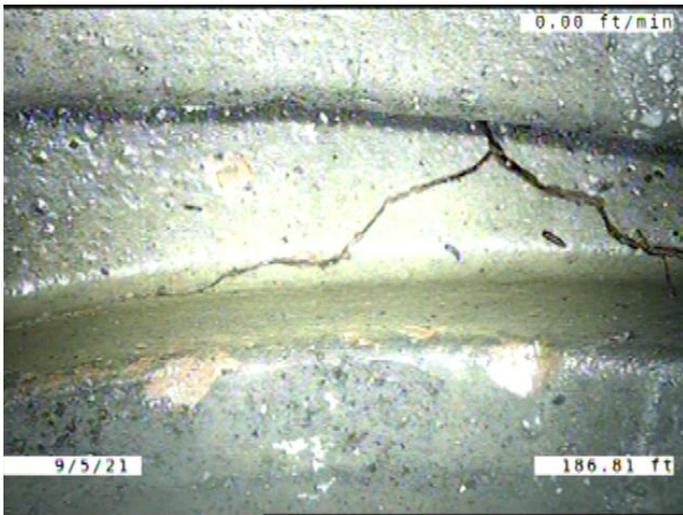
Code: **FM**  
 Description: **Fracture Multiple**

Distance (ft): **186.8**  
 Structural Grade: **4**  
 O&M Grade: **0**  
 Clock Start/From: **12**  
 Clock To: **3**  
 1st Value:  
 2nd Value:  
 Value Percent:  
 Continuous Index:  
 Within 8" of Joint: **YES**  
 Remarks:

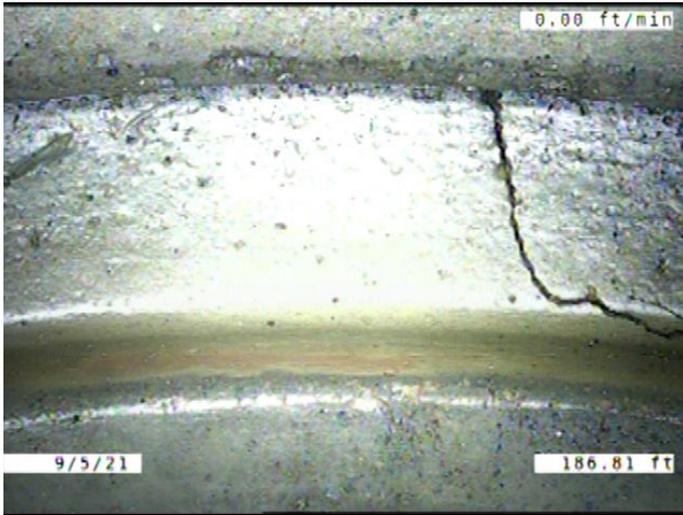
Code: **JAL**  
Description: **Joint Angular Large**

Distance (ft): **186.8**  
Structural Grade: **4**  
O&M Grade: **0**  
Clock Start/From:  
Clock To:  
1st Value:  
2nd Value:  
Value Percent:  
Continuous Index:  
Within 8" of Joint: **NO**  
Remarks:

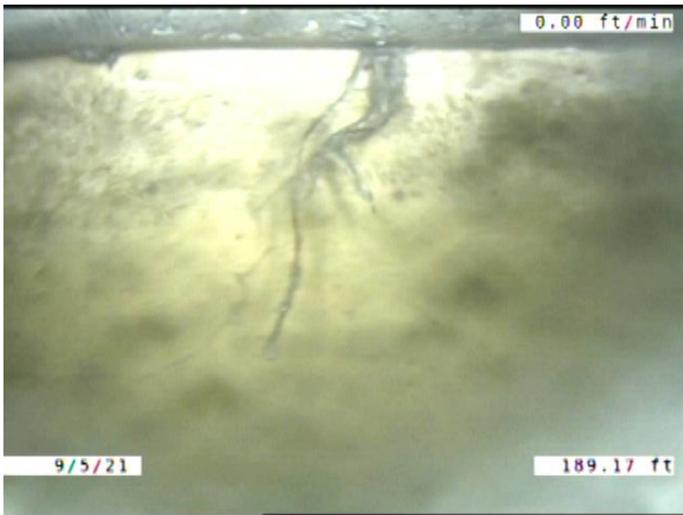
Code: **MCU**  
Description: **Miscellaneous Camera Underwater**

Distance (ft): **189.2**  
Structural Grade: **0**  
O&M Grade: **4**  
Clock Start/From:  
Clock To:  
1st Value:  
2nd Value:  
Value Percent:  
Continuous Index:  
Within 8" of Joint: **NO**  
Remarks: **Out at 189.6**

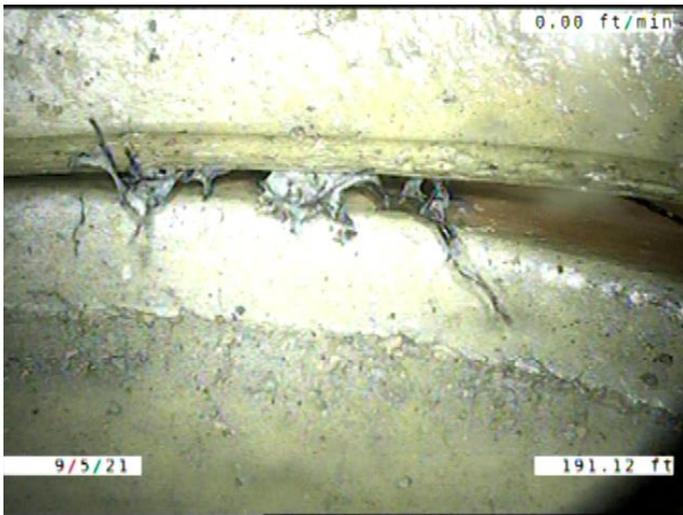
Code: **RFJ**  
Description: **Roots Fine Joint**

Distance (ft): **191.1**  
Structural Grade: **0**  
O&M Grade: **1**  
Clock Start/From: **12**  
Clock To: **1**  
1st Value:  
2nd Value:  
Value Percent:  
Continuous Index:  
Within 8" of Joint: **YES**  
Remarks:

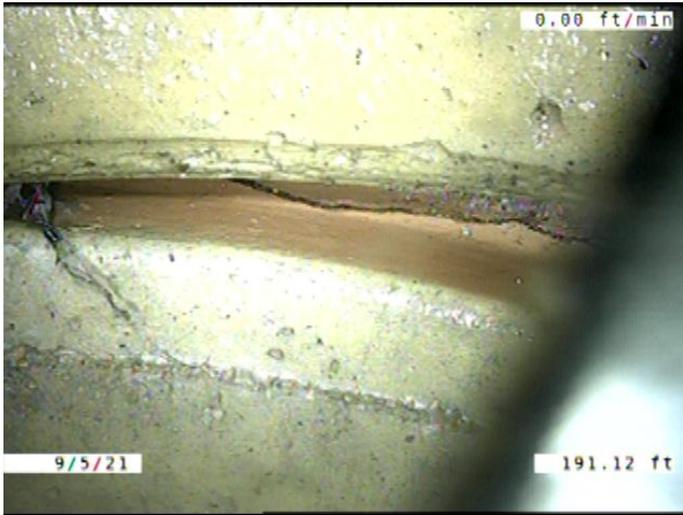
Code: **FM**  
 Description: **Fracture Multiple**

Distance (ft): **191.1**  
 Structural Grade: **4**  
 O&M Grade: **0**  
 Clock Start/From: **1**  
 Clock To: **2**  
 1st Value:  
 2nd Value:  
 Value Percent:  
 Continuous Index:  
 Within 8" of Joint: **YES**  
 Remarks:

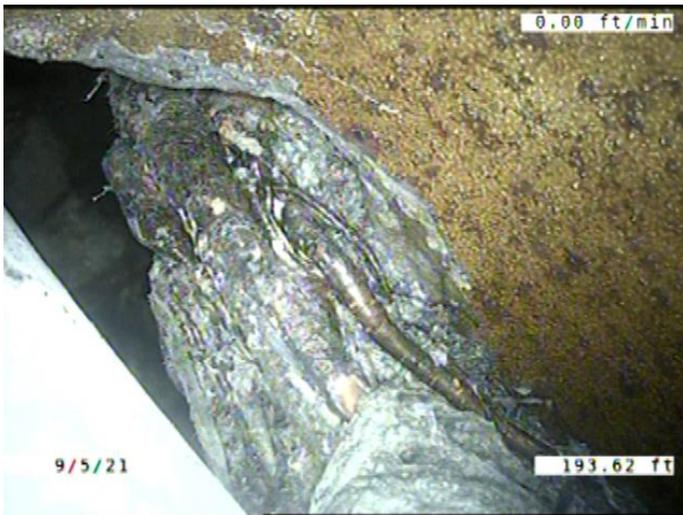
Code: **RTJ**  
 Description: **Roots Tap Joint**

Distance (ft): **193.6**  
 Structural Grade: **0**  
 O&M Grade: **2**  
 Clock Start/From: **9**  
 Clock To: **3**  
 1st Value:  
 2nd Value:  
 Value Percent: **50.000**  
 Continuous Index:  
 Within 8" of Joint: **YES**  
 Remarks:
