# Profile/Photo Observation Report

Date:	09/05/2021	Weather:		Coding:	PACP 7.0
Pipe Length (ft):	195.3	Owner:	City of Hobart	Pre Clean:	Heavy Cleaning
P.O.#:	YES502259	Surveyor:	S. Bucklin	PSR:	P-504-077-076
Customer:	City of Hobart	Clean Date:	09/02/2021	Shape:	C

Street:	North Cavender Street	Flow Control:	Not Controlled
City:	Hobart, IN	Year Renewed:	
Location:	Alley	Tape/Media #:	
Purpose:	Routine Assessment	Dia/Height:	12"
Use:	Sanitary Sewage Pipe	Material:	VCP
Drain Area:		Lining:	
Category:	NA		
Comment:			
Location Details:		Direction of Survey:	Downstream
US MH:	M-504-077	DS MH:	M-504-076
		Total Length Surveyed (ft):	195.3

O&M Index:	2.08	O&M Quick:	4336	O&M Rating:	154.00
Structural Index:	3.11	Structural Quick:	4A3A	Structural Rating:	84.00
Overall Index:	2.36	Overall Quick:	4A3B	Overall Rating:	238.00

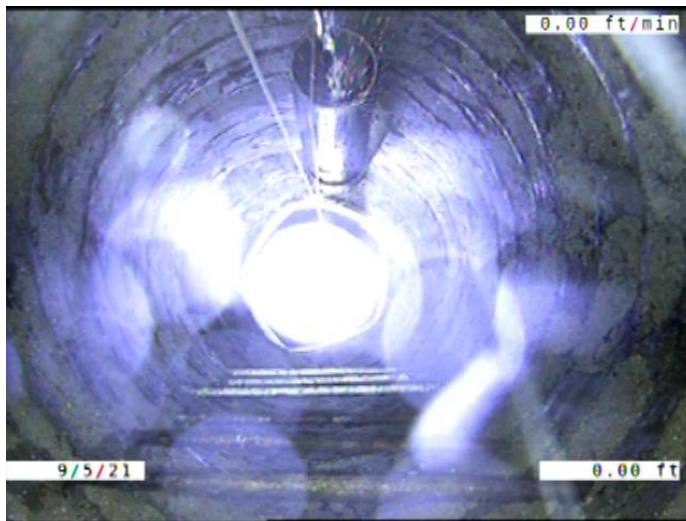
Code: **AMH**  
Description: **Manhole**

Distance (ft): **.0**  
Structural Grade: **0**  
O&M Grade: **0**  
Clock Start/From:  
Clock To:  
1st Value:  
2nd Value:  
Value Percent:  
Continuous Index:  
Within 8" of Joint: **NO**  
Remarks: **M-504-077**

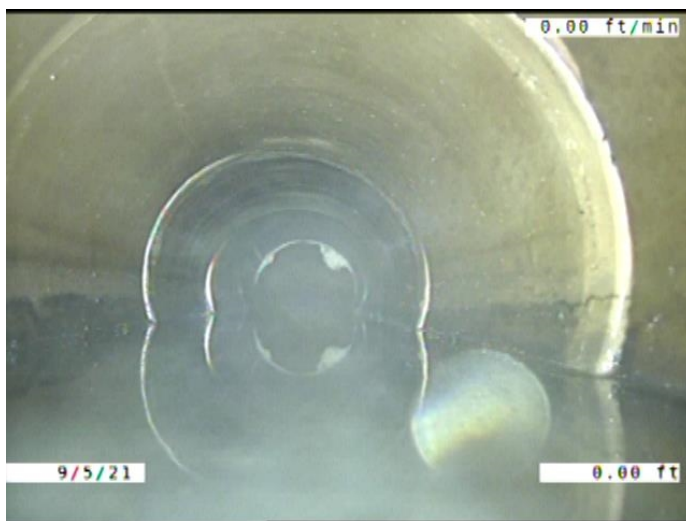
Code: **MWL**  
Description: **Miscellaneous Water Level**

Distance (ft): **.0**  
Structural Grade: **0**  
O&M Grade: **0**  
Clock Start/From:  
Clock To:  
1st Value:  
2nd Value:  
Value Percent: **10.000**  
Continuous Index:  
Within 8" of Joint: **NO**  
Remarks:

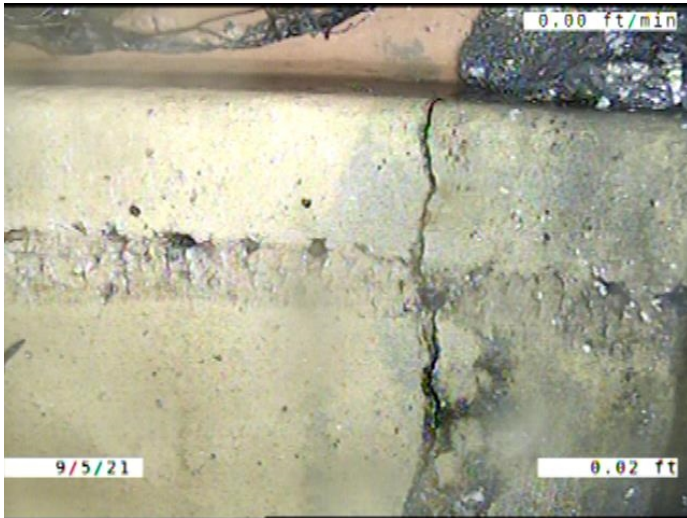
Code: **CM**  
Description: **Crack Multiple**

Distance (ft): **.0**  
Structural Grade: **3**  
O&M Grade: **0**  
Clock Start/From: **2**  
Clock To: **3**  
1st Value:  
2nd Value:  
Value Percent:  
Continuous Index:  
Within 8" of Joint: **YES**  
Remarks:

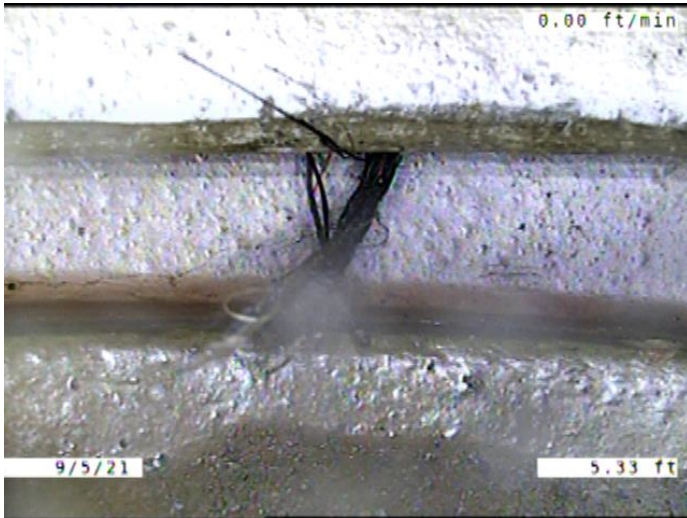
Code: **RFJ**  
Description: **Roots Fine Joint**

Distance (ft): **5.3**  
Structural Grade: **0**  
O&M Grade: **1**  
Clock Start/From: **9**  
Clock To: **11**  
1st Value:  
2nd Value:  
Value Percent:  
Continuous Index:  
Within 8" of Joint: **YES**  
Remarks:

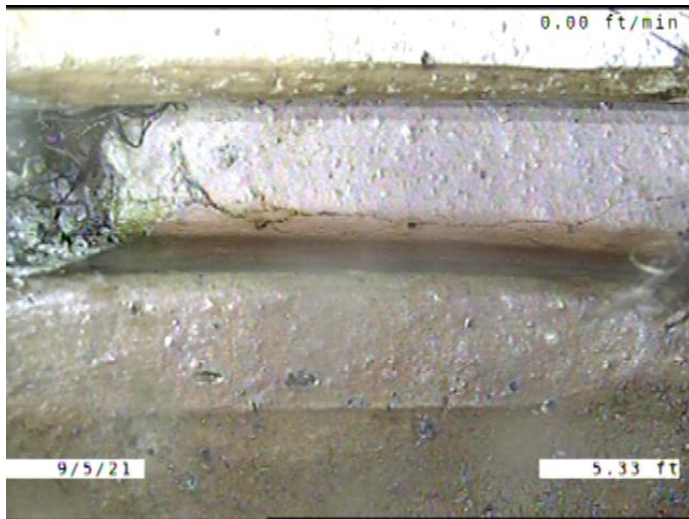
Code: **CM**  
 Description: **Crack Multiple**

Distance (ft): **5.3**  
 Structural Grade: **3**  
 O&M Grade: **0**  
 Clock Start/From: **9**  
 Clock To: **11**  
 1st Value:  
 2nd Value:  
 Value Percent:  
 Continuous Index:  
 Within 8" of Joint: **YES**  
 Remarks:

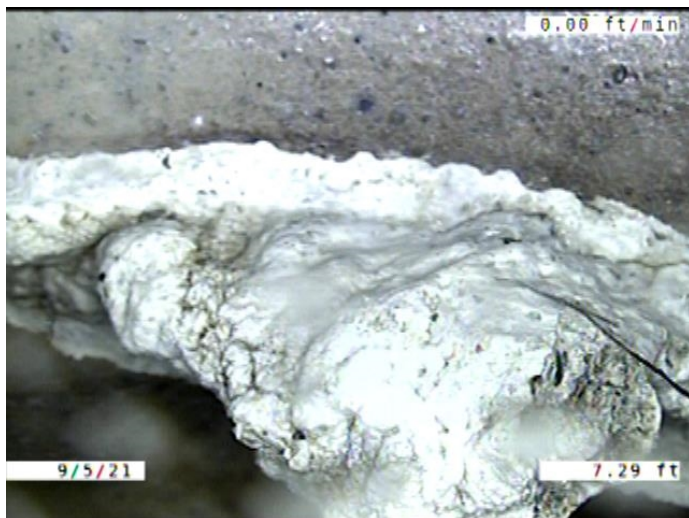
Code: **DAE**  
 Description: **Deposits Attached Encrustation**

Distance (ft): **7.3**  
 Structural Grade: **0**  
 O&M Grade: **2**  
 Clock Start/From: **9**  
 Clock To: **3**  
 1st Value:  
 2nd Value:  
 Value Percent: **5.000**  
 Continuous Index:  
 Within 8" of Joint: **YES**  
 Remarks:

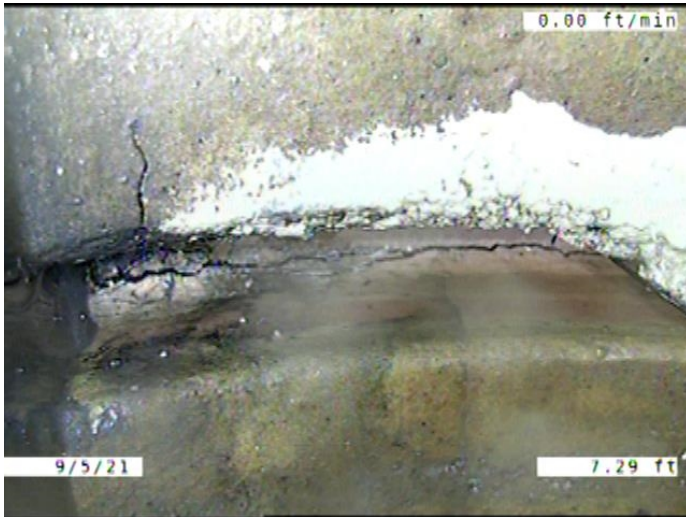
Code: **FM**  
 Description: **Fracture Multiple**

Distance (ft): **7.3**  
 Structural Grade: **4**  
 O&M Grade: **0**  
 Clock Start/From: **9**  
 Clock To: **10**  
 1st Value:  
 2nd Value:  
 Value Percent:  
 Continuous Index:  
 Within 8" of Joint: **YES**  
 Remarks:

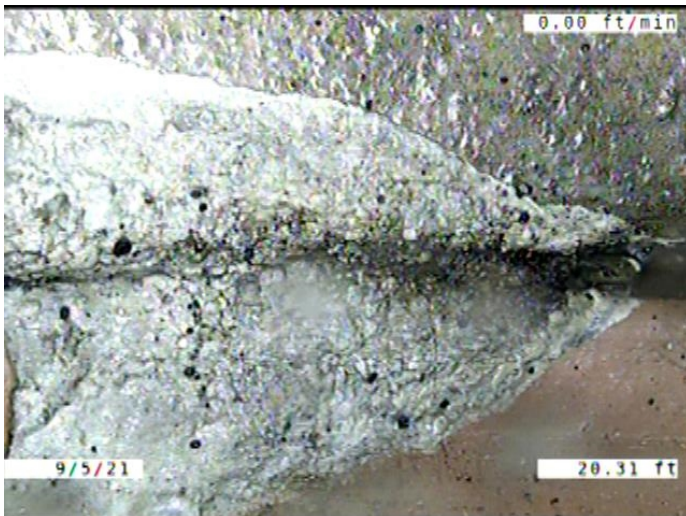
Code: **DAE**  
 Description: **Deposits Attached Encrustation**

Distance (ft): **20.3**  
 Structural Grade: **0**  
 O&M Grade: **2**  
 Clock Start/From: **9**  
 Clock To: **10**  
 1st Value:  
 2nd Value:  
 Value Percent: **5.000**  
 Continuous Index:  
 Within 8" of Joint: **YES**  
 Remarks:

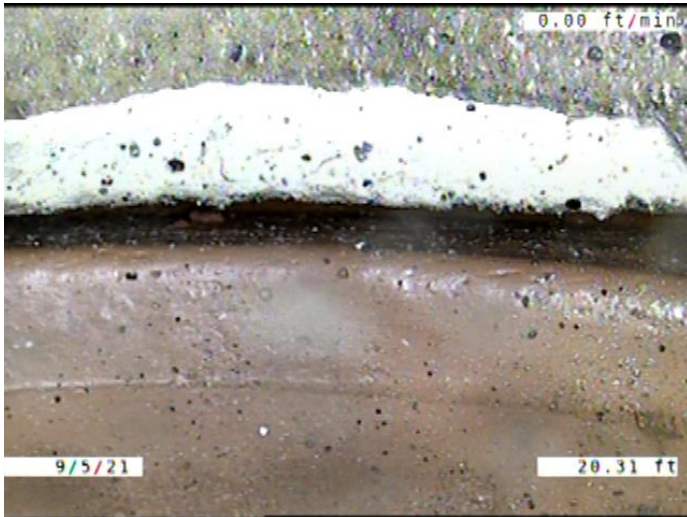
Code: **DAE**  
 Description: **Deposits Attached Encrustation**

Distance (ft): **20.3**  
 Structural Grade: **0**  
 O&M Grade: **2**  
 Clock Start/From: **12**  
 Clock To: **3**  
 1st Value:  
 2nd Value:  
 Value Percent: **5.000**  
 Continuous Index:  
 Within 8" of Joint: **YES**  
 Remarks:

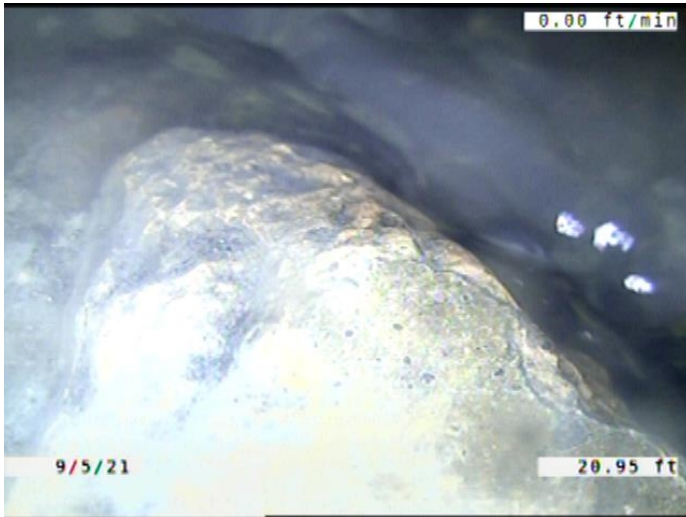
Code:	<b>OBM</b>
Description:	<b>Obstruction Pipe Material in Invert</b>
Distance (ft):	<b>21.0</b>
Structural Grade:	<b>0</b>
O&M Grade:	<b>2</b>
Clock Start/From:	<b>5</b>
Clock To:	<b>6</b>
1st Value:	
2nd Value:	
Value Percent:	<b>5.000</b>
Continuous Index:	
Within 8" of Joint:	<b>YES</b>
Remarks:

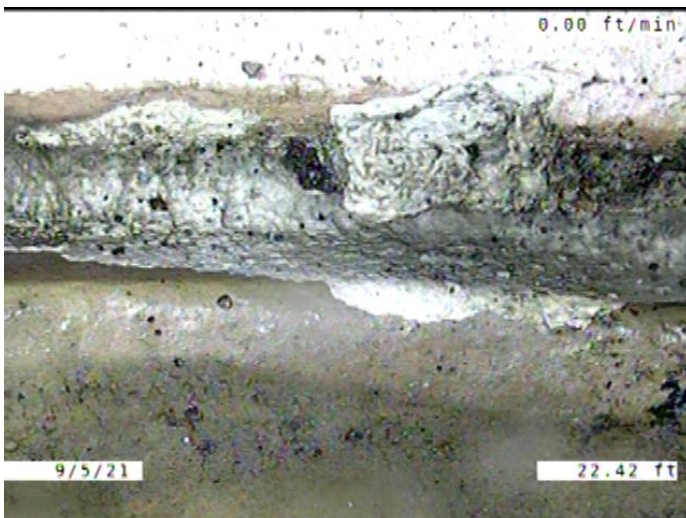
Code:	<b>DAE</b>
Description:	<b>Deposits Attached Encrustation</b>
Distance (ft):	<b>22.4</b>
Structural Grade:	<b>0</b>
O&M Grade:	<b>2</b>
Clock Start/From:	<b>8</b>
Clock To:	<b>10</b>
1st Value:	
2nd Value:	
Value Percent:	<b>5.000</b>
Continuous Index:	
Within 8" of Joint:	<b>YES</b>
Remarks:

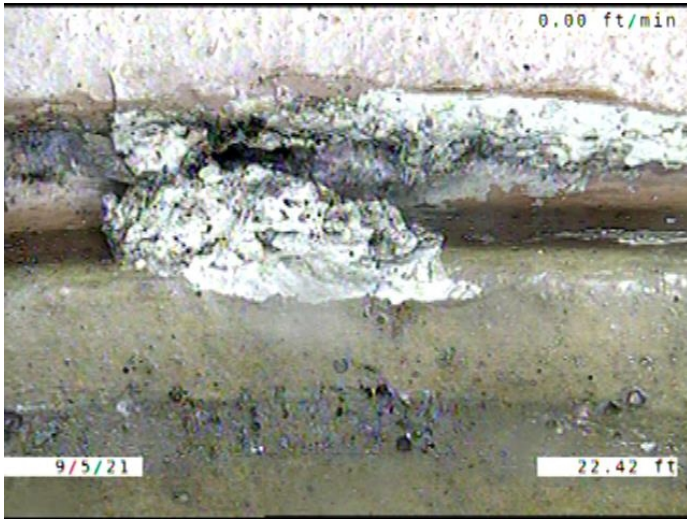
Code: **DAE**  
 Description: **Deposits Attached Encrustation**

Distance (ft): **22.4**  
 Structural Grade: **0**  
 O&M Grade: **2**  
 Clock Start/From: **2**  
 Clock To: **4**  
 1st Value:  
 2nd Value:  
 Value Percent: **5.000**  
 Continuous Index:  
 Within 8" of Joint: **YES**  
 Remarks:

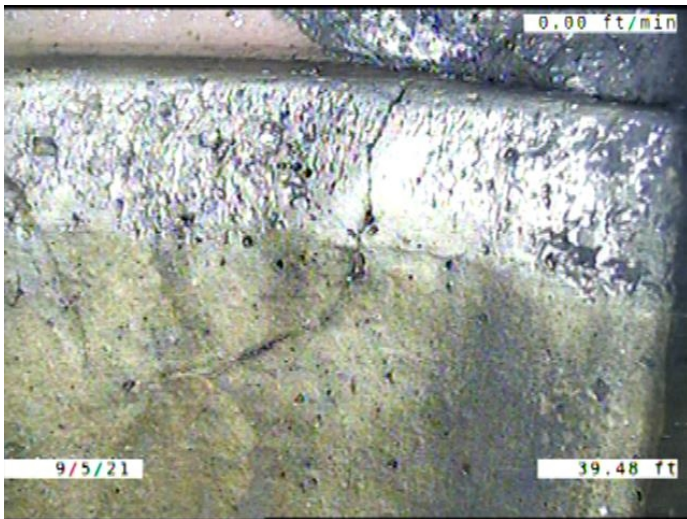
Code: **CL**  
 Description: **Crack Longitudinal**

Distance (ft): **39.5**  
 Structural Grade: **2**  
 O&M Grade: **0**  
 Clock Start/From: **3**  
 Clock To:  
 1st Value:  
 2nd Value:  
 Value Percent:  
 Continuous Index:  
 Within 8" of Joint: **YES**  
 Remarks:

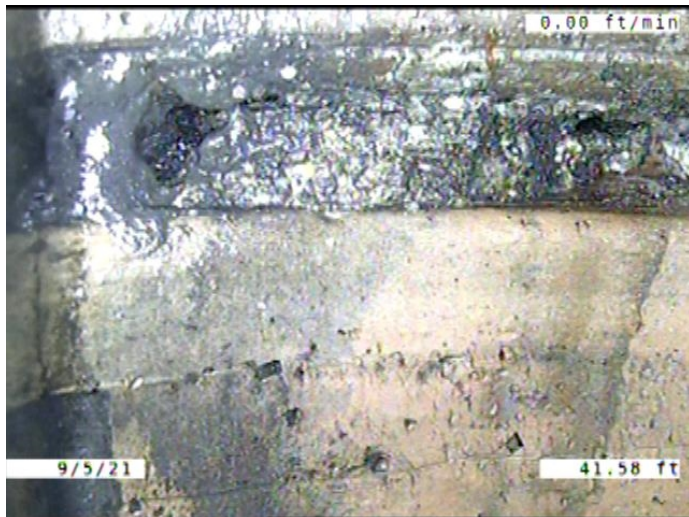
Code: **DAE**  
 Description: **Deposits Attached Encrustation**

Distance (ft): **41.6**  
 Structural Grade: **0**  
 O&M Grade: **2**  
 Clock Start/From: **9**  
 Clock To:  
 1st Value:  
 2nd Value:  
 Value Percent: **5.000**  
 Continuous Index:  
 Within 8" of Joint: **YES**  
 Remarks:

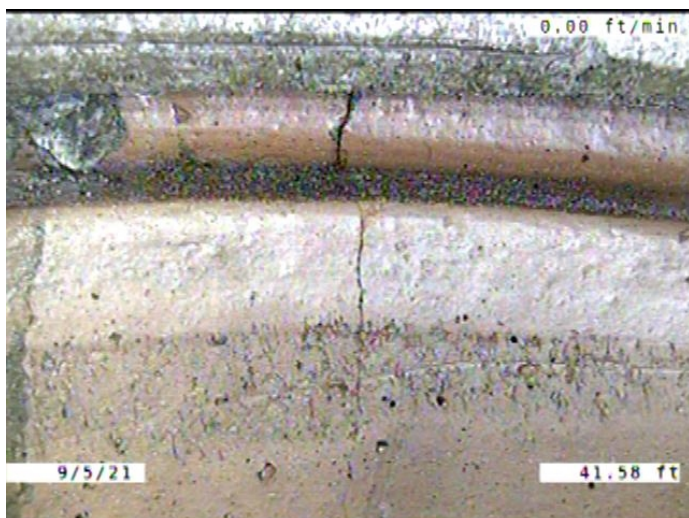
Code: **CL**  
 Description: **Crack Longitudinal**

Distance (ft): **41.6**  
 Structural Grade: **2**  
 O&M Grade: **0**  
 Clock Start/From: **10**  
 Clock To:  
 1st Value:  
 2nd Value:  
 Value Percent:  
 Continuous Index:  
 Within 8" of Joint: **YES**  
 Remarks:

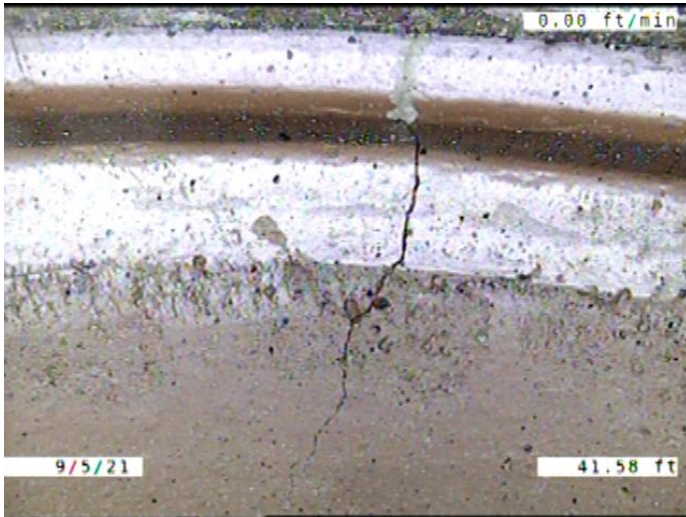
Code: **CL**  
 Description: **Crack Longitudinal**

Distance (ft): **41.6**  
 Structural Grade: **2**  
 O&M Grade: **0**  
 Clock Start/From: **12**  
 Clock To:  
 1st Value:  
 2nd Value:  
 Value Percent:  
 Continuous Index:  
 Within 8" of Joint: **YES**  
 Remarks:

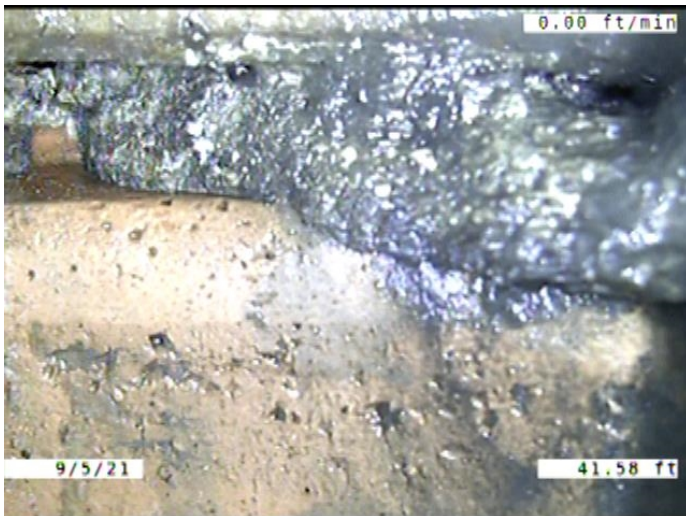
Code: **DAE**  
 Description: **Deposits Attached Encrustation**

Distance (ft): **41.6**  
 Structural Grade: **0**  
 O&M Grade: **2**  
 Clock Start/From: **3**  
 Clock To:  
 1st Value:  
 2nd Value:  
 Value Percent: **5.000**  
 Continuous Index:  
 Within 8" of Joint: **YES**  
 Remarks:

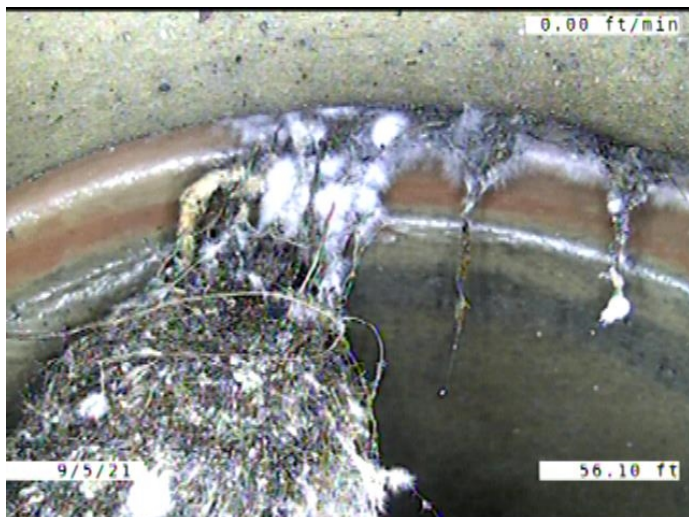
Code: **RMJ**  
 Description: **Roots Medium Joint**

Distance (ft): **56.1**  
 Structural Grade: **0**  
 O&M Grade: **3**  
 Clock Start/From: **11**  
 Clock To: **1**  
 1st Value:  
 2nd Value:  
 Value Percent: **10.000**  
 Continuous Index:  
 Within 8" of Joint: **YES**  
 Remarks:

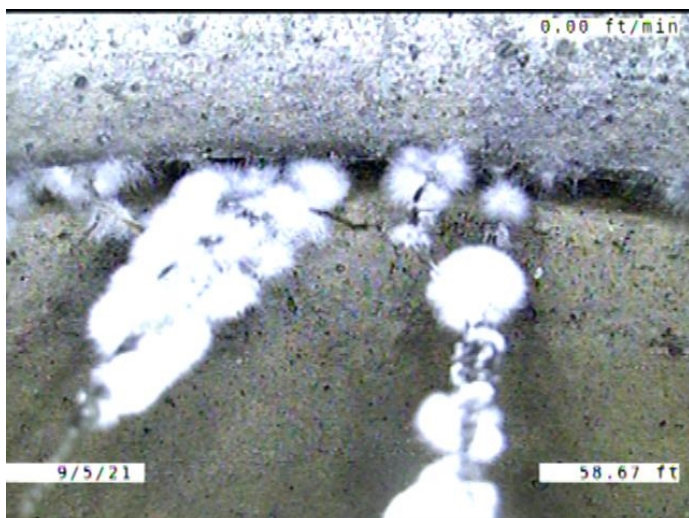
Code: **RFJ**  
 Description: **Roots Fine Joint**

Distance (ft): **58.7**  
 Structural Grade: **0**  
 O&M Grade: **1**  
 Clock Start/From: **11**  
 Clock To: **1**  
 1st Value:  
 2nd Value:  
 Value Percent:  
 Continuous Index:  
 Within 8" of Joint: **YES**  
 Remarks:

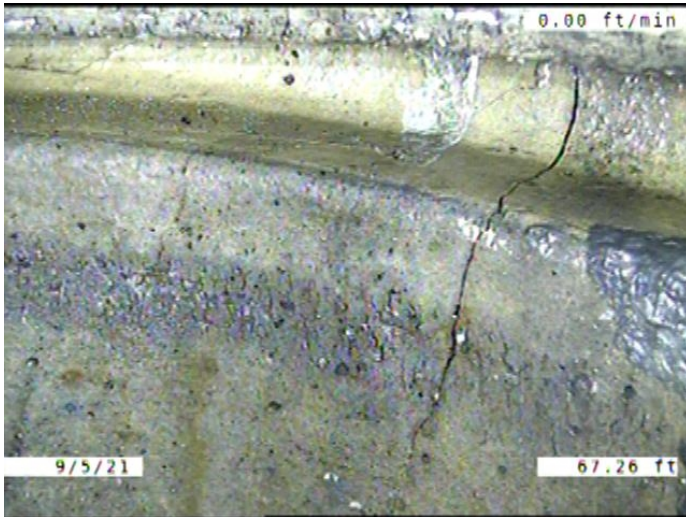
Code: **CL**  
 Description: **Crack Longitudinal**

Distance (ft): **67.3**  
 Structural Grade: **2**  
 O&M Grade: **0**  
 Clock Start/From: **2**  
 Clock To:  
 1st Value:  
 2nd Value:  
 Value Percent:  
 Continuous Index:  
 Within 8" of Joint: **YES**  
 Remarks:

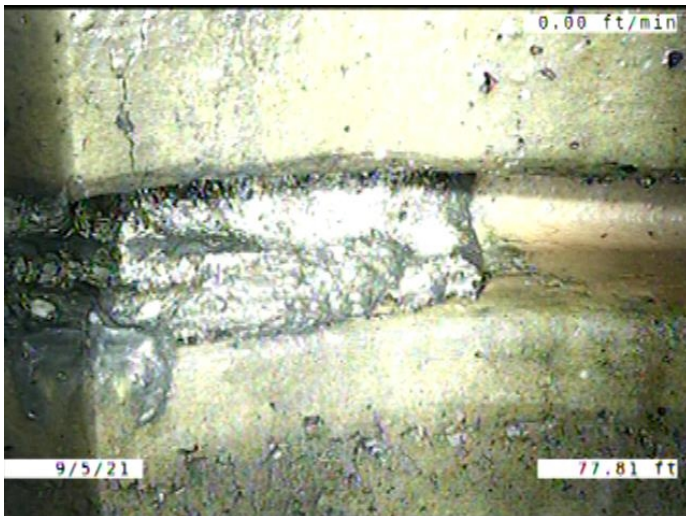
Code: **DAE**  
 Description: **Deposits Attached Encrustation**

Distance (ft): **77.8**  
 Structural Grade: **0**  
 O&M Grade: **2**  
 Clock Start/From: **9**  
 Clock To:  
 1st Value:  
 2nd Value:  
 Value Percent: **5.000**  
 Continuous Index:  
 Within 8" of Joint: **YES**  
 Remarks:

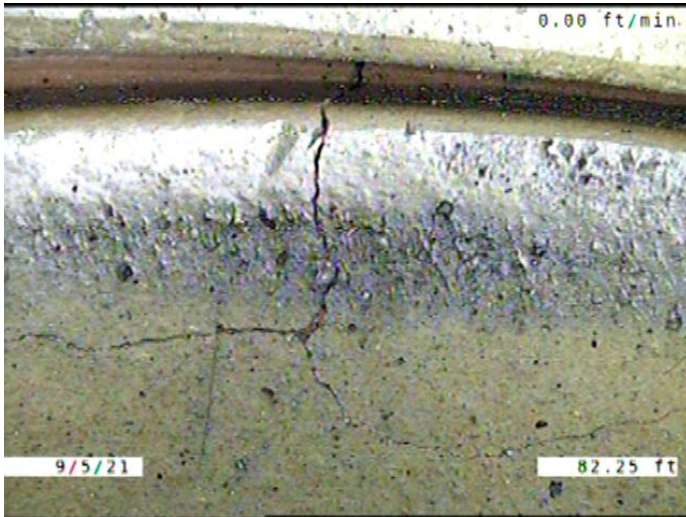
Code: **CM**  
 Description: **Crack Multiple**

Distance (ft): **82.2**  
 Structural Grade: **3**  
 O&M Grade: **0**  
 Clock Start/From: **11**  
 Clock To: **2**  
 1st Value:  
 2nd Value:  
 Value Percent:  
 Continuous Index:  
 Within 8" of Joint: **YES**  
 Remarks:

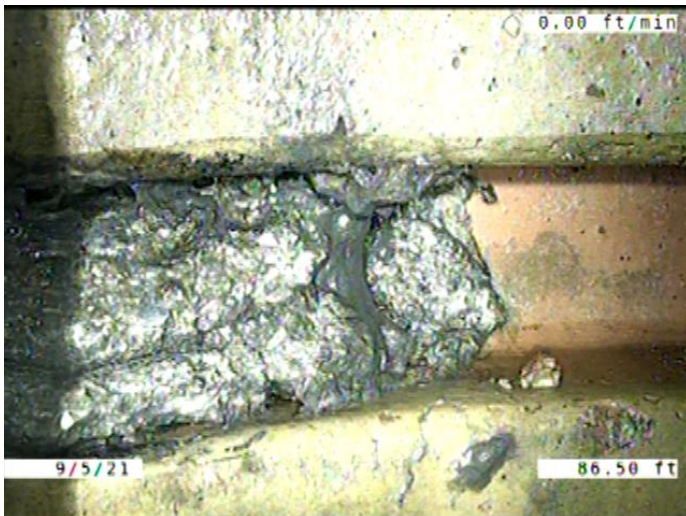
Code: **DAE**  
 Description: **Deposits Attached Encrustation**

Distance (ft): **86.5**  
 Structural Grade: **0**  
 O&M Grade: **2**  
 Clock Start/From: **9**  
 Clock To:  
 1st Value:  
 2nd Value:  
 Value Percent: **5.000**  
 Continuous Index:  
 Within 8" of Joint: **YES**  
 Remarks:

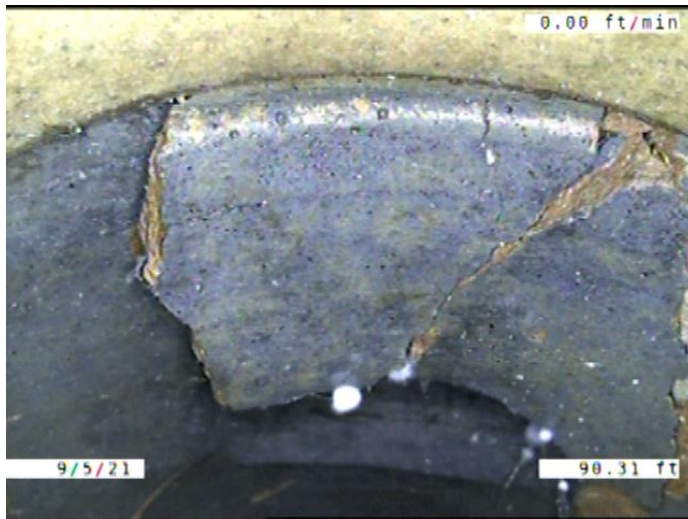
Code: **B**  
 Description: **Broken**

Distance (ft): **90.3**  
 Structural Grade: **4**  
 O&M Grade: **0**  
 Clock Start/From: **8**  
 Clock To: **4**  
 1st Value:  
 2nd Value:  
 Value Percent:  
 Continuous Index:  
 Within 8" of Joint: **YES**  
 Remarks:

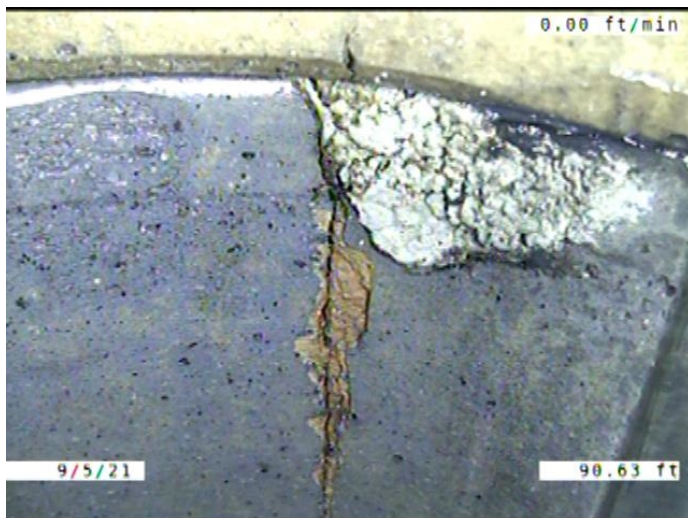
Code: **DAE**  
 Description: **Deposits Attached Encrustation**

Distance (ft): **90.6**  
 Structural Grade: **0**  
 O&M Grade: **2**  
 Clock Start/From: **1**  
 Clock To: **4**  
 1st Value:  
 2nd Value:  
 Value Percent: **5.000**  
 Continuous Index:  
 Within 8" of Joint: **YES**  
 Remarks:

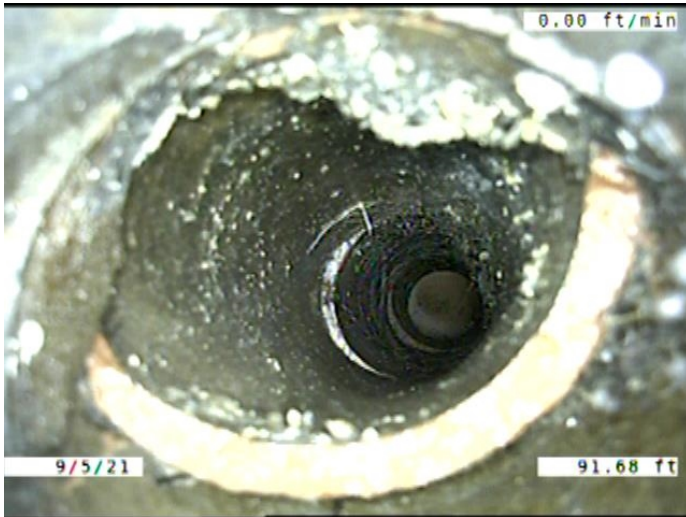
Code: **TFD**  
 Description: **Tap Factory Defective**

Distance (ft): **91.7**  
 Structural Grade: **0**  
 O&M Grade: **3**  
 Clock Start/From: **12**  
 Clock To:  
 1st Value: **6.000**  
 2nd Value:  
 Value Percent:  
 Continuous Index:  
 Within 8" of Joint: **YES**  
 Remarks: **LOOKS TO BE CAPPED**

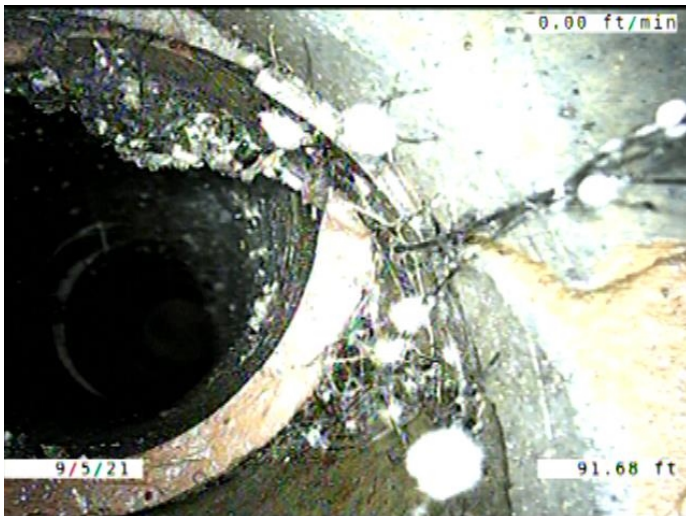
Code: **RFL**  
 Description: **Roots Fine Lateral**

Distance (ft): **91.7**  
 Structural Grade: **0**  
 O&M Grade: **1**  
 Clock Start/From: **11**  
 Clock To: **1**  
 1st Value:  
 2nd Value:  
 Value Percent:  
 Continuous Index:  
 Within 8" of Joint: **NO**  
 Remarks:

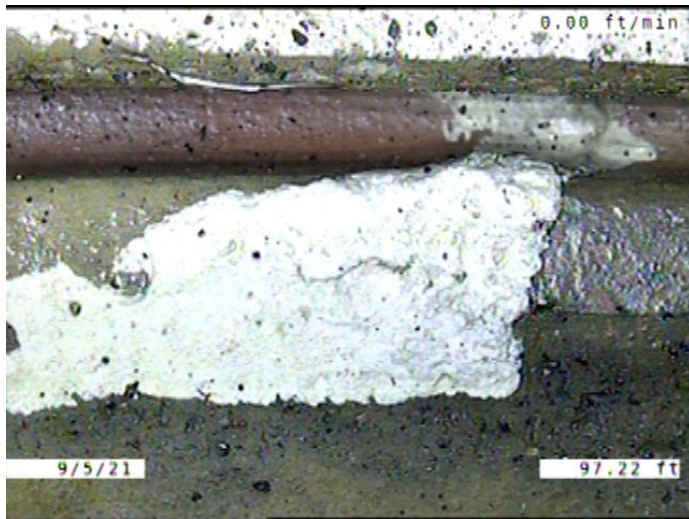
Code: **DAE**  
 Description: **Deposits Attached Encrustation**

Distance (ft): **97.2**  
 Structural Grade: **0**  
 O&M Grade: **2**  
 Clock Start/From: **10**  
 Clock To: **11**  
 1st Value:  
 2nd Value:  
 Value Percent: **5.000**  
 Continuous Index:  
 Within 8" of Joint: **YES**  
 Remarks:

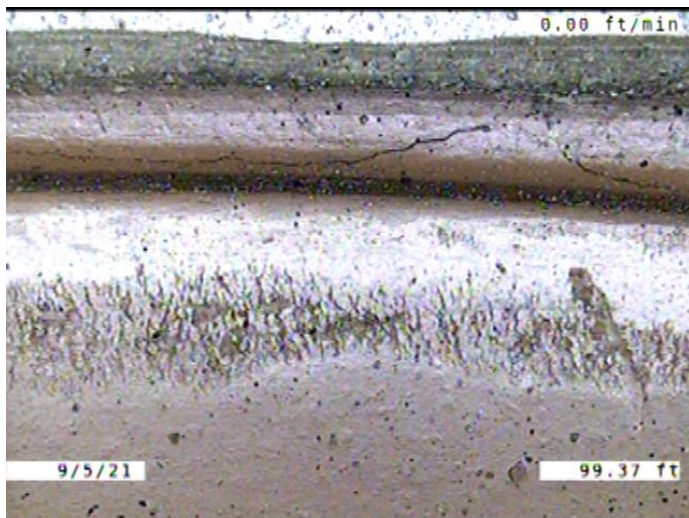
Code: **CM**  
 Description: **Crack Multiple**

Distance (ft): **99.4**  
 Structural Grade: **3**  
 O&M Grade: **0**  
 Clock Start/From: **10**  
 Clock To: **1**  
 1st Value:  
 2nd Value:  
 Value Percent:  
 Continuous Index:  
 Within 8" of Joint: **YES**  
 Remarks:

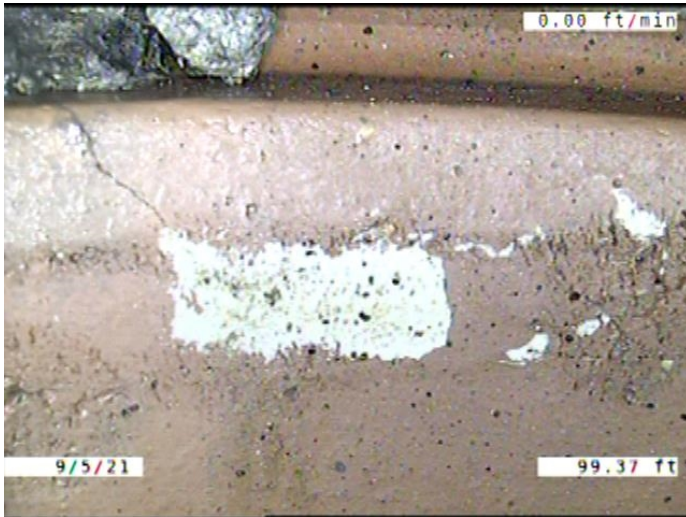
Code: **DAE**  
Description: **Deposits Attached Encrustation**

Distance (ft): **99.4**  
Structural Grade: **0**  
O&M Grade: **2**  
Clock Start/From: **10**  
Clock To:  
1st Value:  
2nd Value:  
Value Percent: **5.000**  
Continuous Index:  
Within 8" of Joint: **YES**  
Remarks:

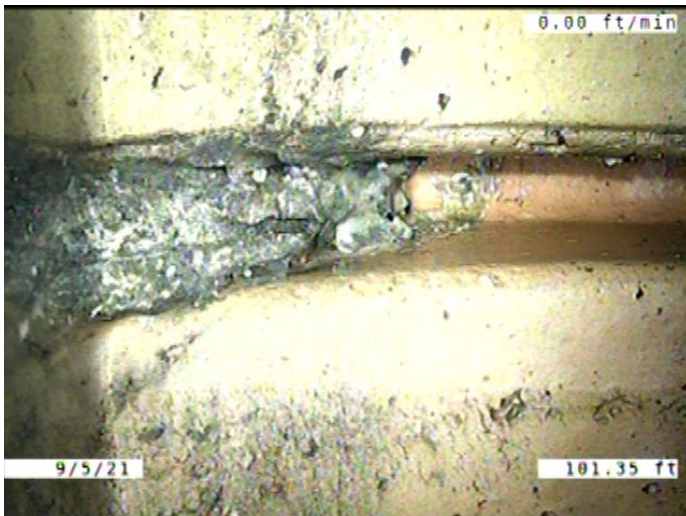
Code: **DAE**  
Description: **Deposits Attached Encrustation**

Distance (ft): **101.4**  
Structural Grade: **0**  
O&M Grade: **2**  
Clock Start/From: **9**  
Clock To:  
1st Value:  
2nd Value:  
Value Percent: **5.000**  
Continuous Index:  
Within 8" of Joint: **YES**  
Remarks:

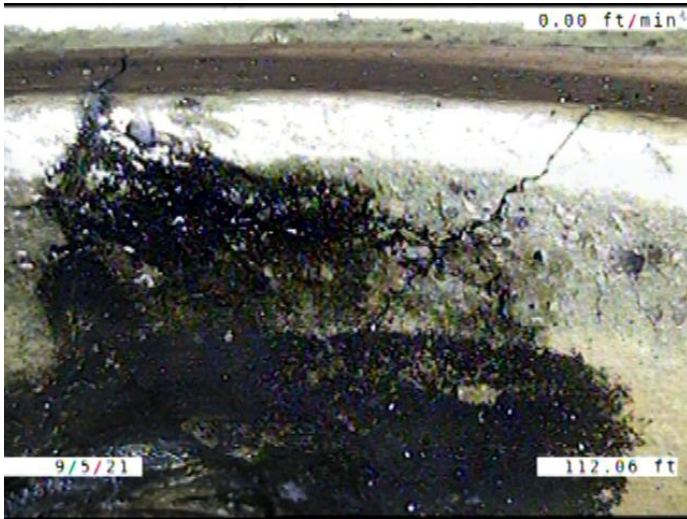
Code: **CM**  
 Description: **Crack Multiple**

Distance (ft): **112.1**  
 Structural Grade: **3**  
 O&M Grade: **0**  
 Clock Start/From: **11**  
 Clock To: **1**  
 1st Value:  
 2nd Value:  
 Value Percent:  
 Continuous Index:  
 Within 8" of Joint: **YES**  
 Remarks:

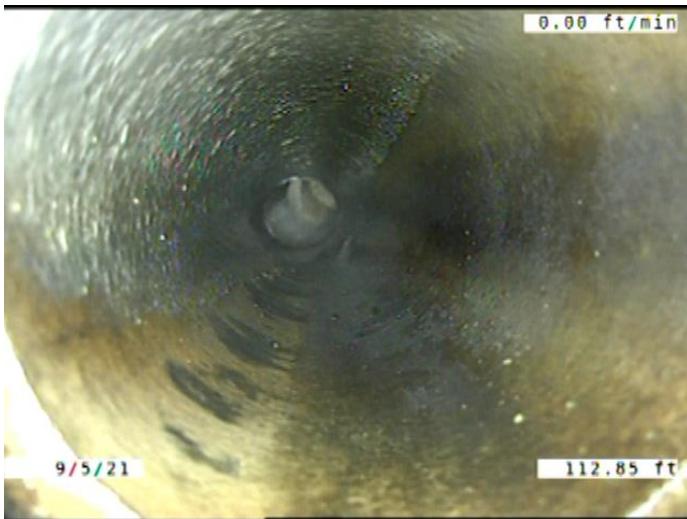
Code: **TBD**  
 Description: **Tap Break-in/Hammer Defective**

Distance (ft): **112.9**  
 Structural Grade: **0**  
 O&M Grade: **3**  
 Clock Start/From: **12**  
 Clock To:  
 1st Value: **6.000**  
 2nd Value:  
 Value Percent:  
 Continuous Index:  
 Within 8" of Joint: **YES**  
 Remarks: **Defective**

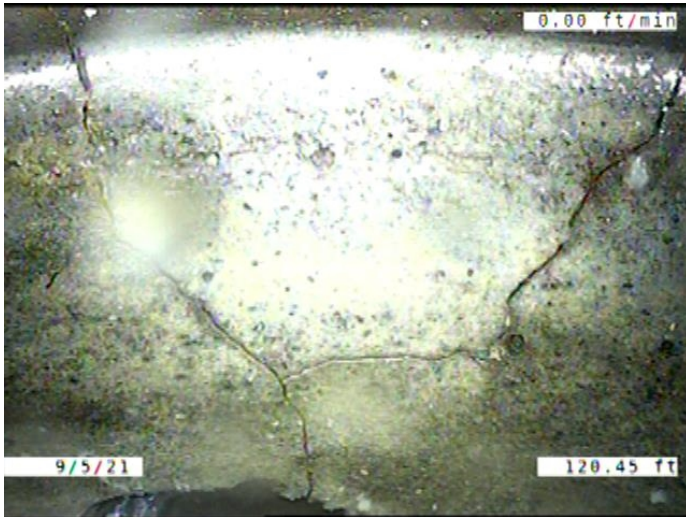
Code: **FM**  
 Description: **Fracture Multiple**

Distance (ft): **120.5**  
 Structural Grade: **4**  
 O&M Grade: **0**  
 Clock Start/From: **11**  
 Clock To: **1**  
 1st Value:  
 2nd Value:  
 Value Percent:  
 Continuous Index:  
 Within 8" of Joint: **YES**  
 Remarks:

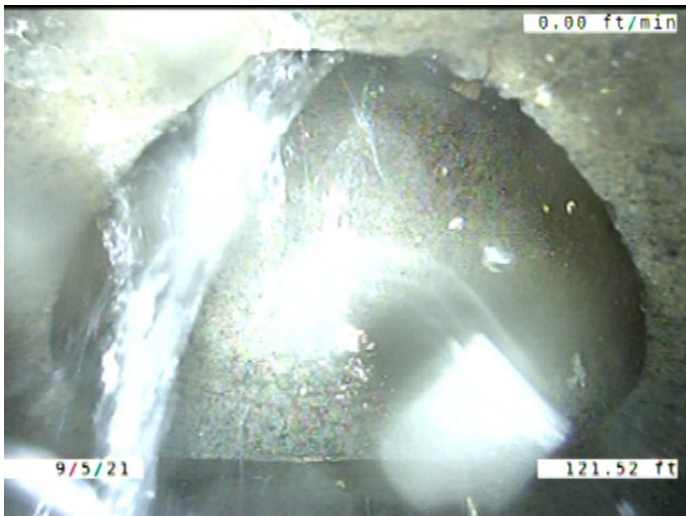
Code: **TFD**  
 Description: **Tap Factory Defective**

Distance (ft): **121.5**  
 Structural Grade: **0**  
 O&M Grade: **3**  
 Clock Start/From: **11**  
 Clock To:  
 1st Value: **6.000**  
 2nd Value:  
 Value Percent:  
 Continuous Index:  
 Within 8" of Joint: **YES**  
 Remarks: **CONSTANTLY RUNNING WATER**

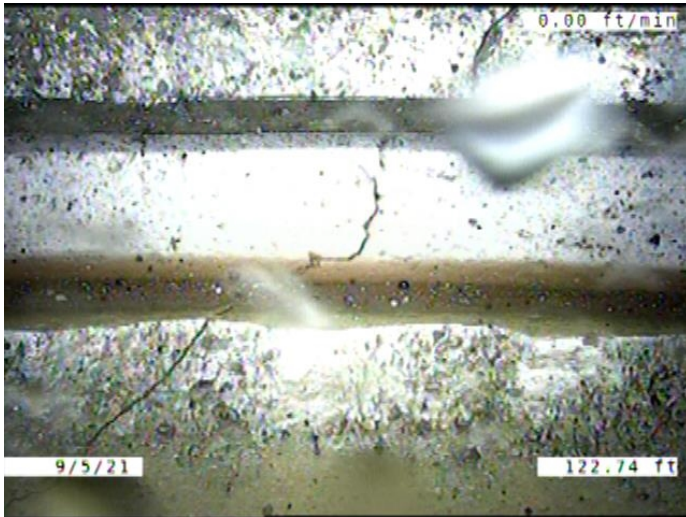
Code: **CM**  
 Description: **Crack Multiple**

Distance (ft): **122.7**  
 Structural Grade: **3**  
 O&M Grade: **0**  
 Clock Start/From: **9**  
 Clock To: **12**  
 1st Value:  
 2nd Value:  
 Value Percent:  
 Continuous Index:  
 Within 8" of Joint: **YES**  
 Remarks:

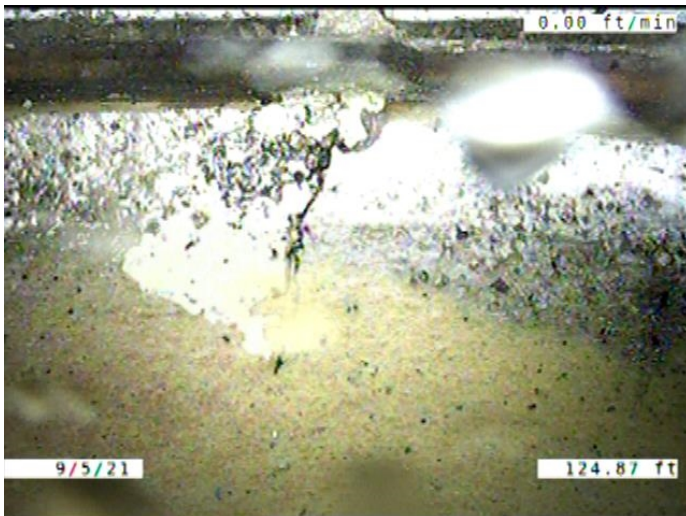
Code: **CL**  
 Description: **Crack Longitudinal**

Distance (ft): **124.9**  
 Structural Grade: **2**  
 O&M Grade: **0**  
 Clock Start/From: **12**  
 Clock To:  
 1st Value:  
 2nd Value:  
 Value Percent:  
 Continuous Index:  
 Within 8" of Joint: **YES**  
 Remarks:

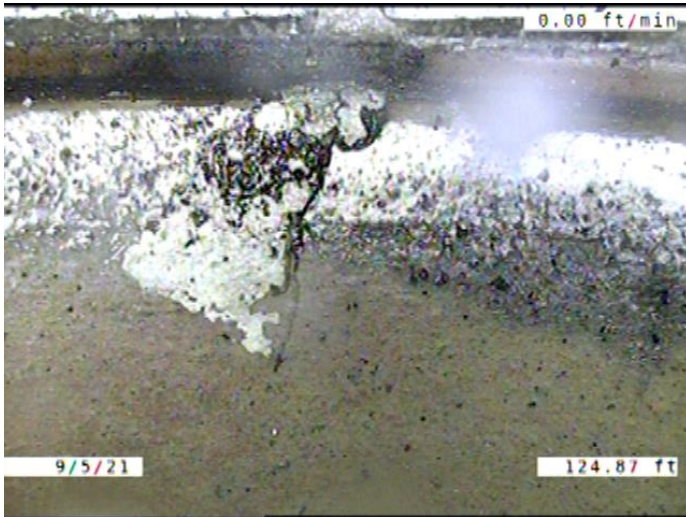
Code:	<b>DAE</b>
Description:	<b>Deposits Attached Encrustation</b>
Distance (ft):	<b>124.9</b>
Structural Grade:	<b>0</b>
O&M Grade:	<b>2</b>
Clock Start/From:	<b>12</b>
Clock To:	
1st Value:	
2nd Value:	
Value Percent:	<b>5.000</b>
Continuous Index:	
Within 8" of Joint:	<b>YES</b>
Remarks:

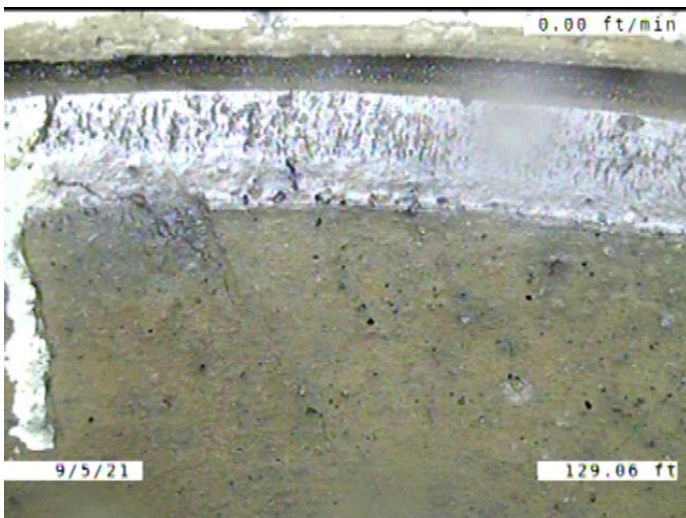
Code:	<b>CM</b>
Description:	<b>Crack Multiple</b>
Distance (ft):	<b>129.1</b>
Structural Grade:	<b>3</b>
O&M Grade:	<b>0</b>
Clock Start/From:	<b>11</b>
Clock To:	<b>1</b>
1st Value:	
2nd Value:	
Value Percent:	
Continuous Index:	
Within 8" of Joint:	<b>YES</b>
Remarks:

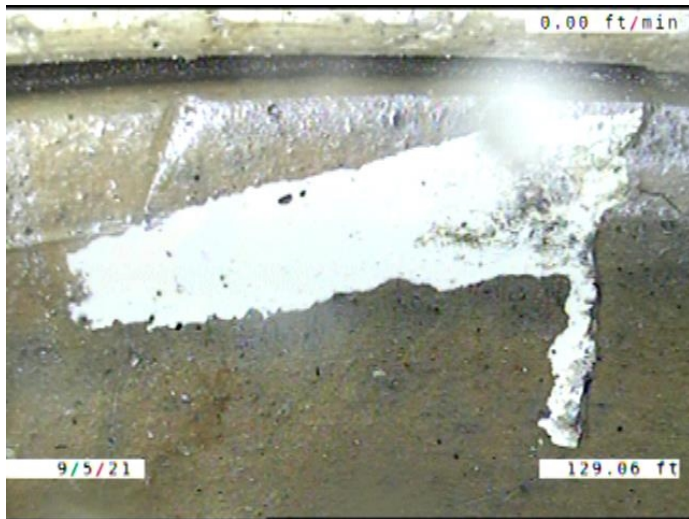
Code: **DAE**  
 Description: **Deposits Attached Encrustation**

Distance (ft): **129.1**  
 Structural Grade: **0**  
 O&M Grade: **2**  
 Clock Start/From: **10**  
 Clock To: **11**  
 1st Value:  
 2nd Value:  
 Value Percent: **5.000**  
 Continuous Index:  
 Within 8" of Joint: **YES**  
 Remarks:

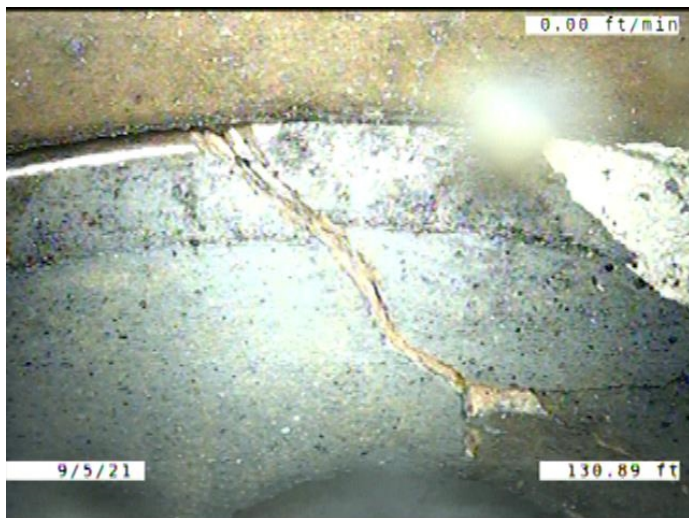
Code: **B**  
 Description: **Broken**

Distance (ft): **130.9**  
 Structural Grade: **4**  
 O&M Grade: **0**  
 Clock Start/From: **10**  
 Clock To: **3**  
 1st Value:  
 2nd Value:  
 Value Percent:  
 Continuous Index:  
 Within 8" of Joint: **YES**  
 Remarks:

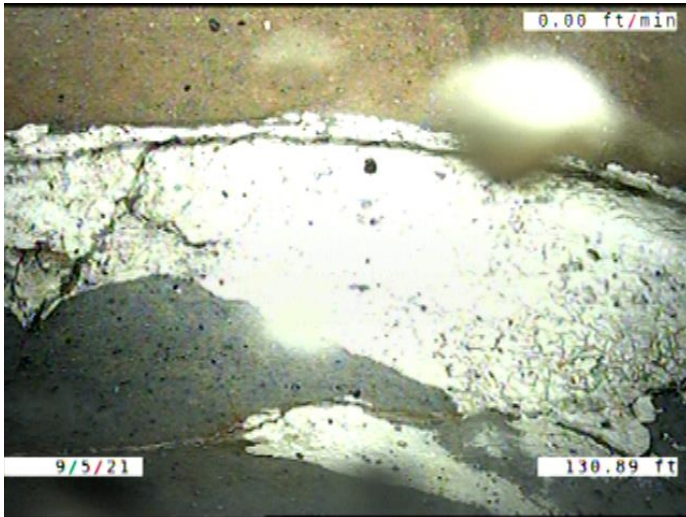
Code: **DAE**  
 Description: **Deposits Attached Encrustation**

Distance (ft): **130.9**  
 Structural Grade: **0**  
 O&M Grade: **2**  
 Clock Start/From: **12**  
 Clock To: **3**  
 1st Value:  
 2nd Value:  
 Value Percent: **5.000**  
 Continuous Index:  
 Within 8" of Joint: **YES**  
 Remarks:

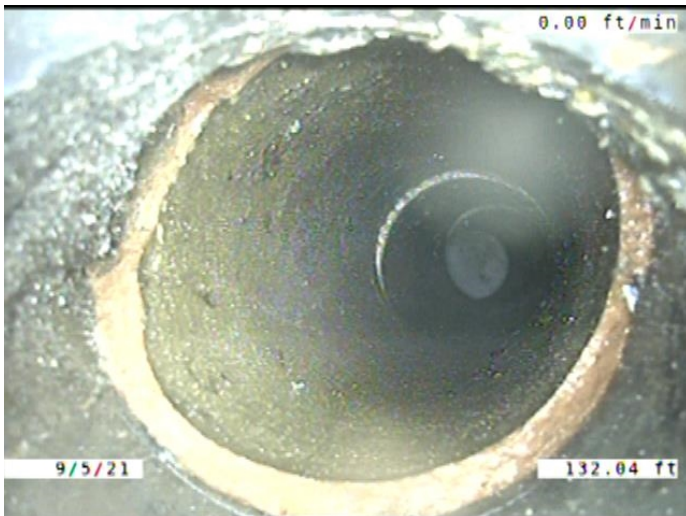
Code: **TFD**  
 Description: **Tap Factory Defective**

Distance (ft): **132.0**  
 Structural Grade: **0**  
 O&M Grade: **3**  
 Clock Start/From: **12**  
 Clock To:  
 1st Value: **6.000**  
 2nd Value:  
 Value Percent:  
 Continuous Index:  
 Within 8" of Joint: **YES**  
 Remarks: **LOOKS TO BE CAPPED**

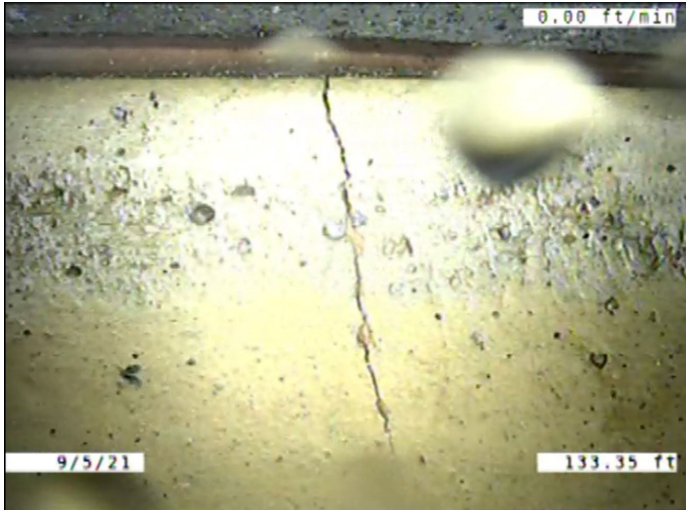
Code: **FM**  
Description: **Fracture Multiple**

Distance (ft): **133.4**  
Structural Grade: **4**  
O&M Grade: **0**  
Clock Start/From: **12**  
Clock To: **3**  
1st Value:  
2nd Value:  
Value Percent:  
Continuous Index:  
Within 8" of Joint: **YES**  
Remarks:

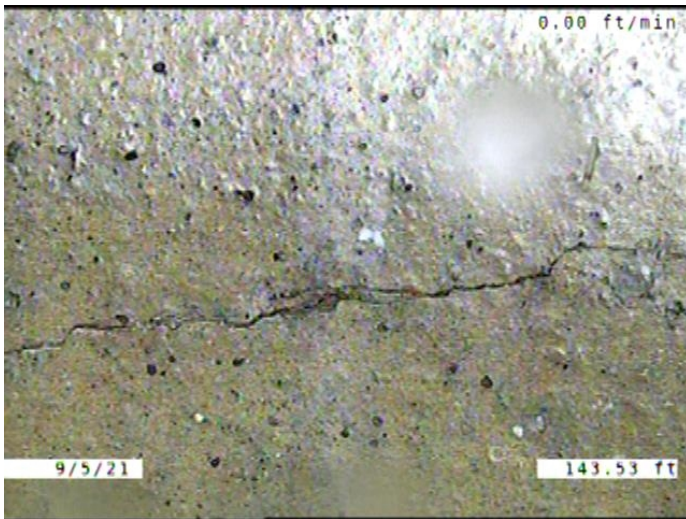
Code: **CM**  
Description: **Crack Multiple**

Distance (ft): **143.5**  
Structural Grade: **3**  
O&M Grade: **0**  
Clock Start/From: **9**  
Clock To: **3**  
1st Value:  
2nd Value:  
Value Percent:  
Continuous Index:  
Within 8" of Joint: **YES**  
Remarks:

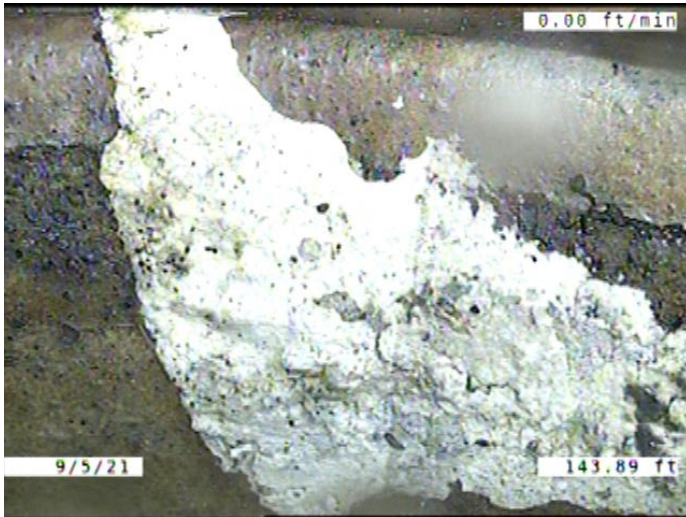
Code: **DAE**  
 Description: **Deposits Attached Encrustation**

Distance (ft): **143.9**  
 Structural Grade: **0**  
 O&M Grade: **2**  
 Clock Start/From: **1**  
 Clock To: **3**  
 1st Value:  
 2nd Value:  
 Value Percent: **5.000**  
 Continuous Index:  
 Within 8" of Joint: **YES**  
 Remarks:

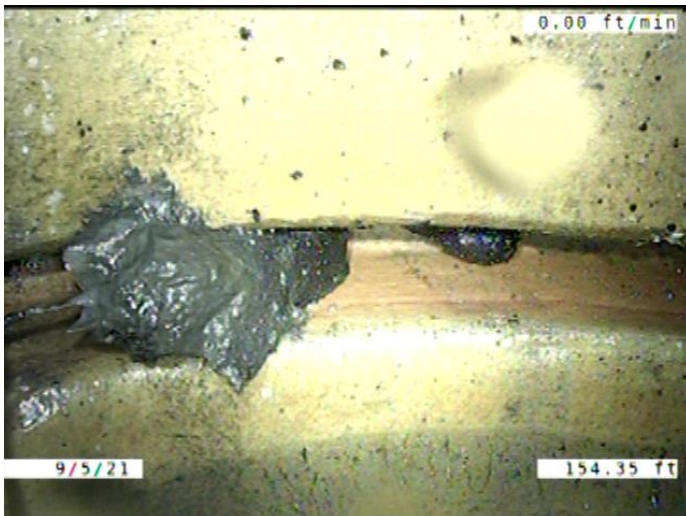
Code: **DAE**  
 Description: **Deposits Attached Encrustation**

Distance (ft): **154.4**  
 Structural Grade: **0**  
 O&M Grade: **2**  
 Clock Start/From: **9**  
 Clock To: **10**  
 1st Value:  
 2nd Value:  
 Value Percent: **5.000**  
 Continuous Index:  
 Within 8" of Joint: **YES**  
 Remarks:

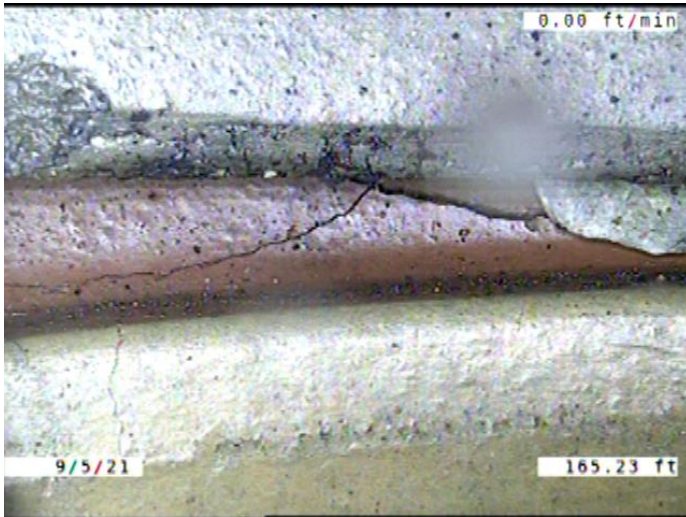
Code: **FM**  
 Description: **Fracture Multiple**

Distance (ft): **165.2**  
 Structural Grade: **4**  
 O&M Grade: **0**  
 Clock Start/From: **10**  
 Clock To: **1**  
 1st Value:  
 2nd Value:  
 Value Percent:  
 Continuous Index:  
 Within 8" of Joint: **YES**  
 Remarks:

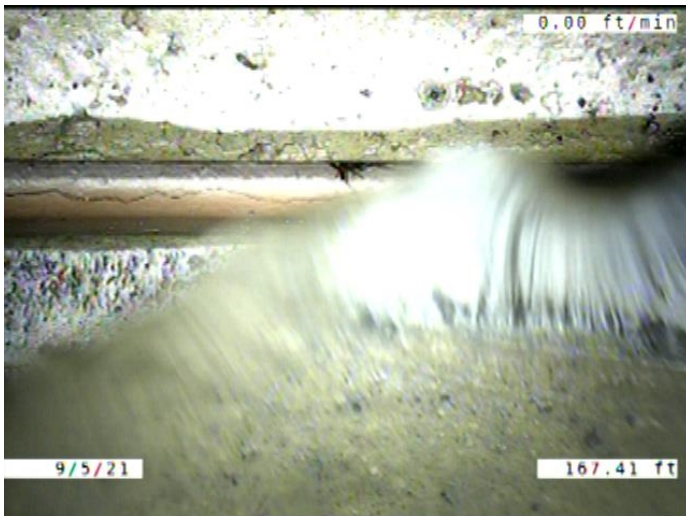
Code: **CM**  
 Description: **Crack Multiple**

Distance (ft): **167.4**  
 Structural Grade: **3**  
 O&M Grade: **0**  
 Clock Start/From: **11**  
 Clock To: **1**  
 1st Value:  
 2nd Value:  
 Value Percent:  
 Continuous Index:  
 Within 8" of Joint: **YES**  
 Remarks:

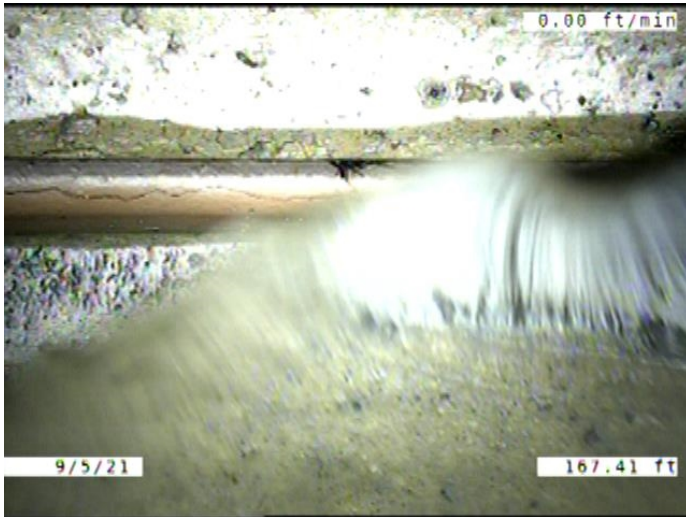
Code: **MCU**  
Description: **Miscellaneous Camera Underwater**

Distance (ft): **167.4**  
Structural Grade: **0**  
O&M Grade: **4**  
Clock Start/From:  
Clock To:  
1st Value:  
2nd Value:  
Value Percent:  
Continuous Index:  
Within 8" of Joint: **NO**  
Remarks: **Out at 169.4**

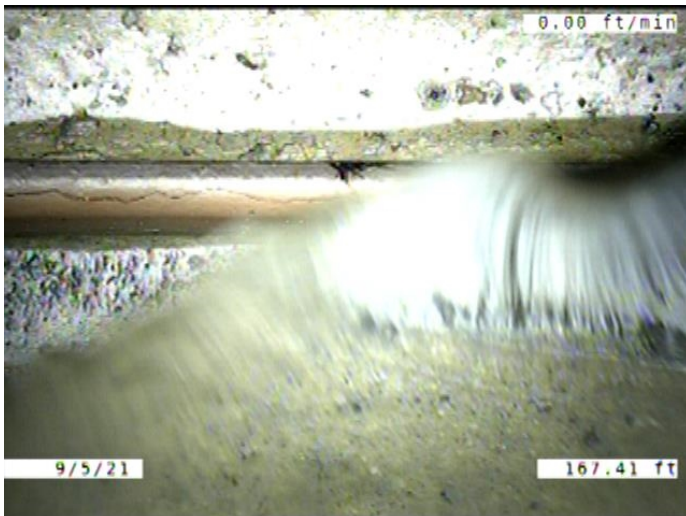
Code: **MWL**  
Description: **Miscellaneous Water Level**

Distance (ft): **167.4**  
Structural Grade: **0**  
O&M Grade: **0**  
Clock Start/From:  
Clock To:  
1st Value:  
2nd Value:  
Value Percent: **25.000**  
Continuous Index:  
Within 8" of Joint: **NO**  
Remarks:

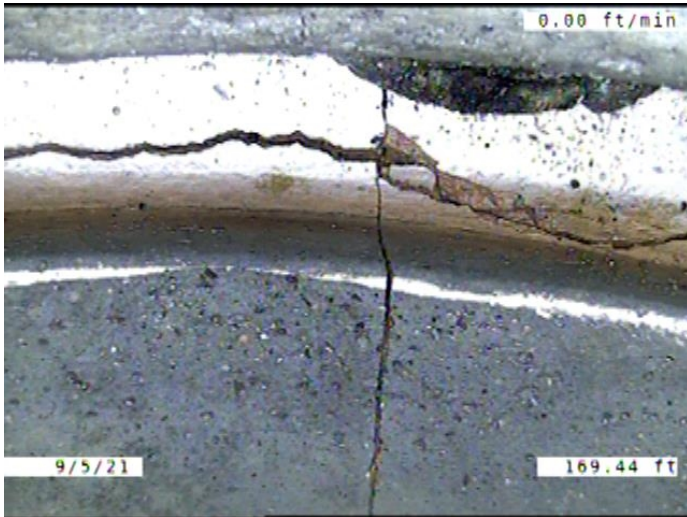
Code: **FM**  
 Description: **Fracture Multiple**

Distance (ft): **169.4**  
 Structural Grade: **4**  
 O&M Grade: **0**  
 Clock Start/From: **10**  
 Clock To: **3**  
 1st Value:  
 2nd Value:  
 Value Percent:  
 Continuous Index:  
 Within 8" of Joint: **YES**  
 Remarks:
