# Profile/Photo Observation Report

Date:	09/05/2021	Weather:		Coding:	PACP 7.0
Pipe Length (ft):	195.3	Owner:	City of Hobart	Pre Clean:	Heavy Cleaning
P.O.#:	YES502259	Surveyor:	S. Bucklin	PSR:	P-504-077-076
Customer:	City of Hobart	Clean Date:	09/02/2021	Shape:	C

Street:	North Cavender Street	Flow Control:	Not Controlled
City:	Hobart, IN	Year Renewed:	
Location:	Alley	Tape/Media #:	
Purpose:	Routine Assessment	Dia/Height:	12"
Use:	Sanitary Sewage Pipe	Material:	VCP
Drain Area:		Lining:	
Category:	NA		
Comment:			
Location Details:		Direction of Survey:	Downstream
US MH:	M-504-077	DS MH:	M-504-076
		Total Length Surveyed (ft):	195.3

O&M Index:	2.08	O&M Quick:	4336	O&M Rating:	154.00
Structural Index:	3.11	Structural Quick:	4A3A	Structural Rating:	84.00
Overall Index:	2.36	Overall Quick:	4A3B	Overall Rating:	238.00

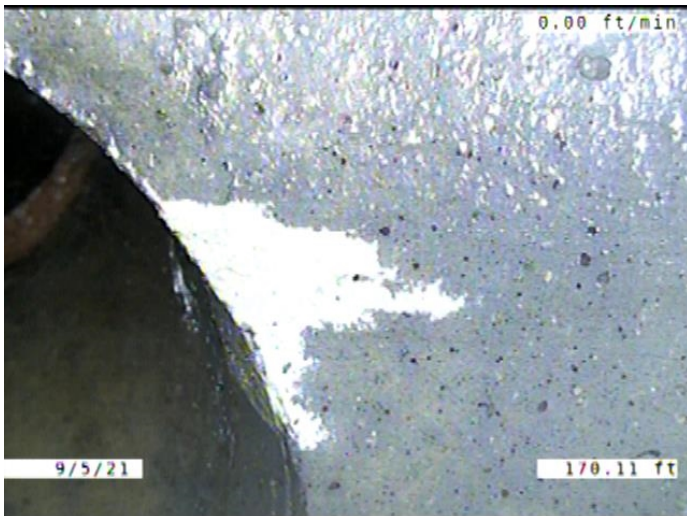
Code: **DAE**  
 Description: **Deposits Attached Encrustation**

Distance (ft): **170.1**  
 Structural Grade: **0**  
 O&M Grade: **2**  
 Clock Start/From: **1**  
 Clock To:  
 1st Value:  
 2nd Value:  
 Value Percent: **5.000**  
 Continuous Index:  
 Within 8" of Joint: **YES**  
 Remarks:

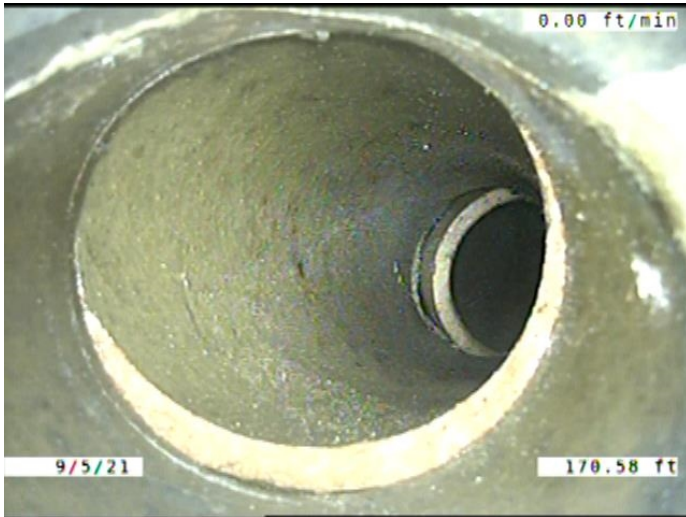
Code: **TFD**  
Description: **Tap Factory Defective**

Distance (ft): **170.6**  
Structural Grade: **0**  
O&M Grade: **3**  
Clock Start/From: **12**  
Clock To:  
1st Value: **6.000**  
2nd Value:  
Value Percent:  
Continuous Index:  
Within 8" of Joint: **YES**  
Remarks: **Defective**

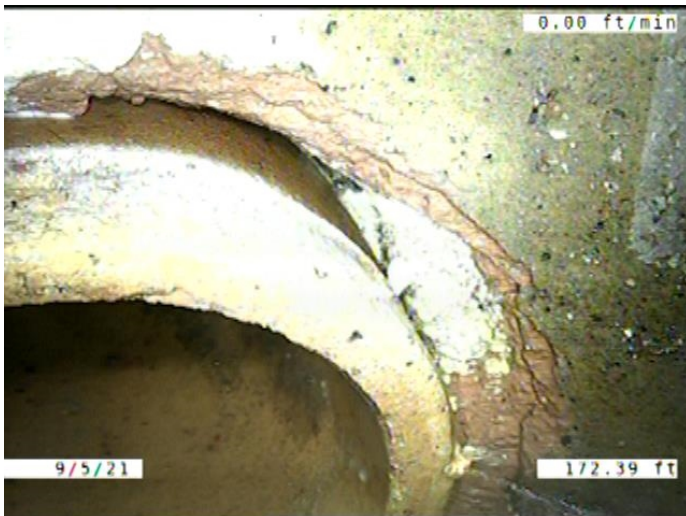
Code: **SSS**  
Description: **Surface Damage Surface Spalling**

Distance (ft): **172.4**  
Structural Grade: **2**  
O&M Grade: **0**  
Clock Start/From: **12**  
Clock To: **2**  
1st Value:  
2nd Value:  
Value Percent:  
Continuous Index:  
Within 8" of Joint: **NO**  
Remarks:

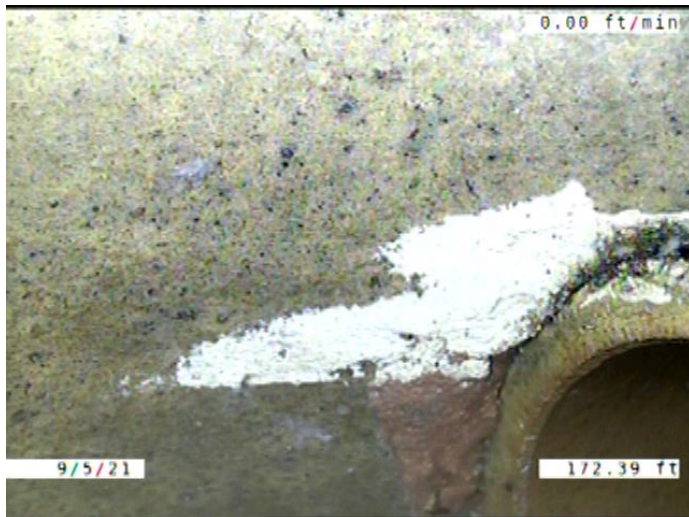
Code:	<b>DAE</b>
Description:	<b>Deposits Attached Encrustation</b>
Distance (ft):	<b>172.4</b>
Structural Grade:	<b>0</b>
O&M Grade:	<b>2</b>
Clock Start/From:	<b>11</b>
Clock To:	<b>3</b>
1st Value:	
2nd Value:	
Value Percent:	<b>5.000</b>
Continuous Index:	
Within 8" of Joint:	<b>YES</b>
Remarks:

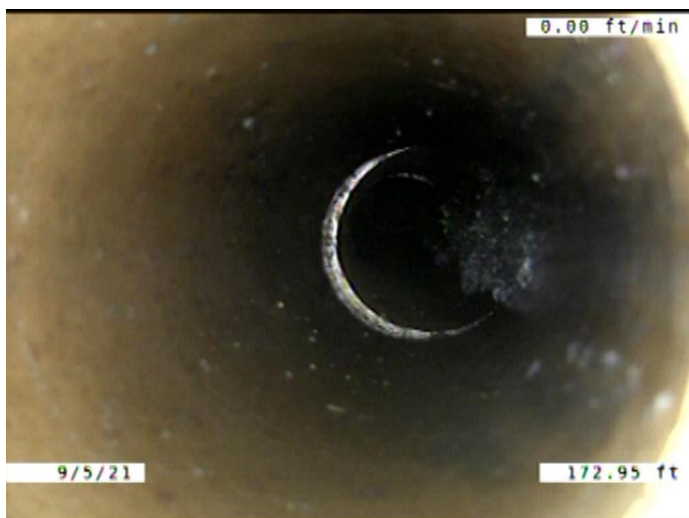
Code:	<b>TBI</b>
Description:	<b>Tap Break-in Intruding</b>
Distance (ft):	<b>173.0</b>
Structural Grade:	<b>0</b>
O&M Grade:	<b>2</b>
Clock Start/From:	<b>1</b>
Clock To:	
1st Value:	<b>6.000</b>
2nd Value:	<b>1.000</b>
Value Percent:	
Continuous Index:	
Within 8" of Joint:	<b>NO</b>
Remarks:	<b>ROOTS GROWING IN THE TAP</b>

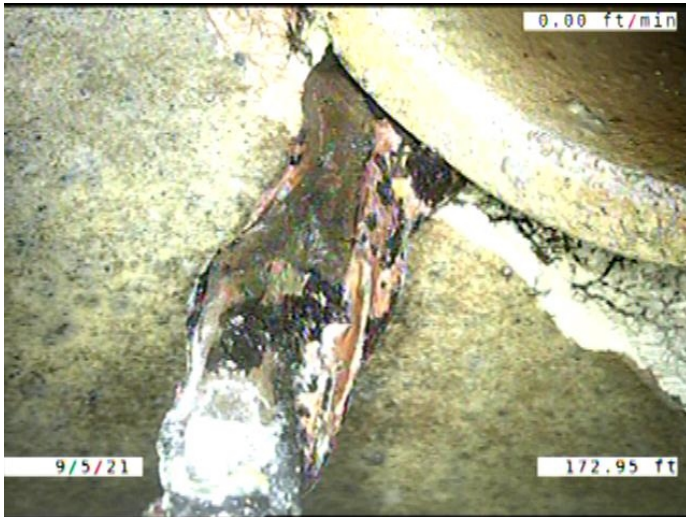
Code: **ISZ**  
 Description: **Intruding Sealing Material Other**

Distance (ft): **173.0**  
 Structural Grade: **0**  
 O&M Grade: **2**  
 Clock Start/From: **11**  
 Clock To: **12**  
 1st Value:  
 2nd Value:  
 Value Percent: **5.000**  
 Continuous Index:  
 Within 8" of Joint: **NO**  
 Remarks: **TAP SEAL HANGING INTO THE MAIN**

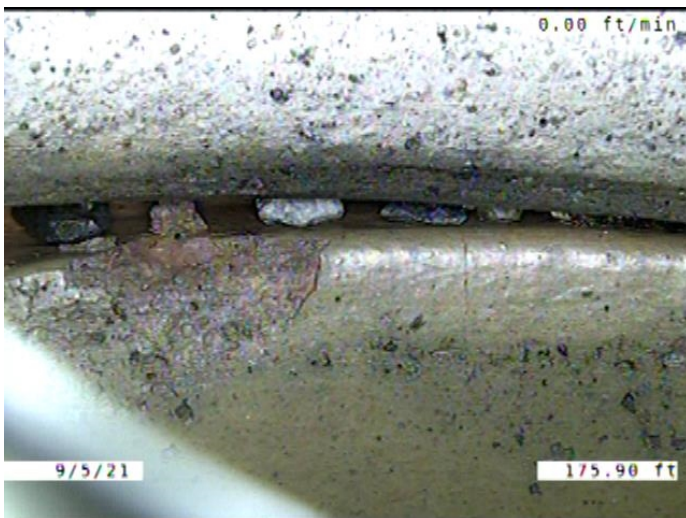
Code: **SSS**  
 Description: **Surface Damage Surface Spalling**

Distance (ft): **175.9**  
 Structural Grade: **2**  
 O&M Grade: **0**  
 Clock Start/From: **11**  
 Clock To:  
 1st Value:  
 2nd Value:  
 Value Percent:  
 Continuous Index:  
 Within 8" of Joint: **YES**  
 Remarks:

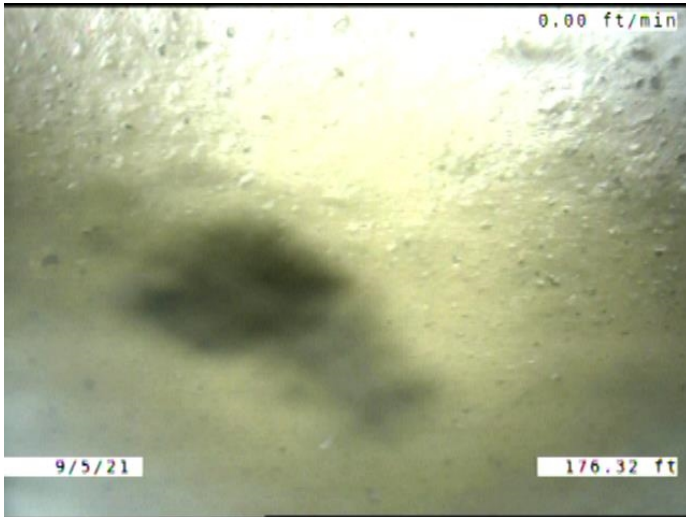
Code:	<b>MCU</b>
Description:	<b>Miscellaneous Camera Underwater</b>
Distance (ft):	<b>176.3</b>
Structural Grade:	<b>0</b>
O&M Grade:	<b>4</b>
Clock Start/From:	
Clock To:	
1st Value:	
2nd Value:	
Value Percent:	
Continuous Index:	
Within 8" of Joint:	<b>NO</b>
Remarks:	<b>Out at 176.9</b>

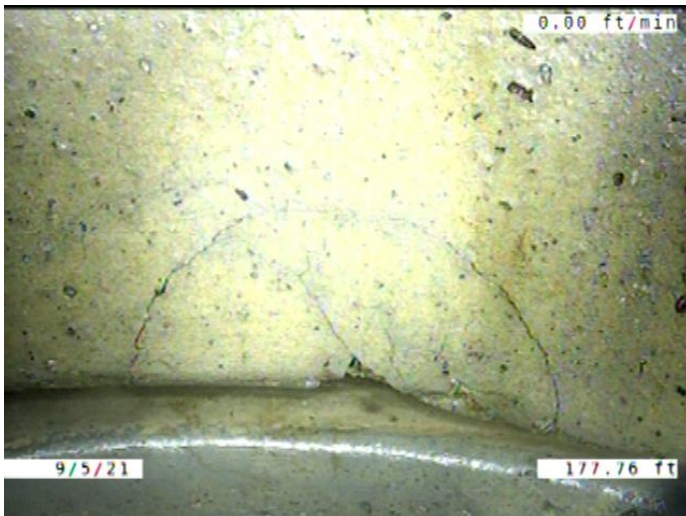
Code:	<b>CM</b>
Description:	<b>Crack Multiple</b>
Distance (ft):	<b>177.8</b>
Structural Grade:	<b>3</b>
O&M Grade:	<b>0</b>
Clock Start/From:	<b>12</b>
Clock To:	<b>1</b>
1st Value:	
2nd Value:	
Value Percent:	
Continuous Index:	
Within 8" of Joint:	<b>YES</b>
Remarks:

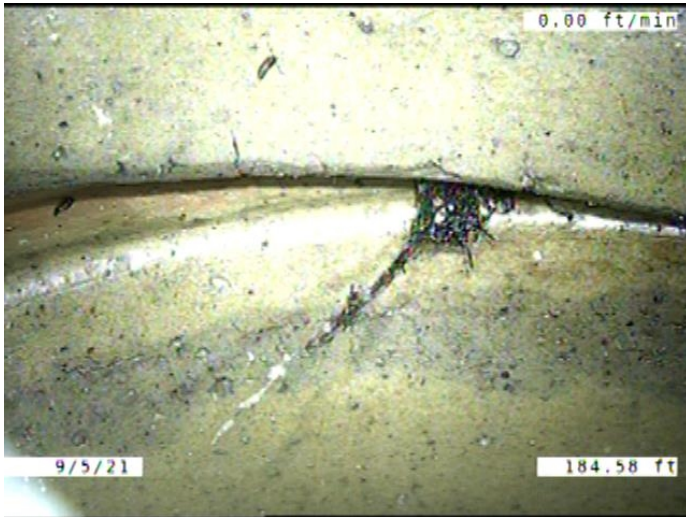
Code: **RFJ**  
 Description: **Roots Fine Joint**

Distance (ft): **184.6**  
 Structural Grade: **0**  
 O&M Grade: **1**  
 Clock Start/From: **11**  
 Clock To:  
 1st Value:  
 2nd Value:  
 Value Percent:  
 Continuous Index:  
 Within 8" of Joint: **YES**  
 Remarks:

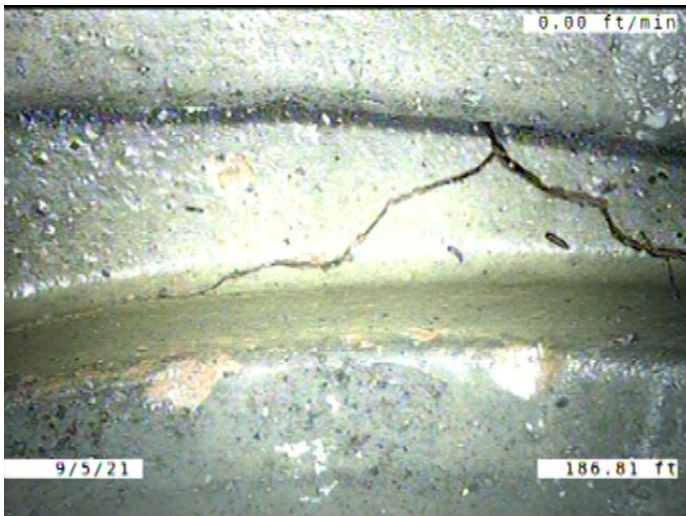
Code: **FM**  
 Description: **Fracture Multiple**

Distance (ft): **186.8**  
 Structural Grade: **4**  
 O&M Grade: **0**  
 Clock Start/From: **12**  
 Clock To: **3**  
 1st Value:  
 2nd Value:  
 Value Percent:  
 Continuous Index:  
 Within 8" of Joint: **YES**  
 Remarks:

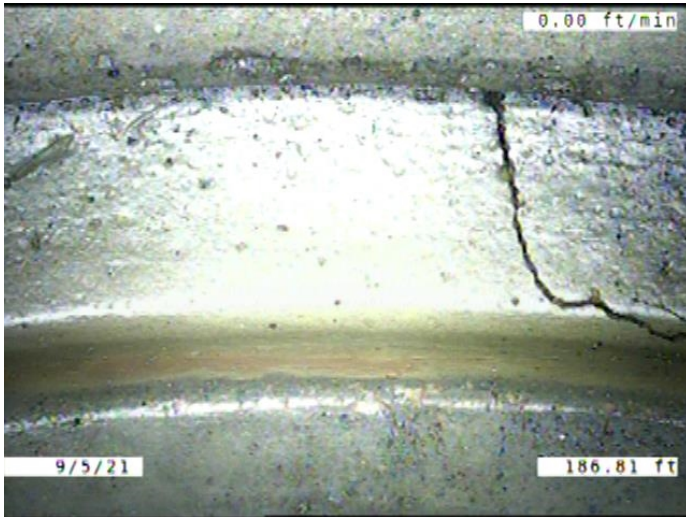
Code: **JAL**  
 Description: **Joint Angular Large**

Distance (ft): **186.8**  
 Structural Grade: **4**  
 O&M Grade: **0**  
 Clock Start/From:  
 Clock To:  
 1st Value:  
 2nd Value:  
 Value Percent:  
 Continuous Index:  
 Within 8" of Joint: **NO**  
 Remarks:

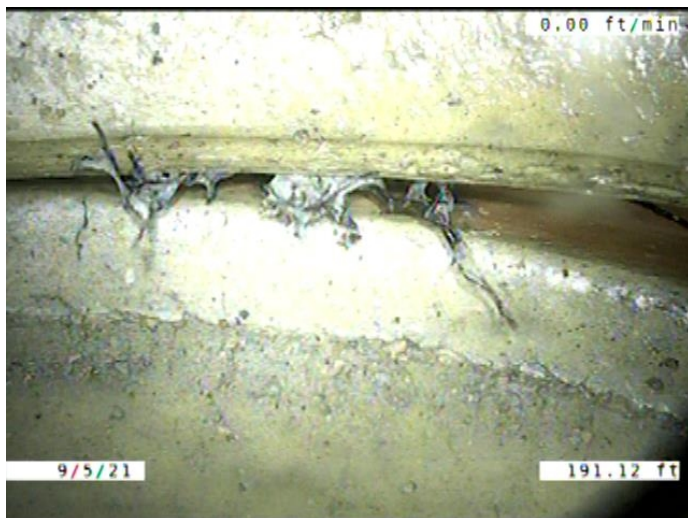
Code: **RFJ**  
 Description: **Roots Fine Joint**

Distance (ft): **191.1**  
 Structural Grade: **0**  
 O&M Grade: **1**  
 Clock Start/From: **12**  
 Clock To: **1**  
 1st Value:  
 2nd Value:  
 Value Percent:  
 Continuous Index:  
 Within 8" of Joint: **YES**  
 Remarks:

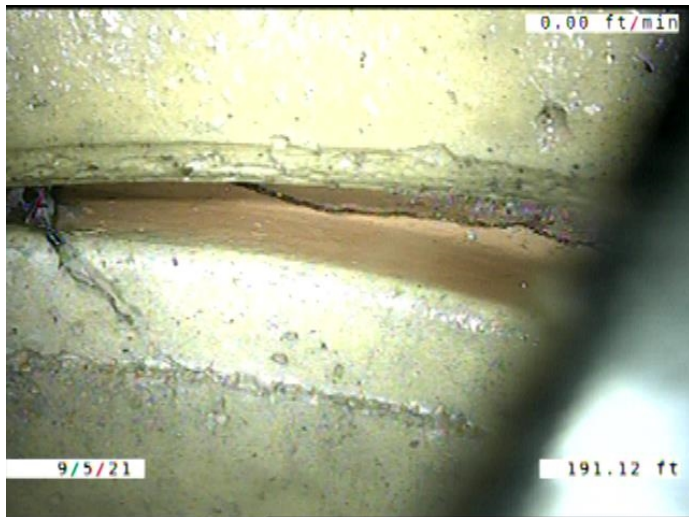
Code: **FM**  
 Description: **Fracture Multiple**

Distance (ft): **191.1**  
 Structural Grade: **4**  
 O&M Grade: **0**  
 Clock Start/From: **1**  
 Clock To: **2**  
 1st Value:  
 2nd Value:  
 Value Percent:  
 Continuous Index:  
 Within 8" of Joint: **YES**  
 Remarks:

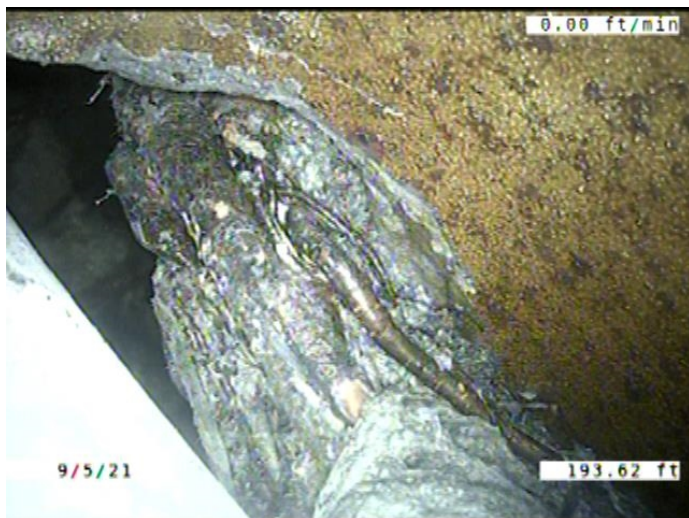
Code: **RTJ**  
 Description: **Roots Tap Joint**

Distance (ft): **193.6**  
 Structural Grade: **0**  
 O&M Grade: **2**  
 Clock Start/From: **9**  
 Clock To: **3**  
 1st Value:  
 2nd Value:  
 Value Percent: **50.000**  
 Continuous Index:  
 Within 8" of Joint: **YES**  
 Remarks:

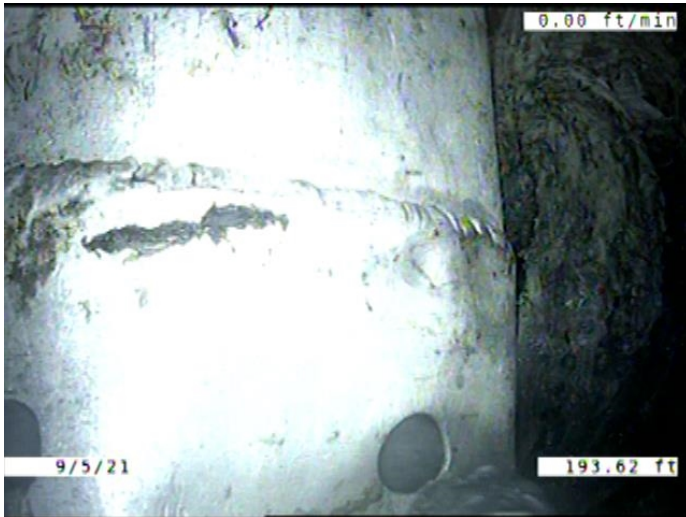
Code: **DSF**  
 Description: **Deposits Settled Fine**

Distance (ft): **193.6**  
 Structural Grade: **0**  
 O&M Grade: **2**  
 Clock Start/From: **5**  
 Clock To: **7**  
 1st Value:  
 2nd Value:  
 Value Percent: **5.000**  
 Continuous Index: **F01**  
 Within 8" of Joint: **YES**  
 Remarks:
