Profile/Photo Observation Report

Date:	04/17/2018	Weather:		Coding:	PACP 6.0
Pipe Length (ft):	190.7	Owner:	NA	Pre Clean:	Not Known
P.O.#:		Surveyor:	Justin Gonzales	PSR:	P-504-078-077
Customer:		Clean Date:	01/01/1900	Shape:	C

Street:	N CAVENDER ST	Flow Control:	Not Controlled
City:	Hobart, IN	Year Renewed:	
Location:	Light Highway	Tape/Media #:	
Purpose:	Not Known	Dia/Height:	12"
Use:	Sanitary	Material:	VCP
Drain Area:	NA	Lining:	
Category:	NA		
Comment:

Location Details:		Direction of Survey:	Downstream
US MH:	M-504-078	DS MH:	M-504-077
		Total Length Surveyed (ft):	159.7

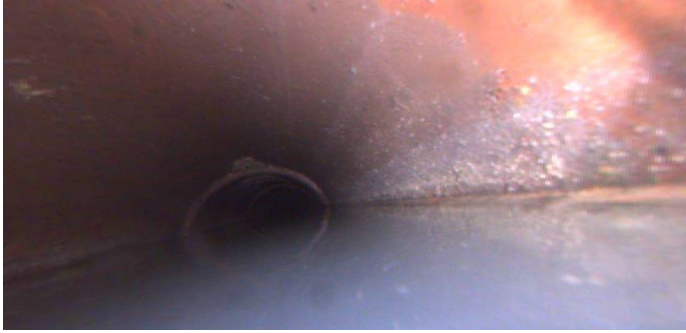
Code: **MWL**
Description: **Water Level**

Distance (ft): **4.7**
Structural Grade: **0**
O&M Grade: **0**
Clock Start/From:
Clock To:
1st Value:
2nd Value:
Value Percent: **15.000**
Continuous Index:
Within 8" of Joint: **NO**
Remarks:

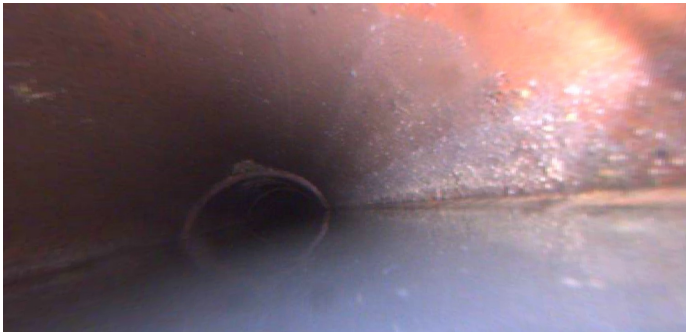
Code: **DAZ**
Description: **Deposits Attached Other**

Distance (ft): **4.7**
Structural Grade: **0**
O&M Grade: **2**
Clock Start/From: **7**
Clock To: **5**
1st Value:
2nd Value:
Value Percent: **5.000**
Continuous Index: **S01**
Within 8" of Joint: **YES**
Remarks: **WANDER**

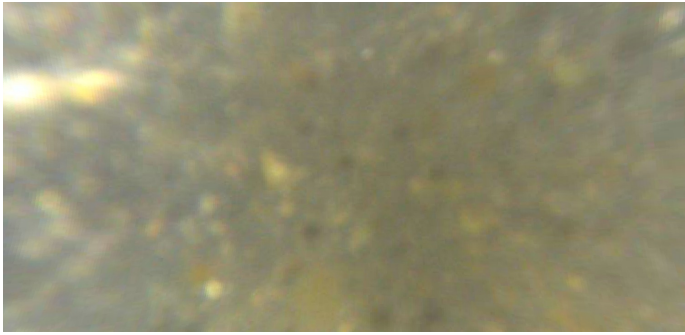
Code:	MGO
Description:	General Observation
Distance (ft):	7.8
Structural Grade:	0
O&M Grade:	0
Clock Start/From:	
Clock To:	
1st Value:	
2nd Value:	
Value Percent:	
Continuous Index:	
Within 8" of Joint:	NO
Remarks:	MCU REAR CAMERA

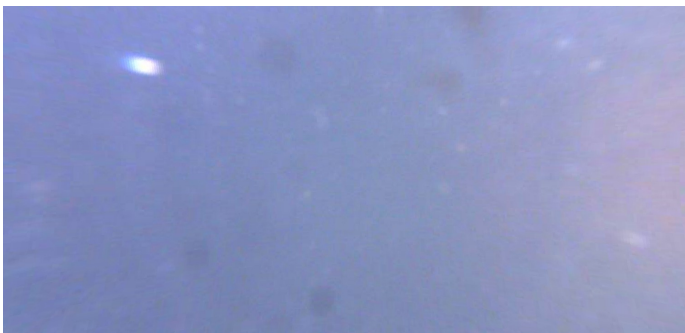
Code:	MCU
Description:	Camera Underwater
Distance (ft):	8.0
Structural Grade:	0
O&M Grade:	4
Clock Start/From:	
Clock To:	
1st Value:	
2nd Value:	
Value Percent:	
Continuous Index:	S02
Within 8" of Joint:	NO
Remarks:

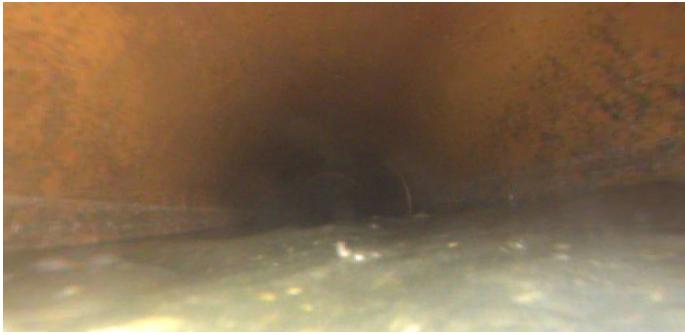
Code: **MCU**
Description: **Camera Underwater**

Distance (ft): **37.7**
Structural Grade: **0**
O&M Grade: **4**
Clock Start/From:
Clock To:
1st Value:
2nd Value:
Value Percent:
Continuous Index: **F02**
Within 8" of Joint: **NO**
Remarks: **EMERGED**

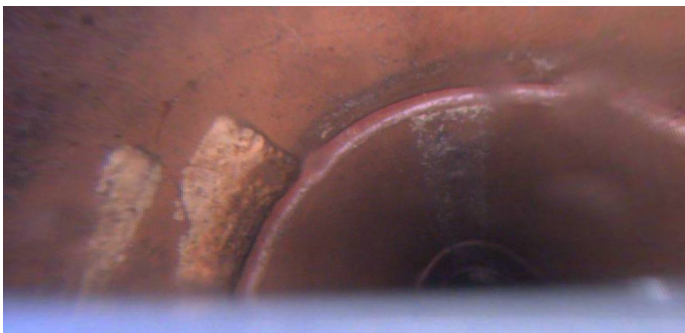
Code: **DAZ**
Description: **Deposits Attached Other**

Distance (ft): **41.2**
Structural Grade: **0**
O&M Grade: **2**
Clock Start/From: **9**
Clock To: **10**
1st Value:
2nd Value:
Value Percent: **5.000**
Continuous Index:
Within 8" of Joint: **NO**
Remarks:

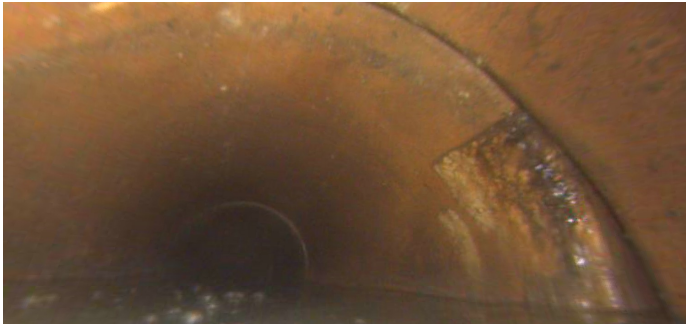
Code: **IW**
Description: **Infil Weeper**

Distance (ft): **42.0**
Structural Grade: **0**
O&M Grade: **2**
Clock Start/From: **9**
Clock To: **11**
1st Value:
2nd Value:
Value Percent:
Continuous Index:
Within 8" of Joint: **YES**
Remarks:

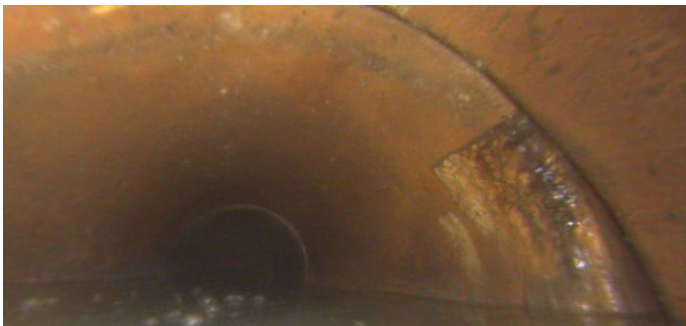
Code: **IW**
Description: **Infil Weeper**

Distance (ft): **42.0**
Structural Grade: **0**
O&M Grade: **2**
Clock Start/From: **11**
Clock To:
1st Value:
2nd Value:
Value Percent:
Continuous Index:
Within 8" of Joint: **YES**
Remarks:

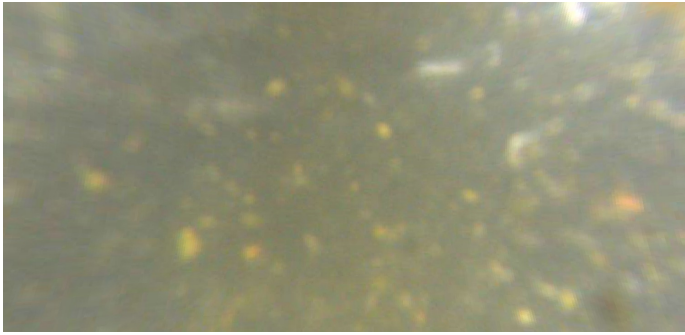
Code: **MCU**
Description: **Camera Underwater**

Distance (ft): **43.6**
Structural Grade: **0**
O&M Grade: **4**
Clock Start/From:
Clock To:
1st Value:
2nd Value:
Value Percent:
Continuous Index: **S03**
Within 8" of Joint: **NO**
Remarks:

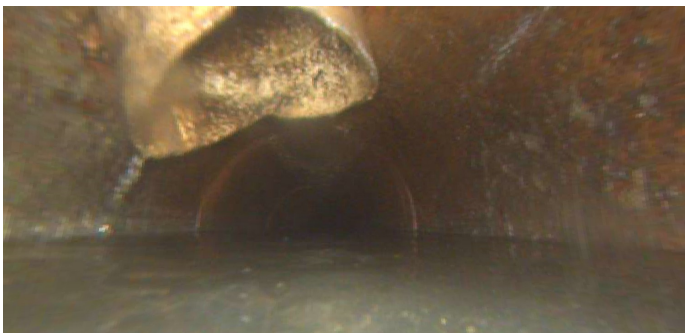
Code: **TBI**
Description: **Tap Break-in Intruding**

Distance (ft): **47.4**
Structural Grade: **0**
O&M Grade: **2**
Clock Start/From: **1**
Clock To:
1st Value: **4.000**
2nd Value: **3.000**
Value Percent:
Continuous Index:
Within 8" of Joint:
Remarks:

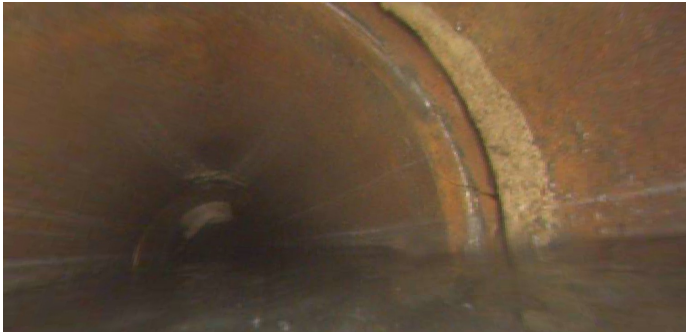
Code: **CL**
Description: **Crack Longitudinal**

Distance (ft): **50.6**
Structural Grade: **2**
O&M Grade: **0**
Clock Start/From: **9**
Clock To:
1st Value:
2nd Value:
Value Percent:
Continuous Index:
Within 8" of Joint:
Remarks:

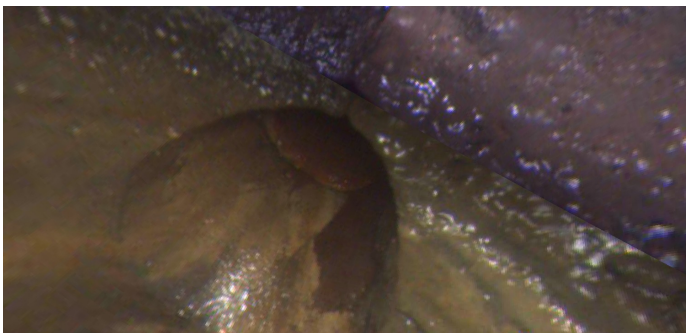
Code: **TFA**
Description: **Tap Factory Active**

Distance (ft): **56.0**
Structural Grade: **0**
O&M Grade: **0**
Clock Start/From: **11**
Clock To:
1st Value: **4.000**
2nd Value:
Value Percent:
Continuous Index:
Within 8" of Joint:
Remarks:

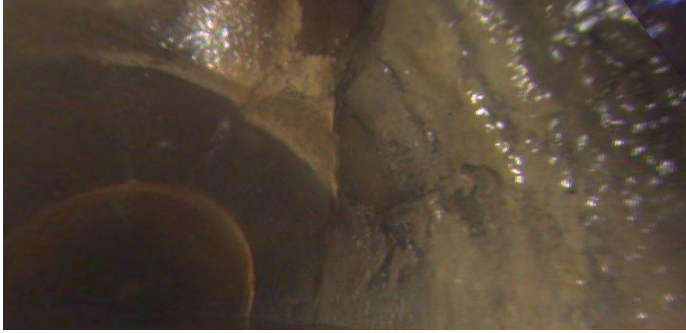
Code: **FM**
Description: **Fracture Multiple**

Distance (ft): **56.0**
Structural Grade: **4**
O&M Grade: **0**
Clock Start/From: **9**
Clock To: **11**
1st Value:
2nd Value:
Value Percent:
Continuous Index:
Within 8" of Joint:
Remarks:

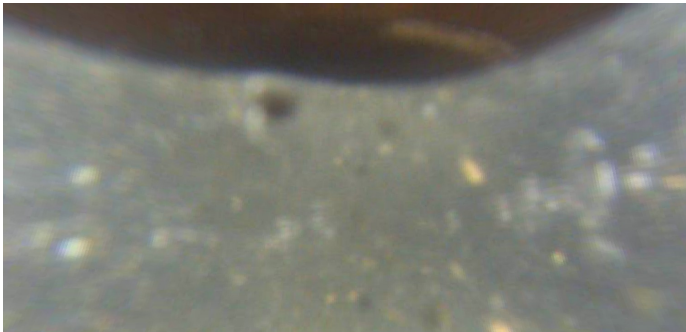
Code: **MWLS**
Description: **Water Level Sag**

Distance (ft): **63.3**
Structural Grade: **3**
O&M Grade: **3**
Clock Start/From:
Clock To:
1st Value:
2nd Value:
Value Percent: **50.000**
Continuous Index:
Within 8" of Joint: **NO**
Remarks:

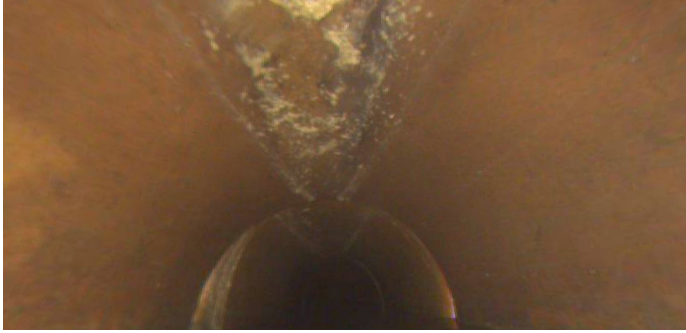
Code: **DAGS**
Description: **Deposits Attached Grease**

Distance (ft): **66.1**
Structural Grade: **0**
O&M Grade: **2**
Clock Start/From: **7**
Clock To: **5**
1st Value:
2nd Value:
Value Percent: **5.000**
Continuous Index: **S04**
Within 8" of Joint: **YES**
Remarks: **WANDER**

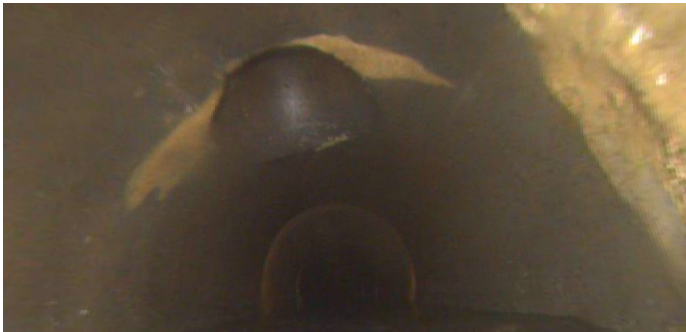
Code: **TF**
Description: **Tap Factory**

Distance (ft): **73.2**
Structural Grade: **0**
O&M Grade: **0**
Clock Start/From: **1**
Clock To:
1st Value: **4.000**
2nd Value:
Value Percent:
Continuous Index:
Within 8" of Joint:
Remarks:

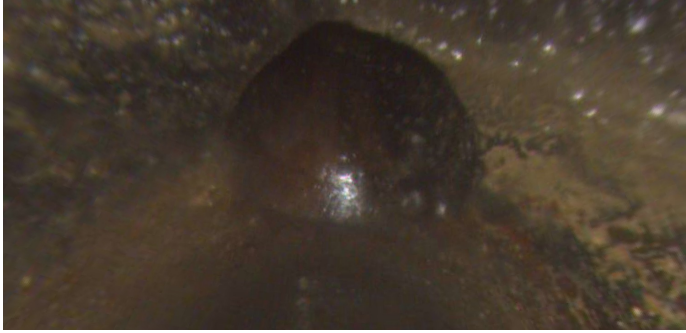
Code: **TFA**
Description: **Tap Factory Active**

Distance (ft): **97.8**
Structural Grade: **0**
O&M Grade: **0**
Clock Start/From: **12**
Clock To:
1st Value: **4.000**
2nd Value:
Value Percent:
Continuous Index:
Within 8" of Joint:
Remarks:

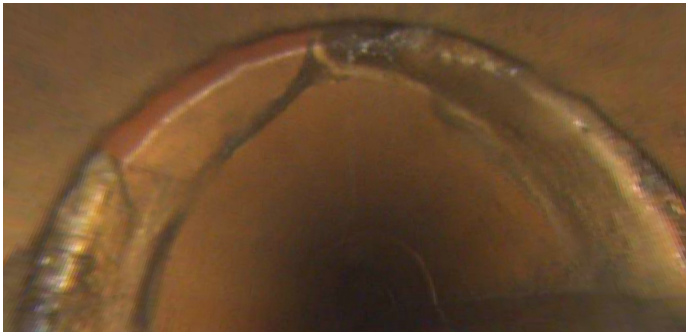
Code: **IW**
Description: **Infil Weeper**

Distance (ft): **102.8**
Structural Grade: **0**
O&M Grade: **2**
Clock Start/From: **7**
Clock To: **5**
1st Value:
2nd Value:
Value Percent:
Continuous Index:
Within 8" of Joint: **YES**
Remarks:

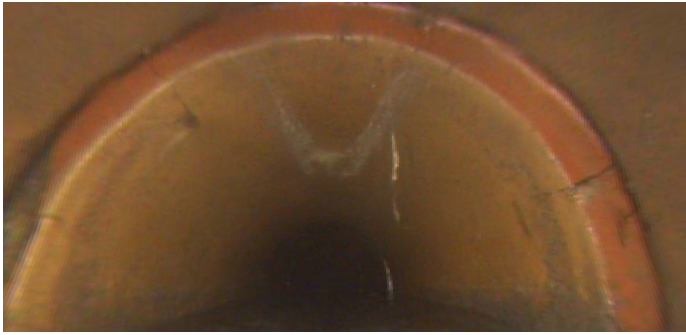
Code: **FM**
Description: **Fracture Multiple**

Distance (ft): **109.1**
Structural Grade: **4**
O&M Grade: **0**
Clock Start/From: **8**
Clock To: **4**
1st Value:
2nd Value:
Value Percent:
Continuous Index:
Within 8" of Joint: **YES**
Remarks:

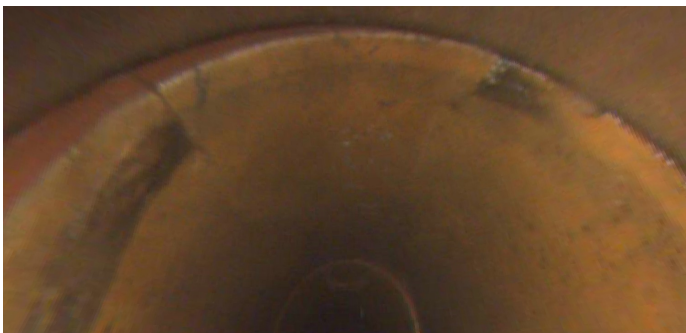
Code: **FM**
Description: **Fracture Multiple**

Distance (ft): **111.1**
Structural Grade: **4**
O&M Grade: **0**
Clock Start/From: **11**
Clock To: **2**
1st Value:
2nd Value:
Value Percent:
Continuous Index:
Within 8" of Joint: **YES**
Remarks:

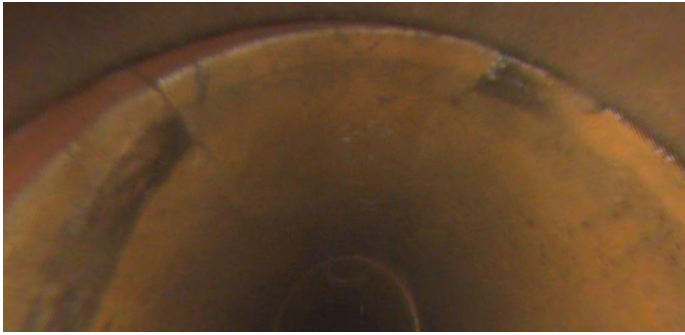
Code: **IS**
Description: **Infil Stain**

Distance (ft): **111.1**
Structural Grade: **0**
O&M Grade: **0**
Clock Start/From: **2**
Clock To: **5**
1st Value:
2nd Value:
Value Percent:
Continuous Index:
Within 8" of Joint:
Remarks:

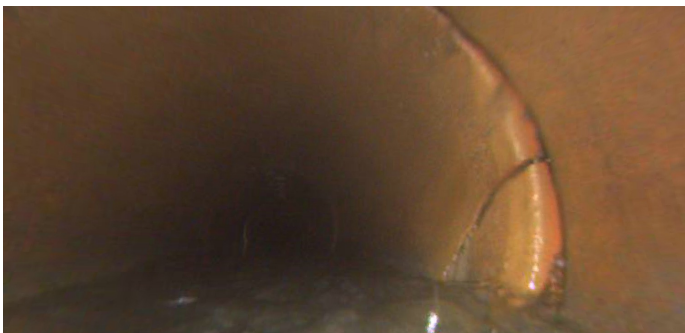
Code: **FS**
Description: **Fracture Spiral**

Distance (ft): **115.3**
Structural Grade: **3**
O&M Grade: **0**
Clock Start/From: **9**
Clock To: **10**
1st Value:
2nd Value:
Value Percent:
Continuous Index:
Within 8" of Joint: **YES**
Remarks:

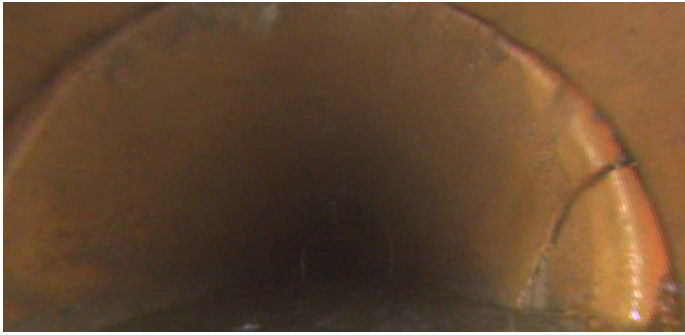
Code: **FC**
Description: **Fracture Circumferential**

Distance (ft): **115.3**
Structural Grade: **2**
O&M Grade: **0**
Clock Start/From: **7**
Clock To: **9**
1st Value:
2nd Value:
Value Percent:
Continuous Index:
Within 8" of Joint: **YES**
Remarks:

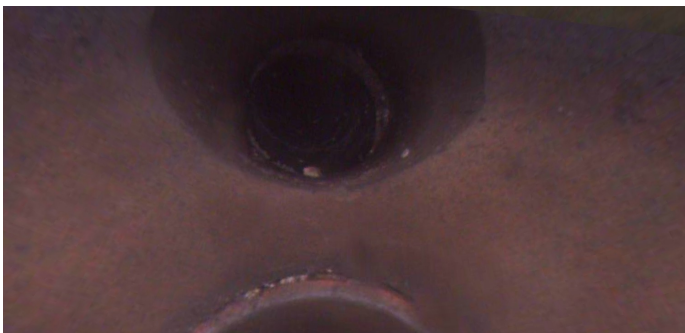
Code: **TF**
Description: **Tap Factory**

Distance (ft): **126.4**
Structural Grade: **0**
O&M Grade: **0**
Clock Start/From: **12**
Clock To:
1st Value: **4.000**
2nd Value:
Value Percent:
Continuous Index:
Within 8" of Joint:
Remarks:

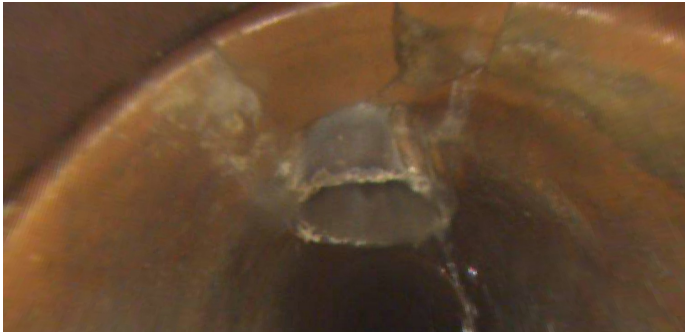
Code: **TBI**
Description: **Tap Break-in Intruding**

Distance (ft): **140.2**
Structural Grade: **0**
O&M Grade: **2**
Clock Start/From: **1**
Clock To:
1st Value: **4.000**
2nd Value: **1.000**
Value Percent:
Continuous Index:
Within 8" of Joint:
Remarks:

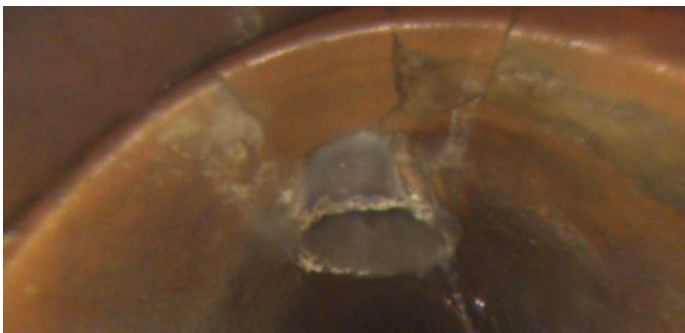
Code: **CM**
Description: **Crack Multiple**

Distance (ft): **140.2**
Structural Grade: **3**
O&M Grade: **0**
Clock Start/From: **11**
Clock To: **12**
1st Value:
2nd Value:
Value Percent:
Continuous Index:
Within 8" of Joint: **YES**
Remarks:

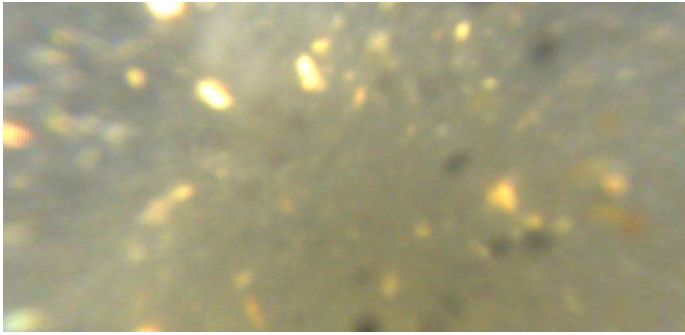
Code: **MCU**
Description: **Camera Underwater**

Distance (ft): **146.0**
Structural Grade: **0**
O&M Grade: **4**
Clock Start/From:
Clock To:
1st Value:
2nd Value:
Value Percent:
Continuous Index:
Within 8" of Joint: **NO**
Remarks:

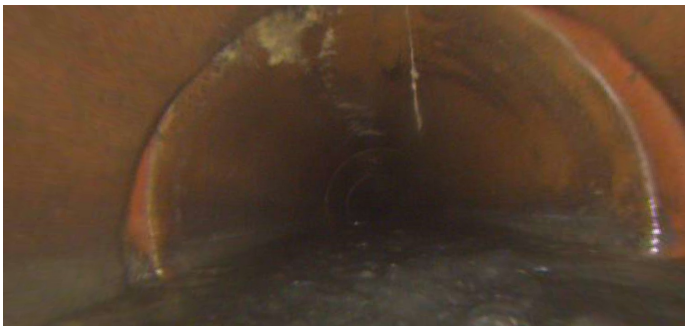
Code: **RFJ**
Description: **Roots Fine Joint**

Distance (ft): **153.0**
Structural Grade: **0**
O&M Grade: **1**
Clock Start/From: **12**
Clock To:
1st Value:
2nd Value:
Value Percent:
Continuous Index:
Within 8" of Joint: **YES**
Remarks:

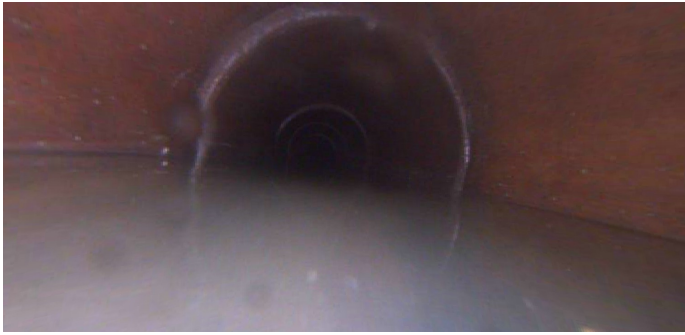
Code: **MSA**
Description: **Abandoned Survey**

Distance (ft): **159.7**
Structural Grade: **0**
O&M Grade: **0**
Clock Start/From:
Clock To:
1st Value:
2nd Value:
Value Percent:
Continuous Index:
Within 8" of Joint: **NO**
Remarks: **ROBOT HAS STOPPED**

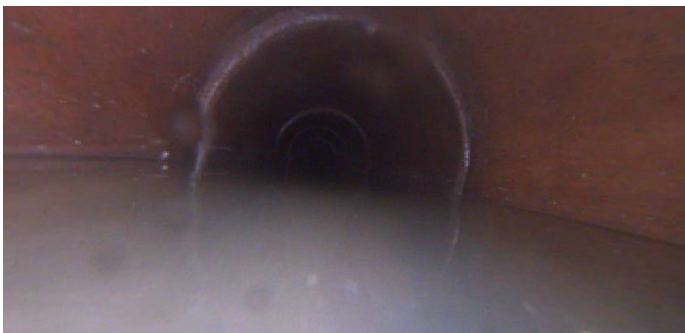
Code: **MCU**
Description: **Camera Underwater**

Distance (ft): **159.7**
Structural Grade: **0**
O&M Grade: **4**
Clock Start/From:
Clock To:
1st Value:
2nd Value:
Value Percent:
Continuous Index: **F03**
Within 8" of Joint: **NO**
Remarks:

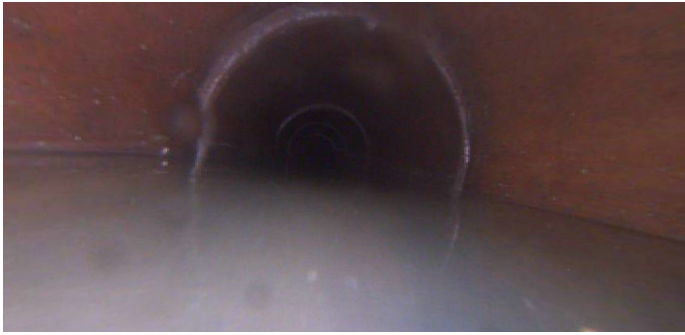
Code: **DAZ**
Description: **Deposits Attached Other**

Distance (ft): **159.7**
Structural Grade: **0**
O&M Grade: **2**
Clock Start/From: **7**
Clock To: **5**
1st Value:
2nd Value:
Value Percent: **5.000**
Continuous Index: **F01**
Within 8" of Joint: **YES**
Remarks: **WANDER**

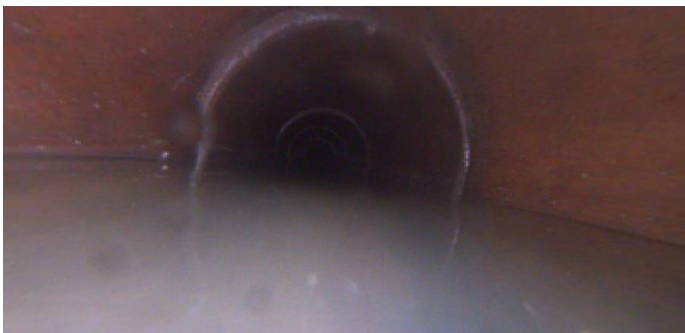
Code: **DAGS**
Description: **Deposits Attached Grease**

Distance (ft): **159.7**
Structural Grade: **0**
O&M Grade: **2**
Clock Start/From: **7**
Clock To: **5**
1st Value:
2nd Value:
Value Percent: **5.000**
Continuous Index: **F04**
Within 8" of Joint: **YES**
Remarks: **WANDER**
