Profile/Photo Observation Report

Date:	04/17/2018	Weather:		Coding:	PACP 6.0
Pipe Length (ft):	190.7	Owner:	NA	Pre Clean:	Not Known
P.O.#:		Surveyor:	Justin Gonzales	PSR:	P-504-078-077
Customer:		Clean Date:	01/01/1900	Shape:	C

Street:	Summerlin	Flow Control:	Not Controlled
City:	Hobart, IN	Year Renewed:	
Location:	Light Highway	Tape/Media #:	
Purpose:	Not Known	Dia/Height:	12"
Use:	Sanitary	Material:	VCP
Drain Area:	NA	Lining:	
Category:	NA		
Comment:

Location Details:		Direction of Survey:	Downstream
US MH:	M-504-078	DS MH:	M-504-077
		Total Length Surveyed (ft):	159.7

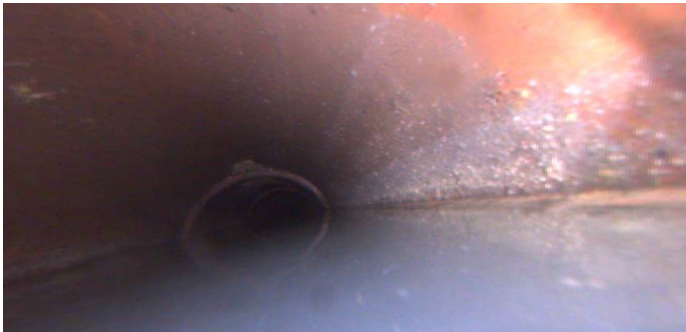
Code: **DAZ**
Description: **Deposits Attached Other**

Distance (ft): **4.7**
Structural Grade: **0**
O&M Grade: **2**
Clock Start/From: **7**
Clock To: **5**
1st Value:
2nd Value:
Value Percent: **5.000**
Continuous Index: **S01**
Within 8" of Joint: **YES**
Remarks: **WANDER**

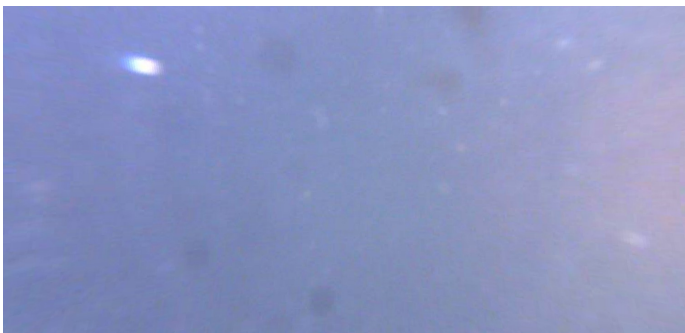
Code:	MCU
Description:	Camera Underwater
Distance (ft):	8.0
Structural Grade:	0
O&M Grade:	4
Clock Start/From:	
Clock To:	
1st Value:	
2nd Value:	
Value Percent:	
Continuous Index:	S02
Within 8" of Joint:	NO
Remarks:

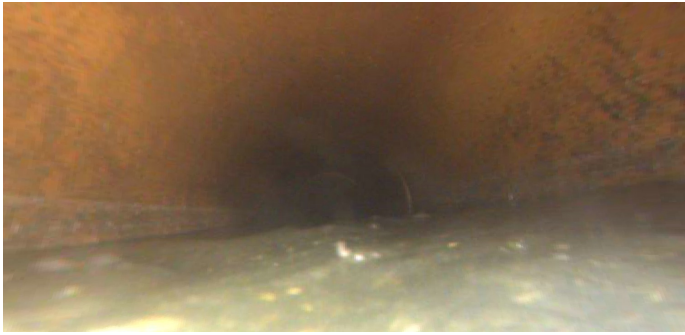
Code: **MCU**
Description: **Camera Underwater**

Distance (ft): **37.7**
Structural Grade: **0**
O&M Grade: **4**
Clock Start/From:
Clock To:
1st Value:
2nd Value:
Value Percent:
Continuous Index: **F02**
Within 8" of Joint: **NO**
Remarks: **EMERGED**

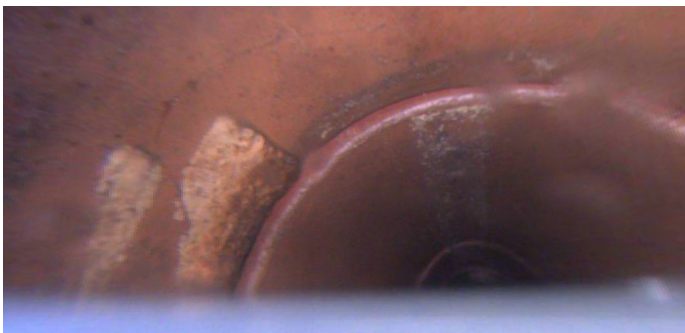
Code: **DAZ**
Description: **Deposits Attached Other**

Distance (ft): **41.2**
Structural Grade: **0**
O&M Grade: **2**
Clock Start/From: **9**
Clock To: **10**
1st Value:
2nd Value:
Value Percent: **5.000**
Continuous Index:
Within 8" of Joint: **NO**
Remarks:

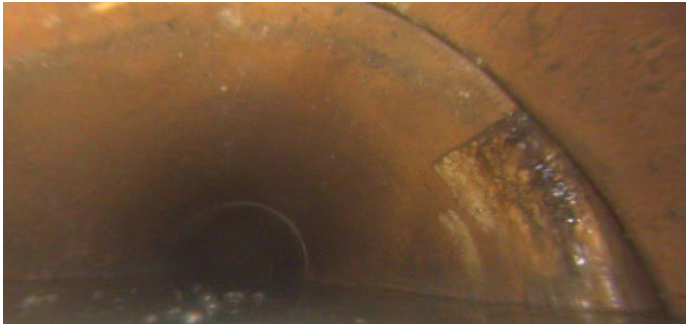
Code: **IW**
Description: **Infil Weeper**

Distance (ft): **42.0**
Structural Grade: **0**
O&M Grade: **2**
Clock Start/From: **9**
Clock To: **11**
1st Value:
2nd Value:
Value Percent:
Continuous Index:
Within 8" of Joint: **YES**
Remarks:

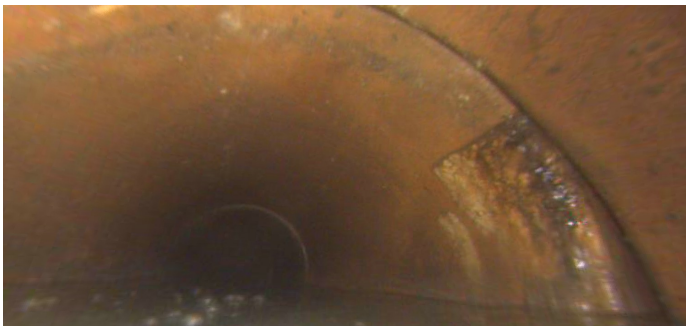
Code: **IW**
Description: **Infil Weeper**

Distance (ft): **42.0**
Structural Grade: **0**
O&M Grade: **2**
Clock Start/From: **11**
Clock To:
1st Value:
2nd Value:
Value Percent:
Continuous Index:
Within 8" of Joint: **YES**
Remarks:

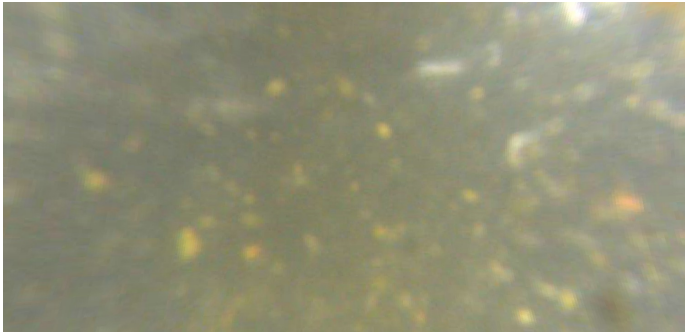
Code: **MCU**
Description: **Camera Underwater**

Distance (ft): **43.6**
Structural Grade: **0**
O&M Grade: **4**
Clock Start/From:
Clock To:
1st Value:
2nd Value:
Value Percent:
Continuous Index: **S03**
Within 8" of Joint: **NO**
Remarks:

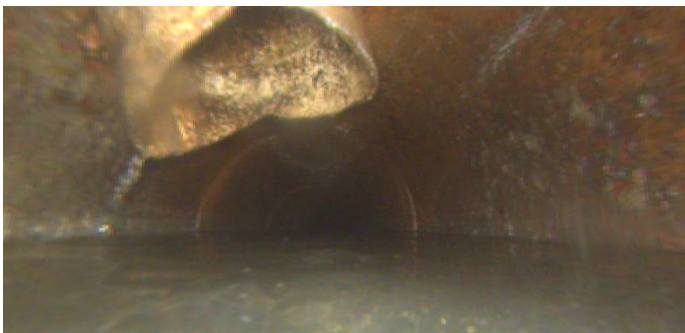
Code: **TBI**
Description: **Tap Break-in Intruding**

Distance (ft): **47.4**
Structural Grade: **0**
O&M Grade: **2**
Clock Start/From: **1**
Clock To:
1st Value: **4.000**
2nd Value: **3.000**
Value Percent:
Continuous Index:
Within 8" of Joint:
Remarks:

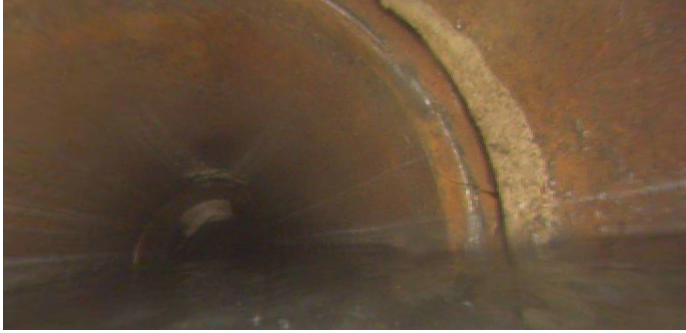
Code: **CL**
Description: **Crack Longitudinal**

Distance (ft): **50.6**
Structural Grade: **2**
O&M Grade: **0**
Clock Start/From: **9**
Clock To:
1st Value:
2nd Value:
Value Percent:
Continuous Index:
Within 8" of Joint:
Remarks:

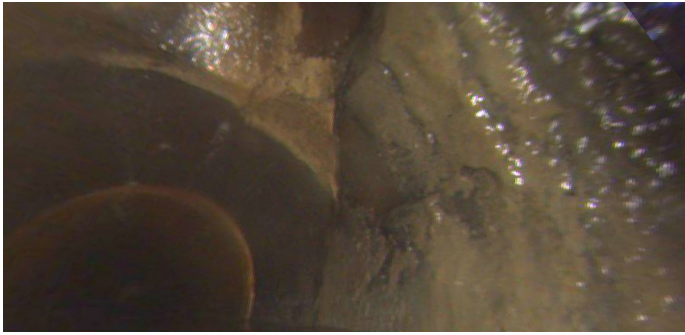
Code: **FM**
Description: **Fracture Multiple**

Distance (ft): **56.0**
Structural Grade: **4**
O&M Grade: **0**
Clock Start/From: **9**
Clock To: **11**
1st Value:
2nd Value:
Value Percent:
Continuous Index:
Within 8" of Joint:
Remarks:

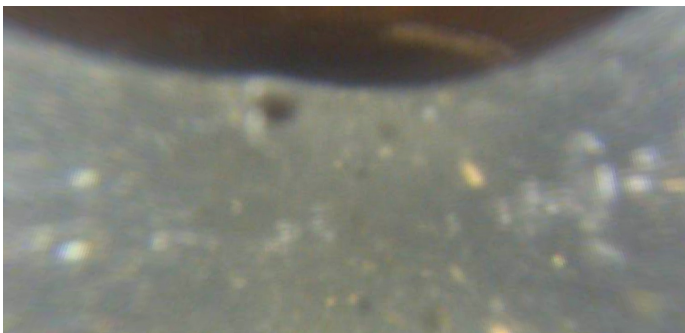
Code: **MWLS**
Description: **Water Level Sag**

Distance (ft): **63.3**
Structural Grade: **3**
O&M Grade: **3**
Clock Start/From:
Clock To:
1st Value:
2nd Value:
Value Percent: **50.000**
Continuous Index:
Within 8" of Joint: **NO**
Remarks:

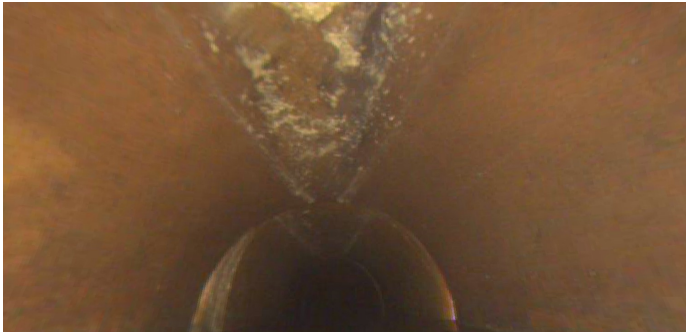
Code: **DAGS**
Description: **Deposits Attached Grease**

Distance (ft): **66.1**
Structural Grade: **0**
O&M Grade: **2**
Clock Start/From: **7**
Clock To: **5**
1st Value:
2nd Value:
Value Percent: **5.000**
Continuous Index: **S04**
Within 8" of Joint: **YES**
Remarks: **WANDER**

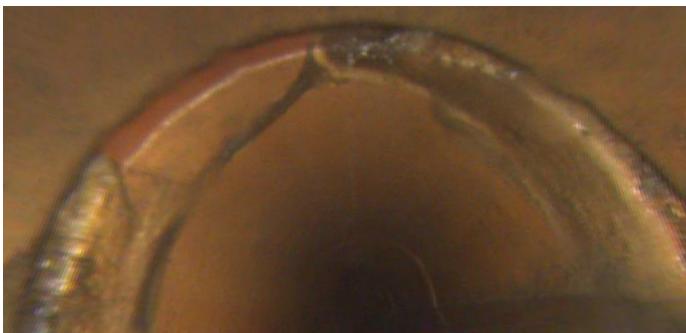
Code: **IW**
Description: **Infil Weeper**

Distance (ft): **102.8**
Structural Grade: **0**
O&M Grade: **2**
Clock Start/From: **7**
Clock To: **5**
1st Value:
2nd Value:
Value Percent:
Continuous Index:
Within 8" of Joint: **YES**
Remarks:

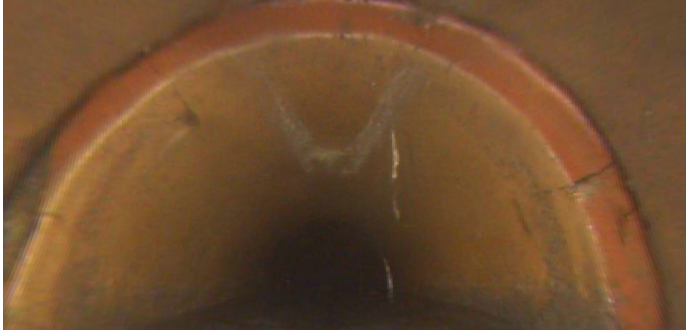
Code: **FM**
Description: **Fracture Multiple**

Distance (ft): **109.1**
Structural Grade: **4**
O&M Grade: **0**
Clock Start/From: **8**
Clock To: **4**
1st Value:
2nd Value:
Value Percent:
Continuous Index:
Within 8" of Joint: **YES**
Remarks:

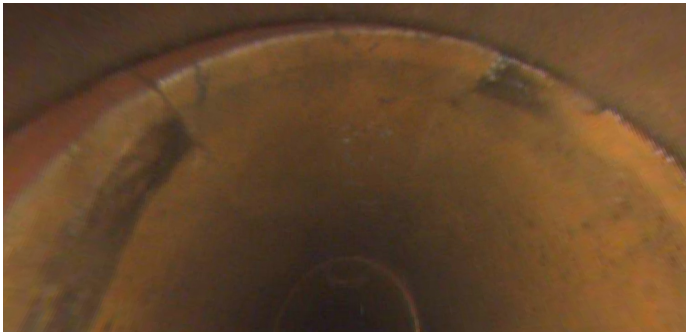
Code: **FM**
Description: **Fracture Multiple**

Distance (ft): **111.1**
Structural Grade: **4**
O&M Grade: **0**
Clock Start/From: **11**
Clock To: **2**
1st Value:
2nd Value:
Value Percent:
Continuous Index:
Within 8" of Joint: **YES**
Remarks:

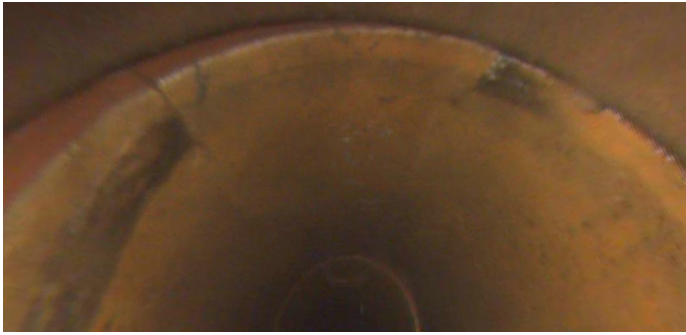
Code: **IS**
Description: **Infil Stain**

Distance (ft): **111.1**
Structural Grade: **0**
O&M Grade: **0**
Clock Start/From: **2**
Clock To: **5**
1st Value:
2nd Value:
Value Percent:
Continuous Index:
Within 8" of Joint:
Remarks:

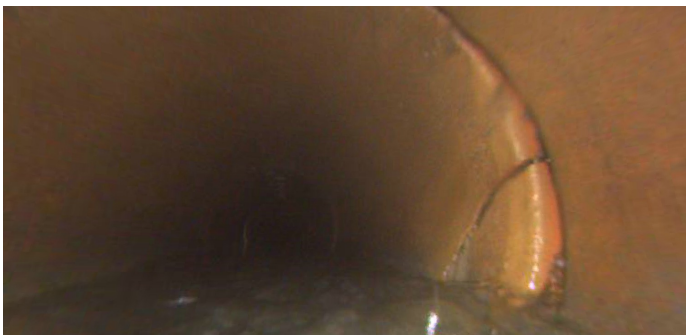
Code: **FS**
Description: **Fracture Spiral**

Distance (ft): **115.3**
Structural Grade: **3**
O&M Grade: **0**
Clock Start/From: **9**
Clock To: **10**
1st Value:
2nd Value:
Value Percent:
Continuous Index:
Within 8" of Joint: **YES**
Remarks:

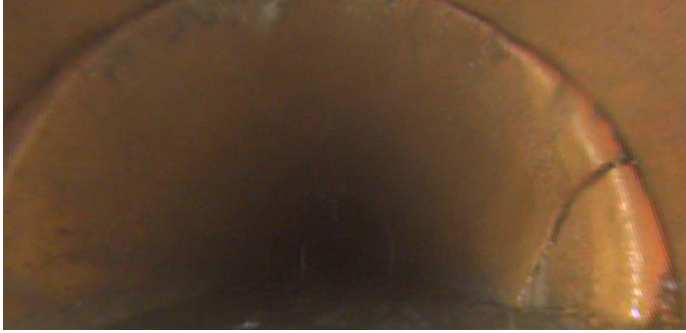
Code: **FC**
Description: **Fracture Circumferential**

Distance (ft): **115.3**
Structural Grade: **2**
O&M Grade: **0**
Clock Start/From: **7**
Clock To: **9**
1st Value:
2nd Value:
Value Percent:
Continuous Index:
Within 8" of Joint: **YES**
Remarks:

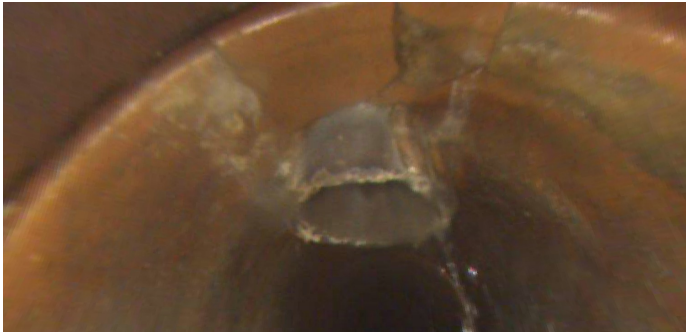
Code: **TBI**
Description: **Tap Break-in Intruding**

Distance (ft): **140.2**
Structural Grade: **0**
O&M Grade: **2**
Clock Start/From: **1**
Clock To:
1st Value: **4.000**
2nd Value: **1.000**
Value Percent:
Continuous Index:
Within 8" of Joint:
Remarks:

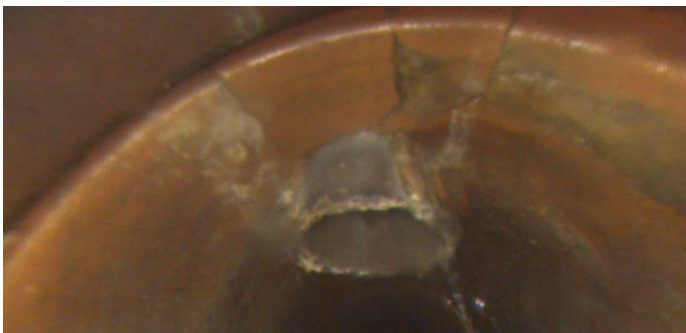
Code: **CM**
Description: **Crack Multiple**

Distance (ft): **140.2**
Structural Grade: **3**
O&M Grade: **0**
Clock Start/From: **11**
Clock To: **12**
1st Value:
2nd Value:
Value Percent:
Continuous Index:
Within 8" of Joint: **YES**
Remarks:

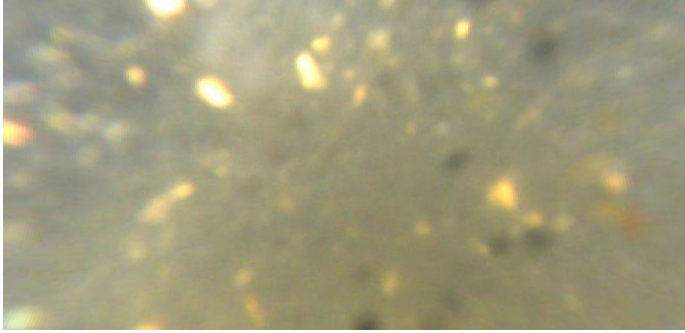
Code: **MCU**
Description: **Camera Underwater**

Distance (ft): **146.0**
Structural Grade: **0**
O&M Grade: **4**
Clock Start/From:
Clock To:
1st Value:
2nd Value:
Value Percent:
Continuous Index:
Within 8" of Joint: **NO**
Remarks:

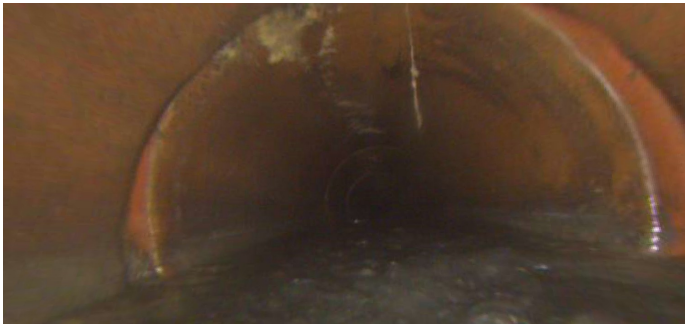
Code: **RFJ**
Description: **Roots Fine Joint**

Distance (ft): **153.0**
Structural Grade: **0**
O&M Grade: **1**
Clock Start/From: **12**
Clock To:
1st Value:
2nd Value:
Value Percent:
Continuous Index:
Within 8" of Joint: **YES**
Remarks:

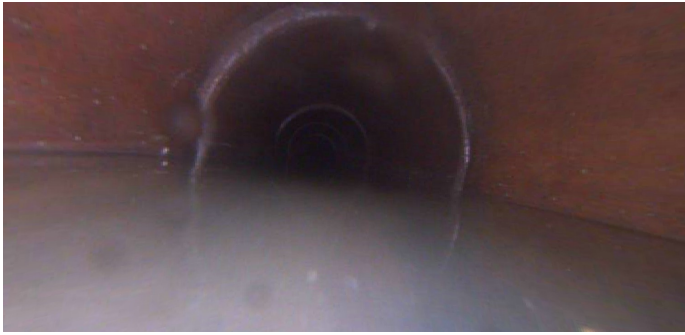
Code: **MSA**
Description: **Abandoned Survey**

Distance (ft): **159.7**
Structural Grade: **0**
O&M Grade: **0**
Clock Start/From:
Clock To:
1st Value:
2nd Value:
Value Percent:
Continuous Index:
Within 8" of Joint: **NO**
Remarks: **ROBOT HAS STOPPED**

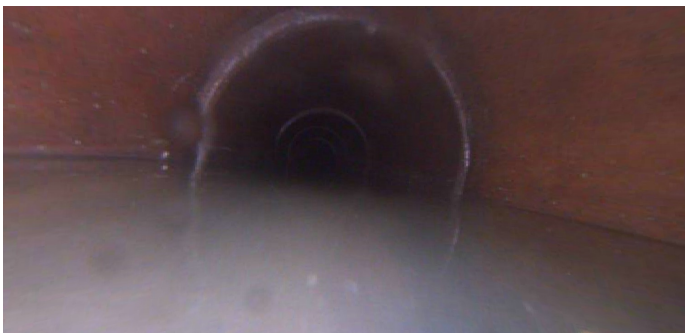
Code: **MCU**
Description: **Camera Underwater**

Distance (ft): **159.7**
Structural Grade: **0**
O&M Grade: **4**
Clock Start/From:
Clock To:
1st Value:
2nd Value:
Value Percent:
Continuous Index: **F03**
Within 8" of Joint: **NO**
Remarks:

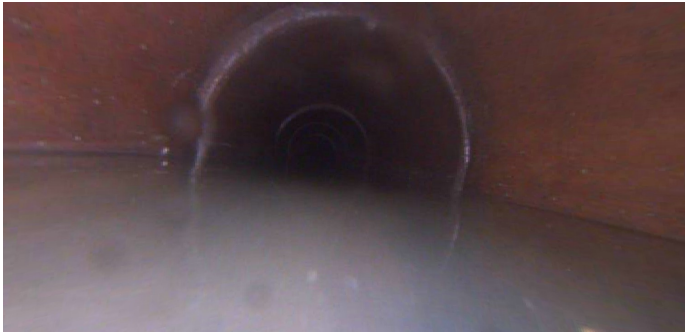
Code: **DAZ**
Description: **Deposits Attached Other**

Distance (ft): **159.7**
Structural Grade: **0**
O&M Grade: **2**
Clock Start/From: **7**
Clock To: **5**
1st Value:
2nd Value:
Value Percent: **5.000**
Continuous Index: **F01**
Within 8" of Joint: **YES**
Remarks: **WANDER**

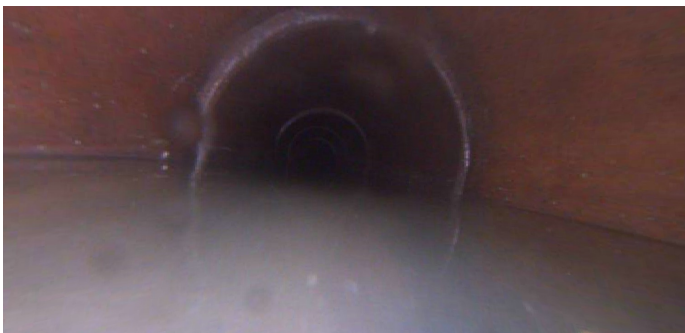
Code: **DAGS**
Description: **Deposits Attached Grease**

Distance (ft): **159.7**
Structural Grade: **0**
O&M Grade: **2**
Clock Start/From: **7**
Clock To: **5**
1st Value:
2nd Value:
Value Percent: **5.000**
Continuous Index: **F04**
Within 8" of Joint: **YES**
Remarks: **WANDER**
