Profile/Photo Observation Report

Date:	09/04/2021	Weather:		Coding:	PACP 7.0
Pipe Length (ft):	189.5	Owner:	City of Hobart	Pre Clean:	Heavy Cleaning
P.O.#:	YES502259	Surveyor:	S. Bucklin	PSR:	P-504-078-077
Customer:	City of Hobart	Clean Date:	09/02/2021	Shape:	C

Street:	North Cavender Street	Flow Control:	Not Controlled
City:	Hobart, IN	Year Renewed:	
Location:	Alley	Tape/Media #:	
Purpose:	Routine Assessment	Dia/Height:	12"
Use:	Sanitary Sewage Pipe	Material:	VCP
Drain Area:		Lining:	
Category:	NA		
Comment:			
Location Details:		Direction of Survey:	Downstream
US MH:	M-504-078	DS MH:	M-504-077
		Total Length Surveyed (ft):	189.5

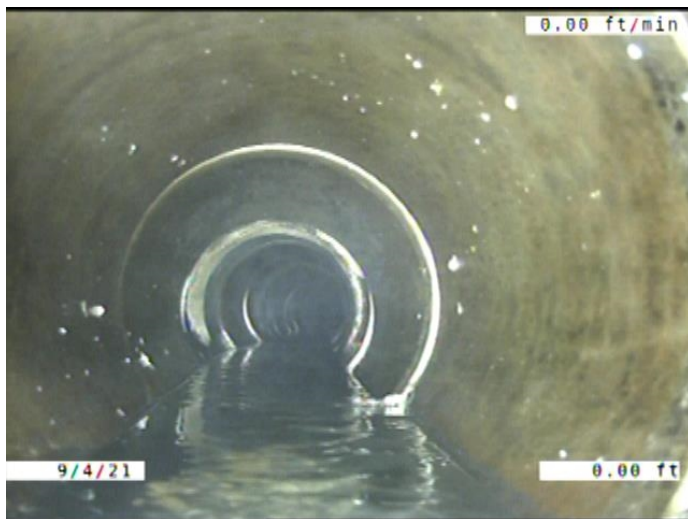
Code: **MWL**
 Description: **Miscellaneous Water Level**

Distance (ft): **.0**
 Structural Grade: **0**
 O&M Grade: **0**
 Clock Start/From:
 Clock To:
 1st Value:
 2nd Value:
 Value Percent: **5.000**
 Continuous Index:
 Within 8" of Joint: **NO**
 Remarks:

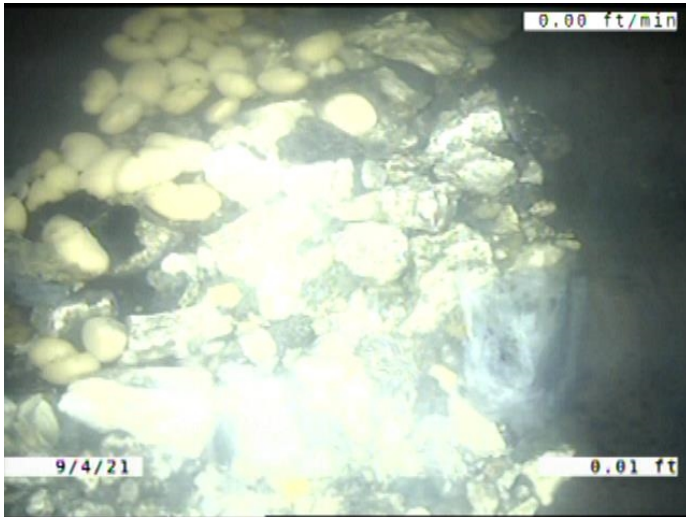
Code:	OBN
Description:	Obstruction Construction Debris
Distance (ft):	.0
Structural Grade:	0
O&M Grade:	2
Clock Start/From:	5
Clock To:	7
1st Value:	
2nd Value:	
Value Percent:	5.000
Continuous Index:	
Within 8" of Joint:	YES
Remarks:

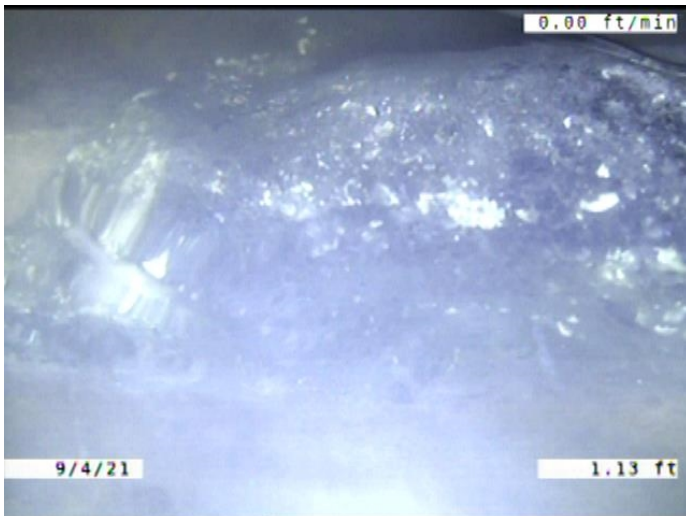
Code:	DAE
Description:	Deposits Attached Encrustation
Distance (ft):	1.1
Structural Grade:	0
O&M Grade:	2
Clock Start/From:	4
Clock To:	7
1st Value:	
2nd Value:	
Value Percent:	5.000
Continuous Index:	
Within 8" of Joint:	YES
Remarks:

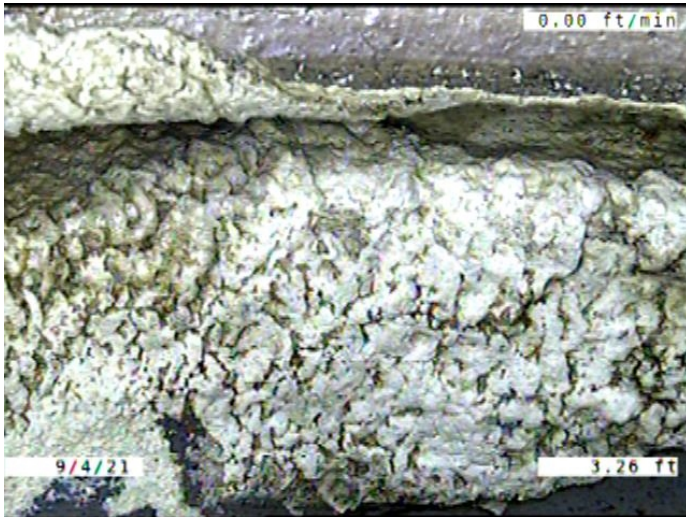
Code: **DAE**
 Description: **Deposits Attached Encrustation**

Distance (ft): **3.3**
 Structural Grade: **0**
 O&M Grade: **2**
 Clock Start/From: **8**
 Clock To: **4**
 1st Value:
 2nd Value:
 Value Percent: **5.000**
 Continuous Index:
 Within 8" of Joint: **YES**
 Remarks:

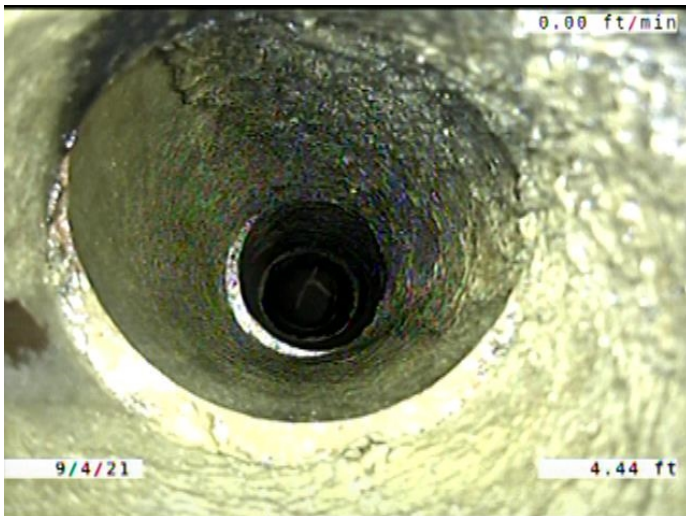
Code: **TFD**
 Description: **Tap Factory Defective**

Distance (ft): **4.4**
 Structural Grade: **0**
 O&M Grade: **3**
 Clock Start/From: **1**
 Clock To:
 1st Value: **6.000**
 2nd Value:
 Value Percent:
 Continuous Index:
 Within 8" of Joint: **YES**
 Remarks: **ENCrustation ALL THE WAY AROUND THE TAP**

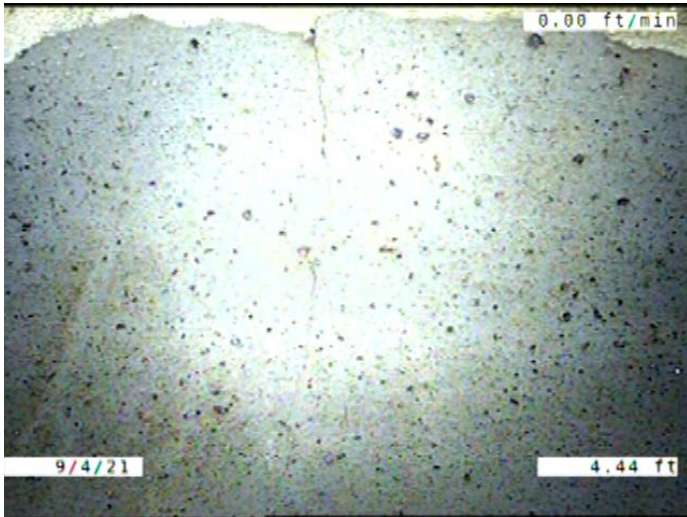
Code: **CM**
 Description: **Crack Multiple**

Distance (ft): **4.4**
 Structural Grade: **3**
 O&M Grade: **0**
 Clock Start/From: **8**
 Clock To: **4**
 1st Value:
 2nd Value:
 Value Percent:
 Continuous Index:
 Within 8" of Joint: **YES**
 Remarks:

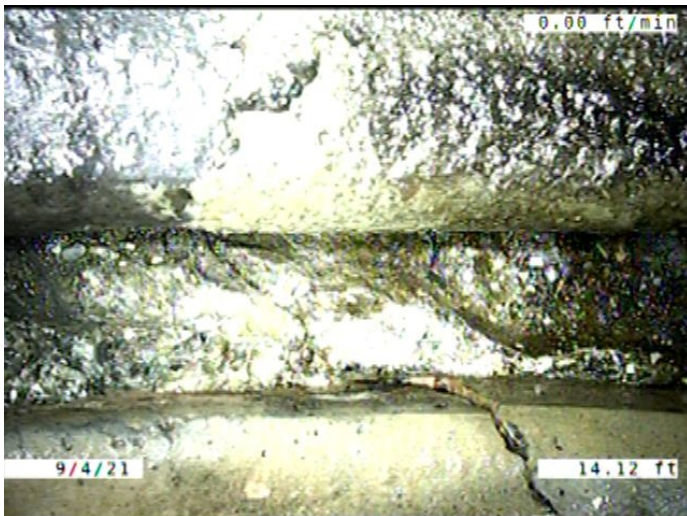
Code: **DAE**
 Description: **Deposits Attached Encrustation**

Distance (ft): **14.1**
 Structural Grade: **0**
 O&M Grade: **2**
 Clock Start/From: **8**
 Clock To: **11**
 1st Value:
 2nd Value:
 Value Percent: **5.000**
 Continuous Index:
 Within 8" of Joint: **YES**
 Remarks:

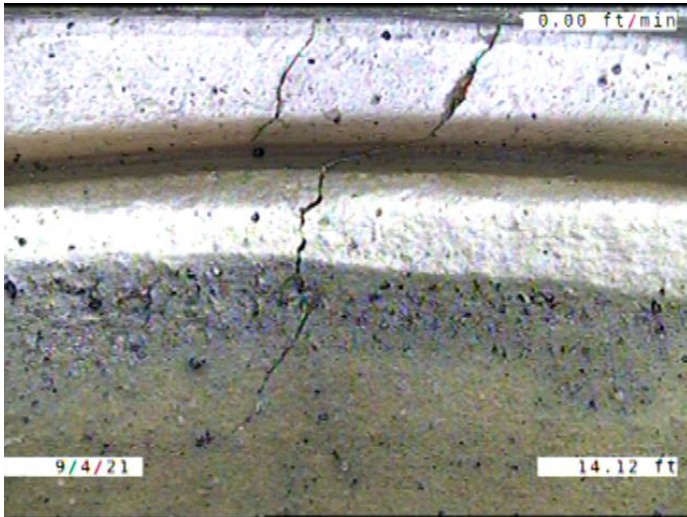
Code: **FM**
 Description: **Fracture Multiple**

Distance (ft): **14.1**
 Structural Grade: **4**
 O&M Grade: **0**
 Clock Start/From: **9**
 Clock To: **1**
 1st Value:
 2nd Value:
 Value Percent:
 Continuous Index:
 Within 8" of Joint: **YES**
 Remarks:

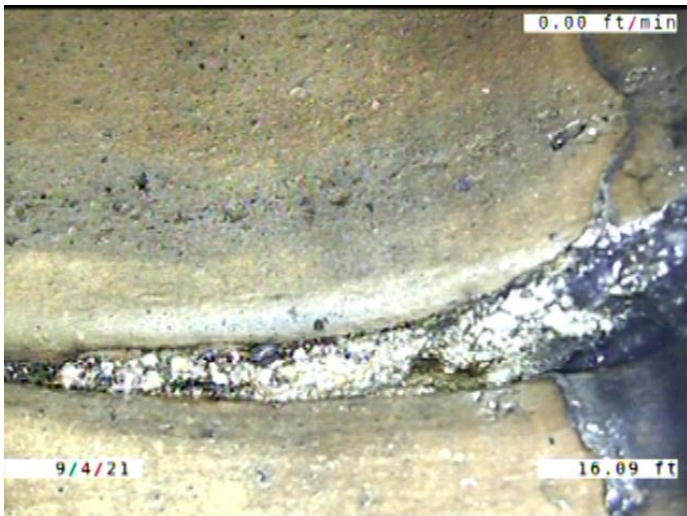
Code: **DAE**
 Description: **Deposits Attached Encrustation**

Distance (ft): **16.1**
 Structural Grade: **0**
 O&M Grade: **2**
 Clock Start/From: **3**
 Clock To: **10**
 1st Value:
 2nd Value:
 Value Percent: **5.000**
 Continuous Index:
 Within 8" of Joint: **YES**
 Remarks:

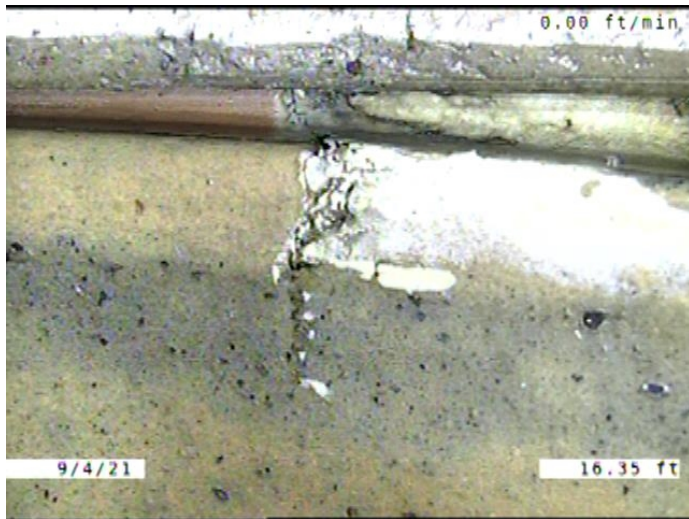
Code: **CL**
 Description: **Crack Longitudinal**

Distance (ft): **16.4**
 Structural Grade: **2**
 O&M Grade: **0**
 Clock Start/From: **2**
 Clock To:
 1st Value:
 2nd Value:
 Value Percent:
 Continuous Index:
 Within 8" of Joint: **YES**
 Remarks:

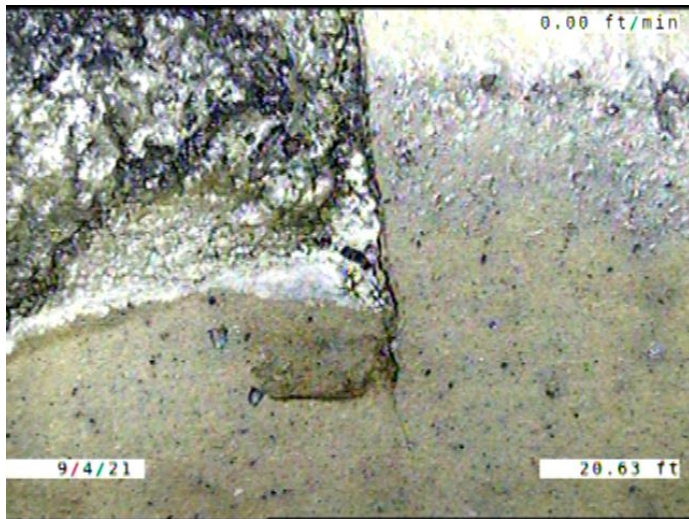
Code: **CL**
 Description: **Crack Longitudinal**

Distance (ft): **20.6**
 Structural Grade: **2**
 O&M Grade: **0**
 Clock Start/From: **11**
 Clock To:
 1st Value:
 2nd Value:
 Value Percent:
 Continuous Index:
 Within 8" of Joint: **YES**
 Remarks:

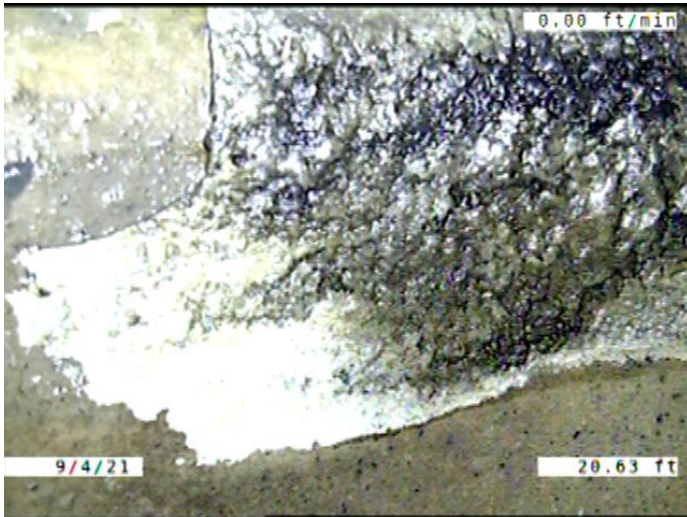
Code: **DAE**
 Description: **Deposits Attached Encrustation**

Distance (ft): **20.6**
 Structural Grade: **0**
 O&M Grade: **2**
 Clock Start/From: **9**
 Clock To: **11**
 1st Value:
 2nd Value:
 Value Percent: **5.000**
 Continuous Index:
 Within 8" of Joint: **YES**
 Remarks:

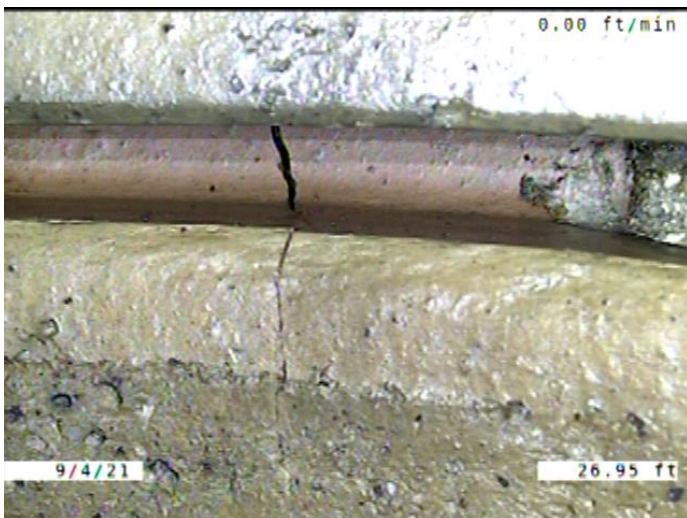
Code: **FM**
 Description: **Fracture Multiple**

Distance (ft): **26.9**
 Structural Grade: **4**
 O&M Grade: **0**
 Clock Start/From: **7**
 Clock To: **5**
 1st Value:
 2nd Value:
 Value Percent:
 Continuous Index: **S01**
 Within 8" of Joint: **YES**
 Remarks:

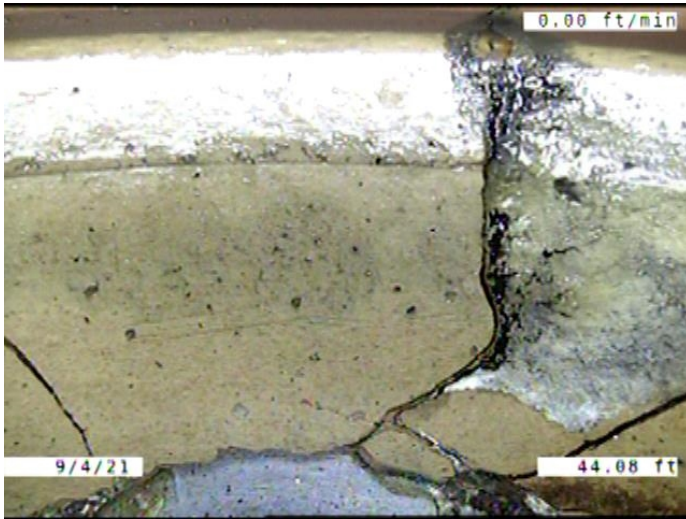
Code: **B**
 Description: **Broken**

Distance (ft): **44.1**
 Structural Grade: **4**
 O&M Grade: **0**
 Clock Start/From: **10**
 Clock To: **1**
 1st Value:
 2nd Value:
 Value Percent:
 Continuous Index:
 Within 8" of Joint: **YES**
 Remarks:

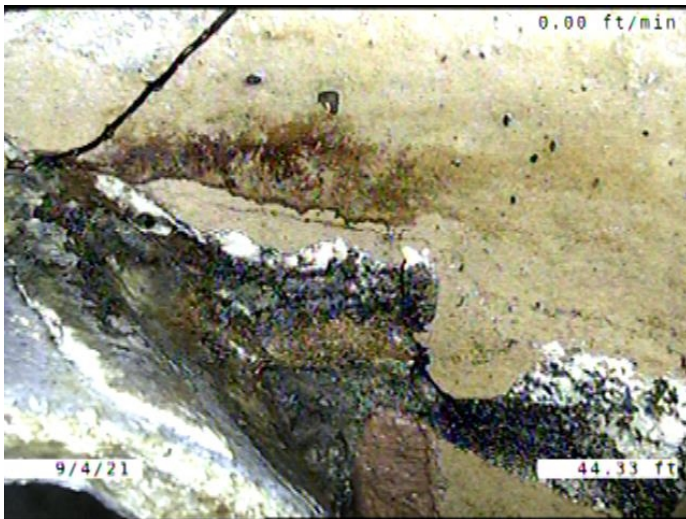
Code: **DAE**
 Description: **Deposits Attached Encrustation**

Distance (ft): **44.3**
 Structural Grade: **0**
 O&M Grade: **2**
 Clock Start/From: **9**
 Clock To: **3**
 1st Value:
 2nd Value:
 Value Percent: **5.000**
 Continuous Index:
 Within 8" of Joint: **YES**
 Remarks:

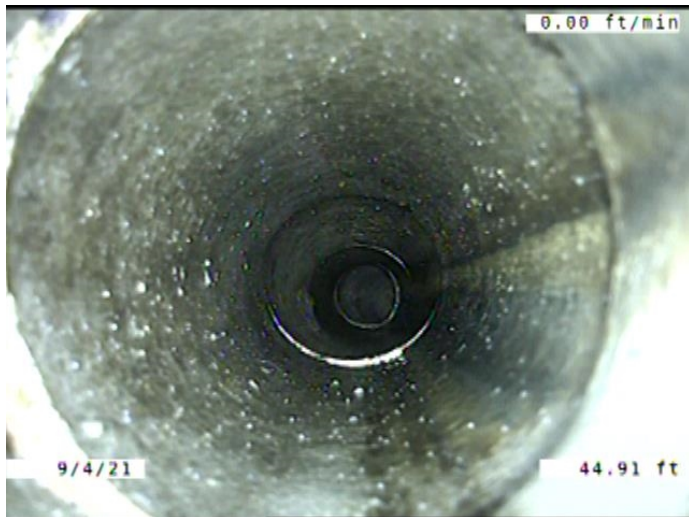
Code: **TBI**
 Description: **Tap Break-in Intruding**

Distance (ft): **44.9**
 Structural Grade: **0**
 O&M Grade: **2**
 Clock Start/From: **12**
 Clock To:
 1st Value: **6.000**
 2nd Value: **3.000**
 Value Percent:
 Continuous Index:
 Within 8" of Joint: **YES**
 Remarks:

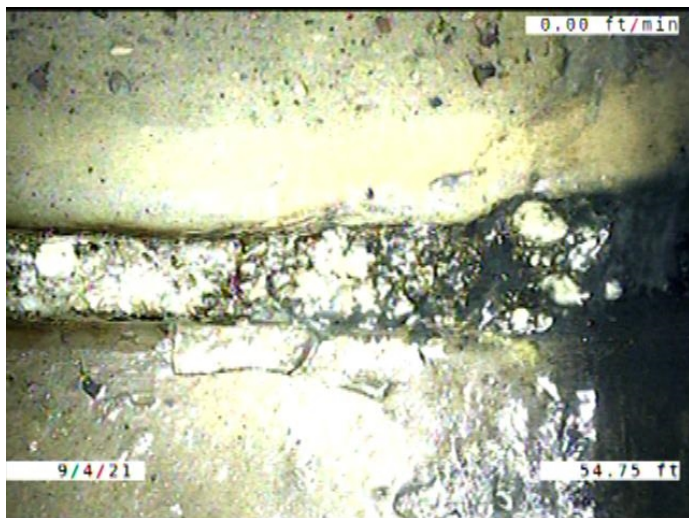
Code: **DAE**
 Description: **Deposits Attached Encrustation**

Distance (ft): **54.8**
 Structural Grade: **0**
 O&M Grade: **2**
 Clock Start/From: **3**
 Clock To: **9**
 1st Value:
 2nd Value:
 Value Percent: **5.000**
 Continuous Index:
 Within 8" of Joint: **YES**
 Remarks:

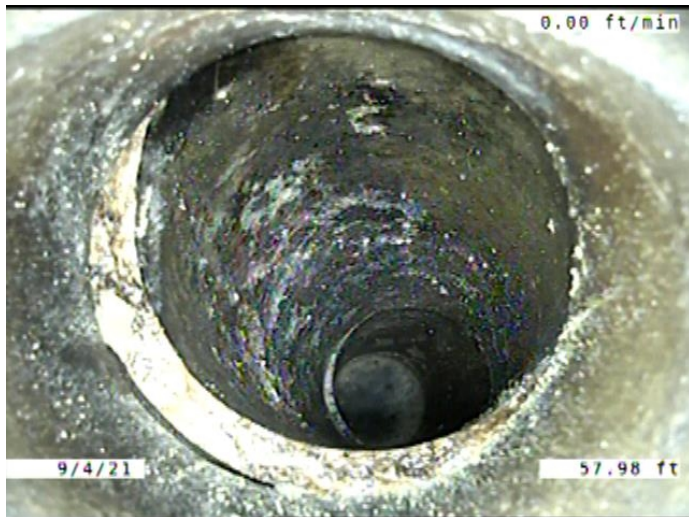
Code: **TFD**
 Description: **Tap Factory Defective**

Distance (ft): **58.0**
 Structural Grade: **0**
 O&M Grade: **3**
 Clock Start/From: **1**
 Clock To:
 1st Value: **6.000**
 2nd Value:
 Value Percent:
 Continuous Index:
 Within 8" of Joint: **YES**
 Remarks: **FIRST JOINT BACK OFFSET**

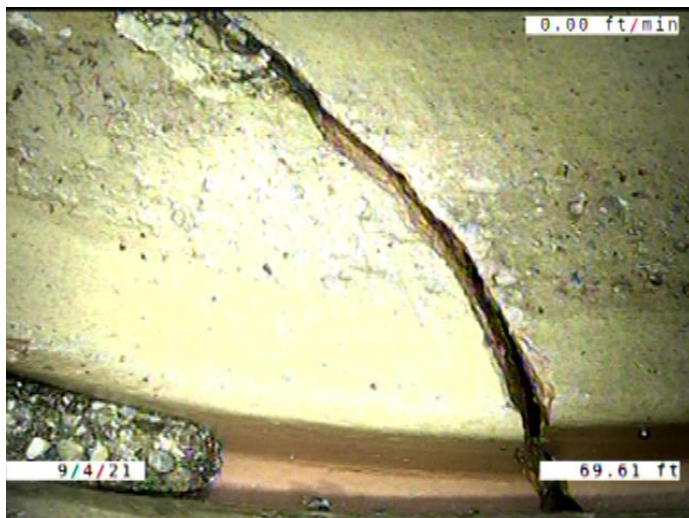
69.6	B	Broken	1060	S 4
82.4	FM(F01)	Fracture Multiple	1141	S 4
82.4	DAE	Deposits Attached Encrustation	1181	M 2
87.9	TFD	Tap Factory Defective	1241	M 3
97.5	CS	Crack Spiral	1338	S 2

Code: **B**
 Description: **Broken**

Distance (ft): **69.6**
 Structural Grade: **4**
 O&M Grade: **0**
 Clock Start/From: **4**
 Clock To: **6**
 1st Value:
 2nd Value:
 Value Percent:
 Continuous Index:
 Within 8" of Joint: **YES**
 Remarks:

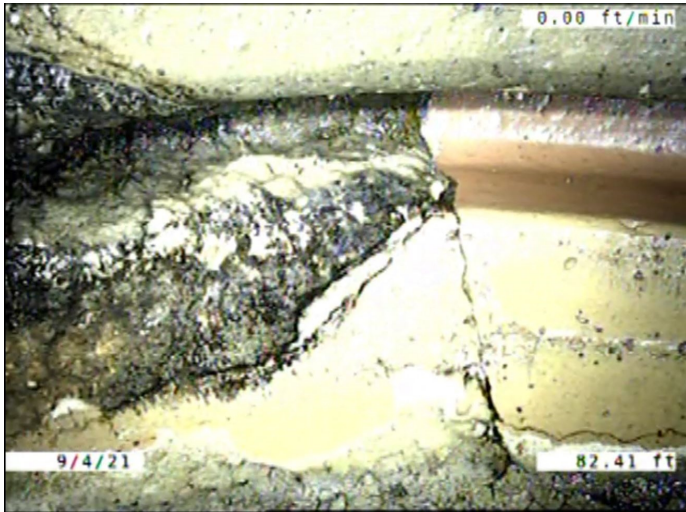
Code: **FM**
 Description: **Fracture Multiple**

Distance (ft): **82.4**
 Structural Grade: **4**
 O&M Grade: **0**
 Clock Start/From: **7**
 Clock To: **5**
 1st Value:
 2nd Value:
 Value Percent:
 Continuous Index: **F01**
 Within 8" of Joint: **YES**
 Remarks:

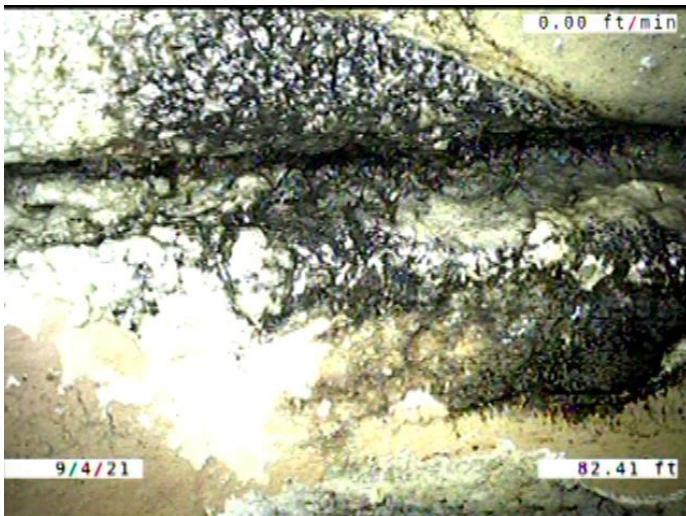
Code: **DAE**
 Description: **Deposits Attached Encrustation**

Distance (ft): **82.4**
 Structural Grade: **0**
 O&M Grade: **2**
 Clock Start/From: **12**
 Clock To: **12**
 1st Value:
 2nd Value:
 Value Percent: **5.000**
 Continuous Index:
 Within 8" of Joint: **YES**
 Remarks:

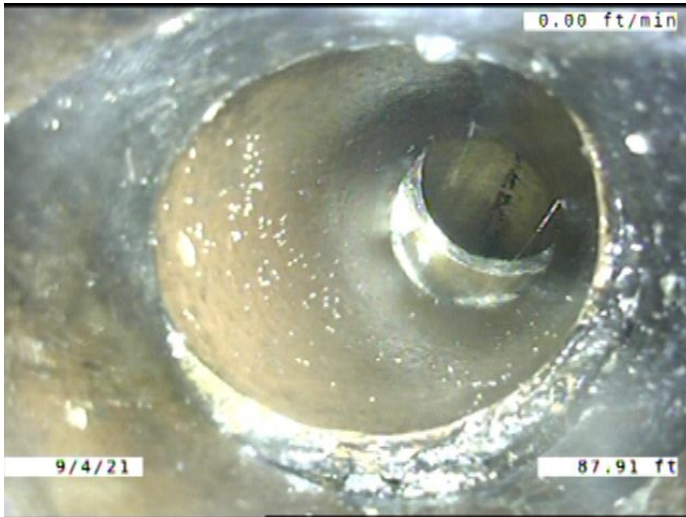
Code:	TFD
Description:	Tap Factory Defective
Distance (ft):	87.9
Structural Grade:	0
O&M Grade:	3
Clock Start/From:	12
Clock To:	
1st Value:	6.000
2nd Value:	
Value Percent:	
Continuous Index:	
Within 8" of Joint:	YES
Remarks:	CONSTANTLY RUNNING WATER. JOINTS ARE ALL OFFSET THAT I CAN

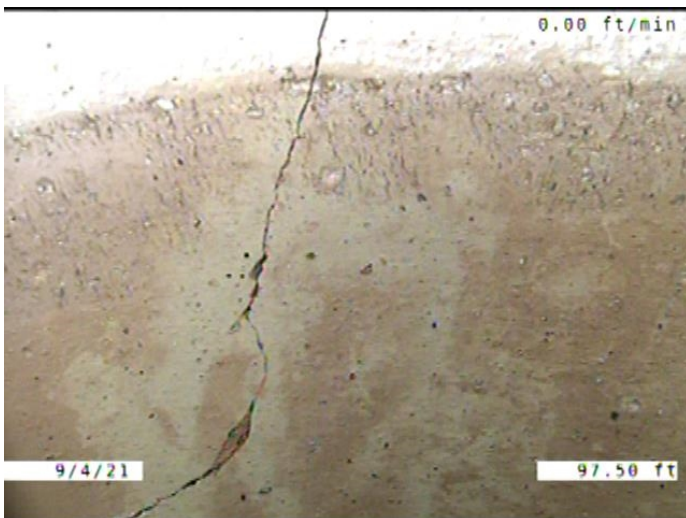
Code:	CS
Description:	Crack Spiral
Distance (ft):	97.5
Structural Grade:	2
O&M Grade:	0
Clock Start/From:	9
Clock To:	11
1st Value:	
2nd Value:	
Value Percent:	
Continuous Index:	
Within 8" of Joint:	YES
Remarks:

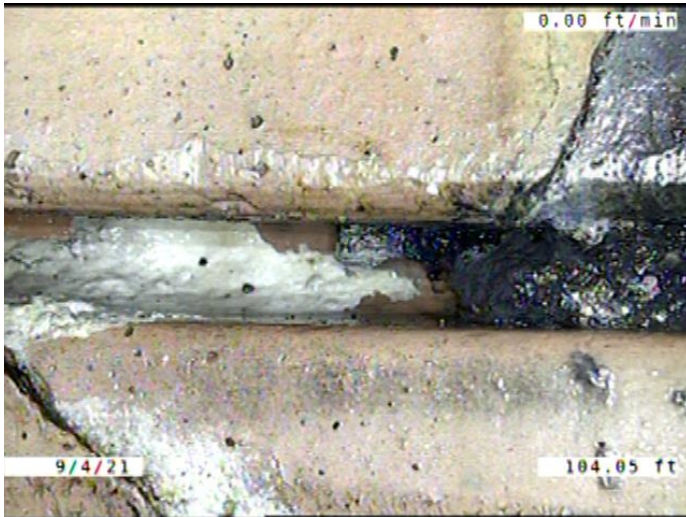
Code: **DAE**
Description: **Deposits Attached Encrustation**

Distance (ft): **104.0**
Structural Grade: **0**
O&M Grade: **2**
Clock Start/From: **8**
Clock To: **4**
1st Value:
2nd Value:
Value Percent: **5.000**
Continuous Index:
Within 8" of Joint: **YES**
Remarks:

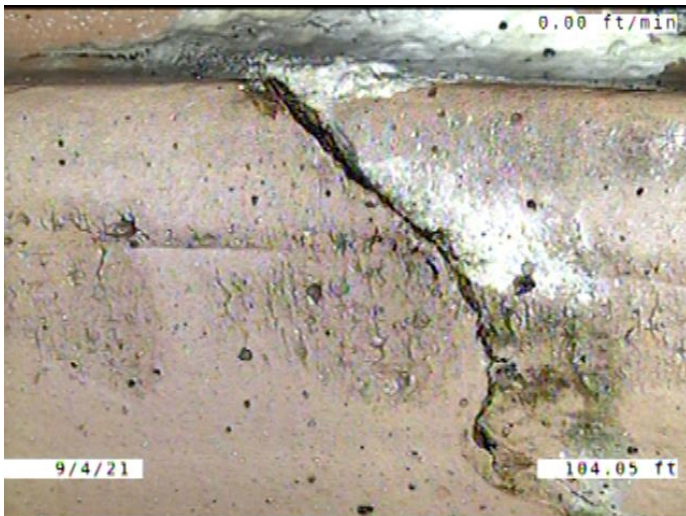
Code: **FM**
Description: **Fracture Multiple**

Distance (ft): **104.0**
Structural Grade: **4**
O&M Grade: **0**
Clock Start/From: **8**
Clock To: **4**
1st Value:
2nd Value:
Value Percent:
Continuous Index:
Within 8" of Joint: **YES**
Remarks:

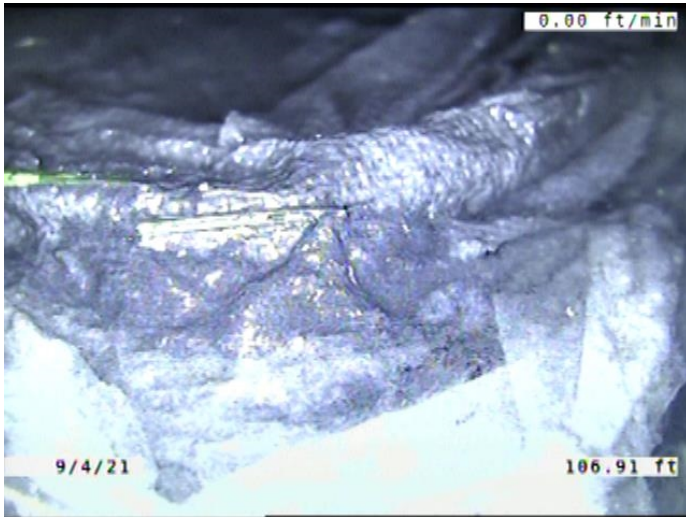
Code: **DAR**
 Description: **Deposits Attached Ragging**

Distance (ft): **106.9**
 Structural Grade: **0**
 O&M Grade: **2**
 Clock Start/From: **6**
 Clock To:
 1st Value:
 2nd Value:
 Value Percent: **5.000**
 Continuous Index:
 Within 8" of Joint: **YES**
 Remarks:

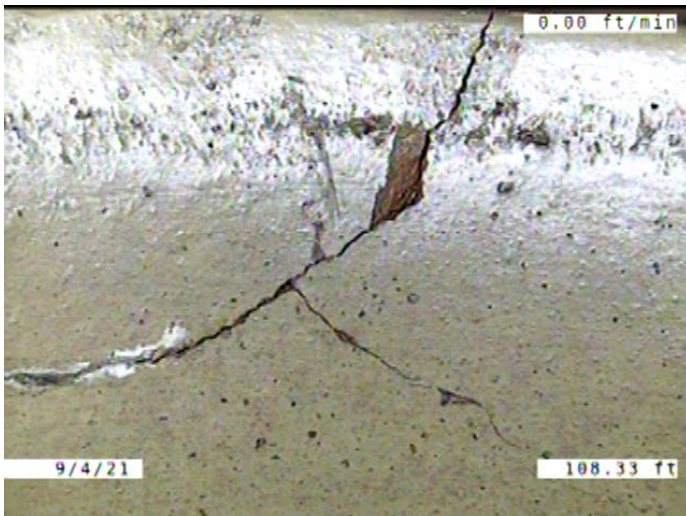
Code: **FM**
 Description: **Fracture Multiple**

Distance (ft): **108.3**
 Structural Grade: **4**
 O&M Grade: **0**
 Clock Start/From: **8**
 Clock To: **12**
 1st Value:
 2nd Value:
 Value Percent:
 Continuous Index:
 Within 8" of Joint: **YES**
 Remarks:

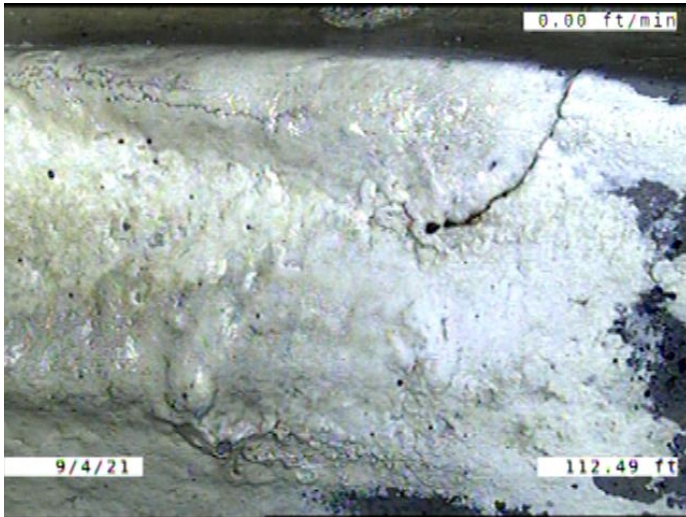
Code: **DAE**
 Description: **Deposits Attached Encrustation**

Distance (ft): **112.5**
 Structural Grade: **0**
 O&M Grade: **2**
 Clock Start/From: **10**
 Clock To: **4**
 1st Value:
 2nd Value:
 Value Percent: **5.000**
 Continuous Index:
 Within 8" of Joint: **YES**
 Remarks:

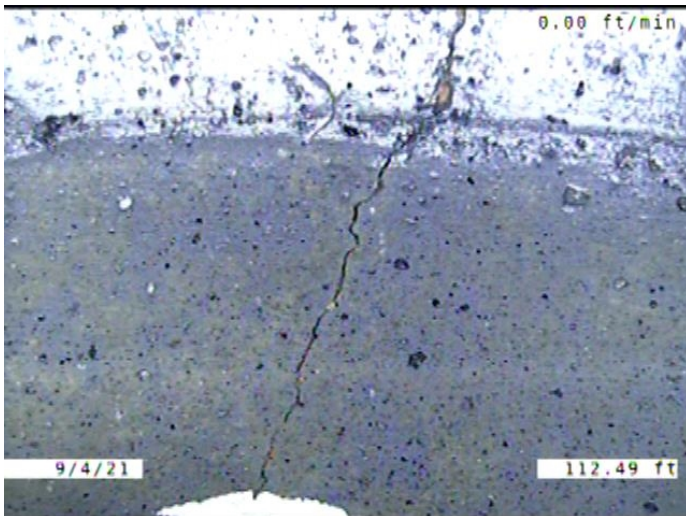
Code: **CM**
 Description: **Crack Multiple**

Distance (ft): **112.5**
 Structural Grade: **3**
 O&M Grade: **0**
 Clock Start/From: **12**
 Clock To: **4**
 1st Value:
 2nd Value:
 Value Percent:
 Continuous Index:
 Within 8" of Joint: **YES**
 Remarks:

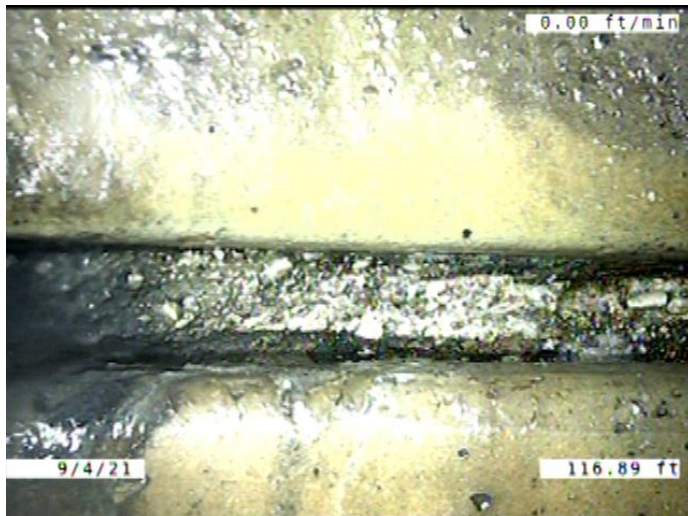
Code: **DAE**
Description: **Deposits Attached Encrustation**

Distance (ft): **116.9**
Structural Grade: **0**
O&M Grade: **2**
Clock Start/From: **3**
Clock To: **9**
1st Value:
2nd Value:
Value Percent: **5.000**
Continuous Index:
Within 8" of Joint: **YES**
Remarks:

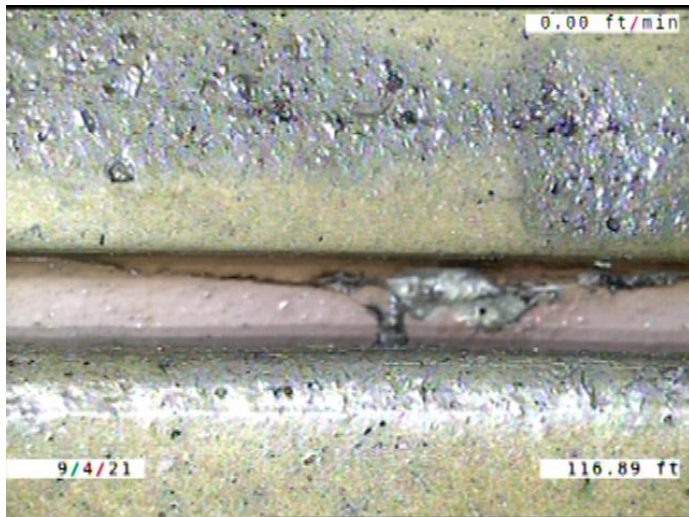
Code: **CM**
 Description: **Crack Multiple**

Distance (ft): **116.9**
 Structural Grade: **3**
 O&M Grade: **0**
 Clock Start/From: **9**
 Clock To: **3**
 1st Value:
 2nd Value:
 Value Percent:
 Continuous Index:
 Within 8" of Joint: **YES**
 Remarks:

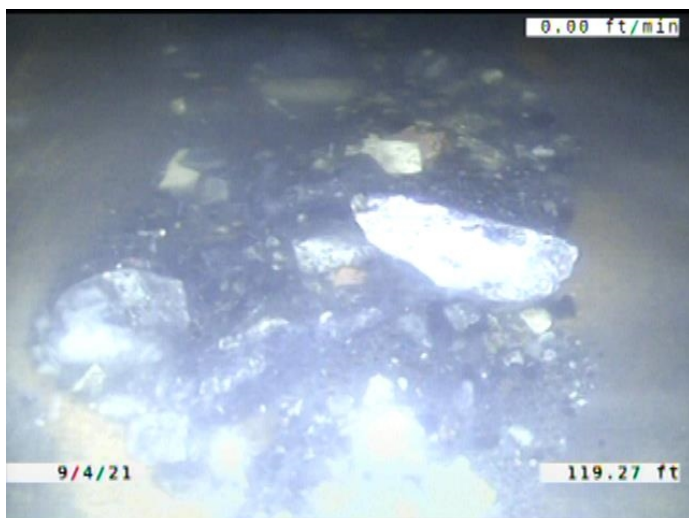
Code: **DSF**
 Description: **Deposits Settled Fine**

Distance (ft): **119.3**
 Structural Grade: **0**
 O&M Grade: **2**
 Clock Start/From: **5**
 Clock To: **7**
 1st Value:
 2nd Value:
 Value Percent: **5.000**
 Continuous Index: **S02**
 Within 8" of Joint: **YES**
 Remarks:

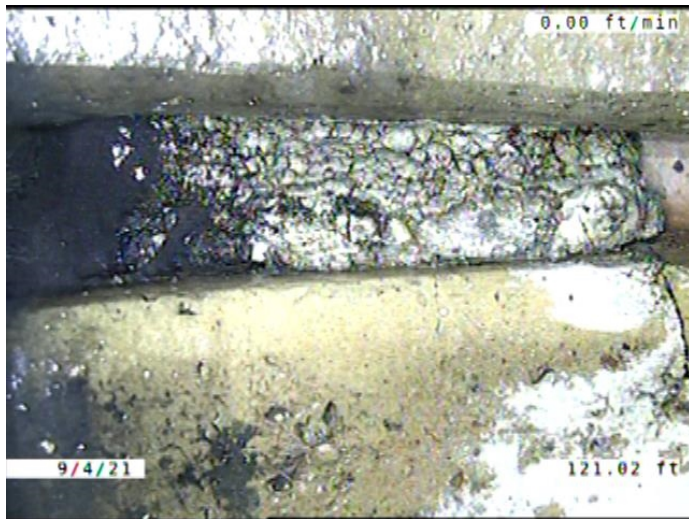
Code: **DAE**
 Description: **Deposits Attached Encrustation**

Distance (ft): **121.0**
 Structural Grade: **0**
 O&M Grade: **2**
 Clock Start/From: **12**
 Clock To: **12**
 1st Value:
 2nd Value:
 Value Percent: **5.000**
 Continuous Index:
 Within 8" of Joint: **YES**
 Remarks:

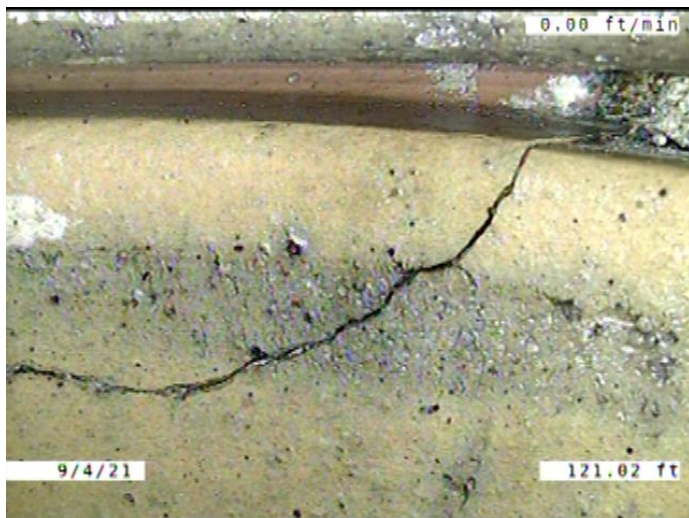
Code: **FM**
 Description: **Fracture Multiple**

Distance (ft): **121.0**
 Structural Grade: **4**
 O&M Grade: **0**
 Clock Start/From: **8**
 Clock To: **4**
 1st Value:
 2nd Value:
 Value Percent:
 Continuous Index: **S03**
 Within 8" of Joint: **YES**
 Remarks:

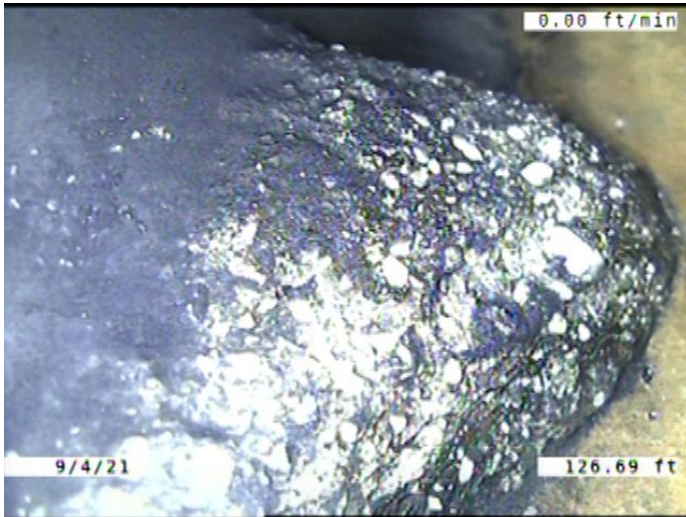
Code: **DAE**
 Description: **Deposits Attached Encrustation**

Distance (ft): **126.7**
 Structural Grade: **0**
 O&M Grade: **2**
 Clock Start/From: **4**
 Clock To: **6**
 1st Value:
 2nd Value:
 Value Percent: **5.000**
 Continuous Index:
 Within 8" of Joint: **NO**
 Remarks:

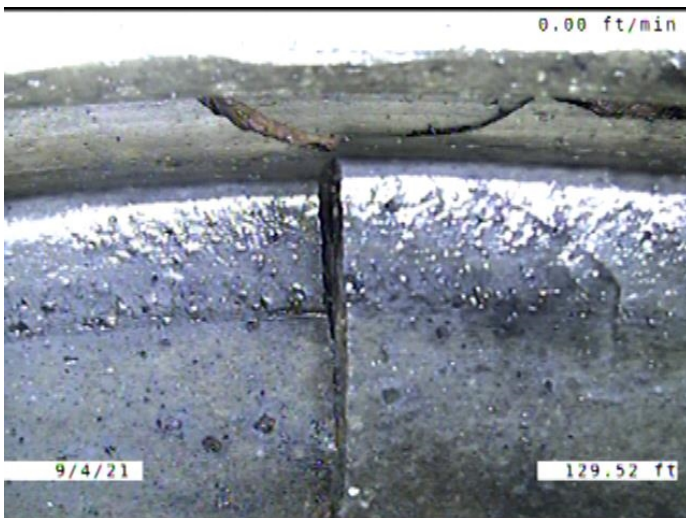
Code: **B**
 Description: **Broken**

Distance (ft): **129.5**
 Structural Grade: **4**
 O&M Grade: **0**
 Clock Start/From: **12**
 Clock To: **2**
 1st Value:
 2nd Value:
 Value Percent:
 Continuous Index:
 Within 8" of Joint: **YES**
 Remarks:

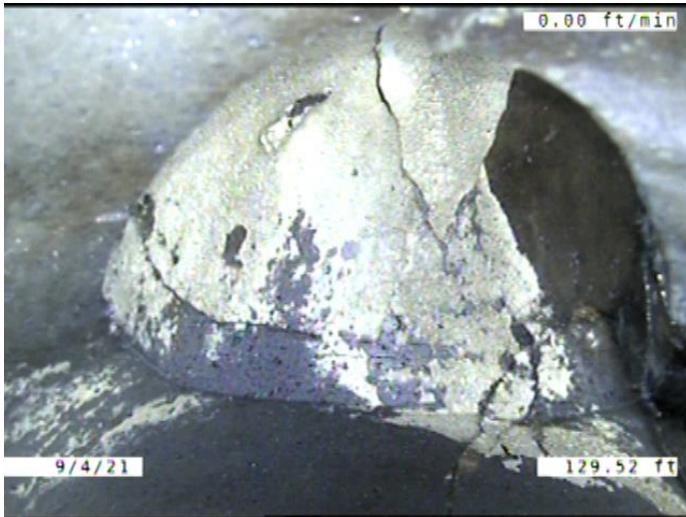
Code: **DAE**
 Description: **Deposits Attached Encrustation**

Distance (ft): **129.5**
 Structural Grade: **0**
 O&M Grade: **2**
 Clock Start/From: **8**
 Clock To: **4**
 1st Value:
 2nd Value:
 Value Percent: **5.000**
 Continuous Index:
 Within 8" of Joint: **YES**
 Remarks:

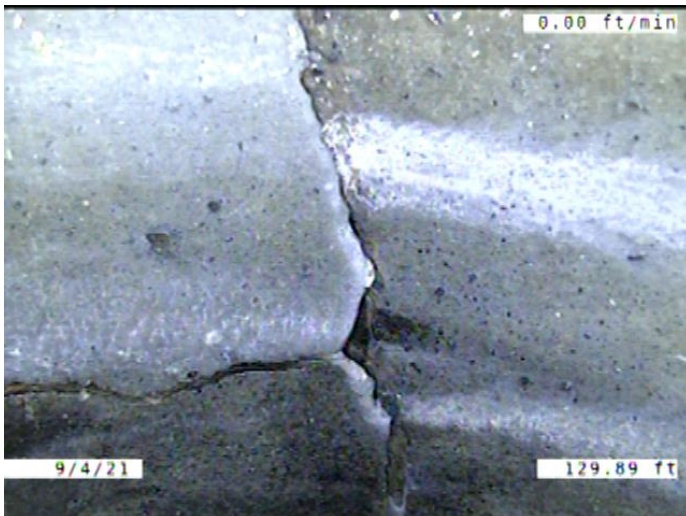
Code: **IRB**
 Description: **Infiltration Runner Barrel**

Distance (ft): **129.9**
 Structural Grade: **0**
 O&M Grade: **4**
 Clock Start/From: **2**
 Clock To:
 1st Value:
 2nd Value:
 Value Percent:
 Continuous Index:
 Within 8" of Joint: **NO**
 Remarks:

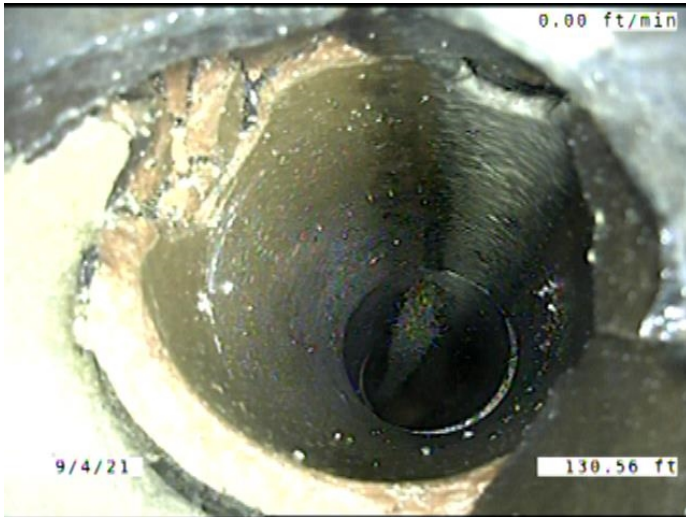
Code: **TFD**
Description: **Tap Factory Defective**

Distance (ft): **130.6**
Structural Grade: **0**
O&M Grade: **3**
Clock Start/From: **1**
Clock To:
1st Value: **6.000**
2nd Value:
Value Percent:
Continuous Index:
Within 8" of Joint: **YES**
Remarks: **BROKEN AND OFFSET**

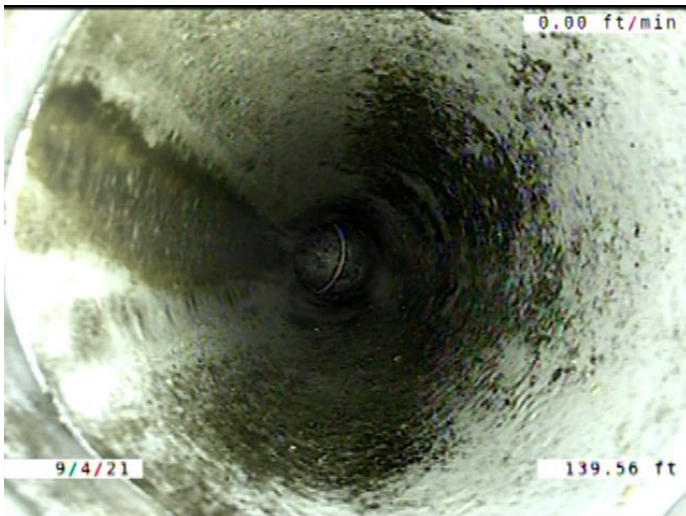
Code: **TBI**
Description: **Tap Break-in Intruding**

Distance (ft): **139.6**
Structural Grade: **0**
O&M Grade: **2**
Clock Start/From: **11**
Clock To:
1st Value: **6.000**
2nd Value: **3.000**
Value Percent:
Continuous Index:
Within 8" of Joint: **YES**
Remarks:

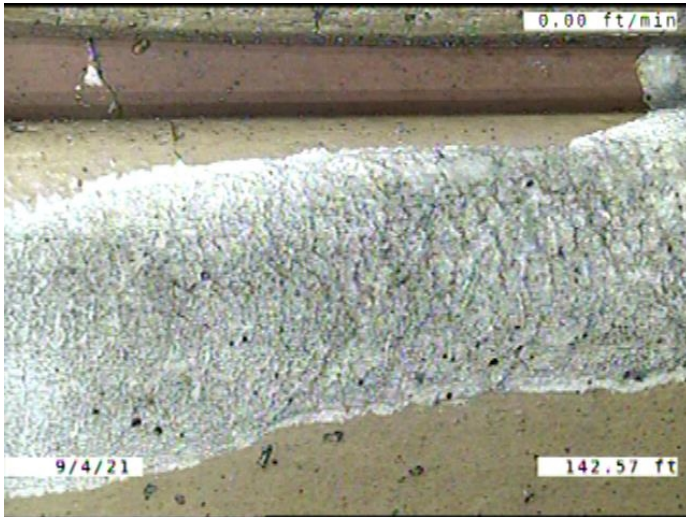
Code: **DAE**
 Description: **Deposits Attached Encrustation**

Distance (ft): **142.6**
 Structural Grade: **0**
 O&M Grade: **2**
 Clock Start/From: **9**
 Clock To: **12**
 1st Value:
 2nd Value:
 Value Percent: **5.000**
 Continuous Index:
 Within 8" of Joint: **YES**
 Remarks:

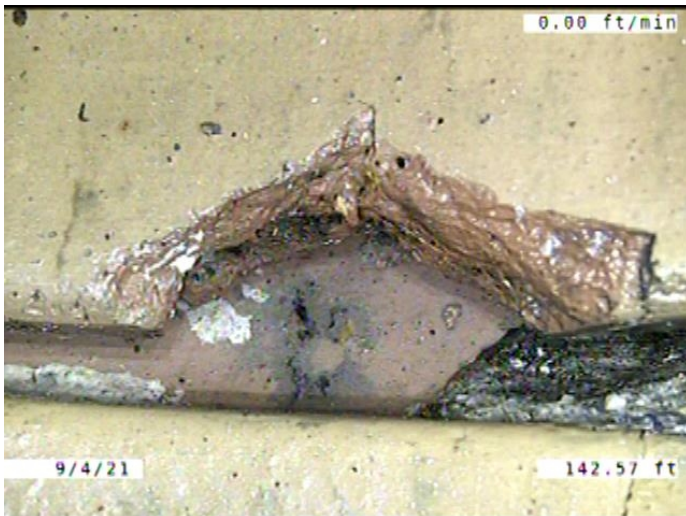
Code: **SMW**
 Description: **Surface Damage Missing Wall**

Distance (ft): **142.6**
 Structural Grade: **5**
 O&M Grade: **0**
 Clock Start/From: **2**
 Clock To: **3**
 1st Value:
 2nd Value:
 Value Percent:
 Continuous Index:
 Within 8" of Joint: **YES**
 Remarks:

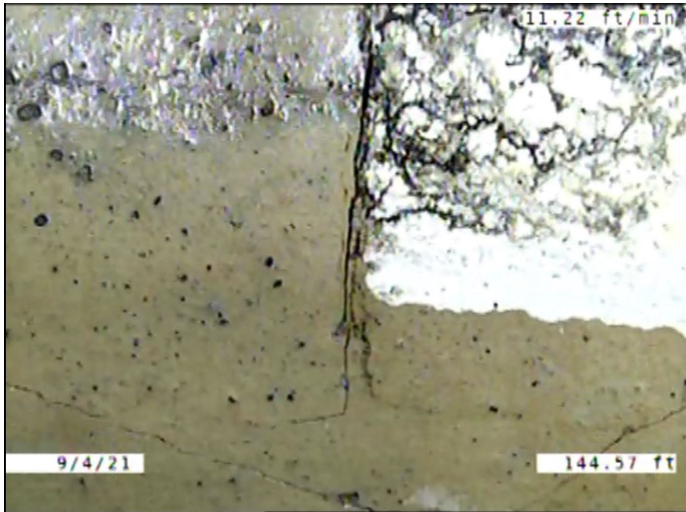
Code: **FM**
 Description: **Fracture Multiple**

Distance (ft): **144.6**
 Structural Grade: **4**
 O&M Grade: **0**
 Clock Start/From: **8**
 Clock To: **4**
 1st Value:
 2nd Value:
 Value Percent:
 Continuous Index: **F03**
 Within 8" of Joint: **YES**
 Remarks:

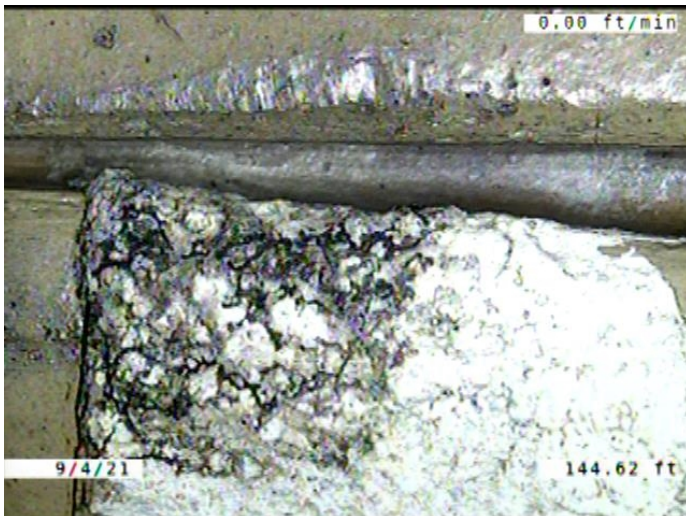
Code: **DAE**
 Description: **Deposits Attached Encrustation**

Distance (ft): **144.6**
 Structural Grade: **0**
 O&M Grade: **2**
 Clock Start/From: **1**
 Clock To: **3**
 1st Value:
 2nd Value:
 Value Percent: **5.000**
 Continuous Index:
 Within 8" of Joint: **YES**
 Remarks:

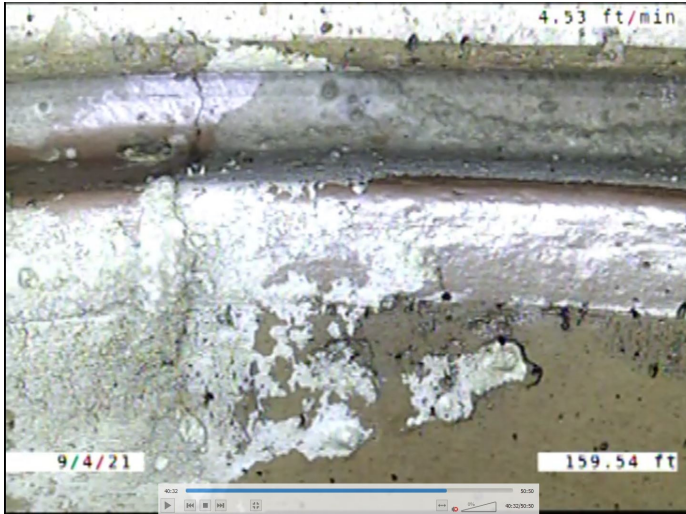
Code: **CL**
Description: **Crack Longitudinal**

Distance (ft): **159.5**
Structural Grade: **2**
O&M Grade: **0**
Clock Start/From: **12**
Clock To:
1st Value:
2nd Value:
Value Percent:
Continuous Index:
Within 8" of Joint: **YES**
Remarks:

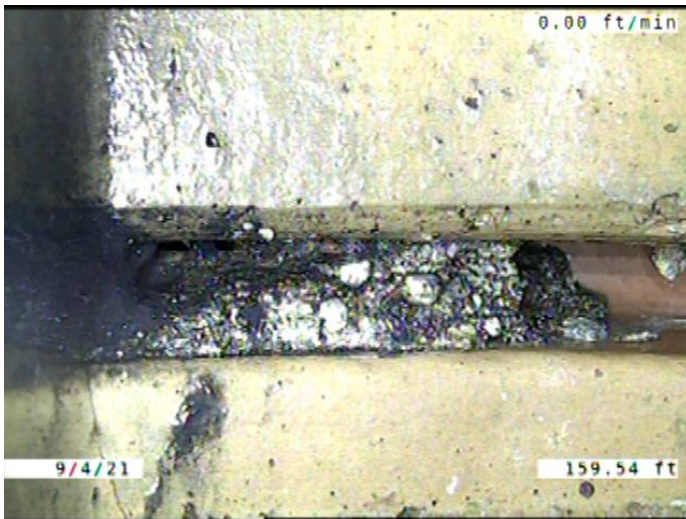
Code: **DAE**
Description: **Deposits Attached Encrustation**

Distance (ft): **159.5**
Structural Grade: **0**
O&M Grade: **2**
Clock Start/From: **8**
Clock To: **4**
1st Value:
2nd Value:
Value Percent: **5.000**
Continuous Index:
Within 8" of Joint: **YES**
Remarks:

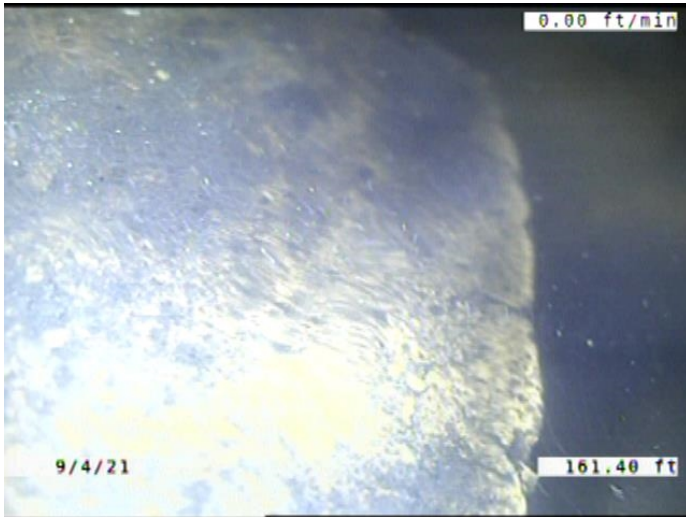
Code:	OBB
Description:	Obstruction Brick or Masonry
Distance (ft):	161.4
Structural Grade:	0
O&M Grade:	2
Clock Start/From:	5
Clock To:	7
1st Value:	
2nd Value:	
Value Percent:	5.000
Continuous Index:	
Within 8" of Joint:	YES
Remarks:

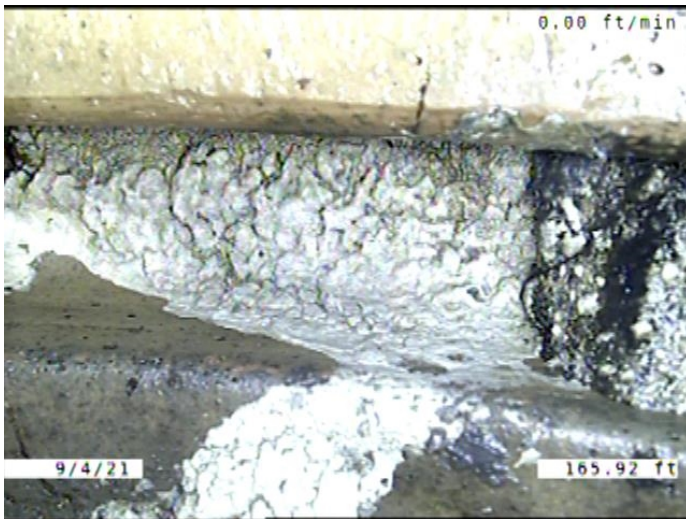
Code:	DAE
Description:	Deposits Attached Encrustation
Distance (ft):	165.9
Structural Grade:	0
O&M Grade:	2
Clock Start/From:	8
Clock To:	4
1st Value:	
2nd Value:	
Value Percent:	5.000
Continuous Index:	
Within 8" of Joint:	YES
Remarks:

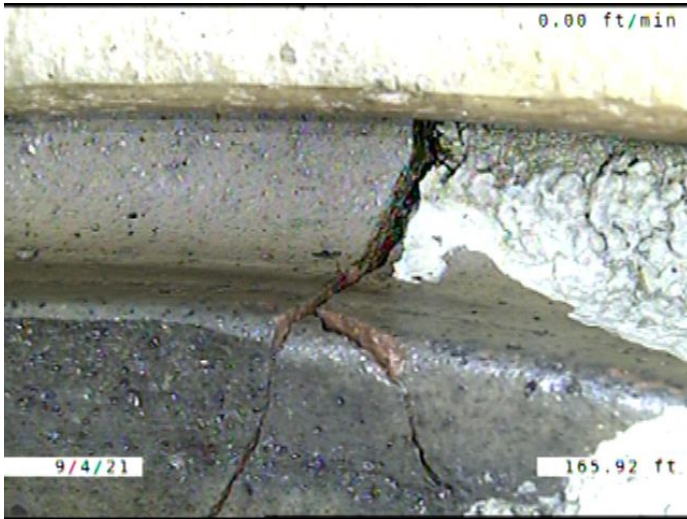
Code: **FM**
Description: **Fracture Multiple**

Distance (ft): **165.9**
Structural Grade: **4**
O&M Grade: **0**
Clock Start/From: **11**
Clock To: **3**
1st Value:
2nd Value:
Value Percent:
Continuous Index:
Within 8" of Joint: **YES**
Remarks:

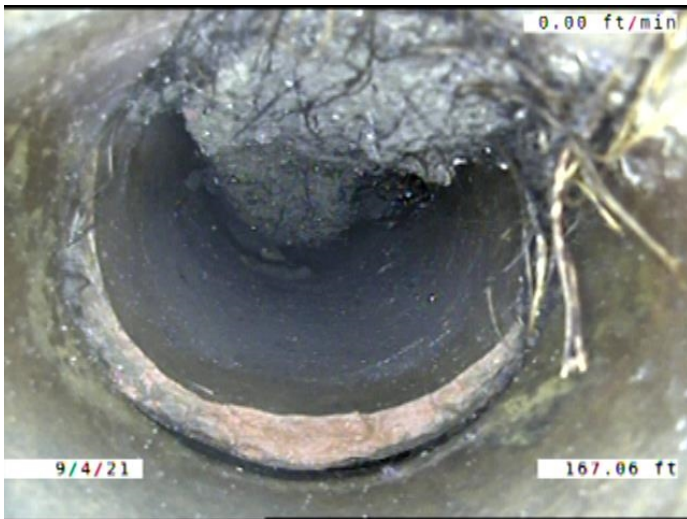
Code: **TFD**
Description: **Tap Factory Defective**

Distance (ft): **167.1**
Structural Grade: **0**
O&M Grade: **3**
Clock Start/From: **1**
Clock To:
1st Value: **6.000**
2nd Value:
Value Percent:
Continuous Index:
Within 8" of Joint: **YES**
Remarks: **LOOKS TO BE 80+% PLUGGED WITH ROOTS**

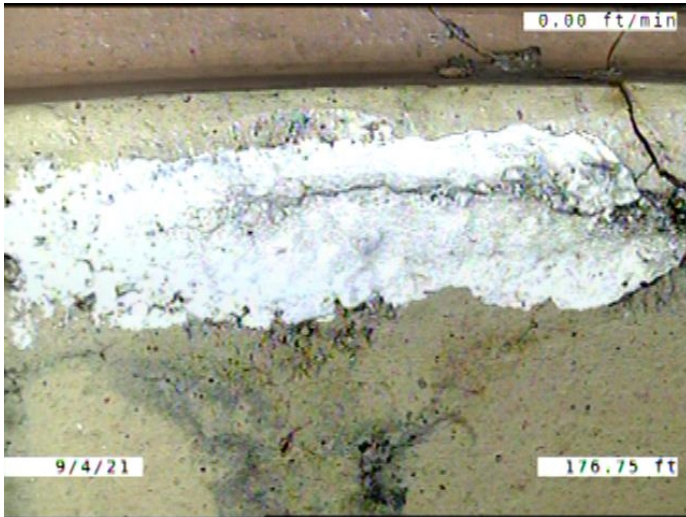
Code: **DAE**
 Description: **Deposits Attached Encrustation**

Distance (ft): **176.7**
 Structural Grade: **0**
 O&M Grade: **2**
 Clock Start/From: **10**
 Clock To: **11**
 1st Value:
 2nd Value:
 Value Percent: **5.000**
 Continuous Index:
 Within 8" of Joint: **YES**
 Remarks:

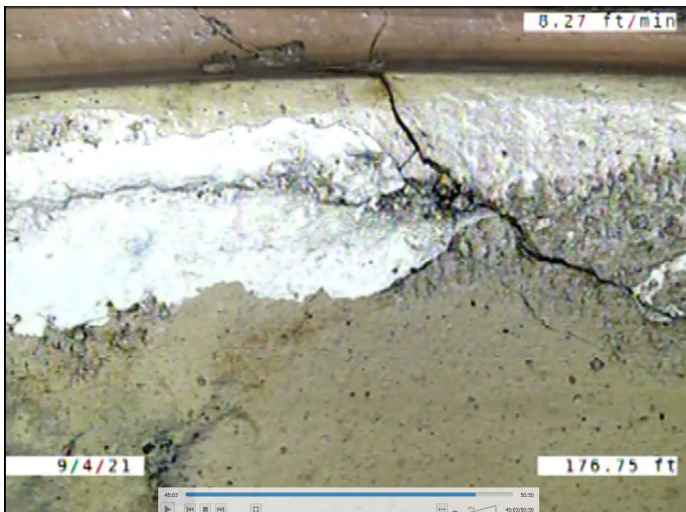
Code: **FM**
 Description: **Fracture Multiple**

Distance (ft): **176.8**
 Structural Grade: **4**
 O&M Grade: **0**
 Clock Start/From: **11**
 Clock To: **1**
 1st Value:
 2nd Value:
 Value Percent:
 Continuous Index:
 Within 8" of Joint: **YES**
 Remarks:
