Profile/Photo Observation Report

Date:	09/04/2021	Weather:		Coding:	PACP 7.0
Pipe Length (ft):	189.5	Owner:	City of Hobart	Pre Clean:	Heavy Cleaning
P.O.#:	YES502259	Surveyor:	S. Bucklin	PSR:	P-504-078-077
Customer:	City of Hobart	Clean Date:	09/02/2021	Shape:	C

Street:	North Cavender Street	Flow Control:	Not Controlled
City:	Hobart, IN	Year Renewed:	
Location:	Alley	Tape/Media #:	
Purpose:	Routine Assessment	Dia/Height:	12"
Use:	Sanitary Sewage Pipe	Material:	VCP
Drain Area:		Lining:	
Category:	NA		
Comment:			
Location Details:		Direction of Survey:	Downstream
US MH:	M-504-078	DS MH:	M-504-077
		Total Length Surveyed (ft):	189.5

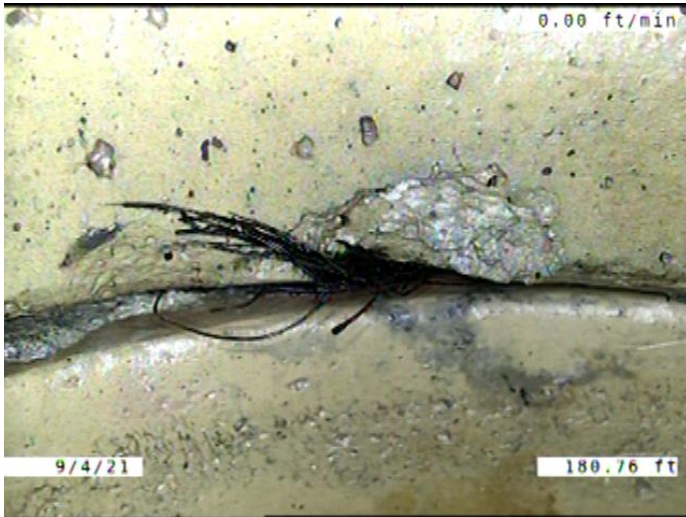
Code: **RFJ**
 Description: **Roots Fine Joint**

Distance (ft): **180.8**
 Structural Grade: **0**
 O&M Grade: **1**
 Clock Start/From: **10**
 Clock To:
 1st Value:
 2nd Value:
 Value Percent:
 Continuous Index:
 Within 8" of Joint: **YES**
 Remarks:

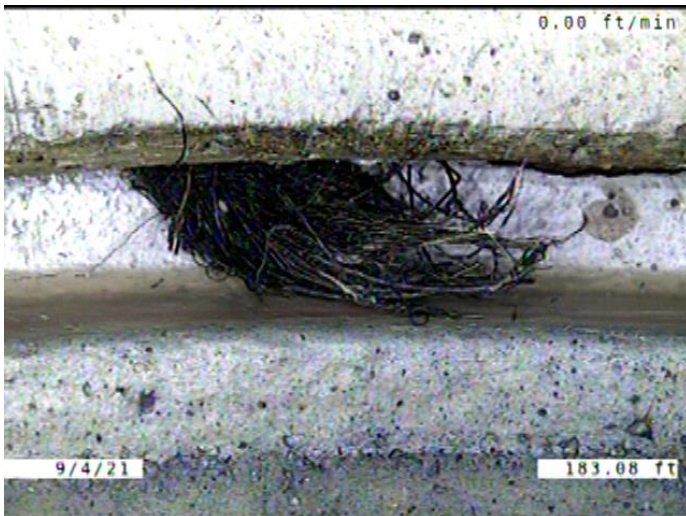
Code: **RFJ**
 Description: **Roots Fine Joint**

Distance (ft): **183.1**
 Structural Grade: **0**
 O&M Grade: **1**
 Clock Start/From: **11**
 Clock To:
 1st Value:
 2nd Value:
 Value Percent:
 Continuous Index:
 Within 8" of Joint: **YES**
 Remarks:

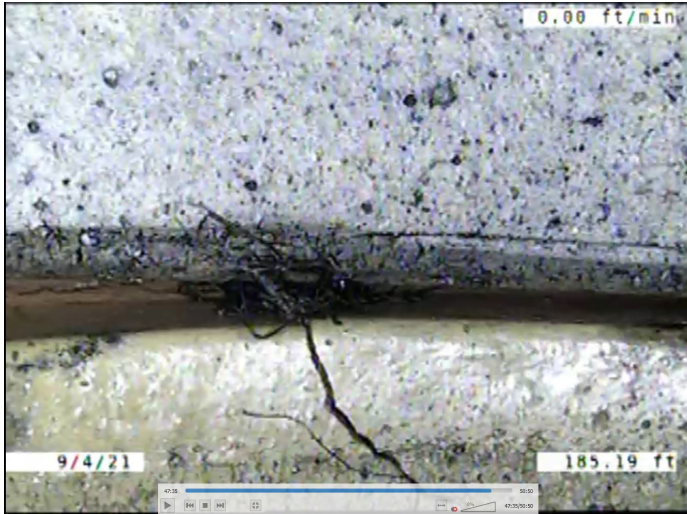
Code: **FM**
Description: **Fracture Multiple**

Distance (ft): **185.2**
Structural Grade: **4**
O&M Grade: **0**
Clock Start/From: **11**
Clock To: **1**
1st Value:
2nd Value:
Value Percent:
Continuous Index:
Within 8" of Joint: **YES**
Remarks:

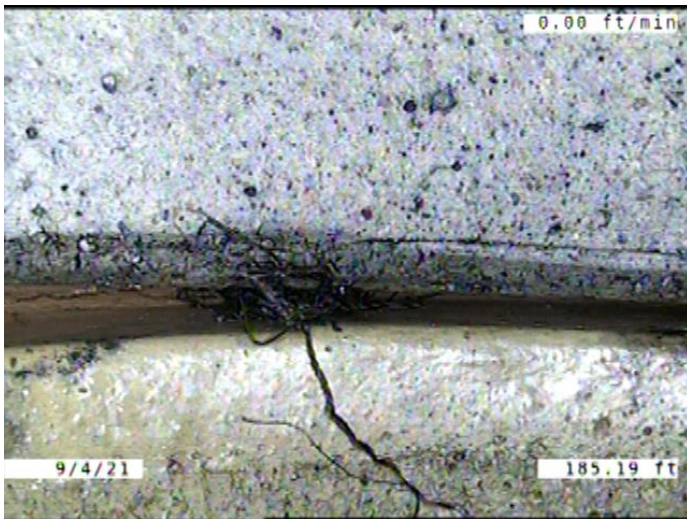
Code: **RFJ**
Description: **Roots Fine Joint**

Distance (ft): **185.2**
Structural Grade: **0**
O&M Grade: **1**
Clock Start/From: **11**
Clock To:
1st Value:
2nd Value:
Value Percent:
Continuous Index:
Within 8" of Joint: **YES**
Remarks:

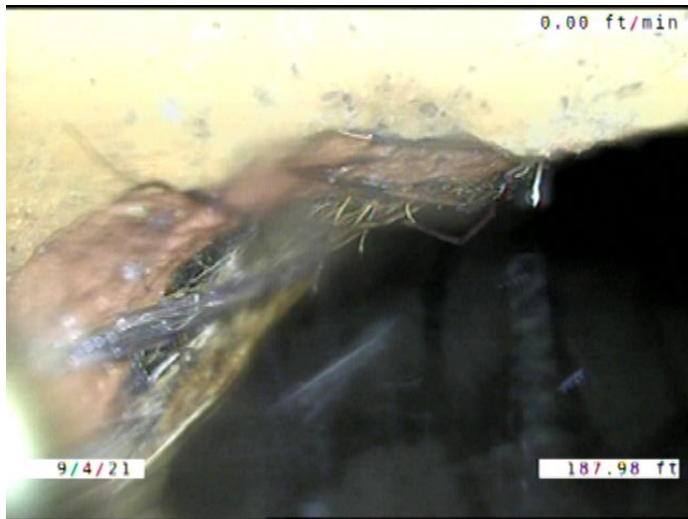
Code: **RMJ**
 Description: **Roots Medium Joint**

Distance (ft): **188.0**
 Structural Grade: **0**
 O&M Grade: **3**
 Clock Start/From: **9**
 Clock To: **3**
 1st Value:
 2nd Value:
 Value Percent: **5.000**
 Continuous Index:
 Within 8" of Joint: **YES**
 Remarks:
