Profile/Photo Observation Report

Date:	09/04/2021	Weather:		Coding:	PACP 7.0
Pipe Length (ft):	189.5	Owner:	City of Hobart	Pre Clean:	Heavy Cleaning
P.O.#:	YES502259	Surveyor:	S. Bucklin	PSR:	P-504-078-077
Customer:	City of Hobart	Clean Date:	09/02/2021	Shape:	C

Street:	North Cavender Street	Flow Control:	Not Controlled
City:	Hobart, IN	Year Renewed:	
Location:	Alley	Tape/Media #:	
Purpose:	Routine Assessment	Dia/Height:	12"
Use:	Sanitary Sewage Pipe	Material:	VCP
Drain Area:		Lining:	
Category:	NA		
Comment:			
Location Details:		Direction of Survey:	Downstream
US MH:	M-504-078	DS MH:	M-504-077
		Total Length Surveyed (ft):	189.5

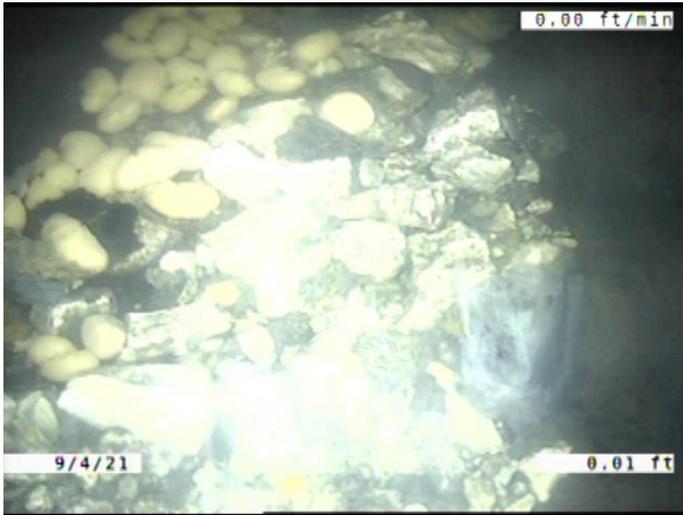
Code: **OBN**
Description: **Obstruction Construction Debris**

Distance (ft): **.0**
Structural Grade: **0**
O&M Grade: **2**
Clock Start/From: **5**
Clock To: **7**
1st Value:
2nd Value:
Value Percent: **5.000**
Continuous Index:
Within 8" of Joint: **YES**
Remarks:

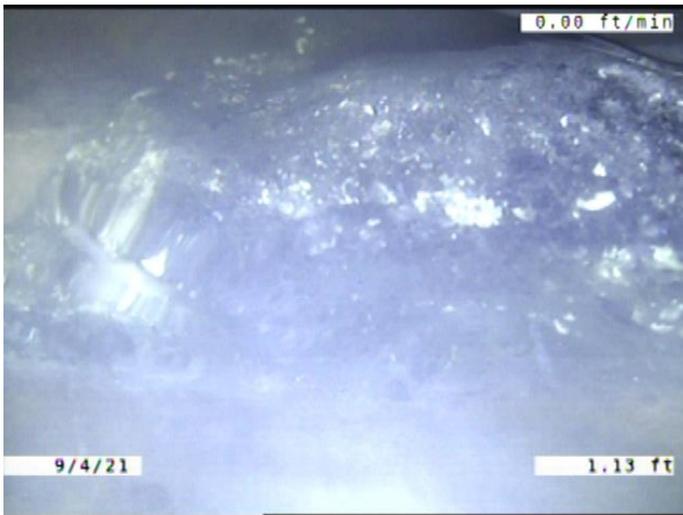
Code: **DAE**
Description: **Deposits Attached Encrustation**

Distance (ft): **1.1**
Structural Grade: **0**
O&M Grade: **2**
Clock Start/From: **4**
Clock To: **7**
1st Value:
2nd Value:
Value Percent: **5.000**
Continuous Index:
Within 8" of Joint: **YES**
Remarks:

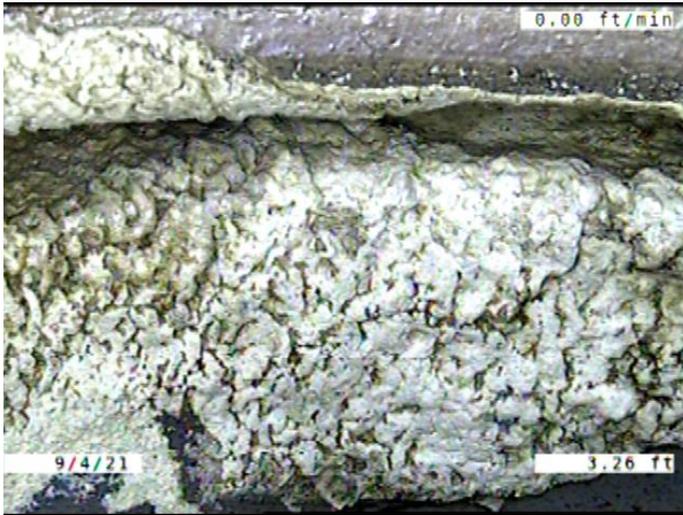
Code: **DAE**
Description: **Deposits Attached Encrustation**

Distance (ft): **3.3**
Structural Grade: **0**
O&M Grade: **2**
Clock Start/From: **8**
Clock To: **4**
1st Value:
2nd Value:
Value Percent: **5.000**
Continuous Index:
Within 8" of Joint: **YES**
Remarks:

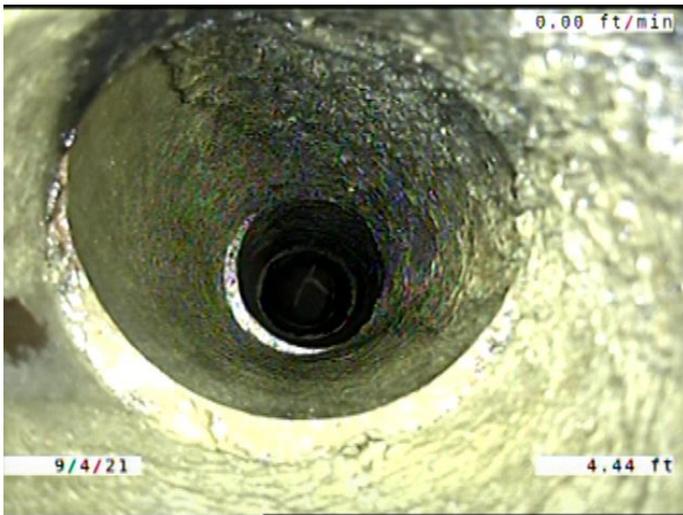
Code: **TFD**
Description: **Tap Factory Defective**

Distance (ft): **4.4**
Structural Grade: **0**
O&M Grade: **3**
Clock Start/From: **1**
Clock To:
1st Value: **6.000**
2nd Value:
Value Percent:
Continuous Index:
Within 8" of Joint: **YES**
Remarks: **ENCrustation ALL THE WAY
AROUND THE TAP**

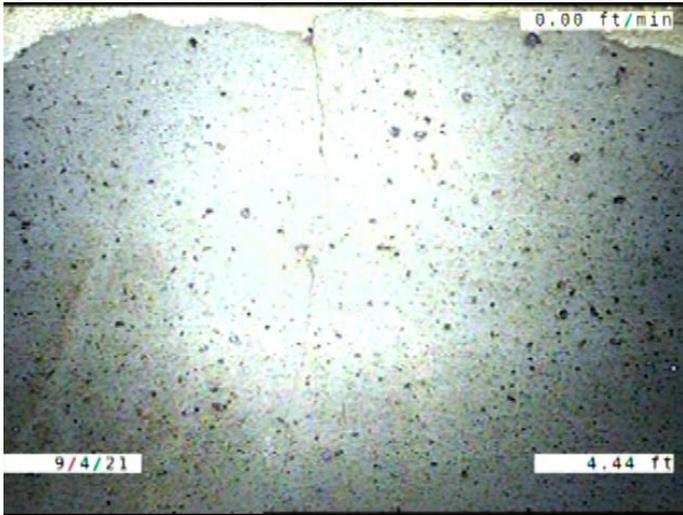
Code: **CM**
Description: **Crack Multiple**

Distance (ft): **4.4**
Structural Grade: **3**
O&M Grade: **0**
Clock Start/From: **8**
Clock To: **4**
1st Value:
2nd Value:
Value Percent:
Continuous Index:
Within 8" of Joint: **YES**
Remarks:

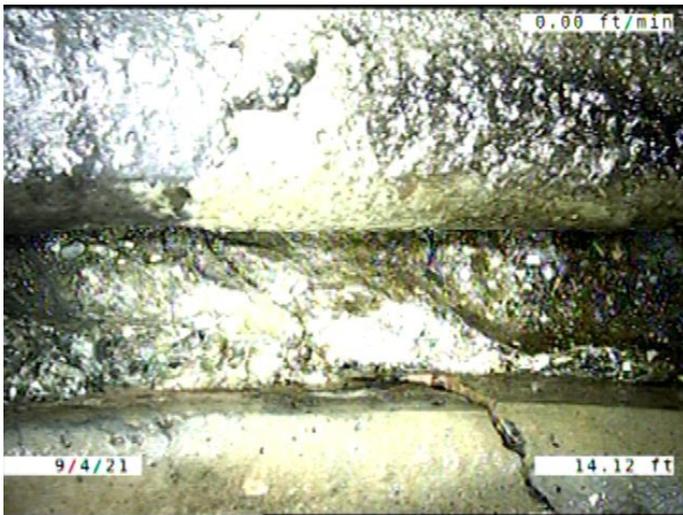
Code: **DAE**
Description: **Deposits Attached Encrustation**

Distance (ft): **14.1**
Structural Grade: **0**
O&M Grade: **2**
Clock Start/From: **8**
Clock To: **11**
1st Value:
2nd Value:
Value Percent: **5.000**
Continuous Index:
Within 8" of Joint: **YES**
Remarks:

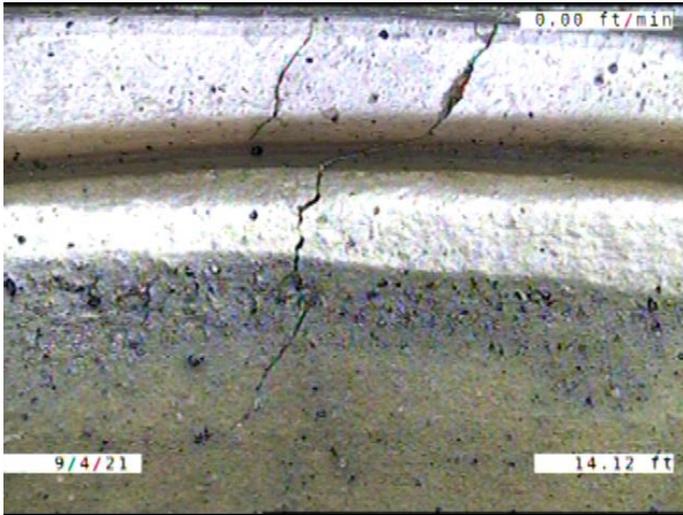
Code: **FM**
 Description: **Fracture Multiple**

Distance (ft): **14.1**
 Structural Grade: **4**
 O&M Grade: **0**
 Clock Start/From: **9**
 Clock To: **1**
 1st Value:
 2nd Value:
 Value Percent:
 Continuous Index:
 Within 8" of Joint: **YES**
 Remarks:

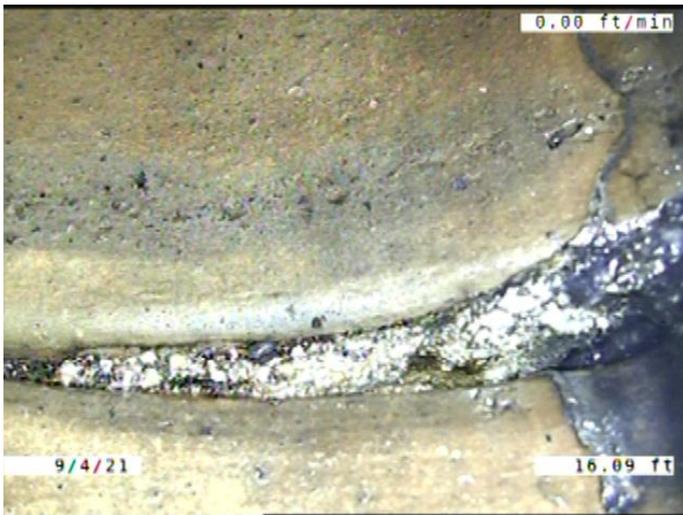
Code: **DAE**
 Description: **Deposits Attached Encrustation**

Distance (ft): **16.1**
 Structural Grade: **0**
 O&M Grade: **2**
 Clock Start/From: **3**
 Clock To: **10**
 1st Value:
 2nd Value:
 Value Percent: **5.000**
 Continuous Index:
 Within 8" of Joint: **YES**
 Remarks:

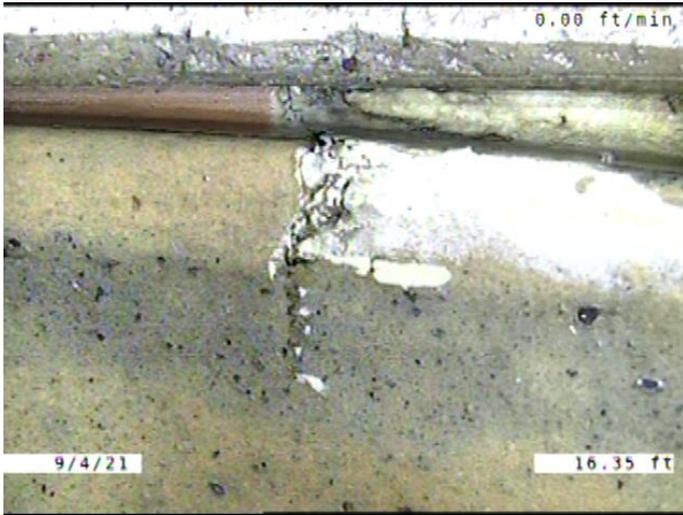
Code: **CL**
Description: **Crack Longitudinal**

Distance (ft): **16.4**
Structural Grade: **2**
O&M Grade: **0**
Clock Start/From: **2**
Clock To:
1st Value:
2nd Value:
Value Percent:
Continuous Index:
Within 8" of Joint: **YES**
Remarks:

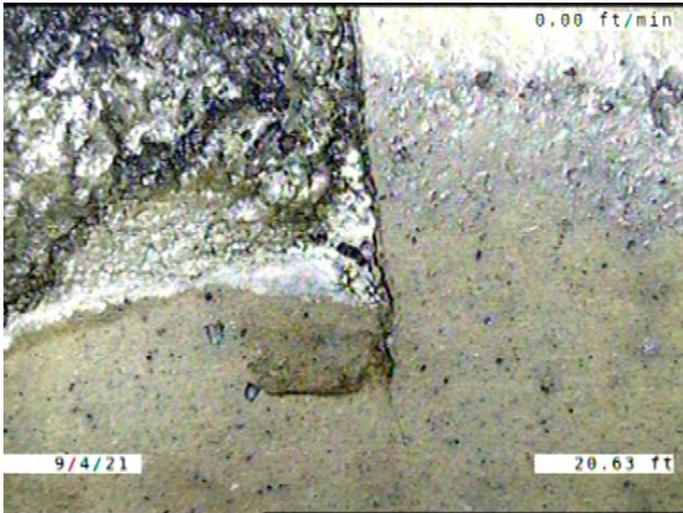
Code: **CL**
Description: **Crack Longitudinal**

Distance (ft): **20.6**
Structural Grade: **2**
O&M Grade: **0**
Clock Start/From: **11**
Clock To:
1st Value:
2nd Value:
Value Percent:
Continuous Index:
Within 8" of Joint: **YES**
Remarks:

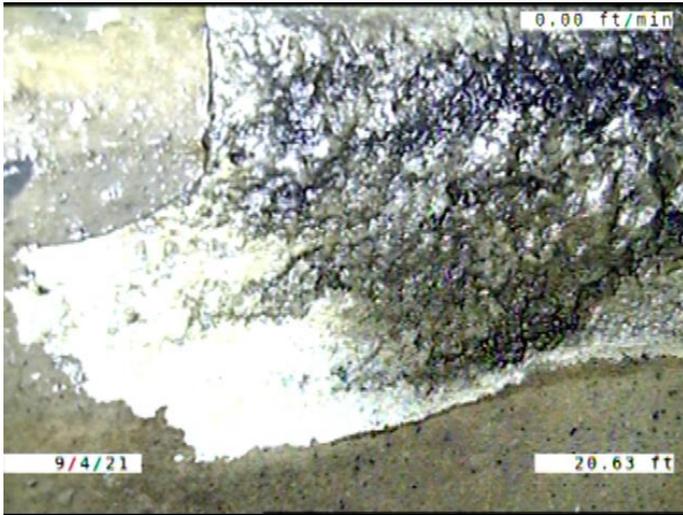
Code: **DAE**
Description: **Deposits Attached Encrustation**

Distance (ft): **20.6**
Structural Grade: **0**
O&M Grade: **2**
Clock Start/From: **9**
Clock To: **11**
1st Value:
2nd Value:
Value Percent: **5.000**
Continuous Index:
Within 8" of Joint: **YES**
Remarks:

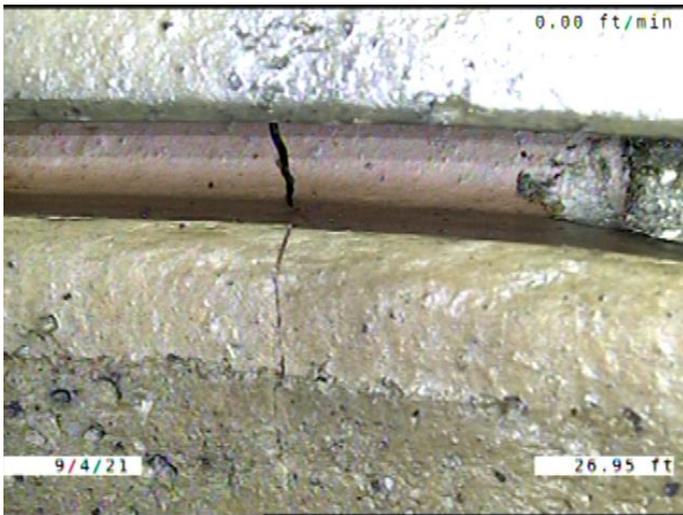
Code: **FM**
Description: **Fracture Multiple**

Distance (ft): **26.9**
Structural Grade: **4**
O&M Grade: **0**
Clock Start/From: **7**
Clock To: **5**
1st Value:
2nd Value:
Value Percent:
Continuous Index: **S01**
Within 8" of Joint: **YES**
Remarks:

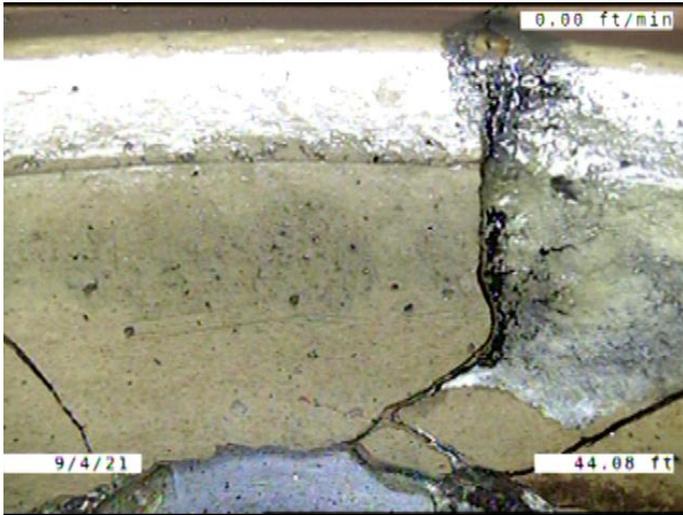
Code: **B**
 Description: **Broken**

Distance (ft): **44.1**
 Structural Grade: **4**
 O&M Grade: **0**
 Clock Start/From: **10**
 Clock To: **1**
 1st Value:
 2nd Value:
 Value Percent:
 Continuous Index:
 Within 8" of Joint: **YES**
 Remarks:

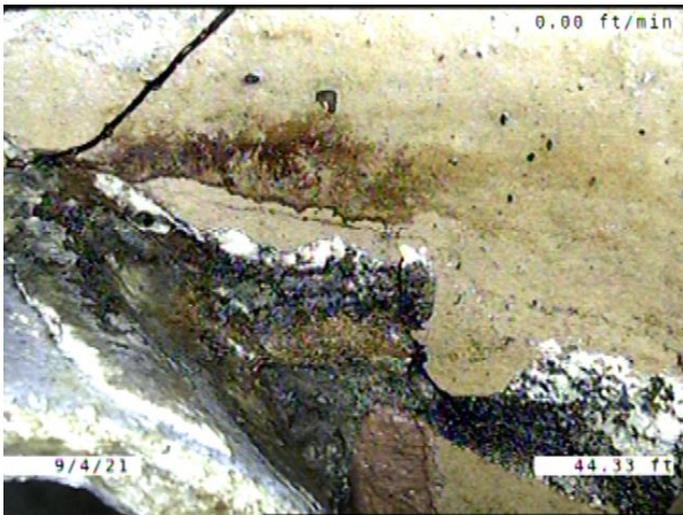
Code: **DAE**
 Description: **Deposits Attached Encrustation**

Distance (ft): **44.3**
 Structural Grade: **0**
 O&M Grade: **2**
 Clock Start/From: **9**
 Clock To: **3**
 1st Value:
 2nd Value:
 Value Percent: **5.000**
 Continuous Index:
 Within 8" of Joint: **YES**
 Remarks:

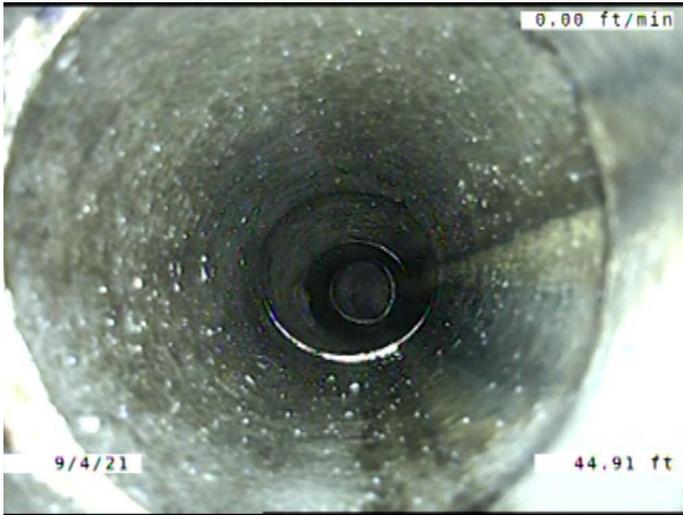
Code: **TBI**
 Description: **Tap Break-in Intruding**

Distance (ft): **44.9**
 Structural Grade: **0**
 O&M Grade: **2**
 Clock Start/From: **12**
 Clock To:
 1st Value: **6.000**
 2nd Value: **3.000**
 Value Percent:
 Continuous Index:
 Within 8" of Joint: **YES**
 Remarks:

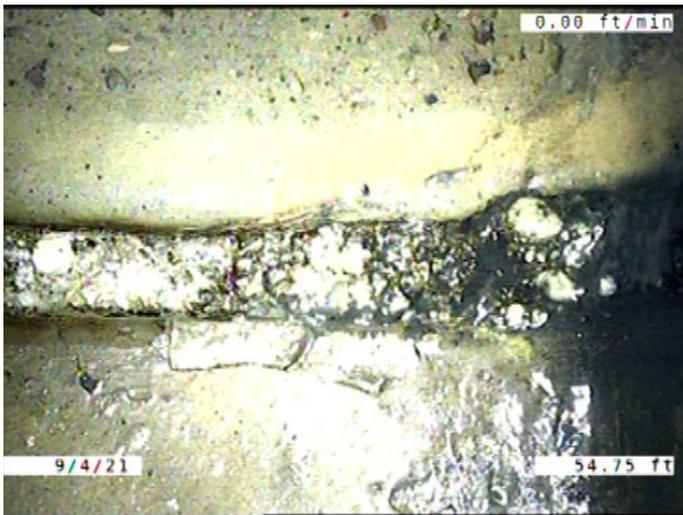
Code: **DAE**
 Description: **Deposits Attached Encrustation**

Distance (ft): **54.8**
 Structural Grade: **0**
 O&M Grade: **2**
 Clock Start/From: **3**
 Clock To: **9**
 1st Value:
 2nd Value:
 Value Percent: **5.000**
 Continuous Index:
 Within 8" of Joint: **YES**
 Remarks:

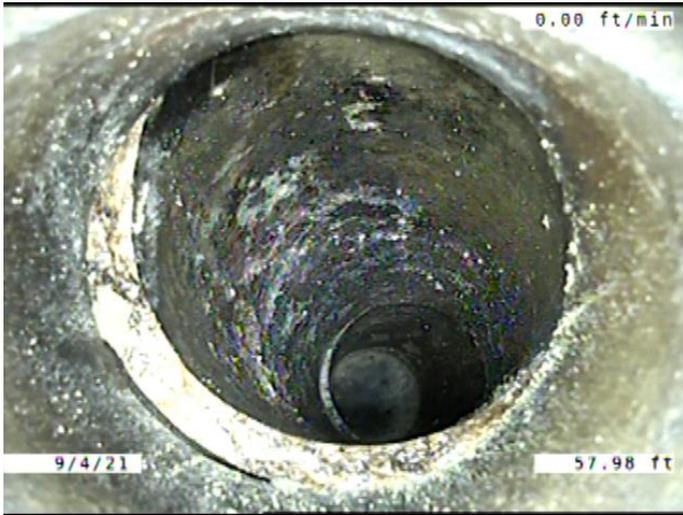
Code: **TFD**
Description: **Tap Factory Defective**

Distance (ft): **58.0**
Structural Grade: **0**
O&M Grade: **3**
Clock Start/From: **1**
Clock To:
1st Value: **6.000**

2nd Value:
Value Percent:
Continuous Index:
Within 8" of Joint: **YES**
Remarks: **FIRST JOINT BACK OFFSET**

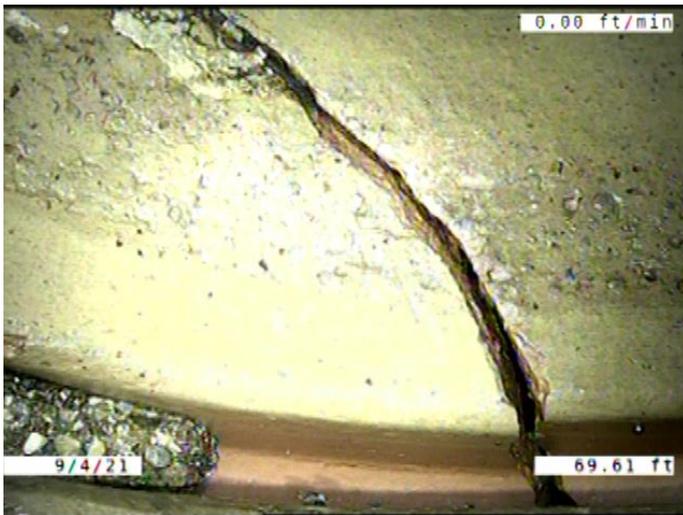
Code: **B**
Description: **Broken**

Distance (ft): **69.6**
Structural Grade: **4**
O&M Grade: **0**
Clock Start/From: **4**
Clock To: **6**

1st Value:
2nd Value:
Value Percent:
Continuous Index:
Within 8" of Joint: **YES**
Remarks:

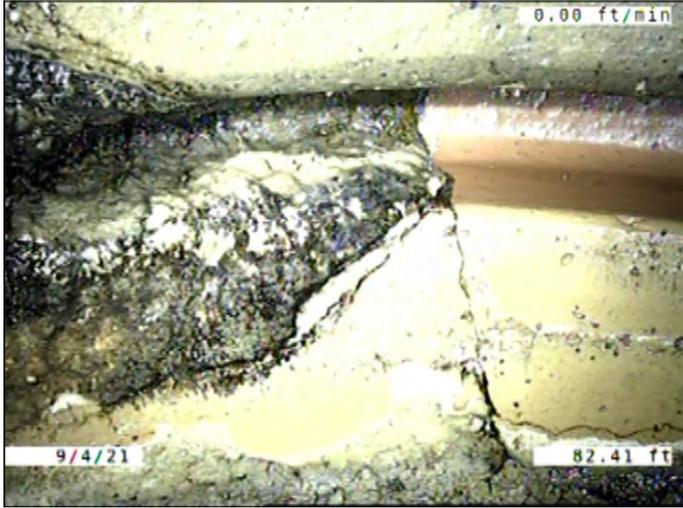
Code: **FM**
 Description: **Fracture Multiple**

Distance (ft): **82.4**
 Structural Grade: **4**
 O&M Grade: **0**
 Clock Start/From: **7**
 Clock To: **5**
 1st Value:
 2nd Value:
 Value Percent:
 Continuous Index: **F01**
 Within 8" of Joint: **YES**
 Remarks:

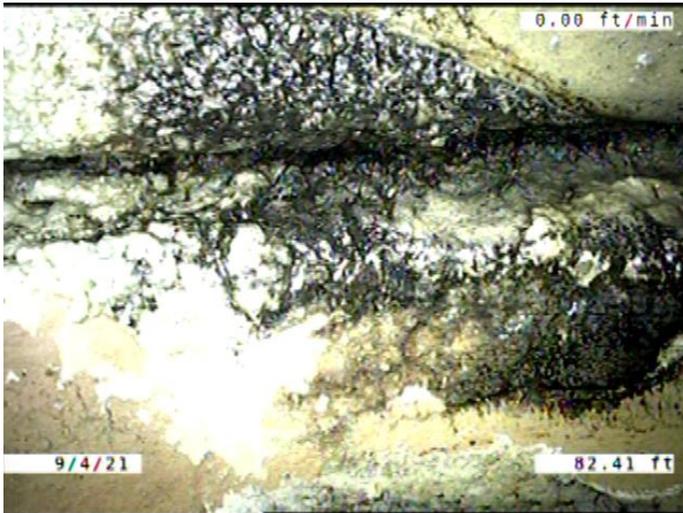
Code: **DAE**
 Description: **Deposits Attached Encrustation**

Distance (ft): **82.4**
 Structural Grade: **0**
 O&M Grade: **2**
 Clock Start/From: **12**
 Clock To: **12**
 1st Value:
 2nd Value:
 Value Percent: **5.000**
 Continuous Index:
 Within 8" of Joint: **YES**
 Remarks:

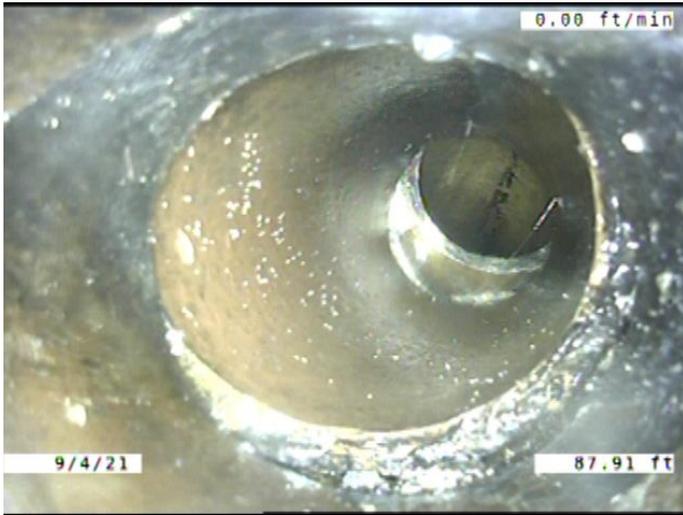
Code: **TFD**
Description: **Tap Factory Defective**

Distance (ft): **87.9**
Structural Grade: **0**
O&M Grade: **3**
Clock Start/From: **12**
Clock To:
1st Value: **6.000**

2nd Value:
Value Percent:
Continuous Index:
Within 8" of Joint: **YES**
Remarks: **CONSTANTLY RUNNING WATER.
JOINTS ARE ALL OFFSET THAT I CAN**

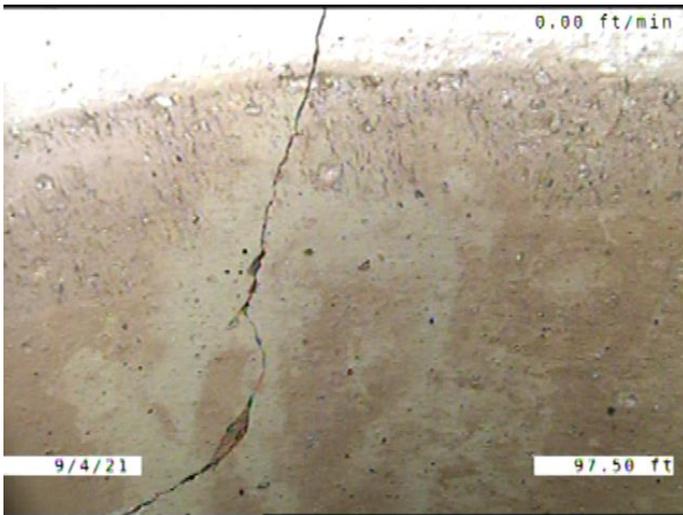
Code: **CS**
Description: **Crack Spiral**

Distance (ft): **97.5**
Structural Grade: **2**
O&M Grade: **0**
Clock Start/From: **9**
Clock To: **11**

1st Value:
2nd Value:
Value Percent:
Continuous Index:
Within 8" of Joint: **YES**
Remarks:

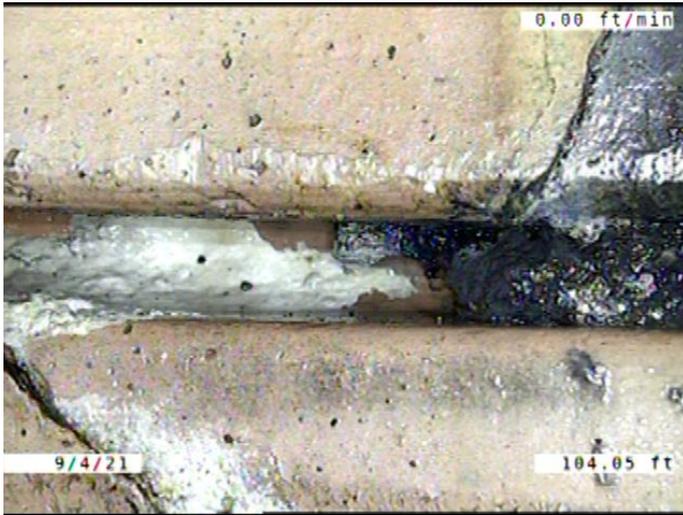
Code: **DAE**
 Description: **Deposits Attached Encrustation**

Distance (ft): **104.0**
 Structural Grade: **0**
 O&M Grade: **2**
 Clock Start/From: **8**
 Clock To: **4**
 1st Value:
 2nd Value:
 Value Percent: **5.000**
 Continuous Index:
 Within 8" of Joint: **YES**
 Remarks:

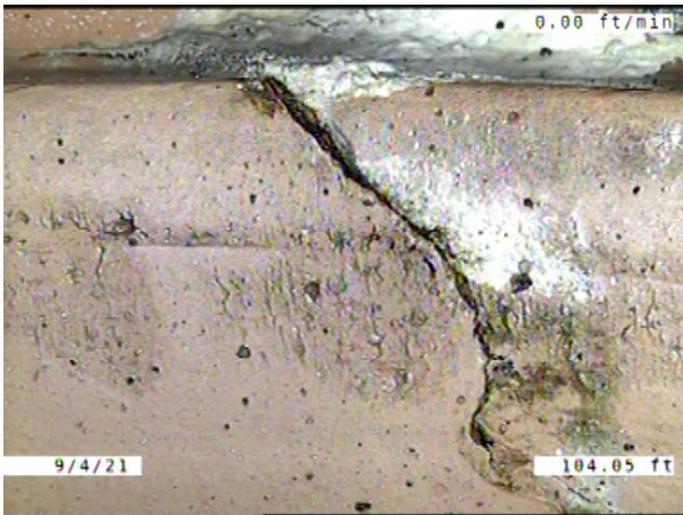
Code: **FM**
 Description: **Fracture Multiple**

Distance (ft): **104.0**
 Structural Grade: **4**
 O&M Grade: **0**
 Clock Start/From: **8**
 Clock To: **4**
 1st Value:
 2nd Value:
 Value Percent:
 Continuous Index:
 Within 8" of Joint: **YES**
 Remarks:

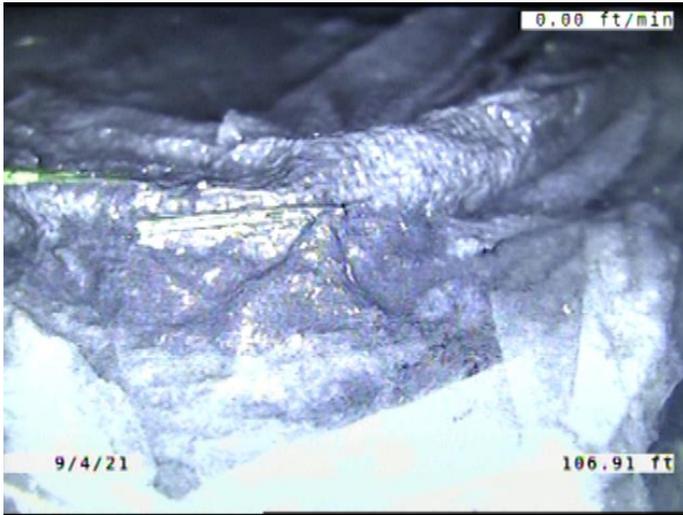
Code: **DAR**
 Description: **Deposits Attached Ragging**

Distance (ft): **106.9**
 Structural Grade: **0**
 O&M Grade: **2**
 Clock Start/From: **6**
 Clock To:
 1st Value:
 2nd Value:
 Value Percent: **5.000**
 Continuous Index:
 Within 8" of Joint: **YES**
 Remarks:

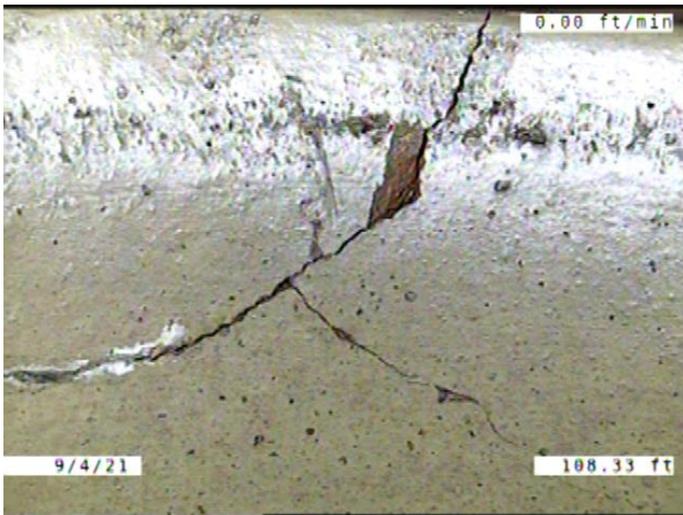
Code: **FM**
 Description: **Fracture Multiple**

Distance (ft): **108.3**
 Structural Grade: **4**
 O&M Grade: **0**
 Clock Start/From: **8**
 Clock To: **12**
 1st Value:
 2nd Value:
 Value Percent:
 Continuous Index:
 Within 8" of Joint: **YES**
 Remarks:

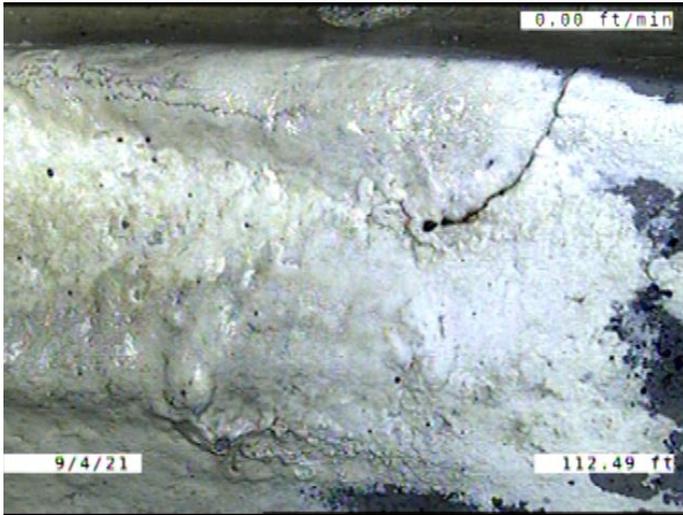
Code: **DAE**
 Description: **Deposits Attached Encrustation**

Distance (ft): **112.5**
 Structural Grade: **0**
 O&M Grade: **2**
 Clock Start/From: **10**
 Clock To: **4**
 1st Value:
 2nd Value:
 Value Percent: **5.000**
 Continuous Index:
 Within 8" of Joint: **YES**
 Remarks:

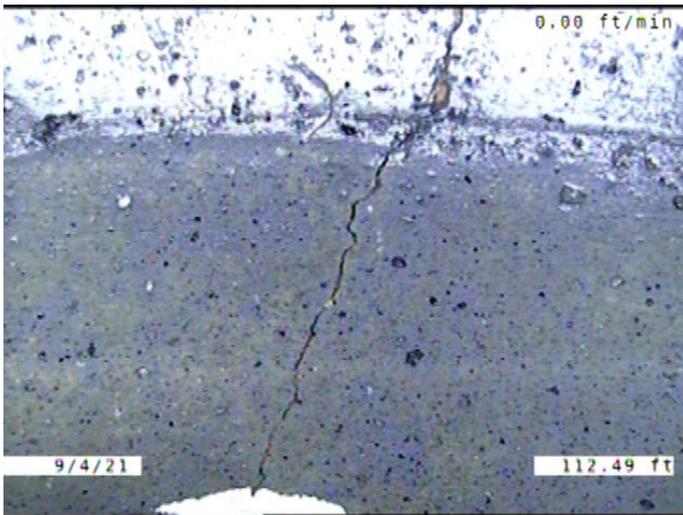
Code: **CM**
 Description: **Crack Multiple**

Distance (ft): **112.5**
 Structural Grade: **3**
 O&M Grade: **0**
 Clock Start/From: **12**
 Clock To: **4**
 1st Value:
 2nd Value:
 Value Percent:
 Continuous Index:
 Within 8" of Joint: **YES**
 Remarks:

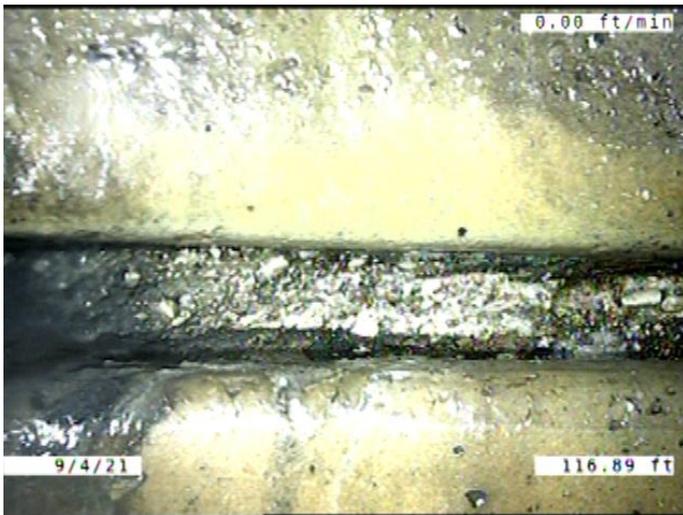
Code: **DAE**
Description: **Deposits Attached Encrustation**

Distance (ft): **116.9**
Structural Grade: **0**
O&M Grade: **2**
Clock Start/From: **3**
Clock To: **9**
1st Value:
2nd Value:
Value Percent: **5.000**
Continuous Index:
Within 8" of Joint: **YES**
Remarks:

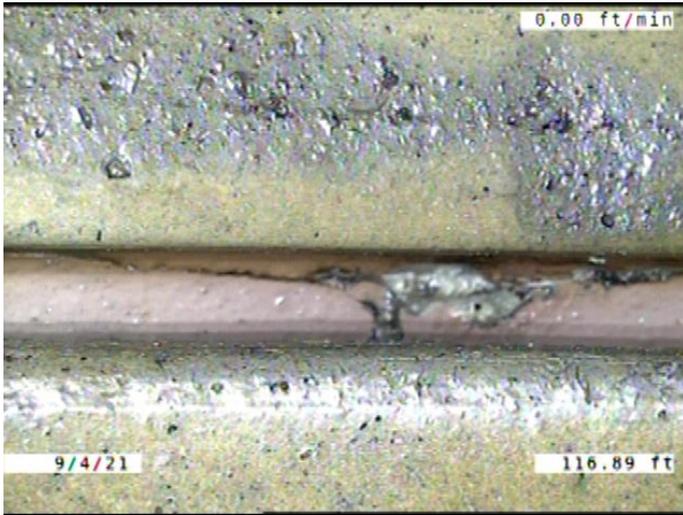
Code: **CM**
 Description: **Crack Multiple**

Distance (ft): **116.9**
 Structural Grade: **3**
 O&M Grade: **0**
 Clock Start/From: **9**
 Clock To: **3**
 1st Value:
 2nd Value:
 Value Percent:
 Continuous Index:
 Within 8" of Joint: **YES**
 Remarks:

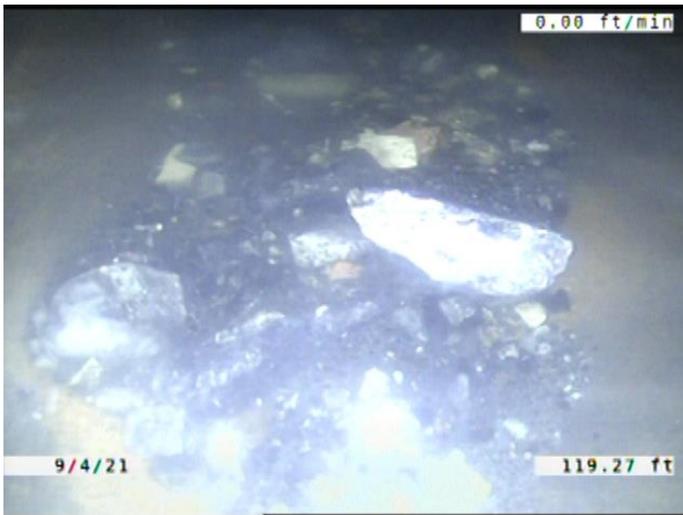
Code: **DSF**
 Description: **Deposits Settled Fine**

Distance (ft): **119.3**
 Structural Grade: **0**
 O&M Grade: **2**
 Clock Start/From: **5**
 Clock To: **7**
 1st Value:
 2nd Value:
 Value Percent: **5.000**
 Continuous Index: **S02**
 Within 8" of Joint: **YES**
 Remarks:

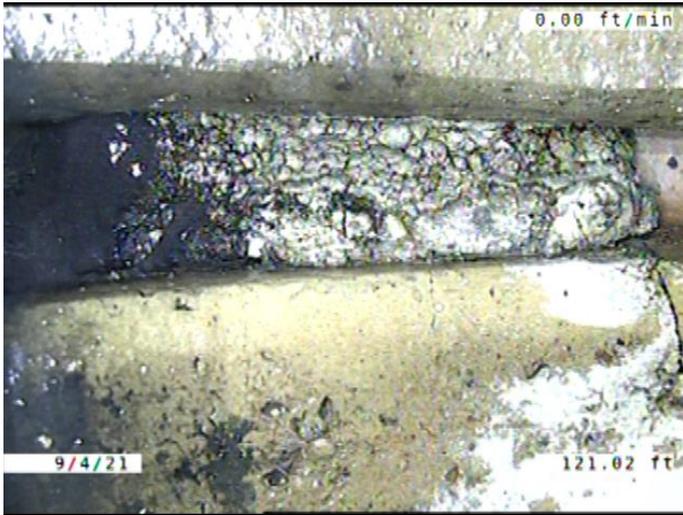
Code: **DAE**
 Description: **Deposits Attached Encrustation**

Distance (ft): **121.0**
 Structural Grade: **0**
 O&M Grade: **2**
 Clock Start/From: **12**
 Clock To: **12**
 1st Value:
 2nd Value:
 Value Percent: **5.000**
 Continuous Index:
 Within 8" of Joint: **YES**
 Remarks:

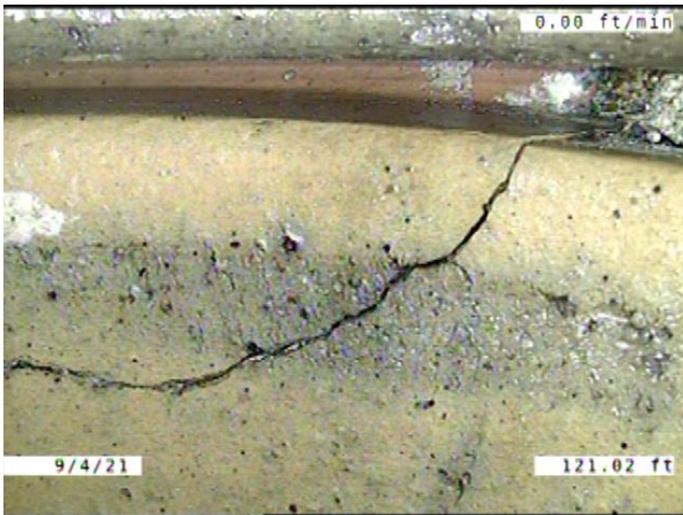
Code: **FM**
 Description: **Fracture Multiple**

Distance (ft): **121.0**
 Structural Grade: **4**
 O&M Grade: **0**
 Clock Start/From: **8**
 Clock To: **4**
 1st Value:
 2nd Value:
 Value Percent:
 Continuous Index: **S03**
 Within 8" of Joint: **YES**
 Remarks:

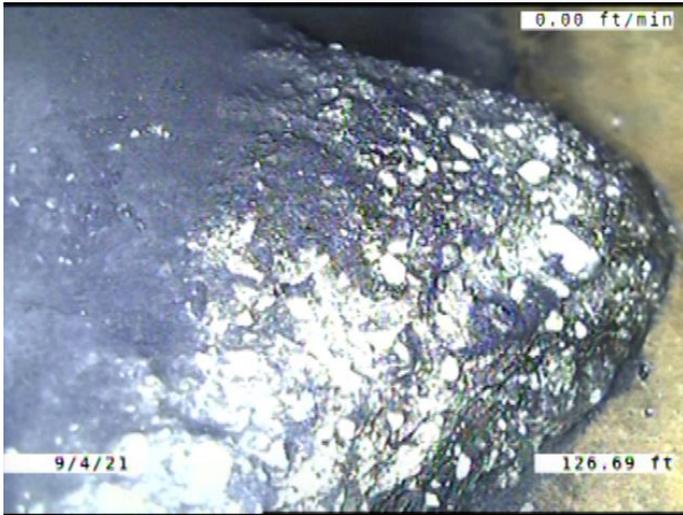
Code: **DAE**
Description: **Deposits Attached Encrustation**

Distance (ft): **126.7**
Structural Grade: **0**
O&M Grade: **2**
Clock Start/From: **4**
Clock To: **6**
1st Value:
2nd Value:
Value Percent: **5.000**
Continuous Index:
Within 8" of Joint: **NO**
Remarks:

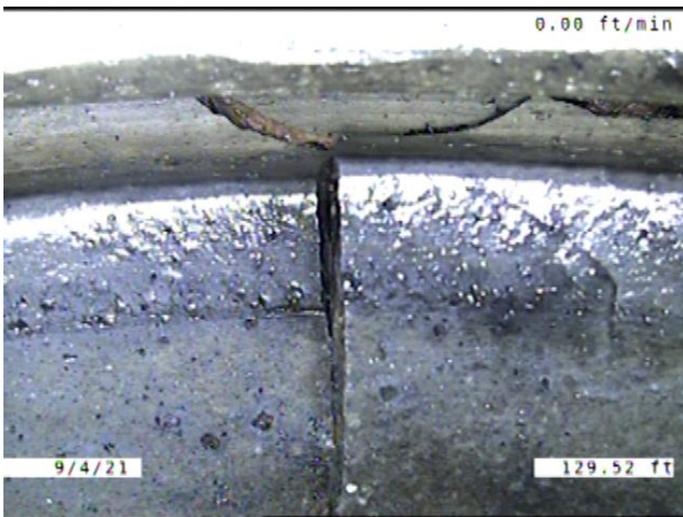
Code: **B**
Description: **Broken**

Distance (ft): **129.5**
Structural Grade: **4**
O&M Grade: **0**
Clock Start/From: **12**
Clock To: **2**
1st Value:
2nd Value:
Value Percent:
Continuous Index:
Within 8" of Joint: **YES**
Remarks:

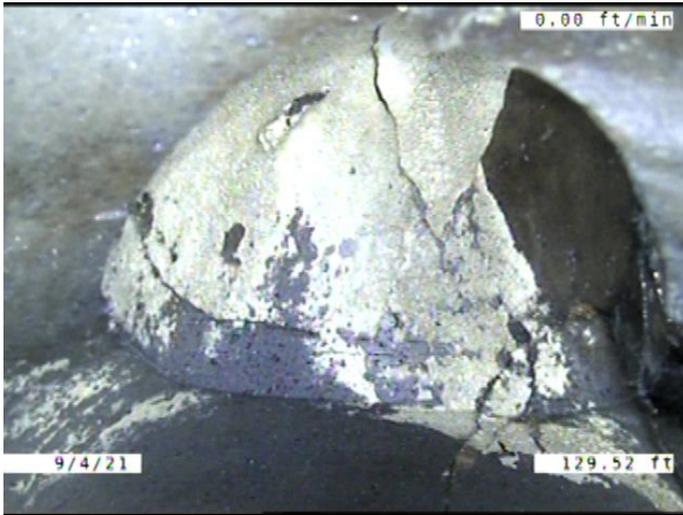
Code: **DAE**
 Description: **Deposits Attached Encrustation**

Distance (ft): **129.5**
 Structural Grade: **0**
 O&M Grade: **2**
 Clock Start/From: **8**
 Clock To: **4**
 1st Value:
 2nd Value:
 Value Percent: **5.000**
 Continuous Index:
 Within 8" of Joint: **YES**
 Remarks:

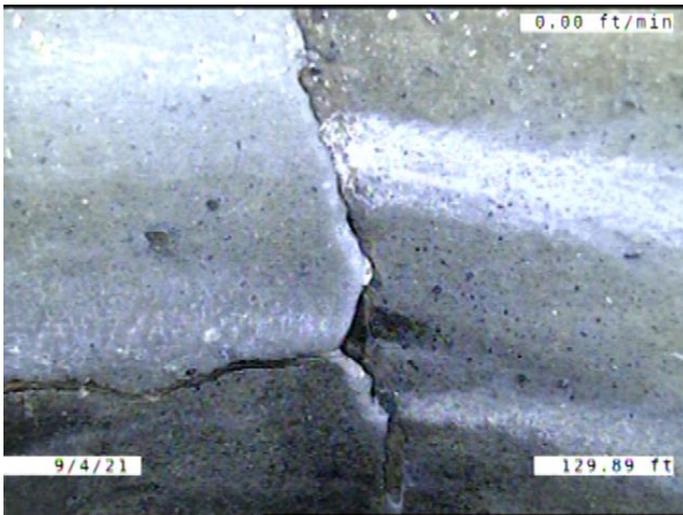
Code: **IRB**
 Description: **Infiltration Runner Barrel**

Distance (ft): **129.9**
 Structural Grade: **0**
 O&M Grade: **4**
 Clock Start/From: **2**
 Clock To:
 1st Value:
 2nd Value:
 Value Percent:
 Continuous Index:
 Within 8" of Joint: **NO**
 Remarks:

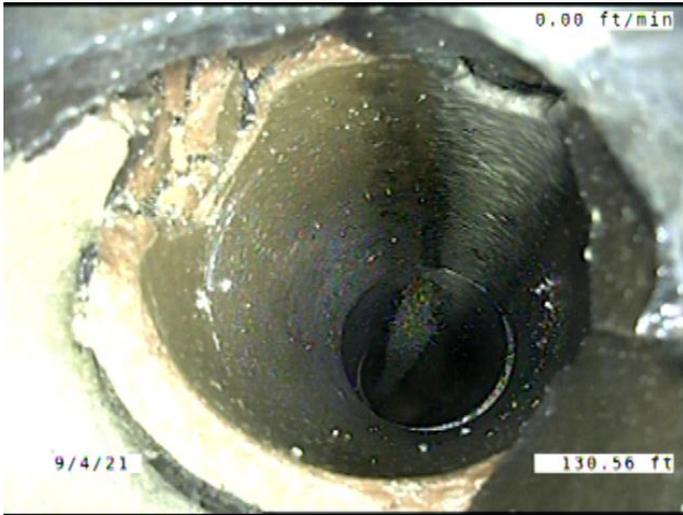
Code: **TFD**
Description: **Tap Factory Defective**

Distance (ft): **130.6**
Structural Grade: **0**
O&M Grade: **3**
Clock Start/From: **1**
Clock To:
1st Value: **6.000**
2nd Value:
Value Percent:
Continuous Index:
Within 8" of Joint: **YES**
Remarks: **BROKEN AND OFFSET**

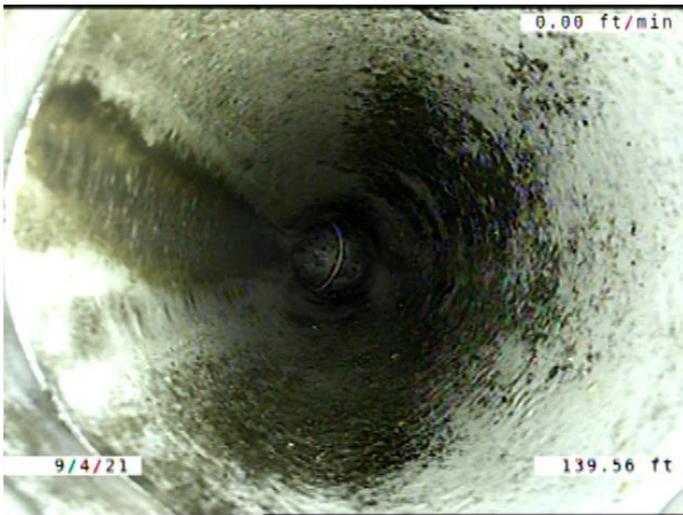
Code: **TBI**
Description: **Tap Break-in Intruding**

Distance (ft): **139.6**
Structural Grade: **0**
O&M Grade: **2**
Clock Start/From: **11**
Clock To:
1st Value: **6.000**
2nd Value: **3.000**
Value Percent:
Continuous Index:
Within 8" of Joint: **YES**
Remarks:

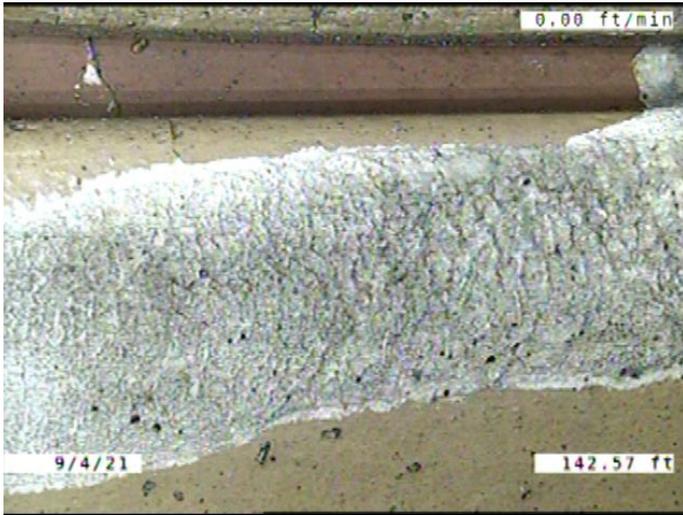
Code: **DAE**
Description: **Deposits Attached Encrustation**

Distance (ft): **142.6**
Structural Grade: **0**
O&M Grade: **2**
Clock Start/From: **9**
Clock To: **12**
1st Value:
2nd Value:
Value Percent: **5.000**
Continuous Index:
Within 8" of Joint: **YES**
Remarks:

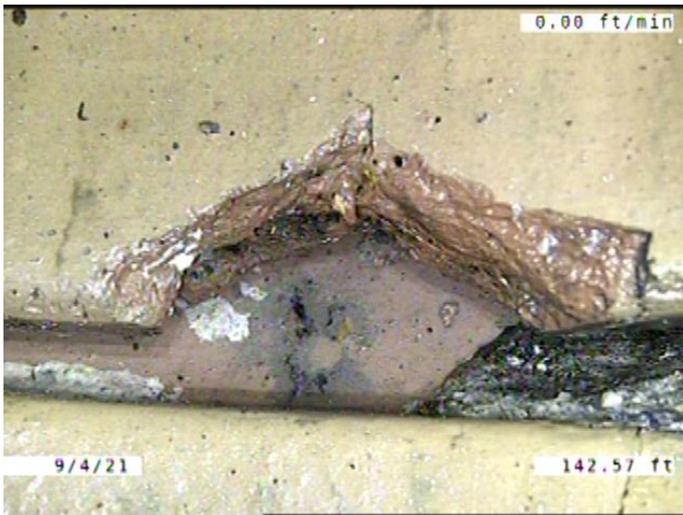
Code: **SMW**
Description: **Surface Damage Missing Wall**

Distance (ft): **142.6**
Structural Grade: **5**
O&M Grade: **0**
Clock Start/From: **2**
Clock To: **3**
1st Value:
2nd Value:
Value Percent:
Continuous Index:
Within 8" of Joint: **YES**
Remarks:

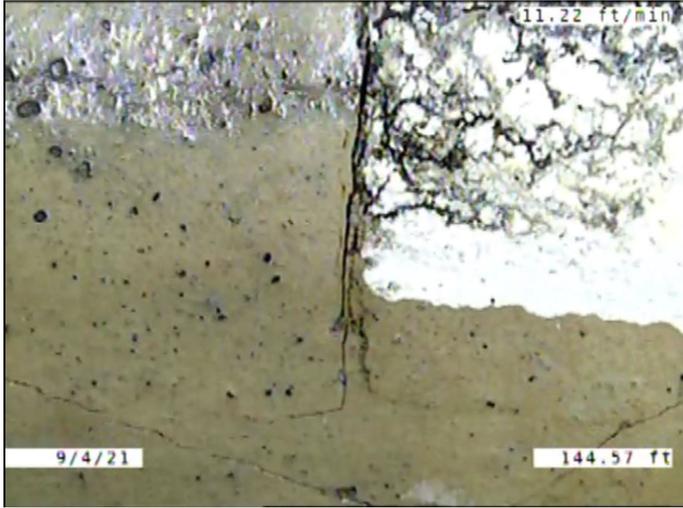
Code: **FM**
 Description: **Fracture Multiple**

Distance (ft): **144.6**
 Structural Grade: **4**
 O&M Grade: **0**
 Clock Start/From: **8**
 Clock To: **4**
 1st Value:
 2nd Value:
 Value Percent:
 Continuous Index: **F03**
 Within 8" of Joint: **YES**
 Remarks:

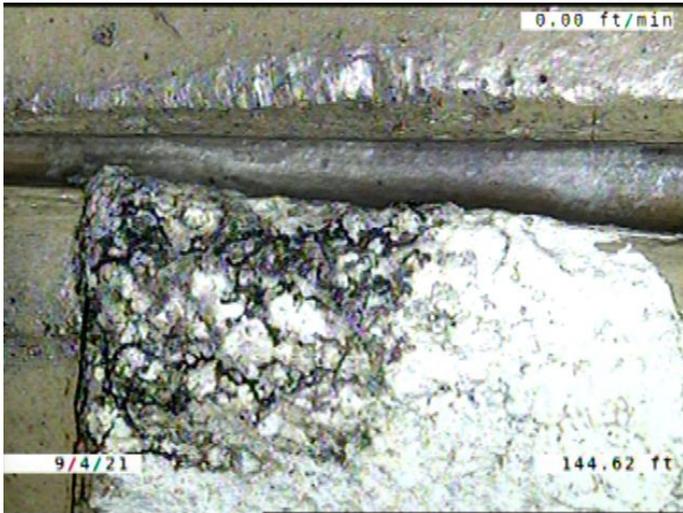
Code: **DAE**
 Description: **Deposits Attached Encrustation**

Distance (ft): **144.6**
 Structural Grade: **0**
 O&M Grade: **2**
 Clock Start/From: **1**
 Clock To: **3**
 1st Value:
 2nd Value:
 Value Percent: **5.000**
 Continuous Index:
 Within 8" of Joint: **YES**
 Remarks:

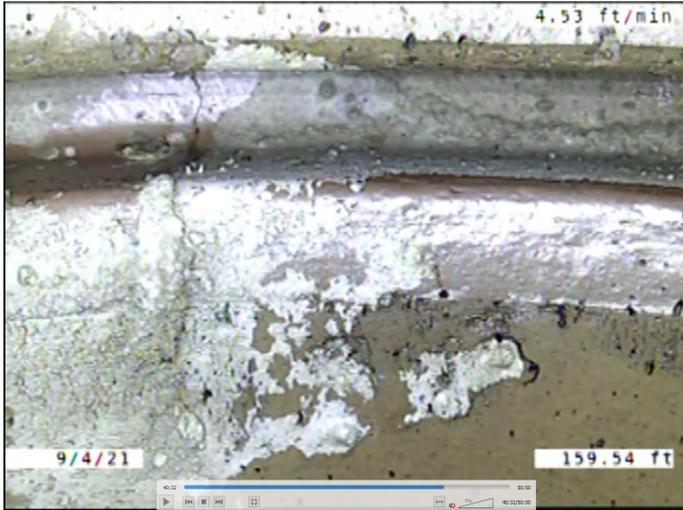
Code: **CL**
 Description: **Crack Longitudinal**

Distance (ft): **159.5**
 Structural Grade: **2**
 O&M Grade: **0**
 Clock Start/From: **12**
 Clock To:
 1st Value:
 2nd Value:
 Value Percent:
 Continuous Index:
 Within 8" of Joint: **YES**
 Remarks:

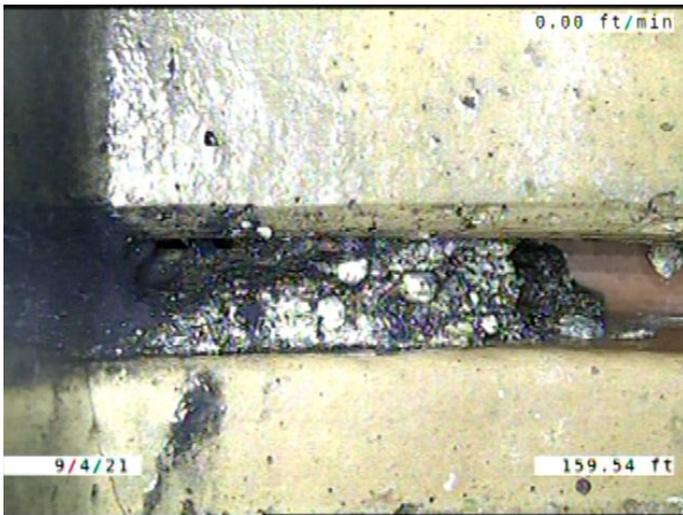
Code: **DAE**
 Description: **Deposits Attached Encrustation**

Distance (ft): **159.5**
 Structural Grade: **0**
 O&M Grade: **2**
 Clock Start/From: **8**
 Clock To: **4**
 1st Value:
 2nd Value:
 Value Percent: **5.000**
 Continuous Index:
 Within 8" of Joint: **YES**
 Remarks:

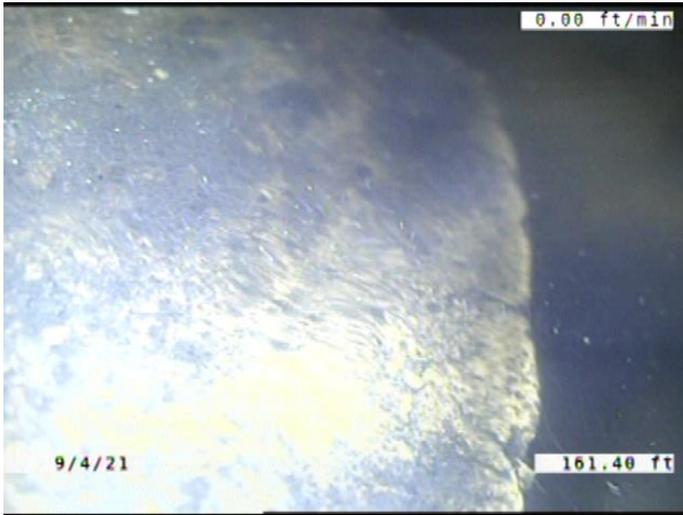
Code: **OBB**
Description: **Obstruction Brick or Masonry**

Distance (ft): **161.4**
Structural Grade: **0**
O&M Grade: **2**
Clock Start/From: **5**
Clock To: **7**
1st Value:
2nd Value:
Value Percent: **5.000**
Continuous Index:
Within 8" of Joint: **YES**
Remarks:

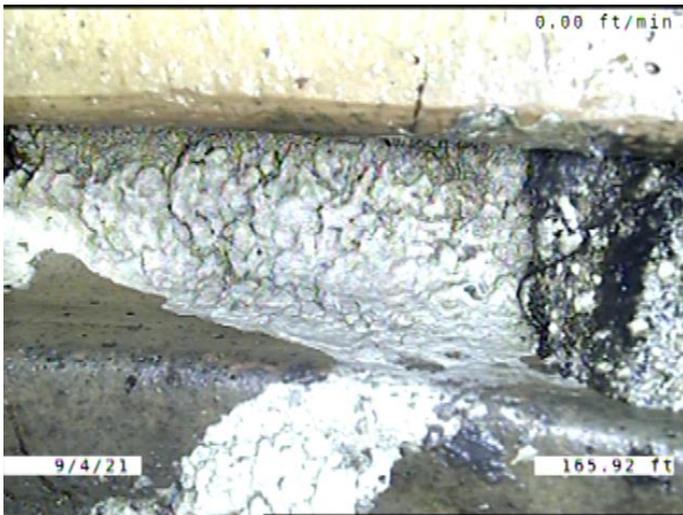
Code: **DAE**
Description: **Deposits Attached Encrustation**

Distance (ft): **165.9**
Structural Grade: **0**
O&M Grade: **2**
Clock Start/From: **8**
Clock To: **4**
1st Value:
2nd Value:
Value Percent: **5.000**
Continuous Index:
Within 8" of Joint: **YES**
Remarks:

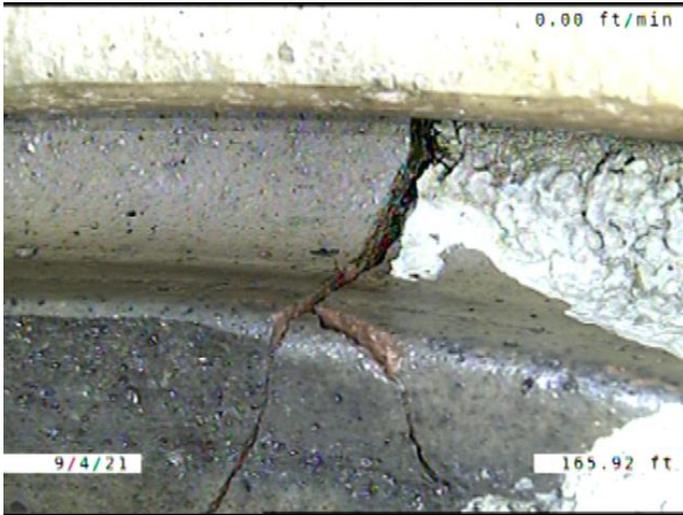
Code: **FM**
Description: **Fracture Multiple**

Distance (ft): **165.9**
Structural Grade: **4**
O&M Grade: **0**
Clock Start/From: **11**
Clock To: **3**
1st Value:
2nd Value:
Value Percent:
Continuous Index:
Within 8" of Joint: **YES**
Remarks:

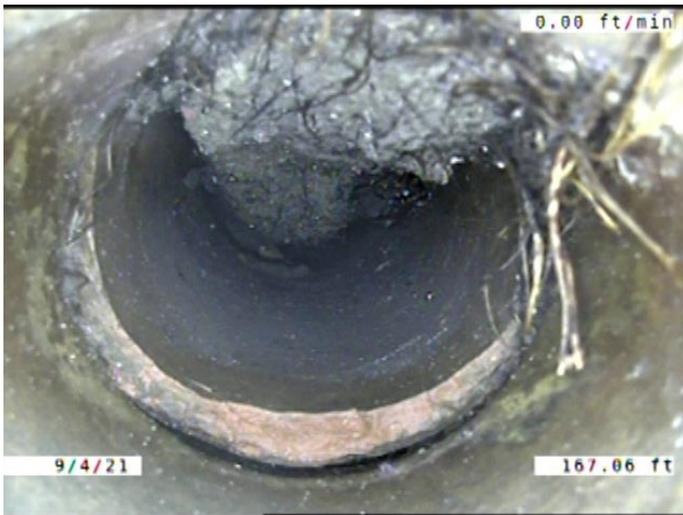
Code: **TFD**
Description: **Tap Factory Defective**

Distance (ft): **167.1**
Structural Grade: **0**
O&M Grade: **3**
Clock Start/From: **1**
Clock To:
1st Value: **6.000**
2nd Value:
Value Percent:
Continuous Index:
Within 8" of Joint: **YES**
Remarks: **LOOKS TO BE 80+% PLUGGED WITH ROOTS**

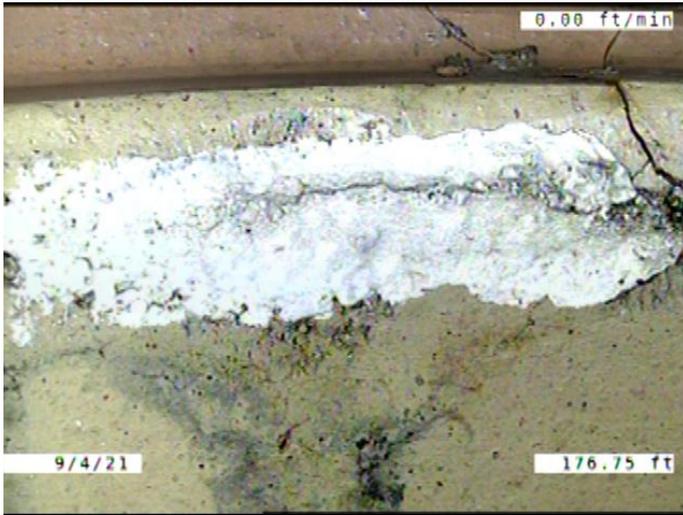
Code: **DAE**
 Description: **Deposits Attached Encrustation**

Distance (ft): **176.7**
 Structural Grade: **0**
 O&M Grade: **2**
 Clock Start/From: **10**
 Clock To: **11**
 1st Value:
 2nd Value:
 Value Percent: **5.000**
 Continuous Index:
 Within 8" of Joint: **YES**
 Remarks:

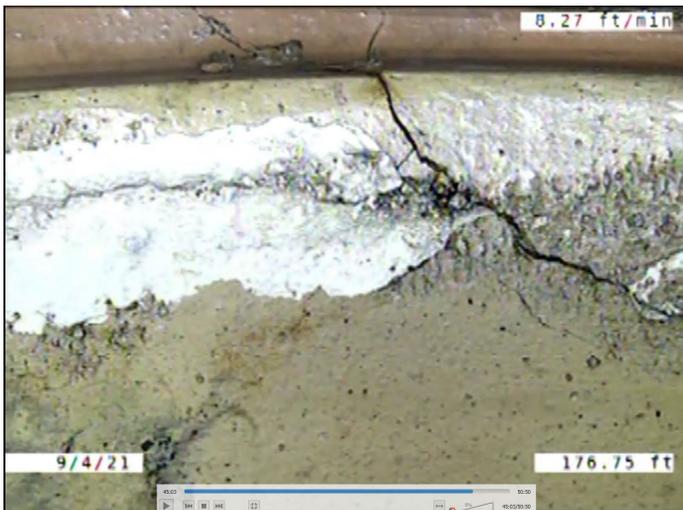
Code: **FM**
 Description: **Fracture Multiple**

Distance (ft): **176.8**
 Structural Grade: **4**
 O&M Grade: **0**
 Clock Start/From: **11**
 Clock To: **1**
 1st Value:
 2nd Value:
 Value Percent:
 Continuous Index:
 Within 8" of Joint: **YES**
 Remarks:

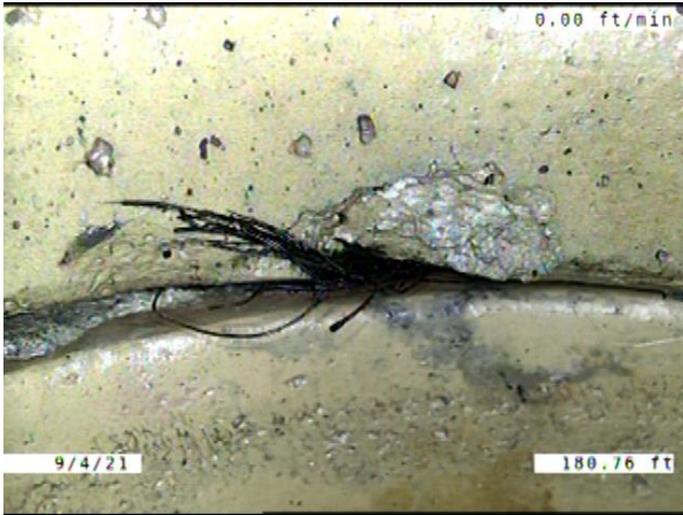
Code: **RFJ**
Description: **Roots Fine Joint**

Distance (ft): **180.8**
Structural Grade: **0**
O&M Grade: **1**
Clock Start/From: **10**
Clock To:
1st Value:
2nd Value:
Value Percent:
Continuous Index:
Within 8" of Joint: **YES**
Remarks:

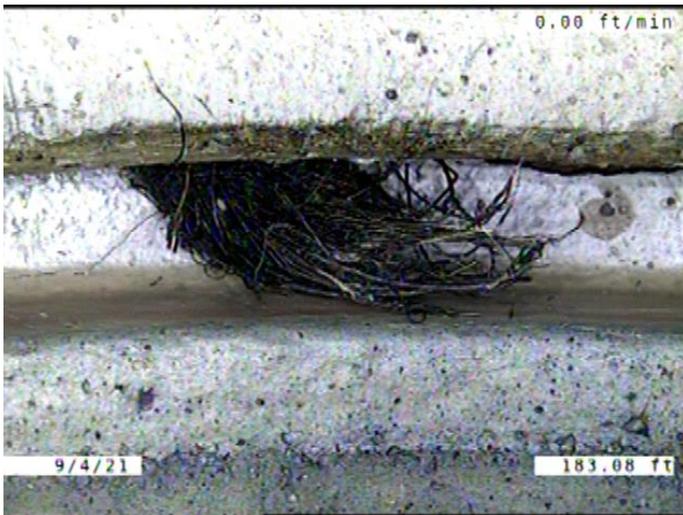
Code: **RFJ**
Description: **Roots Fine Joint**

Distance (ft): **183.1**
Structural Grade: **0**
O&M Grade: **1**
Clock Start/From: **11**
Clock To:
1st Value:
2nd Value:
Value Percent:
Continuous Index:
Within 8" of Joint: **YES**
Remarks:
