Profile/Photo Observation Report

Date:	09/04/2021	Weather:		Coding:	PACP 7.0
Pipe Length (ft):	189.5	Owner:	City of Hobart	Pre Clean:	Heavy Cleaning
P.O.#:	YES502259	Surveyor:	S. Bucklin	PSR:	P-504-078-077
Customer:	City of Hobart	Clean Date:	09/02/2021	Shape:	C

Street:	North Cavender Street	Flow Control:	Not Controlled
City:	Hobart, IN	Year Renewed:	
Location:	Alley	Tape/Media #:	
Purpose:	Routine Assessment	Dia/Height:	12"
Use:	Sanitary Sewage Pipe	Material:	VCP
Drain Area:		Lining:	
Category:	NA		
Comment:			
Location Details:		Direction of Survey:	Downstream
US MH:	M-504-078	DS MH:	M-504-077
		Total Length Surveyed (ft):	189.5

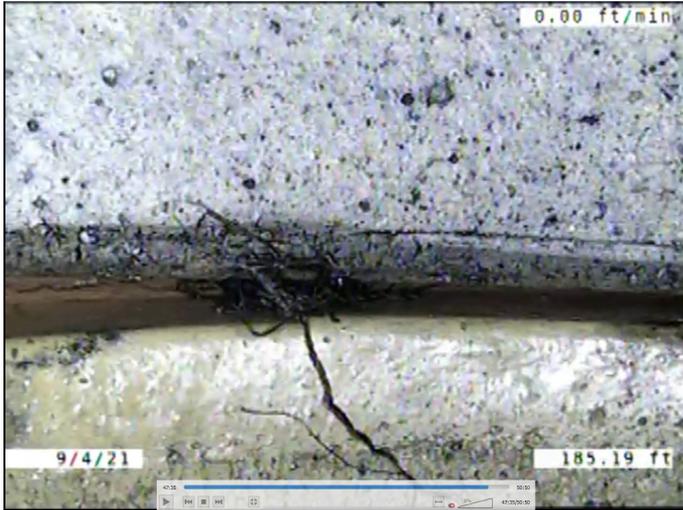
Code: **FM**
Description: **Fracture Multiple**

Distance (ft): **185.2**
Structural Grade: **4**
O&M Grade: **0**
Clock Start/From: **11**
Clock To: **1**
1st Value:
2nd Value:
Value Percent:
Continuous Index:
Within 8" of Joint: **YES**
Remarks:

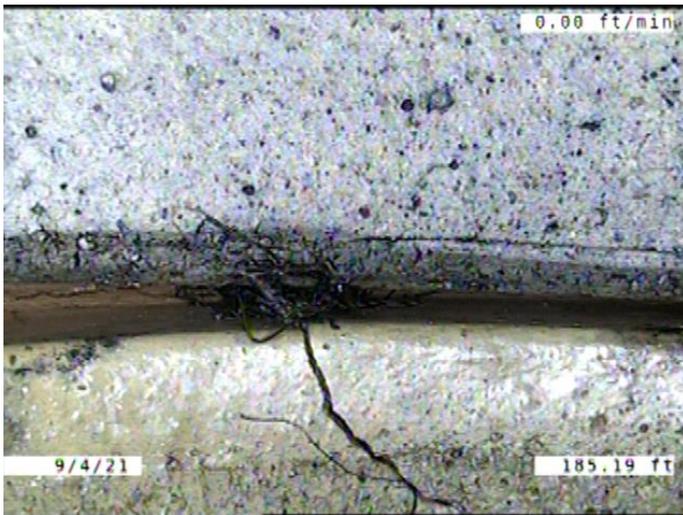
Code: **RFJ**
Description: **Roots Fine Joint**

Distance (ft): **185.2**
Structural Grade: **0**
O&M Grade: **1**
Clock Start/From: **11**
Clock To:
1st Value:
2nd Value:
Value Percent:
Continuous Index:
Within 8" of Joint: **YES**
Remarks:

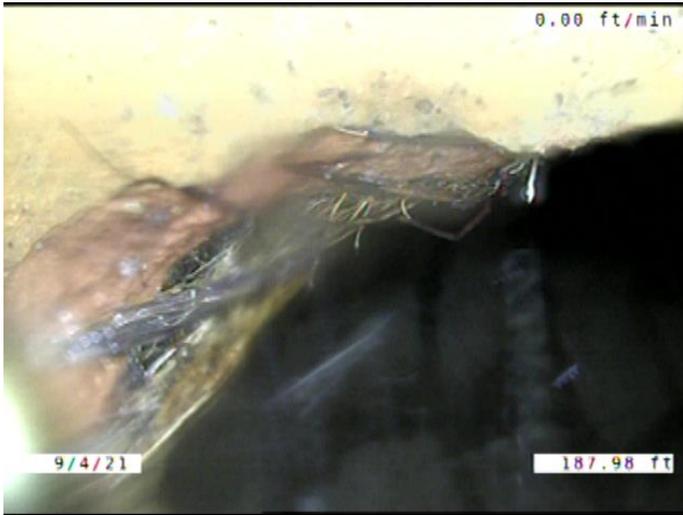
Code: **RMJ**
 Description: **Roots Medium Joint**

Distance (ft): **188.0**
 Structural Grade: **0**
 O&M Grade: **3**
 Clock Start/From: **9**
 Clock To: **3**
 1st Value:
 2nd Value:
 Value Percent: **5.000**
 Continuous Index:
 Within 8" of Joint: **YES**
 Remarks:
