M-504-079

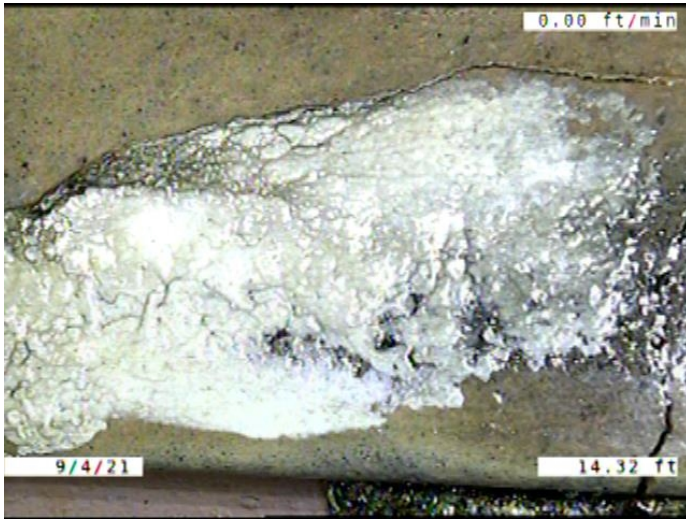
Code: **DAE**
 Description: **Deposits Attached Encrustation**

Distance (ft): **14.3**
 Structural Grade: **0**
 O&M Grade: **2**
 Clock Start/From: **2**
 Clock To: **4**
 1st Value:
 2nd Value:
 Value Percent: **5.000**
 Continuous Index:
 Within 8" of Joint: **YES**
 Remarks:

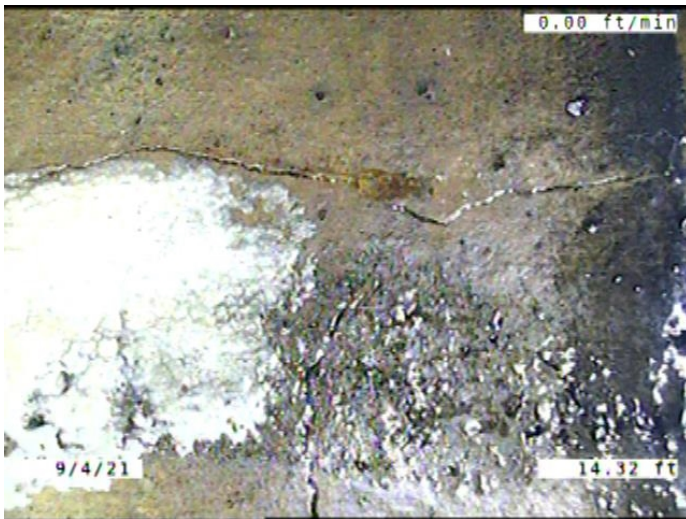
Code: **FM**
 Description: **Fracture Multiple**

Distance (ft): **14.3**
 Structural Grade: **4**
 O&M Grade: **0**
 Clock Start/From: **11**
 Clock To: **4**
 1st Value:
 2nd Value:
 Value Percent:
 Continuous Index:
 Within 8" of Joint: **YES**
 Remarks:

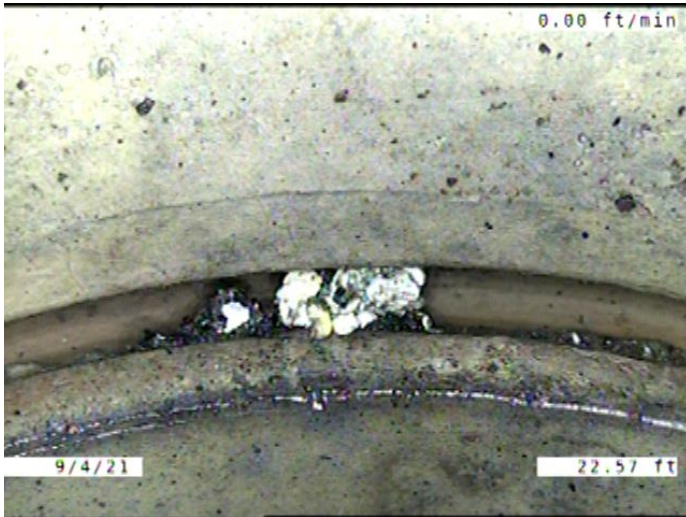
Code: **JOM**
Description: **Joint Offset Medium**

Distance (ft): **22.6**
Structural Grade: **3**
O&M Grade: **0**
Clock Start/From:
Clock To:
1st Value:
2nd Value:
Value Percent:
Continuous Index:
Within 8" of Joint: **NO**
Remarks:

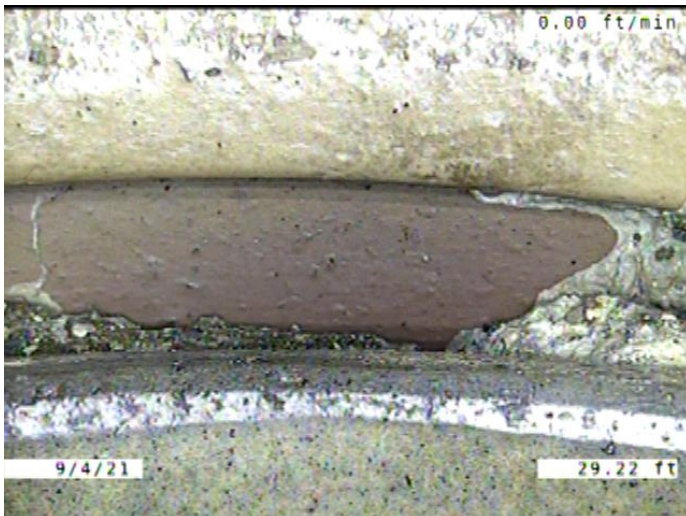
Code: **JAM**
Description: **Joint Angular Medium**

Distance (ft): **29.2**
Structural Grade: **3**
O&M Grade: **0**
Clock Start/From:
Clock To:
1st Value:
2nd Value:
Value Percent:
Continuous Index:
Within 8" of Joint: **NO**
Remarks:

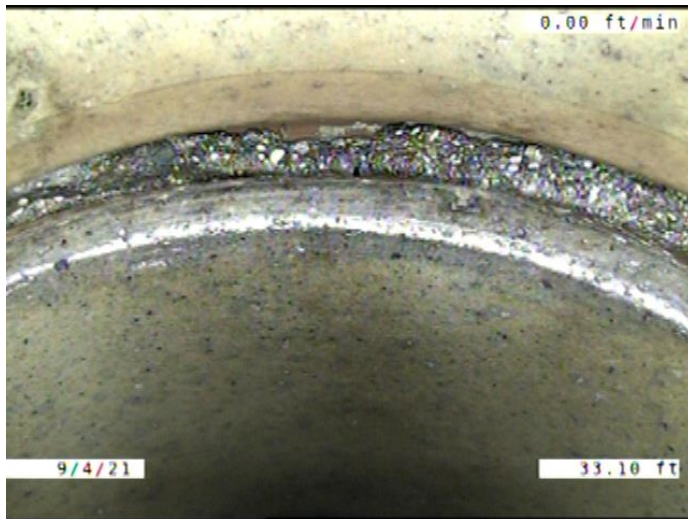
Code: **JOM**
 Description: **Joint Offset Medium**

Distance (ft): **33.1**
 Structural Grade: **3**
 O&M Grade: **0**
 Clock Start/From:
 Clock To:
 1st Value:
 2nd Value:
 Value Percent:
 Continuous Index:
 Within 8" of Joint: **NO**
 Remarks:

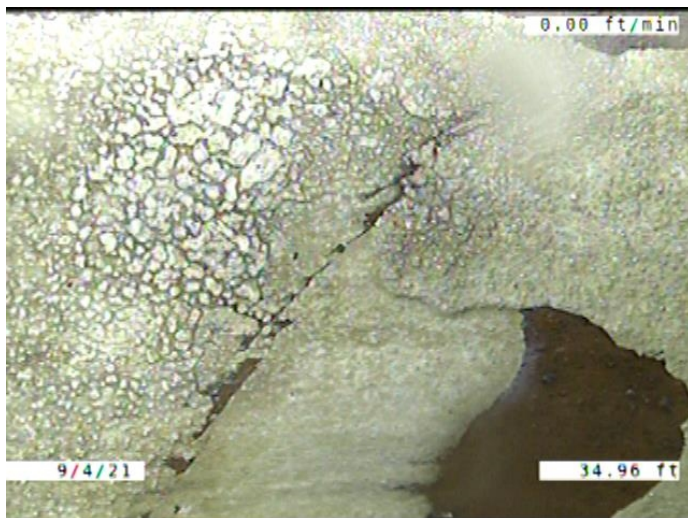
Code: **DAE**
 Description: **Deposits Attached Encrustation**

Distance (ft): **35.0**
 Structural Grade: **0**
 O&M Grade: **2**
 Clock Start/From: **9**
 Clock To: **3**
 1st Value:
 2nd Value:
 Value Percent: **5.000**
 Continuous Index:
 Within 8" of Joint: **YES**
 Remarks:

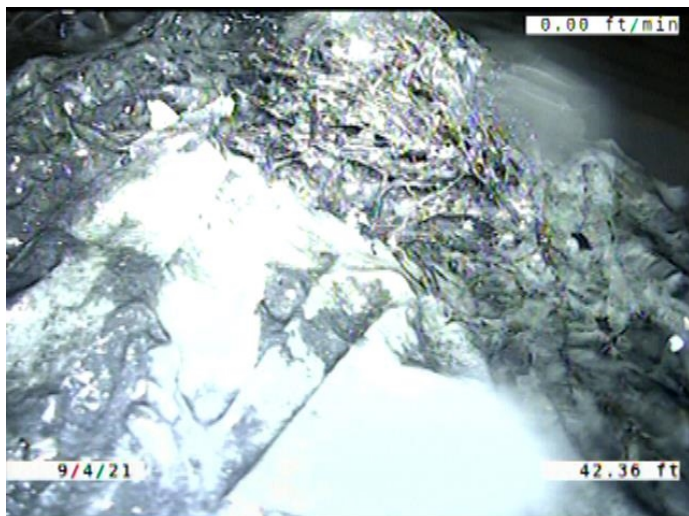
Code: **OBZ**
 Description: **Obstruction Other**

Distance (ft): **42.4**
 Structural Grade: **0**
 O&M Grade: **2**
 Clock Start/From: **5**
 Clock To: **7**
 1st Value:
 2nd Value:
 Value Percent: **5.000**

Continuous Index:
 Within 8" of Joint: **YES**
 Remarks: **ROOTS THAT FLOATED DOWN THE LINE**

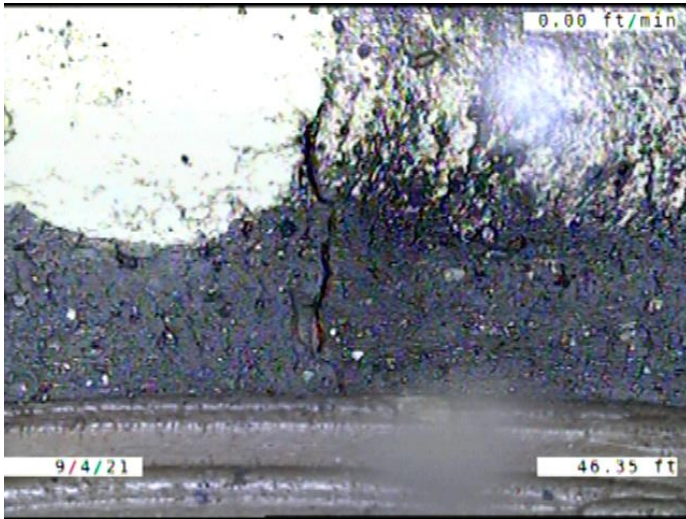
Code: **FM**
Description: **Fracture Multiple**

Distance (ft): **46.4**
Structural Grade: **4**
O&M Grade: **0**
Clock Start/From: **11**
Clock To: **1**
1st Value:
2nd Value:
Value Percent:
Continuous Index:
Within 8" of Joint: **YES**
Remarks:

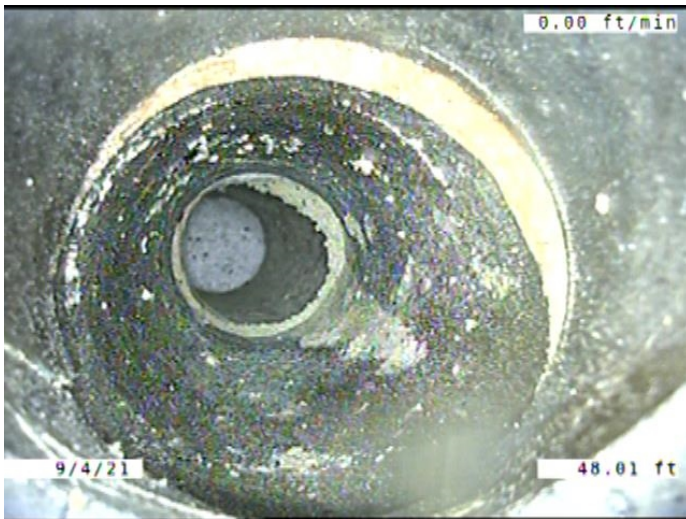
Code: **TFC**
Description: **Tap Factory Capped**

Distance (ft): **48.0**
Structural Grade: **0**
O&M Grade: **0**
Clock Start/From: **1**
Clock To:
1st Value: **6.000**
2nd Value:
Value Percent:
Continuous Index:
Within 8" of Joint: **YES**
Remarks: **FIRST JOINT BACK OFFSET**

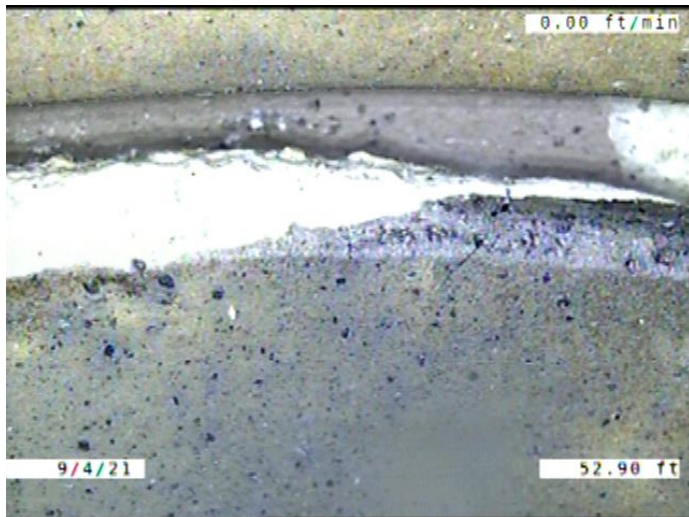
Code: **DAE**
 Description: **Deposits Attached Encrustation**

Distance (ft): **52.9**
 Structural Grade: **0**
 O&M Grade: **2**
 Clock Start/From: **8**
 Clock To: **4**
 1st Value:
 2nd Value:
 Value Percent: **5.000**
 Continuous Index:
 Within 8" of Joint: **YES**
 Remarks:

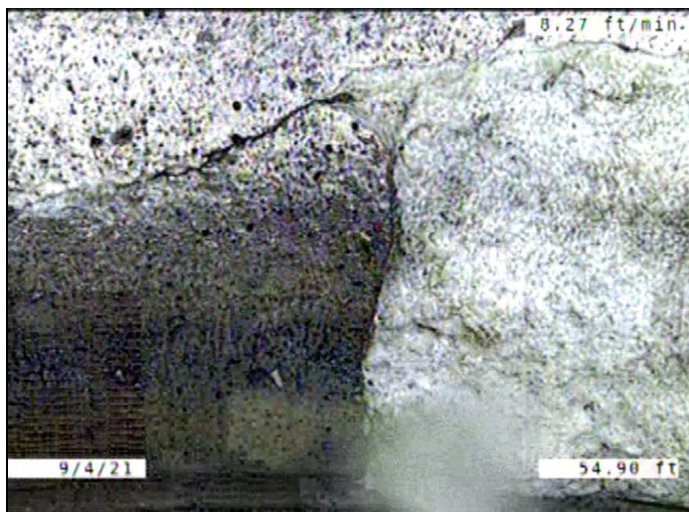
Code: **CC**
 Description: **Crack Circumferential**

Distance (ft): **54.9**
 Structural Grade: **1**
 O&M Grade: **0**
 Clock Start/From: **11**
 Clock To: **1**
 1st Value:
 2nd Value:
 Value Percent:
 Continuous Index:
 Within 8" of Joint: **YES**
 Remarks:

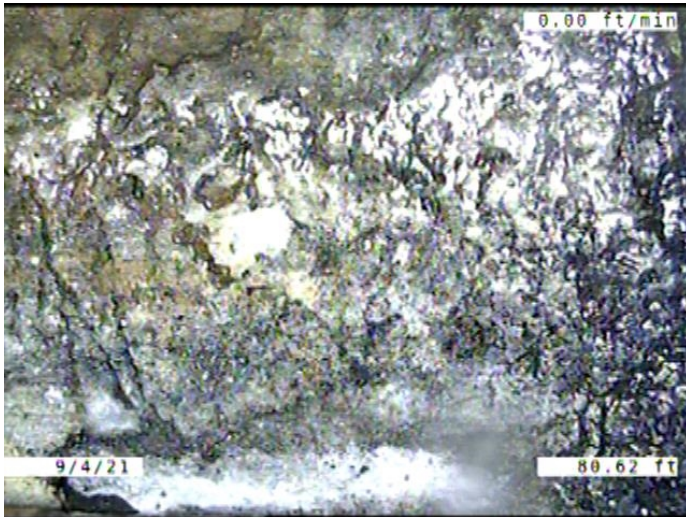
Code: **DAE**
 Description: **Deposits Attached Encrustation**

Distance (ft): **80.6**
 Structural Grade: **0**
 O&M Grade: **2**
 Clock Start/From: **12**
 Clock To: **4**
 1st Value:
 2nd Value:
 Value Percent: **5.000**
 Continuous Index:
 Within 8" of Joint: **YES**
 Remarks:

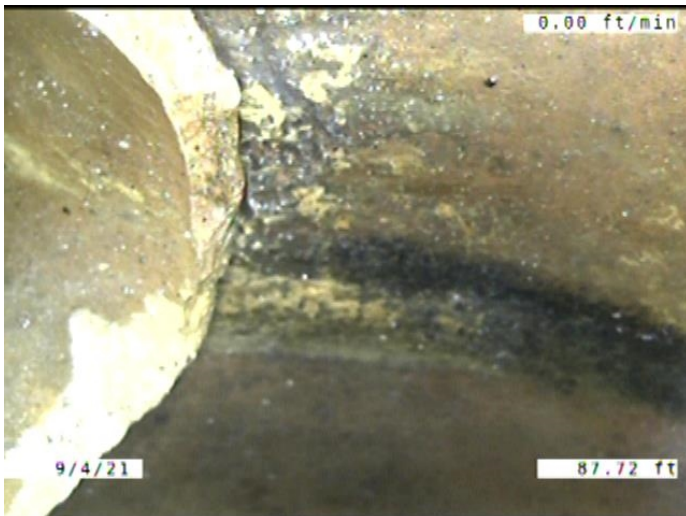
Code: **ISB**
 Description: **Infiltration Stain Barrel**

Distance (ft): **87.7**
 Structural Grade: **0**
 O&M Grade: **1**
 Clock Start/From: **2**
 Clock To: **4**
 1st Value:
 2nd Value:
 Value Percent:
 Continuous Index:
 Within 8" of Joint: **YES**
 Remarks:

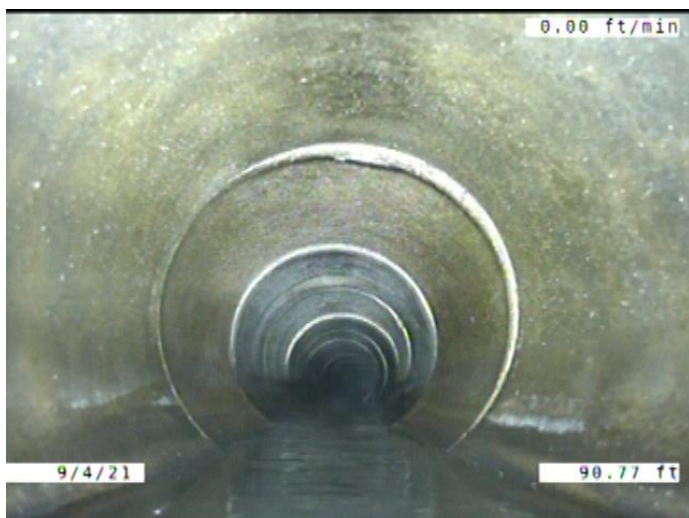
Code:	DAE
Description:	Deposits Attached Encrustation
Distance (ft):	90.8
Structural Grade:	0
O&M Grade:	2
Clock Start/From:	2
Clock To:	9
1st Value:	
2nd Value:	
Value Percent:	5.000
Continuous Index:	F01
Within 8" of Joint:	YES
Remarks:

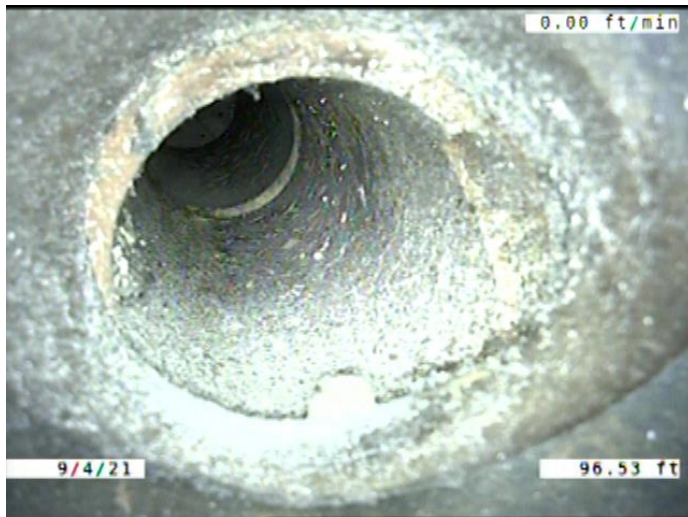
Code:	TFC
Description:	Tap Factory Capped
Distance (ft):	96.5
Structural Grade:	0
O&M Grade:	0
Clock Start/From:	12
Clock To:	
1st Value:	6.000
2nd Value:	
Value Percent:	
Continuous Index:	
Within 8" of Joint:	YES
Remarks:	FIRST JOINT BACK OFFSET. LOOKS TO BE CAPPED

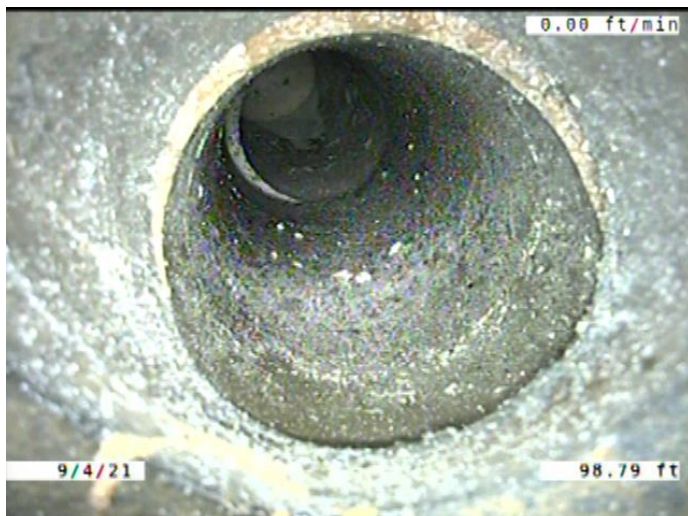
Code:	TFD
Description:	Tap Factory Defective
Distance (ft):	98.8
Structural Grade:	0
O&M Grade:	3
Clock Start/From:	1
Clock To:	
1st Value:	6.000
2nd Value:	
Value Percent:	
Continuous Index:	
Within 8" of Joint:	YES
Remarks:	FIRST JOINT BACK OFFSET. LOOKS TO BE CAPPED

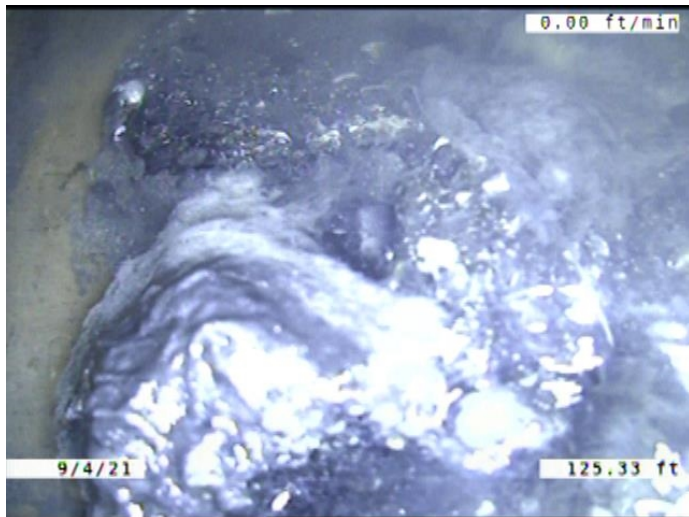
Code: **DAE**
 Description: **Deposits Attached Encrustation**

Distance (ft): **125.3**
 Structural Grade: **0**
 O&M Grade: **2**
 Clock Start/From: **7**
 Clock To: **8**
 1st Value:
 2nd Value:
 Value Percent: **5.000**
 Continuous Index:
 Within 8" of Joint: **YES**
 Remarks:

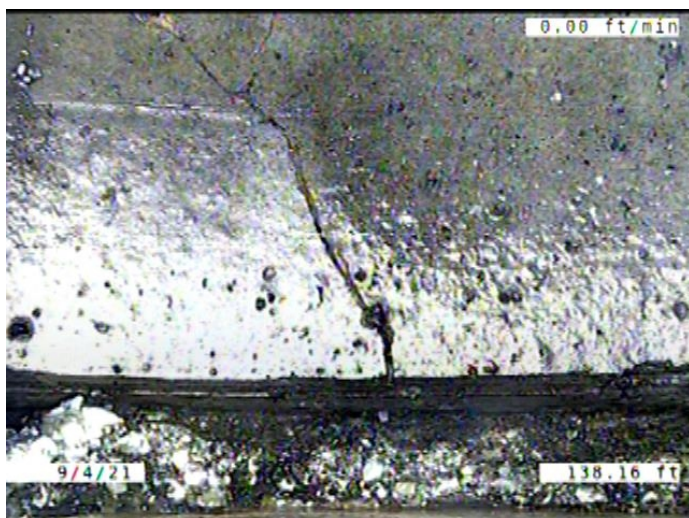
Code: **CM**
 Description: **Crack Multiple**

Distance (ft): **138.2**
 Structural Grade: **3**
 O&M Grade: **0**
 Clock Start/From: **4**
 Clock To: **5**
 1st Value:
 2nd Value:
 Value Percent:
 Continuous Index:
 Within 8" of Joint: **YES**
 Remarks:
