RedZone  
ROBOTICS

Street:	42nd Avenue	Flow Control:	Not Controlled
City:	Hobart, IN	Year Renewed:	
Location:	Alley	Tape/Media #:	
Purpose:	Routine Assessment	Dia/Height:	12"
Use:	Sanitary Sewage Pipe	Material:	VCP
Drain Area:		Lining:	
Category:	NA		
Comment:			
Location Details:		Direction of Survey:	Upstream
US MH:	M-504-079	DS MH:	M-504-078
			Total Length Surveyed (ft)

**M-504-079**

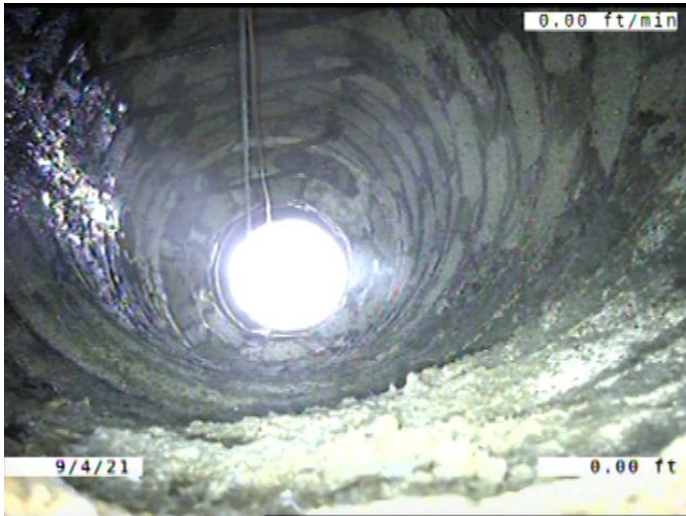
Code: **AMH**  
Description: **Manhole**

Distance (ft): **.0**  
Structural Grade: **0**  
O&M Grade: **0**  
Clock Start/From:  
Clock To:  
1st Value:  
2nd Value:  
Value Percent:  
Continuous Index:  
Within 8" of Joint: **NO**  
Remarks: **M-504-078**

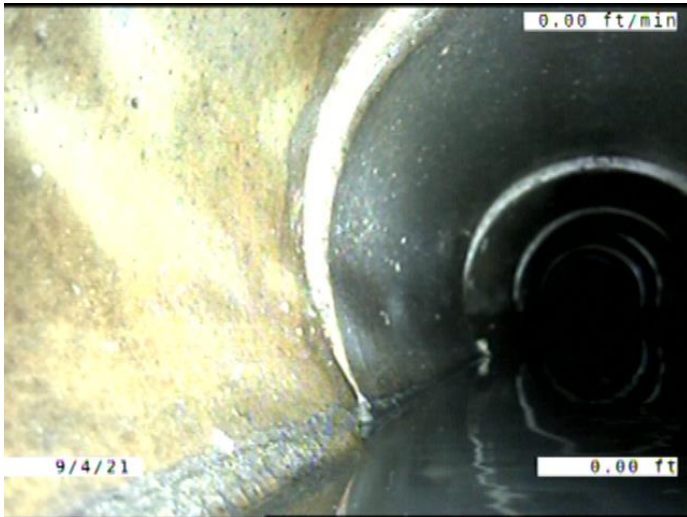
Code: **MWL**  
 Description: **Miscellaneous Water Level**

Distance (ft): **.0**  
 Structural Grade: **0**  
 O&M Grade: **0**  
 Clock Start/From:  
 Clock To:  
 1st Value:  
 2nd Value:  
 Value Percent: **10.000**  
 Continuous Index:  
 Within 8" of Joint: **NO**  
 Remarks:

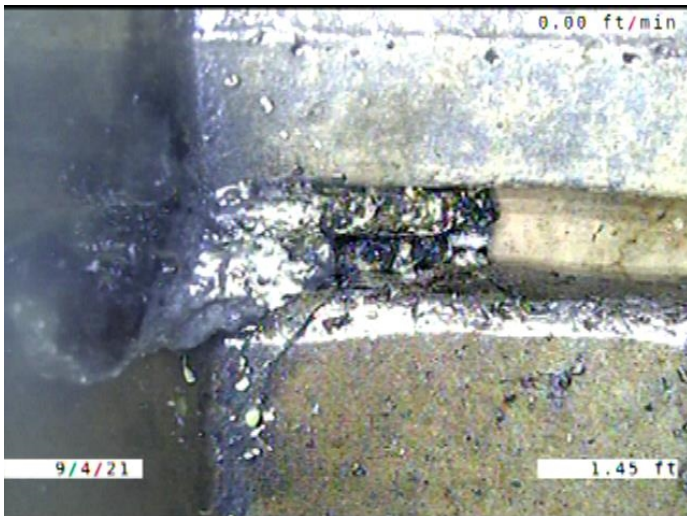
Code: **DAE**  
 Description: **Deposits Attached Encrustation**

Distance (ft): **1.5**  
 Structural Grade: **0**  
 O&M Grade: **2**  
 Clock Start/From: **8**  
 Clock To: **9**  
 1st Value:  
 2nd Value:  
 Value Percent: **5.000**  
 Continuous Index:  
 Within 8" of Joint: **YES**  
 Remarks:

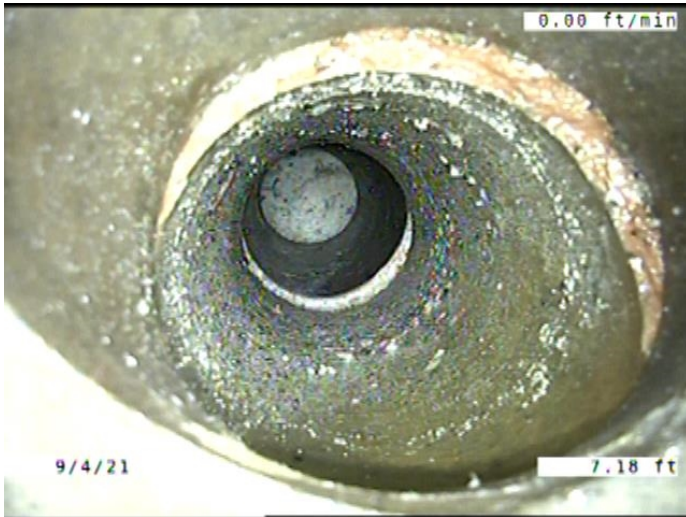
Code: **TFC**  
 Description: **Tap Factory Capped**

Distance (ft): **7.2**  
 Structural Grade: **0**  
 O&M Grade: **0**  
 Clock Start/From: **11**  
 Clock To:  
 1st Value: **6.000**  
 2nd Value:  
 Value Percent:  
 Continuous Index:  
 Within 8" of Joint: **YES**  
 Remarks: **FIRST JOINT BACK OFFSET**

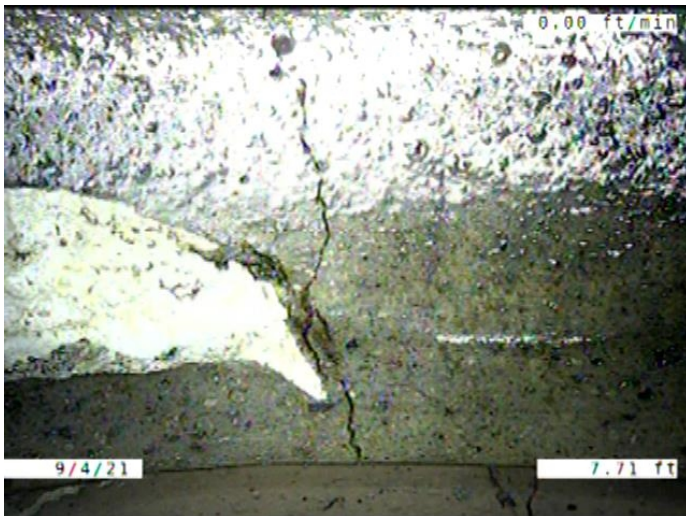
Code: **CL**  
 Description: **Crack Longitudinal**

Distance (ft): **7.7**  
 Structural Grade: **2**  
 O&M Grade: **0**  
 Clock Start/From: **11**  
 Clock To:  
 1st Value:  
 2nd Value:  
 Value Percent:  
 Continuous Index:  
 Within 8" of Joint: **YES**  
 Remarks:

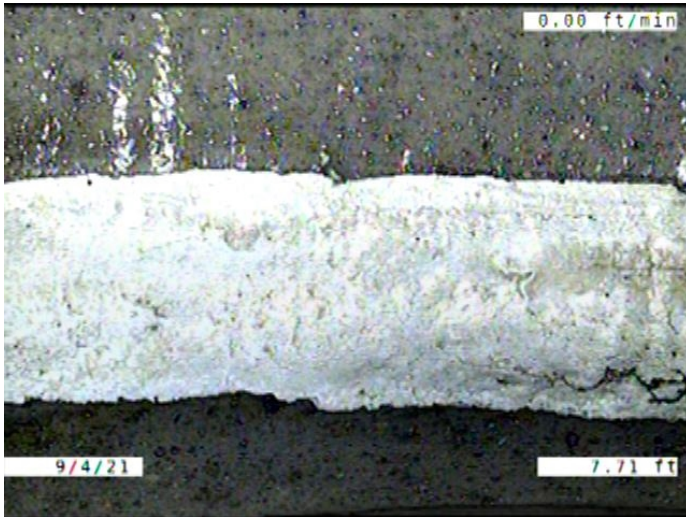
Code: **DAE**  
 Description: **Deposits Attached Encrustation**

Distance (ft): **7.7**  
 Structural Grade: **0**  
 O&M Grade: **2**  
 Clock Start/From: **9**  
 Clock To: **11**  
 1st Value:  
 2nd Value:  
 Value Percent: **5.000**  
 Continuous Index:  
 Within 8" of Joint: **YES**  
 Remarks:

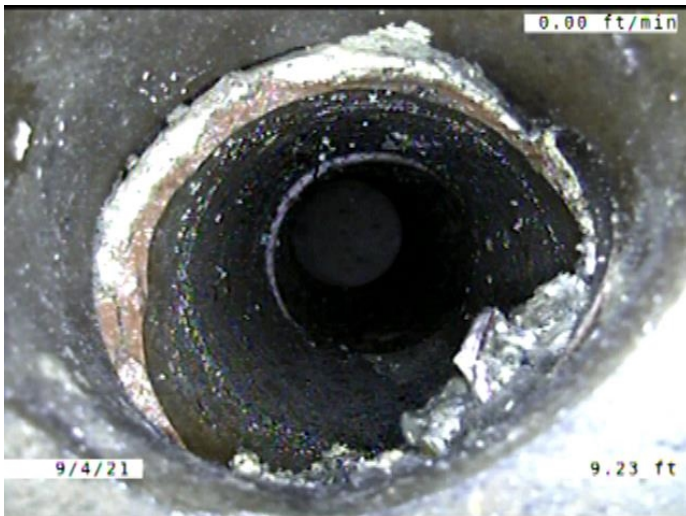
Code: **TFC**  
 Description: **Tap Factory Capped**

Distance (ft): **9.2**  
 Structural Grade: **0**  
 O&M Grade: **0**  
 Clock Start/From: **1**  
 Clock To:  
 1st Value: **6.000**  
 2nd Value:  
 Value Percent:  
 Continuous Index:  
 Within 8" of Joint: **YES**  
 Remarks: **FIRST JOINT BACK OFFSET**

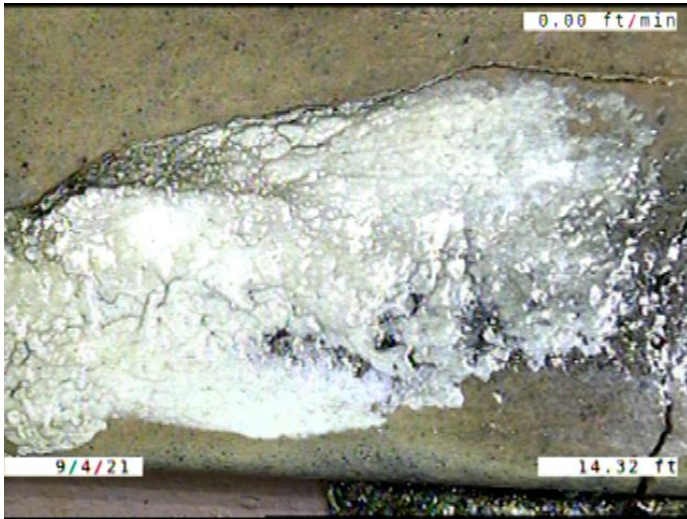
Code: **DAE**  
 Description: **Deposits Attached Encrustation**

Distance (ft): **14.3**  
 Structural Grade: **0**  
 O&M Grade: **2**  
 Clock Start/From: **2**  
 Clock To: **4**  
 1st Value:  
 2nd Value:  
 Value Percent: **5.000**  
 Continuous Index:  
 Within 8" of Joint: **YES**  
 Remarks:

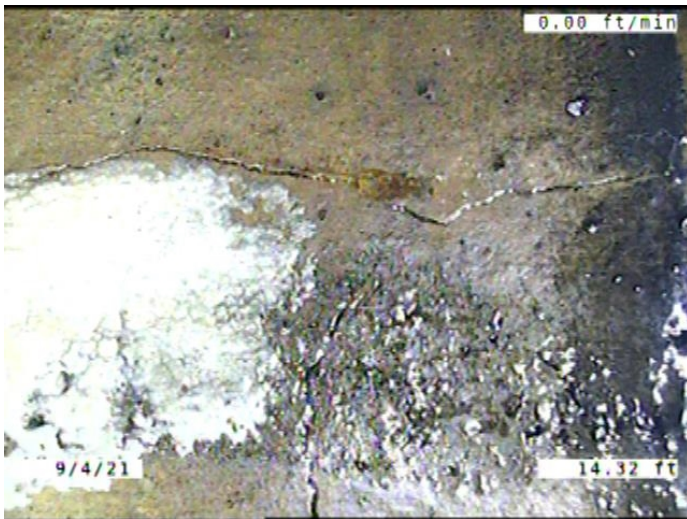
Code: **FM**  
 Description: **Fracture Multiple**

Distance (ft): **14.3**  
 Structural Grade: **4**  
 O&M Grade: **0**  
 Clock Start/From: **11**  
 Clock To: **4**  
 1st Value:  
 2nd Value:  
 Value Percent:  
 Continuous Index:  
 Within 8" of Joint: **YES**  
 Remarks:

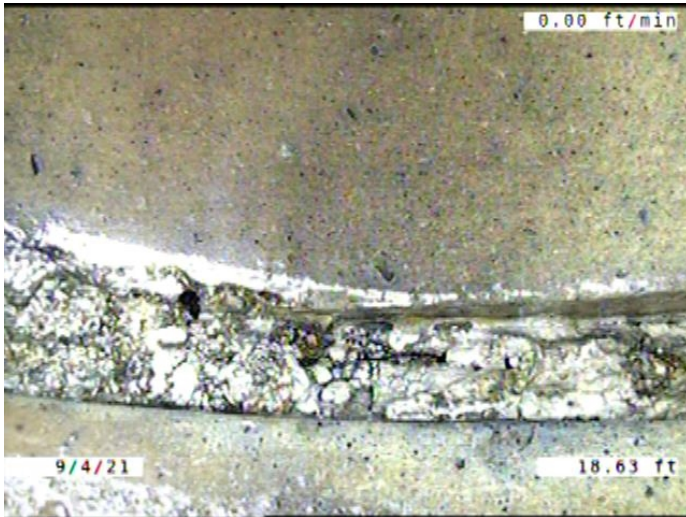
Code: **DAE**  
Description: **Deposits Attached Encrustation**

Distance (ft): **18.6**  
Structural Grade: **0**  
O&M Grade: **2**  
Clock Start/From: **2**  
Clock To: **9**  
1st Value:  
2nd Value:  
Value Percent: **5.000**  
Continuous Index: **S01**  
Within 8" of Joint: **YES**  
Remarks:

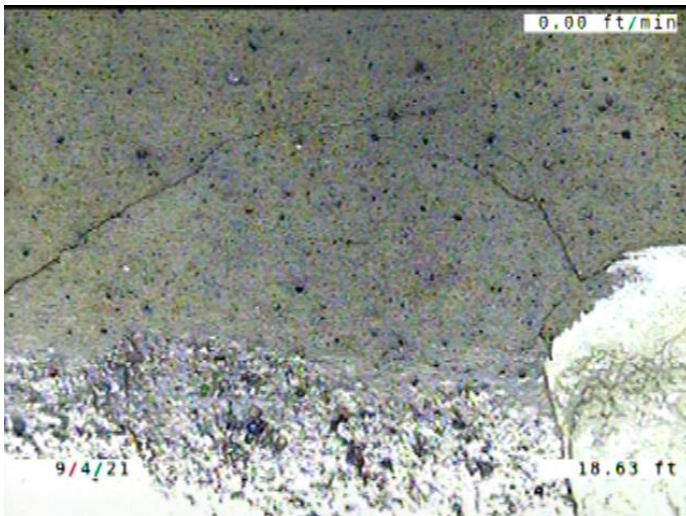
Code: **CM**  
Description: **Crack Multiple**

Distance (ft): **18.6**  
Structural Grade: **3**  
O&M Grade: **0**  
Clock Start/From: **11**  
Clock To: **1**  
1st Value:  
2nd Value:  
Value Percent:  
Continuous Index:  
Within 8" of Joint: **YES**  
Remarks:

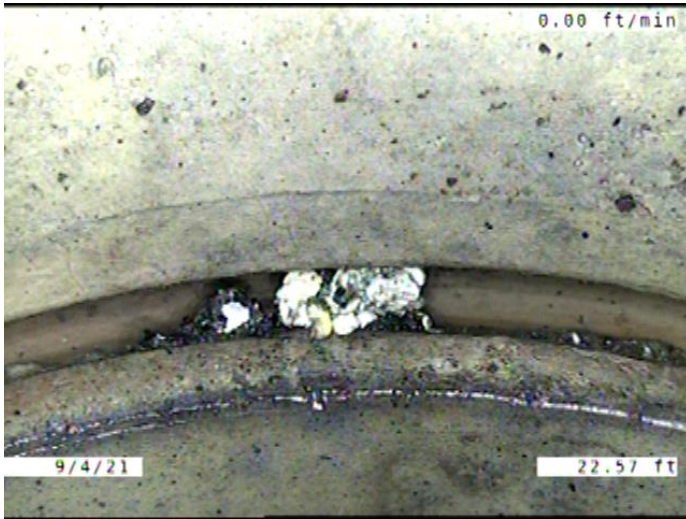
Code: **JOM**  
Description: **Joint Offset Medium**

Distance (ft): **22.6**  
Structural Grade: **3**  
O&M Grade: **0**  
Clock Start/From:  
Clock To:  
1st Value:  
2nd Value:  
Value Percent:  
Continuous Index:  
Within 8" of Joint: **NO**  
Remarks:

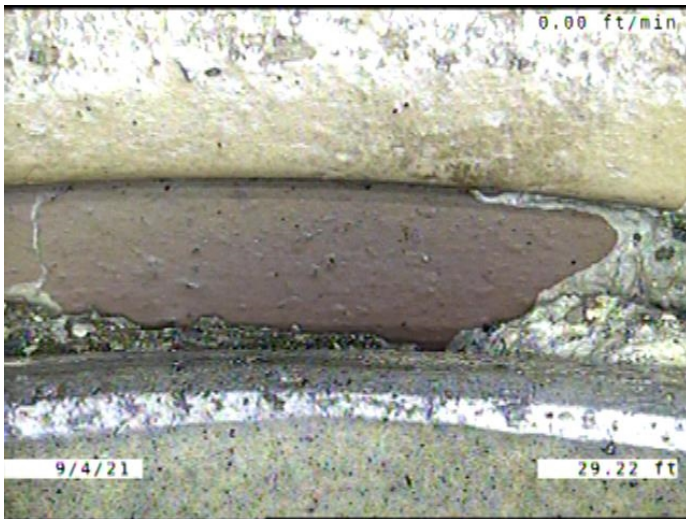
Code: **JAM**  
Description: **Joint Angular Medium**

Distance (ft): **29.2**  
Structural Grade: **3**  
O&M Grade: **0**  
Clock Start/From:  
Clock To:  
1st Value:  
2nd Value:  
Value Percent:  
Continuous Index:  
Within 8" of Joint: **NO**  
Remarks:

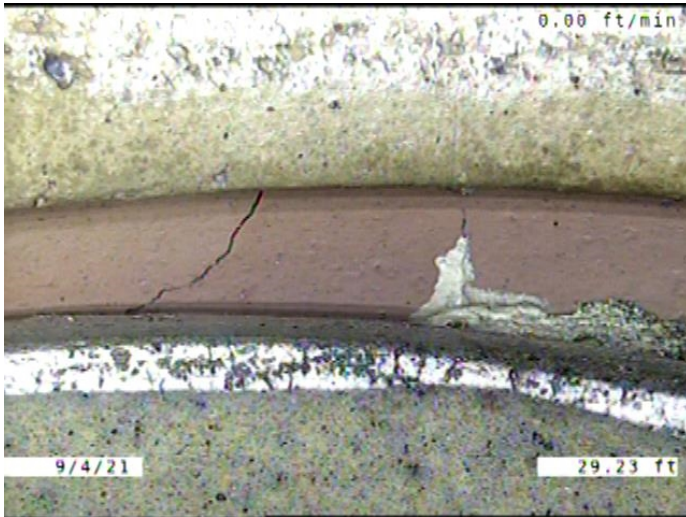
Code: **CM**  
 Description: **Crack Multiple**

Distance (ft): **29.2**  
 Structural Grade: **3**  
 O&M Grade: **0**  
 Clock Start/From: **10**  
 Clock To: **12**  
 1st Value:  
 2nd Value:  
 Value Percent:  
 Continuous Index:  
 Within 8" of Joint: **YES**  
 Remarks:

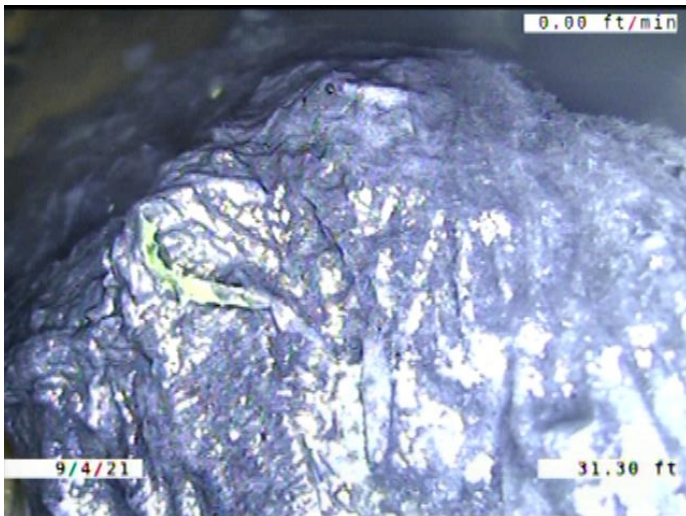
Code: **OBZ**  
 Description: **Obstruction Other**

Distance (ft): **31.3**  
 Structural Grade: **0**  
 O&M Grade: **2**  
 Clock Start/From: **6**  
 Clock To: **8**  
 1st Value:  
 2nd Value:  
 Value Percent: **5.000**  
 Continuous Index:  
 Within 8" of Joint: **YES**  
 Remarks: **TP AND RAGS**

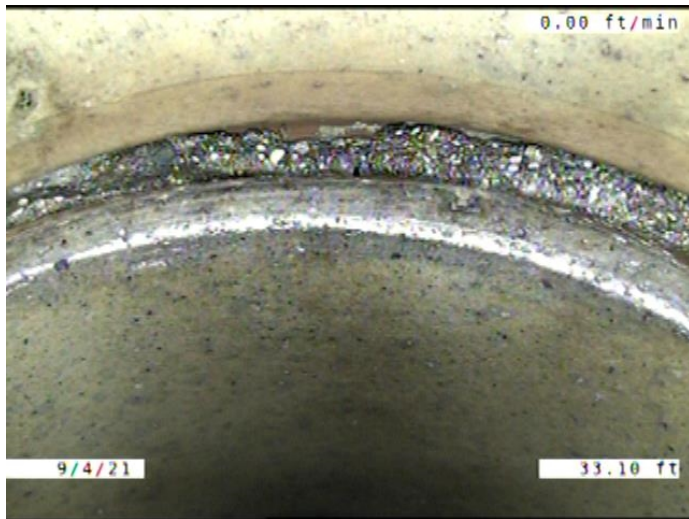
Code: **JOM**  
 Description: **Joint Offset Medium**

Distance (ft): **33.1**  
 Structural Grade: **3**  
 O&M Grade: **0**  
 Clock Start/From:  
 Clock To:  
 1st Value:  
 2nd Value:  
 Value Percent:  
 Continuous Index:  
 Within 8" of Joint: **NO**  
 Remarks:

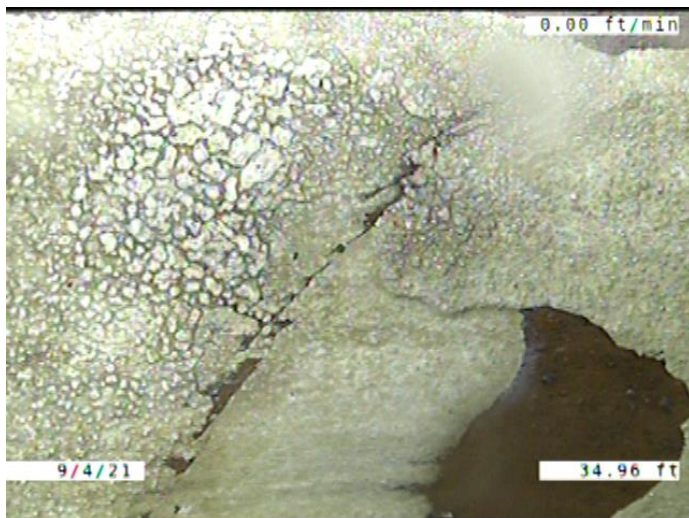
Code: **DAE**  
 Description: **Deposits Attached Encrustation**

Distance (ft): **35.0**  
 Structural Grade: **0**  
 O&M Grade: **2**  
 Clock Start/From: **9**  
 Clock To: **3**  
 1st Value:  
 2nd Value:  
 Value Percent: **5.000**  
 Continuous Index:  
 Within 8" of Joint: **YES**  
 Remarks:

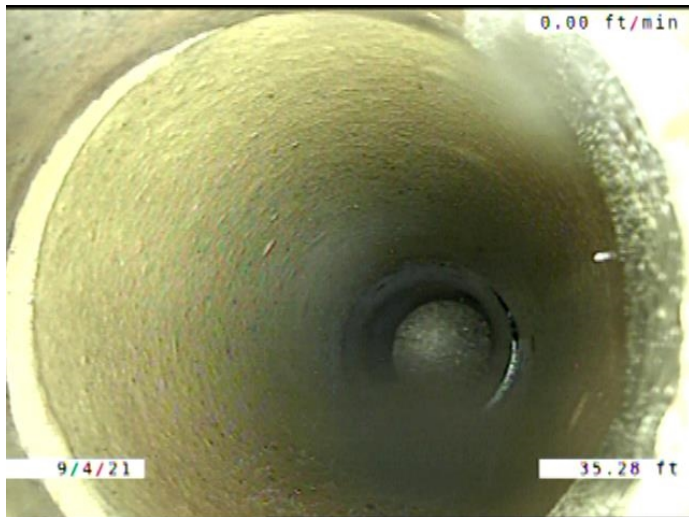
Code: **TBI**  
 Description: **Tap Break-in Intruding**

Distance (ft): **35.3**  
 Structural Grade: **0**  
 O&M Grade: **2**  
 Clock Start/From: **12**  
 Clock To:  
 1st Value: **6.000**  
 2nd Value: **2.000**

Value Percent:  
 Continuous Index:  
 Within 8" of Joint: **YES**  
 Remarks: **CONSTANTLY RUNNING WATER. LOOKS TO BE CAPPED**

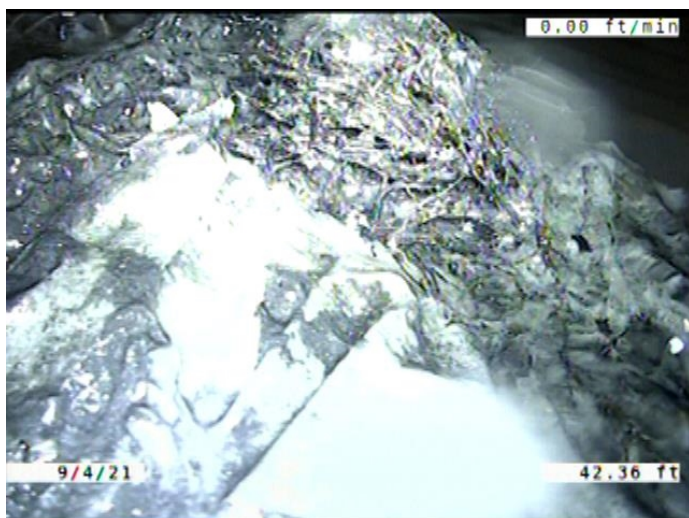
Code: **OBZ**  
 Description: **Obstruction Other**

Distance (ft): **42.4**  
 Structural Grade: **0**  
 O&M Grade: **2**  
 Clock Start/From: **5**  
 Clock To: **7**  
 1st Value:  
 2nd Value:  
 Value Percent: **5.000**

Continuous Index:  
 Within 8" of Joint: **YES**  
 Remarks: **ROOTS THAT FLOATED DOWN THE LINE**

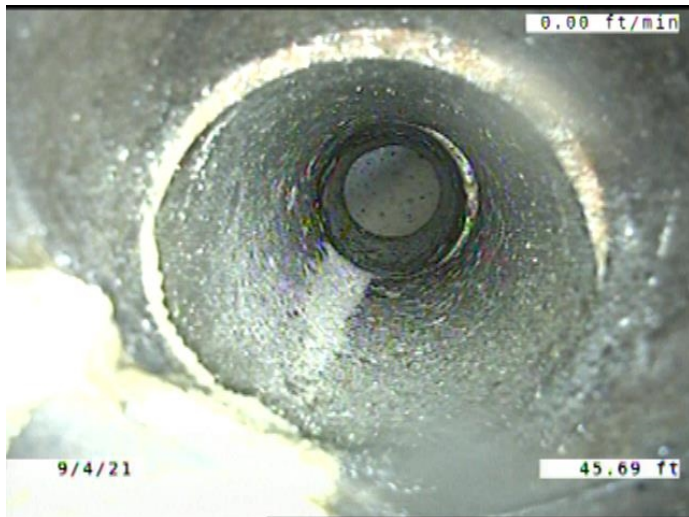
Code: **TFC**  
 Description: **Tap Factory Capped**

Distance (ft): **45.7**  
 Structural Grade: **0**  
 O&M Grade: **0**  
 Clock Start/From: **11**  
 Clock To:  
 1st Value: **6.000**  
 2nd Value:  
 Value Percent:  
 Continuous Index:  
 Within 8" of Joint: **YES**  
 Remarks:

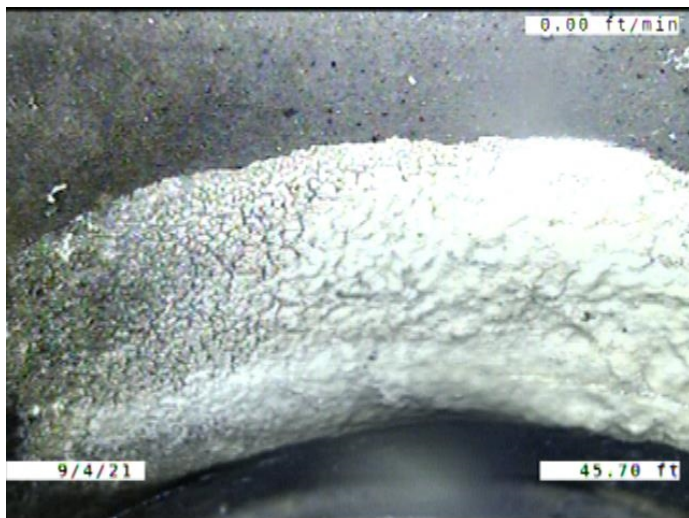
Code: **DAE**  
 Description: **Deposits Attached Encrustation**

Distance (ft): **45.7**  
 Structural Grade: **0**  
 O&M Grade: **2**  
 Clock Start/From: **8**  
 Clock To: **11**  
 1st Value:  
 2nd Value:  
 Value Percent: **5.000**  
 Continuous Index:  
 Within 8" of Joint: **YES**  
 Remarks:

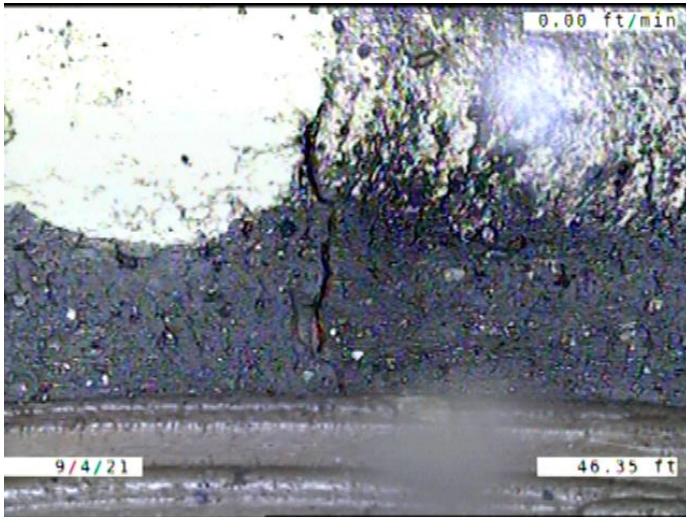
Code: **FM**  
Description: **Fracture Multiple**

Distance (ft): **46.4**  
Structural Grade: **4**  
O&M Grade: **0**  
Clock Start/From: **11**  
Clock To: **1**  
1st Value:  
2nd Value:  
Value Percent:  
Continuous Index:  
Within 8" of Joint: **YES**  
Remarks:

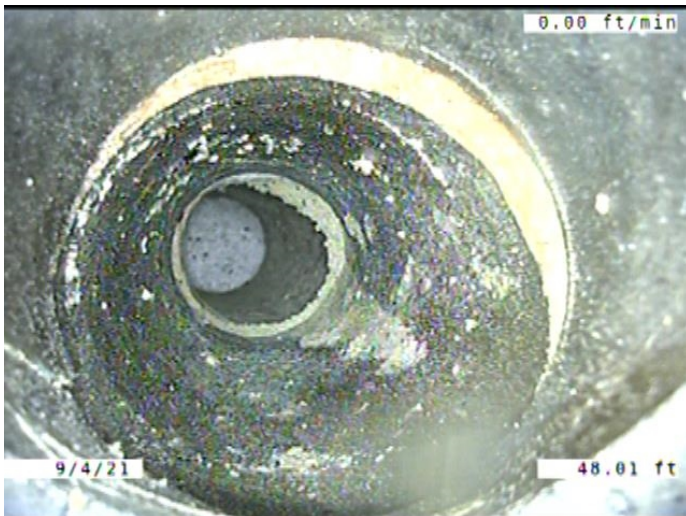
Code: **TFC**  
Description: **Tap Factory Capped**

Distance (ft): **48.0**  
Structural Grade: **0**  
O&M Grade: **0**  
Clock Start/From: **1**  
Clock To:  
1st Value: **6.000**  
2nd Value:  
Value Percent:  
Continuous Index:  
Within 8" of Joint: **YES**  
Remarks: **FIRST JOINT BACK OFFSET**

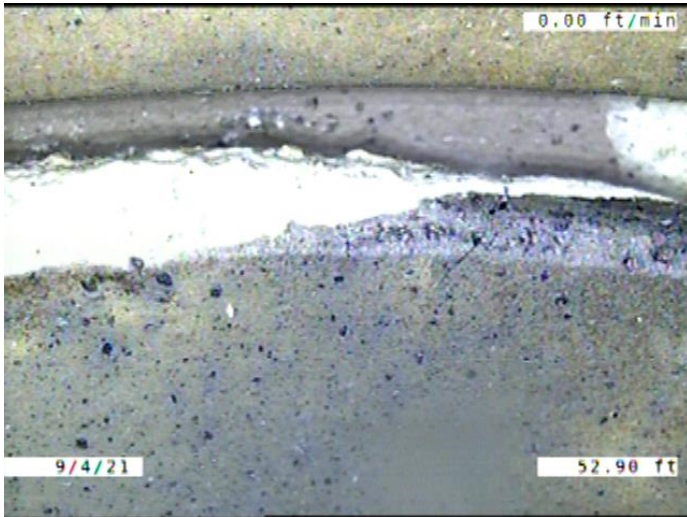
Code: **DAE**  
 Description: **Deposits Attached Encrustation**

Distance (ft): **52.9**  
 Structural Grade: **0**  
 O&M Grade: **2**  
 Clock Start/From: **8**  
 Clock To: **4**  
 1st Value:  
 2nd Value:  
 Value Percent: **5.000**  
 Continuous Index:  
 Within 8" of Joint: **YES**  
 Remarks:

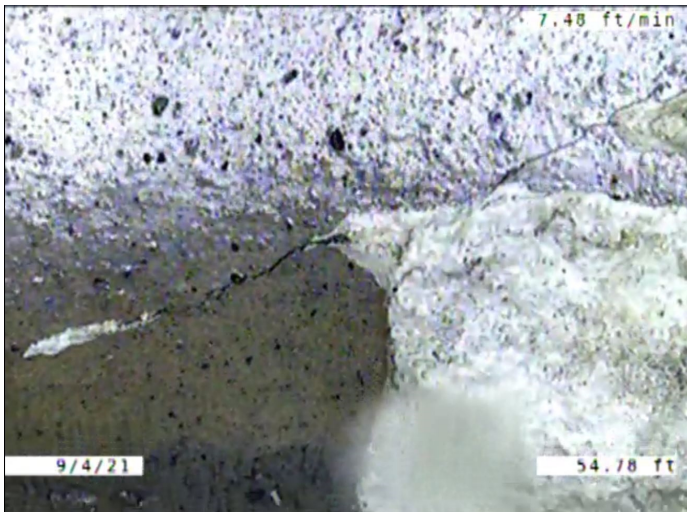
Code: **CC**  
 Description: **Crack Circumferential**

Distance (ft): **54.9**  
 Structural Grade: **1**  
 O&M Grade: **0**  
 Clock Start/From: **11**  
 Clock To: **1**  
 1st Value:  
 2nd Value:  
 Value Percent:  
 Continuous Index:  
 Within 8" of Joint: **YES**  
 Remarks:

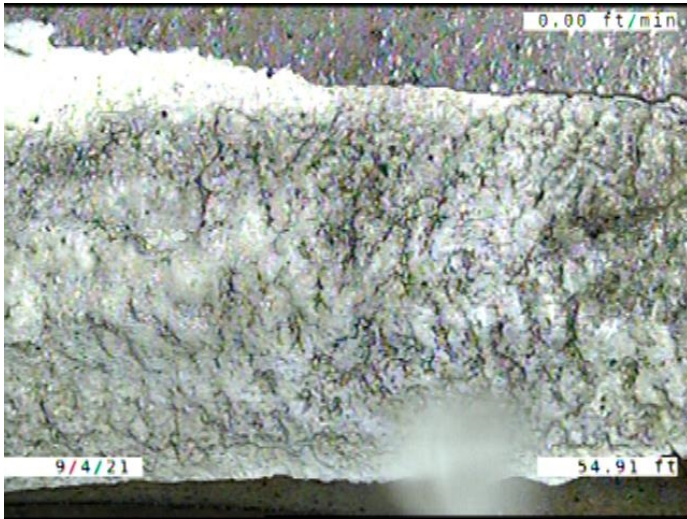
Code: **DAE**  
 Description: **Deposits Attached Encrustation**

Distance (ft): **54.9**  
 Structural Grade: **0**  
 O&M Grade: **2**  
 Clock Start/From: **10**  
 Clock To: **4**  
 1st Value:  
 2nd Value:  
 Value Percent: **5.000**  
 Continuous Index:  
 Within 8" of Joint: **YES**  
 Remarks:

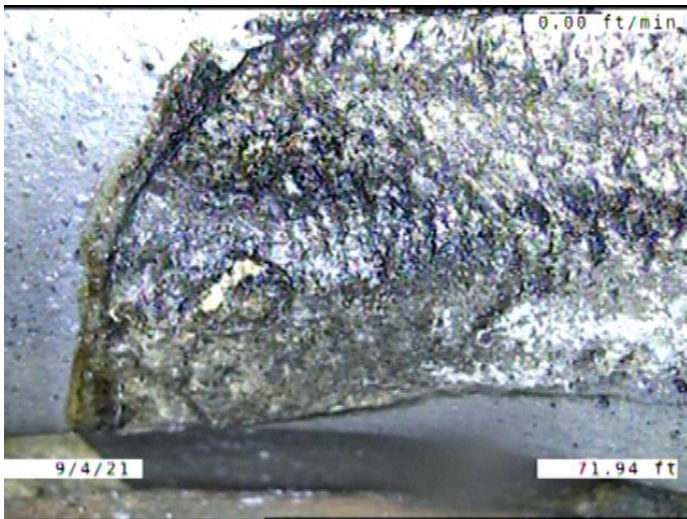
Code: **DAE**  
 Description: **Deposits Attached Encrustation**

Distance (ft): **71.9**  
 Structural Grade: **0**  
 O&M Grade: **2**  
 Clock Start/From: **2**  
 Clock To: **4**  
 1st Value:  
 2nd Value:  
 Value Percent: **5.000**  
 Continuous Index:  
 Within 8" of Joint: **YES**  
 Remarks:

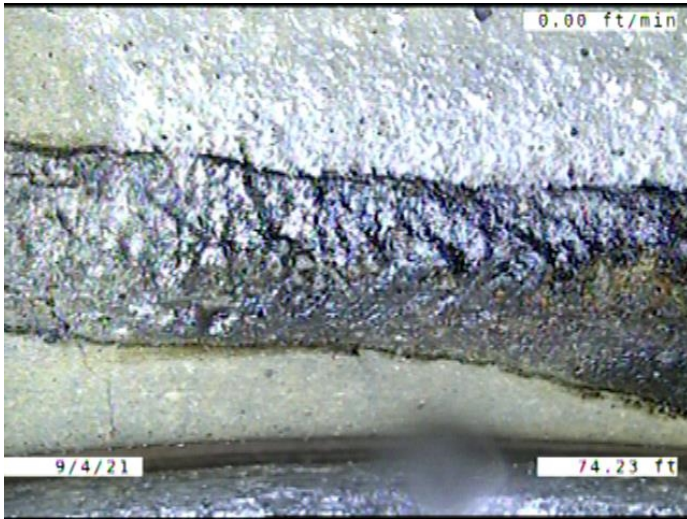
Code: **DAE**  
 Description: **Deposits Attached Encrustation**

Distance (ft): **74.2**  
 Structural Grade: **0**  
 O&M Grade: **2**  
 Clock Start/From: **9**  
 Clock To: **12**  
 1st Value:  
 2nd Value:  
 Value Percent: **5.000**  
 Continuous Index:  
 Within 8" of Joint: **YES**  
 Remarks:

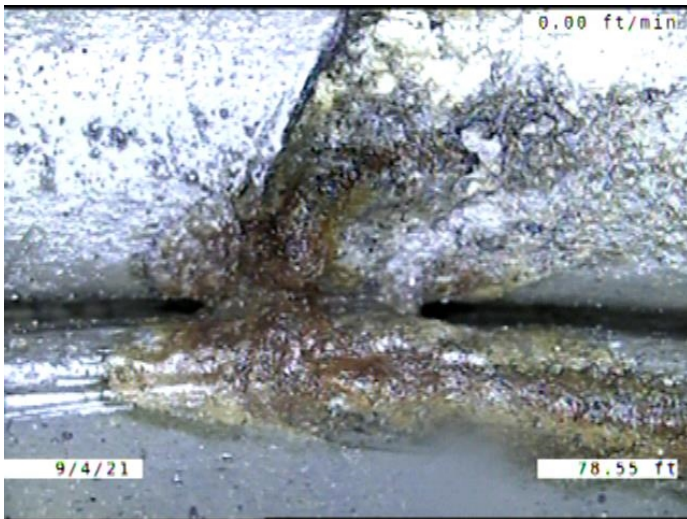
Code: **DAE**  
 Description: **Deposits Attached Encrustation**

Distance (ft): **78.5**  
 Structural Grade: **0**  
 O&M Grade: **2**  
 Clock Start/From: **12**  
 Clock To: **4**  
 1st Value:  
 2nd Value:  
 Value Percent: **5.000**  
 Continuous Index:  
 Within 8" of Joint: **YES**  
 Remarks:

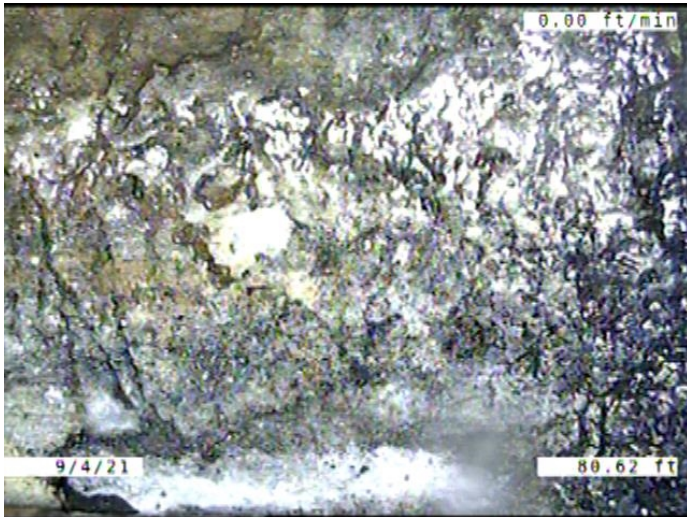
Code: **DAE**  
 Description: **Deposits Attached Encrustation**

Distance (ft): **80.6**  
 Structural Grade: **0**  
 O&M Grade: **2**  
 Clock Start/From: **12**  
 Clock To: **4**  
 1st Value:  
 2nd Value:  
 Value Percent: **5.000**  
 Continuous Index:  
 Within 8" of Joint: **YES**  
 Remarks:

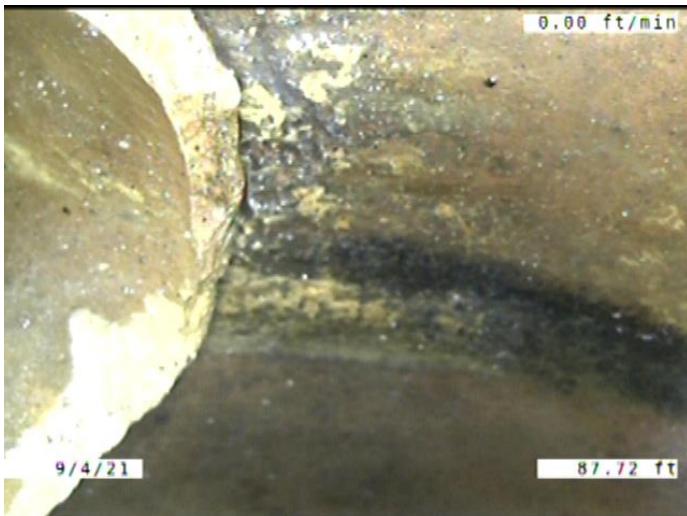
Code: **ISB**  
 Description: **Infiltration Stain Barrel**

Distance (ft): **87.7**  
 Structural Grade: **0**  
 O&M Grade: **1**  
 Clock Start/From: **2**  
 Clock To: **4**  
 1st Value:  
 2nd Value:  
 Value Percent:  
 Continuous Index:  
 Within 8" of Joint: **YES**  
 Remarks:

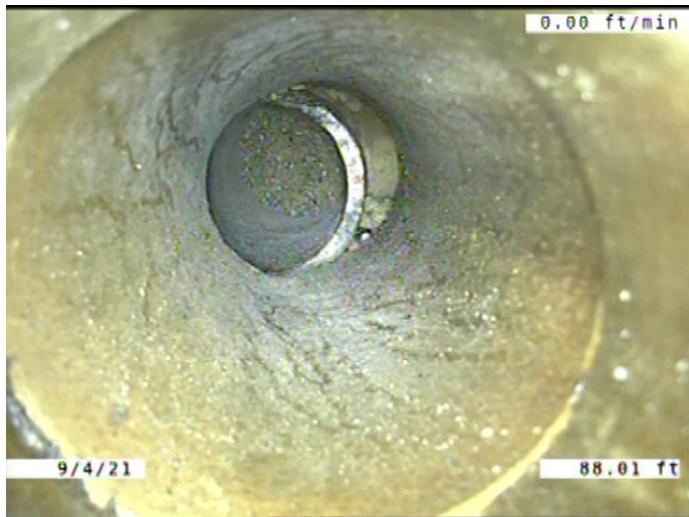
Code:	<b>TBI</b>
Description:	<b>Tap Break-in Intruding</b>
Distance (ft):	<b>88.0</b>
Structural Grade:	<b>0</b>
O&M Grade:	<b>2</b>
Clock Start/From:	<b>1</b>
Clock To:	
1st Value:	<b>6.000</b>
2nd Value:	<b>3.000</b>
Value Percent:	
Continuous Index:	
Within 8" of Joint:	<b>YES</b>
Remarks:	<b>SECOND JOINT BACK OFFSET. CONSTANTLY RUNNING WATER. LO</b>

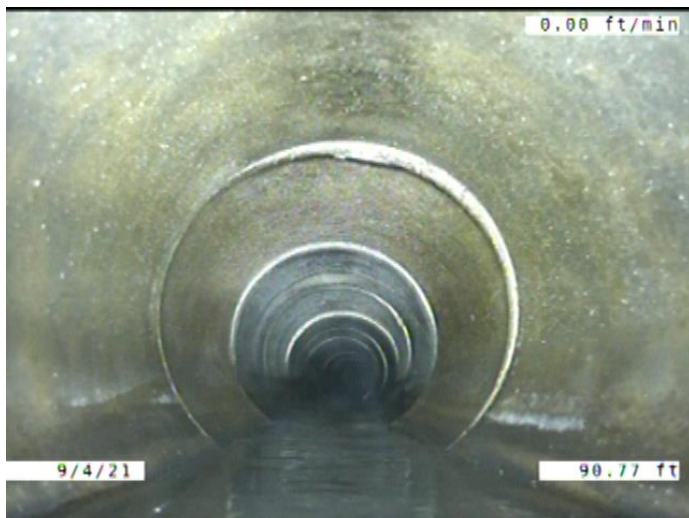
Code:	<b>DAE</b>
Description:	<b>Deposits Attached Encrustation</b>
Distance (ft):	<b>90.8</b>
Structural Grade:	<b>0</b>
O&M Grade:	<b>2</b>
Clock Start/From:	<b>2</b>
Clock To:	<b>9</b>
1st Value:	
2nd Value:	
Value Percent:	<b>5.000</b>
Continuous Index:	<b>F01</b>
Within 8" of Joint:	<b>YES</b>
Remarks:

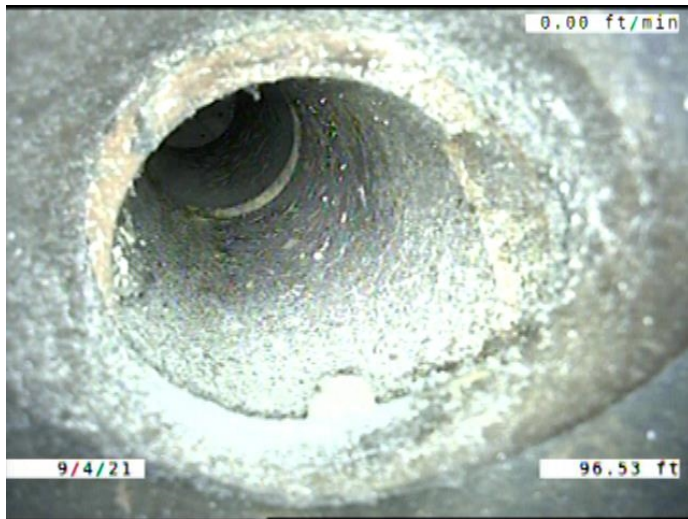
Code:	<b>TFC</b>
Description:	<b>Tap Factory Capped</b>
Distance (ft):	<b>96.5</b>
Structural Grade:	<b>0</b>
O&M Grade:	<b>0</b>
Clock Start/From:	<b>12</b>
Clock To:	
1st Value:	<b>6.000</b>
2nd Value:	
Value Percent:	
Continuous Index:	
Within 8" of Joint:	<b>YES</b>
Remarks:	<b>FIRST JOINT BACK OFFSET. LOOKS TO BE CAPPED</b>

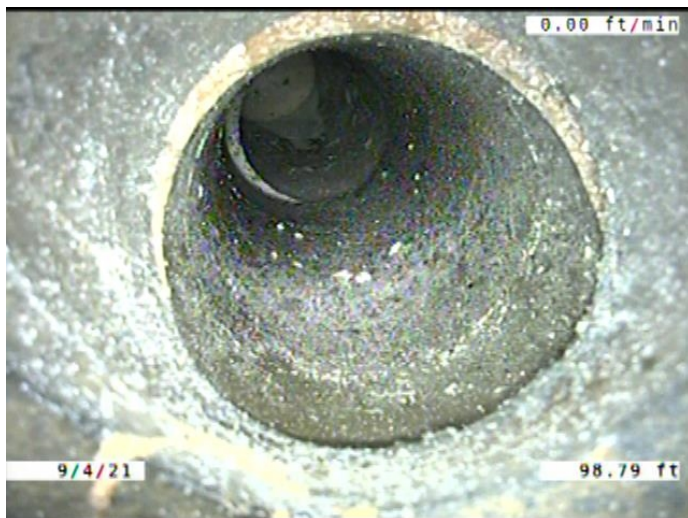
Code:	<b>TFD</b>
Description:	<b>Tap Factory Defective</b>
Distance (ft):	<b>98.8</b>
Structural Grade:	<b>0</b>
O&M Grade:	<b>3</b>
Clock Start/From:	<b>1</b>
Clock To:	
1st Value:	<b>6.000</b>
2nd Value:	
Value Percent:	
Continuous Index:	
Within 8" of Joint:	<b>YES</b>
Remarks:	<b>FIRST JOINT BACK OFFSET. LOOKS TO BE CAPPED</b>

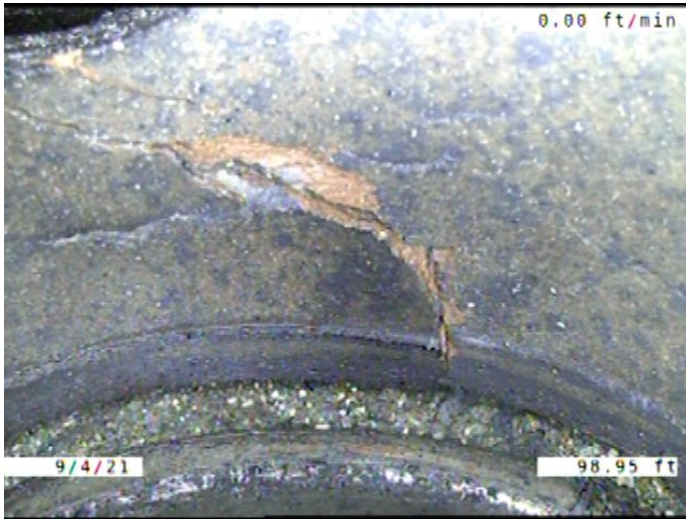
Code: **B**  
 Description: **Broken**

Distance (ft): **98.9**  
 Structural Grade: **4**  
 O&M Grade: **0**  
 Clock Start/From: **12**  
 Clock To: **1**  
 1st Value:  
 2nd Value:  
 Value Percent:  
 Continuous Index:  
 Within 8" of Joint: **YES**  
 Remarks:

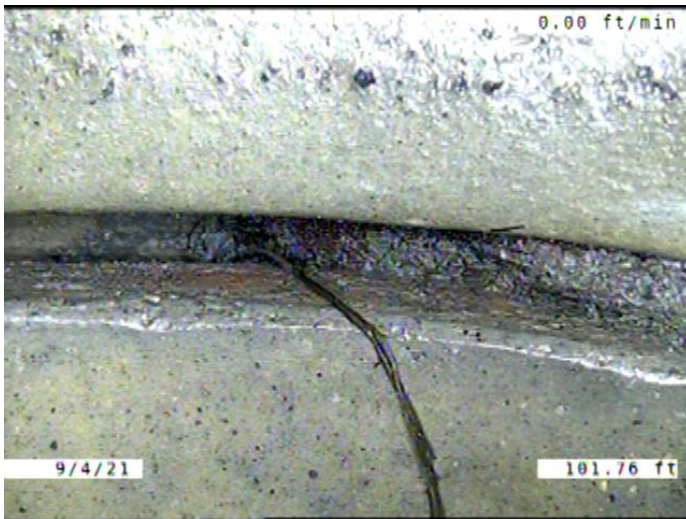
Code: **RFJ**  
 Description: **Roots Fine Joint**

Distance (ft): **101.8**  
 Structural Grade: **0**  
 O&M Grade: **1**  
 Clock Start/From: **3**  
 Clock To:  
 1st Value:  
 2nd Value:  
 Value Percent:  
 Continuous Index:  
 Within 8" of Joint: **YES**  
 Remarks:

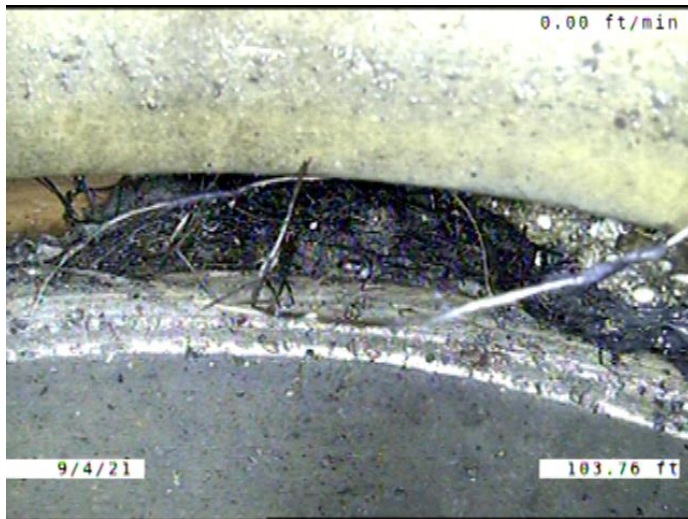
Code: **RFJ**  
 Description: **Roots Fine Joint**

Distance (ft): **103.8**  
 Structural Grade: **0**  
 O&M Grade: **1**  
 Clock Start/From: **2**  
 Clock To: **3**  
 1st Value:  
 2nd Value:  
 Value Percent:  
 Continuous Index:  
 Within 8" of Joint: **YES**  
 Remarks:

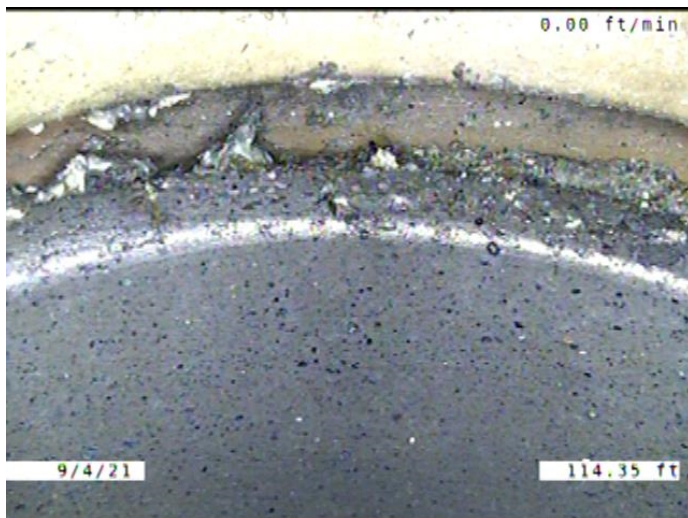
Code: **JOM**  
 Description: **Joint Offset Medium**

Distance (ft): **114.3**  
 Structural Grade: **3**  
 O&M Grade: **0**  
 Clock Start/From:  
 Clock To:  
 1st Value:  
 2nd Value:  
 Value Percent:  
 Continuous Index:  
 Within 8" of Joint: **NO**  
 Remarks:

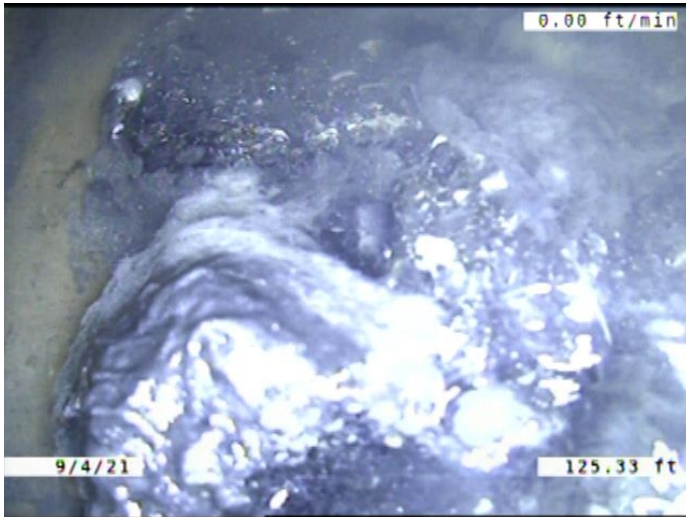
Code: **DAE**  
 Description: **Deposits Attached Encrustation**

Distance (ft): **125.3**  
 Structural Grade: **0**  
 O&M Grade: **2**  
 Clock Start/From: **7**  
 Clock To: **8**  
 1st Value:  
 2nd Value:  
 Value Percent: **5.000**  
 Continuous Index:  
 Within 8" of Joint: **YES**  
 Remarks:

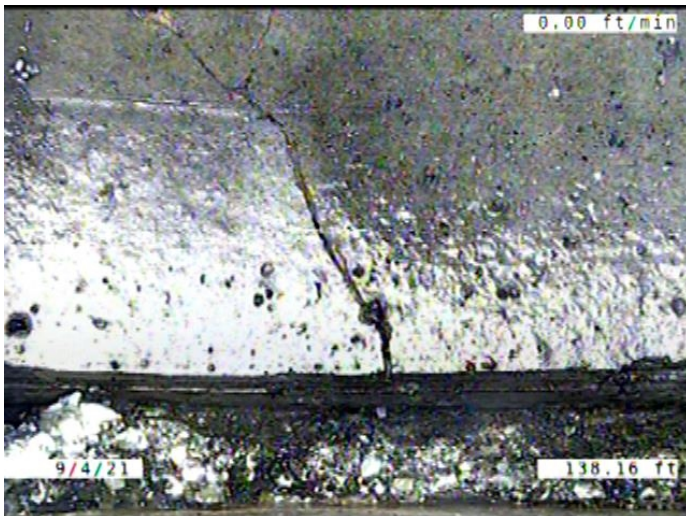
Code: **CM**  
 Description: **Crack Multiple**

Distance (ft): **138.2**  
 Structural Grade: **3**  
 O&M Grade: **0**  
 Clock Start/From: **4**  
 Clock To: **5**  
 1st Value:  
 2nd Value:  
 Value Percent:  
 Continuous Index:  
 Within 8" of Joint: **YES**  
 Remarks:

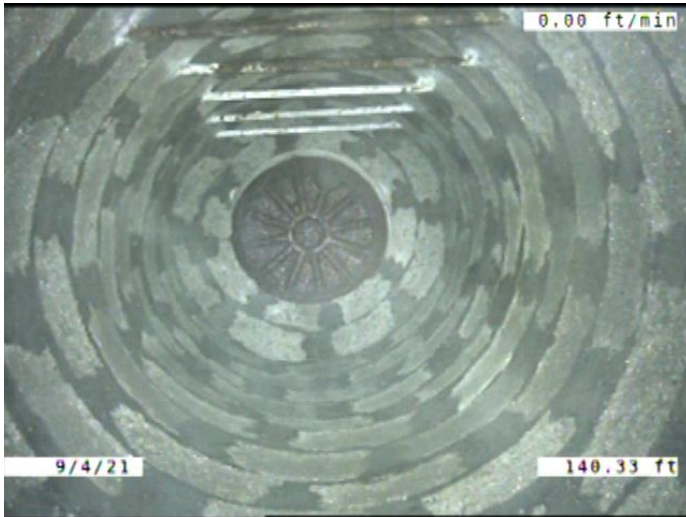
Code:	<b>AMH</b>
Description:	<b>Manhole</b>
Distance (ft):	<b>140.3</b>
Structural Grade:	<b>0</b>
O&M Grade:	<b>0</b>
Clock Start/From:	
Clock To:	
1st Value:	
2nd Value:	
Value Percent:	
Continuous Index:	
Within 8" of Joint:	<b>NO</b>
Remarks:	<b>M-504-079</b>
