Profile/Photo Observation Report

Date:	04/18/2018	Weather:		Coding:	PACP 6.0
Pipe Length (ft):	193.6	Owner:	NA	Pre Clean:	Not Known
P.O.#:		Surveyor:	Byrd Fitzgerald	PSR:	P-504-087-086
Customer:		Clean Date:	01/01/1900	Shape:	C

Street:	Summerlin	Flow Control:	Not Controlled
City:	Hobart, IN	Year Renewed:	
Location:	Light Highway	Tape/Media #:	
Purpose:	Not Known	Dia/Height:	12"
Use:	Sanitary	Material:	PVC
Drain Area:	NA	Lining:	
Category:	NA		
Comment:

Location Details:		Direction of Survey:	Downstream
US MH:	M-504-086	DS MH:	M-504-087
		Total Length Surveyed (ft):	192.4

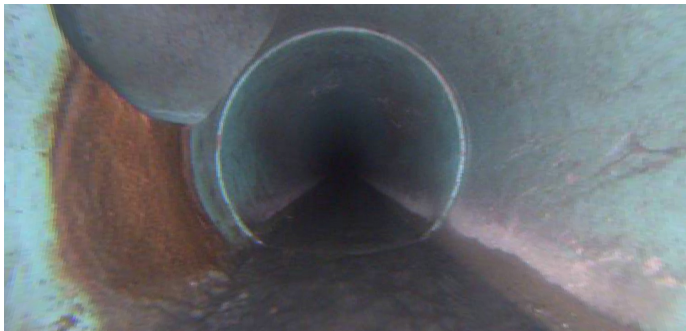
Code: **AMH**
Description: **Manhole**

Distance (ft): **.0**
Structural Grade: **0**
O&M Grade: **0**
Clock Start/From:
Clock To:
1st Value:
2nd Value:
Value Percent:
Continuous Index:
Within 8" of Joint: **NO**
Remarks: **M-504-086**

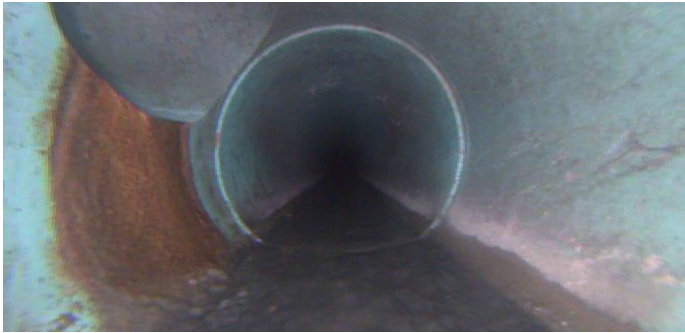
Code:	MWL
Description:	Water Level

Distance (ft):	.0
Structural Grade:	0
O&M Grade:	0
Clock Start/From:	
Clock To:	
1st Value:	
2nd Value:	
Value Percent:	5.000
Continuous Index:	
Within 8" of Joint:	NO
Remarks:

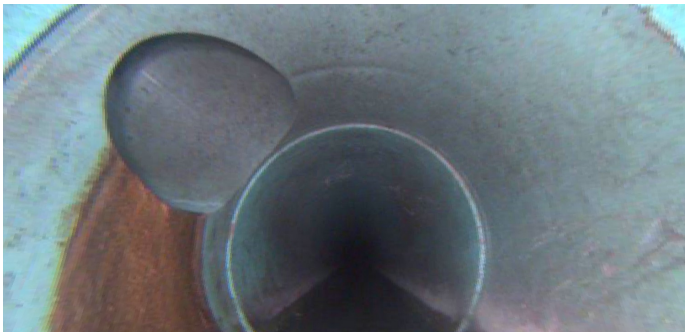
Code:	TF
Description:	Tap Factory

Distance (ft):	.0
Structural Grade:	0
O&M Grade:	0
Clock Start/From:	11
Clock To:	
1st Value:	4.000
2nd Value:	
Value Percent:	
Continuous Index:	
Within 8" of Joint:	YES
Remarks:

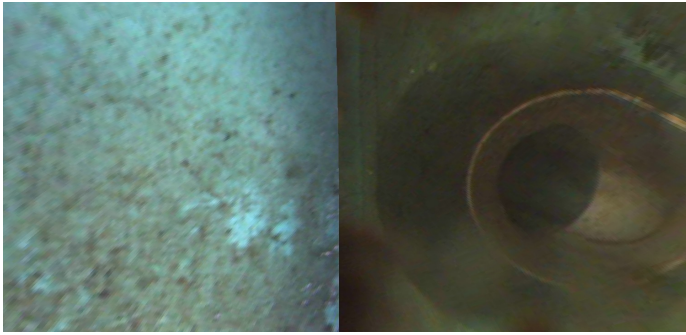
Code: **TF**
Description: **Tap Factory**

Distance (ft): **12.0**
Structural Grade: **0**
O&M Grade: **0**
Clock Start/From: **2**
Clock To:
1st Value: **4.000**
2nd Value:
Value Percent:
Continuous Index:
Within 8" of Joint: **YES**
Remarks:

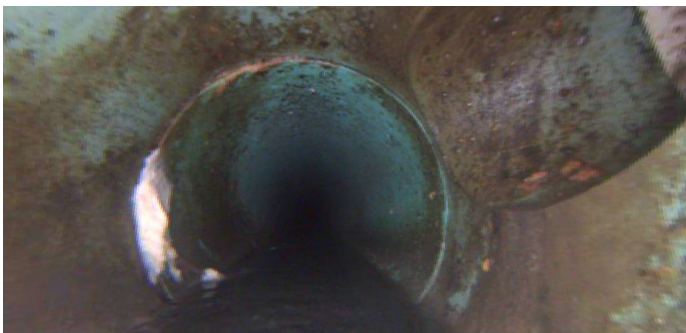
Code: **DAZ**
Description: **Deposits Attached Other**

Distance (ft): **40.5**
Structural Grade: **0**
O&M Grade: **2**
Clock Start/From: **9**
Clock To:
1st Value:
2nd Value:
Value Percent: **5.000**
Continuous Index:
Within 8" of Joint: **NO**
Remarks: **tissue**

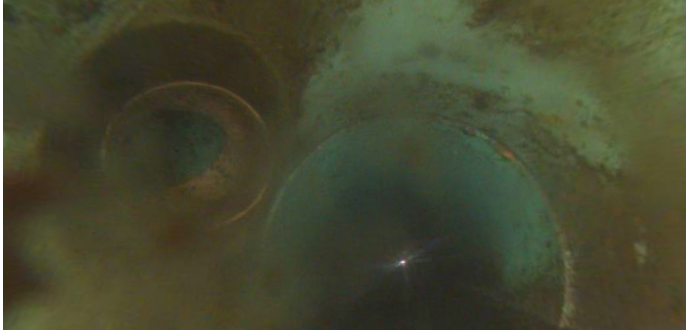
Code: **TF**
Description: **Tap Factory**

Distance (ft): **41.6**
Structural Grade: **0**
O&M Grade: **0**
Clock Start/From: **2**
Clock To:
1st Value: **4.000**
2nd Value:
Value Percent:
Continuous Index:
Within 8" of Joint:
Remarks:

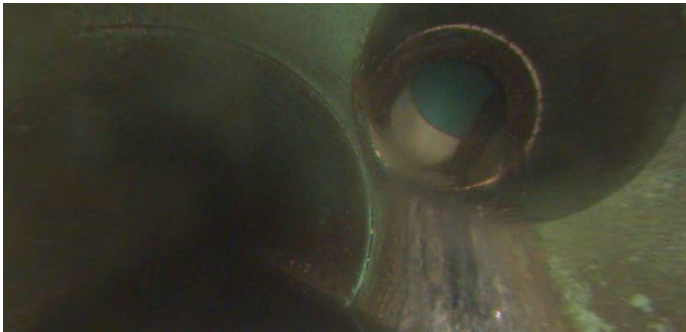
Code: **TFA**
Description: **Tap Factory Active**

Distance (ft): **117.1**
Structural Grade: **0**
O&M Grade: **0**
Clock Start/From: **10**
Clock To:
1st Value: **4.000**
2nd Value:
Value Percent:
Continuous Index:
Within 8" of Joint:
Remarks:

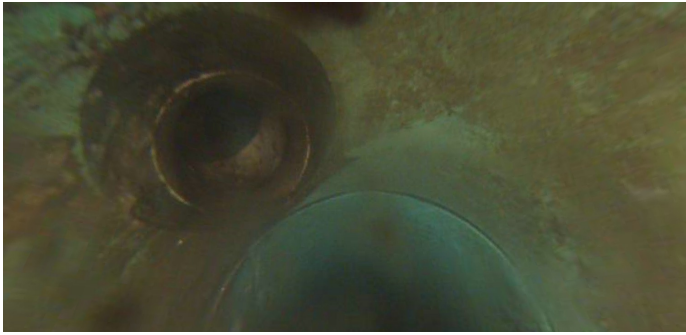
Code: **TF**
Description: **Tap Factory**

Distance (ft): **124.1**
Structural Grade: **0**
O&M Grade: **0**
Clock Start/From: **1**
Clock To:
1st Value: **4.000**
2nd Value:
Value Percent:
Continuous Index:
Within 8" of Joint:
Remarks:

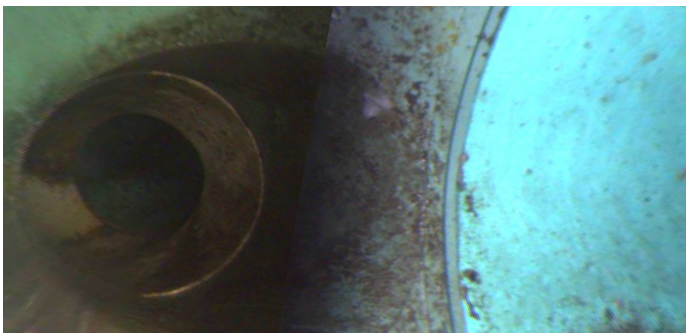
Code: **TF**
Description: **Tap Factory**

Distance (ft): **166.8**
Structural Grade: **0**
O&M Grade: **0**
Clock Start/From: **10**
Clock To:
1st Value: **4.000**
2nd Value:
Value Percent:
Continuous Index:
Within 8" of Joint: **YES**
Remarks:

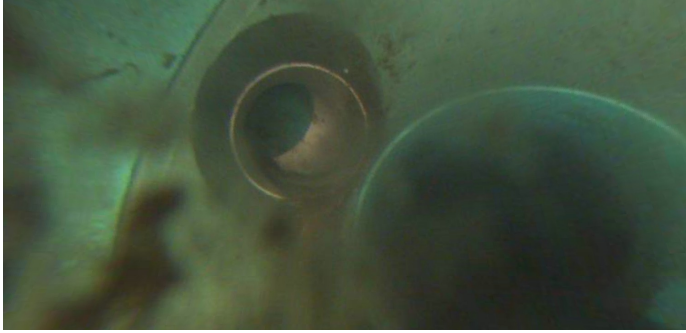
Code: **TF**
Description: **Tap Factory**

Distance (ft): **180.7**
Structural Grade: **0**
O&M Grade: **0**
Clock Start/From: **2**
Clock To:
1st Value: **4.000**
2nd Value:
Value Percent:
Continuous Index:
Within 8" of Joint:
Remarks:

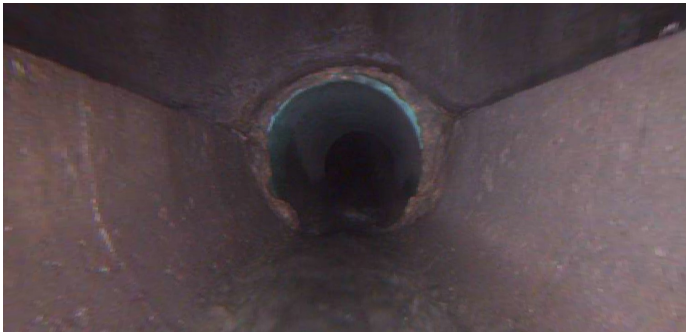
Code: **AMH**
Description: **Manhole**

Distance (ft): **192.4**
Structural Grade: **0**
O&M Grade: **0**
Clock Start/From:
Clock To:
1st Value:
2nd Value:
Value Percent:
Continuous Index:
Within 8" of Joint: **NO**
Remarks: **M-504-087**
