Profile/Photo Observation Report

Date:	09/12/2021	Weather:		Coding:	PACP 7.0
Pipe Length (ft):	191.0	Owner:	City of Hobart	Pre Clean:	Heavy Cleaning
P.O.#:	YES502259	Surveyor:	S. Bucklin	PSR:	P-504-130-087
Customer:	City of Hobart	Clean Date:	08/29/2021	Shape:	C

Street:	West 42nd Avenue	Flow Control:	Not Controlled
City:	Hobart, IN	Year Renewed:	
Location:	Alley	Tape/Media #:	
Purpose:	Routine Assessment	Dia/Height:	12"
Use:	Sanitary Sewage Pipe	Material:	VCP
Drain Area:		Lining:	None
Category:	NA		
Comment:

Location Details:		Direction of Survey:	Downstream
US MH:	M-504-087	DS MH:	M-504-130
		Total Length Surveyed (ft):	11.7

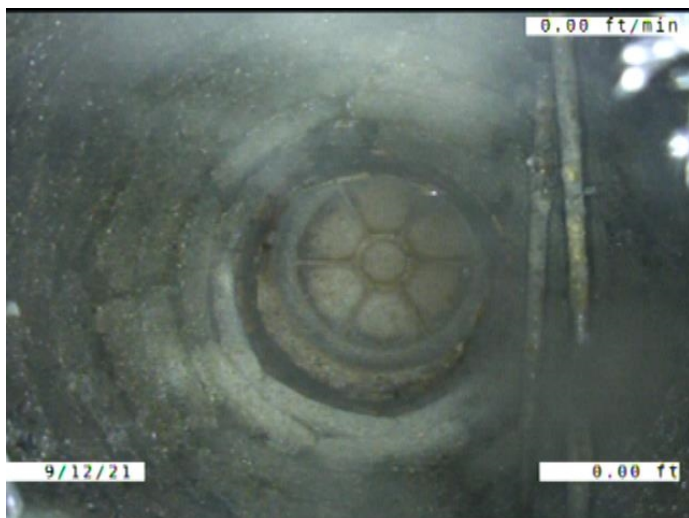
Code: **AMH**
 Description: **Manhole**

Distance (ft): **.0**
 Structural Grade: **0**
 O&M Grade: **0**
 Clock Start/From:
 Clock To:
 1st Value:
 2nd Value:
 Value Percent:
 Continuous Index:
 Within 8" of Joint: **NO**
 Remarks: **M-504-087**

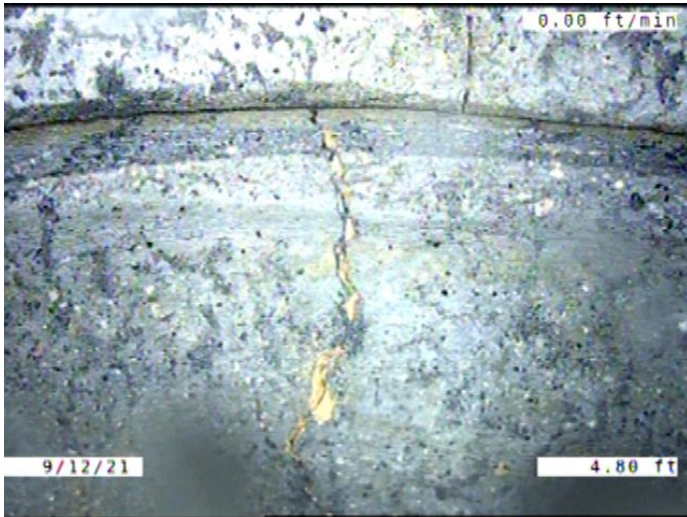
Code: **FM**
Description: **Fracture Multiple**

Distance (ft): **4.8**
Structural Grade: **4**
O&M Grade: **0**
Clock Start/From: **11**
Clock To: **1**
1st Value:
2nd Value:
Value Percent:
Continuous Index: **S02**
Within 8" of Joint: **YES**
Remarks:

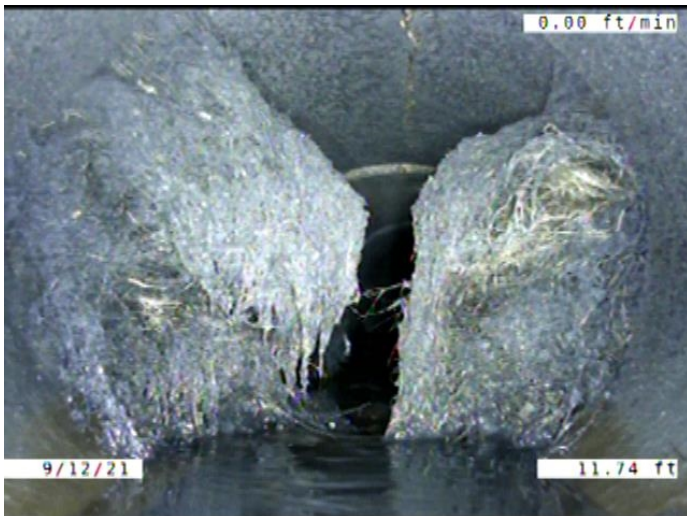
Code: **RMJ**
Description: **Roots Medium Joint**

Distance (ft): **11.7**
Structural Grade: **0**
O&M Grade: **3**
Clock Start/From: **9**
Clock To: **3**
1st Value:
2nd Value:
Value Percent: **25.000**
Continuous Index: **F01**
Within 8" of Joint: **YES**
Remarks:

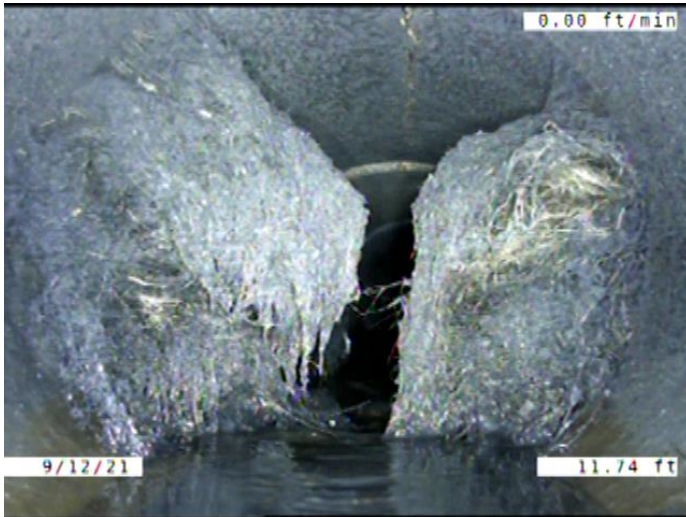
Code: **FM**
 Description: **Fracture Multiple**

Distance (ft): **11.7**
 Structural Grade: **4**
 O&M Grade: **0**
 Clock Start/From: **11**
 Clock To: **1**
 1st Value:
 2nd Value:
 Value Percent:
 Continuous Index: **F02**
 Within 8" of Joint: **YES**
 Remarks:

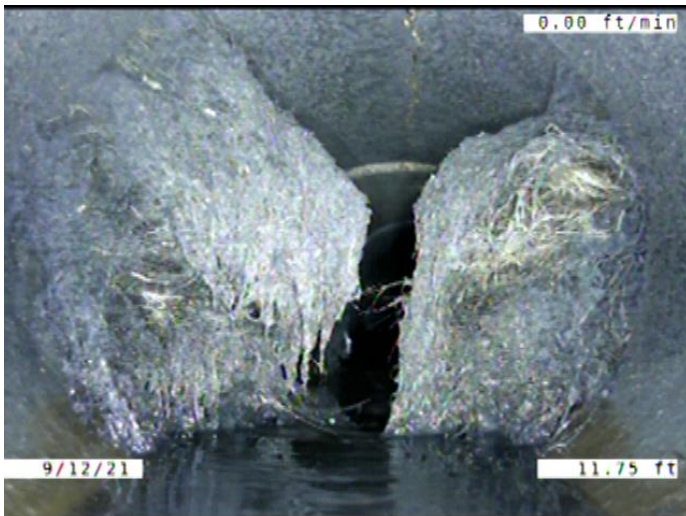
Code: **MSA**
 Description: **Miscellaneous Survey Abandoned**

Distance (ft): **11.7**
 Structural Grade: **0**
 O&M Grade: **0**
 Clock Start/From:
 Clock To:
 1st Value:
 2nd Value:
 Value Percent:
 Continuous Index:
 Within 8" of Joint: **NO**
 Remarks: **CAMERA CANT MAKE IT PAST ROOTS**
