## Profile/Photo Observation Report

Date:	<b>09/12/2021</b>	Weather:		Coding:	<b>PACP 7.0</b>
Pipe Length (ft):	<b>191.0</b>	Owner:	<b>City of Hobart</b>	Pre Clean:	<b>Heavy Cleaning</b>
P.O.#:	<b>YES502259</b>	Surveyor:	<b>S. Bucklin</b>	PSR:	<b>P-504-130-087</b>
Customer:	<b>City of Hobart</b>	Clean Date:	<b>08/29/2021</b>	Shape:	<b>C</b>

Street:	<b>West 42nd Avenue</b>	Flow Control:	<b>Not Controlled</b>
City:	<b>Hobart, IN</b>	Year Renewed:	
Location:	<b>Alley</b>	Tape/Media #:	
Purpose:	<b>Routine Assessment</b>	Dia/Height:	<b>12"</b>
Use:	<b>Sanitary Sewage Pipe</b>	Material:	<b>VCP</b>
Drain Area:		Lining:	<b>None</b>
Category:	<b>NA</b>

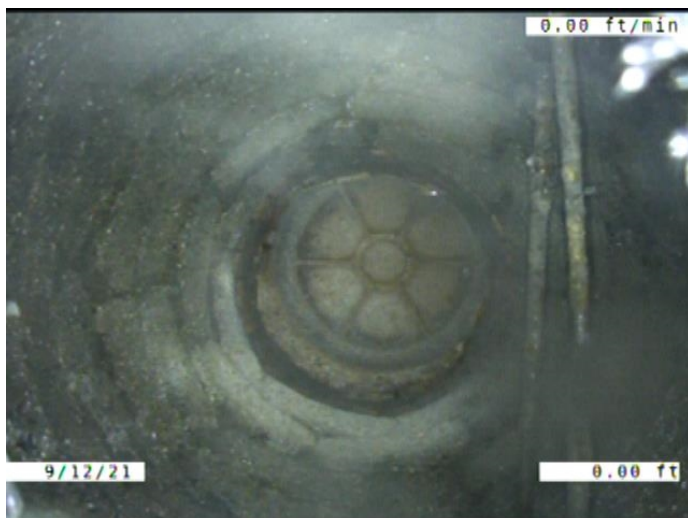
Code: **AMH**  
 Description: **Manhole**

Distance (ft): **.0**  
 Structural Grade: **0**  
 O&M Grade: **0**  
 Clock Start/From:  
 Clock To:  
 1st Value:  
 2nd Value:  
 Value Percent:  
 Continuous Index:  
 Within 8" of Joint: **NO**  
 Remarks: **M-504-087**

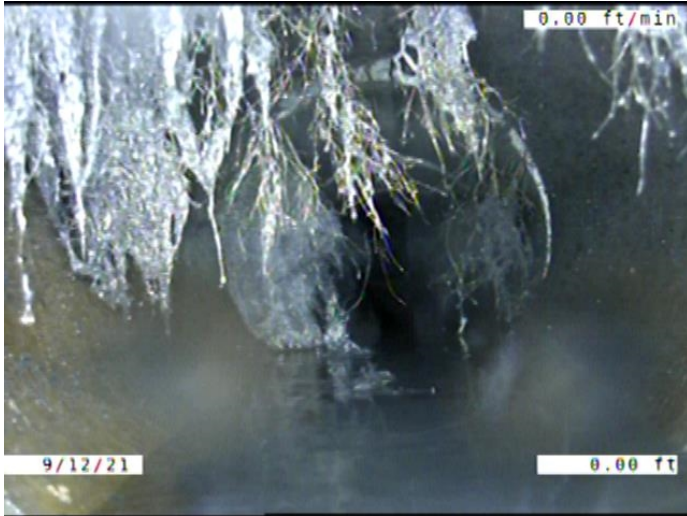
Code: **MWL**  
Description: **Miscellaneous Water Level**

Distance (ft): **.0**  
Structural Grade: **0**  
O&M Grade: **0**  
Clock Start/From:  
Clock To:  
1st Value:  
2nd Value:  
Value Percent: **5.000**  
Continuous Index:  
Within 8" of Joint: **NO**  
Remarks:

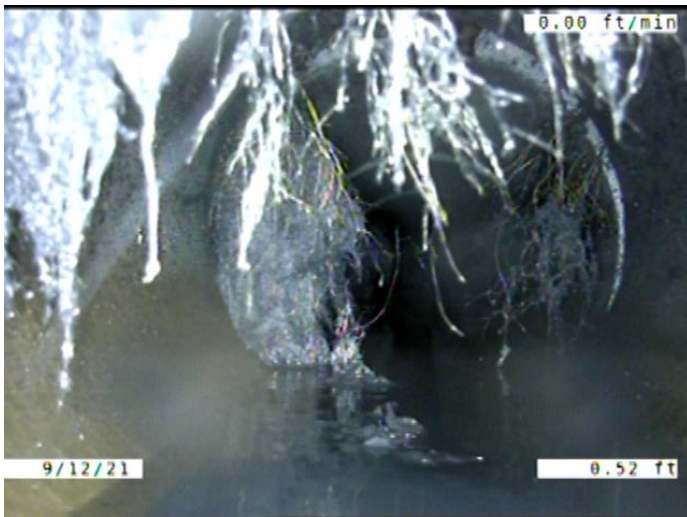
Code: **RMJ**  
Description: **Roots Medium Joint**

Distance (ft): **.5**  
Structural Grade: **0**  
O&M Grade: **3**  
Clock Start/From: **9**  
Clock To: **3**  
1st Value:  
2nd Value:  
Value Percent: **25.000**  
Continuous Index: **S01**  
Within 8" of Joint: **YES**  
Remarks:

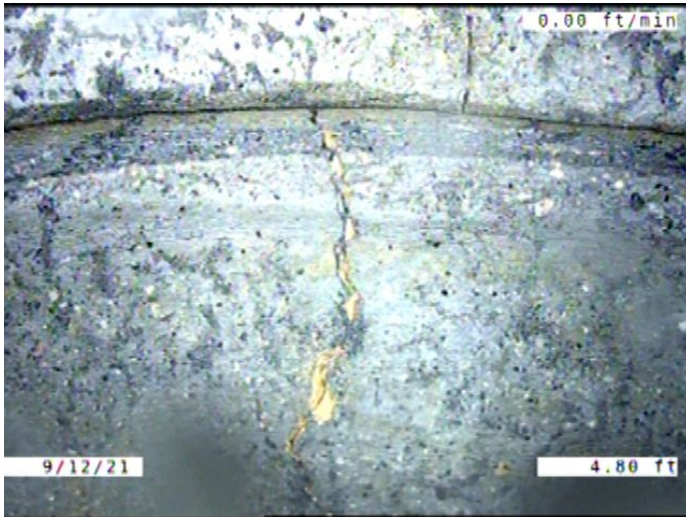
Code: **FM**  
 Description: **Fracture Multiple**

Distance (ft): **4.8**  
 Structural Grade: **4**  
 O&M Grade: **0**  
 Clock Start/From: **11**  
 Clock To: **1**  
 1st Value:  
 2nd Value:  
 Value Percent:  
 Continuous Index: **S02**  
 Within 8" of Joint: **YES**  
 Remarks:

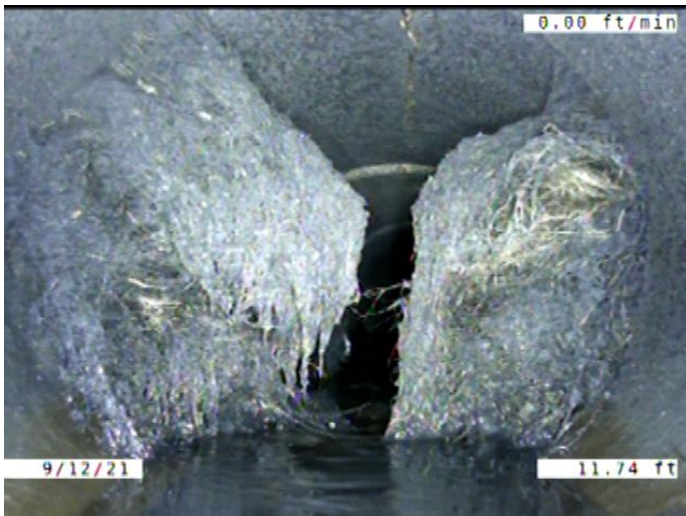
Code: **RMJ**  
 Description: **Roots Medium Joint**

Distance (ft): **11.7**  
 Structural Grade: **0**  
 O&M Grade: **3**  
 Clock Start/From: **9**  
 Clock To: **3**  
 1st Value:  
 2nd Value:  
 Value Percent: **25.000**  
 Continuous Index: **F01**  
 Within 8" of Joint: **YES**  
 Remarks:

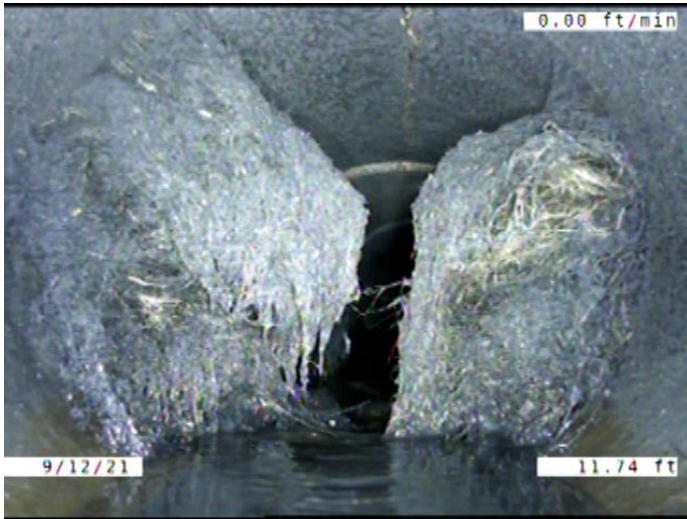
Code: **FM**  
 Description: **Fracture Multiple**

Distance (ft): **11.7**  
 Structural Grade: **4**  
 O&M Grade: **0**  
 Clock Start/From: **11**  
 Clock To: **1**  
 1st Value:  
 2nd Value:  
 Value Percent:  
 Continuous Index: **F02**  
 Within 8" of Joint: **YES**  
 Remarks:

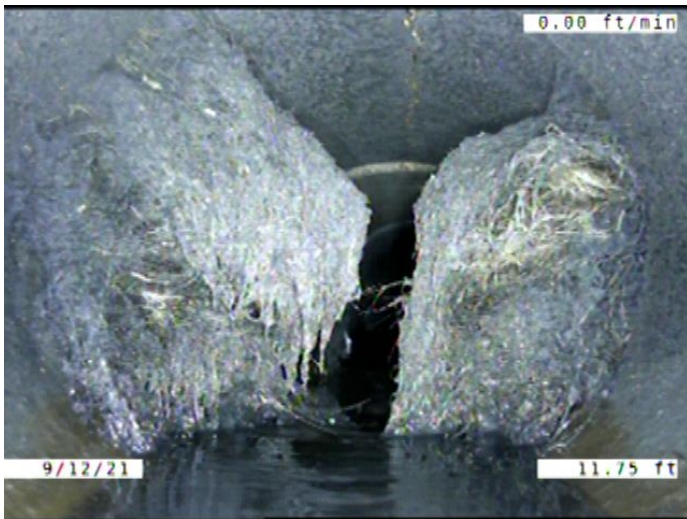
Code: **MSA**  
 Description: **Miscellaneous Survey Abandoned**

Distance (ft): **11.7**  
 Structural Grade: **0**  
 O&M Grade: **0**  
 Clock Start/From:  
 Clock To:  
 1st Value:  
 2nd Value:  
 Value Percent:  
 Continuous Index:  
 Within 8" of Joint: **NO**  
 Remarks: **CAMERA CANT MAKE IT PAST ROOTS**
