Profile/Photo Observation Report

Date:	10/22/2021	Weather:		Coding:	PACP 7.0
Pipe Length (ft):	191.0	Owner:	City of Hobart	Pre Clean:	Heavy Cleaning
P.O.#:	YES502259	Surveyor:	S. Bucklin	PSR:	P-504-130-087
Customer:	City of Hobart	Clean Date:	08/29/2021	Shape:	C

Street:	West 42nd Avenue	Flow Control:	Not Controlled
City:	Hobart, IN	Year Renewed:	
Location:	Alley	Tape/Media #:	
Purpose:	Routine Assessment	Dia/Height:	12"
Use:	Sanitary Sewage Pipe	Material:	VCP
Drain Area:		Lining:	None
Category:	NA		
Comment:			
Location Details:		Direction of Survey:	Upstream
US MH:	M-504-087	DS MH:	M-504-130
		Total Length Surveyed (ft):	147.3

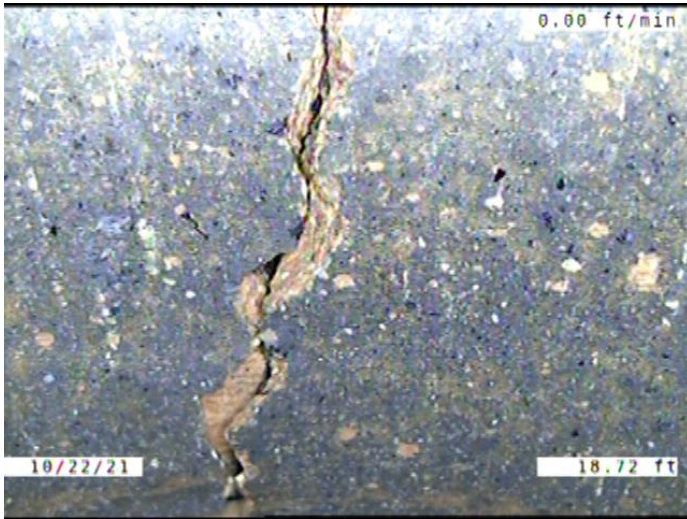
Code: **DR**
 Description: **Deformed Rigid**

Distance (ft): **18.7**
 Structural Grade: **4**
 O&M Grade: **0**
 Clock Start/From:
 Clock To:
 1st Value:
 2nd Value:
 Value Percent: **5.000**
 Continuous Index: **S02**
 Within 8" of Joint: **NO**
 Remarks:

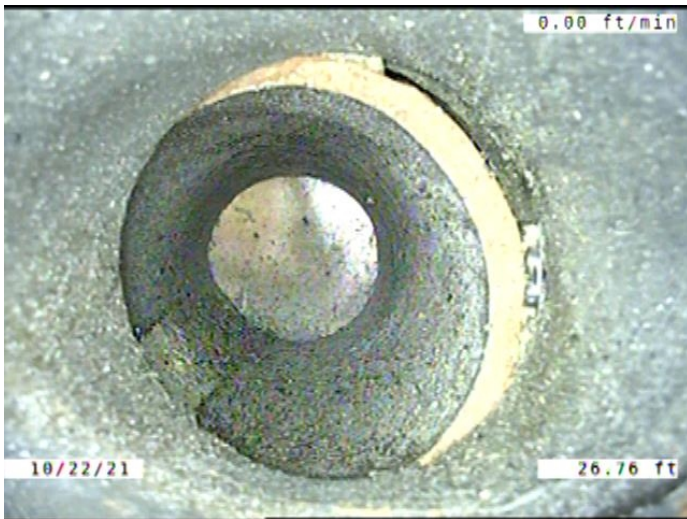
Code: **TFD**
 Description: **Tap Factory Defective**

Distance (ft): **26.8**
 Structural Grade: **0**
 O&M Grade: **3**
 Clock Start/From: **11**
 Clock To:
 1st Value: **4.000**
 2nd Value:
 Value Percent:
 Continuous Index:
 Within 8" of Joint: **YES**
 Remarks: **CAPPED. LARGE OFFSET FIRST JOINT BACK. SOIL VISIBLE**

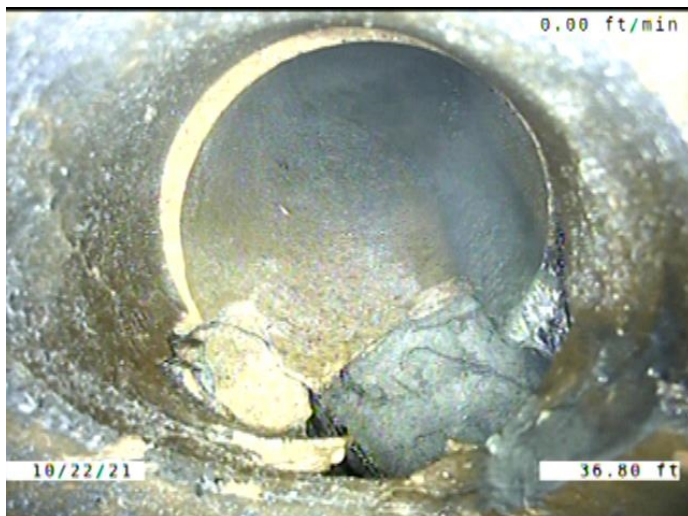
Code: **TFD**
 Description: **Tap Factory Defective**

Distance (ft): **36.8**
 Structural Grade: **0**
 O&M Grade: **3**
 Clock Start/From: **1**
 Clock To:
 1st Value: **4.000**
 2nd Value:
 Value Percent:
 Continuous Index:
 Within 8" of Joint: **YES**
 Remarks: **TAP BROKEN. SOIL VISIBLE. WATER RUNNING OUTSIDE OF THE MAIN**

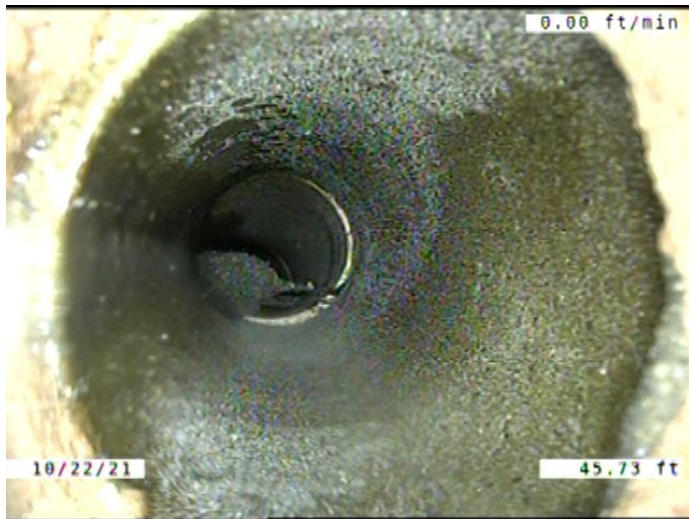
Code: **TBD**
Description: **Tap Break-in/Hammer Defective**

Distance (ft): **45.7**
Structural Grade: **0**
O&M Grade: **3**
Clock Start/From: **11**
Clock To:
1st Value: **4.000**
2nd Value:
Value Percent:
Continuous Index:
Within 8" of Joint: **YES**
Remarks: **Defective**

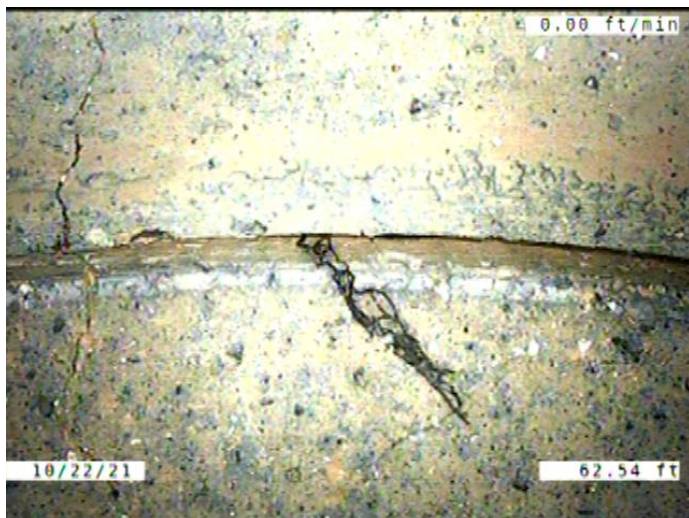
Code: **RFJ**
Description: **Roots Fine Joint**

Distance (ft): **62.5**
Structural Grade: **0**
O&M Grade: **1**
Clock Start/From: **12**
Clock To:
1st Value:
2nd Value:
Value Percent:
Continuous Index:
Within 8" of Joint: **YES**
Remarks:

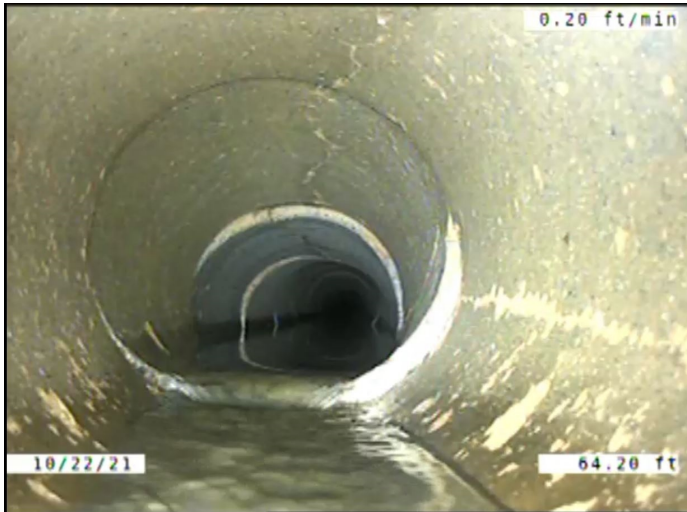
Code: **DR**
Description: **Deformed Rigid**

Distance (ft): **64.2**
Structural Grade: **4**
O&M Grade: **0**
Clock Start/From:
Clock To:
1st Value:
2nd Value:
Value Percent: **5.000**
Continuous Index:
Within 8" of Joint: **NO**
Remarks:

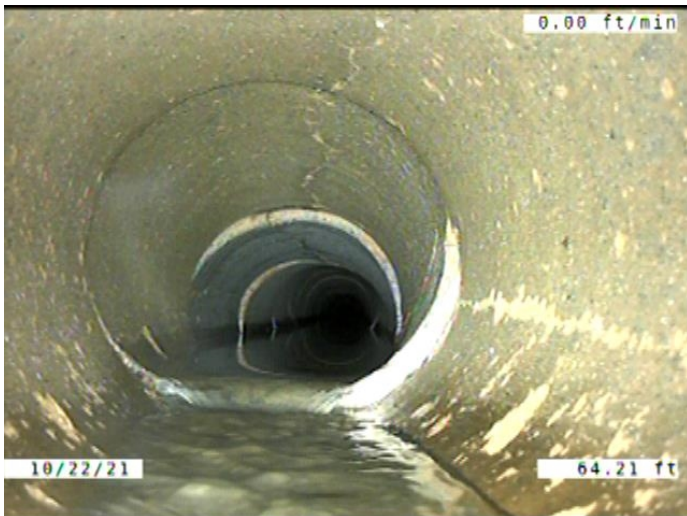
Code: **SSS**
Description: **Surface Damage Surface Spalling**

Distance (ft): **64.2**
Structural Grade: **2**
O&M Grade: **0**
Clock Start/From: **4**
Clock To: **8**
1st Value:
2nd Value:
Value Percent:
Continuous Index:
Within 8" of Joint: **YES**
Remarks:

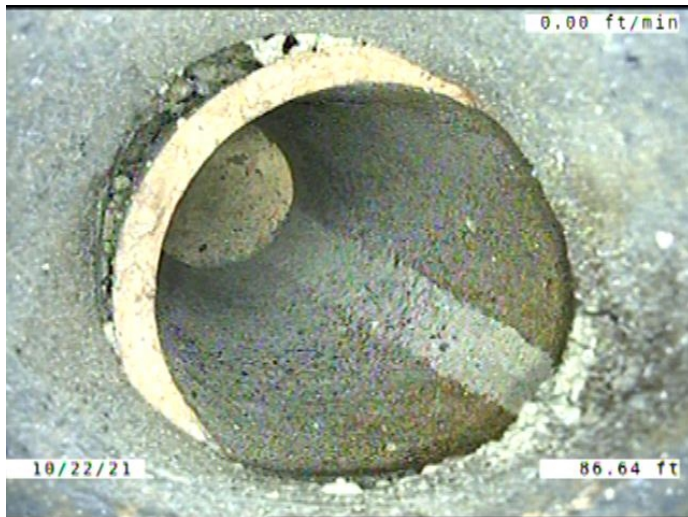
Code: **TFD**
 Description: **Tap Factory Defective**

Distance (ft): **86.6**
 Structural Grade: **0**
 O&M Grade: **3**
 Clock Start/From: **1**
 Clock To:
 1st Value: **4.000**
 2nd Value:
 Value Percent:
 Continuous Index:
 Within 8" of Joint: **YES**
 Remarks: **CAPPED. LARGE OFFSET FIRST JOINT BACK. SOIL VISIBLE**

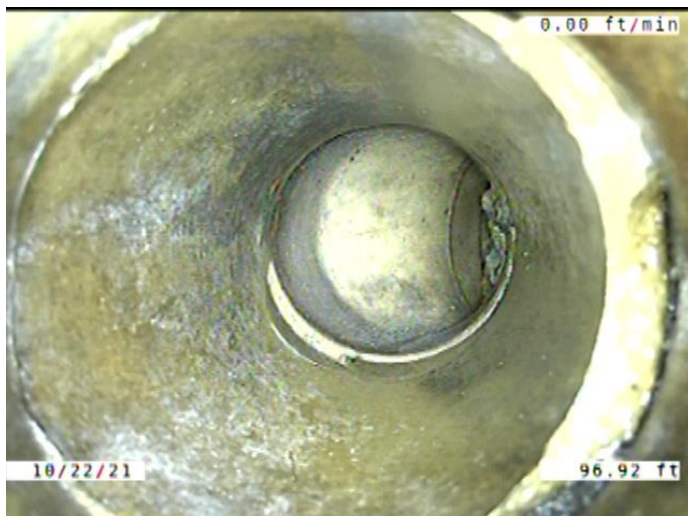
Code: **TBI**
 Description: **Tap Break-in Intruding**

Distance (ft): **96.9**
 Structural Grade: **0**
 O&M Grade: **2**
 Clock Start/From: **12**
 Clock To:
 1st Value: **4.000**
 2nd Value: **1.000**
 Value Percent:
 Continuous Index:
 Within 8" of Joint: **YES**
 Remarks:

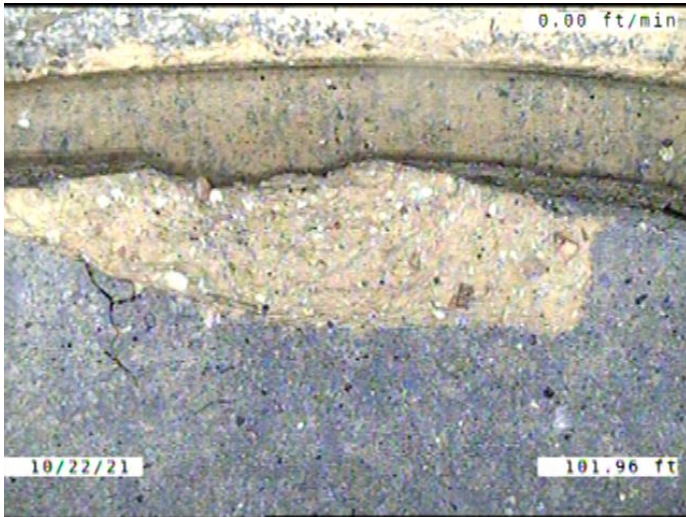
Code:	SZ
Description:	Surface Damage Other
Distance (ft):	102.0
Structural Grade:	0
O&M Grade:	0
Clock Start/From:	10
Clock To:	11
1st Value:	
2nd Value:	
Value Percent:	
Continuous Index:	
Within 8" of Joint:	YES
Remarks:	A PIECE CHIPPED AWAY FROM THE JOINT

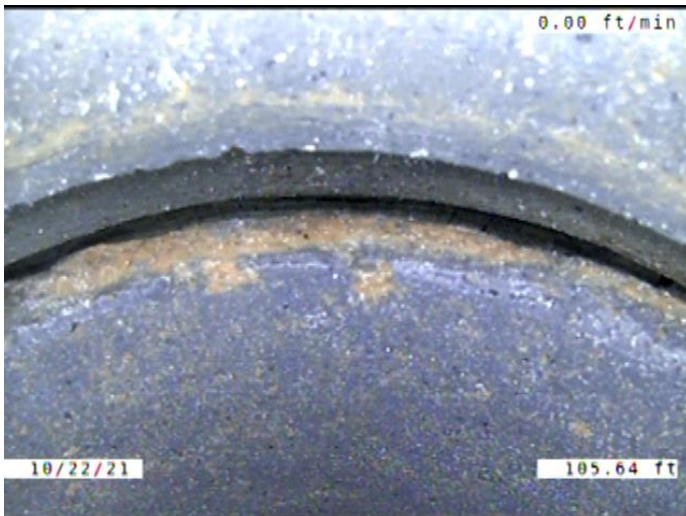
Code:	JAM
Description:	Joint Angular Medium
Distance (ft):	105.6
Structural Grade:	3
O&M Grade:	0
Clock Start/From:	
Clock To:	
1st Value:	
2nd Value:	
Value Percent:	
Continuous Index:	
Within 8" of Joint:	NO
Remarks:	SOIL VISIBLE

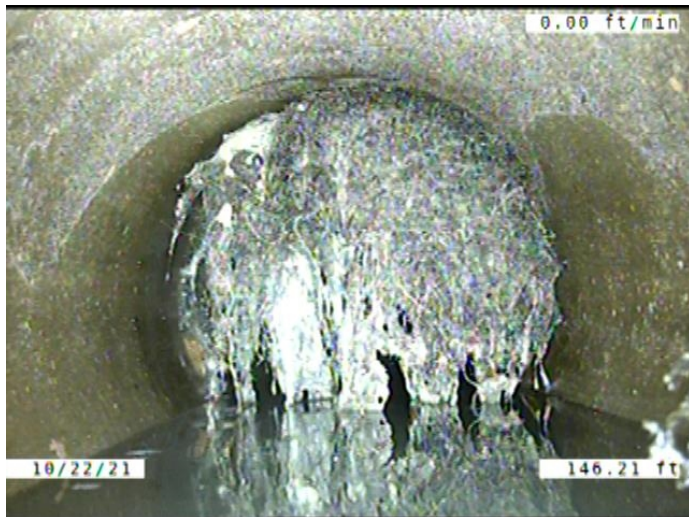
Code: **RBJ**
 Description: **Roots Ball Joint**

Distance (ft): **146.2**
 Structural Grade: **0**
 O&M Grade: **4**
 Clock Start/From: **8**
 Clock To: **4**
 1st Value:
 2nd Value:
 Value Percent: **85.000**
 Continuous Index:
 Within 8" of Joint: **YES**
 Remarks:

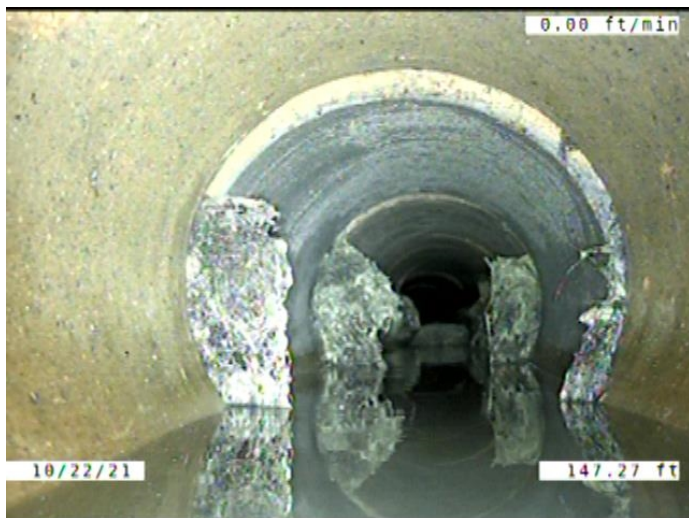
Code: **FM**
 Description: **Fracture Multiple**

Distance (ft): **147.3**
 Structural Grade: **4**
 O&M Grade: **0**
 Clock Start/From: **8**
 Clock To: **4**
 1st Value:
 2nd Value:
 Value Percent:
 Continuous Index: **F01**
 Within 8" of Joint: **YES**
 Remarks:

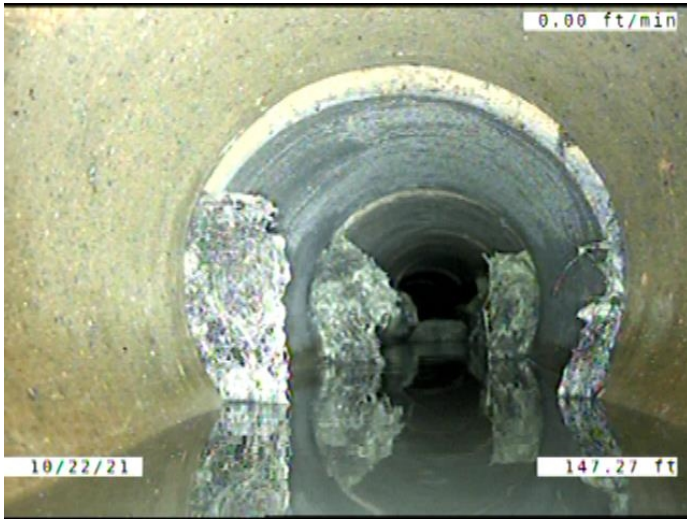
Code: **RMJ**
Description: **Roots Medium Joint**

Distance (ft): **147.3**
Structural Grade: **0**
O&M Grade: **3**
Clock Start/From: **1**
Clock To: **3**
1st Value:
2nd Value:
Value Percent: **5.000**
Continuous Index: **F05**
Within 8" of Joint: **YES**
Remarks:

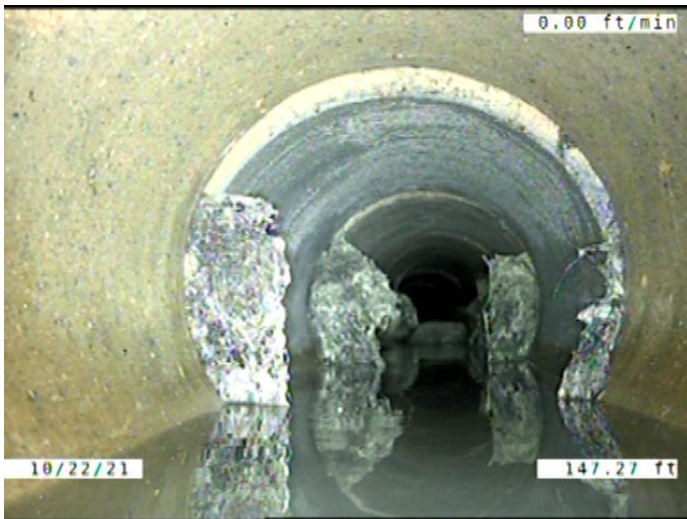
Code: **RMJ**
Description: **Roots Medium Joint**

Distance (ft): **147.3**
Structural Grade: **0**
O&M Grade: **3**
Clock Start/From: **8**
Clock To: **10**
1st Value:
2nd Value:
Value Percent: **5.000**
Continuous Index: **F06**
Within 8" of Joint: **YES**
Remarks:
