## Profile/Photo Observation Report

Date:	<b>10/22/2021</b>	Weather:		Coding:	<b>PACP 7.0</b>
Pipe Length (ft):	<b>191.0</b>	Owner:	<b>City of Hobart</b>	Pre Clean:	<b>Heavy Cleaning</b>
P.O.#:	<b>YES502259</b>	Surveyor:	<b>S. Bucklin</b>	PSR:	<b>P-504-130-087</b>
Customer:	<b>City of Hobart</b>	Clean Date:	<b>08/29/2021</b>	Shape:	<b>C</b>

Street:	<b>West 42nd Avenue</b>	Flow Control:	<b>Not Controlled</b>
City:	<b>Hobart, IN</b>	Year Renewed:	
Location:	<b>Alley</b>	Tape/Media #:	
Purpose:	<b>Routine Assessment</b>	Dia/Height:	<b>12"</b>
Use:	<b>Sanitary Sewage Pipe</b>	Material:	<b>VCP</b>
Drain Area:		Lining:	<b>None</b>
Category:	<b>NA</b>		
Comment:			
Location Details:		Direction of Survey:	<b>Upstream</b>
US MH:	<b>M-504-087</b>	DS MH:	<b>M-504-130</b>
		Total Length Surveyed (ft):	<b>147.3</b>

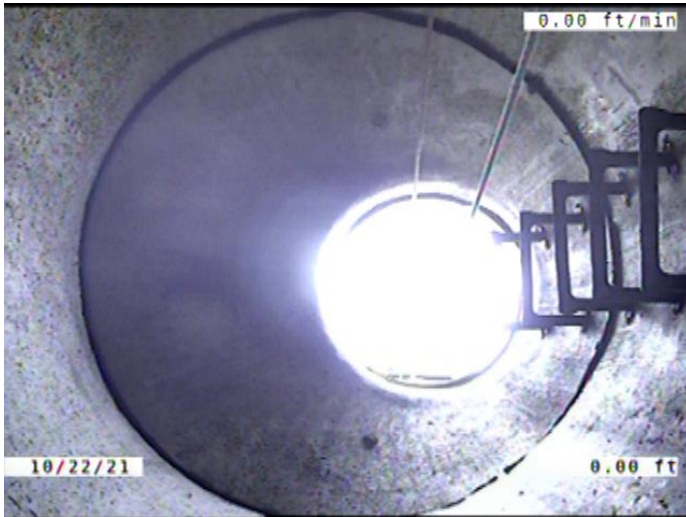
Code: **AMH**  
 Description: **Manhole**

Distance (ft): **.0**  
 Structural Grade: **0**  
 O&M Grade: **0**  
 Clock Start/From:  
 Clock To:  
 1st Value:  
 2nd Value:  
 Value Percent:  
 Continuous Index:  
 Within 8" of Joint: **NO**  
 Remarks: **M-504-130**

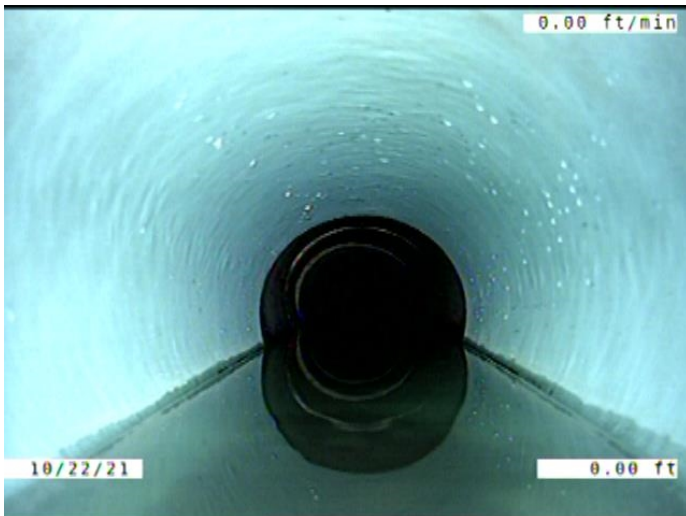
Code: **MWL**  
 Description: **Miscellaneous Water Level**

Distance (ft): **.0**  
 Structural Grade: **0**  
 O&M Grade: **0**  
 Clock Start/From:  
 Clock To:  
 1st Value:  
 2nd Value:  
 Value Percent: **15.000**  
 Continuous Index:  
 Within 8" of Joint: **NO**  
 Remarks:

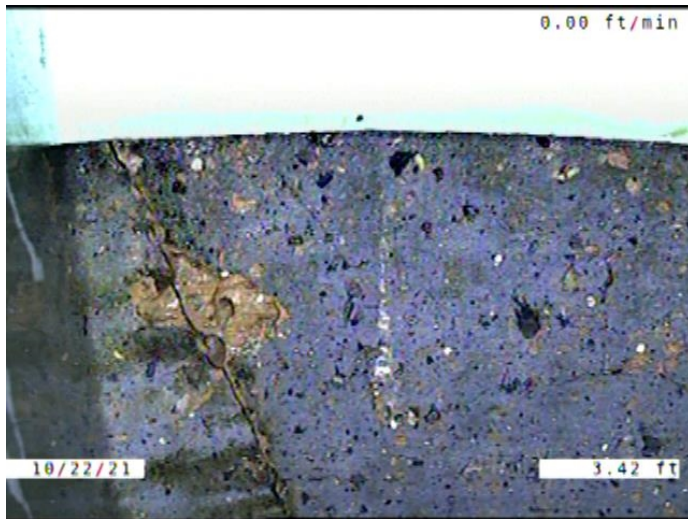
Code: **FM**  
 Description: **Fracture Multiple**

Distance (ft): **3.4**  
 Structural Grade: **4**  
 O&M Grade: **0**  
 Clock Start/From: **8**  
 Clock To: **4**  
 1st Value:  
 2nd Value:  
 Value Percent:  
 Continuous Index: **S01**  
 Within 8" of Joint: **YES**  
 Remarks:

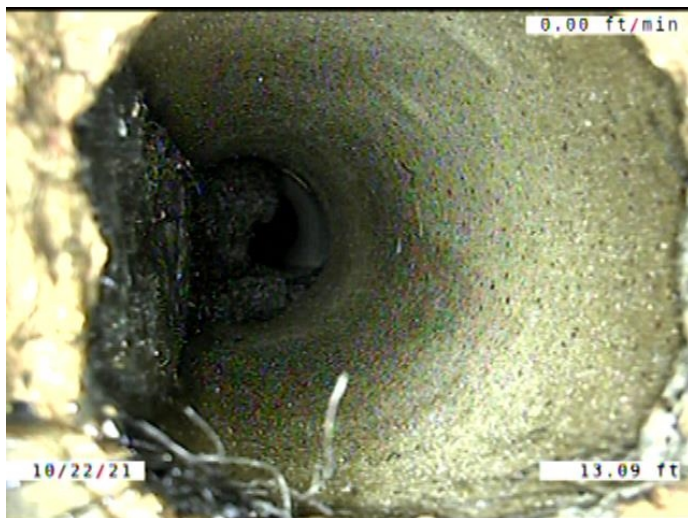
Code: **TBD**  
 Description: **Tap Break-in/Hammer Defective**

Distance (ft): **13.1**  
 Structural Grade: **0**  
 O&M Grade: **3**  
 Clock Start/From: **11**  
 Clock To:  
 1st Value: **4.000**  
 2nd Value:  
 Value Percent:  
 Continuous Index:  
 Within 8" of Joint: **YES**  
 Remarks: **CONSTANTLY RUNNING WATER**

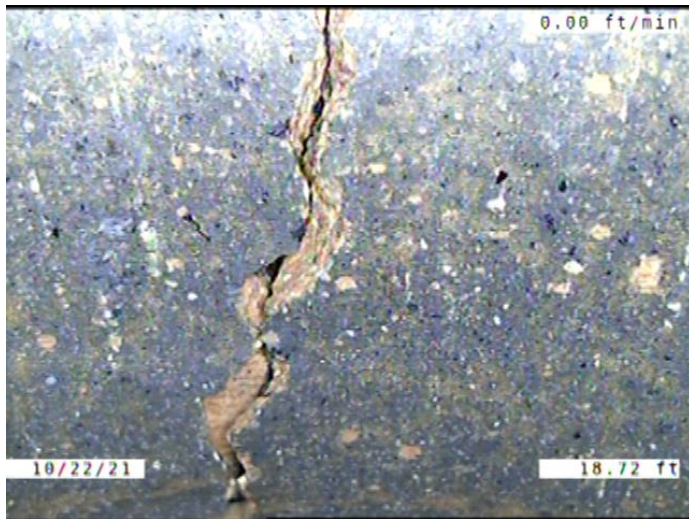
Code: **DR**  
 Description: **Deformed Rigid**

Distance (ft): **18.7**  
 Structural Grade: **4**  
 O&M Grade: **0**  
 Clock Start/From:  
 Clock To:  
 1st Value:  
 2nd Value:  
 Value Percent: **5.000**  
 Continuous Index: **S02**  
 Within 8" of Joint: **NO**  
 Remarks:

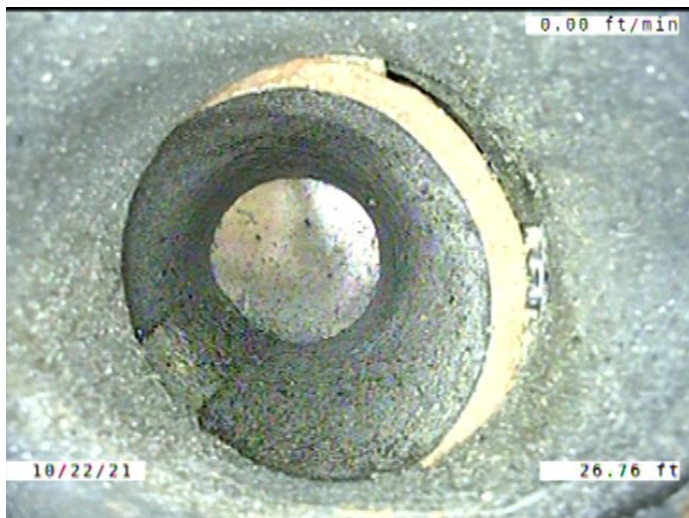
Code: **TFD**  
 Description: **Tap Factory Defective**

Distance (ft): **26.8**  
 Structural Grade: **0**  
 O&M Grade: **3**  
 Clock Start/From: **11**  
 Clock To:  
 1st Value: **4.000**  
 2nd Value:  
 Value Percent:  
 Continuous Index:  
 Within 8" of Joint: **YES**  
 Remarks: **CAPPED. LARGE OFFSET FIRST JOINT BACK. SOIL VISIBLE**

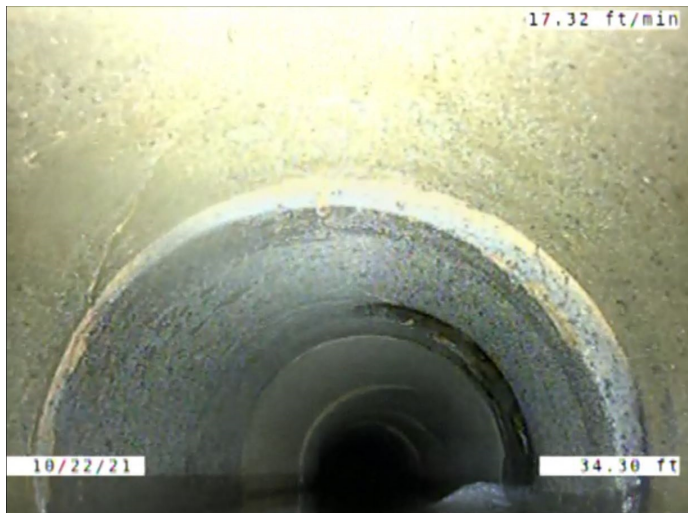
Code: **DR**  
 Description: **Deformed Rigid**

Distance (ft): **34.3**  
 Structural Grade: **4**  
 O&M Grade: **0**  
 Clock Start/From:  
 Clock To:  
 1st Value:  
 2nd Value:  
 Value Percent: **5.000**  
 Continuous Index: **F02**  
 Within 8" of Joint: **NO**  
 Remarks:

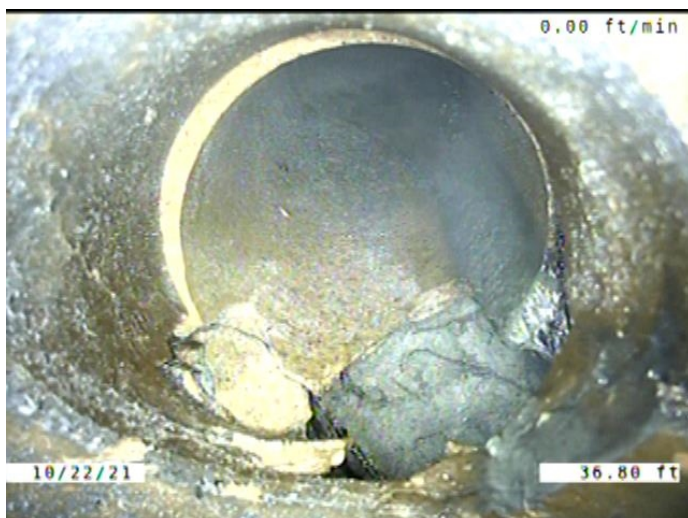
Code: **TFD**  
 Description: **Tap Factory Defective**

Distance (ft): **36.8**  
 Structural Grade: **0**  
 O&M Grade: **3**  
 Clock Start/From: **1**  
 Clock To:  
 1st Value: **4.000**  
 2nd Value:  
 Value Percent:  
 Continuous Index:  
 Within 8" of Joint: **YES**  
 Remarks: **TAP BROKEN. SOIL VISIBLE. WATER RUNNING OUTSIDE OF THE MAIN**

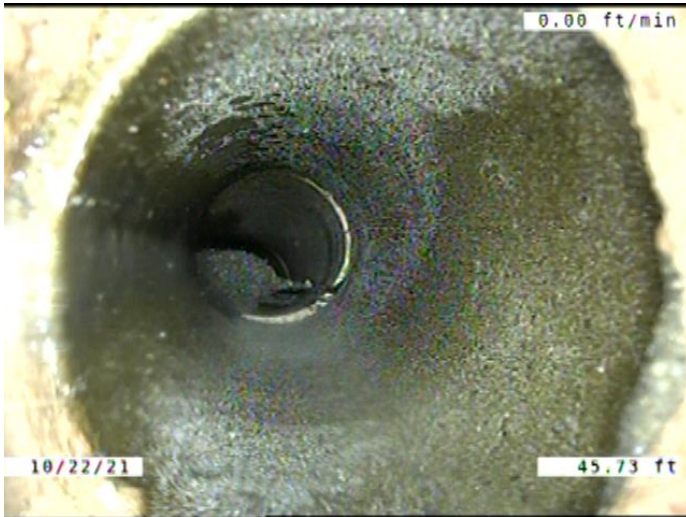
Code: **TBD**  
 Description: **Tap Break-in/Hammer Defective**

Distance (ft): **45.7**  
 Structural Grade: **0**  
 O&M Grade: **3**  
 Clock Start/From: **11**  
 Clock To:  
 1st Value: **4.000**  
 2nd Value:  
 Value Percent:  
 Continuous Index:  
 Within 8" of Joint: **YES**  
 Remarks: **Defective**

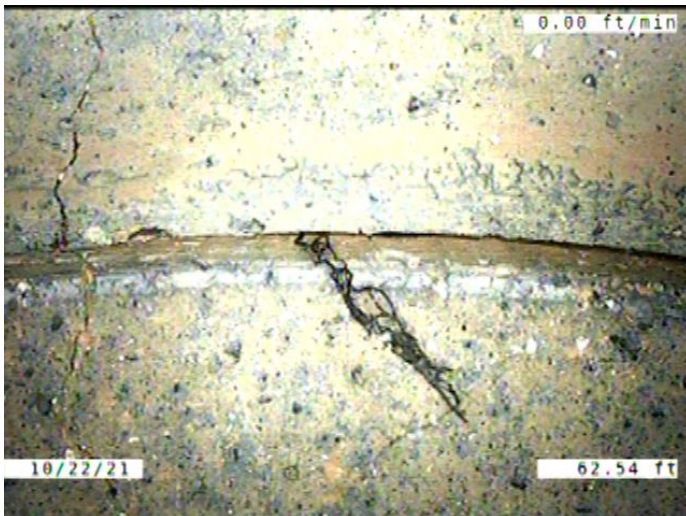
Code: **RFJ**  
 Description: **Roots Fine Joint**

Distance (ft): **62.5**  
 Structural Grade: **0**  
 O&M Grade: **1**  
 Clock Start/From: **12**  
 Clock To:  
 1st Value:  
 2nd Value:  
 Value Percent:  
 Continuous Index:  
 Within 8" of Joint: **YES**  
 Remarks:

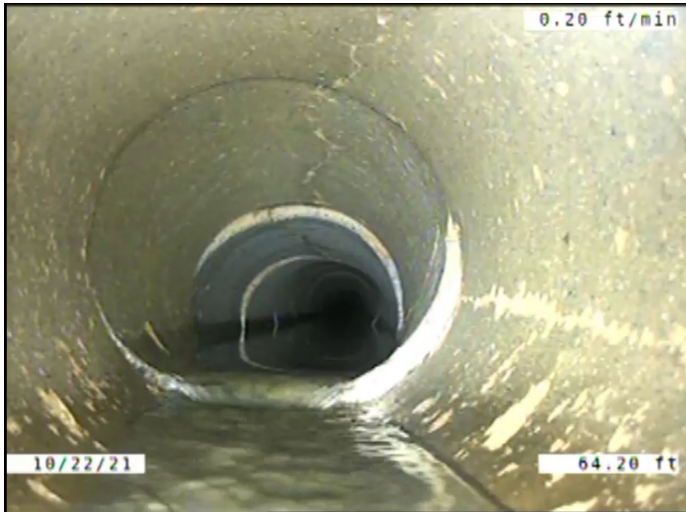
Code: **DR**  
Description: **Deformed Rigid**

Distance (ft): **64.2**  
Structural Grade: **4**  
O&M Grade: **0**  
Clock Start/From:  
Clock To:  
1st Value:  
2nd Value:  
Value Percent: **5.000**  
Continuous Index:  
Within 8" of Joint: **NO**  
Remarks:

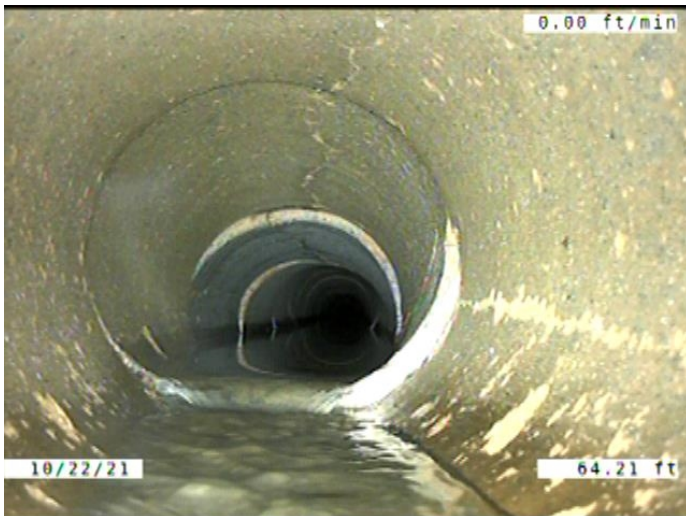
Code: **SSS**  
Description: **Surface Damage Surface Spalling**

Distance (ft): **64.2**  
Structural Grade: **2**  
O&M Grade: **0**  
Clock Start/From: **4**  
Clock To: **8**  
1st Value:  
2nd Value:  
Value Percent:  
Continuous Index:  
Within 8" of Joint: **YES**  
Remarks:

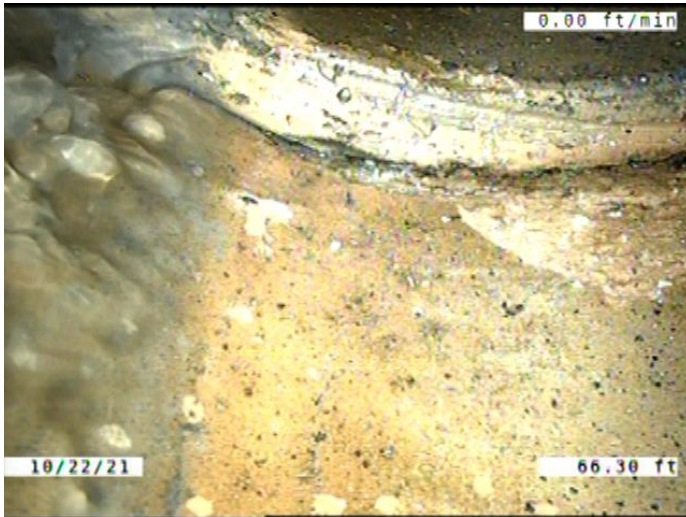
Code: **JOM**  
 Description: **Joint Offset Medium**

Distance (ft): **66.3**  
 Structural Grade: **3**  
 O&M Grade: **0**  
 Clock Start/From:  
 Clock To:  
 1st Value:  
 2nd Value:  
 Value Percent:  
 Continuous Index:  
 Within 8" of Joint: **NO**  
 Remarks:

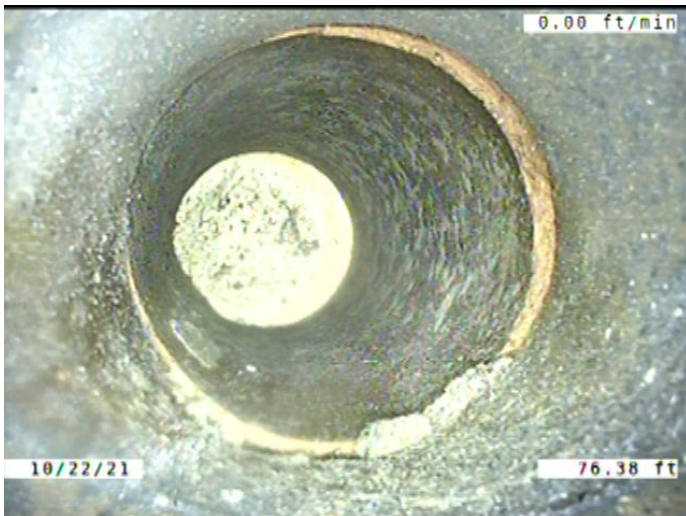
Code: **TFC**  
 Description: **Tap Factory Capped**

Distance (ft): **76.4**  
 Structural Grade: **0**  
 O&M Grade: **0**  
 Clock Start/From: **11**  
 Clock To:  
 1st Value: **4.000**  
 2nd Value:  
 Value Percent:  
 Continuous Index:  
 Within 8" of Joint: **YES**  
 Remarks:

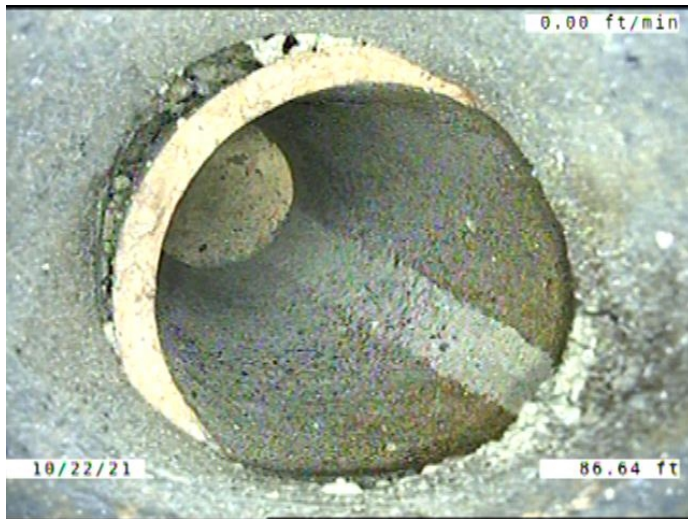
Code: **TFD**  
 Description: **Tap Factory Defective**

Distance (ft): **86.6**  
 Structural Grade: **0**  
 O&M Grade: **3**  
 Clock Start/From: **1**  
 Clock To:  
 1st Value: **4.000**  
 2nd Value:  
 Value Percent:  
 Continuous Index:  
 Within 8" of Joint: **YES**  
 Remarks: **CAPPED. LARGE OFFSET FIRST JOINT BACK. SOIL VISIBLE**

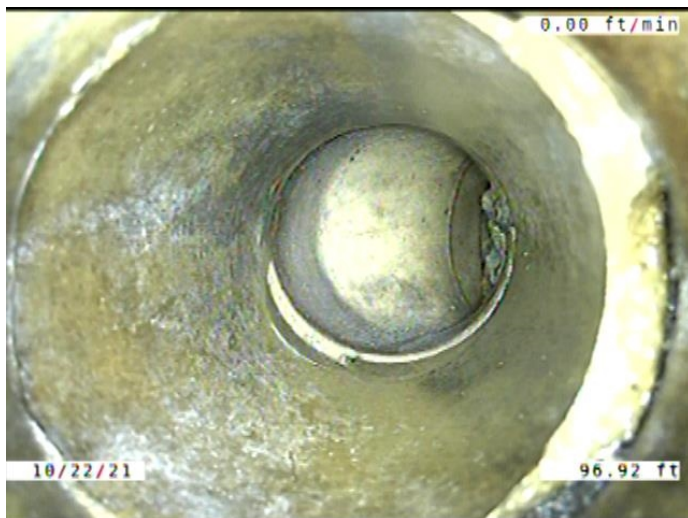
Code: **TBI**  
 Description: **Tap Break-in Intruding**

Distance (ft): **96.9**  
 Structural Grade: **0**  
 O&M Grade: **2**  
 Clock Start/From: **12**  
 Clock To:  
 1st Value: **4.000**  
 2nd Value: **1.000**  
 Value Percent:  
 Continuous Index:  
 Within 8" of Joint: **YES**  
 Remarks:

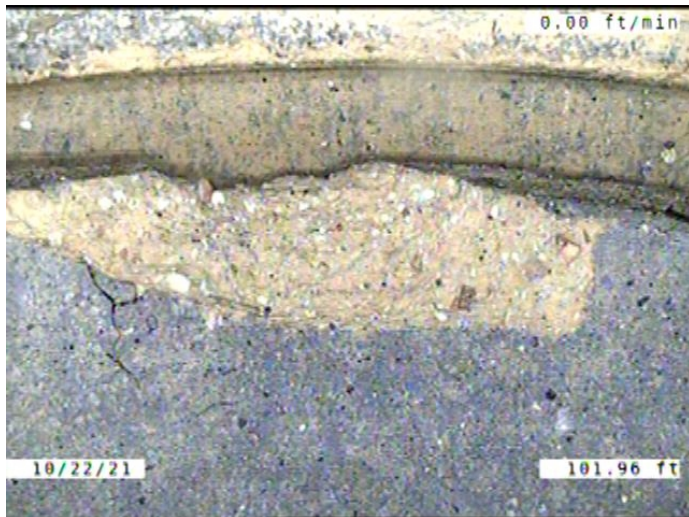
Code: **SZ**  
 Description: **Surface Damage Other**

Distance (ft): **102.0**  
 Structural Grade: **0**  
 O&M Grade: **0**  
 Clock Start/From: **10**  
 Clock To: **11**  
 1st Value:  
 2nd Value:  
 Value Percent:  
 Continuous Index:  
 Within 8" of Joint: **YES**  
 Remarks: **A PIECE CHIPPED AWAY FROM THE JOINT**

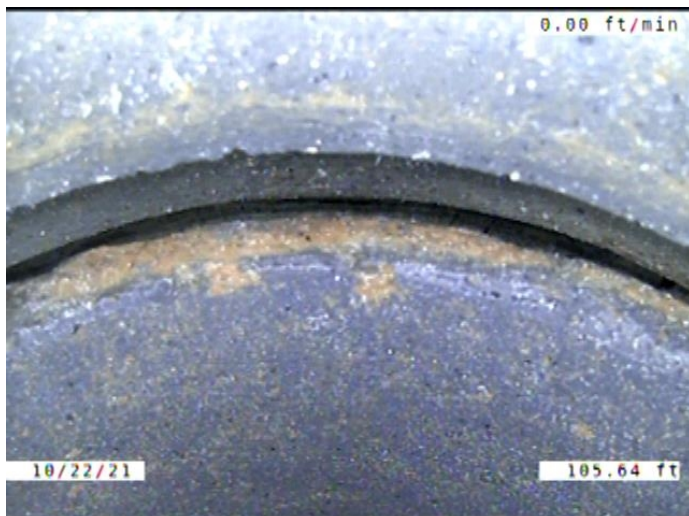
Code: **JAM**  
 Description: **Joint Angular Medium**

Distance (ft): **105.6**  
 Structural Grade: **3**  
 O&M Grade: **0**  
 Clock Start/From:  
 Clock To:  
 1st Value:  
 2nd Value:  
 Value Percent:  
 Continuous Index:  
 Within 8" of Joint: **NO**  
 Remarks: **SOIL VISIBLE**

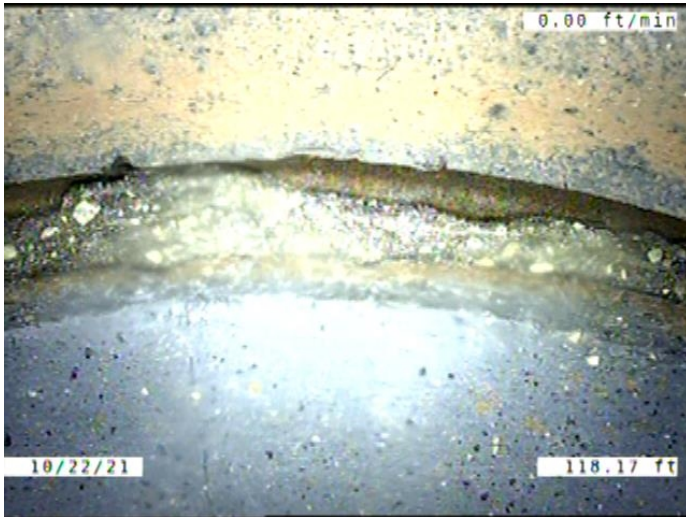
Code: **JOMD**  
 Description: **Joint Offset Medium Defective**

Distance (ft): **118.2**  
 Structural Grade: **3**  
 O&M Grade: **0**  
 Clock Start/From:  
 Clock To:  
 1st Value:  
 2nd Value:  
 Value Percent:  
 Continuous Index:  
 Within 8" of Joint: **NO**  
 Remarks:

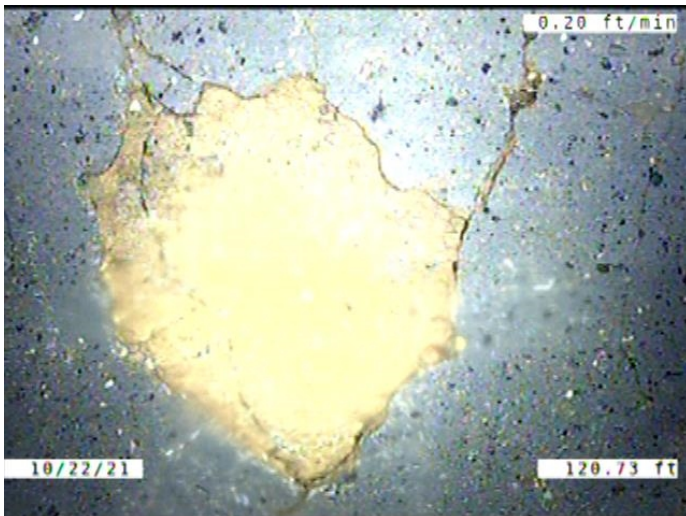
Code: **SSS**  
 Description: **Surface Damage Surface Spalling**

Distance (ft): **120.7**  
 Structural Grade: **2**  
 O&M Grade: **0**  
 Clock Start/From: **12**  
 Clock To: **1**  
 1st Value:  
 2nd Value:  
 Value Percent:  
 Continuous Index:  
 Within 8" of Joint: **YES**  
 Remarks:

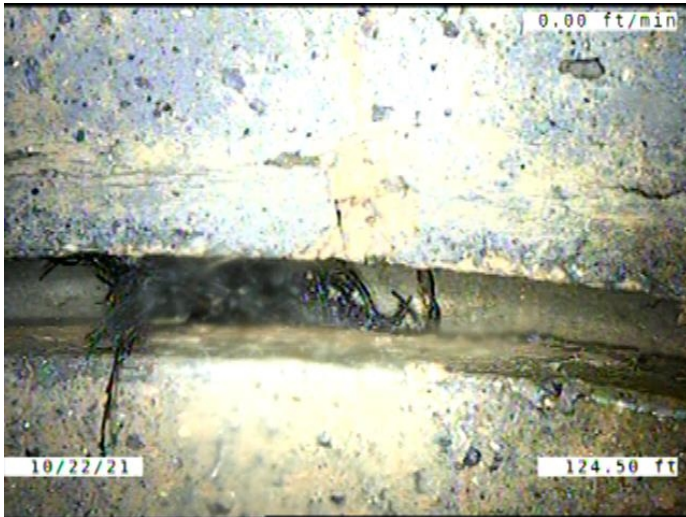
Code: **RFJ**  
Description: **Roots Fine Joint**

Distance (ft): **124.5**  
Structural Grade: **0**  
O&M Grade: **1**  
Clock Start/From: **3**  
Clock To:  
1st Value:  
2nd Value:  
Value Percent:  
Continuous Index: **S03**  
Within 8" of Joint: **YES**  
Remarks:

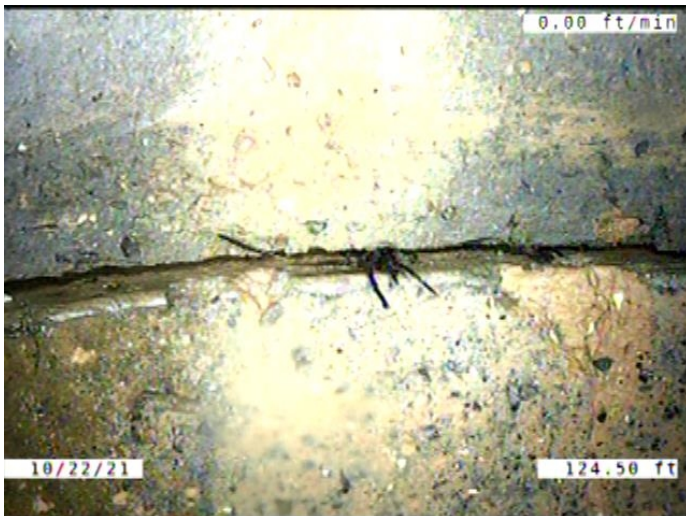
Code: **RFJ**  
Description: **Roots Fine Joint**

Distance (ft): **124.5**  
Structural Grade: **0**  
O&M Grade: **1**  
Clock Start/From: **9**  
Clock To:  
1st Value:  
2nd Value:  
Value Percent:  
Continuous Index: **S04**  
Within 8" of Joint: **YES**  
Remarks:

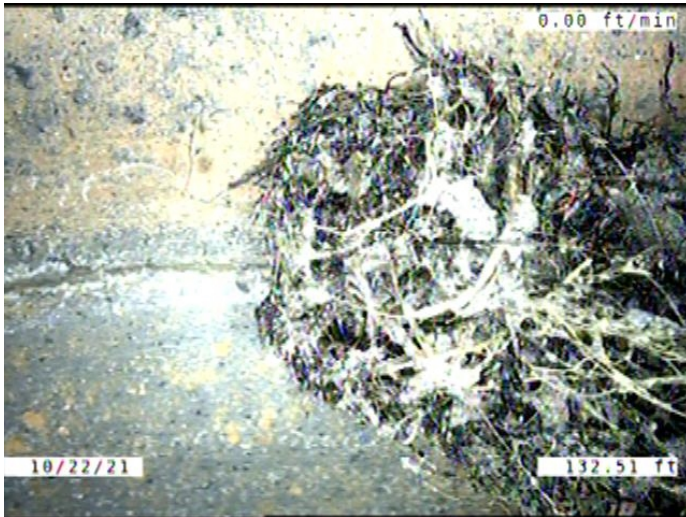
Code: **RMJ**  
Description: **Roots Medium Joint**

Distance (ft): **132.5**  
Structural Grade: **0**  
O&M Grade: **3**  
Clock Start/From: **1**  
Clock To: **3**  
1st Value:  
2nd Value:  
Value Percent: **5.000**  
Continuous Index: **S05**  
Within 8" of Joint: **YES**  
Remarks:

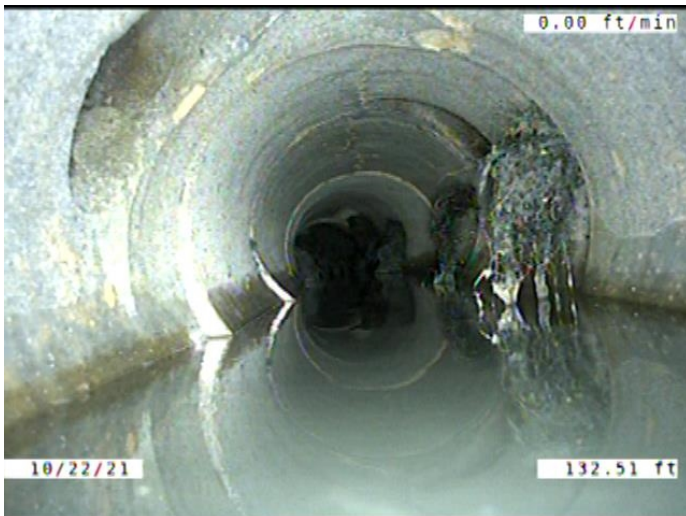
Code: **RFJ**  
Description: **Roots Fine Joint**

Distance (ft): **132.5**  
Structural Grade: **0**  
O&M Grade: **1**  
Clock Start/From: **3**  
Clock To:  
1st Value:  
2nd Value:  
Value Percent:  
Continuous Index: **F03**  
Within 8" of Joint: **YES**  
Remarks:

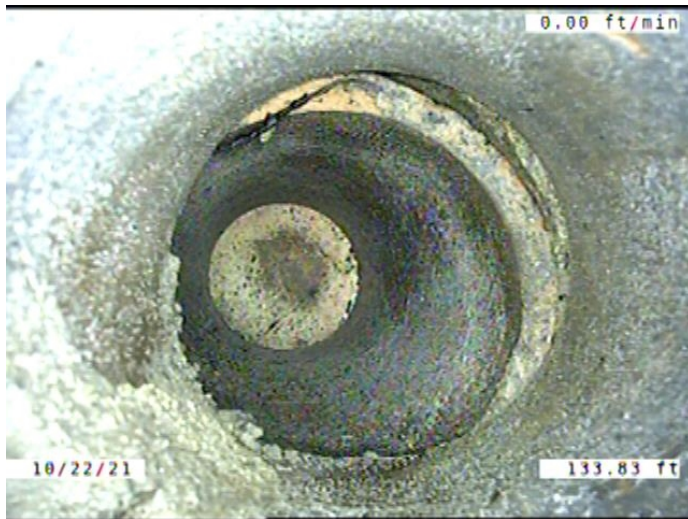
Code: **TFD**  
Description: **Tap Factory Defective**

Distance (ft): **133.8**  
Structural Grade: **0**  
O&M Grade: **3**  
Clock Start/From: **11**  
Clock To:  
1st Value: **4.000**  
2nd Value:  
Value Percent:  
Continuous Index:  
Within 8" of Joint: **YES**  
Remarks: **CAPPED. LARGE OFFSET FIRST JOINT BACK. SOIL VISIBLE**

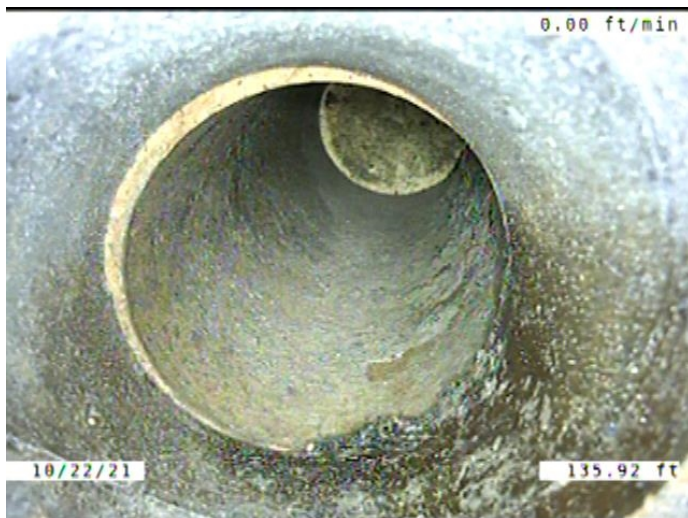
Code: **TFC**  
Description: **Tap Factory Capped**

Distance (ft): **135.9**  
Structural Grade: **0**  
O&M Grade: **0**  
Clock Start/From: **1**  
Clock To:  
1st Value: **4.000**  
2nd Value:  
Value Percent:  
Continuous Index:  
Within 8" of Joint: **YES**  
Remarks: **ROOTS GROWING AROUND THE CAP AND FROM THE JOINT**

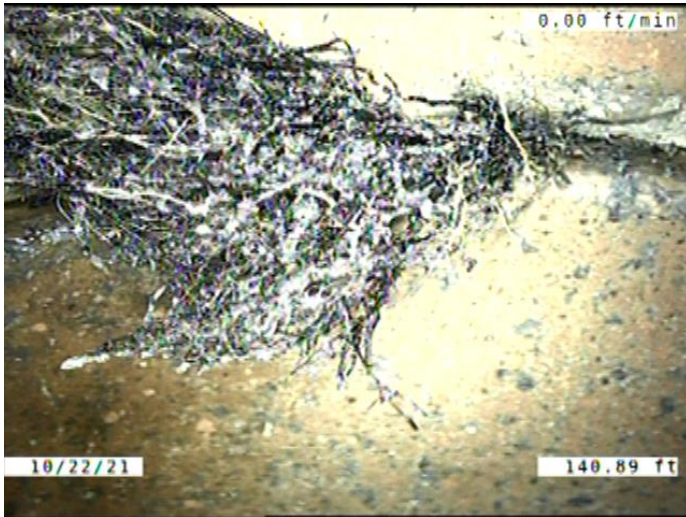
Code: **RMJ**  
 Description: **Roots Medium Joint**

Distance (ft): **140.9**  
 Structural Grade: **0**  
 O&M Grade: **3**  
 Clock Start/From: **8**  
 Clock To: **10**  
 1st Value:  
 2nd Value:  
 Value Percent: **5.000**  
 Continuous Index: **S06**  
 Within 8" of Joint: **YES**  
 Remarks:

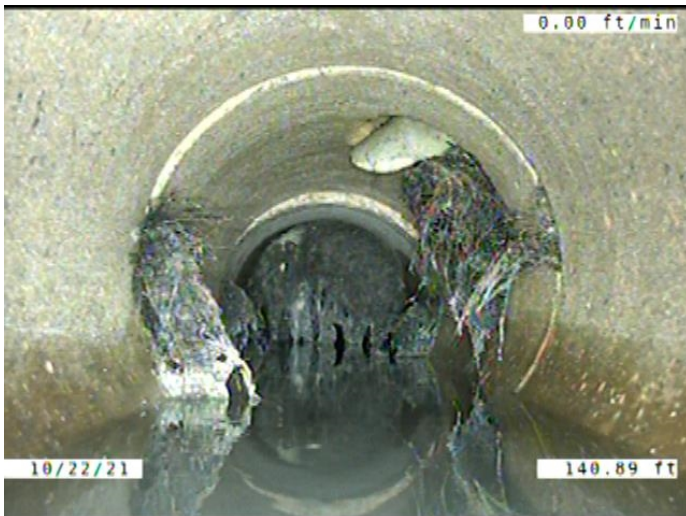
Code: **RFJ**  
 Description: **Roots Fine Joint**

Distance (ft): **140.9**  
 Structural Grade: **0**  
 O&M Grade: **1**  
 Clock Start/From: **9**  
 Clock To:  
 1st Value:  
 2nd Value:  
 Value Percent:  
 Continuous Index: **F04**  
 Within 8" of Joint: **YES**  
 Remarks:

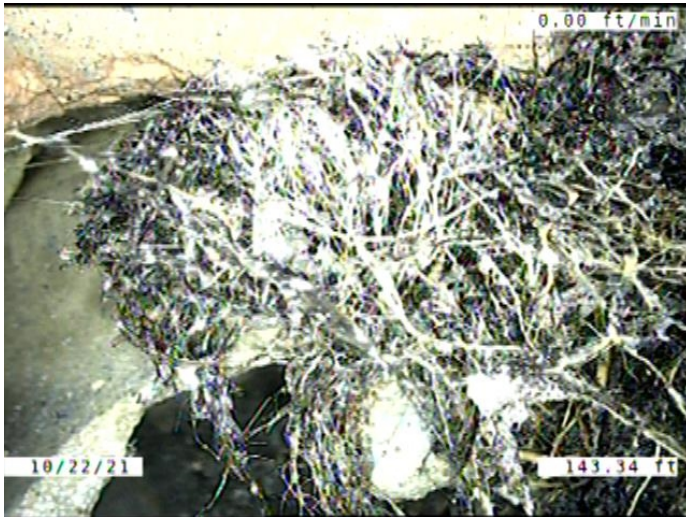
Code: **RMC**  
 Description: **Roots Medium Connection**

Distance (ft): **143.3**  
 Structural Grade: **0**  
 O&M Grade: **3**  
 Clock Start/From: **1**  
 Clock To: **4**  
 1st Value:  
 2nd Value:  
 Value Percent: **10.000**  
 Continuous Index:  
 Within 8" of Joint: **NO**  
 Remarks:

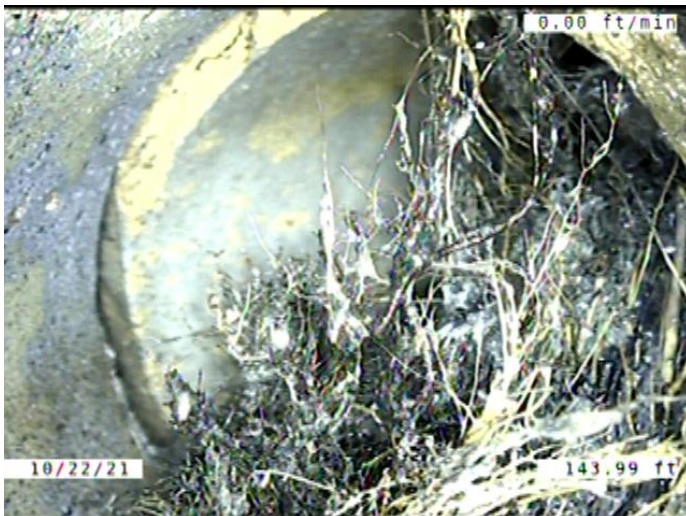
Code: **TBI**  
 Description: **Tap Break-in Intruding**

Distance (ft): **144.0**  
 Structural Grade: **0**  
 O&M Grade: **2**  
 Clock Start/From: **1**  
 Clock To:  
 1st Value: **4.000**  
 2nd Value: **1.000**  
 Value Percent:  
 Continuous Index:  
 Within 8" of Joint: **YES**  
 Remarks:

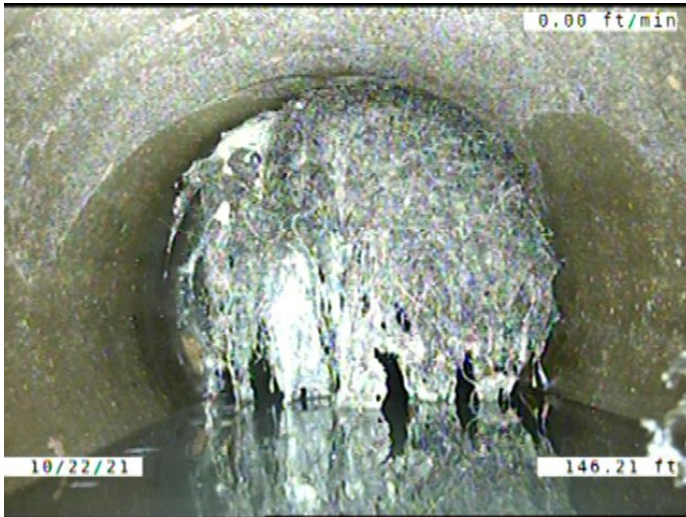
Code: **RBJ**  
 Description: **Roots Ball Joint**

Distance (ft): **146.2**  
 Structural Grade: **0**  
 O&M Grade: **4**  
 Clock Start/From: **8**  
 Clock To: **4**  
 1st Value:  
 2nd Value:  
 Value Percent: **85.000**  
 Continuous Index:  
 Within 8" of Joint: **YES**  
 Remarks:

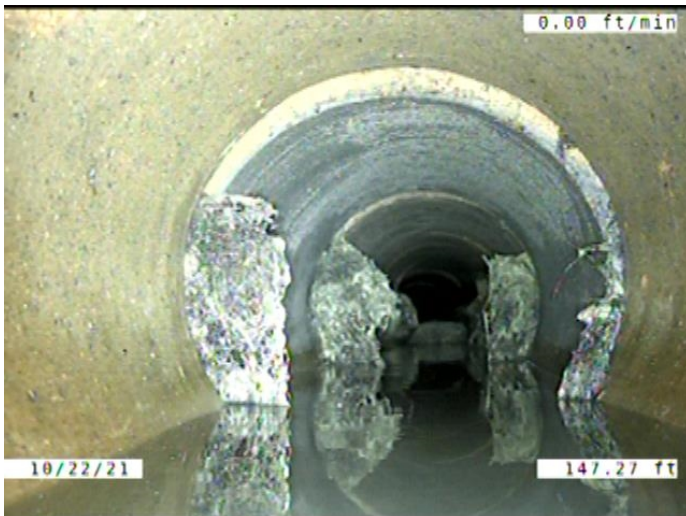
Code: **FM**  
 Description: **Fracture Multiple**

Distance (ft): **147.3**  
 Structural Grade: **4**  
 O&M Grade: **0**  
 Clock Start/From: **8**  
 Clock To: **4**  
 1st Value:  
 2nd Value:  
 Value Percent:  
 Continuous Index: **F01**  
 Within 8" of Joint: **YES**  
 Remarks:

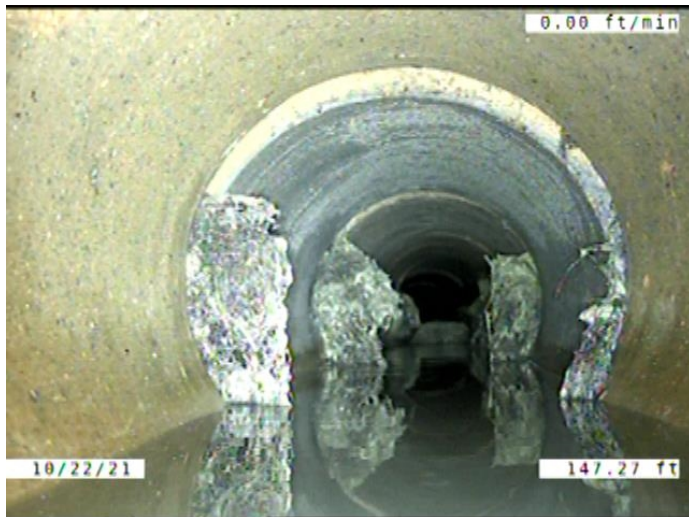
Code: **RMJ**  
 Description: **Roots Medium Joint**

Distance (ft): **147.3**  
 Structural Grade: **0**  
 O&M Grade: **3**  
 Clock Start/From: **1**  
 Clock To: **3**  
 1st Value:  
 2nd Value:  
 Value Percent: **5.000**  
 Continuous Index: **F05**  
 Within 8" of Joint: **YES**  
 Remarks:

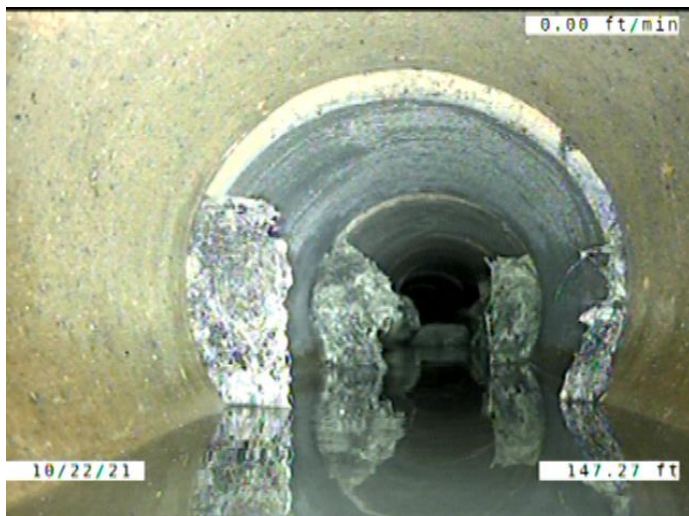
Code: **RMJ**  
 Description: **Roots Medium Joint**

Distance (ft): **147.3**  
 Structural Grade: **0**  
 O&M Grade: **3**  
 Clock Start/From: **8**  
 Clock To: **10**  
 1st Value:  
 2nd Value:  
 Value Percent: **5.000**  
 Continuous Index: **F06**  
 Within 8" of Joint: **YES**  
 Remarks:

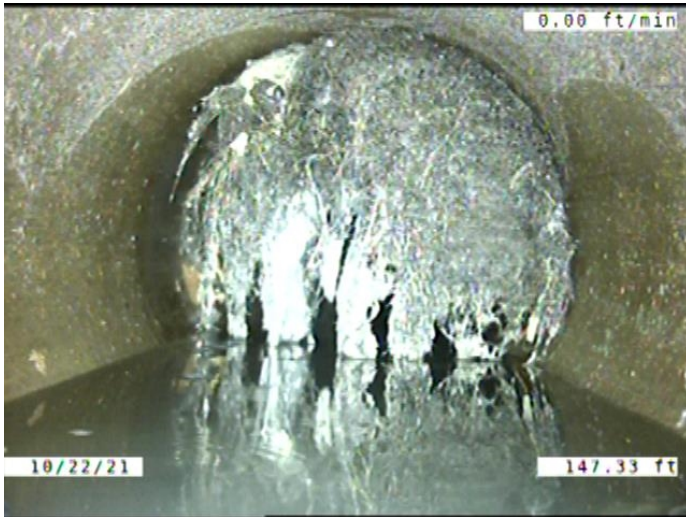
Code:	<b>MSA</b>
Description:	<b>Miscellaneous Survey Abandoned</b>
Distance (ft):	<b>147.3</b>
Structural Grade:	<b>0</b>
O&M Grade:	<b>0</b>
Clock Start/From:	
Clock To:	
1st Value:	
2nd Value:	
Value Percent:	
Continuous Index:	
Within 8" of Joint:	<b>NO</b>
Remarks:	<b>CAMERA CANT MAKE IT PAST ROOTS</b>
