Profile/Photo Observation Report

Date:	04/18/2018	Weather:		Coding:	PACP 6.0
Pipe Length (ft):	167.1	Owner:	NA	Pre Clean:	Not Known
P.O.#:		Surveyor:	Byrd Fitzgerald	PSR:	P-504-090-089
Customer:		Clean Date:	01/01/1900	Shape:	C

Street:	Summerlin	Flow Control:	Not Controlled
City:	Hobart, IN	Year Renewed:	
Location:	Light Highway	Tape/Media #:	
Purpose:	Not Known	Dia/Height:	12"
Use:	Sanitary	Material:	VCP
Drain Area:	NA	Lining:	
Category:	NA		
Comment:

Location Details:		Direction of Survey:	Downstream
US MH:	M-504-089	DS MH:	M-504-090
		Total Length Surveyed (ft):	25.1

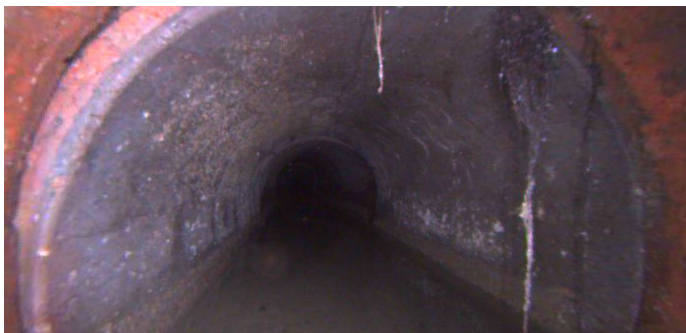
Code: **RFJ**
Description: **Roots Fine Joint**

Distance (ft): **.0**
Structural Grade: **0**
O&M Grade: **1**
Clock Start/From: **12**
Clock To: **2**
1st Value:
2nd Value:
Value Percent:
Continuous Index:
Within 8" of Joint: **YES**
Remarks:

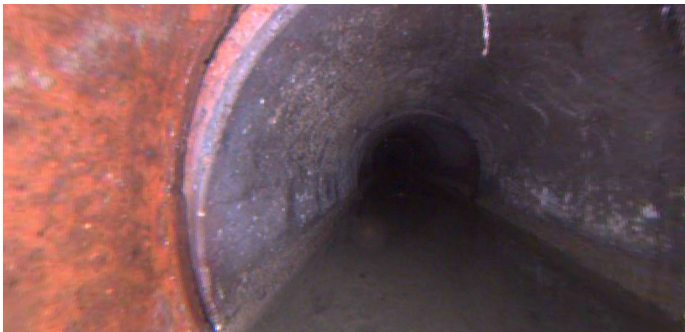
Code: **MWL**
Description: **Water Level**

Distance (ft): **.0**
Structural Grade: **0**
O&M Grade: **0**
Clock Start/From:
Clock To:
1st Value:
2nd Value:
Value Percent: **5.000**
Continuous Index:
Within 8" of Joint: **NO**
Remarks:

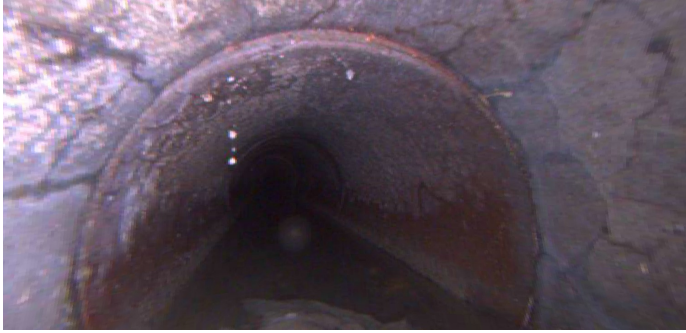
Code: **CM**
Description: **Crack Multiple**

Distance (ft): **3.3**
Structural Grade: **3**
O&M Grade: **0**
Clock Start/From: **10**
Clock To: **5**
1st Value:
2nd Value:
Value Percent:
Continuous Index: **S01**
Within 8" of Joint: **YES**
Remarks: **wandering**

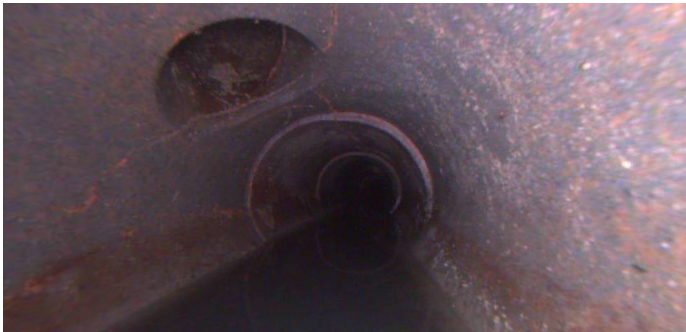
Code: **FM**
Description: **Fracture Multiple**

Distance (ft): **18.6**
Structural Grade: **4**
O&M Grade: **0**
Clock Start/From: **8**
Clock To: **12**
1st Value:
2nd Value:
Value Percent:
Continuous Index:
Within 8" of Joint: **YES**
Remarks:

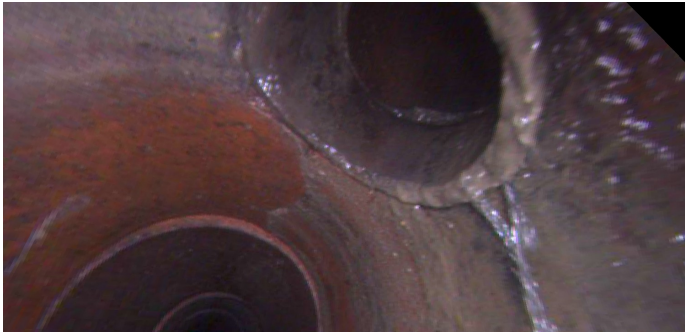
Code: **TB**
Description: **Tap Break-in**

Distance (ft): **24.8**
Structural Grade: **0**
O&M Grade: **0**
Clock Start/From: **1**
Clock To:
1st Value: **4.000**
2nd Value:
Value Percent:
Continuous Index:
Within 8" of Joint:
Remarks:

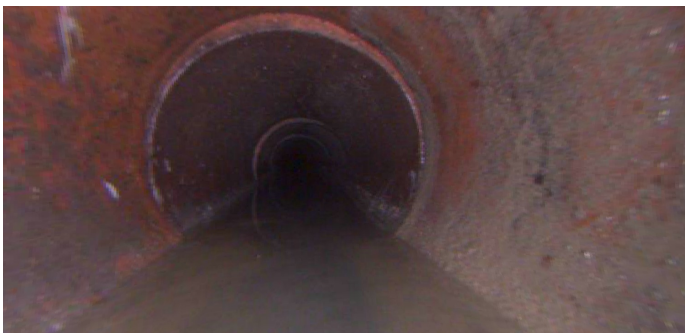
Code: **MSA**
Description: **Abandoned Survey**

Distance (ft): **25.1**
Structural Grade: **0**
O&M Grade: **0**
Clock Start/From:
Clock To:
1st Value:
2nd Value:
Value Percent:
Continuous Index:
Within 8" of Joint: **NO**
Remarks: **no blockage**

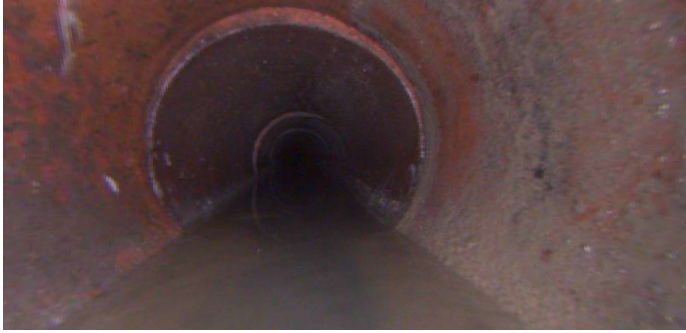
Code:	CM
Description:	Crack Multiple
Distance (ft):	25.1
Structural Grade:	3
O&M Grade:	0
Clock Start/From:	10
Clock To:	5
1st Value:	
2nd Value:	
Value Percent:	
Continuous Index:	F01
Within 8" of Joint:	YES
Remarks:	wandering
