## Profile/Photo Observation Report

Date:	<b>04/17/2018</b>	Weather:		Coding:	<b>PACP 6.0</b>
Pipe Length (ft):	<b>231.2</b>	Owner:	<b>NA</b>	Pre Clean:	<b>Not Known</b>
P.O.#:		Surveyor:	<b>Jen Costello</b>	PSR:	<b>P-504-102-101</b>
Customer:		Clean Date:	<b>01/01/1900</b>	Shape:	<b>C</b>

Street:	<b>ALLEY BETWEEN N DELAWARE ST &amp;</b>	Flow Control:	<b>Not Controlled</b>
City:	<b>Hobart, IN</b>	Year Renewed:	
Location:	<b>Light Highway</b>	Tape/Media #:	
Purpose:	<b>Not Known</b>	Dia/Height:	<b>10"</b>
Use:	<b>Sanitary</b>	Material:	<b>CP</b>
Drain Area:	<b>NA</b>	Lining:	
Category:	<b>NA</b>		
Comment:

Location Details:		Direction of Survey:	<b>Downstream</b>
US MH:	<b>M-504-101</b>	DS MH:	<b>M-504-102</b>
		Total Length Surveyed (ft):	<b>24.9</b>

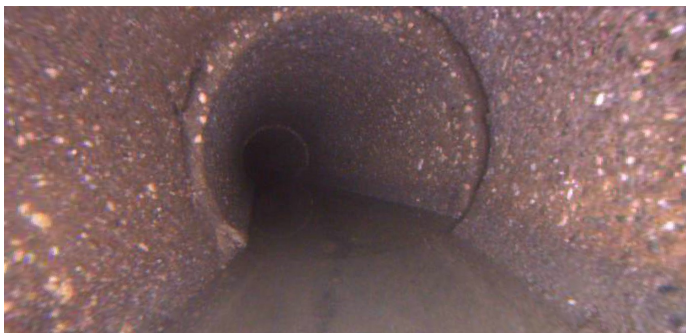
Code: **AMH**  
Description: **Manhole**

Distance (ft): **.0**  
Structural Grade: **0**  
O&M Grade: **0**  
Clock Start/From:  
Clock To:  
1st Value:  
2nd Value:  
Value Percent:  
Continuous Index:  
Within 8" of Joint: **NO**  
Remarks: **M-504-101**

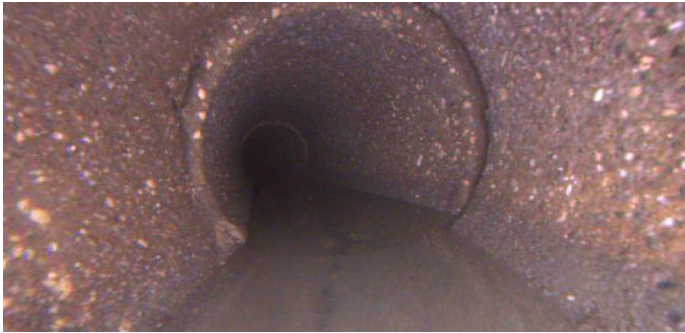
Code:	<b>MWL</b>
Description:	<b>Water Level</b>

Distance (ft):	<b>.0</b>
Structural Grade:	<b>0</b>
O&M Grade:	<b>0</b>
Clock Start/From:	
Clock To:	
1st Value:	
2nd Value:	
Value Percent:	<b>10.000</b>
Continuous Index:	
Within 8" of Joint:	<b>NO</b>
Remarks:

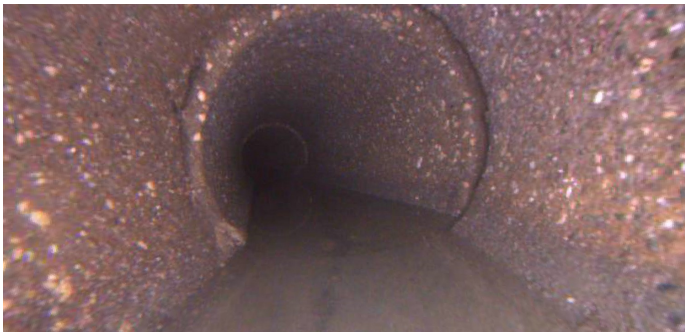
Code:	<b>SAP</b>
Description:	<b>Surface Aggregate Projecting</b>

Distance (ft):	<b>.0</b>
Structural Grade:	<b>3</b>
O&M Grade:	<b>0</b>
Clock Start/From:	<b>8</b>
Clock To:	<b>4</b>
1st Value:	
2nd Value:	
Value Percent:	
Continuous Index:	<b>S01</b>
Within 8" of Joint:	
Remarks:

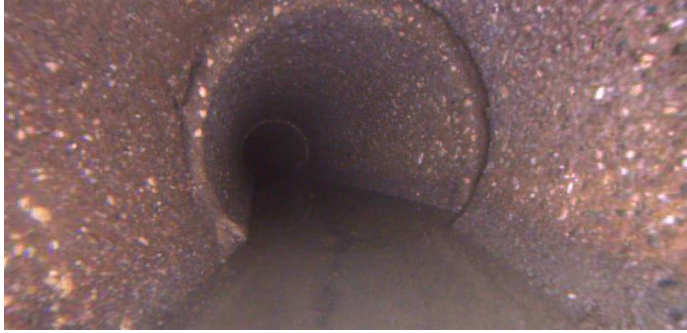
Code: **LL**  
Description: **Alignment Left**

Distance (ft): **.0**  
Structural Grade: **0**  
O&M Grade: **1**  
Clock Start/From:  
Clock To:  
1st Value:  
2nd Value:  
Value Percent: **5.000**  
Continuous Index: **S02**  
Within 8" of Joint: **NO**  
Remarks:

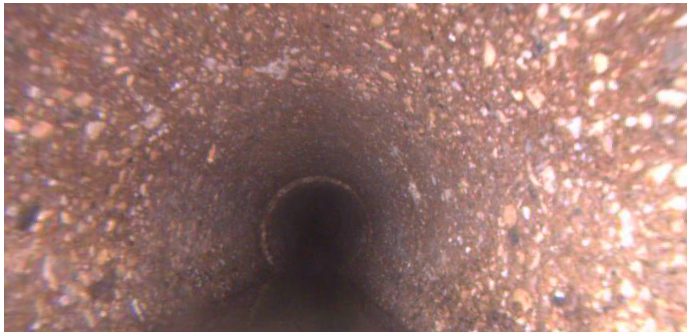
Code: **LL**  
Description: **Alignment Left**

Distance (ft): **5.5**  
Structural Grade: **0**  
O&M Grade: **1**  
Clock Start/From:  
Clock To:  
1st Value:  
2nd Value:  
Value Percent: **5.000**  
Continuous Index: **F02**  
Within 8" of Joint: **NO**  
Remarks:

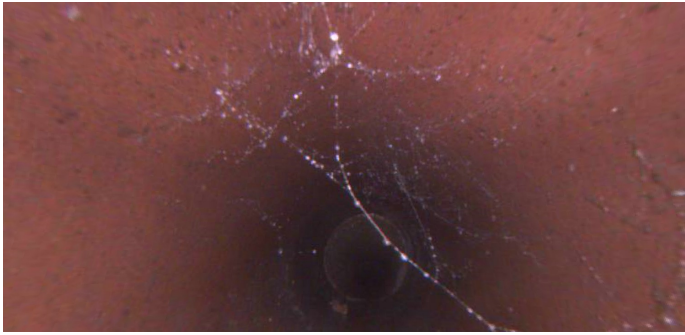
Code: **MMC**  
Description: **Material Change**

Distance (ft): **13.7**  
Structural Grade: **0**  
O&M Grade: **0**  
Clock Start/From:  
Clock To:  
1st Value:  
2nd Value:  
Value Percent:  
Continuous Index:  
Within 8" of Joint: **NO**  
Remarks: **vcp**

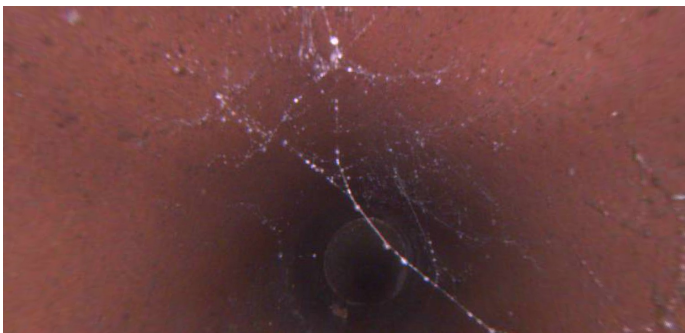
Code: **SAP**  
Description: **Surface Aggregate Projecting**

Distance (ft): **13.7**  
Structural Grade: **3**  
O&M Grade: **0**  
Clock Start/From: **8**  
Clock To: **4**  
1st Value:  
2nd Value:  
Value Percent:  
Continuous Index: **F01**  
Within 8" of Joint:  
Remarks:

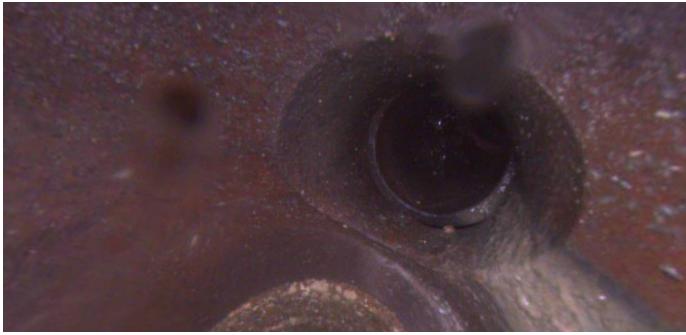
Code: **TF**  
Description: **Tap Factory**

Distance (ft): **15.5**  
Structural Grade: **0**  
O&M Grade: **0**  
Clock Start/From: **1**  
Clock To:  
1st Value: **4.000**  
2nd Value:  
Value Percent:  
Continuous Index:  
Within 8" of Joint:  
Remarks:

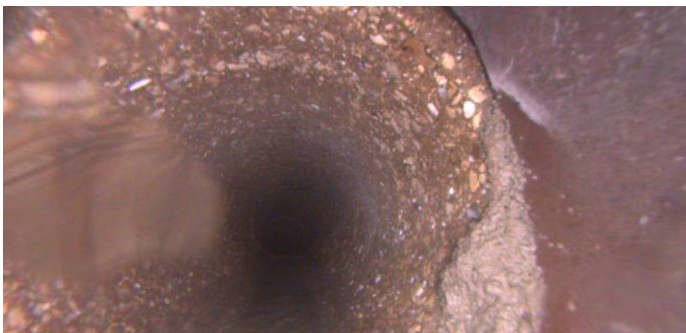
Code: **DAGS**  
Description: **Deposits Attached Grease**

Distance (ft): **16.2**  
Structural Grade: **0**  
O&M Grade: **2**  
Clock Start/From: **3**  
Clock To: **4**  
1st Value:  
2nd Value:  
Value Percent: **5.000**  
Continuous Index:  
Within 8" of Joint: **YES**  
Remarks:

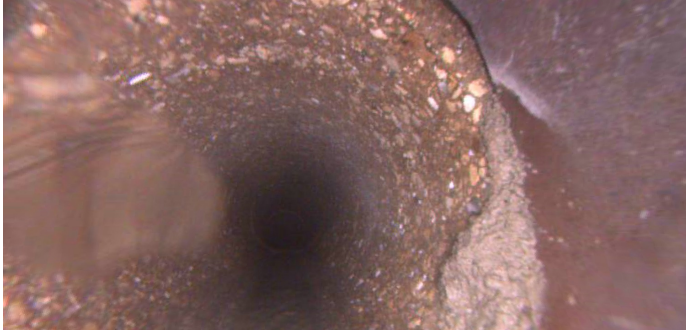
Code: **SAP**  
Description: **Surface Aggregate Projecting**

Distance (ft): **16.2**  
Structural Grade: **3**  
O&M Grade: **0**  
Clock Start/From: **8**  
Clock To: **4**  
1st Value:  
2nd Value:  
Value Percent:  
Continuous Index: **S03**  
Within 8" of Joint:  
Remarks:

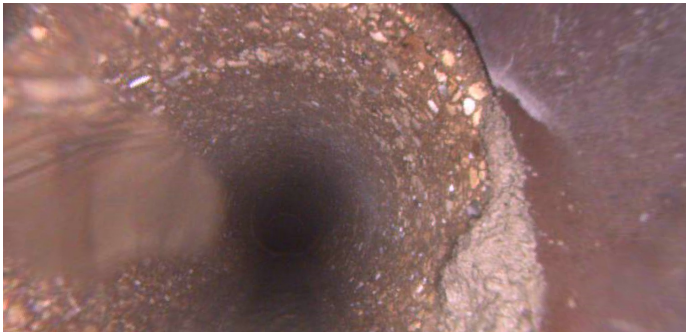
Code: **MMC**  
Description: **Material Change**

Distance (ft): **16.2**  
Structural Grade: **0**  
O&M Grade: **0**  
Clock Start/From:  
Clock To:  
1st Value:  
2nd Value:  
Value Percent:  
Continuous Index:  
Within 8" of Joint: **NO**  
Remarks: **cp**

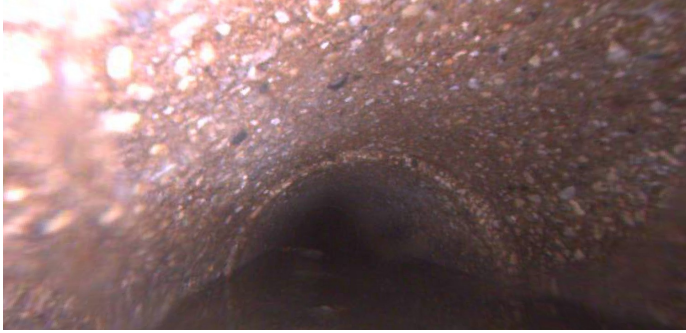
Code: **SAP**  
Description: **Surface Aggregate Projecting**

Distance (ft): **24.9**  
Structural Grade: **3**  
O&M Grade: **0**  
Clock Start/From: **8**  
Clock To: **4**  
1st Value:  
2nd Value:  
Value Percent:  
Continuous Index: **F03**  
Within 8" of Joint:  
Remarks:

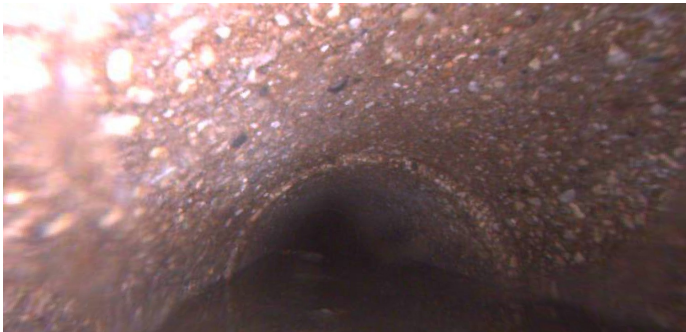
Code: **MWL**  
Description: **Water Level**

Distance (ft): **24.9**  
Structural Grade: **0**  
O&M Grade: **0**  
Clock Start/From:  
Clock To:  
1st Value:  
2nd Value:  
Value Percent: **40.000**  
Continuous Index:  
Within 8" of Joint: **NO**  
Remarks:

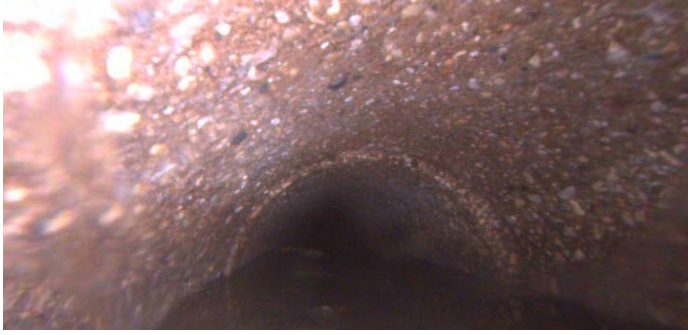
Code:	<b>MSA</b>
Description:	<b>Abandoned Survey</b>
Distance (ft):	<b>24.9</b>
Structural Grade:	<b>0</b>
O&M Grade:	<b>0</b>
Clock Start/From:	
Clock To:	
1st Value:	
2nd Value:	
Value Percent:	
Continuous Index:	
Within 8" of Joint:	<b>NO</b>
Remarks:	<b>debris under water</b>
