## Profile/Photo Observation Report

Date:	<b>04/17/2018</b>	Weather:		Coding:	<b>PACP 6.0</b>
Pipe Length (ft):	<b>231.2</b>	Owner:	<b>NA</b>	Pre Clean:	<b>Not Known</b>
P.O.#:		Surveyor:	<b>Jen Costello</b>	PSR:	<b>P-504-102-101</b>
Customer:		Clean Date:	<b>01/01/1900</b>	Shape:	<b>C</b>

Street:	<b>Summerlin</b>	Flow Control:	<b>Not Controlled</b>
City:	<b>Hobart, IN</b>	Year Renewed:	
Location:	<b>Light Highway</b>	Tape/Media #:	
Purpose:	<b>Not Known</b>	Dia/Height:	<b>10"</b>
Use:	<b>Sanitary</b>	Material:	<b>CP</b>
Drain Area:	<b>NA</b>	Lining:	
Category:	<b>NA</b>		
Comment:

Location Details:		Direction of Survey:	<b>Downstream</b>
US MH:	<b>M-504-101</b>	DS MH:	<b>M-504-102</b>
		Total Length Surveyed (ft):	<b>24.9</b>

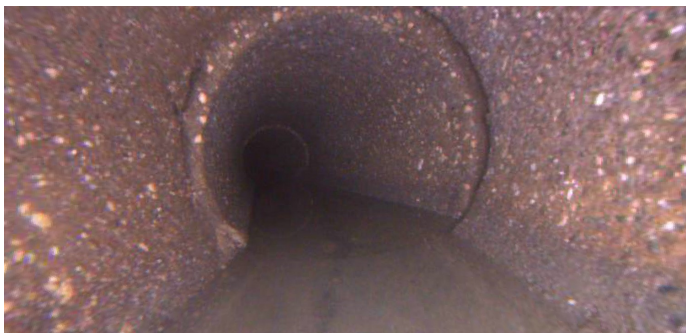
Code: **AMH**  
Description: **Manhole**

Distance (ft): **.0**  
Structural Grade: **0**  
O&M Grade: **0**  
Clock Start/From:  
Clock To:  
1st Value:  
2nd Value:  
Value Percent:  
Continuous Index:  
Within 8" of Joint: **NO**  
Remarks: **M-504-101**

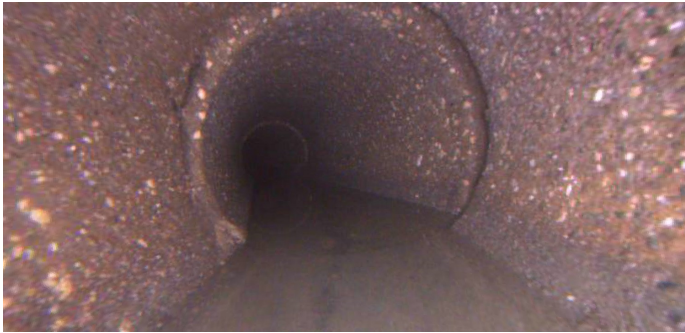
Code:	<b>MWL</b>
Description:	<b>Water Level</b>

Distance (ft):	<b>.0</b>
Structural Grade:	<b>0</b>
O&M Grade:	<b>0</b>
Clock Start/From:	
Clock To:	
1st Value:	
2nd Value:	
Value Percent:	<b>10.000</b>
Continuous Index:	
Within 8" of Joint:	<b>NO</b>
Remarks:

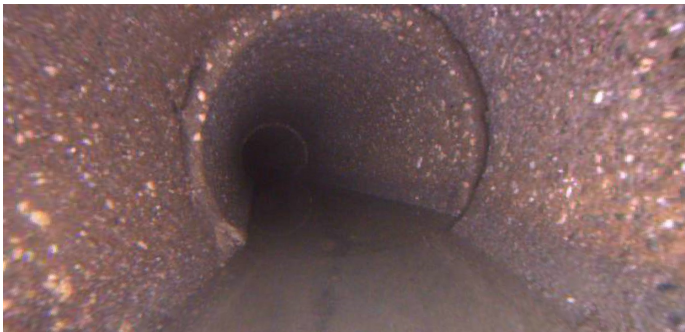
Code:	<b>SAP</b>
Description:	<b>Surface Aggregate Projecting</b>

Distance (ft):	<b>.0</b>
Structural Grade:	<b>3</b>
O&M Grade:	<b>0</b>
Clock Start/From:	<b>8</b>
Clock To:	<b>4</b>
1st Value:	
2nd Value:	
Value Percent:	
Continuous Index:	<b>S01</b>
Within 8" of Joint:	
Remarks:

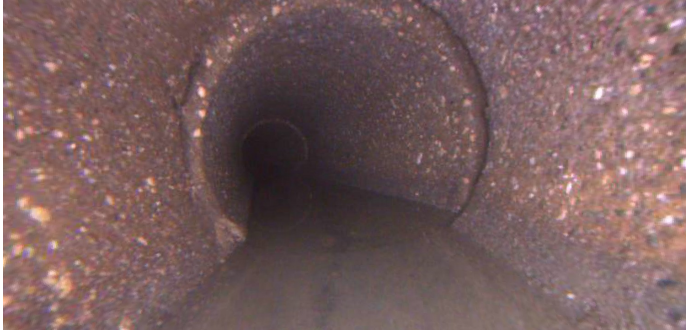
Code: **LL**  
Description: **Alignment Left**

Distance (ft): **.0**  
Structural Grade: **0**  
O&M Grade: **1**  
Clock Start/From:  
Clock To:  
1st Value:  
2nd Value:  
Value Percent: **5.000**  
Continuous Index: **S02**  
Within 8" of Joint: **NO**  
Remarks:

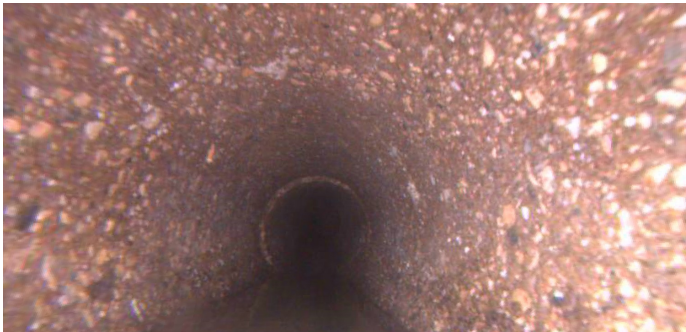
Code: **LL**  
Description: **Alignment Left**

Distance (ft): **5.5**  
Structural Grade: **0**  
O&M Grade: **1**  
Clock Start/From:  
Clock To:  
1st Value:  
2nd Value:  
Value Percent: **5.000**  
Continuous Index: **F02**  
Within 8" of Joint: **NO**  
Remarks:

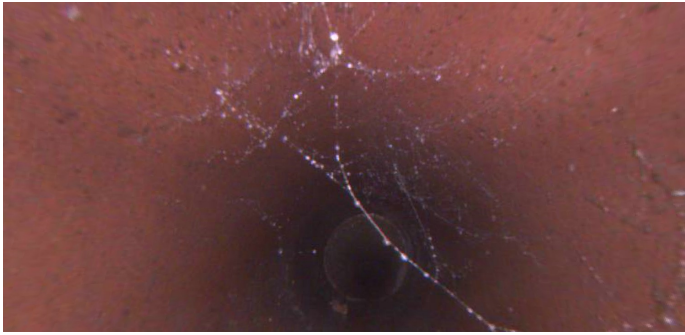
Code: **MMC**  
Description: **Material Change**

Distance (ft): **13.7**  
Structural Grade: **0**  
O&M Grade: **0**  
Clock Start/From:  
Clock To:  
1st Value:  
2nd Value:  
Value Percent:  
Continuous Index:  
Within 8" of Joint: **NO**  
Remarks: **vcp**

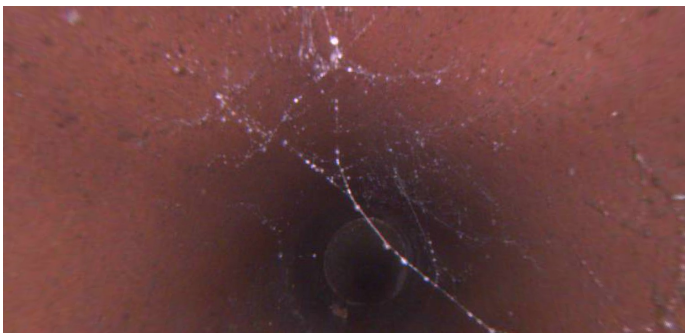
Code: **SAP**  
Description: **Surface Aggregate Projecting**

Distance (ft): **13.7**  
Structural Grade: **3**  
O&M Grade: **0**  
Clock Start/From: **8**  
Clock To: **4**  
1st Value:  
2nd Value:  
Value Percent:  
Continuous Index: **F01**  
Within 8" of Joint:  
Remarks:

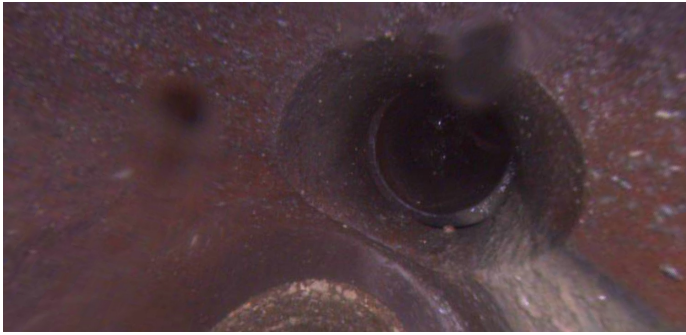
Code: **TF**  
Description: **Tap Factory**

Distance (ft): **15.5**  
Structural Grade: **0**  
O&M Grade: **0**  
Clock Start/From: **1**  
Clock To:  
1st Value: **4.000**  
2nd Value:  
Value Percent:  
Continuous Index:  
Within 8" of Joint:  
Remarks:

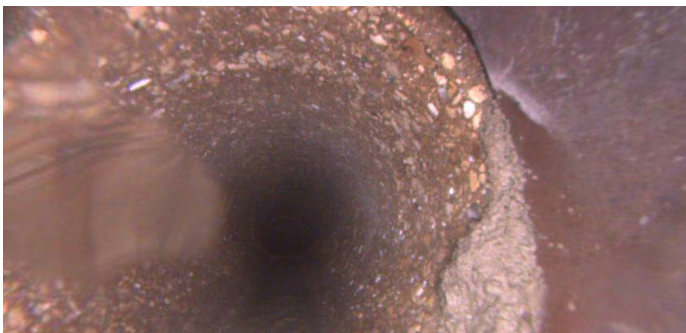
Code: **DAGS**  
Description: **Deposits Attached Grease**

Distance (ft): **16.2**  
Structural Grade: **0**  
O&M Grade: **2**  
Clock Start/From: **3**  
Clock To: **4**  
1st Value:  
2nd Value:  
Value Percent: **5.000**  
Continuous Index:  
Within 8" of Joint: **YES**  
Remarks:

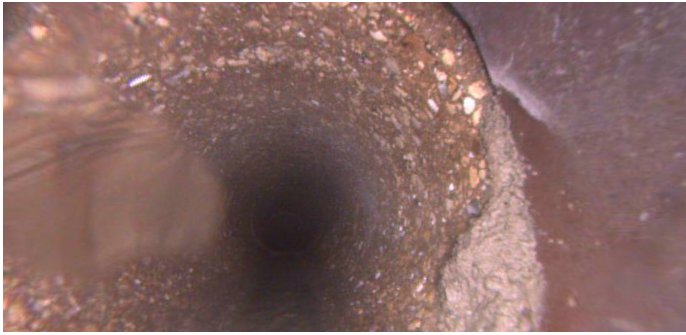
Code: **SAP**  
Description: **Surface Aggregate Projecting**

Distance (ft): **16.2**  
Structural Grade: **3**  
O&M Grade: **0**  
Clock Start/From: **8**  
Clock To: **4**  
1st Value:  
2nd Value:  
Value Percent:  
Continuous Index: **S03**  
Within 8" of Joint:  
Remarks:

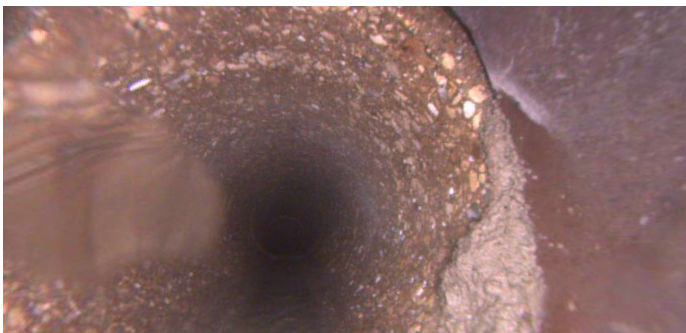
Code: **MMC**  
Description: **Material Change**

Distance (ft): **16.2**  
Structural Grade: **0**  
O&M Grade: **0**  
Clock Start/From:  
Clock To:  
1st Value:  
2nd Value:  
Value Percent:  
Continuous Index:  
Within 8" of Joint: **NO**  
Remarks: **cp**

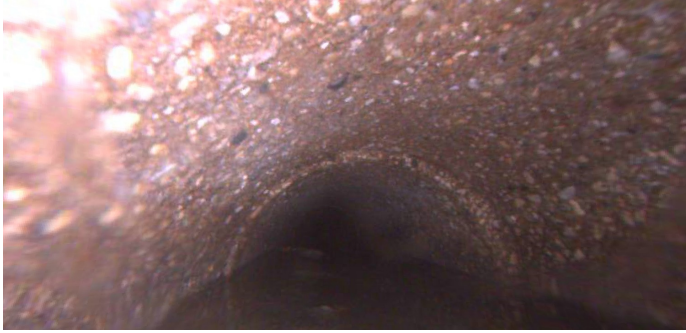
Code: **SAP**  
Description: **Surface Aggregate Projecting**

Distance (ft): **24.9**  
Structural Grade: **3**  
O&M Grade: **0**  
Clock Start/From: **8**  
Clock To: **4**  
1st Value:  
2nd Value:  
Value Percent:  
Continuous Index: **F03**  
Within 8" of Joint:  
Remarks:

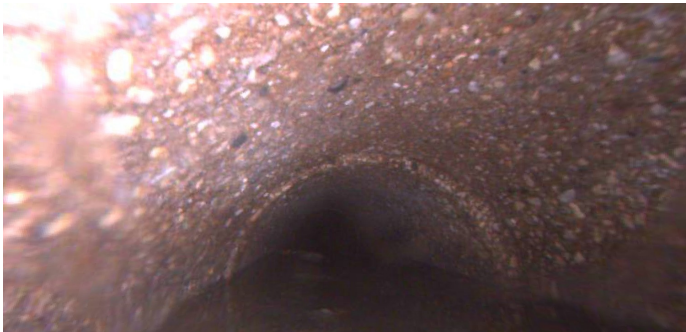
Code: **MWL**  
Description: **Water Level**

Distance (ft): **24.9**  
Structural Grade: **0**  
O&M Grade: **0**  
Clock Start/From:  
Clock To:  
1st Value:  
2nd Value:  
Value Percent: **40.000**  
Continuous Index:  
Within 8" of Joint: **NO**  
Remarks:

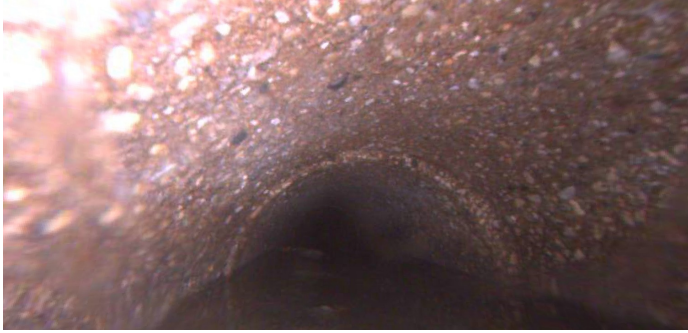
Code:	<b>MSA</b>
Description:	<b>Abandoned Survey</b>
Distance (ft):	<b>24.9</b>
Structural Grade:	<b>0</b>
O&M Grade:	<b>0</b>
Clock Start/From:	
Clock To:	
1st Value:	
2nd Value:	
Value Percent:	
Continuous Index:	
Within 8" of Joint:	<b>NO</b>
Remarks:	<b>debris under water</b>
