Profile/Photo Observation Report

Date:	04/17/2018	Weather:		Coding:	PACP 6.0
Pipe Length (ft):	231.2	Owner:	NA	Pre Clean:	Not Known
P.O.#:		Surveyor:	Byrd Fitzgerald	PSR:	P-504-102-101
Customer:		Clean Date:	01/01/1900	Shape:	C

Street:	ALLEY BETWEEN N DELAWARE ST &	Flow Control:	Not Controlled
City:	Hobart, IN	Year Renewed:	
Location:	Light Highway	Tape/Media #:	
Purpose:	Not Known	Dia/Height:	10"
Use:	Sanitary	Material:	CP
Drain Area:	NA	Lining:	
Category:	NA		
Comment:

Location Details:		Direction of Survey:	Upstream
US MH:	M-504-101	DS MH:	M-504-102
		Total Length Surveyed (ft):	26.2

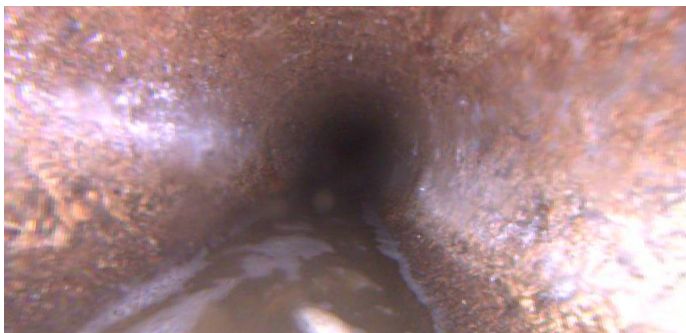
Code: **AMH**
Description: **Manhole**

Distance (ft): **.0**
Structural Grade: **0**
O&M Grade: **0**
Clock Start/From:
Clock To:
1st Value:
2nd Value:
Value Percent:
Continuous Index:
Within 8" of Joint: **NO**
Remarks: **M-504-101**

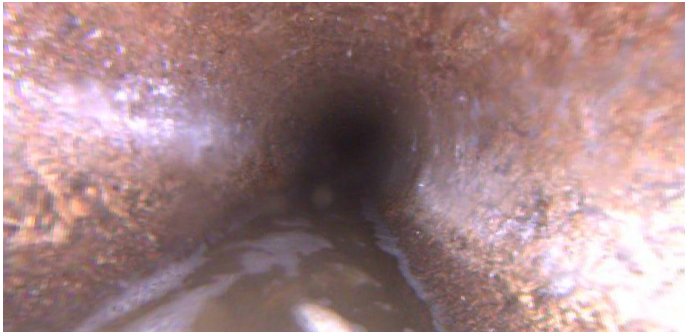
Code:	MWL
Description:	Water Level

Distance (ft):	.0
Structural Grade:	0
O&M Grade:	0
Clock Start/From:	
Clock To:	
1st Value:	
2nd Value:	
Value Percent:	5.000
Continuous Index:	
Within 8" of Joint:	NO
Remarks:

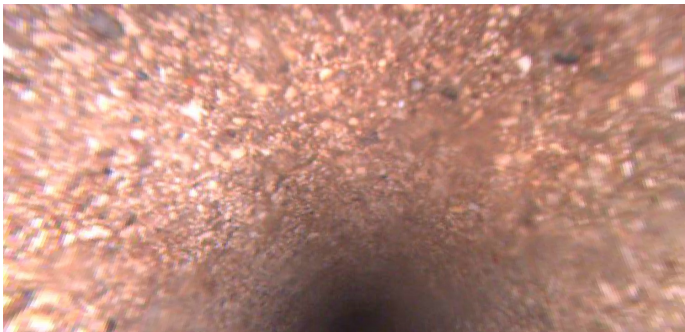
Code:	SAV
Description:	Surface Aggregate Visible

Distance (ft):	8.7
Structural Grade:	3
O&M Grade:	0
Clock Start/From:	7
Clock To:	5
1st Value:	
2nd Value:	
Value Percent:	
Continuous Index:	S01
Within 8" of Joint:	
Remarks:

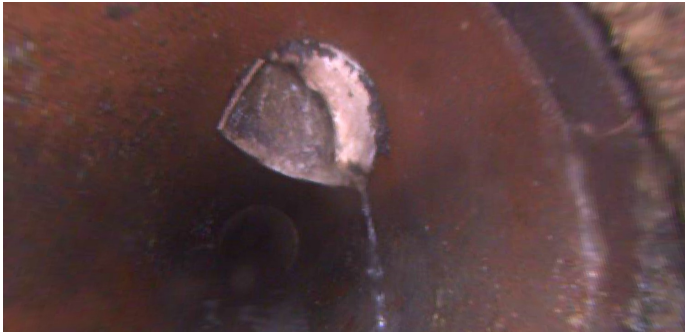
Code: **TBI**
Description: **Tap Break-in Intruding**

Distance (ft): **14.3**
Structural Grade: **0**
O&M Grade: **2**
Clock Start/From: **1**
Clock To:
1st Value: **4.000**
2nd Value: **2.000**
Value Percent:
Continuous Index:
Within 8" of Joint:
Remarks:

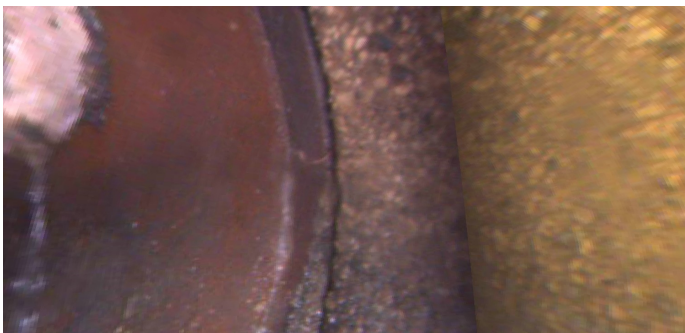
Code: **MMC**
Description: **Material Change**

Distance (ft): **14.3**
Structural Grade: **0**
O&M Grade: **0**
Clock Start/From:
Clock To:
1st Value:
2nd Value:
Value Percent:
Continuous Index:
Within 8" of Joint: **NO**
Remarks: **vcp**

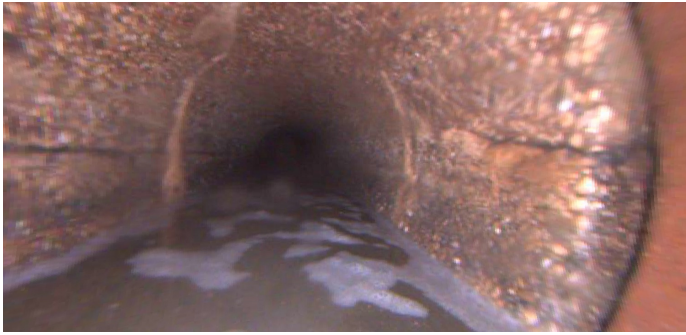
Code: **MMC**
Description: **Material Change**

Distance (ft): **17.2**
Structural Grade: **0**
O&M Grade: **0**
Clock Start/From:
Clock To:
1st Value:
2nd Value:
Value Percent:
Continuous Index:
Within 8" of Joint: **NO**
Remarks: **cp**

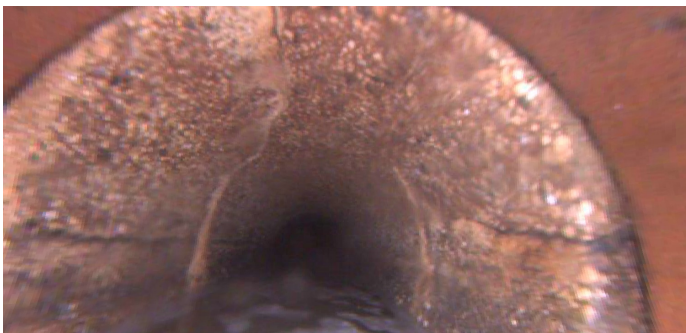
Code: **FM**
Description: **Fracture Multiple**

Distance (ft): **17.2**
Structural Grade: **4**
O&M Grade: **0**
Clock Start/From: **9**
Clock To: **3**
1st Value:
2nd Value:
Value Percent:
Continuous Index:
Within 8" of Joint: **YES**
Remarks:

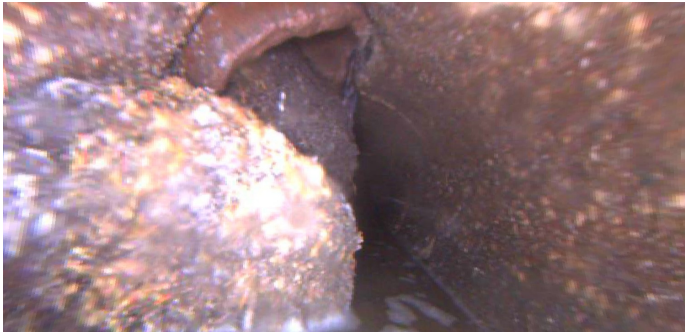
Code: **RBL**
Description: **Roots Ball Lateral**

Distance (ft): **24.4**
Structural Grade: **0**
O&M Grade: **4**
Clock Start/From: **7**
Clock To: **10**
1st Value:
2nd Value:
Value Percent: **55.000**
Continuous Index:
Within 8" of Joint: **NO**
Remarks:

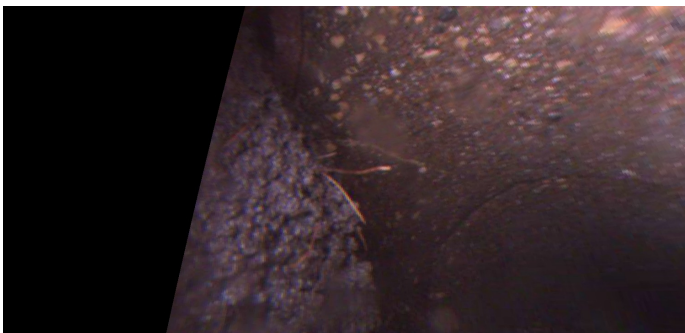
Code: **TFD**
Description: **Tap Factory Defective**

Distance (ft): **26.2**
Structural Grade: **0**
O&M Grade: **2**
Clock Start/From: **10**
Clock To:
1st Value: **4.000**
2nd Value:
Value Percent:
Continuous Index:
Within 8" of Joint:
Remarks: **blocked by rootball**

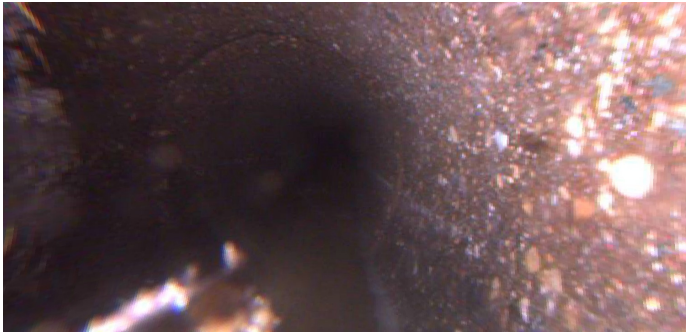
Code: **MSA**
Description: **Abandoned Survey**

Distance (ft): **26.2**
Structural Grade: **0**
O&M Grade: **0**
Clock Start/From:
Clock To:
1st Value:
2nd Value:
Value Percent:
Continuous Index:
Within 8" of Joint: **NO**
Remarks: **rbj**

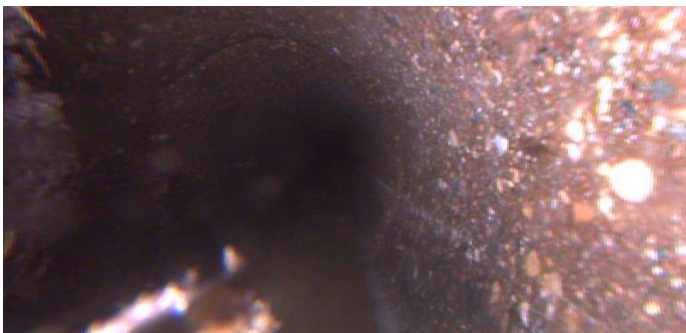
Code: **SAV**
Description: **Surface Aggregate Visible**

Distance (ft): **26.2**
Structural Grade: **3**
O&M Grade: **0**
Clock Start/From: **7**
Clock To: **5**
1st Value:
2nd Value:
Value Percent:
Continuous Index: **F01**
Within 8" of Joint:
Remarks:
