## Profile/Photo Observation Report

Street:	<b>Summerlin</b>	Flow Control:	<b>Not Controlled</b>
City:	<b>Hobart, IN</b>	Year Renewed:	
Location:	<b>Light Highway</b>	Tape/Media #:	
Purpose:	<b>Not Known</b>	Dia/Height:	<b>10"</b>
Use:	<b>Sanitary</b>	Material:	<b>CP</b>
Drain Area:	<b>NA</b>	Lining:	
Category:	<b>NA</b>		
Comment:

Location Details:		Direction of Survey:	<b>Upstream</b>
US MH:	<b>M-504-101</b>	DS MH:	<b>M-504-102</b>
		Total Length Surveyed (ft):	<b>26.2</b>

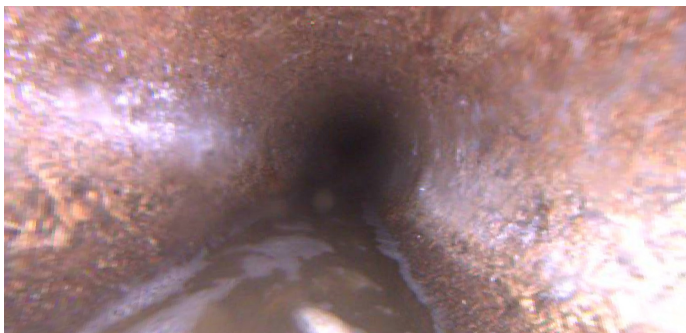
Code: **AMH**  
Description: **Manhole**

Distance (ft): **.0**  
Structural Grade: **0**  
O&M Grade: **0**  
Clock Start/From:  
Clock To:  
1st Value:  
2nd Value:  
Value Percent:  
Continuous Index:  
Within 8" of Joint: **NO**  
Remarks: **M-504-101**

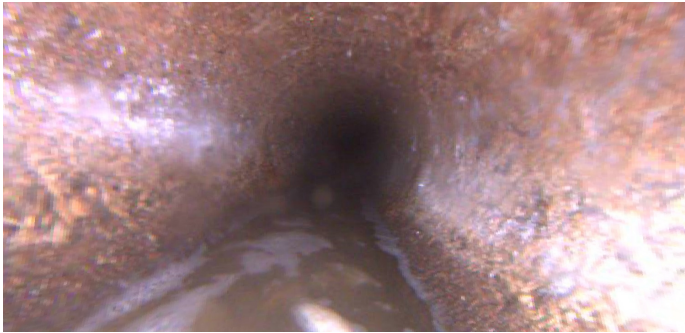
Code:	<b>MWL</b>
Description:	<b>Water Level</b>

Distance (ft):	<b>.0</b>
Structural Grade:	<b>0</b>
O&M Grade:	<b>0</b>
Clock Start/From:	
Clock To:	
1st Value:	
2nd Value:	
Value Percent:	<b>5.000</b>
Continuous Index:	
Within 8" of Joint:	<b>NO</b>
Remarks:

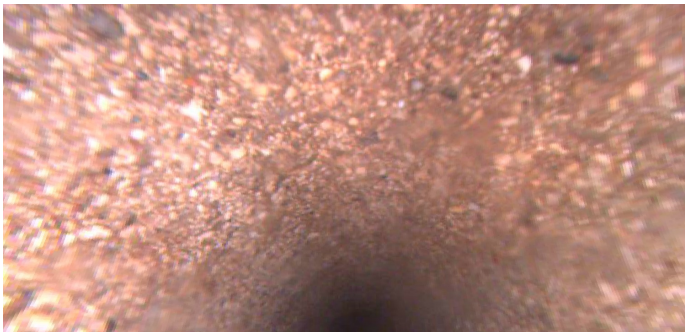
Code:	<b>SAV</b>
Description:	<b>Surface Aggregate Visible</b>

Distance (ft):	<b>8.7</b>
Structural Grade:	<b>3</b>
O&M Grade:	<b>0</b>
Clock Start/From:	<b>7</b>
Clock To:	<b>5</b>
1st Value:	
2nd Value:	
Value Percent:	
Continuous Index:	<b>S01</b>
Within 8" of Joint:	
Remarks:

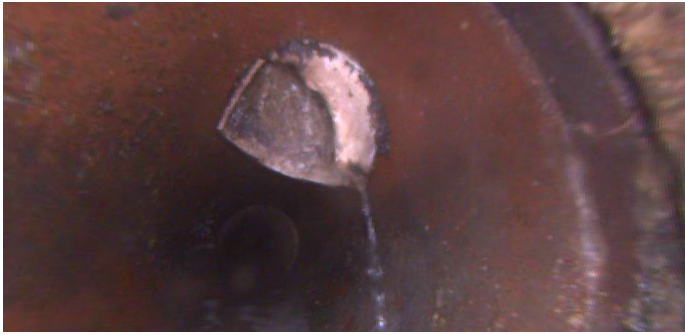
Code: **TBI**  
Description: **Tap Break-in Intruding**

Distance (ft): **14.3**  
Structural Grade: **0**  
O&M Grade: **2**  
Clock Start/From: **1**  
Clock To:  
1st Value: **4.000**  
2nd Value: **2.000**  
Value Percent:  
Continuous Index:  
Within 8" of Joint:  
Remarks:

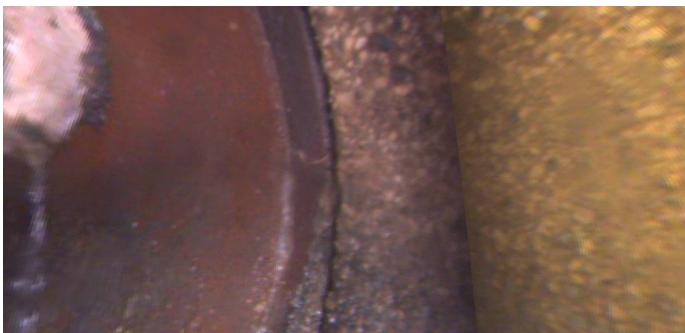
Code: **MMC**  
Description: **Material Change**

Distance (ft): **14.3**  
Structural Grade: **0**  
O&M Grade: **0**  
Clock Start/From:  
Clock To:  
1st Value:  
2nd Value:  
Value Percent:  
Continuous Index:  
Within 8" of Joint: **NO**  
Remarks: **vcp**

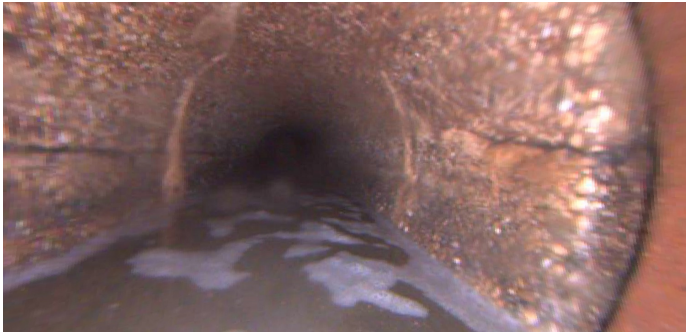
Code: **MMC**  
Description: **Material Change**

Distance (ft): **17.2**  
Structural Grade: **0**  
O&M Grade: **0**  
Clock Start/From:  
Clock To:  
1st Value:  
2nd Value:  
Value Percent:  
Continuous Index:  
Within 8" of Joint: **NO**  
Remarks: **cp**

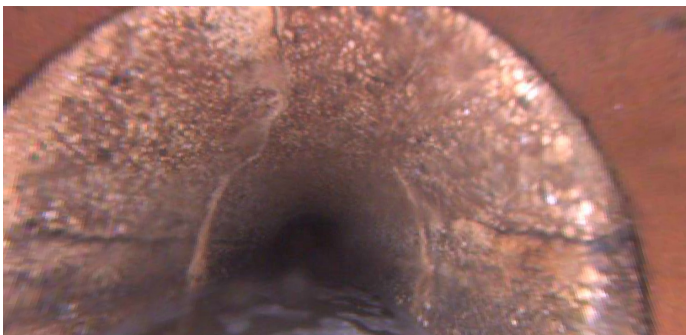
Code: **FM**  
Description: **Fracture Multiple**

Distance (ft): **17.2**  
Structural Grade: **4**  
O&M Grade: **0**  
Clock Start/From: **9**  
Clock To: **3**  
1st Value:  
2nd Value:  
Value Percent:  
Continuous Index:  
Within 8" of Joint: **YES**  
Remarks:

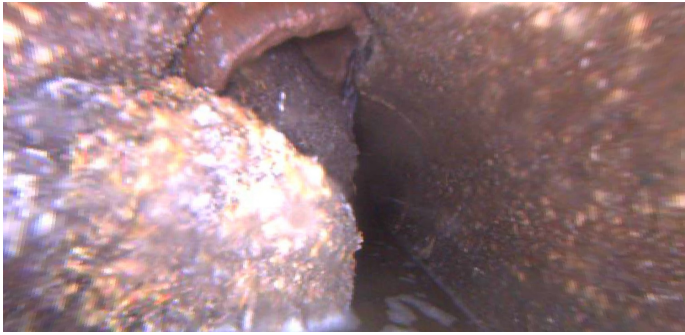
Code: **RBL**  
Description: **Roots Ball Lateral**

Distance (ft): **24.4**  
Structural Grade: **0**  
O&M Grade: **4**  
Clock Start/From: **7**  
Clock To: **10**  
1st Value:  
2nd Value:  
Value Percent: **55.000**  
Continuous Index:  
Within 8" of Joint: **NO**  
Remarks:

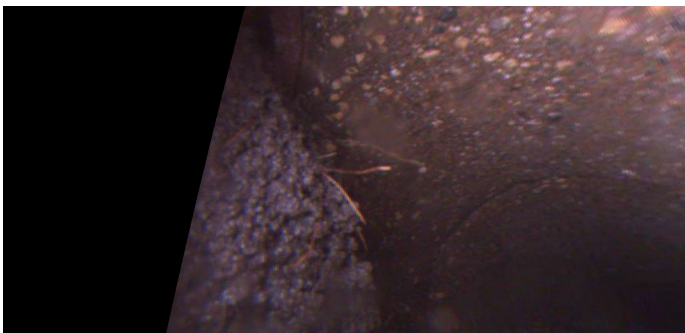
Code: **TFD**  
Description: **Tap Factory Defective**

Distance (ft): **26.2**  
Structural Grade: **0**  
O&M Grade: **2**  
Clock Start/From: **10**  
Clock To:  
1st Value: **4.000**  
2nd Value:  
Value Percent:  
Continuous Index:  
Within 8" of Joint:  
Remarks: **blocked by rootball**

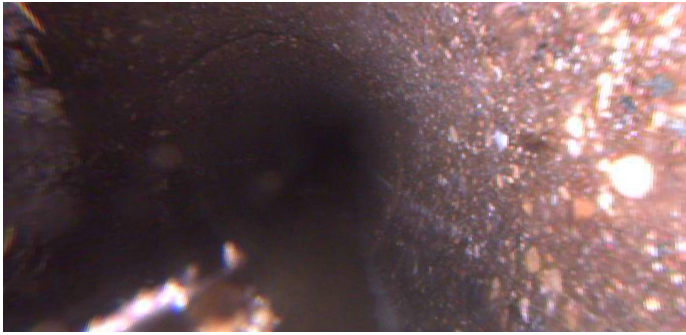
Code: **MSA**  
Description: **Abandoned Survey**

Distance (ft): **26.2**  
Structural Grade: **0**  
O&M Grade: **0**  
Clock Start/From:  
Clock To:  
1st Value:  
2nd Value:  
Value Percent:  
Continuous Index:  
Within 8" of Joint: **NO**  
Remarks: **rbj**

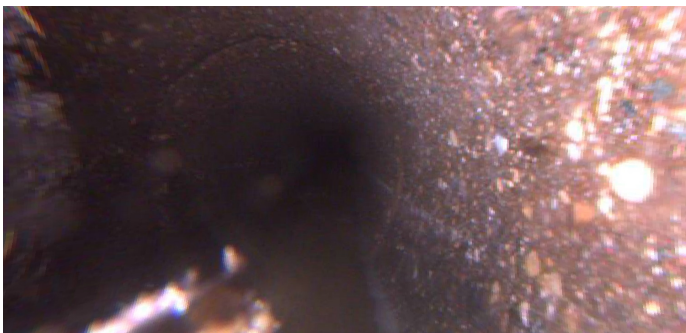
Code: **SAV**  
Description: **Surface Aggregate Visible**

Distance (ft): **26.2**  
Structural Grade: **3**  
O&M Grade: **0**  
Clock Start/From: **7**  
Clock To: **5**  
1st Value:  
2nd Value:  
Value Percent:  
Continuous Index: **F01**  
Within 8" of Joint:  
Remarks:
