## **Profile/Photo Observation Report**

RUBUTICS
Date: Pipe Length (ft):	09/11/2021 231.0	Weather: Owner:	City of Hobart	0	PACP 7.0 Light Cleaning
P.O.#:	YES502259	Surveyor:	S. Bucklin		P-504-102-101
Customer:	City of Hobart	, Clean Date:	08/27/2021		с
Street:	North Delaware St	reet	Flow Control:	Not Controlled	
City:	Hobart, IN		Year Renewed:		
Location:	Alley		Tape/Media #:		
Purpose:	Routine Assessme	nt	Dia/Height:	10"	
Use:	Sanitary Sewage P	ipe	Material:	СР	
Drain Area:			Lining:	None	
Category:	NA				
Comment:					
Location Details	:		Direction of Survey	: Upstream	
US MH:	M-504-101	DS MH:	M-504-102	Total Length Surveyed (ft):	207.4
)&M Index:	1.97	O&M Quick:	4136	O&M Rating:	154.00
tructural Index:	2.97	 Structural Qui	ck: 514A	Structural Rating:	116.00
verall Index:	2.31	Overall Quick:	54.44	Overall Rating:	270.00

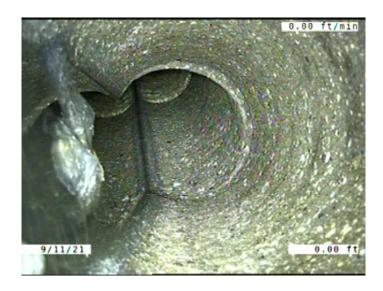
Code:	DSF
Description:	Deposits Settled Fine
Distance (ft): Structural Grade: O&M Grade: Clock Start/From: Clock To: 1st Value: 2nd Value: Value Percent: Continuous Index: Within 8" of Joint: Remarks:	.0 0 2 5 7 5.000 S01 YES

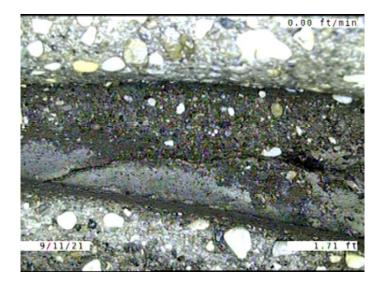
FS Fracture Spiral
Fracture Spiral
1.7
3
0
2
3
YES

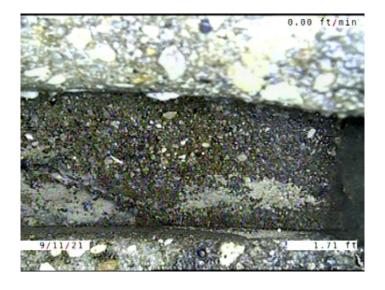
Code: Description:	JAL Joint Angular Large
Distance (ft):	1.7
Structural Grade:	4
O&M Grade:	0
Clock Start/From:	
Clock To:	
1st Value:	
2nd Value:	
Value Percent:	
Continuous Index:	
Within 8" of Joint:	NO
Remarks:

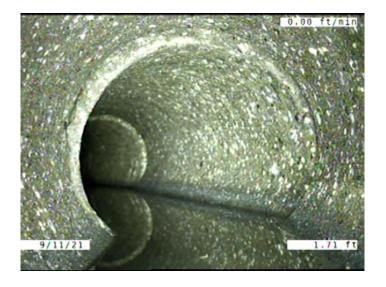
Code:	LL
Description:	Line Left
	4 7
Distance (ft):	1.7
Structural Grade:	0
O&M Grade:	4
Clock Start/From:	
Clock To:	
1st Value:	
2nd Value:	
Value Percent:	30.000
Continuous Index:	
Within 8" of Joint:	NO
Remarks:

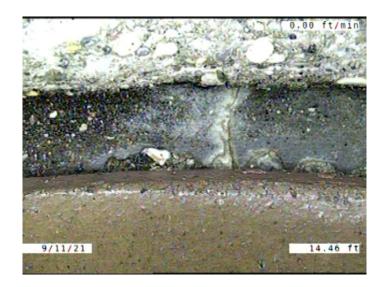
Code:	CL
Description:	Crack Longitudinal
Distance (ft): Structural Grade: O&M Grade: Clock Start/From: Clock To: 1st Value: 2nd Value: Value Percent: Continuous Index: Within 8" of Joint: Remarks:	14.5 2 0 10 YES

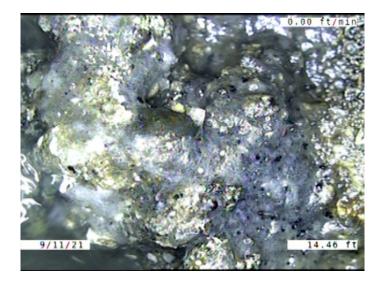
Code:	DAE
Description:	Deposits Attached Encrustation
Distance (ft):	14.5
Structural Grade:	0
O&M Grade:	2
Clock Start/From:	6
Clock To:	9
1st Value:	
2nd Value:	
Value Percent:	5.000
Continuous Index:	
Within 8" of Joint:	YES
Remarks:

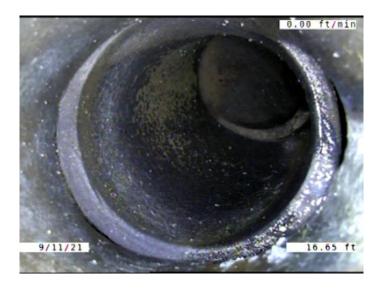
Code:	TFD
Description:	Tap Factory Defective
Distance (ft): Structural Grade: O&M Grade: Clock Start/From: Clock To: 1st Value: 2nd Value: Value Percent: Continuous Index:	16.7 0 3 1 4.000
Within 8" of Joint:	YES
Remarks:	Defective

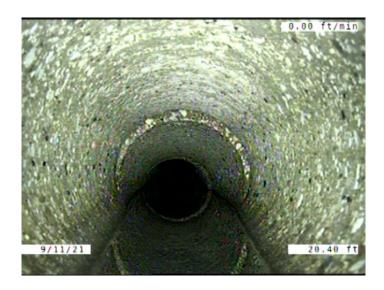
Code: Description:	MWLS Miscellaneous Water Level Sag
Distance (ft):	20.4
Structural Grade:	2
O&M Grade:	0
Clock Start/From:	
Clock To:	
1st Value:	
2nd Value:	
Value Percent:	20.000
Continuous Index:	S02
Within 8" of Joint:	NO
Remarks:

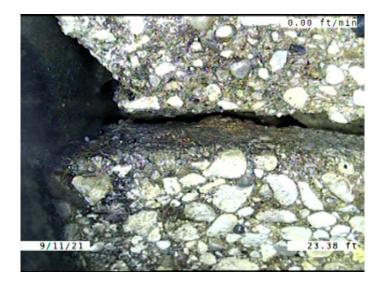
Code: Description:	BSV Broken Soil Visible
Distance (ft):	23.4
Structural Grade:	5
O&M Grade:	0
Clock Start/From:	8
Clock To:	10
1st Value:	
2nd Value:	
Value Percent:	
Continuous Index:	
Within 8" of Joint:	YES
Remarks:

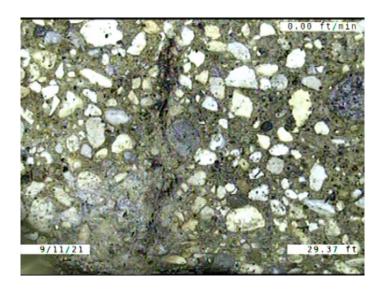
Code: Description:	FL Fracture Longitudinal
Distance (ft): Structural Grade: O&M Grade: Clock Start/From: Clock To: 1st Value: 2nd Value: Value Percent: Continuous Index: Within 8" of Joint:	29.4 3 0 12 YES
Remarks:

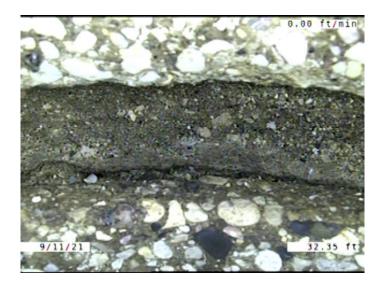
Code: Description:	JAM Joint Angular Medium
Distance (ft):	32.3
Structural Grade:	3
O&M Grade:	0
Clock Start/From:	
Clock To:	
1st Value:	
2nd Value:	
Value Percent:	
Continuous Index:	
Within 8" of Joint:	NO
Remarks:

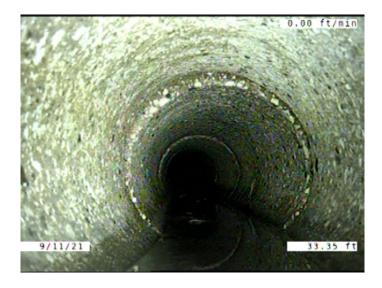
Code: Description:	MWLS Miscellaneous Water Level Sag
Distance (ft):	33.3
Structural Grade:	2
O&M Grade:	0
Clock Start/From:	
Clock To:	
1st Value:	
2nd Value:	
Value Percent:	20.000
Continuous Index:	F02
Within 8" of Joint:	NO
Remarks:

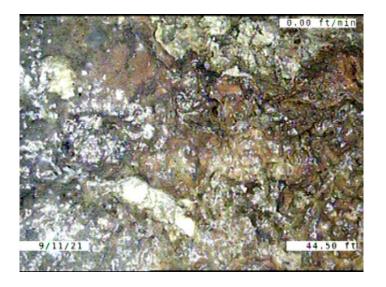
Code: Description:	DAE Deposits Attached Encrustation
Distance (ft):	44.5
Structural Grade:	0
O&M Grade:	2
Clock Start/From:	3
Clock To:	5
1st Value:	
2nd Value:	
Value Percent:	5.000
Continuous Index:	
Within 8" of Joint:	YES
Remarks:

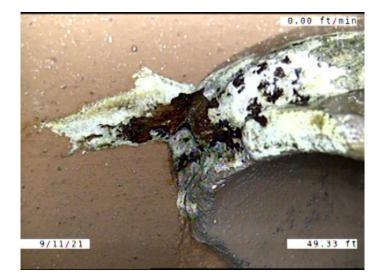
Code:	В
Description:	Broken
Distance (ft):	49.3
Structural Grade:	4
O&M Grade:	0
Clock Start/From:	12
Clock To:	3
1st Value:	
2nd Value:	
Value Percent:	
Continuous Index:	
Within 8" of Joint:	NO
Remarks:

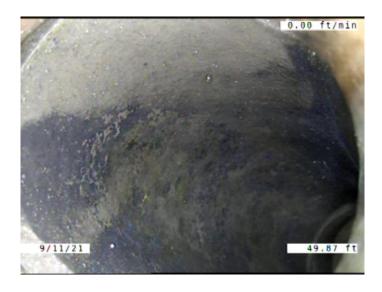
Code: Description:	TBI Tap Break-in Intruding
Distance (ft): Structural Grade: O&M Grade: Clock Start/From: Clock To: 1st Value: 2nd Value: Value Percent: Continuous Index: Within 8" of Joint: Remarks:	49.9 0 2 1 4.000 1.000 YES

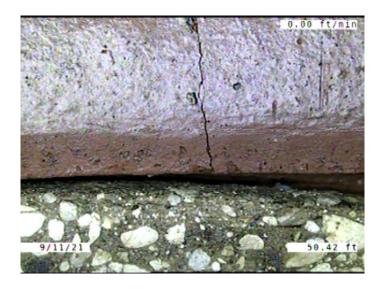
Code: Description:	CL Crack Longitudinal
Distance (ft): Structural Grade: O&M Grade: Clock Start/From: Clock To: 1st Value: 2nd Value: Value Percent: Continuous Index: Within 8" of Joint: Remarks:	50.4 2 0 11 YES

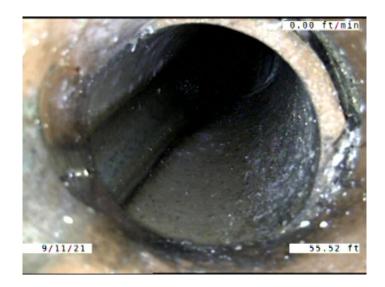
Code:	TFD
Description:	Tap Factory Defective
Distance (ft):	55.5
Structural Grade:	0
O&M Grade:	3
Clock Start/From:	11
Clock To: 1st Value: 2nd Value:	4.000
Value Percent: Continuous Index: Within 8" of Joint: Remarks:	YES Defective

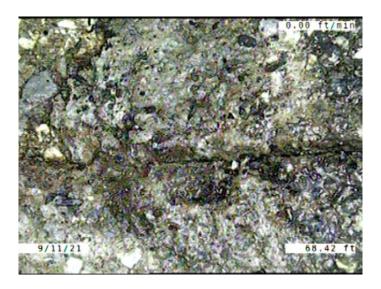
Code: Description:	DAE Deposits Attached Encrustation
Distance (ft): Structural Grade: O&M Grade: Clock Start/From: Clock To: 1st Value: 2nd Value: Value Percent: Continuous Index: Within 8" of Joint: Remarks:	68.4 0 2 8 10 5.000 YES
Actual K3.

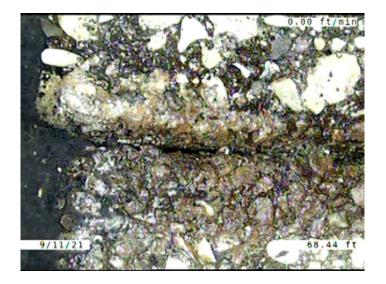
Code: Description:	ISJ Infiltration Stain Joint
Distance (ft):	68.4
Structural Grade:	0
O&M Grade:	1
Clock Start/From:	2
Clock To:	4
1st Value:	
2nd Value:	
Value Percent:	
Continuous Index:	
Within 8" of Joint:	YES
Remarks:

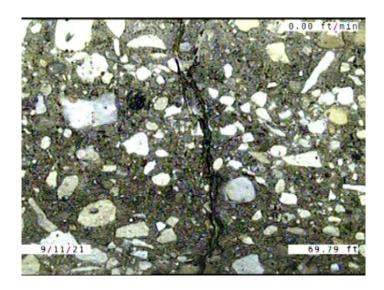
Code: Description:	FM Fracture Multiple
Distance (ft):	69.8
Structural Grade:	4
O&M Grade:	0
Clock Start/From:	11
Clock To:	1
1st Value:	
2nd Value:	
Value Percent:	
Continuous Index:	S03
Within 8" of Joint:	YES
Remarks:

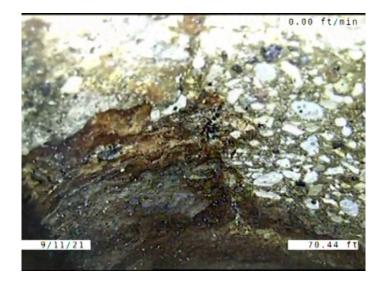
Code: Description:	DAE Deposits Attached Encrustation
Distance (ft):	70.4
Structural Grade:	0
O&M Grade:	2
Clock Start/From:	8
Clock To:	1
1st Value:	
2nd Value:	
Value Percent:	5.000
Continuous Index:	
Within 8" of Joint:	YES
Remarks:

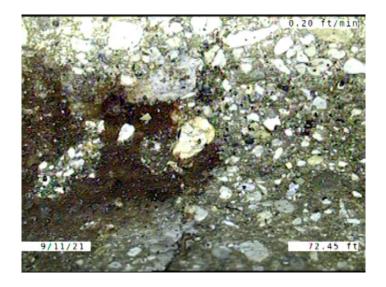
Code: Description:	CM Crack Multiple
Distance (ft):	72.4
Structural Grade:	3
O&M Grade:	0
Clock Start/From:	8
Clock To:	9
1st Value:	
2nd Value:	
Value Percent:	
Continuous Index:	
Within 8" of Joint:	YES
Remarks:

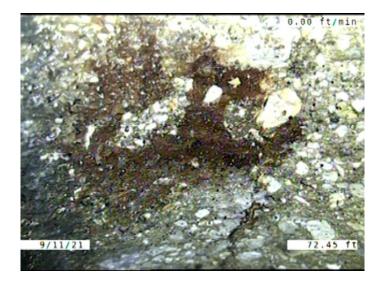
Code: Description:	ISB Infiltration Stain Barrel
Distance (ft):	72.4
Structural Grade:	0
O&M Grade:	1
Clock Start/From:	8
Clock To:	9
1st Value:	
2nd Value:	
Value Percent:	
Continuous Index:	
Within 8" of Joint:	NO
Remarks:

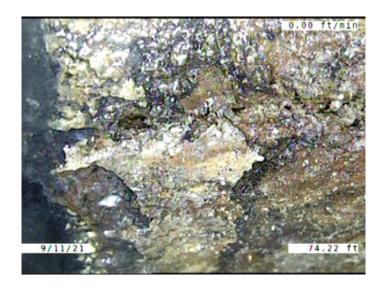
Code: Description:	DAE Deposits Attached Encrustation
Distance (ft): Structural Grade: O&M Grade: Clock Start/From: Clock To: 1st Value: 2nd Value: Value Percent: Continuous Index: Within 8" of Joint: Remarks:	74.2 0 2 8 11 5.000 YES

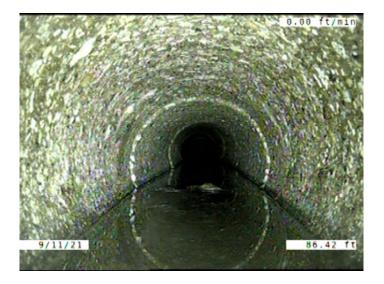
Code:	FM
Description:	Fracture Multiple
Distance (ft):	86.4
. ,	
Structural Grade:	4
O&M Grade:	0
Clock Start/From:	11
Clock To:	1
1st Value:	
2nd Value:	
Value Percent:	
Continuous Index:	F03
Within 8" of Joint:	YES
Remarks:

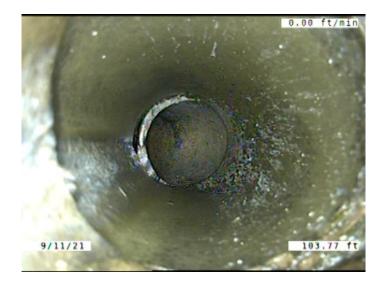
Code:	ТВІ
Description:	Tap Break-in Intruding
	400.4
Distance (ft):	103.4
Structural Grade:	0
O&M Grade:	2
Clock Start/From:	11
Clock To:	
1st Value:	4.000
2nd Value:	1.000
Value Percent:	
Continuous Index:	
Within 8" of Joint:	YES
Remarks:

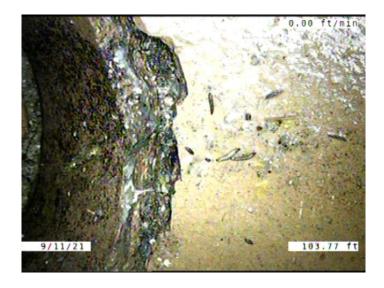
Code: Description:	B Broken
Distance (ft):	103.8
Structural Grade:	4
O&M Grade:	0
Clock Start/From:	10
Clock To:	12
1st Value:	
2nd Value:	
Value Percent:	
Continuous Index:	
Within 8" of Joint:	YES
Remarks:

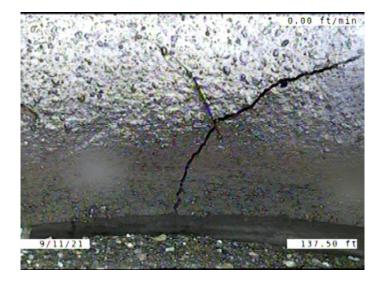
Code: Description:	FM Fracture Multiple
Distance (ft): Structural Grade: O&M Grade: Clock Start/From: Clock To: 1st Value: 2nd Value: Value Percent: Continuous Index: Within 8" of Joint:	137.5 4 0 11 3 YES
Remarks:

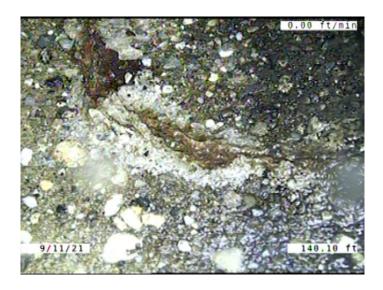
Code: Description:	CM Crack Multiple
Distance (ft):	140.1
Structural Grade:	3
O&M Grade:	0
Clock Start/From:	7
Clock To:	8
1st Value:	
2nd Value:	
Value Percent:	
Continuous Index:	
Within 8" of Joint:	YES
Remarks:

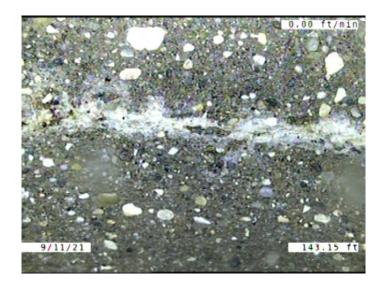
Code: Description:	CM Crack Multiple
Distance (ft):	143.1
Structural Grade:	3
O&M Grade:	0
Clock Start/From:	12
Clock To:	12
1st Value:	
2nd Value:	
Value Percent:	
Continuous Index:	
Within 8" of Joint:	YES
Remarks:

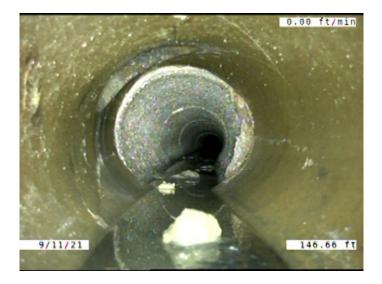
Code:	В
Description:	Broken
Distance (ft):	146.7
	140.7
Structural Grade:	4
O&M Grade:	0
Clock Start/From:	12
Clock To:	12
1st Value:	
2nd Value:	
Value Percent:	
Continuous Index:	
Within 8" of Joint:	YES
Remarks:

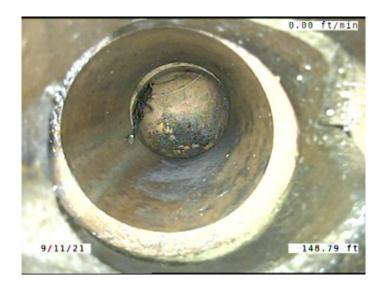
Code: Description:	TFD Tap Factory Defective
Distance (ft): Structural Grade: O&M Grade: Clock Start/From: Clock To: 1st Value: 2nd Value: Value Percent:	148.8 0 3 11 4.000
Continuous Index: Within 8" of Joint: Remarks:	YES Defective

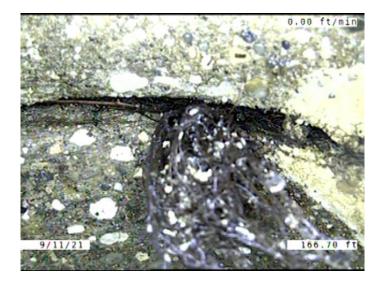
Code:	RFJ
Description:	<b>Roots Fine Joint</b>
Distance (ft):	166.7
Structural Grade:	0
O&M Grade:	1
Clock Start/From:	1
Clock To:	4
1st Value:	
2nd Value:	
Value Percent:	
Continuous Index:	
Within 8" of Joint:	YES
Remarks:

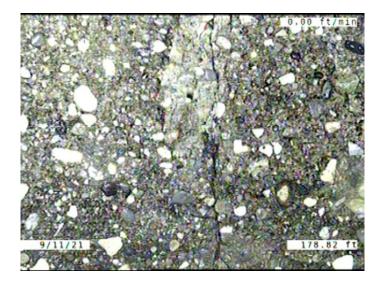
Code:	СМ
Description:	Crack Multiple
Distance (ft):	178.8
Structural Grade:	3
O&M Grade:	0
Clock Start/From:	9
Clock To:	10
1st Value:	
2nd Value:	
Value Percent:	
Continuous Index:	
Within 8" of Joint:	YES
Remarks:

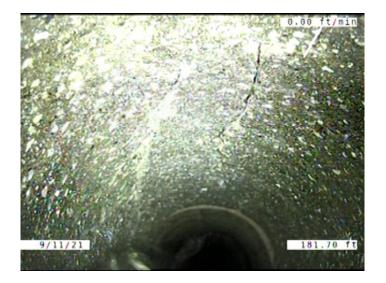
FM
Fracture Multiple
181.7
4
0
7
4
S06
YES

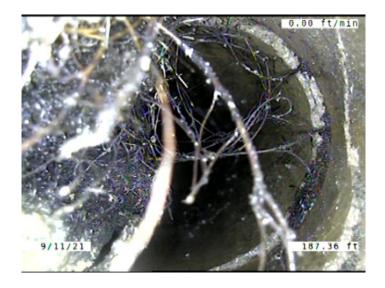
Code: Description:	TFD Tap Factory Defective
Distance (ft): Structural Grade: O&M Grade: Clock Start/From: Clock To: 1st Value: 2nd Value:	187.4 0 3 11 4.000
Value Percent: Continuous Index: Within 8" of Joint: Remarks:	YES Defective

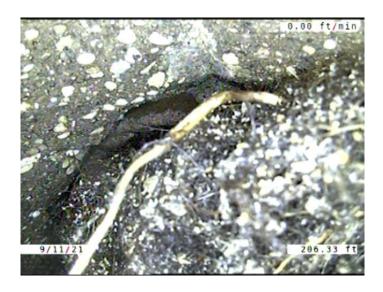
TBD Tap Break-in/Hammer Defective
206.3
0
3
1
4.000
YES
100% PLUGGED WITH ROOTS

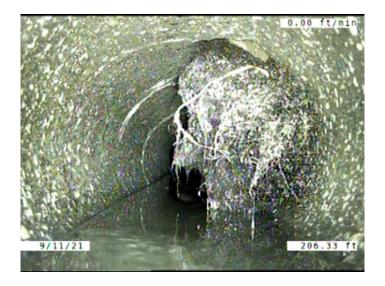
Code: Description:	RML Roots Medium Lateral
Distance (ft):	206.3
Structural Grade:	0
O&M Grade:	3
Clock Start/From:	12
Clock To:	5
1st Value:	
2nd Value:	
Value Percent:	45.000
Continuous Index:	
Within 8" of Joint:	NO
Remarks:

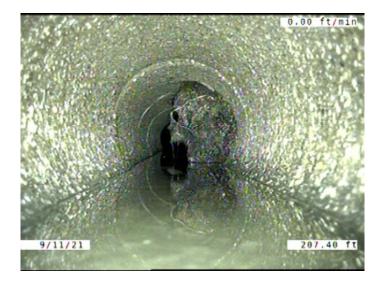
Code:	FM
Description:	Fracture Multiple
Distance (ft):	207.4
Structural Grade:	4
O&M Grade:	0
Clock Start/From:	7
Clock To:	4
1st Value:	
2nd Value:	
Value Percent:	
Continuous Index:	F06
Within 8" of Joint:	YES
Remarks:

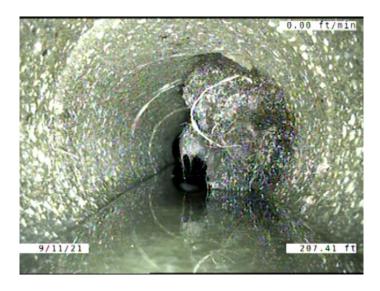
Code: Description:	MSA Miscellaneous Survey Abandoned
Distance (ft):	207.4
Structural Grade:	0
O&M Grade:	0
Clock Start/From:	
Clock To:	
1st Value:	
2nd Value:	
Value Percent:	
Continuous Index:	
Within 8" of Joint:	NO
Remarks:	CAMERA CANT MAKE IT PAST ROOTS.
