RedZone
ROBOTICS

Street:	North Delaware Street		Flow Control:	Not Controlled	
City:	Hobart, IN		Year Renewed:		
Location:	Alley		Tape/Media #:		
Purpose:	Routine Assessment		Dia/Height:	10"	
Use:	Sanitary Sewage Pipe		Material:	CP	
Drain Area:			Lining:	None	
Category:	NA				
Comment:					
Location Details:			Direction of Survey:	Upstream	
US MH:	M-504-101	DS MH:	M-504-102	Total Length Surveyed (ft):	207.4

O&M Index:	1.97	O&M Quick:	4136	O&M Rating:	154.00
Structural Index:	2.97	Structural Quick:	514A	Structural Rating:	116.00
Overall Index:	2.31	Overall Quick:	514A	Overall Rating:	270.00

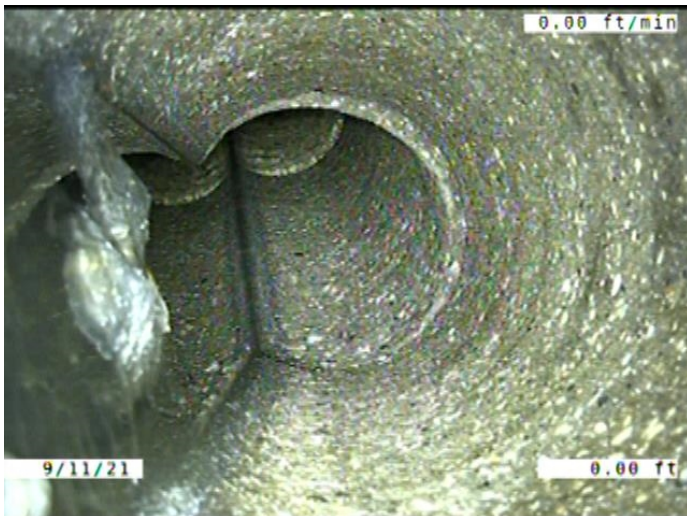
Code: **DSF**
 Description: **Deposits Settled Fine**

Distance (ft): **.0**
 Structural Grade: **0**
 O&M Grade: **2**
 Clock Start/From: **5**
 Clock To: **7**
 1st Value:
 2nd Value:
 Value Percent: **5.000**
 Continuous Index: **S01**
 Within 8" of Joint: **YES**
 Remarks:

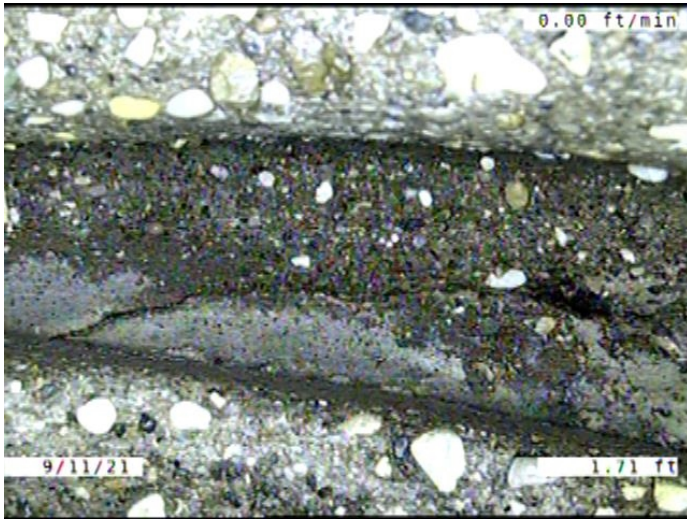
Code: **FS**
 Description: **Fracture Spiral**

Distance (ft): **1.7**
 Structural Grade: **3**
 O&M Grade: **0**
 Clock Start/From: **2**
 Clock To: **3**
 1st Value:
 2nd Value:
 Value Percent:
 Continuous Index:
 Within 8" of Joint: **YES**
 Remarks:

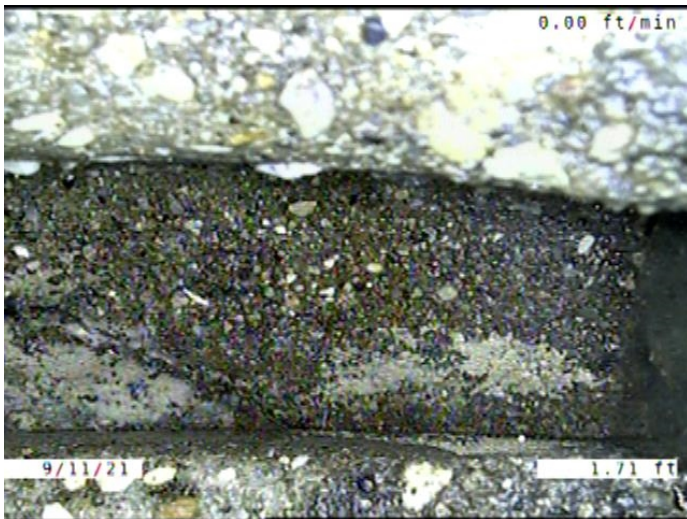
Code: **JAL**
 Description: **Joint Angular Large**

Distance (ft): **1.7**
 Structural Grade: **4**
 O&M Grade: **0**
 Clock Start/From:
 Clock To:
 1st Value:
 2nd Value:
 Value Percent:
 Continuous Index:
 Within 8" of Joint: **NO**
 Remarks:

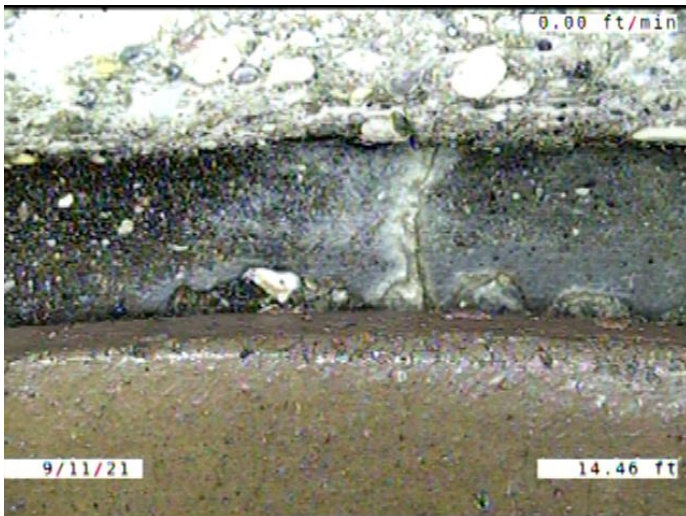
Code: **CL**
 Description: **Crack Longitudinal**

Distance (ft): **14.5**
 Structural Grade: **2**
 O&M Grade: **0**
 Clock Start/From: **10**
 Clock To:
 1st Value:
 2nd Value:
 Value Percent:
 Continuous Index:
 Within 8" of Joint: **YES**
 Remarks:

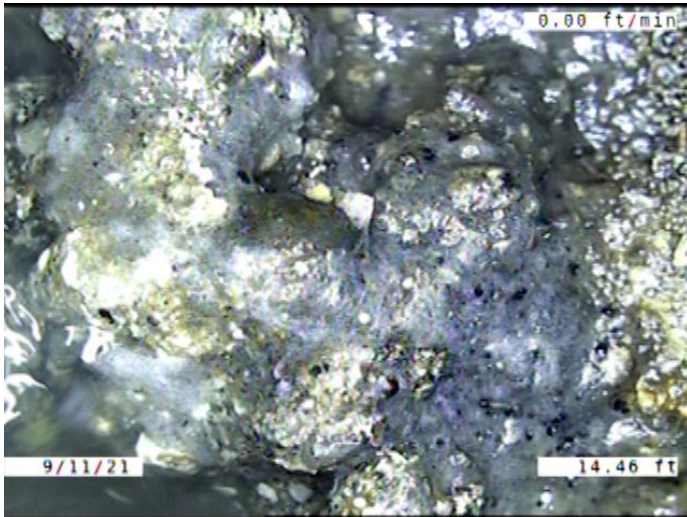
Code: **DAE**
 Description: **Deposits Attached Encrustation**

Distance (ft): **14.5**
 Structural Grade: **0**
 O&M Grade: **2**
 Clock Start/From: **6**
 Clock To: **9**
 1st Value:
 2nd Value:
 Value Percent: **5.000**
 Continuous Index:
 Within 8" of Joint: **YES**
 Remarks:

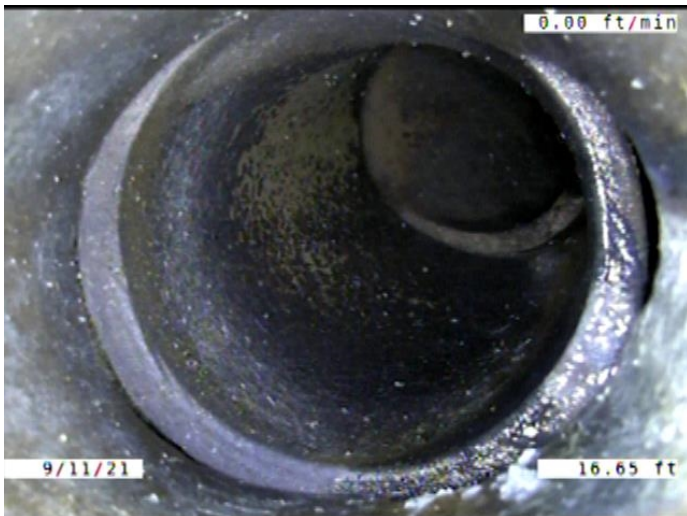
Code: **TFD**
 Description: **Tap Factory Defective**

Distance (ft): **16.7**
 Structural Grade: **0**
 O&M Grade: **3**
 Clock Start/From: **1**
 Clock To:
 1st Value: **4.000**
 2nd Value:
 Value Percent:
 Continuous Index:
 Within 8" of Joint: **YES**
 Remarks: **Defective**

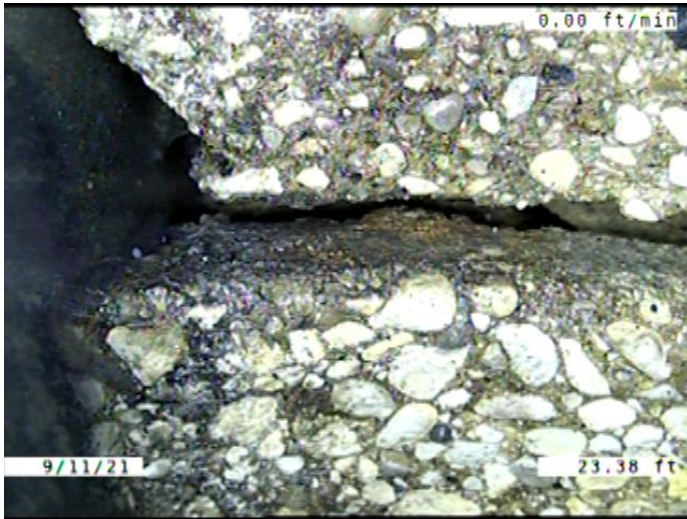
Code: **BSV**
 Description: **Broken Soil Visible**

Distance (ft): **23.4**
 Structural Grade: **5**
 O&M Grade: **0**
 Clock Start/From: **8**
 Clock To: **10**
 1st Value:
 2nd Value:
 Value Percent:
 Continuous Index:
 Within 8" of Joint: **YES**
 Remarks:

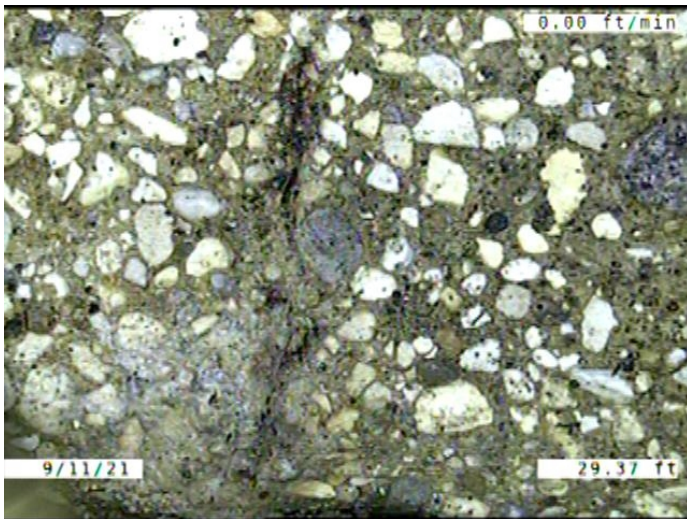
Code: **FL**
 Description: **Fracture Longitudinal**

Distance (ft): **29.4**
 Structural Grade: **3**
 O&M Grade: **0**
 Clock Start/From: **12**
 Clock To:
 1st Value:
 2nd Value:
 Value Percent:
 Continuous Index:
 Within 8" of Joint: **YES**
 Remarks:

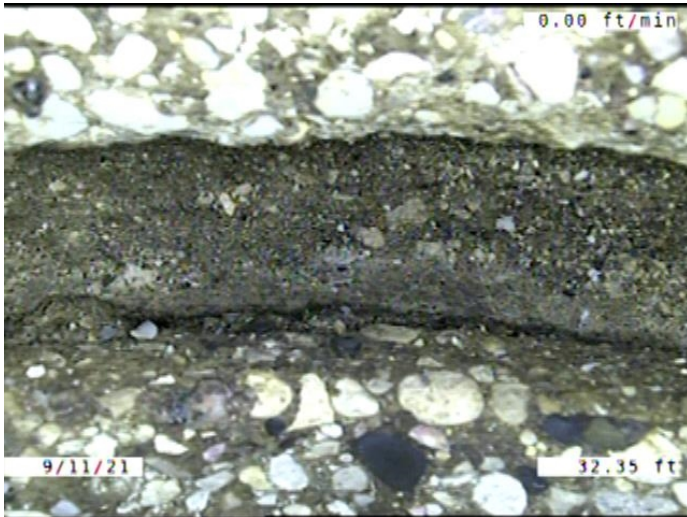
Code: **JAM**
 Description: **Joint Angular Medium**

Distance (ft): **32.3**
 Structural Grade: **3**
 O&M Grade: **0**
 Clock Start/From:
 Clock To:
 1st Value:
 2nd Value:
 Value Percent:
 Continuous Index:
 Within 8" of Joint: **NO**
 Remarks:

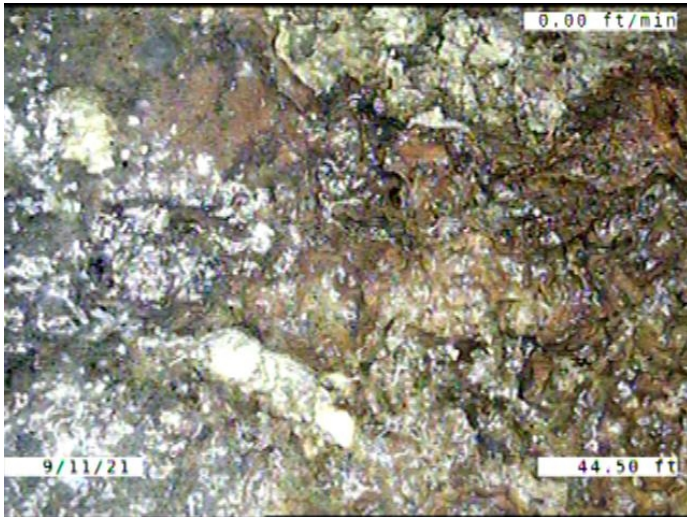
Code: **DAE**
 Description: **Deposits Attached Encrustation**

Distance (ft): **44.5**
 Structural Grade: **0**
 O&M Grade: **2**
 Clock Start/From: **3**
 Clock To: **5**
 1st Value:
 2nd Value:
 Value Percent: **5.000**
 Continuous Index:
 Within 8" of Joint: **YES**
 Remarks:

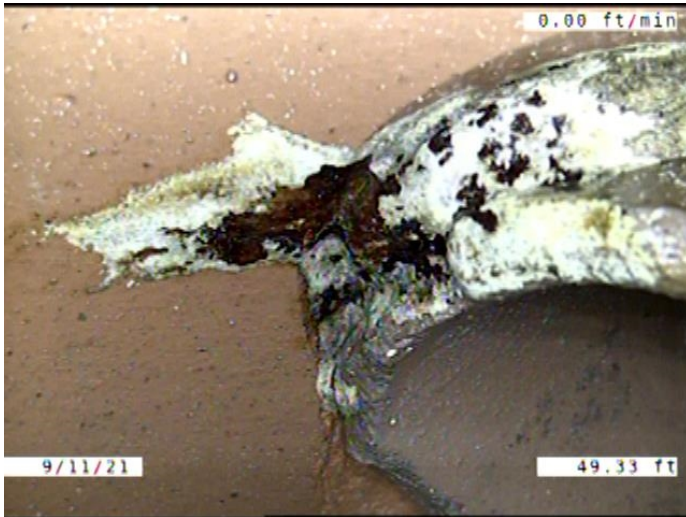
Code: **B**
 Description: **Broken**

Distance (ft): **49.3**
 Structural Grade: **4**
 O&M Grade: **0**
 Clock Start/From: **12**
 Clock To: **3**
 1st Value:
 2nd Value:
 Value Percent:
 Continuous Index:
 Within 8" of Joint: **NO**
 Remarks:

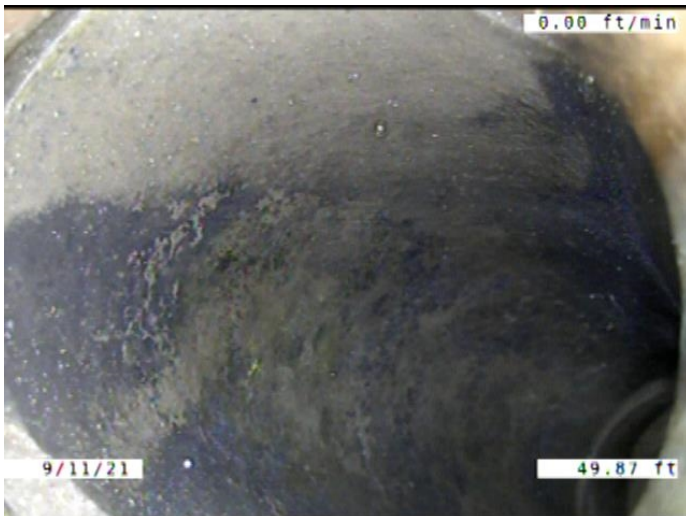
Code: **TBI**
 Description: **Tap Break-in Intruding**

Distance (ft): **49.9**
 Structural Grade: **0**
 O&M Grade: **2**
 Clock Start/From: **1**
 Clock To:
 1st Value: **4.000**
 2nd Value: **1.000**
 Value Percent:
 Continuous Index:
 Within 8" of Joint: **YES**
 Remarks:

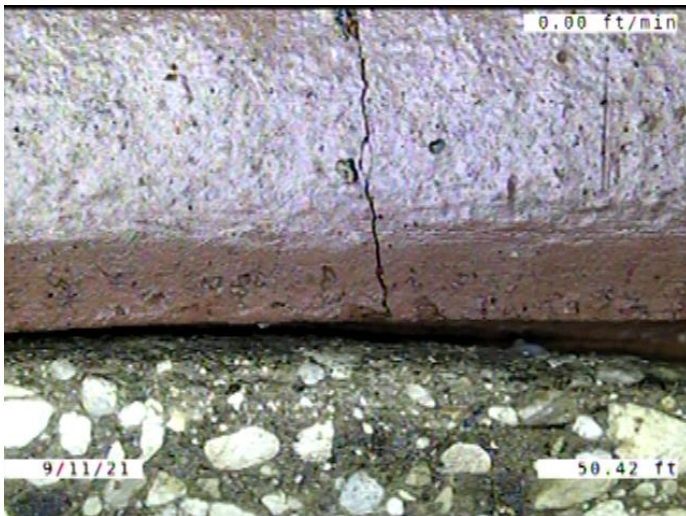
Code: **CL**
 Description: **Crack Longitudinal**

Distance (ft): **50.4**
 Structural Grade: **2**
 O&M Grade: **0**
 Clock Start/From: **11**
 Clock To:
 1st Value:
 2nd Value:
 Value Percent:
 Continuous Index:
 Within 8" of Joint: **YES**
 Remarks:

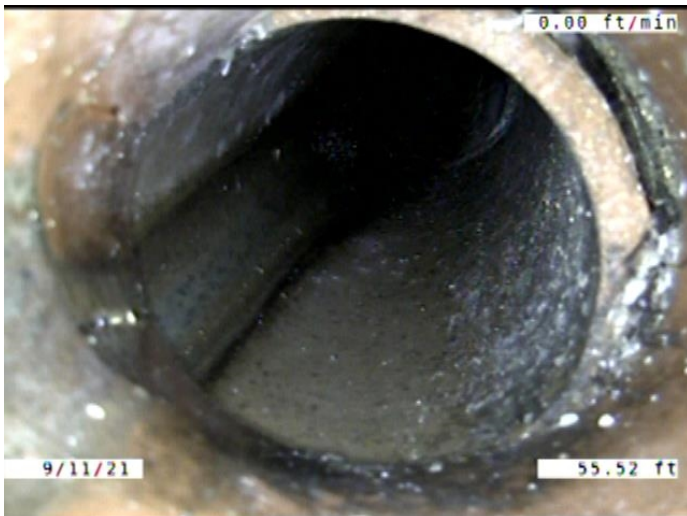
Code: **TFD**
 Description: **Tap Factory Defective**

Distance (ft): **55.5**
 Structural Grade: **0**
 O&M Grade: **3**
 Clock Start/From: **11**
 Clock To:
 1st Value: **4.000**
 2nd Value:
 Value Percent:
 Continuous Index:
 Within 8" of Joint: **YES**
 Remarks: **Defective**

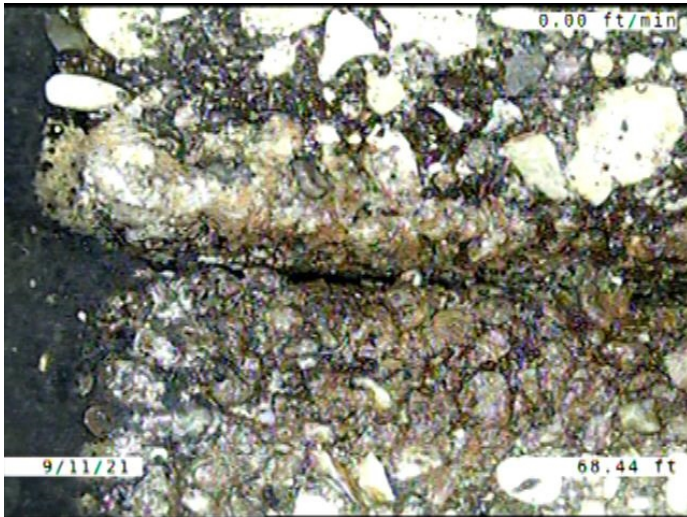
Code: **ISJ**
 Description: **Infiltration Stain Joint**

Distance (ft): **68.4**
 Structural Grade: **0**
 O&M Grade: **1**
 Clock Start/From: **2**
 Clock To: **4**
 1st Value:
 2nd Value:
 Value Percent:
 Continuous Index:
 Within 8" of Joint: **YES**
 Remarks:

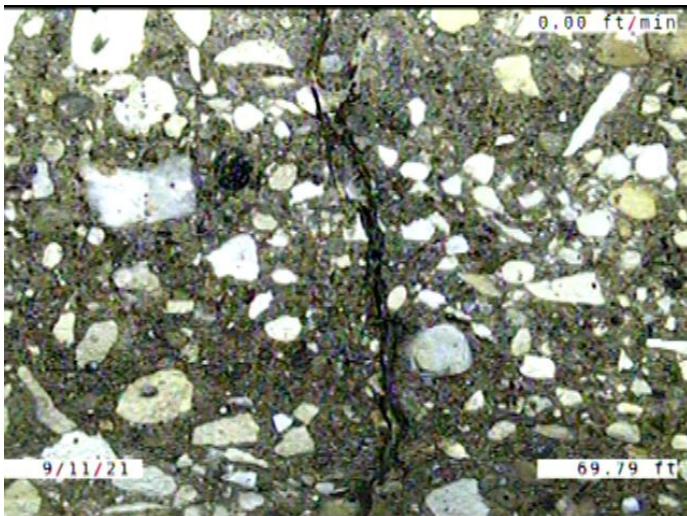
Code: **FM**
 Description: **Fracture Multiple**

Distance (ft): **69.8**
 Structural Grade: **4**
 O&M Grade: **0**
 Clock Start/From: **11**
 Clock To: **1**
 1st Value:
 2nd Value:
 Value Percent:
 Continuous Index: **S03**
 Within 8" of Joint: **YES**
 Remarks:

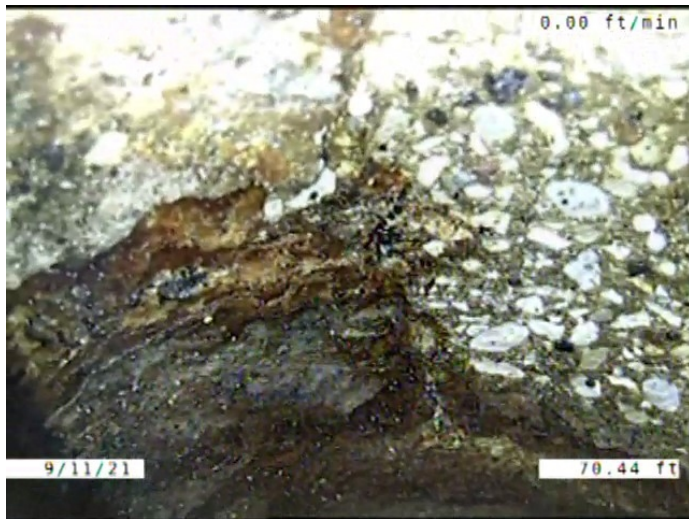
Code:	DAE
Description:	Deposits Attached Encrustation
Distance (ft):	70.4
Structural Grade:	0
O&M Grade:	2
Clock Start/From:	8
Clock To:	1
1st Value:	
2nd Value:	
Value Percent:	5.000
Continuous Index:	
Within 8" of Joint:	YES
Remarks:

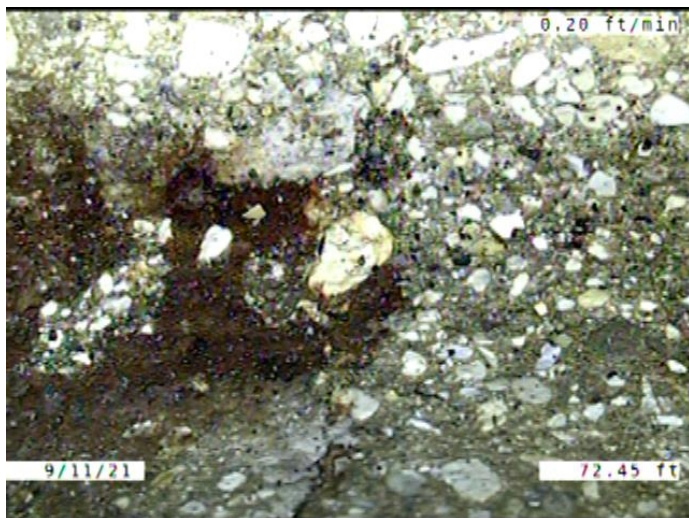
Code:	CM
Description:	Crack Multiple
Distance (ft):	72.4
Structural Grade:	3
O&M Grade:	0
Clock Start/From:	8
Clock To:	9
1st Value:	
2nd Value:	
Value Percent:	
Continuous Index:	
Within 8" of Joint:	YES
Remarks:

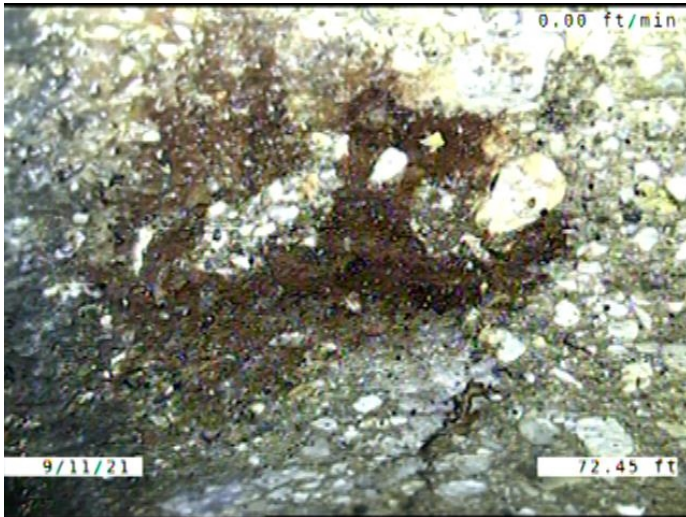
Code: **ISB**
 Description: **Infiltration Stain Barrel**

Distance (ft): **72.4**
 Structural Grade: **0**
 O&M Grade: **1**
 Clock Start/From: **8**
 Clock To: **9**
 1st Value:
 2nd Value:
 Value Percent:
 Continuous Index:
 Within 8" of Joint: **NO**
 Remarks:

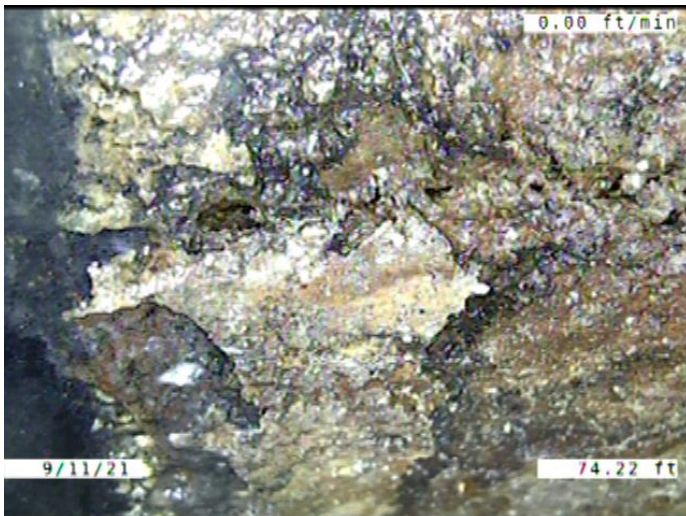
Code: **DAE**
 Description: **Deposits Attached Encrustation**

Distance (ft): **74.2**
 Structural Grade: **0**
 O&M Grade: **2**
 Clock Start/From: **8**
 Clock To: **11**
 1st Value:
 2nd Value:
 Value Percent: **5.000**
 Continuous Index:
 Within 8" of Joint: **YES**
 Remarks:

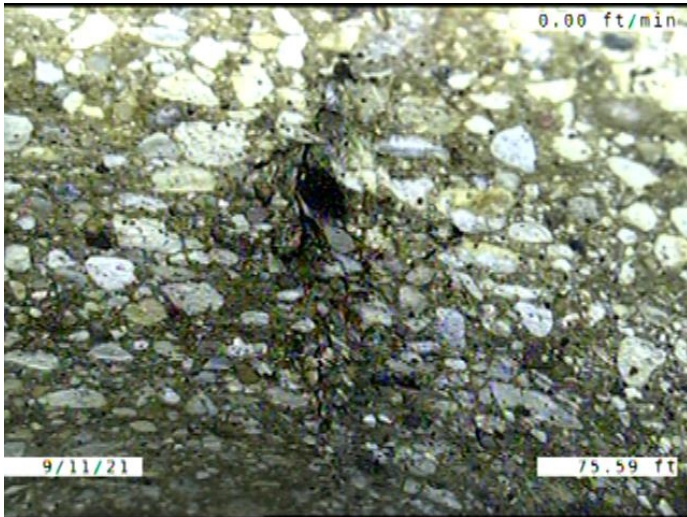
Code: **CM**
 Description: **Crack Multiple**

Distance (ft): **75.6**
 Structural Grade: **3**
 O&M Grade: **0**
 Clock Start/From: **2**
 Clock To: **3**
 1st Value:
 2nd Value:
 Value Percent:
 Continuous Index:
 Within 8" of Joint: **YES**
 Remarks:

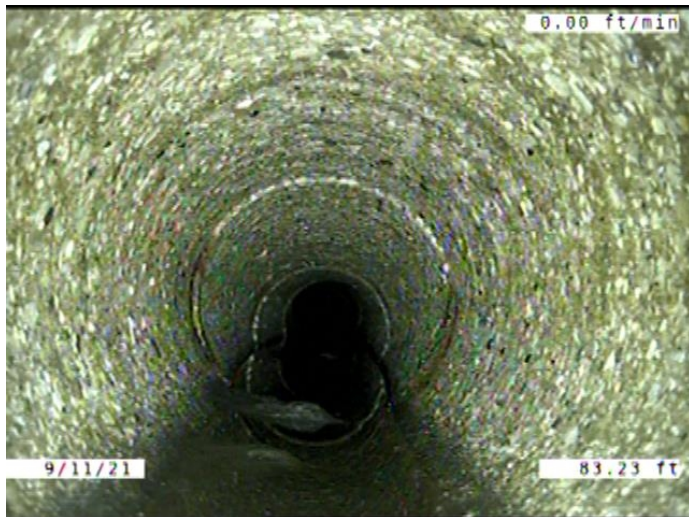
Code: **MWLS**
 Description: **Miscellaneous Water Level Sag**

Distance (ft): **83.2**
 Structural Grade: **2**
 O&M Grade: **0**
 Clock Start/From:
 Clock To:
 1st Value:
 2nd Value:
 Value Percent: **15.000**
 Continuous Index: **S04**
 Within 8" of Joint: **NO**
 Remarks:

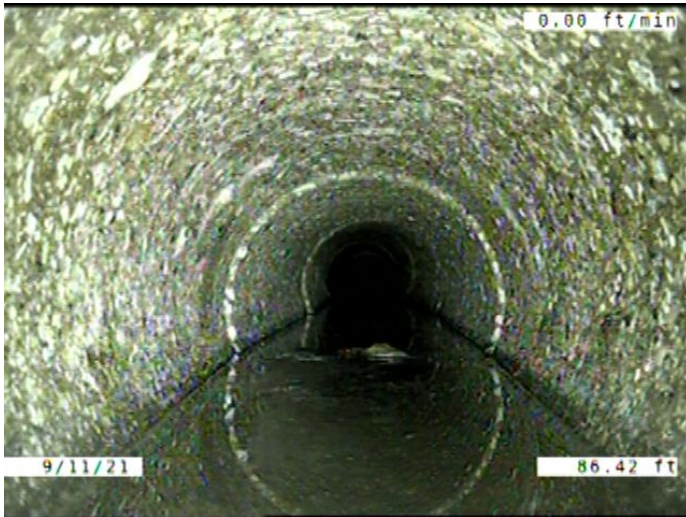
Code: **FM**
 Description: **Fracture Multiple**

Distance (ft): **86.4**
 Structural Grade: **4**
 O&M Grade: **0**
 Clock Start/From: **11**
 Clock To: **1**
 1st Value:
 2nd Value:
 Value Percent:
 Continuous Index: **F03**
 Within 8" of Joint: **YES**
 Remarks:

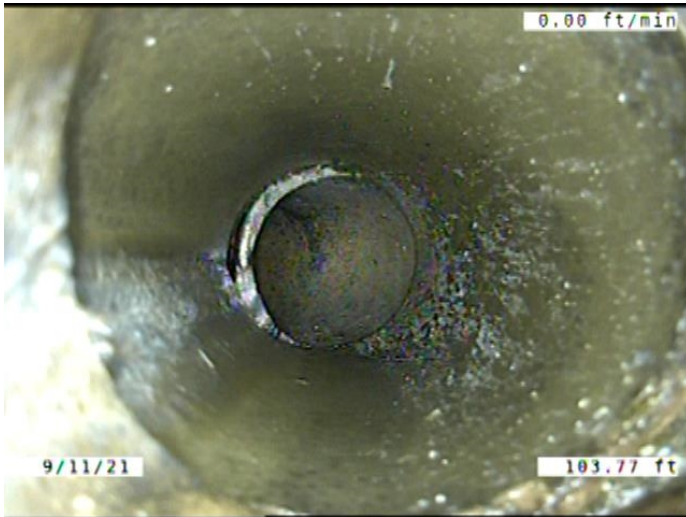
Code: **TBI**
 Description: **Tap Break-in Intruding**

Distance (ft): **103.4**
 Structural Grade: **0**
 O&M Grade: **2**
 Clock Start/From: **11**
 Clock To:
 1st Value: **4.000**
 2nd Value: **1.000**
 Value Percent:
 Continuous Index:
 Within 8" of Joint: **YES**
 Remarks:

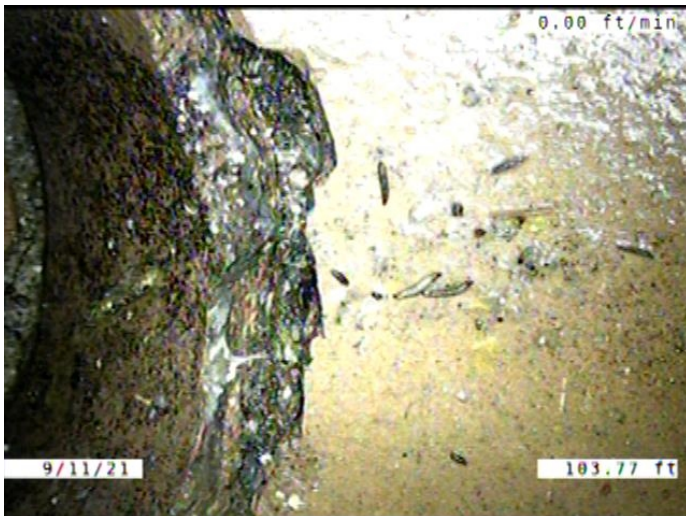
Code: **B**
 Description: **Broken**

Distance (ft): **103.8**
 Structural Grade: **4**
 O&M Grade: **0**
 Clock Start/From: **10**
 Clock To: **12**
 1st Value:
 2nd Value:
 Value Percent:
 Continuous Index:
 Within 8" of Joint: **YES**
 Remarks:

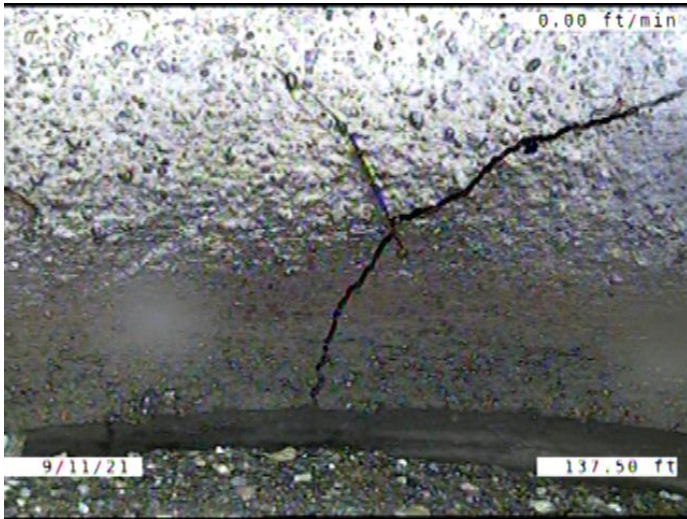
Code: **FM**
 Description: **Fracture Multiple**

Distance (ft): **137.5**
 Structural Grade: **4**
 O&M Grade: **0**
 Clock Start/From: **11**
 Clock To: **3**
 1st Value:
 2nd Value:
 Value Percent:
 Continuous Index:
 Within 8" of Joint: **YES**
 Remarks:

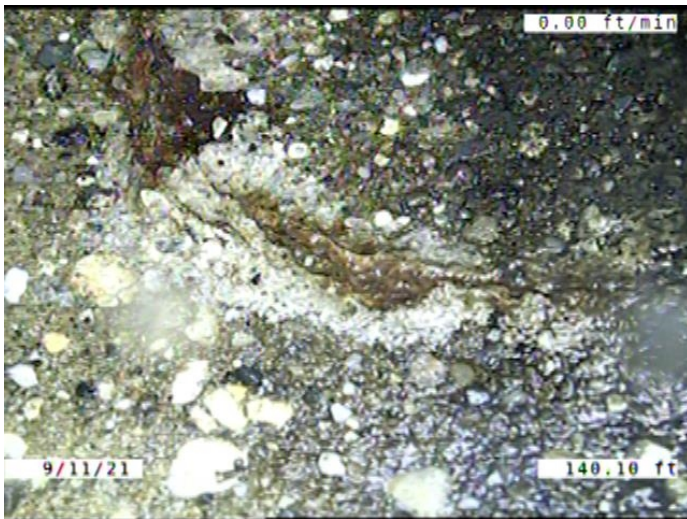
Code: **CM**
 Description: **Crack Multiple**

Distance (ft): **140.1**
 Structural Grade: **3**
 O&M Grade: **0**
 Clock Start/From: **7**
 Clock To: **8**
 1st Value:
 2nd Value:
 Value Percent:
 Continuous Index:
 Within 8" of Joint: **YES**
 Remarks:

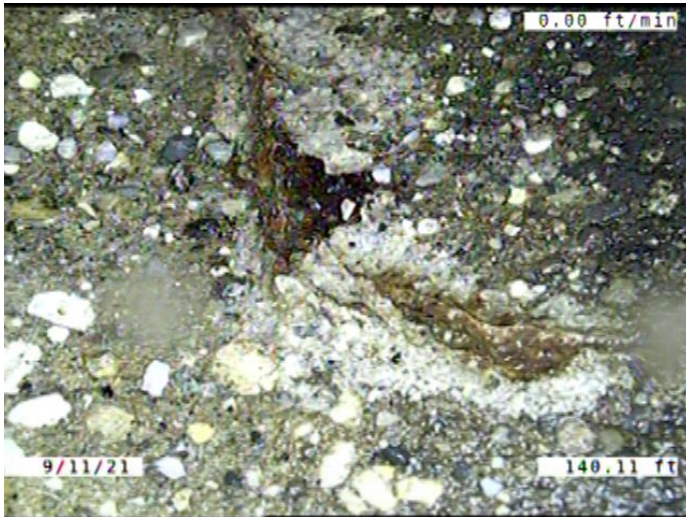
Code: **ISB**
 Description: **Infiltration Stain Barrel**

Distance (ft): **140.1**
 Structural Grade: **0**
 O&M Grade: **1**
 Clock Start/From: **8**
 Clock To: **9**
 1st Value:
 2nd Value:
 Value Percent:
 Continuous Index:
 Within 8" of Joint: **YES**
 Remarks:

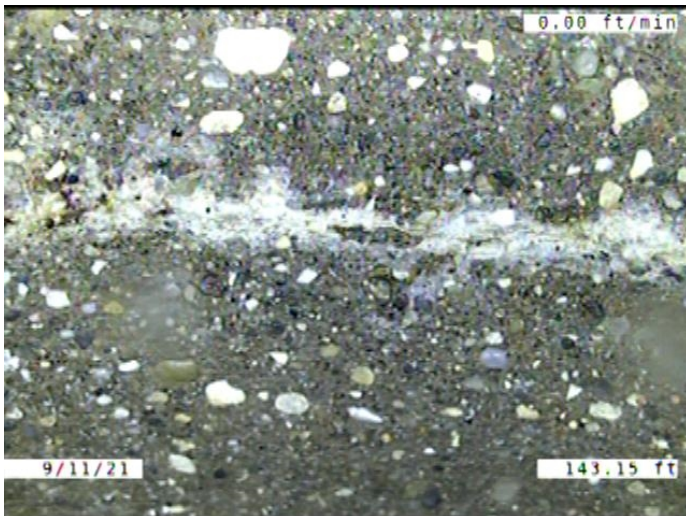
Code: **CM**
 Description: **Crack Multiple**

Distance (ft): **143.1**
 Structural Grade: **3**
 O&M Grade: **0**
 Clock Start/From: **12**
 Clock To: **12**
 1st Value:
 2nd Value:
 Value Percent:
 Continuous Index:
 Within 8" of Joint: **YES**
 Remarks:

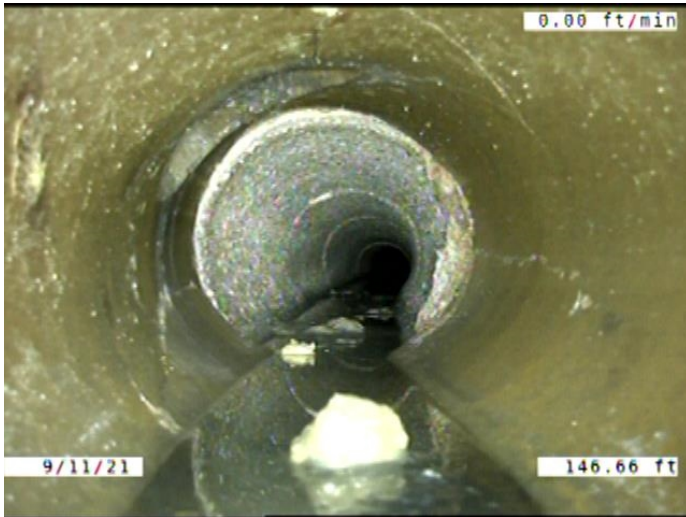
Code: **B**
 Description: **Broken**

Distance (ft): **146.7**
 Structural Grade: **4**
 O&M Grade: **0**
 Clock Start/From: **12**
 Clock To: **12**
 1st Value:
 2nd Value:
 Value Percent:
 Continuous Index:
 Within 8" of Joint: **YES**
 Remarks:

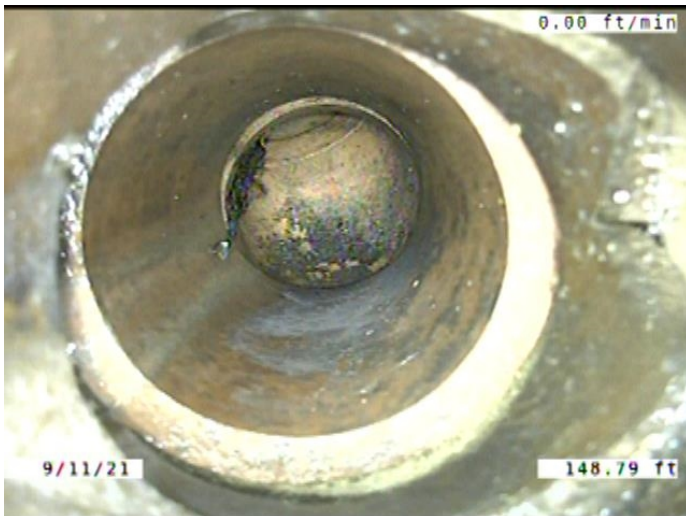
Code: **TFD**
 Description: **Tap Factory Defective**

Distance (ft): **148.8**
 Structural Grade: **0**
 O&M Grade: **3**
 Clock Start/From: **11**
 Clock To:
 1st Value: **4.000**
 2nd Value:
 Value Percent:
 Continuous Index:
 Within 8" of Joint: **YES**
 Remarks: **Defective**

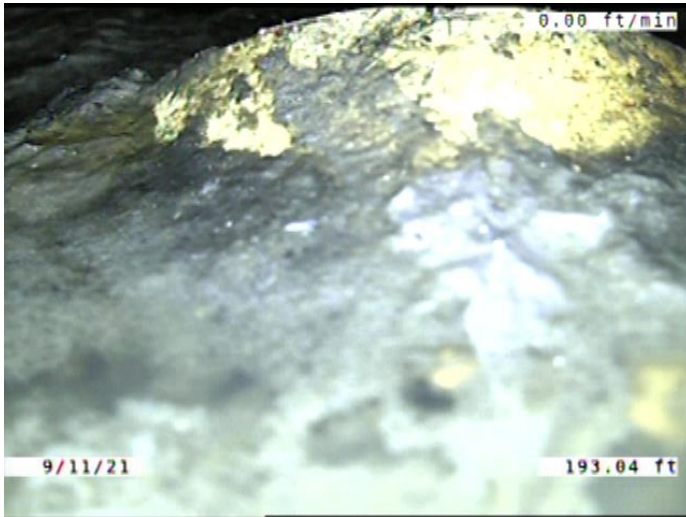
Code:	OBM
Description:	Obstruction Pipe Material in Invert
Distance (ft):	193.0
Structural Grade:	0
O&M Grade:	2
Clock Start/From:	5
Clock To:	7
1st Value:	
2nd Value:	
Value Percent:	10.000
Continuous Index:	
Within 8" of Joint:	YES
Remarks:
