## Profile/Photo Observation Report

Date:	<b>09/11/2021</b>	Weather:		Coding:	<b>PACP 7.0</b>
Pipe Length (ft):	<b>231.0</b>	Owner:	<b>City of Hobart</b>	Pre Clean:	<b>Light Cleaning</b>
P.O.#:	<b>YES502259</b>	Surveyor:	<b>S. Bucklin</b>	PSR:	<b>P-504-102-101</b>
Customer:	<b>City of Hobart</b>	Clean Date:	<b>08/27/2021</b>	Shape:	<b>C</b>

Street:	<b>North Delaware Street</b>	Flow Control:	<b>Not Controlled</b>
City:	<b>Hobart, IN</b>	Year Renewed:	
Location:	<b>Alley</b>	Tape/Media #:	
Purpose:	<b>Routine Assessment</b>	Dia/Height:	<b>10"</b>
Use:	<b>Sanitary Sewage Pipe</b>	Material:	<b>CP</b>
Drain Area:		Lining:	<b>None</b>
Category:	<b>NA</b>		
Comment:

Location Details:		Direction of Survey:	<b>Downstream</b>
US MH:	<b>M-504-101</b>	DS MH:	<b>M-504-102</b>
		Total Length Surveyed (ft):	<b>26.9</b>

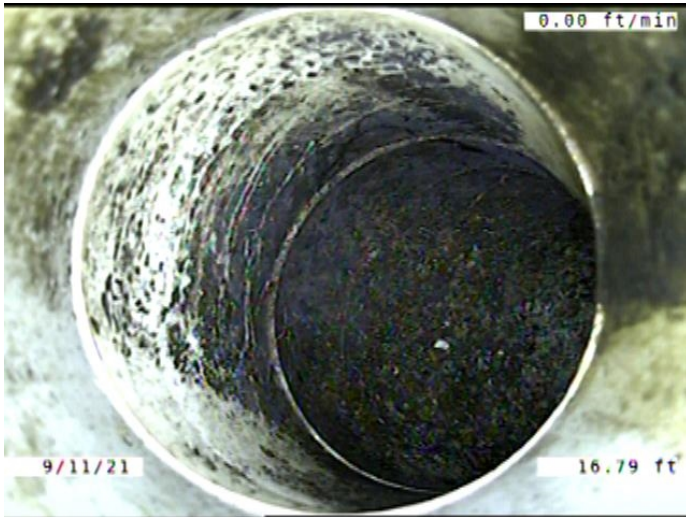
Code: **TFI**  
 Description: **Tap Factory Intruding**

Distance (ft): **16.8**  
 Structural Grade: **0**  
 O&M Grade: **2**  
 Clock Start/From: **1**  
 Clock To:  
 1st Value: **4.000**  
 2nd Value: **3.000**  
 Value Percent:  
 Continuous Index:  
 Within 8" of Joint: **YES**  
 Remarks:

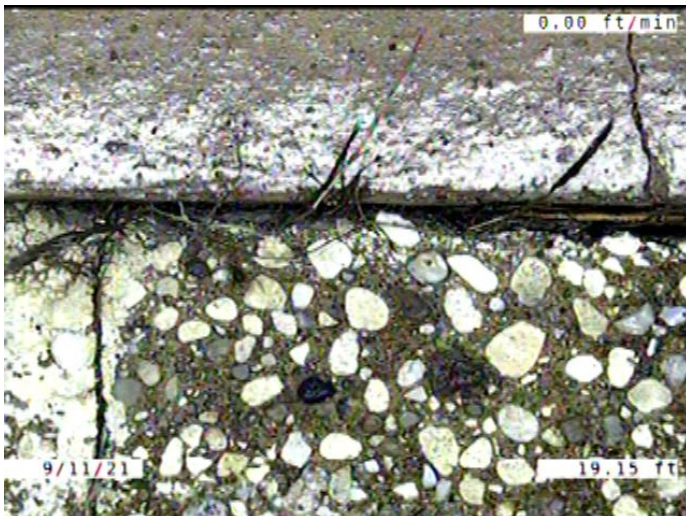
Code: **MMC**  
 Description: **Miscellaneous Material Change**

Distance (ft): **19.2**  
 Structural Grade: **0**  
 O&M Grade: **0**  
 Clock Start/From:  
 Clock To:  
 1st Value:  
 2nd Value:  
 Value Percent:  
 Continuous Index:  
 Within 8" of Joint: **NO**  
 Remarks: **VCP TO CONCRETE**

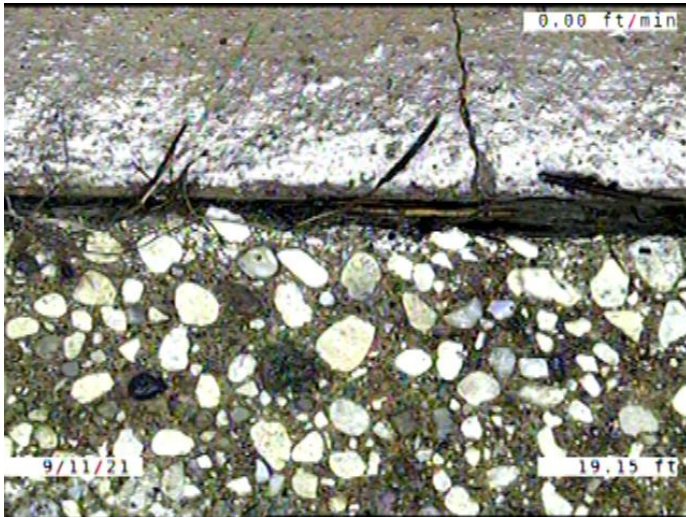
Code: **RFJ**  
 Description: **Roots Fine Joint**

Distance (ft): **19.2**  
 Structural Grade: **0**  
 O&M Grade: **1**  
 Clock Start/From: **11**  
 Clock To: **3**  
 1st Value:  
 2nd Value:  
 Value Percent:  
 Continuous Index:  
 Within 8" of Joint: **YES**  
 Remarks:

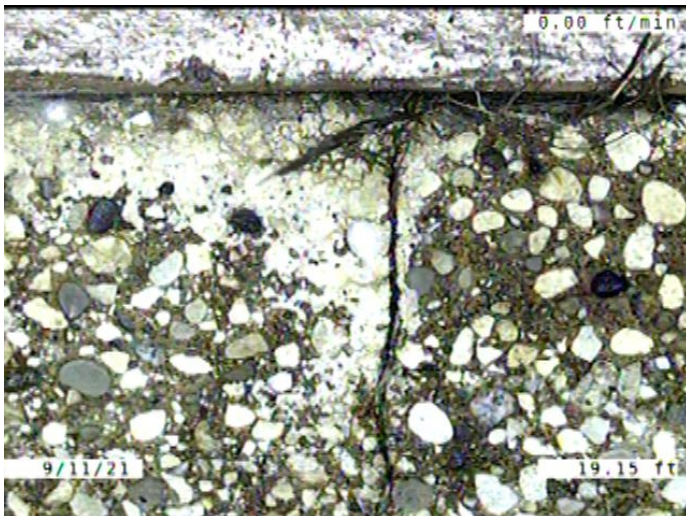
Code: **FM**  
 Description: **Fracture Multiple**

Distance (ft): **19.2**  
 Structural Grade: **4**  
 O&M Grade: **0**  
 Clock Start/From: **9**  
 Clock To: **3**  
 1st Value:  
 2nd Value:  
 Value Percent:  
 Continuous Index: **S02**  
 Within 8" of Joint: **YES**  
 Remarks:

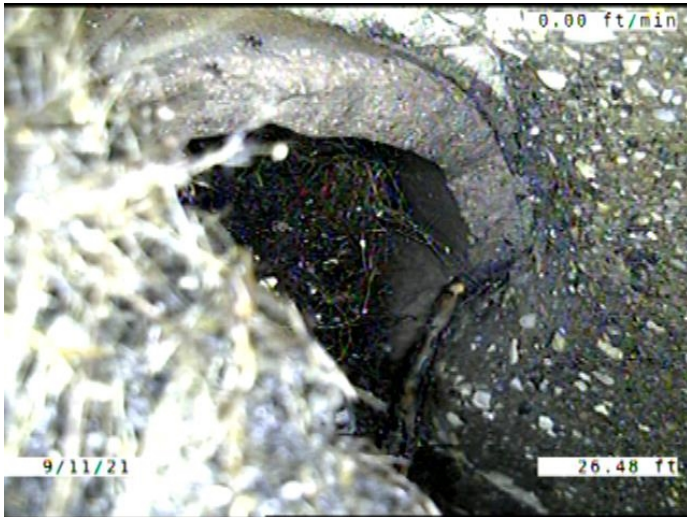
Code: **TBI**  
 Description: **Tap Break-in Intruding**

Distance (ft): **26.5**  
 Structural Grade: **0**  
 O&M Grade: **2**  
 Clock Start/From: **11**  
 Clock To:  
 1st Value: **4.000**  
 2nd Value: **1.000**  
 Value Percent:  
 Continuous Index:  
 Within 8" of Joint: **YES**  
 Remarks:

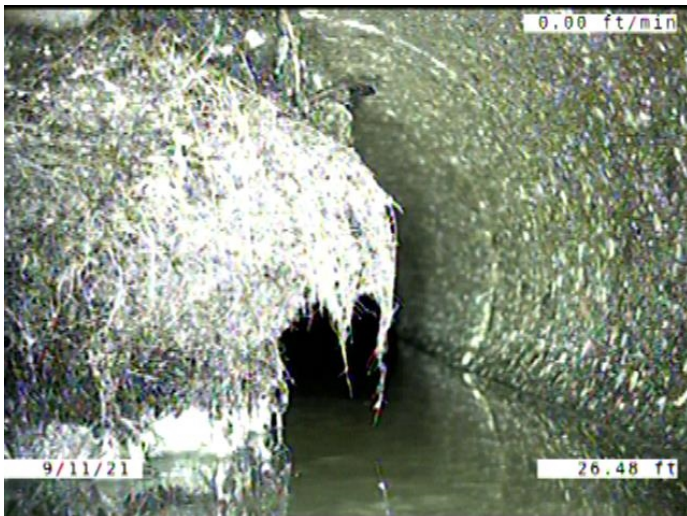
Code: **DSF**  
 Description: **Deposits Settled Fine**

Distance (ft): **26.5**  
 Structural Grade: **0**  
 O&M Grade: **2**  
 Clock Start/From: **5**  
 Clock To: **7**  
 1st Value:  
 2nd Value:  
 Value Percent: **5.000**  
 Continuous Index: **F01**  
 Within 8" of Joint: **YES**  
 Remarks:
