## Profile/Photo Observation Report

Date:	<b>09/11/2021</b>	Weather:		Coding:	<b>PACP 7.0</b>
Pipe Length (ft):	<b>231.0</b>	Owner:	<b>City of Hobart</b>	Pre Clean:	<b>Light Cleaning</b>
P.O.#:	<b>YES502259</b>	Surveyor:	<b>S. Bucklin</b>	PSR:	<b>P-504-102-101</b>
Customer:	<b>City of Hobart</b>	Clean Date:	<b>08/27/2021</b>	Shape:	<b>C</b>

Location Details:		Direction of Survey:	<b>Downstream</b>
US MH:	<b>M-504-101</b>	DS MH:	<b>M-504-102</b>
		Total Length Surveyed (ft):	<b>26.9</b>

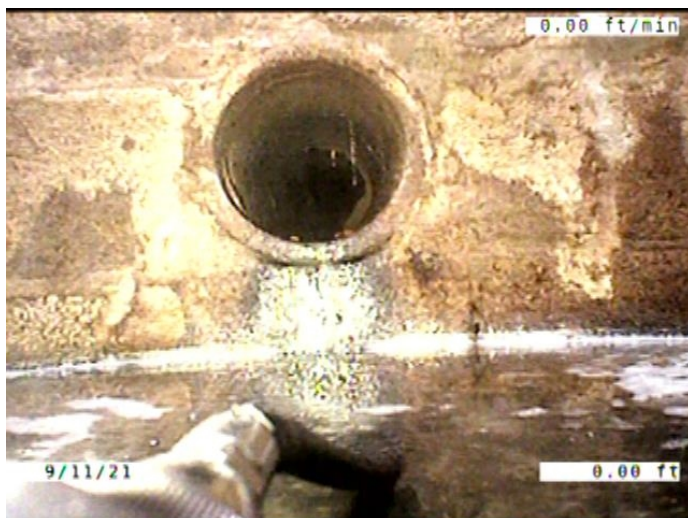
Code: **AMH**  
Description: **Manhole**

Distance (ft): **.0**  
Structural Grade: **0**  
O&M Grade: **0**  
Clock Start/From:  
Clock To:  
1st Value:  
2nd Value:  
Value Percent:  
Continuous Index:  
Within 8" of Joint: **NO**  
Remarks: **M-504-101**

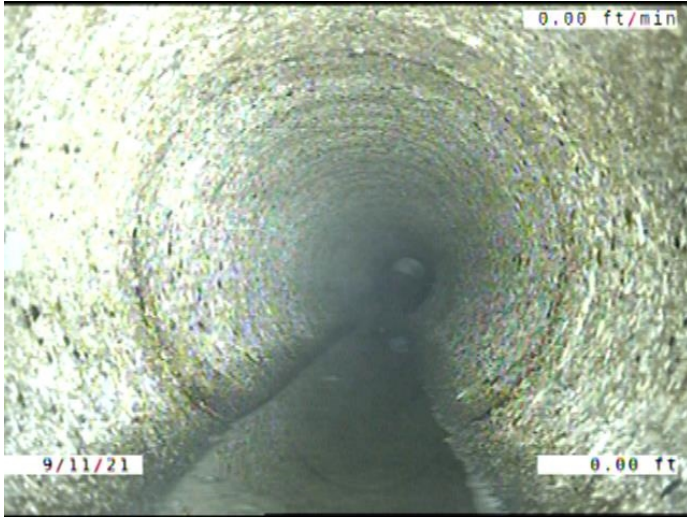
Code:	<b>MWL</b>
Description:	<b>Miscellaneous Water Level</b>
Distance (ft):	<b>.0</b>
Structural Grade:	<b>0</b>
O&M Grade:	<b>0</b>
Clock Start/From:	
Clock To:	
1st Value:	
2nd Value:	
Value Percent:	<b>5.000</b>
Continuous Index:	
Within 8" of Joint:	<b>NO</b>
Remarks:

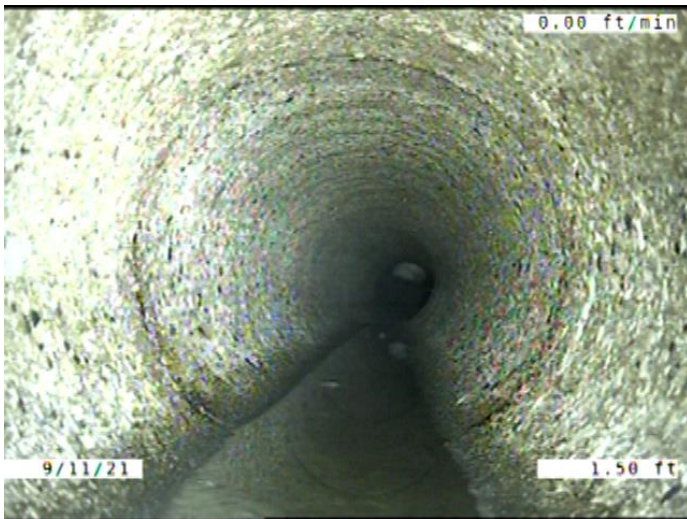
Code:	<b>MGO</b>
Description:	<b>Miscellaneous General Observation</b>
Distance (ft):	<b>1.5</b>
Structural Grade:	<b>0</b>
O&M Grade:	<b>0</b>
Clock Start/From:	
Clock To:	
1st Value:	
2nd Value:	
Value Percent:	
Continuous Index:	
Within 8" of Joint:	<b>NO</b>
Remarks:	<b>DROP INTO THE MANHOLE. HAD TO START IN THE PIPE.</b>

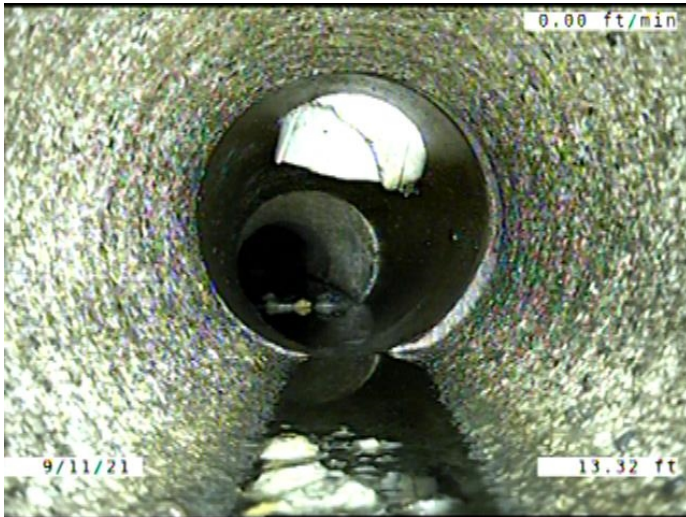
Code: **DSF**  
 Description: **Deposits Settled Fine**

Distance (ft): **13.3**  
 Structural Grade: **0**  
 O&M Grade: **2**  
 Clock Start/From: **5**  
 Clock To: **7**  
 1st Value:  
 2nd Value:  
 Value Percent: **5.000**  
 Continuous Index: **S01**  
 Within 8" of Joint: **YES**  
 Remarks:

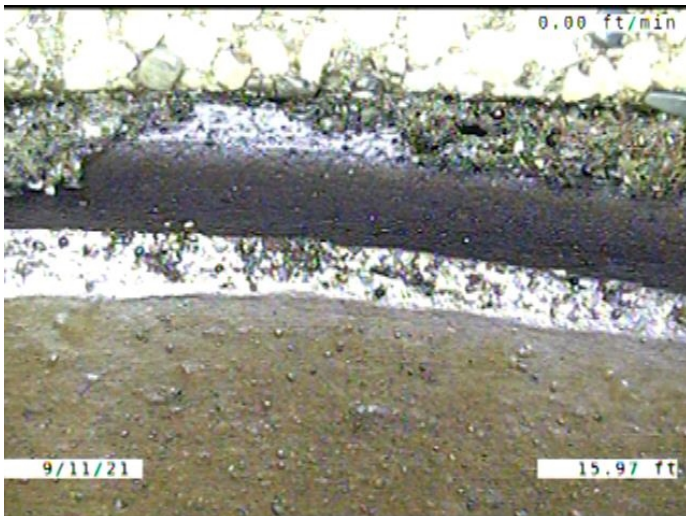
Code: **MMC**  
 Description: **Miscellaneous Material Change**

Distance (ft): **16.0**  
 Structural Grade: **0**  
 O&M Grade: **0**  
 Clock Start/From:  
 Clock To:  
 1st Value:  
 2nd Value:  
 Value Percent:  
 Continuous Index:  
 Within 8" of Joint: **NO**  
 Remarks: **CONCRETE TO VCP**

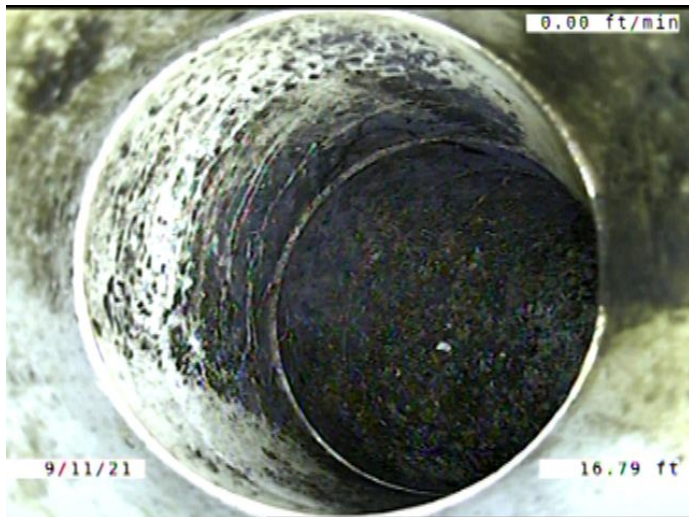
Code: **TFI**  
 Description: **Tap Factory Intruding**

Distance (ft): **16.8**  
 Structural Grade: **0**  
 O&M Grade: **2**  
 Clock Start/From: **1**  
 Clock To:  
 1st Value: **4.000**  
 2nd Value: **3.000**  
 Value Percent:  
 Continuous Index:  
 Within 8" of Joint: **YES**  
 Remarks:

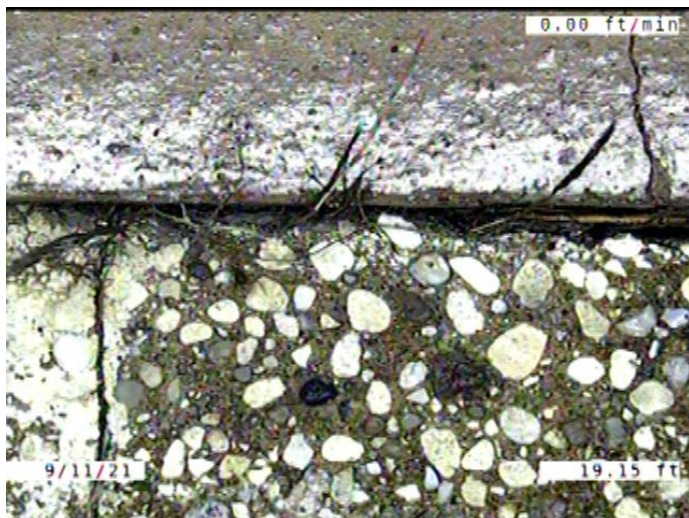
Code: **MMC**  
 Description: **Miscellaneous Material Change**

Distance (ft): **19.2**  
 Structural Grade: **0**  
 O&M Grade: **0**  
 Clock Start/From:  
 Clock To:  
 1st Value:  
 2nd Value:  
 Value Percent:  
 Continuous Index:  
 Within 8" of Joint: **NO**  
 Remarks: **VCP TO CONCRETE**

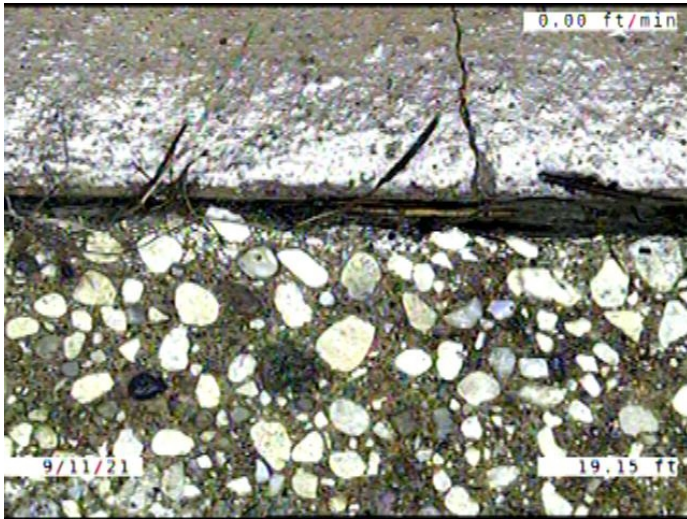
Code: **RFJ**  
 Description: **Roots Fine Joint**

Distance (ft): **19.2**  
 Structural Grade: **0**  
 O&M Grade: **1**  
 Clock Start/From: **11**  
 Clock To: **3**  
 1st Value:  
 2nd Value:  
 Value Percent:  
 Continuous Index:  
 Within 8" of Joint: **YES**  
 Remarks:

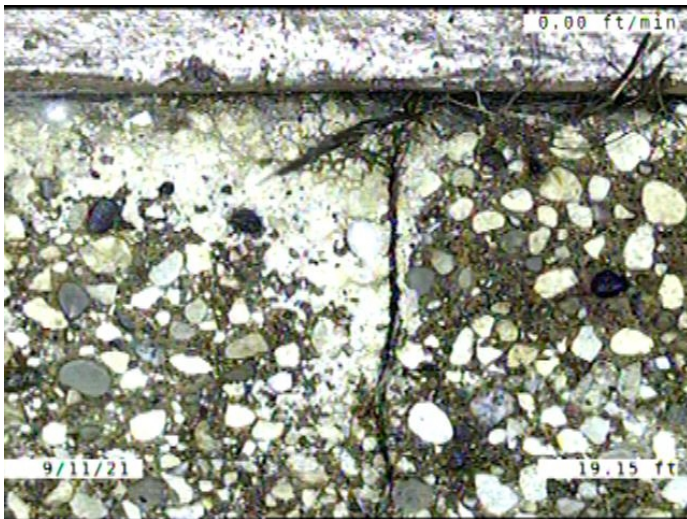
Code: **FM**  
 Description: **Fracture Multiple**

Distance (ft): **19.2**  
 Structural Grade: **4**  
 O&M Grade: **0**  
 Clock Start/From: **9**  
 Clock To: **3**  
 1st Value:  
 2nd Value:  
 Value Percent:  
 Continuous Index: **S02**  
 Within 8" of Joint: **YES**  
 Remarks:

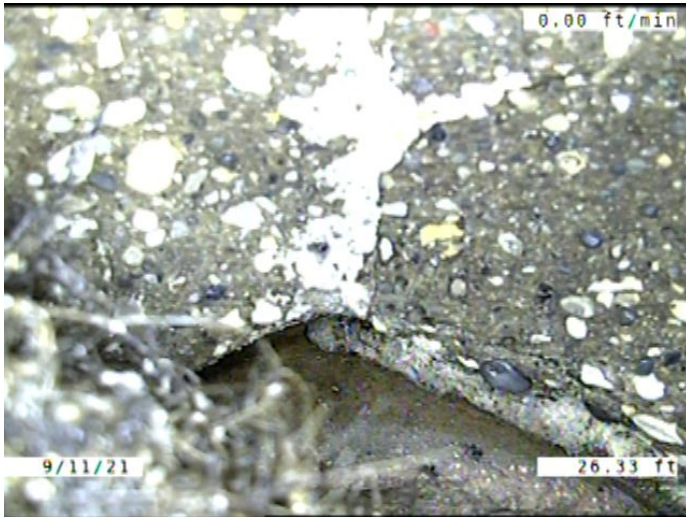
Code: **B**  
 Description: **Broken**

Distance (ft): **26.3**  
 Structural Grade: **4**  
 O&M Grade: **0**  
 Clock Start/From: **10**  
 Clock To: **12**  
 1st Value:  
 2nd Value:  
 Value Percent:  
 Continuous Index:  
 Within 8" of Joint: **YES**  
 Remarks:

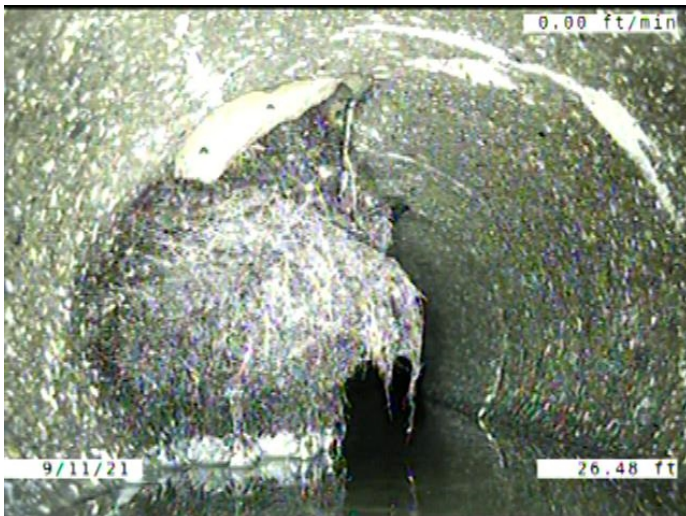
Code: **RML**  
 Description: **Roots Medium Lateral**

Distance (ft): **26.5**  
 Structural Grade: **0**  
 O&M Grade: **3**  
 Clock Start/From: **7**  
 Clock To: **11**  
 1st Value:  
 2nd Value:  
 Value Percent: **50.000**  
 Continuous Index:  
 Within 8" of Joint: **NO**  
 Remarks:

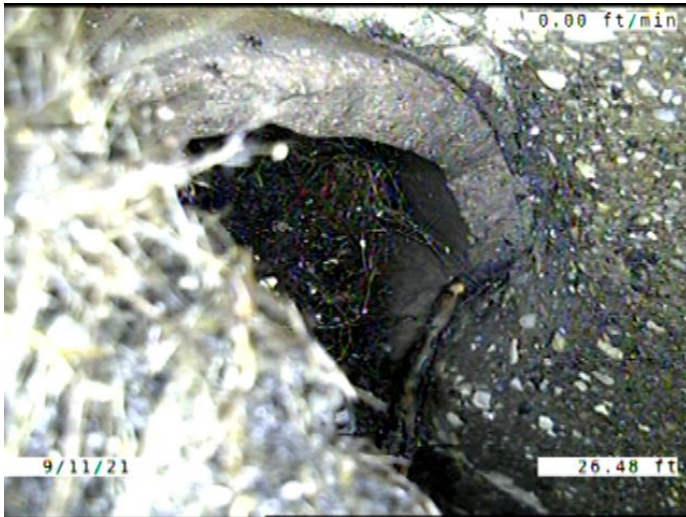
Code: **TBI**  
 Description: **Tap Break-in Intruding**

Distance (ft): **26.5**  
 Structural Grade: **0**  
 O&M Grade: **2**  
 Clock Start/From: **11**  
 Clock To:  
 1st Value: **4.000**  
 2nd Value: **1.000**  
 Value Percent:  
 Continuous Index:  
 Within 8" of Joint: **YES**  
 Remarks:

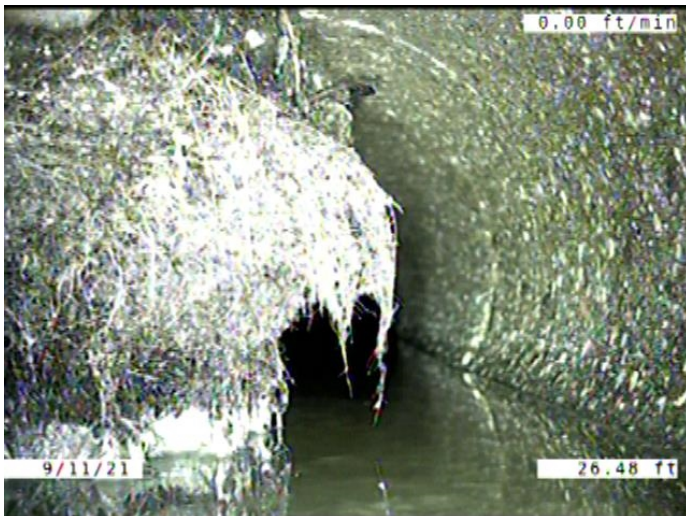
Code: **DSF**  
 Description: **Deposits Settled Fine**

Distance (ft): **26.5**  
 Structural Grade: **0**  
 O&M Grade: **2**  
 Clock Start/From: **5**  
 Clock To: **7**  
 1st Value:  
 2nd Value:  
 Value Percent: **5.000**  
 Continuous Index: **F01**  
 Within 8" of Joint: **YES**  
 Remarks:

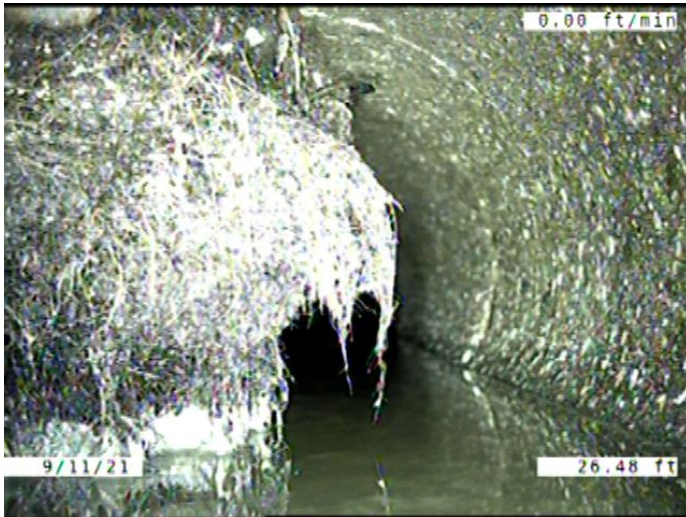
Code: **FM**  
 Description: **Fracture Multiple**

Distance (ft): **26.5**  
 Structural Grade: **4**  
 O&M Grade: **0**  
 Clock Start/From: **9**  
 Clock To: **3**  
 1st Value:  
 2nd Value:  
 Value Percent:  
 Continuous Index: **F02**  
 Within 8" of Joint: **YES**  
 Remarks:

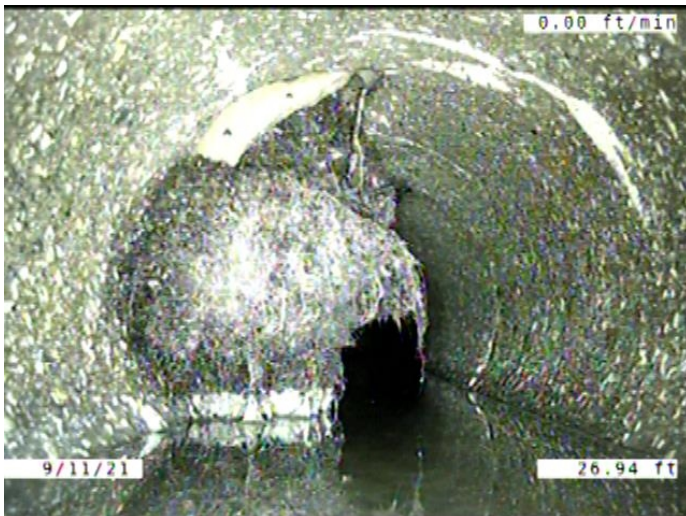
Code: **MSA**  
 Description: **Miscellaneous Survey Abandoned**

Distance (ft): **26.9**  
 Structural Grade: **0**  
 O&M Grade: **0**  
 Clock Start/From:  
 Clock To:  
 1st Value:  
 2nd Value:  
 Value Percent:  
 Continuous Index:  
 Within 8" of Joint: **NO**  
 Remarks: **CAMERA CANT MAKE IT PAST  
 ROOTS. MADE IT TO THE POINT OF**
