Profile/Photo Observation Report

Street:	ALLEY BETWEEN N DELAWARE ST &	Flow Control:	Not Controlled
City:	Hobart, IN	Year Renewed:	
Location:	Light Highway	Tape/Media #:	
Purpose:	Not Known	Dia/Height:	12"
Use:	Sanitary	Material:	CP
Drain Area:	NA	Lining:	
Category:	NA		
Comment:

Location Details:		Direction of Survey:	Downstream
US MH:	M-504-103	DS MH:	M-504-104
		Total Length Surveyed (ft):	13.2

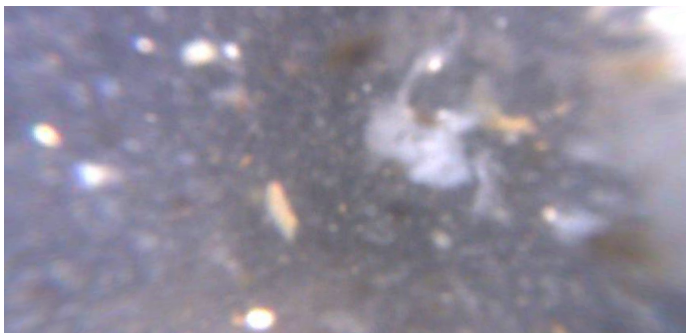
Code: **AMH**
Description: **Manhole**

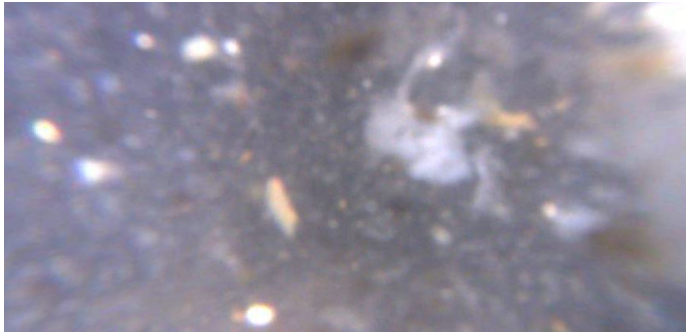
Code:	MWL
Description:	Water Level

Distance (ft):	.0
Structural Grade:	0
O&M Grade:	0
Clock Start/From:	
Clock To:	
1st Value:	
2nd Value:	
Value Percent:	100.000
Continuous Index:	
Within 8" of Joint:	NO
Remarks:

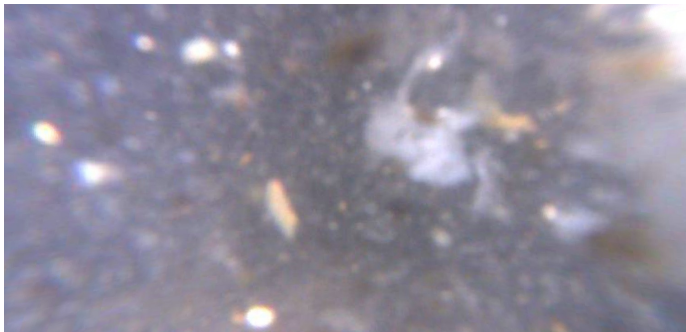
Code:	MCU
Description:	Camera Underwater

Distance (ft):	.0
Structural Grade:	0
O&M Grade:	4
Clock Start/From:	
Clock To:	
1st Value:	
2nd Value:	
Value Percent:	
Continuous Index:	S01
Within 8" of Joint:	NO
Remarks:

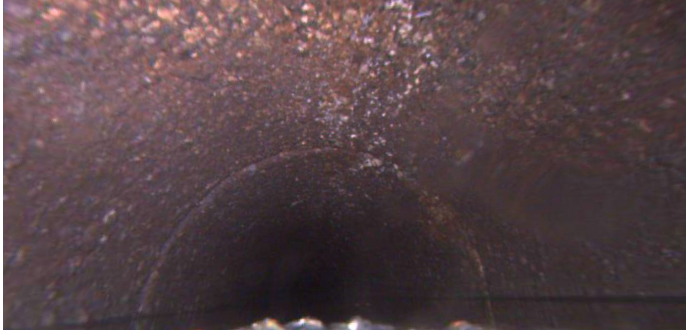
Code: **MCU**
Description: **Camera Underwater**

Distance (ft): **3.2**
Structural Grade: **0**
O&M Grade: **4**
Clock Start/From:
Clock To:
1st Value:
2nd Value:
Value Percent:
Continuous Index: **F01**
Within 8" of Joint: **NO**
Remarks:

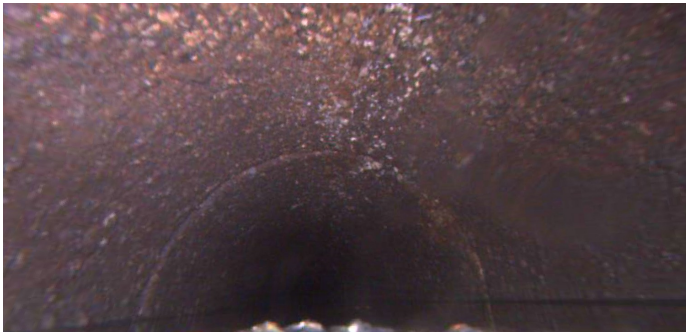
Code: **SAP**
Description: **Surface Aggregate Projecting**

Distance (ft): **3.2**
Structural Grade: **3**
O&M Grade: **0**
Clock Start/From: **8**
Clock To: **4**
1st Value:
2nd Value:
Value Percent:
Continuous Index: **S02**
Within 8" of Joint:
Remarks:

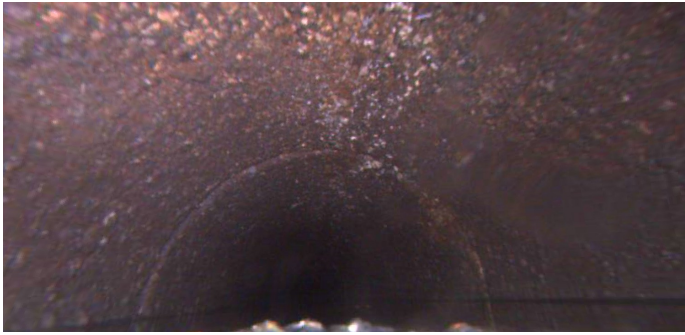
Code: **MWL**
Description: **Water Level**

Distance (ft): **3.2**
Structural Grade: **0**
O&M Grade: **0**
Clock Start/From:
Clock To:
1st Value:
2nd Value:
Value Percent: **40.000**
Continuous Index:
Within 8" of Joint: **NO**
Remarks:

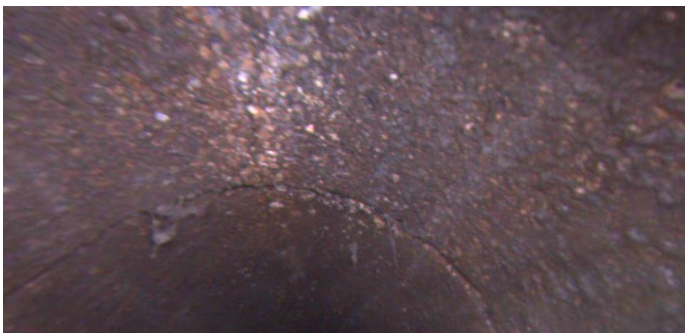
Code: **FL**
Description: **Fracture Longitudinal**

Distance (ft): **9.3**
Structural Grade: **3**
O&M Grade: **0**
Clock Start/From: **12**
Clock To:
1st Value:
2nd Value:
Value Percent:
Continuous Index:
Within 8" of Joint: **YES**
Remarks:

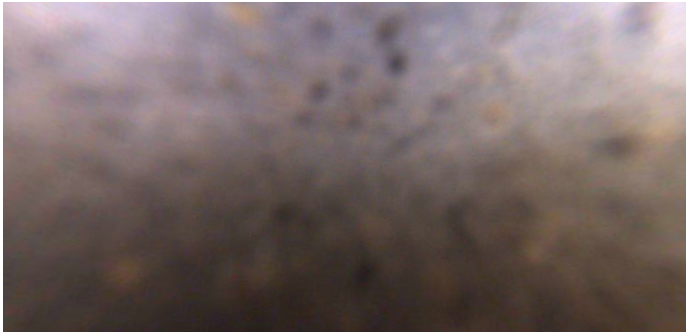
Code: **SAP**
Description: **Surface Aggregate Projecting**

Distance (ft): **13.2**
Structural Grade: **3**
O&M Grade: **0**
Clock Start/From: **8**
Clock To: **4**
1st Value:
2nd Value:
Value Percent:
Continuous Index: **F02**
Within 8" of Joint:
Remarks:

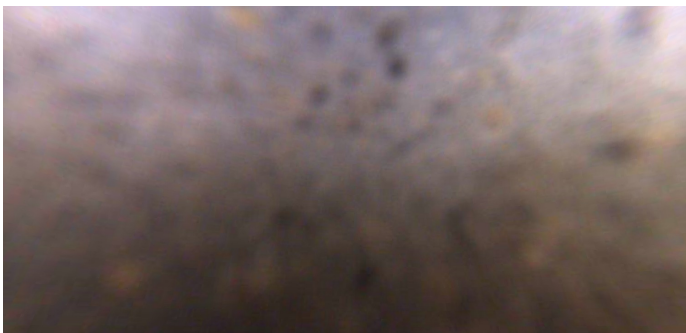
Code: **MCU**
Description: **Camera Underwater**

Distance (ft): **13.2**
Structural Grade: **0**
O&M Grade: **4**
Clock Start/From:
Clock To:
1st Value:
2nd Value:
Value Percent:
Continuous Index:
Within 8" of Joint: **NO**
Remarks:

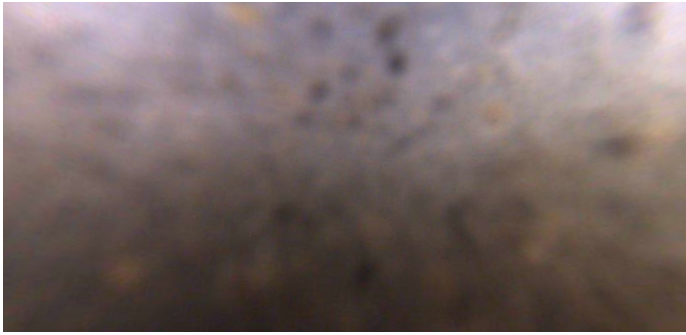
Code: **MWL**
Description: **Water Level**

Distance (ft): **13.2**
Structural Grade: **0**
O&M Grade: **0**
Clock Start/From:
Clock To:
1st Value:
2nd Value:
Value Percent: **100.000**
Continuous Index:
Within 8" of Joint: **NO**
Remarks:

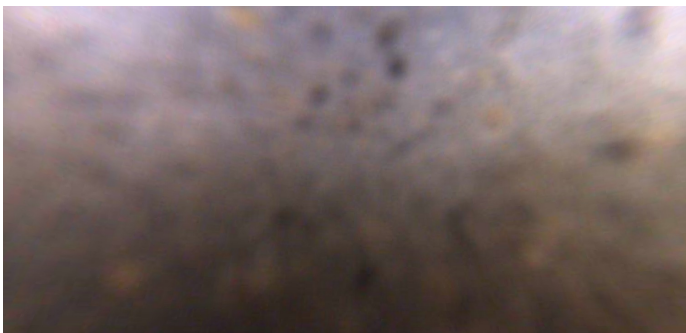
Code: **MSA**
Description: **Abandoned Survey**

Distance (ft): **13.2**
Structural Grade: **0**
O&M Grade: **0**
Clock Start/From:
Clock To:
1st Value:
2nd Value:
Value Percent:
Continuous Index:
Within 8" of Joint: **NO**
Remarks: **mcu**
