## Profile/Photo Observation Report

Date:	<b>04/17/2018</b>	Weather:		Coding:	<b>PACP 6.0</b>
Pipe Length (ft):	<b>195.3</b>	Owner:	<b>NA</b>	Pre Clean:	<b>Not Known</b>
P.O.#:		Surveyor:	<b>Jen Costello</b>	PSR:	<b>P-504-104-103</b>
Customer:		Clean Date:	<b>01/01/1900</b>	Shape:	<b>C</b>

Street:	<b>Summerlin</b>	Flow Control:	<b>Not Controlled</b>
City:	<b>Hobart, IN</b>	Year Renewed:	
Location:	<b>Light Highway</b>	Tape/Media #:	
Purpose:	<b>Not Known</b>	Dia/Height:	<b>12"</b>
Use:	<b>Sanitary</b>	Material:	<b>CP</b>
Drain Area:	<b>NA</b>	Lining:	
Category:	<b>NA</b>		
Comment:

Location Details:		Direction of Survey:	<b>Downstream</b>
US MH:	<b>M-504-103</b>	DS MH:	<b>M-504-104</b>
		Total Length Surveyed (ft):	<b>13.2</b>

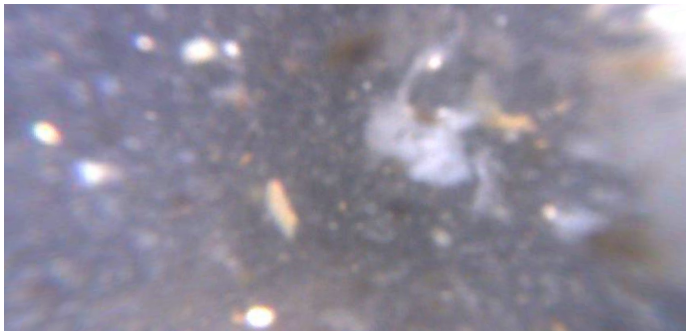
Code: **AMH**  
Description: **Manhole**

Distance (ft): **.0**  
Structural Grade: **0**  
O&M Grade: **0**  
Clock Start/From:  
Clock To:  
1st Value:  
2nd Value:  
Value Percent:  
Continuous Index:  
Within 8" of Joint: **NO**  
Remarks: **M-504-103**

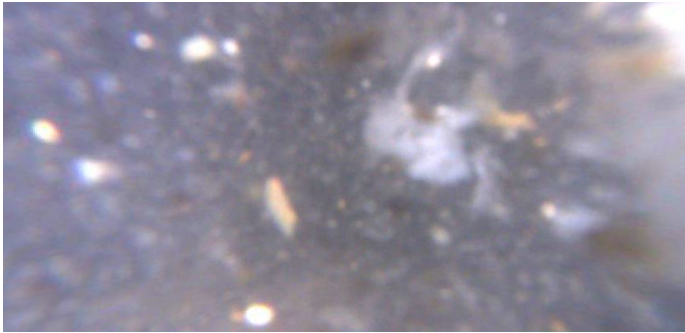
Code:	<b>MWL</b>
Description:	<b>Water Level</b>

Distance (ft):	<b>.0</b>
Structural Grade:	<b>0</b>
O&M Grade:	<b>0</b>
Clock Start/From:	
Clock To:	
1st Value:	
2nd Value:	
Value Percent:	<b>100.000</b>
Continuous Index:	
Within 8" of Joint:	<b>NO</b>
Remarks:

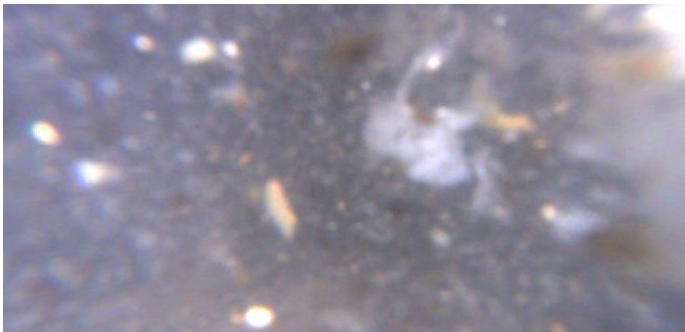
Code:	<b>MCU</b>
Description:	<b>Camera Underwater</b>

Distance (ft):	<b>.0</b>
Structural Grade:	<b>0</b>
O&M Grade:	<b>4</b>
Clock Start/From:	
Clock To:	
1st Value:	
2nd Value:	
Value Percent:	
Continuous Index:	<b>S01</b>
Within 8" of Joint:	<b>NO</b>
Remarks:

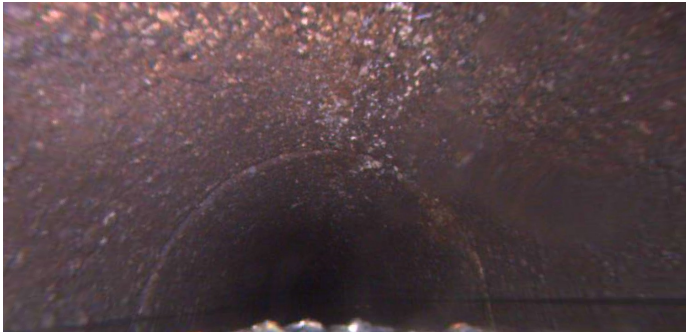
Code: **MCU**  
Description: **Camera Underwater**

Distance (ft): **3.2**  
Structural Grade: **0**  
O&M Grade: **4**  
Clock Start/From:  
Clock To:  
1st Value:  
2nd Value:  
Value Percent:  
Continuous Index: **F01**  
Within 8" of Joint: **NO**  
Remarks:

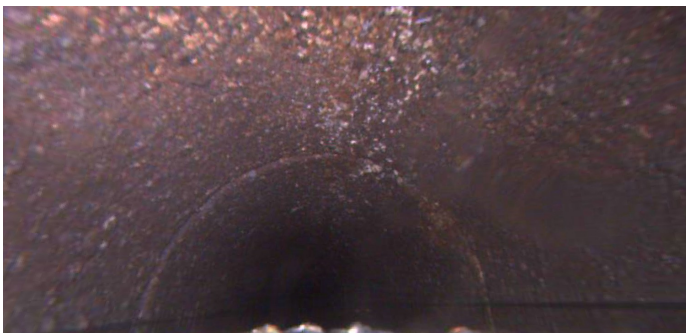
Code: **SAP**  
Description: **Surface Aggregate Projecting**

Distance (ft): **3.2**  
Structural Grade: **3**  
O&M Grade: **0**  
Clock Start/From: **8**  
Clock To: **4**  
1st Value:  
2nd Value:  
Value Percent:  
Continuous Index: **S02**  
Within 8" of Joint:  
Remarks:

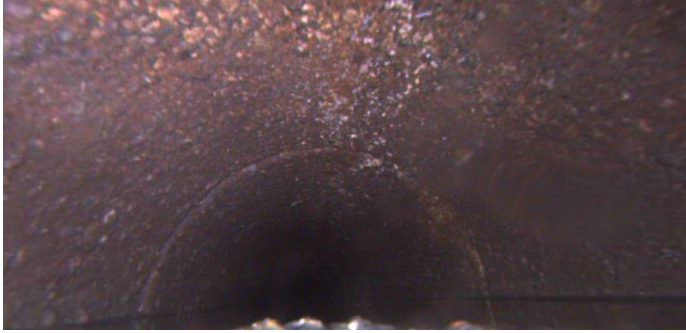
Code: **MWL**  
Description: **Water Level**

Distance (ft): **3.2**  
Structural Grade: **0**  
O&M Grade: **0**  
Clock Start/From:  
Clock To:  
1st Value:  
2nd Value:  
Value Percent: **40.000**  
Continuous Index:  
Within 8" of Joint: **NO**  
Remarks:

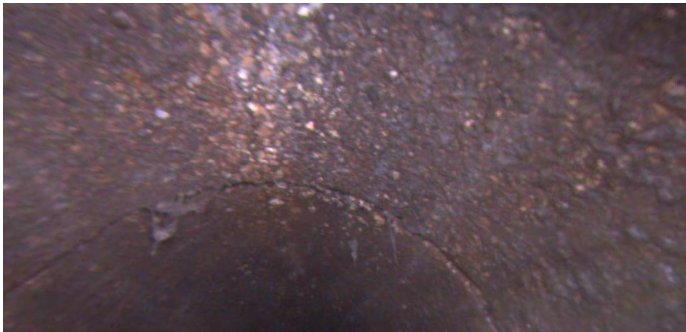
Code: **FL**  
Description: **Fracture Longitudinal**

Distance (ft): **9.3**  
Structural Grade: **3**  
O&M Grade: **0**  
Clock Start/From: **12**  
Clock To:  
1st Value:  
2nd Value:  
Value Percent:  
Continuous Index:  
Within 8" of Joint: **YES**  
Remarks:

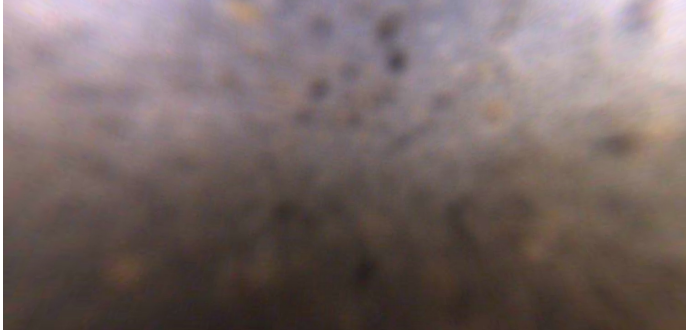
Code: **SAP**  
Description: **Surface Aggregate Projecting**

Distance (ft): **13.2**  
Structural Grade: **3**  
O&M Grade: **0**  
Clock Start/From: **8**  
Clock To: **4**  
1st Value:  
2nd Value:  
Value Percent:  
Continuous Index: **F02**  
Within 8" of Joint:  
Remarks:

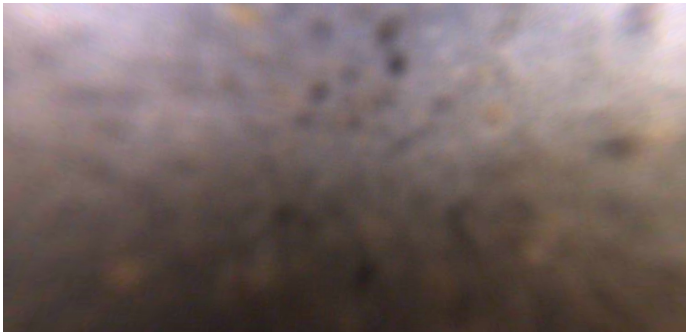
Code: **MCU**  
Description: **Camera Underwater**

Distance (ft): **13.2**  
Structural Grade: **0**  
O&M Grade: **4**  
Clock Start/From:  
Clock To:  
1st Value:  
2nd Value:  
Value Percent:  
Continuous Index:  
Within 8" of Joint: **NO**  
Remarks:

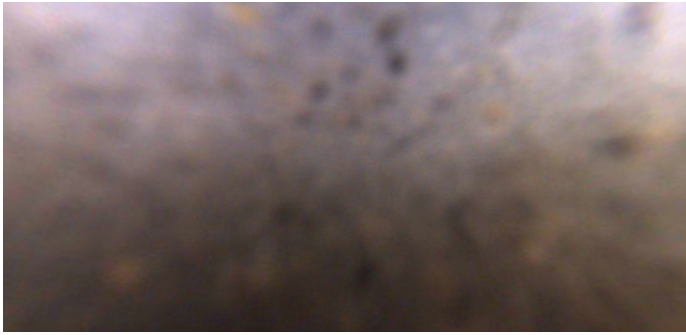
Code: **MWL**  
Description: **Water Level**

Distance (ft): **13.2**  
Structural Grade: **0**  
O&M Grade: **0**  
Clock Start/From:  
Clock To:  
1st Value:  
2nd Value:  
Value Percent: **100.000**  
Continuous Index:  
Within 8" of Joint: **NO**  
Remarks:

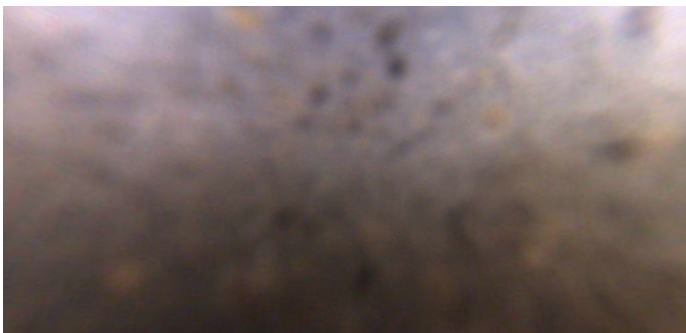
Code: **MSA**  
Description: **Abandoned Survey**

Distance (ft): **13.2**  
Structural Grade: **0**  
O&M Grade: **0**  
Clock Start/From:  
Clock To:  
1st Value:  
2nd Value:  
Value Percent:  
Continuous Index:  
Within 8" of Joint: **NO**  
Remarks: **mcu**
