Profile/Photo Observation Report

Date:	09/10/2021	Weather:		Coding:	PACP 7.0
Pipe Length (ft):	188.3	Owner:	City of Hobart	Pre Clean:	Heavy Cleaning
P.O.#:	YES502259	Surveyor:	S. Bucklin	PSR:	P-504-104-103
Customer:	City of Hobart	Clean Date:	08/27/2021	Shape:	C

Street:	North Colorado Street	Flow Control:	Not Controlled
City:	Hobart, IN	Year Renewed:	
Location:	Alley	Tape/Media #:	
Purpose:	Routine Assessment	Dia/Height:	12"
Use:	Sanitary Sewage Pipe	Material:	CP
Drain Area:		Lining:	None
Category:	NA		
Comment:			
Location Details:		Direction of Survey:	Downstream
US MH:	M-504-103	DS MH:	M-504-104
		Total Length Surveyed (ft):	188.3

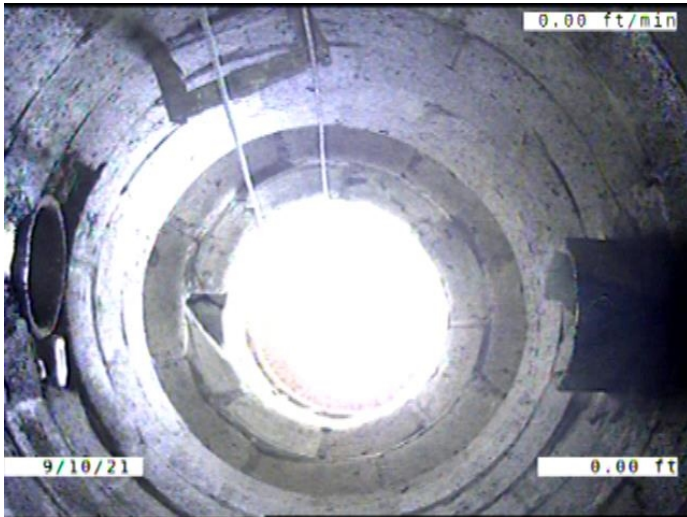
Code: **AMH**
 Description: **Manhole**

Distance (ft): **.0**
 Structural Grade: **0**
 O&M Grade: **0**
 Clock Start/From:
 Clock To:
 1st Value:
 2nd Value:
 Value Percent:
 Continuous Index:
 Within 8" of Joint: **NO**
 Remarks: **M-504-103**

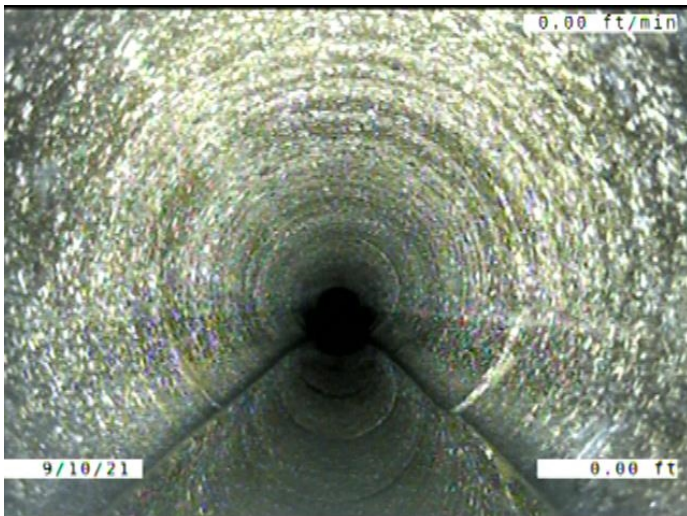
Code: **MWL**
 Description: **Miscellaneous Water Level**

Distance (ft): **.0**
 Structural Grade: **0**
 O&M Grade: **0**
 Clock Start/From:
 Clock To:
 1st Value:
 2nd Value:
 Value Percent: **5.000**
 Continuous Index:
 Within 8" of Joint: **NO**
 Remarks:

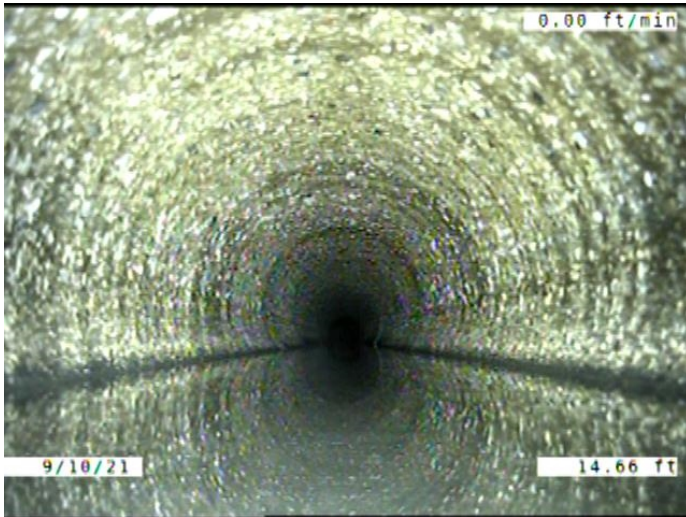
Code: **MWLS**
Description: **Miscellaneous Water Level Sag**

Distance (ft): **14.7**
Structural Grade: **2**
O&M Grade: **0**
Clock Start/From:
Clock To:
1st Value:
2nd Value:
Value Percent: **15.000**
Continuous Index: **S01**
Within 8" of Joint: **NO**
Remarks:

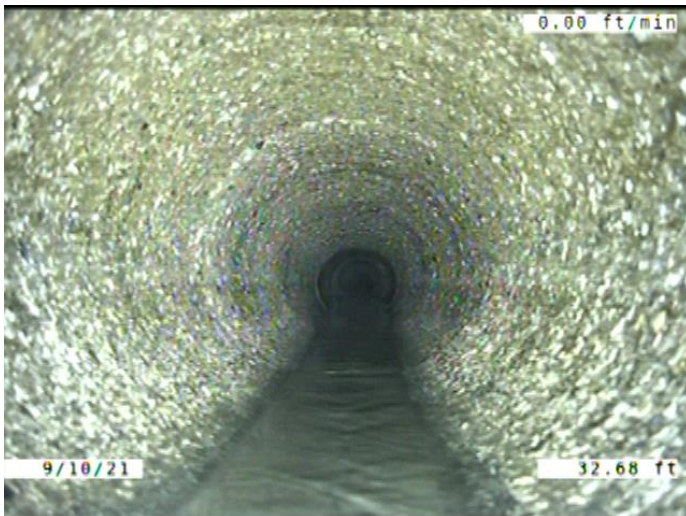
Code: **MWLS**
Description: **Miscellaneous Water Level Sag**

Distance (ft): **32.7**
Structural Grade: **2**
O&M Grade: **0**
Clock Start/From:
Clock To:
1st Value:
2nd Value:
Value Percent: **15.000**
Continuous Index: **F01**
Within 8" of Joint: **NO**
Remarks:

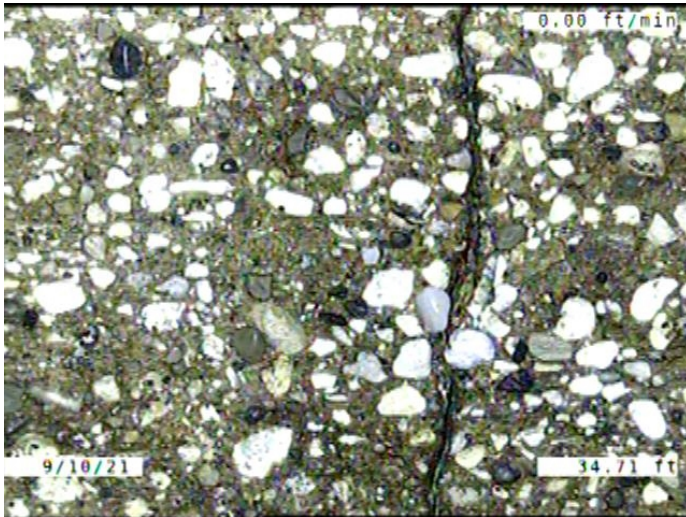
Code: **FL**
 Description: **Fracture Longitudinal**

Distance (ft): **34.7**
 Structural Grade: **3**
 O&M Grade: **0**
 Clock Start/From: **12**
 Clock To:
 1st Value:
 2nd Value:
 Value Percent:
 Continuous Index: **S02**
 Within 8" of Joint: **YES**
 Remarks:

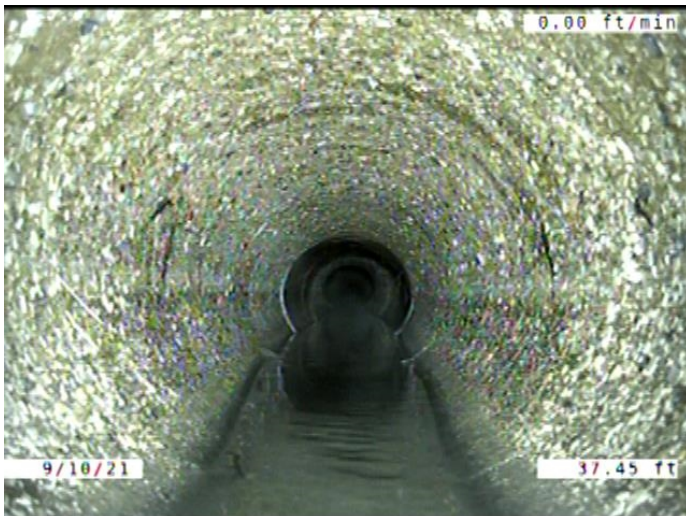
Code: **MWLS**
 Description: **Miscellaneous Water Level Sag**

Distance (ft): **37.4**
 Structural Grade: **2**
 O&M Grade: **0**
 Clock Start/From:
 Clock To:
 1st Value:
 2nd Value:
 Value Percent: **10.000**
 Continuous Index: **S03**
 Within 8" of Joint: **NO**
 Remarks:

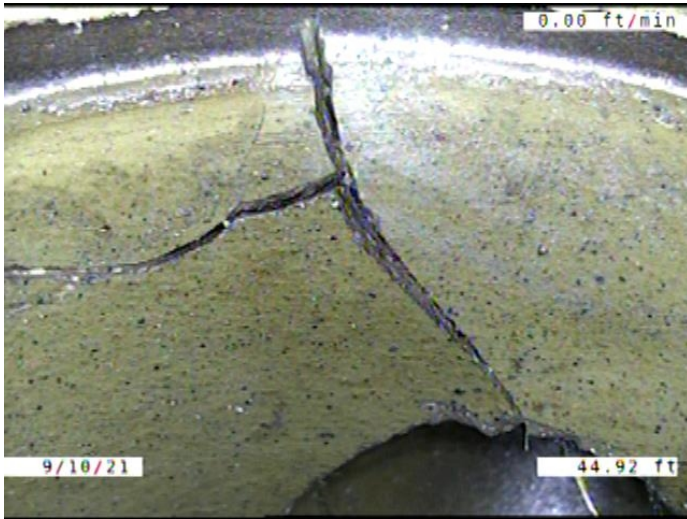
Code: **B**
Description: **Broken**

Distance (ft): **44.9**
Structural Grade: **4**
O&M Grade: **0**
Clock Start/From: **8**
Clock To: **4**
1st Value:
2nd Value:
Value Percent:
Continuous Index:
Within 8" of Joint: **YES**
Remarks:

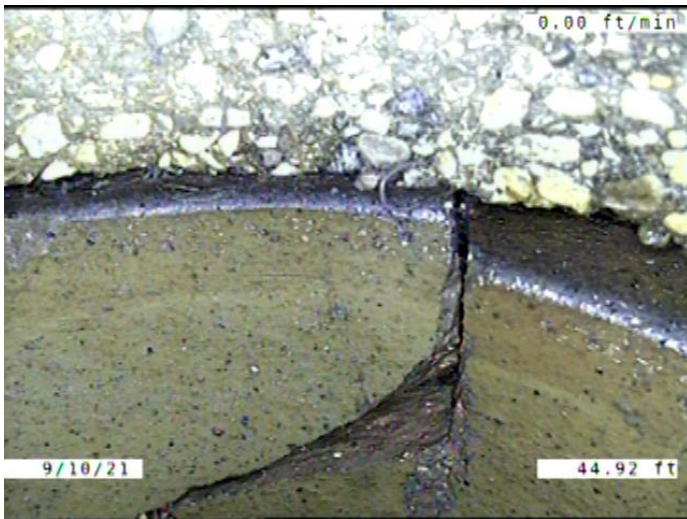
Code: **MMC**
Description: **Miscellaneous Material Change**

Distance (ft): **44.9**
Structural Grade: **0**
O&M Grade: **0**
Clock Start/From:
Clock To:
1st Value:
2nd Value:
Value Percent:
Continuous Index:
Within 8" of Joint: **NO**
Remarks: **CONCRETE TO VCP**

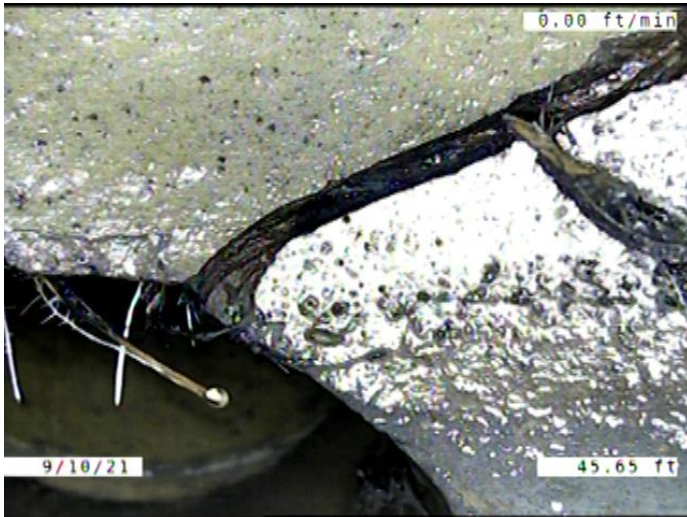
Code: **RFB**
 Description: **Roots Fine Barrel**

Distance (ft): **45.7**
 Structural Grade: **0**
 O&M Grade: **2**
 Clock Start/From: **1**
 Clock To: **2**
 1st Value:
 2nd Value:
 Value Percent:
 Continuous Index:
 Within 8" of Joint: **NO**
 Remarks:

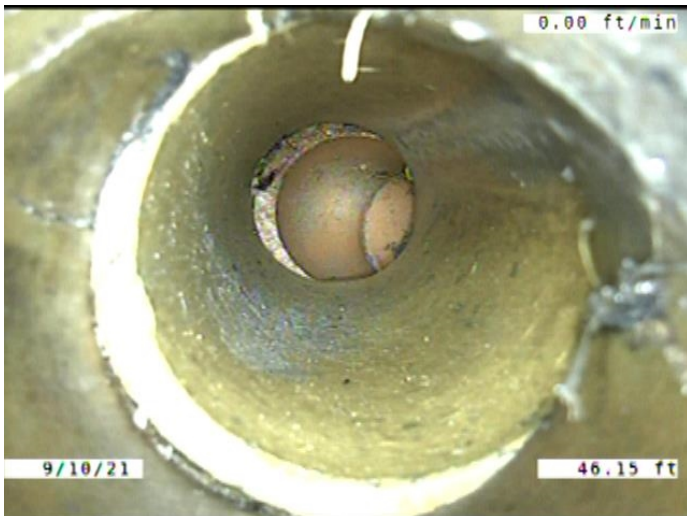
Code: **TFD**
 Description: **Tap Factory Defective**

Distance (ft): **46.1**
 Structural Grade: **0**
 O&M Grade: **3**
 Clock Start/From: **1**
 Clock To:
 1st Value: **4.000**
 2nd Value:
 Value Percent:
 Continuous Index:
 Within 8" of Joint: **YES**
 Remarks: **Defective**

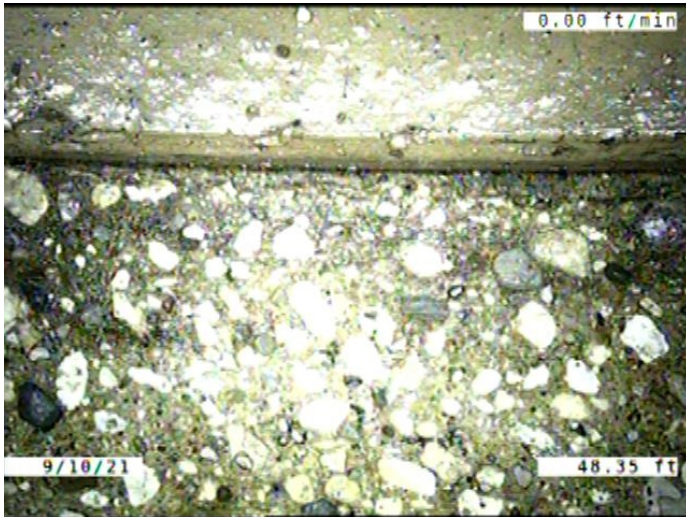
Code: **MMC**
 Description: **Miscellaneous Material Change**

Distance (ft): **48.3**
 Structural Grade: **0**
 O&M Grade: **0**
 Clock Start/From:
 Clock To:
 1st Value:
 2nd Value:
 Value Percent:
 Continuous Index:
 Within 8" of Joint: **NO**
 Remarks: **VCP TO CONCRETE**

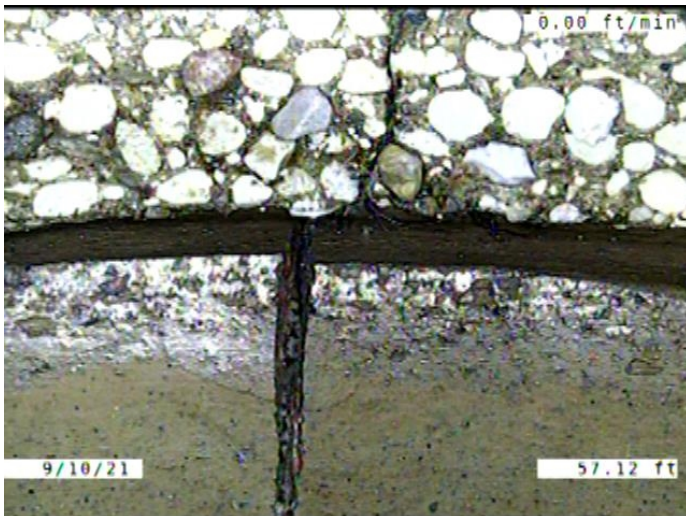
Code: **MMC**
 Description: **Miscellaneous Material Change**

Distance (ft): **57.1**
 Structural Grade: **0**
 O&M Grade: **0**
 Clock Start/From:
 Clock To:
 1st Value:
 2nd Value:
 Value Percent:
 Continuous Index:
 Within 8" of Joint: **NO**
 Remarks: **CONCRETE TO VCP**

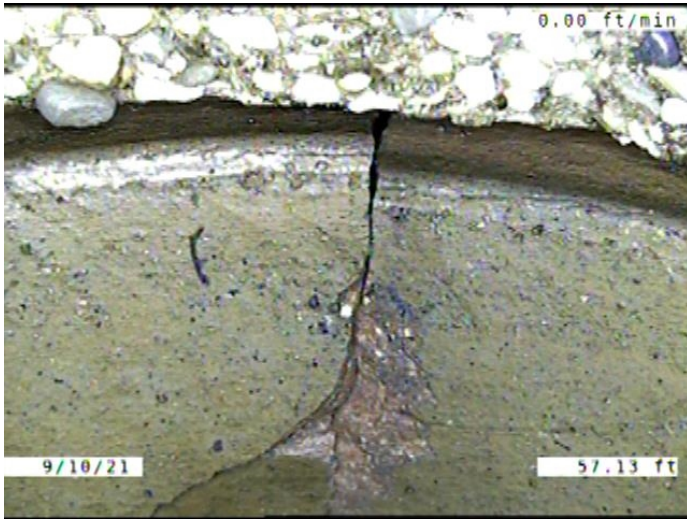
Code: **B**
Description: **Broken**

Distance (ft): **57.1**
Structural Grade: **4**
O&M Grade: **0**
Clock Start/From: **12**
Clock To: **12**
1st Value:
2nd Value:
Value Percent:
Continuous Index:
Within 8" of Joint: **YES**
Remarks:

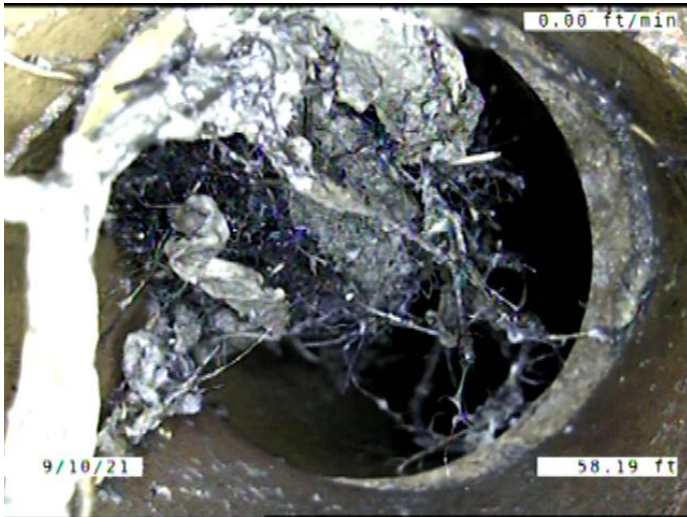
Code: **TFD**
Description: **Tap Factory Defective**

Distance (ft): **58.2**
Structural Grade: **0**
O&M Grade: **3**
Clock Start/From: **11**
Clock To:
1st Value: **4.000**
2nd Value:
Value Percent:
Continuous Index:
Within 8" of Joint: **YES**
Remarks: **Defective**

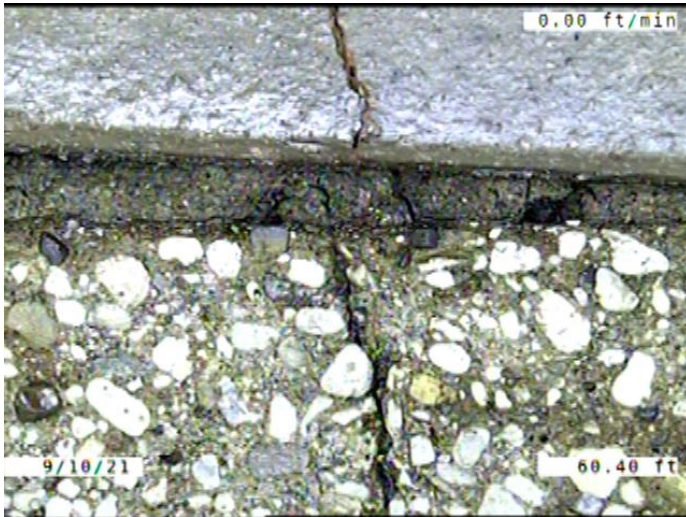
Code: **MMC**
 Description: **Miscellaneous Material Change**

Distance (ft): **60.4**
 Structural Grade: **0**
 O&M Grade: **0**
 Clock Start/From:
 Clock To:
 1st Value:
 2nd Value:
 Value Percent:
 Continuous Index:
 Within 8" of Joint: **NO**
 Remarks: **VCP TO CONCRETE**

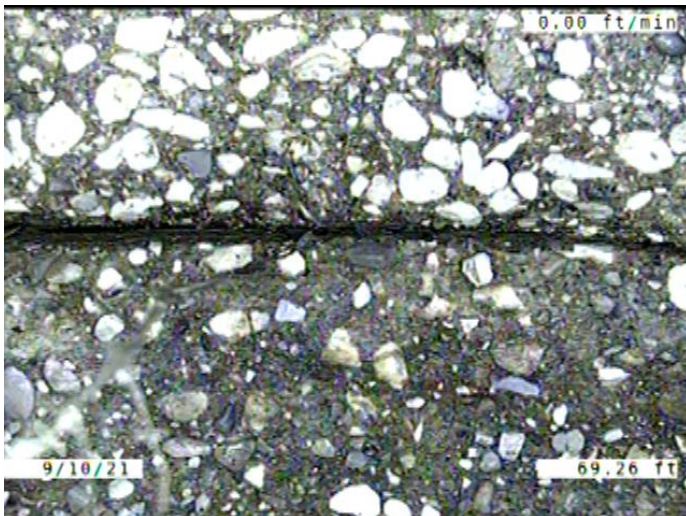
Code: **RFJ**
 Description: **Roots Fine Joint**

Distance (ft): **69.3**
 Structural Grade: **0**
 O&M Grade: **1**
 Clock Start/From: **12**
 Clock To:
 1st Value:
 2nd Value:
 Value Percent:
 Continuous Index:
 Within 8" of Joint: **YES**
 Remarks:

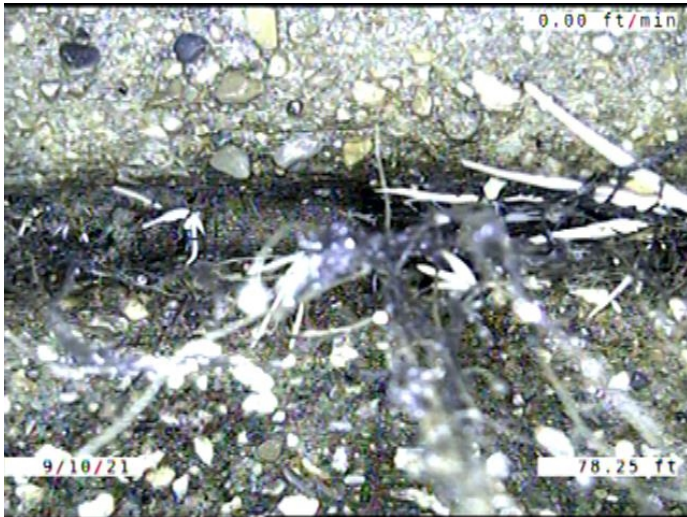
Code: **RMJ**
 Description: **Roots Medium Joint**

Distance (ft): **78.3**
 Structural Grade: **0**
 O&M Grade: **3**
 Clock Start/From: **8**
 Clock To: **4**
 1st Value:
 2nd Value:
 Value Percent: **5.000**
 Continuous Index:
 Within 8" of Joint: **YES**
 Remarks:

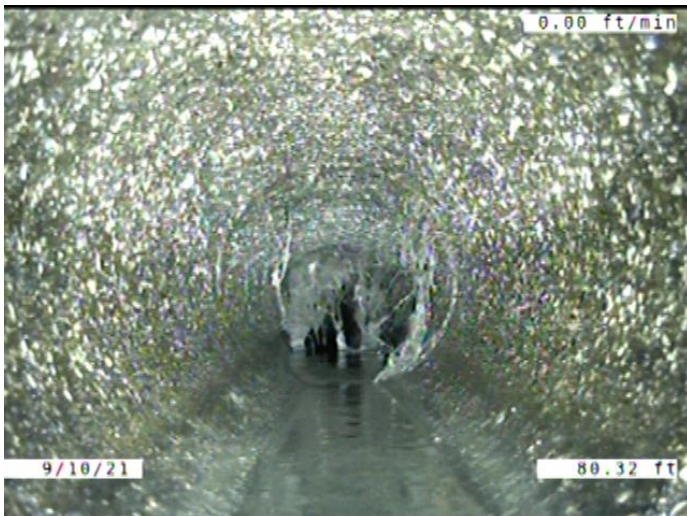
Code: **MWLS**
 Description: **Miscellaneous Water Level Sag**

Distance (ft): **80.3**
 Structural Grade: **2**
 O&M Grade: **0**
 Clock Start/From:
 Clock To:
 1st Value:
 2nd Value:
 Value Percent: **10.000**
 Continuous Index: **F03**
 Within 8" of Joint: **NO**
 Remarks:

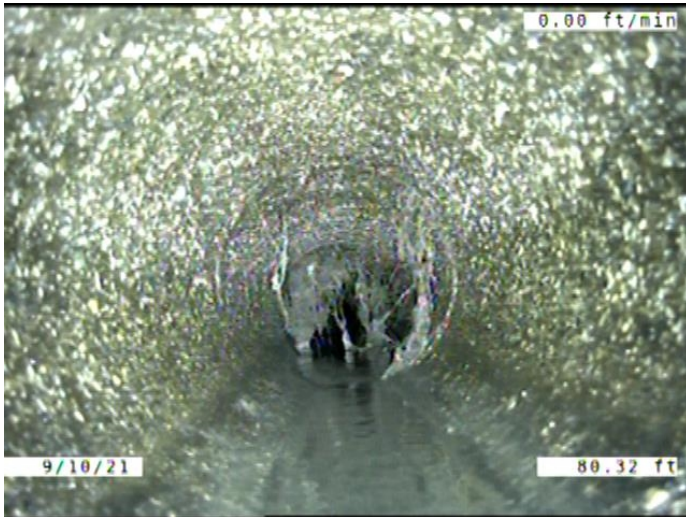
Code: **FL**
 Description: **Fracture Longitudinal**

Distance (ft): **80.3**
 Structural Grade: **3**
 O&M Grade: **0**
 Clock Start/From: **12**
 Clock To:
 1st Value:
 2nd Value:
 Value Percent:
 Continuous Index: **F02**
 Within 8" of Joint: **YES**
 Remarks:

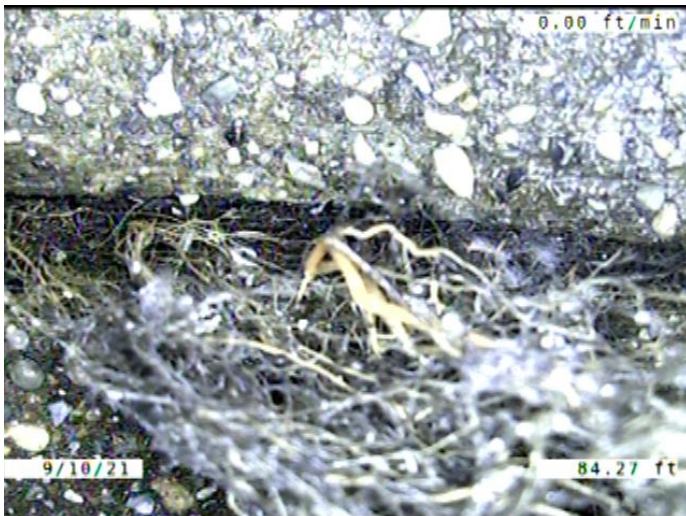
Code: **RMJ**
 Description: **Roots Medium Joint**

Distance (ft): **84.3**
 Structural Grade: **0**
 O&M Grade: **3**
 Clock Start/From: **11**
 Clock To: **4**
 1st Value:
 2nd Value:
 Value Percent: **5.000**
 Continuous Index:
 Within 8" of Joint: **YES**
 Remarks:

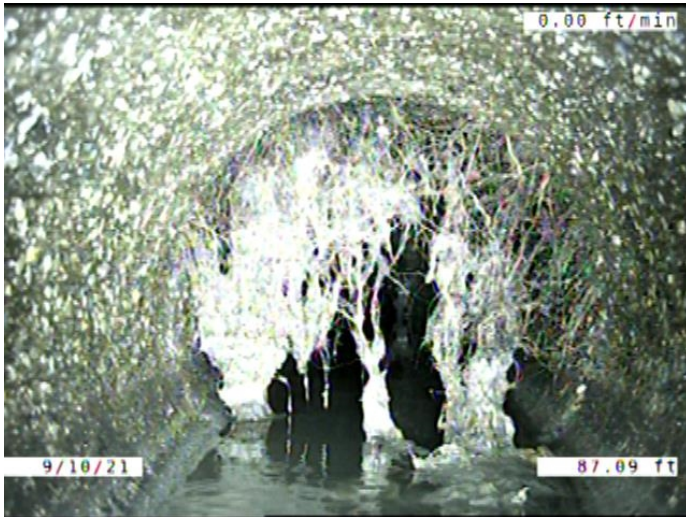
Code: **RMJ**
 Description: **Roots Medium Joint**

Distance (ft): **87.1**
 Structural Grade: **0**
 O&M Grade: **3**
 Clock Start/From: **9**
 Clock To: **3**
 1st Value:
 2nd Value:
 Value Percent: **50.000**
 Continuous Index:
 Within 8" of Joint: **YES**
 Remarks:

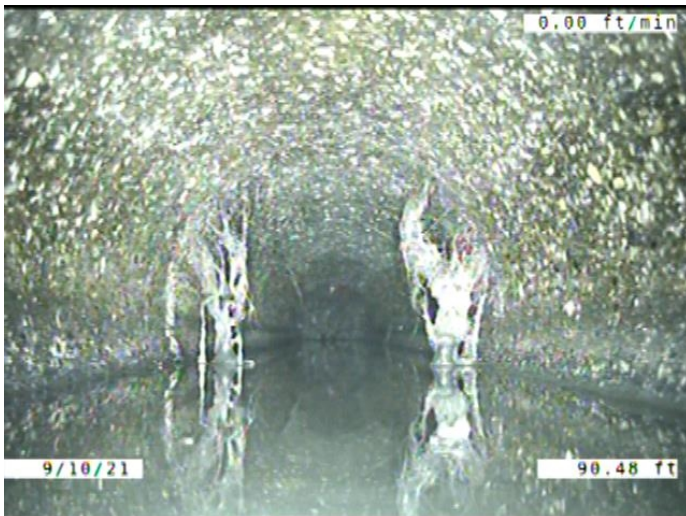
Code: **MWL**
 Description: **Miscellaneous Water Level**

Distance (ft): **90.5**
 Structural Grade: **0**
 O&M Grade: **0**
 Clock Start/From:
 Clock To:
 1st Value:
 2nd Value:
 Value Percent: **15.000**
 Continuous Index:
 Within 8" of Joint: **NO**
 Remarks:

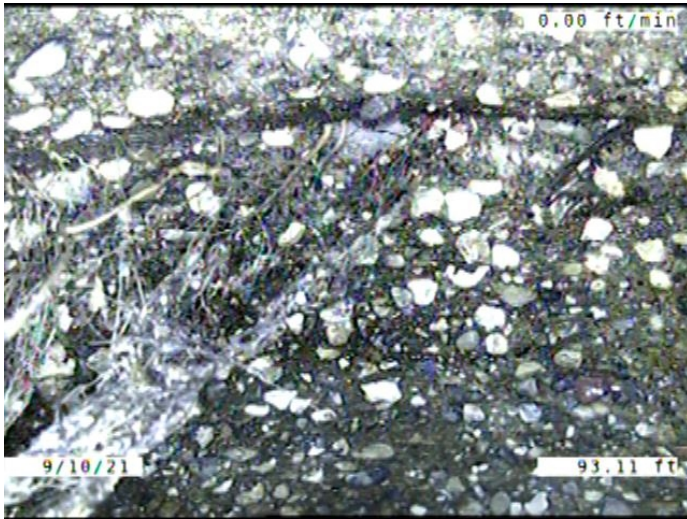
Code: **RMJ**
 Description: **Roots Medium Joint**

Distance (ft): **93.1**
 Structural Grade: **0**
 O&M Grade: **3**
 Clock Start/From: **9**
 Clock To: **3**
 1st Value:
 2nd Value:
 Value Percent: **5.000**
 Continuous Index:
 Within 8" of Joint: **YES**
 Remarks:

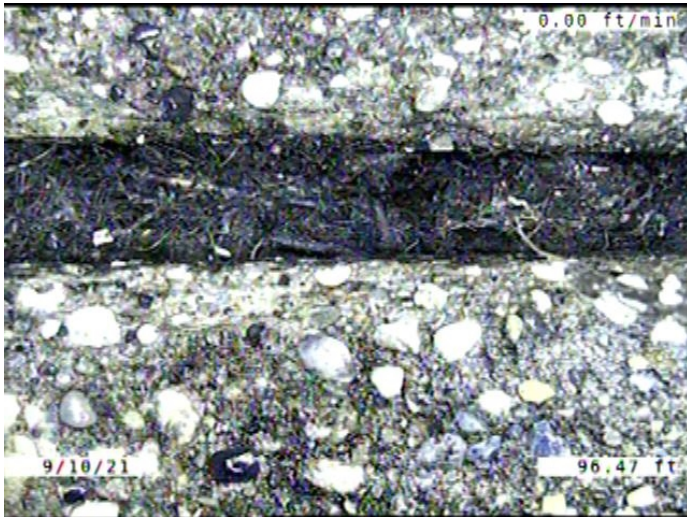
Code: **RFJ**
 Description: **Roots Fine Joint**

Distance (ft): **96.5**
 Structural Grade: **0**
 O&M Grade: **1**
 Clock Start/From: **9**
 Clock To: **3**
 1st Value:
 2nd Value:
 Value Percent:
 Continuous Index:
 Within 8" of Joint: **YES**
 Remarks:

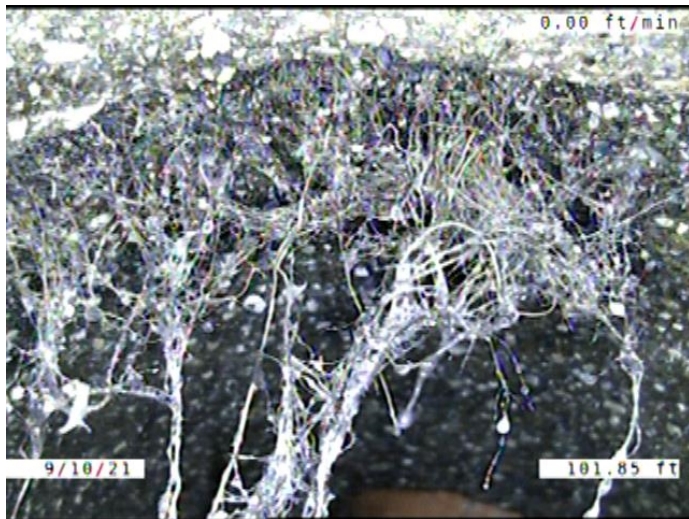
Code: **RMJ**
 Description: **Roots Medium Joint**

Distance (ft): **101.9**
 Structural Grade: **0**
 O&M Grade: **3**
 Clock Start/From: **10**
 Clock To: **1**
 1st Value:
 2nd Value:
 Value Percent: **5.000**
 Continuous Index:
 Within 8" of Joint: **YES**
 Remarks:

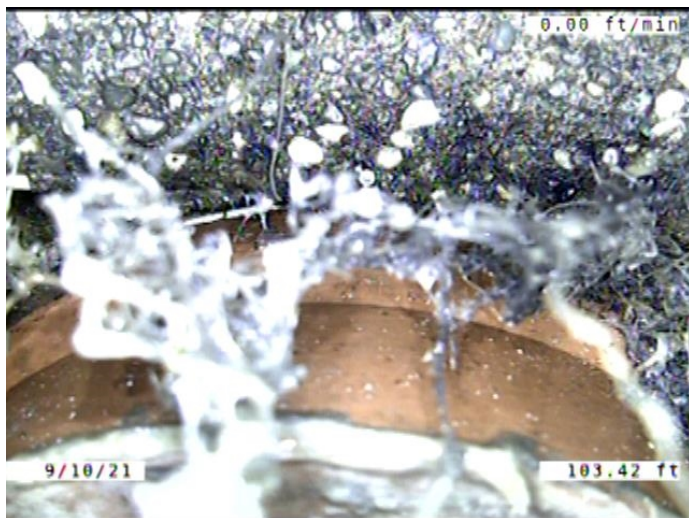
Code: **RML**
 Description: **Roots Medium Lateral**

Distance (ft): **103.4**
 Structural Grade: **0**
 O&M Grade: **3**
 Clock Start/From: **11**
 Clock To: **1**
 1st Value:
 2nd Value:
 Value Percent: **50.000**
 Continuous Index:
 Within 8" of Joint: **NO**
 Remarks:

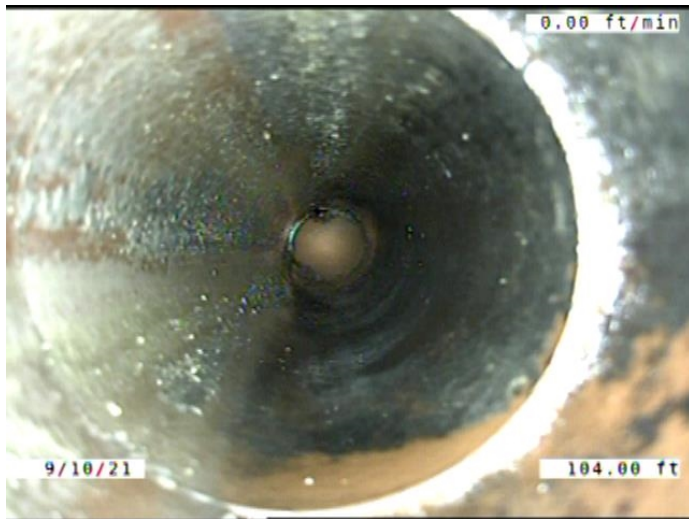
Code:	TBI
Description:	Tap Break-in Intruding
Distance (ft):	104.0
Structural Grade:	0
O&M Grade:	2
Clock Start/From:	12
Clock To:	
1st Value:	4.000
2nd Value:	2.000
Value Percent:	
Continuous Index:	
Within 8" of Joint:	NO
Remarks:	CONSTANTLY RUNNING WATER

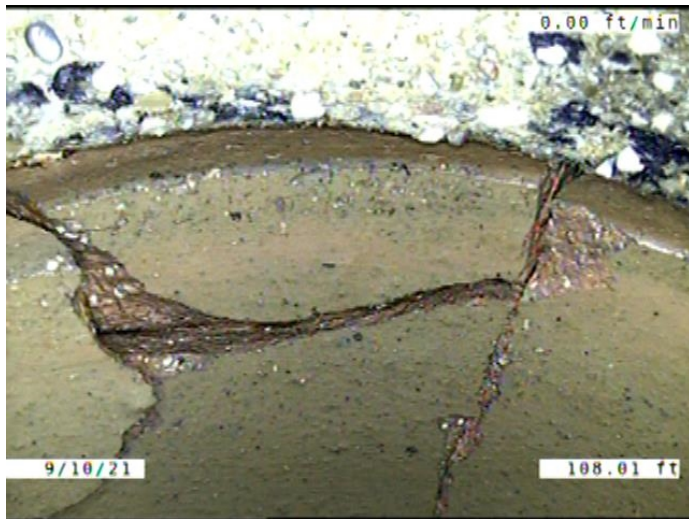
Code:	B
Description:	Broken
Distance (ft):	108.0
Structural Grade:	4
O&M Grade:	0
Clock Start/From:	8
Clock To:	4
1st Value:	
2nd Value:	
Value Percent:	
Continuous Index:	
Within 8" of Joint:	YES
Remarks:

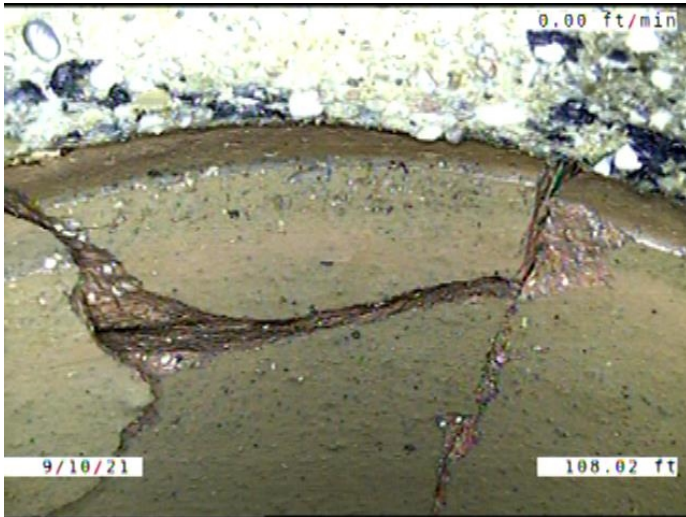
Code: **MMC**
Description: **Miscellaneous Material Change**

Distance (ft): **108.0**
Structural Grade: **0**
O&M Grade: **0**
Clock Start/From:
Clock To:
1st Value:
2nd Value:
Value Percent:
Continuous Index:
Within 8" of Joint: **NO**
Remarks: **CONCRETE TO VCP**

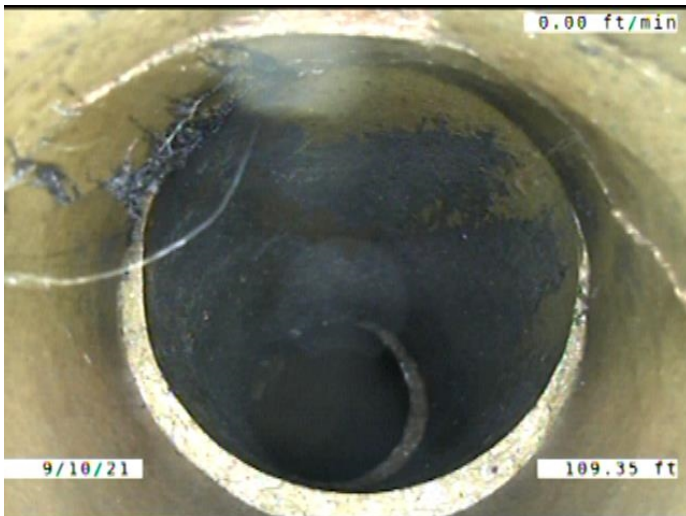
Code: **TFD**
Description: **Tap Factory Defective**

Distance (ft): **109.4**
Structural Grade: **0**
O&M Grade: **3**
Clock Start/From: **12**
Clock To:
1st Value: **4.000**
2nd Value:
Value Percent:
Continuous Index:
Within 8" of Joint: **YES**
Remarks: **Defective**

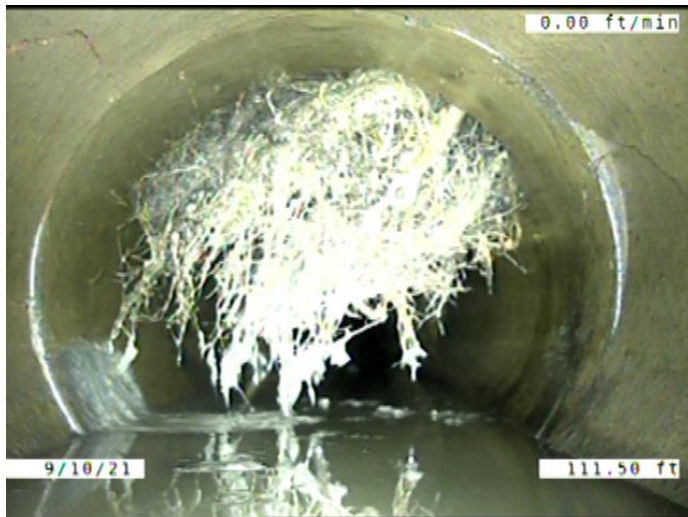
Code: **RML**
 Description: **Roots Medium Lateral**

Distance (ft): **111.5**
 Structural Grade: **0**
 O&M Grade: **3**
 Clock Start/From: **10**
 Clock To: **2**
 1st Value:
 2nd Value:
 Value Percent: **40.000**
 Continuous Index:
 Within 8" of Joint: **NO**
 Remarks:

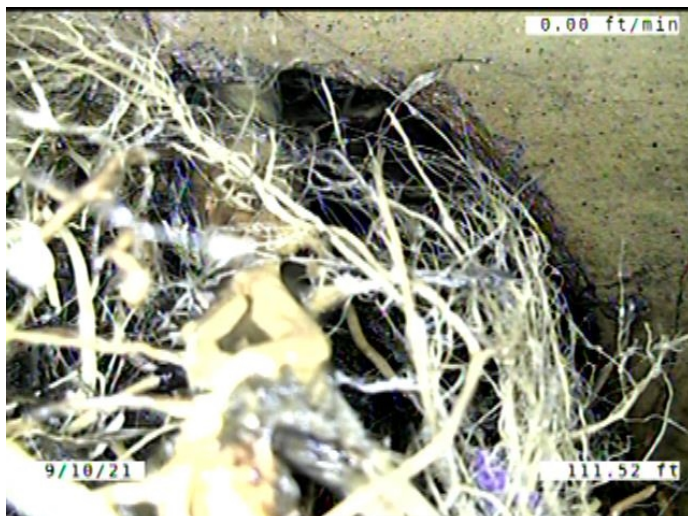
Code: **TBD**
 Description: **Tap Break-in/Hammer Defective**

Distance (ft): **111.5**
 Structural Grade: **0**
 O&M Grade: **3**
 Clock Start/From: **1**
 Clock To:
 1st Value: **4.000**
 2nd Value:
 Value Percent:
 Continuous Index:
 Within 8" of Joint: **YES**
 Remarks: **Defective**

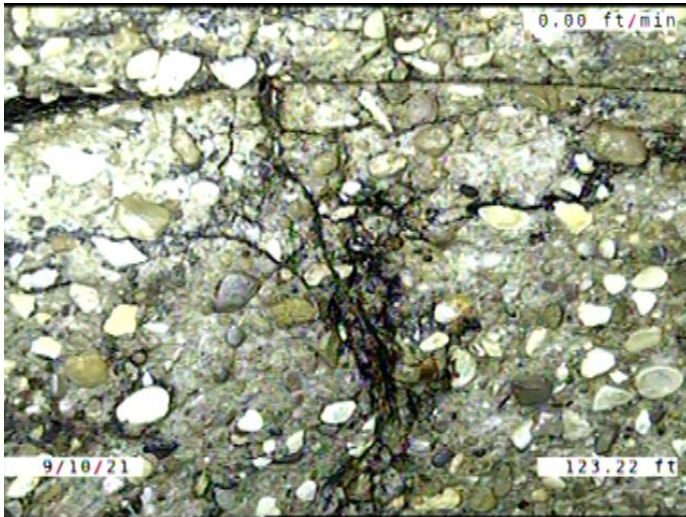
Code: **CM**
 Description: **Crack Multiple**

Distance (ft): **123.2**
 Structural Grade: **3**
 O&M Grade: **0**
 Clock Start/From: **9**
 Clock To: **10**
 1st Value:
 2nd Value:
 Value Percent:
 Continuous Index:
 Within 8" of Joint: **YES**
 Remarks:

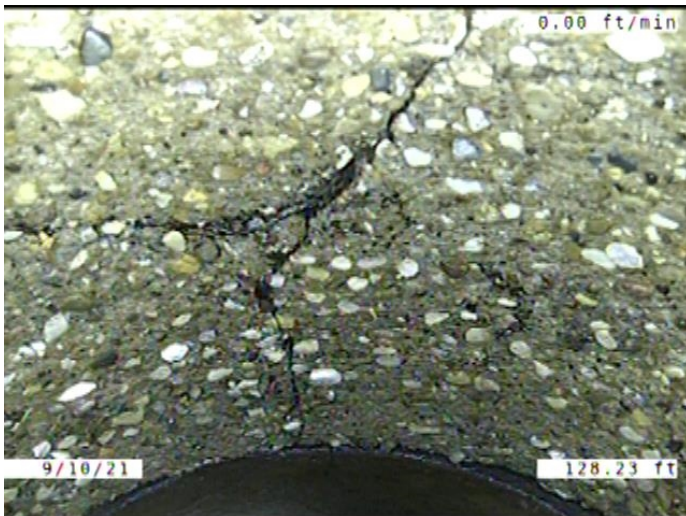
Code: **FM**
 Description: **Fracture Multiple**

Distance (ft): **128.2**
 Structural Grade: **4**
 O&M Grade: **0**
 Clock Start/From: **8**
 Clock To: **1**
 1st Value:
 2nd Value:
 Value Percent:
 Continuous Index:
 Within 8" of Joint: **YES**
 Remarks:

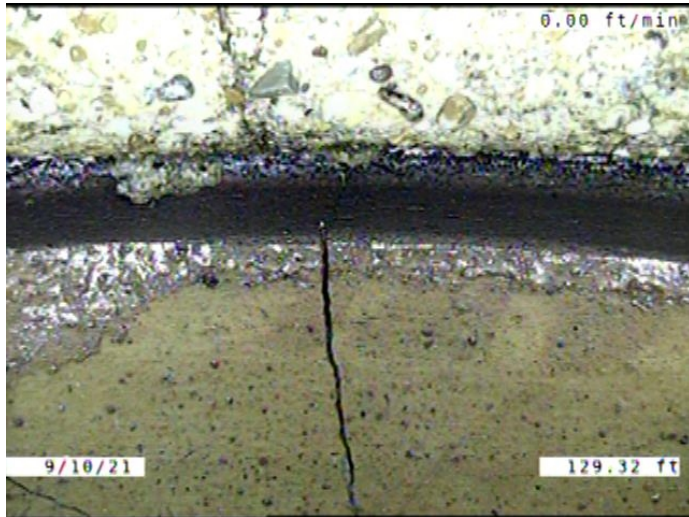
Code: **MMC**
Description: **Miscellaneous Material Change**

Distance (ft): **129.3**
Structural Grade: **0**
O&M Grade: **0**
Clock Start/From:
Clock To:
1st Value:
2nd Value:
Value Percent:
Continuous Index:
Within 8" of Joint: **NO**
Remarks: **CONCRETE TO VCP**

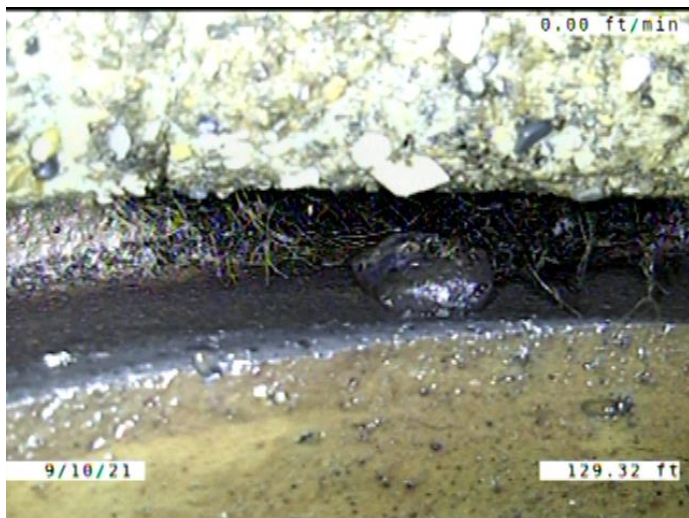
Code: **RFJ**
Description: **Roots Fine Joint**

Distance (ft): **129.3**
Structural Grade: **0**
O&M Grade: **1**
Clock Start/From: **9**
Clock To: **10**
1st Value:
2nd Value:
Value Percent:
Continuous Index:
Within 8" of Joint: **YES**
Remarks:

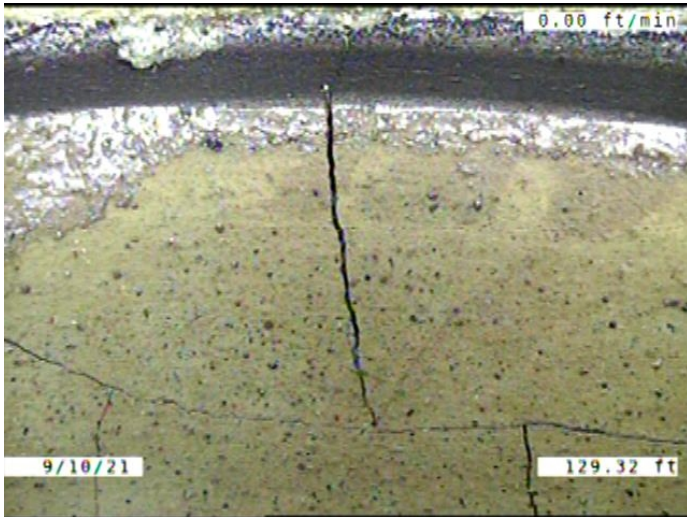
Code: **FM**
Description: **Fracture Multiple**

Distance (ft): **129.3**
Structural Grade: **4**
O&M Grade: **0**
Clock Start/From: **8**
Clock To: **4**
1st Value:
2nd Value:
Value Percent:
Continuous Index:
Within 8" of Joint: **YES**
Remarks:

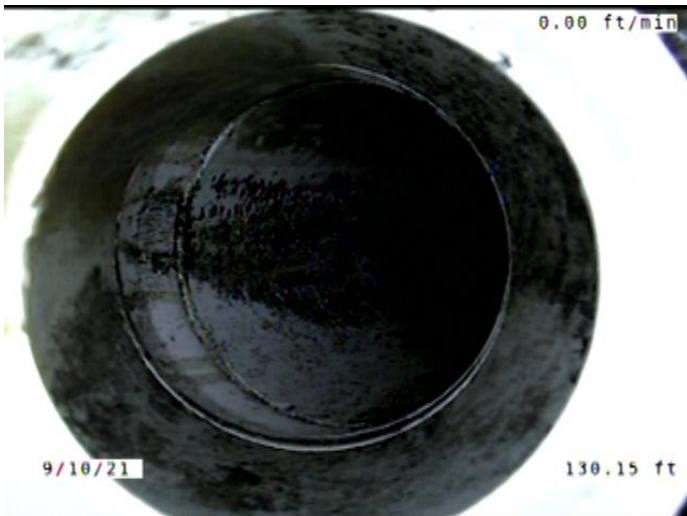
Code: **TFI**
Description: **Tap Factory Intruding**

Distance (ft): **130.1**
Structural Grade: **0**
O&M Grade: **2**
Clock Start/From: **11**
Clock To:
1st Value: **4.000**
2nd Value: **1.000**
Value Percent:
Continuous Index:
Within 8" of Joint: **YES**
Remarks: **CONSTANTLY RUNNING WATER**

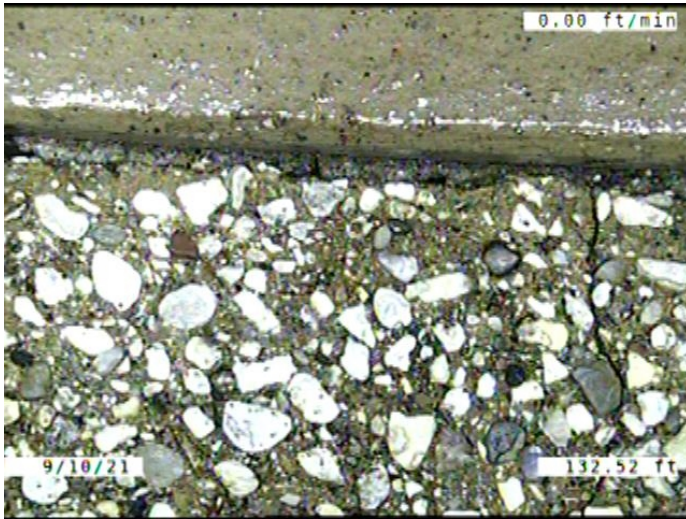
Code: **MMC**
 Description: **Miscellaneous Material Change**

Distance (ft): **132.5**
 Structural Grade: **0**
 O&M Grade: **0**
 Clock Start/From:
 Clock To:
 1st Value:
 2nd Value:
 Value Percent:
 Continuous Index:
 Within 8" of Joint: **NO**
 Remarks: **VCP TO CONCRETE**

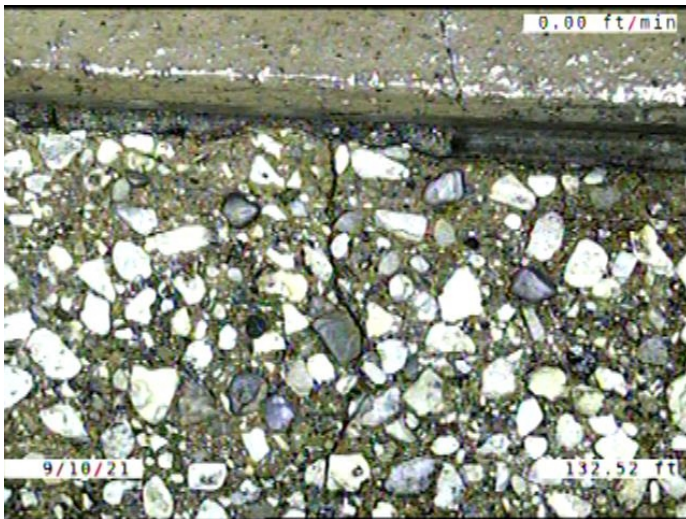
Code: **CL**
 Description: **Crack Longitudinal**

Distance (ft): **132.5**
 Structural Grade: **2**
 O&M Grade: **0**
 Clock Start/From: **12**
 Clock To:
 1st Value:
 2nd Value:
 Value Percent:
 Continuous Index:
 Within 8" of Joint: **YES**
 Remarks:

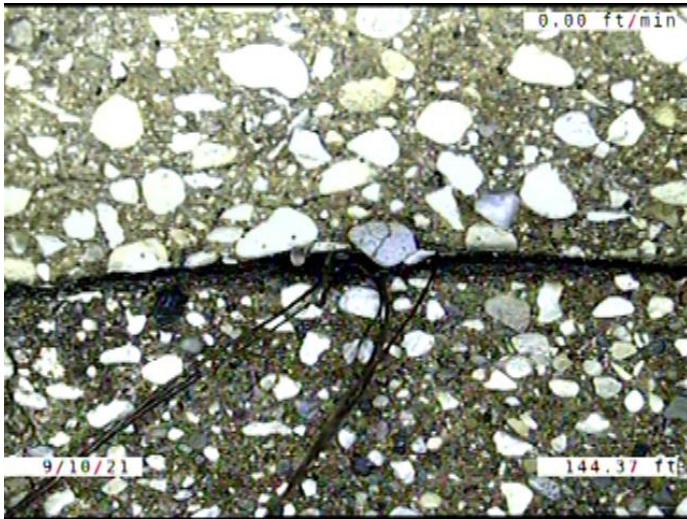
Code: **RFJ**
Description: **Roots Fine Joint**

Distance (ft): **144.4**
Structural Grade: **0**
O&M Grade: **1**
Clock Start/From: **9**
Clock To: **10**
1st Value:
2nd Value:
Value Percent:
Continuous Index:
Within 8" of Joint: **YES**
Remarks:

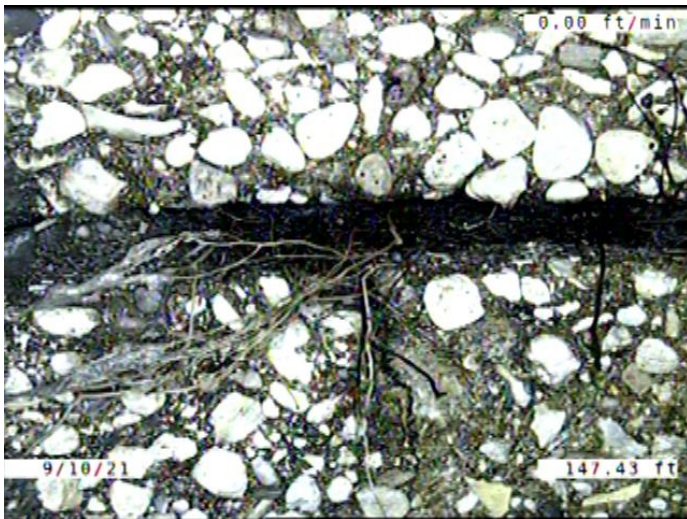
Code: **RFJ**
Description: **Roots Fine Joint**

Distance (ft): **147.4**
Structural Grade: **0**
O&M Grade: **1**
Clock Start/From: **9**
Clock To: **11**
1st Value:
2nd Value:
Value Percent:
Continuous Index:
Within 8" of Joint: **YES**
Remarks:

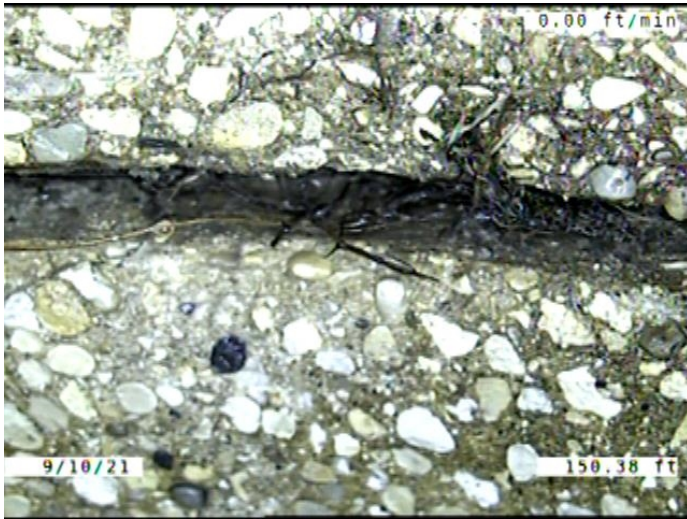
Code: **RFJ**
 Description: **Roots Fine Joint**

Distance (ft): **150.4**
 Structural Grade: **0**
 O&M Grade: **1**
 Clock Start/From: **1**
 Clock To: **3**
 1st Value:
 2nd Value:
 Value Percent:
 Continuous Index:
 Within 8" of Joint: **YES**
 Remarks:

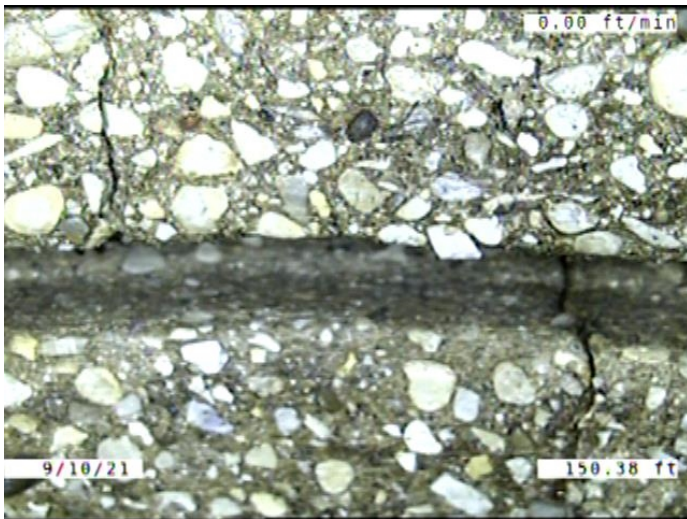
Code: **CS**
 Description: **Crack Spiral**

Distance (ft): **150.4**
 Structural Grade: **2**
 O&M Grade: **0**
 Clock Start/From: **11**
 Clock To: **12**
 1st Value:
 2nd Value:
 Value Percent:
 Continuous Index:
 Within 8" of Joint: **YES**
 Remarks:

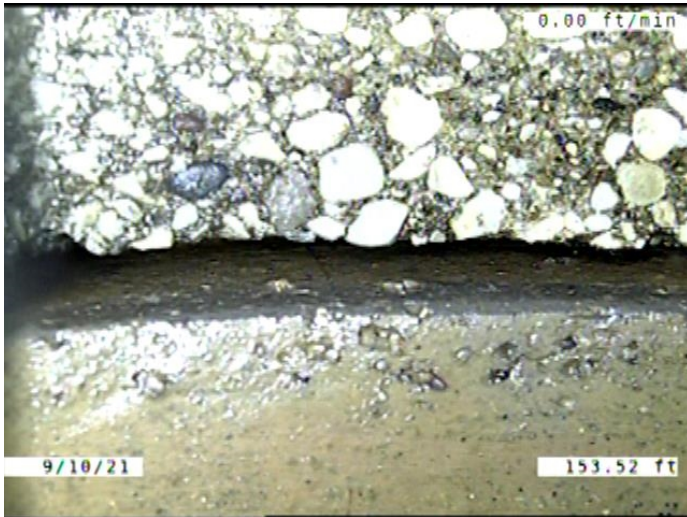
Code:	MMC
Description:	Miscellaneous Material Change
Distance (ft):	153.5
Structural Grade:	0
O&M Grade:	0
Clock Start/From:	
Clock To:	
1st Value:	
2nd Value:	
Value Percent:	
Continuous Index:	
Within 8" of Joint:	NO
Remarks:	CONCRETE TO VCP

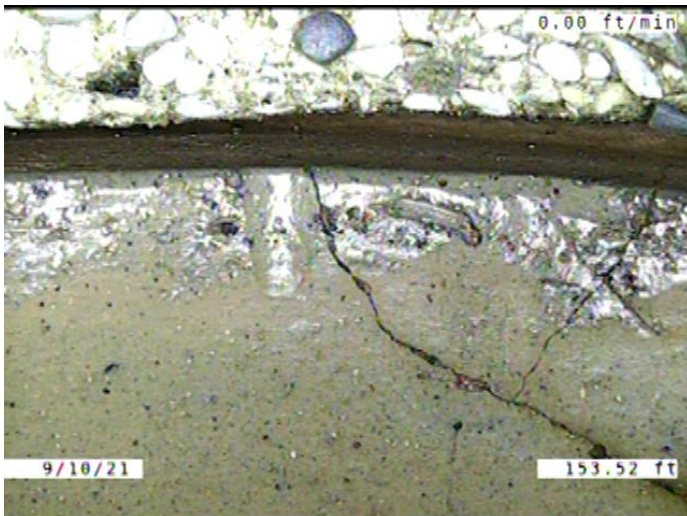
Code:	CM
Description:	Crack Multiple
Distance (ft):	153.5
Structural Grade:	3
O&M Grade:	0
Clock Start/From:	12
Clock To:	4
1st Value:	
2nd Value:	
Value Percent:	
Continuous Index:	
Within 8" of Joint:	YES
Remarks:

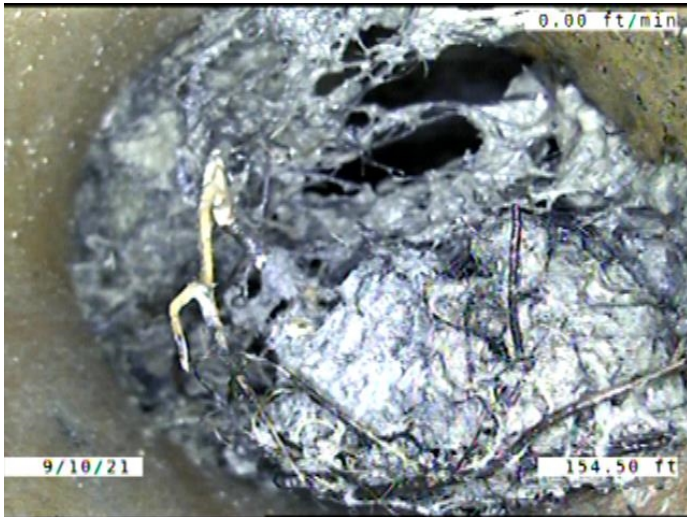
Code: **TFD**
Description: **Tap Factory Defective**

Distance (ft): **154.5**
Structural Grade: **0**
O&M Grade: **3**
Clock Start/From: **1**
Clock To:
1st Value: **4.000**
2nd Value:
Value Percent:
Continuous Index:
Within 8" of Joint: **YES**
Remarks: **90% PLUGGED WITH ROOTS**

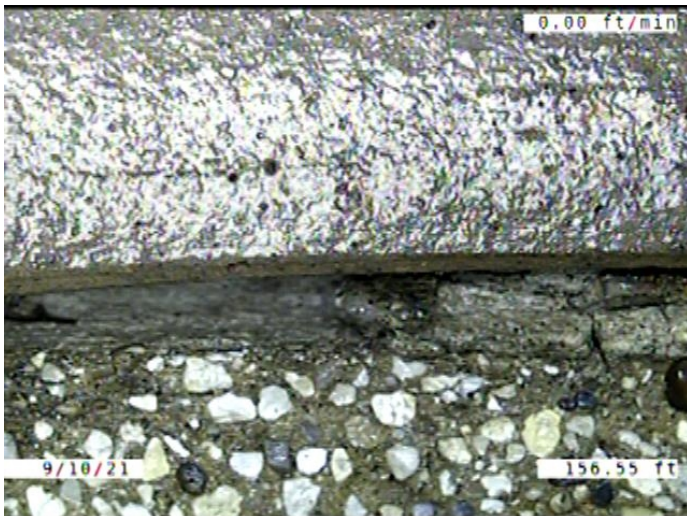
Code: **MMC**
Description: **Miscellaneous Material Change**

Distance (ft): **156.5**
Structural Grade: **0**
O&M Grade: **0**
Clock Start/From:
Clock To:
1st Value:
2nd Value:
Value Percent:
Continuous Index:
Within 8" of Joint: **NO**
Remarks: **VCP TO CONCRETE**

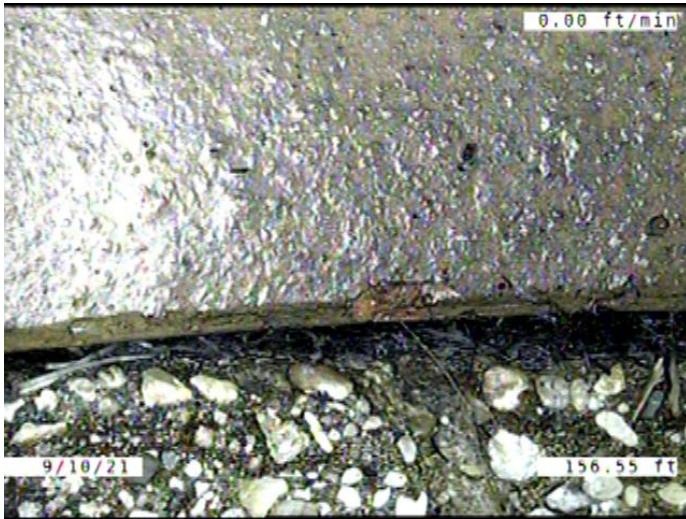
Code: **RFJ**
Description: **Roots Fine Joint**

Distance (ft): **156.5**
Structural Grade: **0**
O&M Grade: **1**
Clock Start/From: **9**
Clock To: **11**
1st Value:
2nd Value:
Value Percent:
Continuous Index:
Within 8" of Joint: **YES**
Remarks:

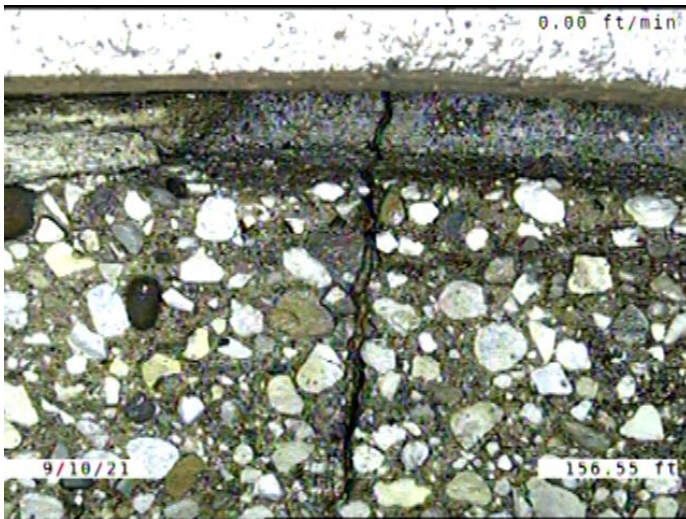
Code: **FS**
Description: **Fracture Spiral**

Distance (ft): **156.5**
Structural Grade: **3**
O&M Grade: **0**
Clock Start/From: **12**
Clock To: **1**
1st Value:
2nd Value:
Value Percent:
Continuous Index: **S04**
Within 8" of Joint: **YES**
Remarks:

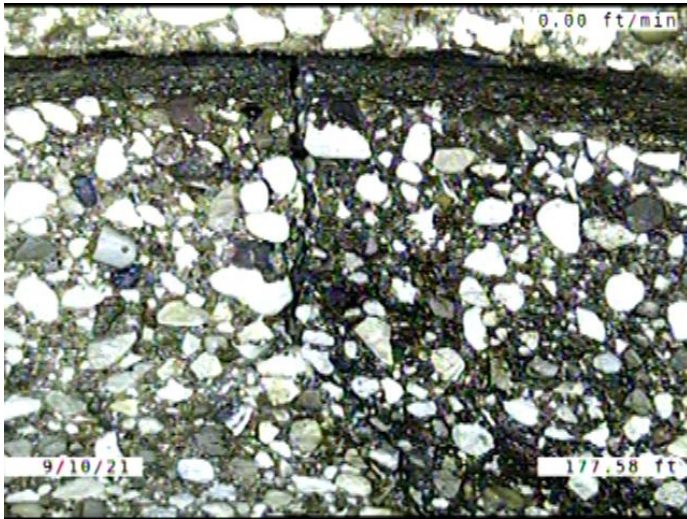
Code: **FM**
Description: **Fracture Multiple**

Distance (ft): **177.6**
Structural Grade: **4**
O&M Grade: **0**
Clock Start/From: **12**
Clock To: **4**
1st Value:
2nd Value:
Value Percent:
Continuous Index:
Within 8" of Joint: **YES**
Remarks:

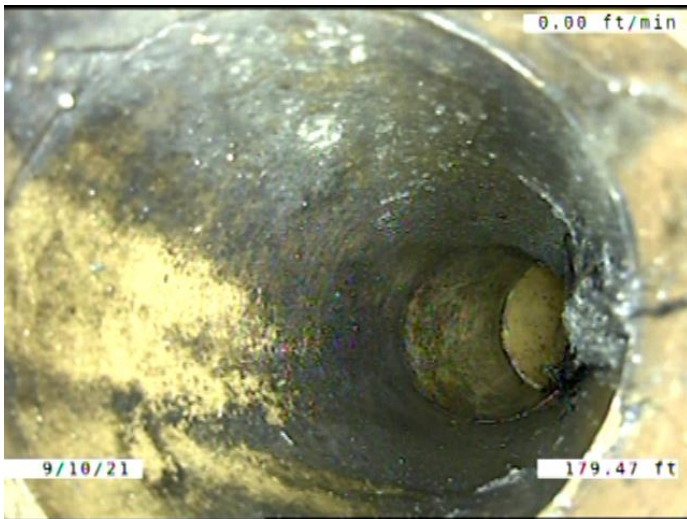
Code: **TBI**
Description: **Tap Break-in Intruding**

Distance (ft): **179.5**
Structural Grade: **0**
O&M Grade: **2**
Clock Start/From: **12**
Clock To:
1st Value: **4.000**
2nd Value: **1.000**
Value Percent:
Continuous Index:
Within 8" of Joint: **YES**
Remarks:

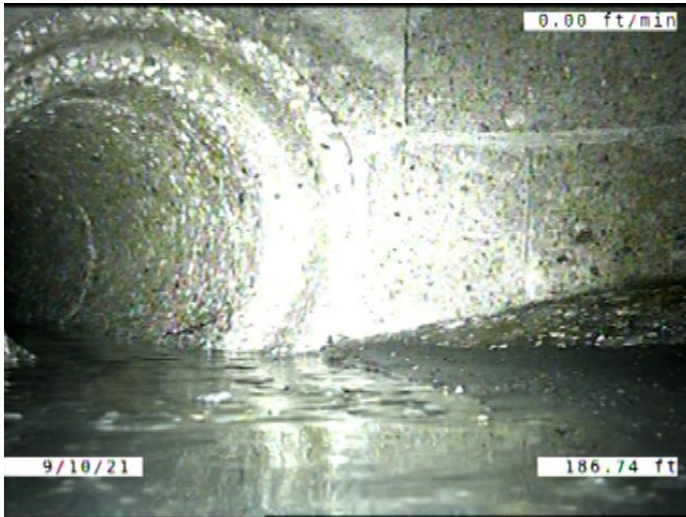
Code: **FS**
 Description: **Fracture Spiral**

Distance (ft): **186.7**
 Structural Grade: **3**
 O&M Grade: **0**
 Clock Start/From: **12**
 Clock To: **1**
 1st Value:
 2nd Value:
 Value Percent:
 Continuous Index: **F04**
 Within 8" of Joint: **YES**
 Remarks:
