Profile/Photo Observation Report

Date:	09/10/2021	Weather:		Coding:	PACP 7.0
Pipe Length (ft):	188.3	Owner:	City of Hobart	Pre Clean:	Heavy Cleaning
P.O.#:	YES502259	Surveyor:	S. Bucklin	PSR:	P-504-104-103
Customer:	City of Hobart	Clean Date:	08/27/2021	Shape:	C

Street:	North Colorado Street	Flow Control:	Not Controlled
City:	Hobart, IN	Year Renewed:	
Location:	Alley	Tape/Media #:	
Purpose:	Routine Assessment	Dia/Height:	12"
Use:	Sanitary Sewage Pipe	Material:	CP
Drain Area:		Lining:	None
Category:	NA		
Comment:			
Location Details:		Direction of Survey:	Downstream
US MH:	M-504-103	DS MH:	M-504-104
		Total Length Surveyed (ft):	188.3

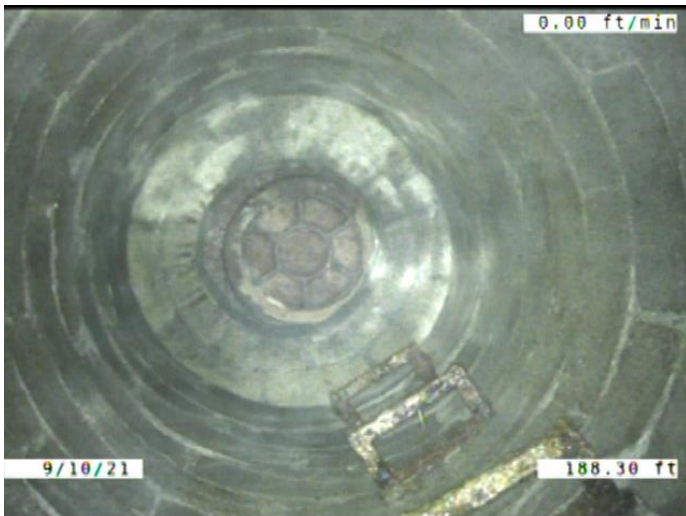
Code: **AMH**
 Description: **Manhole**

Distance (ft): **188.3**
 Structural Grade: **0**
 O&M Grade: **0**
 Clock Start/From:
 Clock To:
 1st Value:
 2nd Value:
 Value Percent:
 Continuous Index:
 Within 8" of Joint: **NO**
 Remarks: **M-504-104**
