# Profile/Photo Observation Report

Date:	<b>09/10/2021</b>	Weather:		Coding:	<b>PACP 7.0</b>
Pipe Length (ft):	<b>188.3</b>	Owner:	<b>City of Hobart</b>	Pre Clean:	<b>Heavy Cleaning</b>
P.O.#:	<b>YES502259</b>	Surveyor:	<b>S. Bucklin</b>	PSR:	<b>P-504-104-103</b>
Customer:	<b>City of Hobart</b>	Clean Date:	<b>08/27/2021</b>	Shape:	<b>C</b>

Street:	<b>North Colorado Street</b>	Flow Control:	<b>Not Controlled</b>
City:	<b>Hobart, IN</b>	Year Renewed:	
Location:	<b>Alley</b>	Tape/Media #:	
Purpose:	<b>Routine Assessment</b>	Dia/Height:	<b>12"</b>
Use:	<b>Sanitary Sewage Pipe</b>	Material:	<b>CP</b>
Drain Area:		Lining:	<b>None</b>
Category:	<b>NA</b>		
Comment:			
Location Details:		Direction of Survey:	<b>Downstream</b>
US MH:	<b>M-504-103</b>	DS MH:	<b>M-504-104</b>
		Total Length Surveyed (ft):	<b>188.3</b>

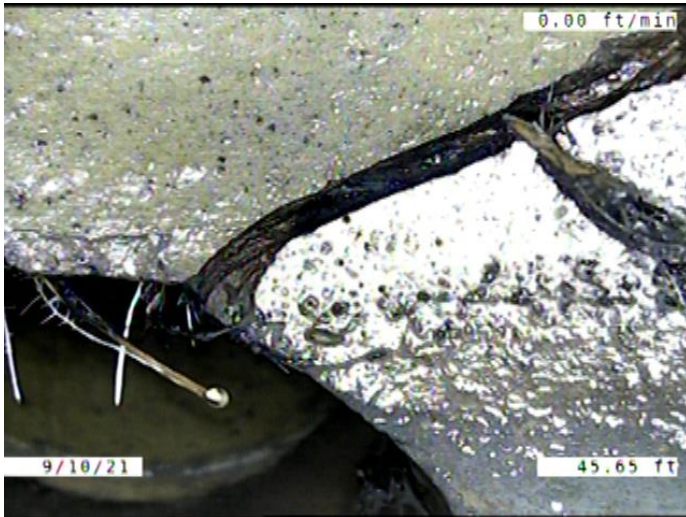
Code: **RFB**  
 Description: **Roots Fine Barrel**

Distance (ft): **45.7**  
 Structural Grade: **0**  
 O&M Grade: **2**  
 Clock Start/From: **1**  
 Clock To: **2**  
 1st Value:  
 2nd Value:  
 Value Percent:  
 Continuous Index:  
 Within 8" of Joint: **NO**  
 Remarks:

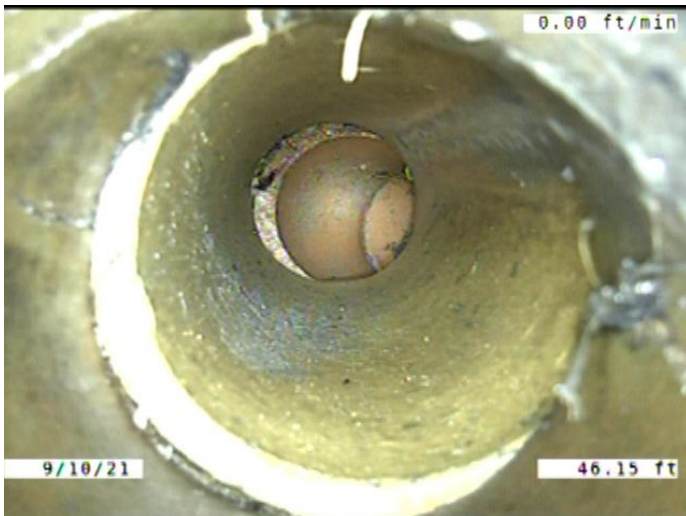
Code: **TFD**  
 Description: **Tap Factory Defective**

Distance (ft): **46.1**  
 Structural Grade: **0**  
 O&M Grade: **3**  
 Clock Start/From: **1**  
 Clock To:  
 1st Value: **4.000**  
 2nd Value:  
 Value Percent:  
 Continuous Index:  
 Within 8" of Joint: **YES**  
 Remarks: **Defective**

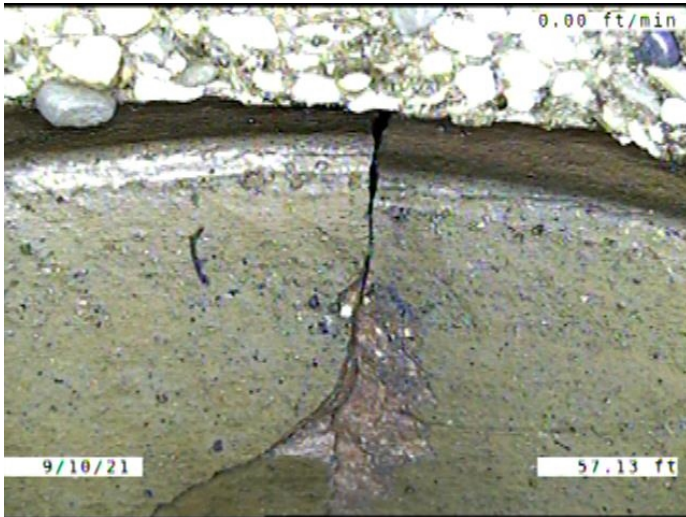
Code: **B**  
 Description: **Broken**

Distance (ft): **57.1**  
 Structural Grade: **4**  
 O&M Grade: **0**  
 Clock Start/From: **12**  
 Clock To: **12**  
 1st Value:  
 2nd Value:  
 Value Percent:  
 Continuous Index:  
 Within 8" of Joint: **YES**  
 Remarks:

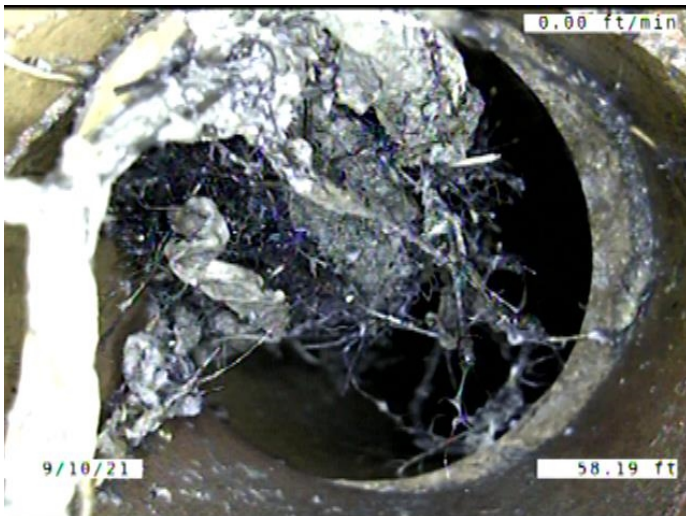
Code: **TFD**  
 Description: **Tap Factory Defective**

Distance (ft): **58.2**  
 Structural Grade: **0**  
 O&M Grade: **3**  
 Clock Start/From: **11**  
 Clock To:  
 1st Value: **4.000**  
 2nd Value:  
 Value Percent:  
 Continuous Index:  
 Within 8" of Joint: **YES**  
 Remarks: **Defective**

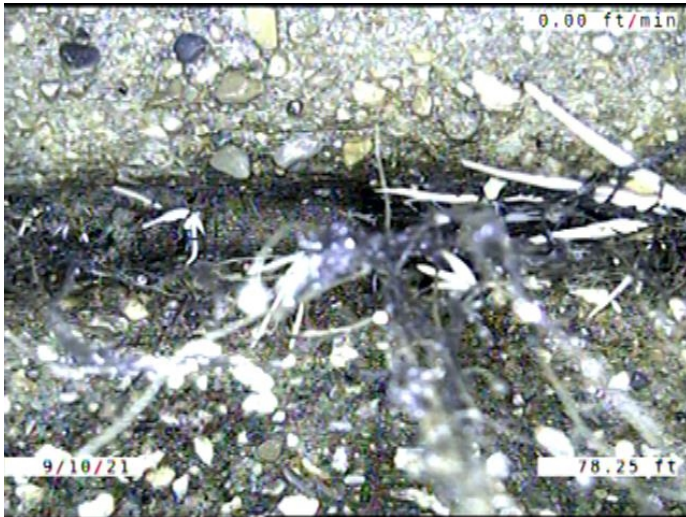
Code: **RMJ**  
 Description: **Roots Medium Joint**

Distance (ft): **78.3**  
 Structural Grade: **0**  
 O&M Grade: **3**  
 Clock Start/From: **8**  
 Clock To: **4**  
 1st Value:  
 2nd Value:  
 Value Percent: **5.000**  
 Continuous Index:  
 Within 8" of Joint: **YES**  
 Remarks:

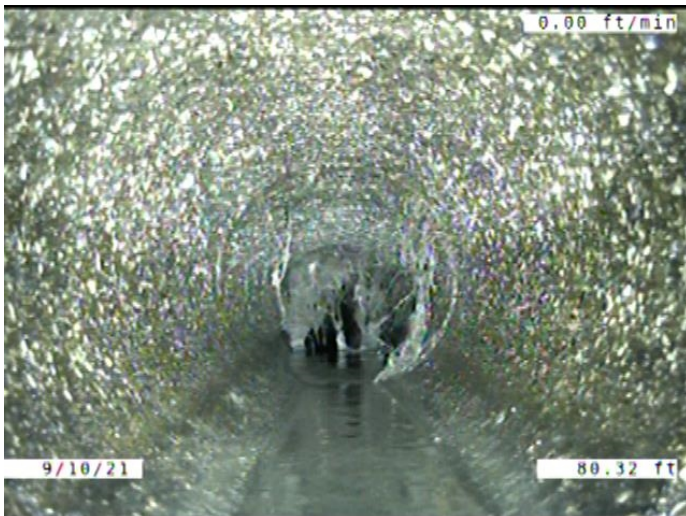
Code: **MWLS**  
 Description: **Miscellaneous Water Level Sag**

Distance (ft): **80.3**  
 Structural Grade: **2**  
 O&M Grade: **0**  
 Clock Start/From:  
 Clock To:  
 1st Value:  
 2nd Value:  
 Value Percent: **10.000**  
 Continuous Index: **F03**  
 Within 8" of Joint: **NO**  
 Remarks:

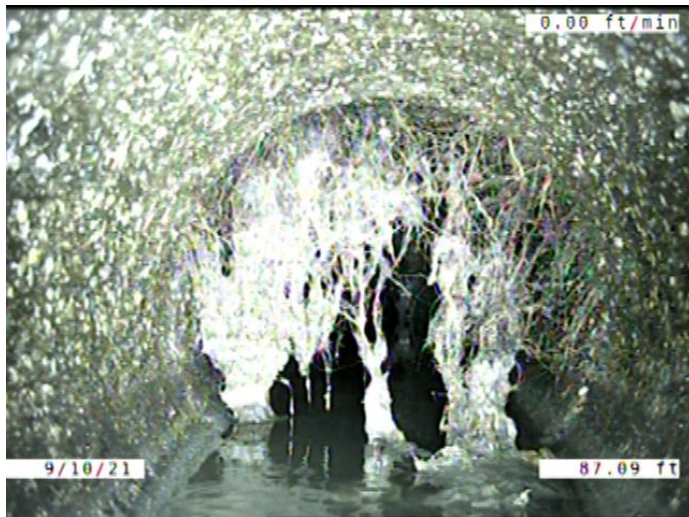
Code: **RMJ**  
 Description: **Roots Medium Joint**

Distance (ft): **87.1**  
 Structural Grade: **0**  
 O&M Grade: **3**  
 Clock Start/From: **9**  
 Clock To: **3**  
 1st Value:  
 2nd Value:  
 Value Percent: **50.000**  
 Continuous Index:  
 Within 8" of Joint: **YES**  
 Remarks:

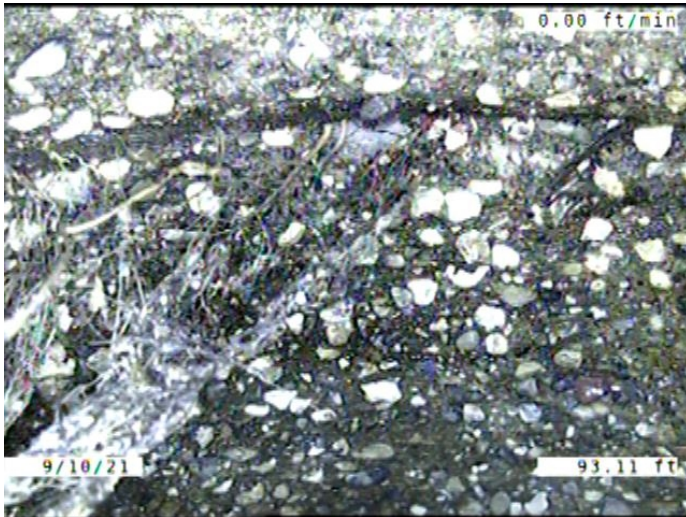
Code: **RMJ**  
 Description: **Roots Medium Joint**

Distance (ft): **93.1**  
 Structural Grade: **0**  
 O&M Grade: **3**  
 Clock Start/From: **9**  
 Clock To: **3**  
 1st Value:  
 2nd Value:  
 Value Percent: **5.000**  
 Continuous Index:  
 Within 8" of Joint: **YES**  
 Remarks:

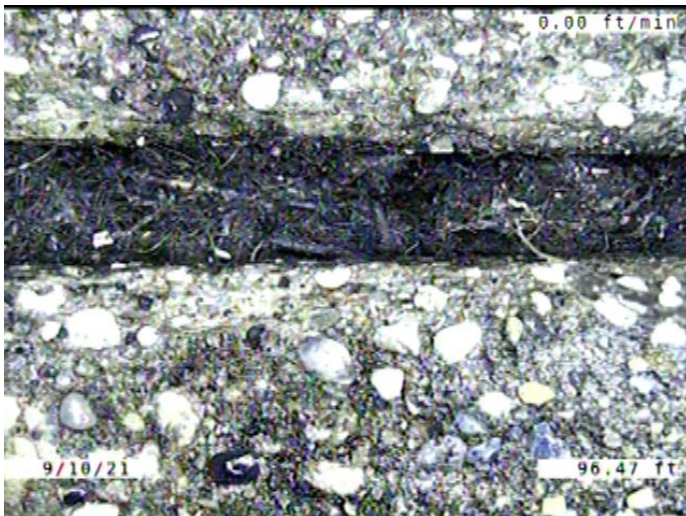
Code: **RFJ**  
 Description: **Roots Fine Joint**

Distance (ft): **96.5**  
 Structural Grade: **0**  
 O&M Grade: **1**  
 Clock Start/From: **9**  
 Clock To: **3**  
 1st Value:  
 2nd Value:  
 Value Percent:  
 Continuous Index:  
 Within 8" of Joint: **YES**  
 Remarks:

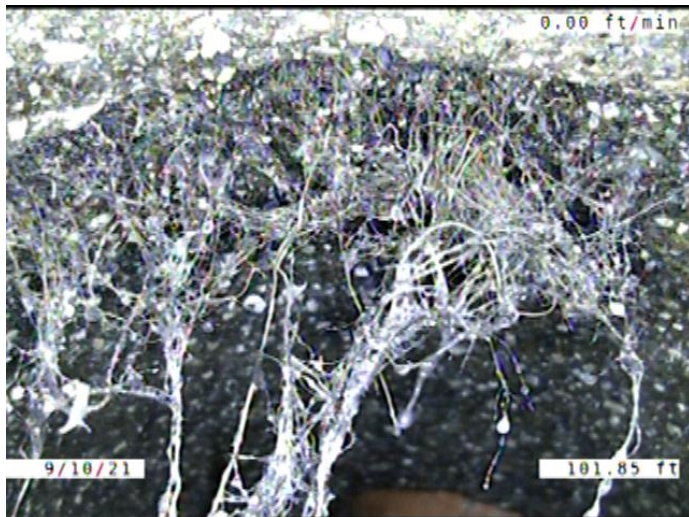
Code: **RMJ**  
 Description: **Roots Medium Joint**

Distance (ft): **101.9**  
 Structural Grade: **0**  
 O&M Grade: **3**  
 Clock Start/From: **10**  
 Clock To: **1**  
 1st Value:  
 2nd Value:  
 Value Percent: **5.000**  
 Continuous Index:  
 Within 8" of Joint: **YES**  
 Remarks:

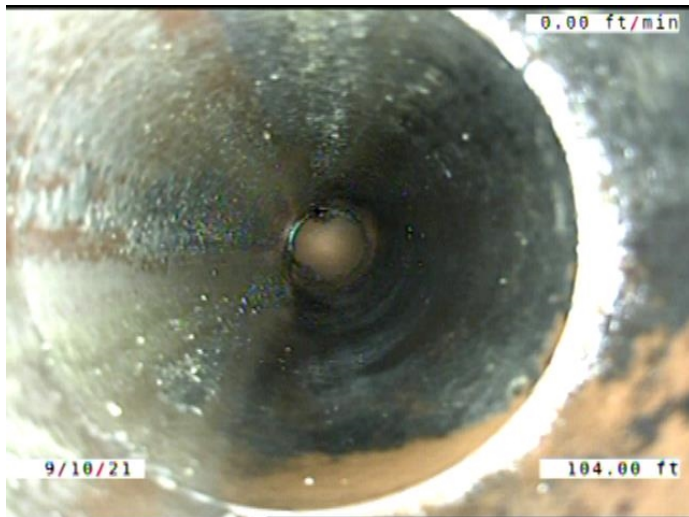
Code: **TBI**  
 Description: **Tap Break-in Intruding**

Distance (ft): **104.0**  
 Structural Grade: **0**  
 O&M Grade: **2**  
 Clock Start/From: **12**  
 Clock To:  
 1st Value: **4.000**  
 2nd Value: **2.000**  
 Value Percent:  
 Continuous Index:  
 Within 8" of Joint: **NO**  
 Remarks: **CONSTANTLY RUNNING WATER**

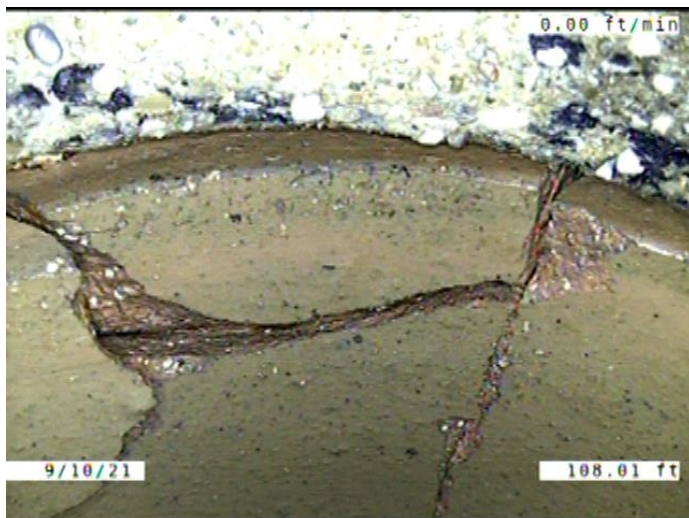
Code: **B**  
 Description: **Broken**

Distance (ft): **108.0**  
 Structural Grade: **4**  
 O&M Grade: **0**  
 Clock Start/From: **8**  
 Clock To: **4**  
 1st Value:  
 2nd Value:  
 Value Percent:  
 Continuous Index:  
 Within 8" of Joint: **YES**  
 Remarks:

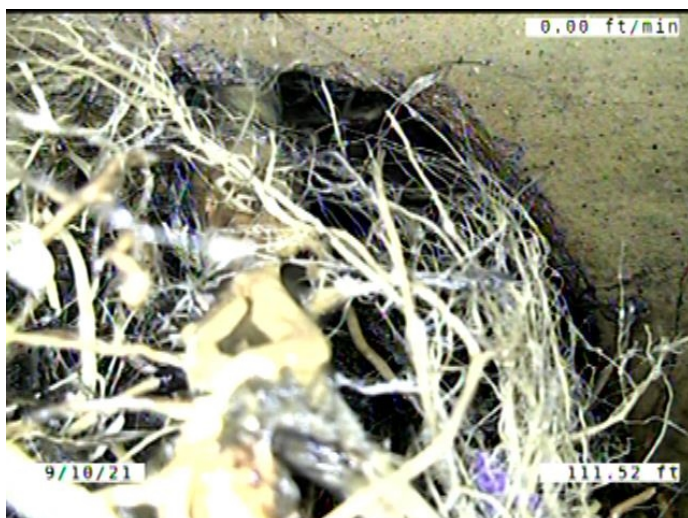
Code: **TBD**  
 Description: **Tap Break-in/Hammer Defective**

Distance (ft): **111.5**  
 Structural Grade: **0**  
 O&M Grade: **3**  
 Clock Start/From: **1**  
 Clock To:  
 1st Value: **4.000**  
 2nd Value:  
 Value Percent:  
 Continuous Index:  
 Within 8" of Joint: **YES**  
 Remarks: **Defective**

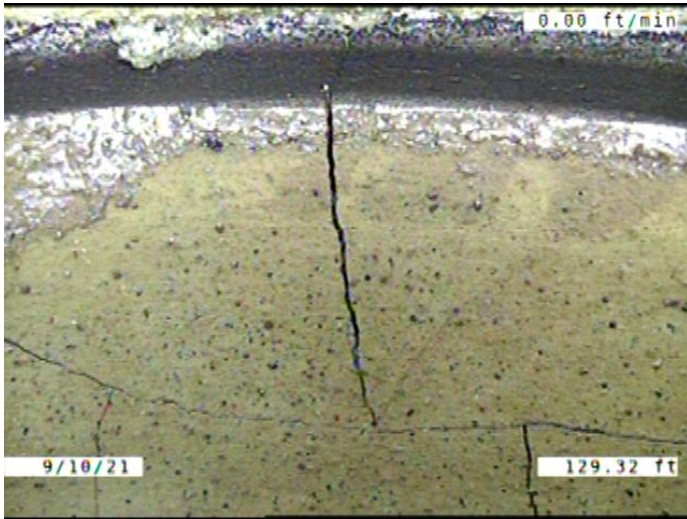
Code: **FM**  
 Description: **Fracture Multiple**

Distance (ft): **129.3**  
 Structural Grade: **4**  
 O&M Grade: **0**  
 Clock Start/From: **8**  
 Clock To: **4**  
 1st Value:  
 2nd Value:  
 Value Percent:  
 Continuous Index:  
 Within 8" of Joint: **YES**  
 Remarks:

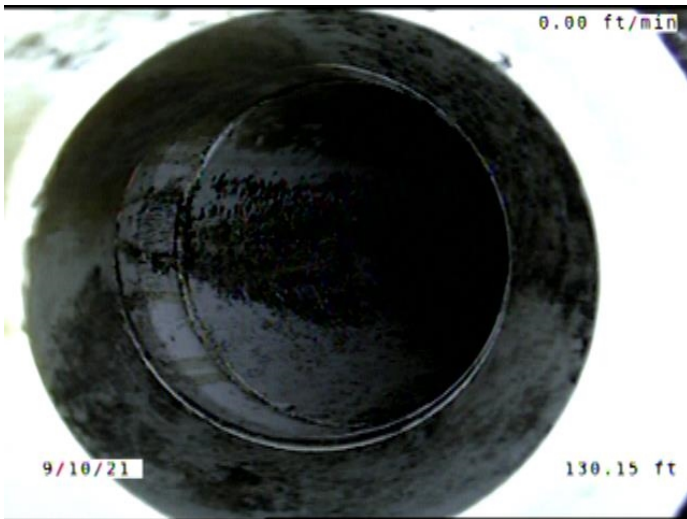
Code: **TFI**  
 Description: **Tap Factory Intruding**

Distance (ft): **130.1**  
 Structural Grade: **0**  
 O&M Grade: **2**  
 Clock Start/From: **11**  
 Clock To:  
 1st Value: **4.000**  
 2nd Value: **1.000**  
 Value Percent:  
 Continuous Index:  
 Within 8" of Joint: **YES**  
 Remarks: **CONSTANTLY RUNNING WATER**

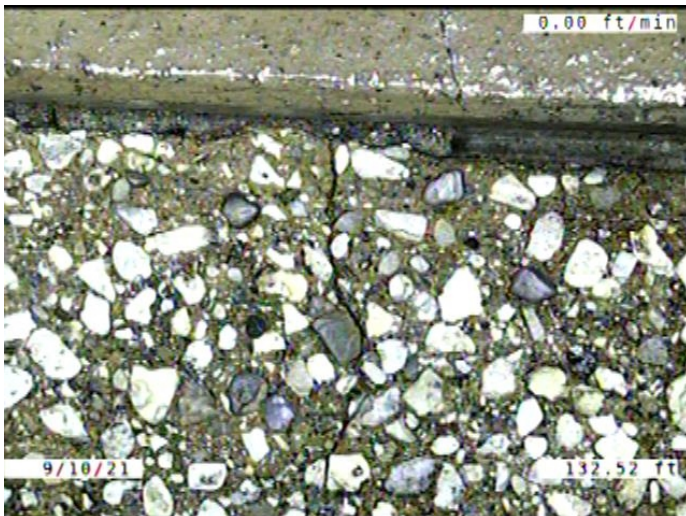
Code: **CL**  
 Description: **Crack Longitudinal**

Distance (ft): **132.5**  
 Structural Grade: **2**  
 O&M Grade: **0**  
 Clock Start/From: **12**  
 Clock To:  
 1st Value:  
 2nd Value:  
 Value Percent:  
 Continuous Index:  
 Within 8" of Joint: **YES**  
 Remarks:

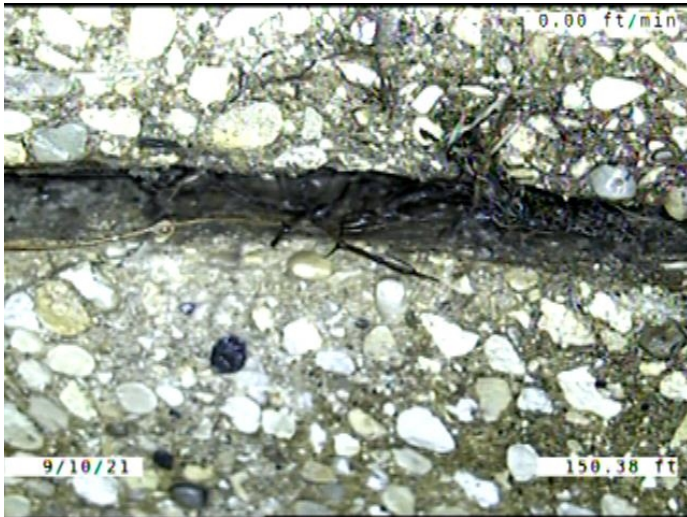
Code: **RFJ**  
 Description: **Roots Fine Joint**

Distance (ft): **150.4**  
 Structural Grade: **0**  
 O&M Grade: **1**  
 Clock Start/From: **1**  
 Clock To: **3**  
 1st Value:  
 2nd Value:  
 Value Percent:  
 Continuous Index:  
 Within 8" of Joint: **YES**  
 Remarks:

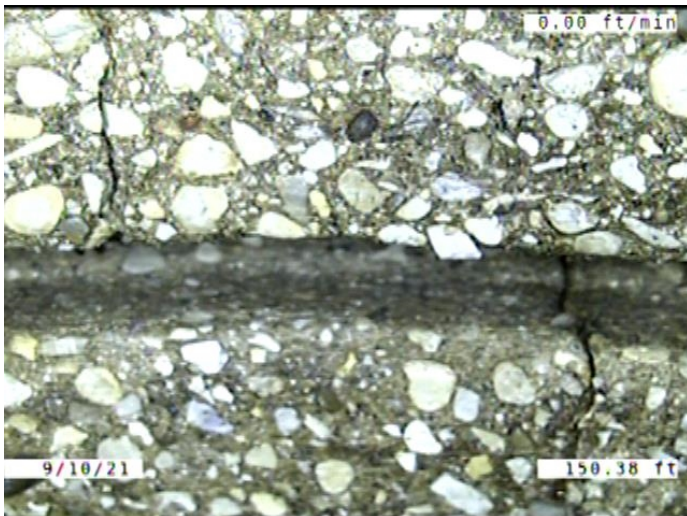
Code: **CS**  
 Description: **Crack Spiral**

Distance (ft): **150.4**  
 Structural Grade: **2**  
 O&M Grade: **0**  
 Clock Start/From: **11**  
 Clock To: **12**  
 1st Value:  
 2nd Value:  
 Value Percent:  
 Continuous Index:  
 Within 8" of Joint: **YES**  
 Remarks:
