Profile/Photo Observation Report

Street: Summerlin Flow Control: Not Controlled

City: Hobart, IN Year Renewed:
Location: Light Highway Tape/Media #:

US MH: M-504-105 DS MH: M-504-106 Total Length Surveyed (ft): 124.8

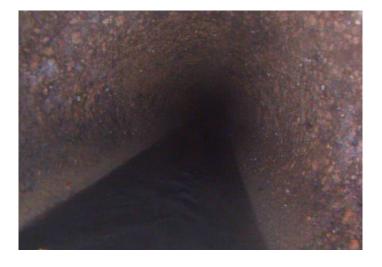
Code: Description:	AMH Manhole
Distance (ft):	.0
Structural Grade:	0
O&M Grade:	0
Clock Start/From:	
Clock To:	
1st Value:	
2nd Value:	
Value Percent:	
Continuous Index:	
Within 8" of Joint:	NO
Remarks:	M-504-105

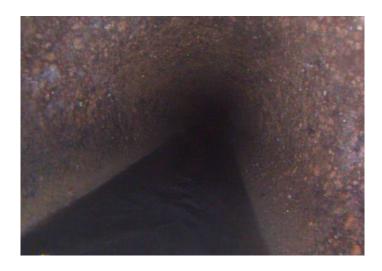
Code: MWL

Description: **Water Level**

Distance (ft): .0 Structural Grade: 0 O&M Grade: 0

10.000

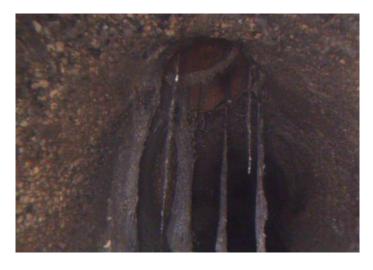
Code: TBD

Description: **Tap Break-in Defective**

Distance (ft): 28.7 Structural Grade: 0 O&M Grade: 3 Clock Start/From: 11

1st Value: 6.000

Remarks: **RFC**

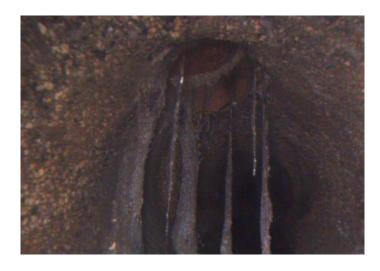
Code: RFC

Description: Roots Fine Connection

Distance (ft): 28.7
Structural Grade: 0

O&M Grade: 1

Clock Start/From: 11

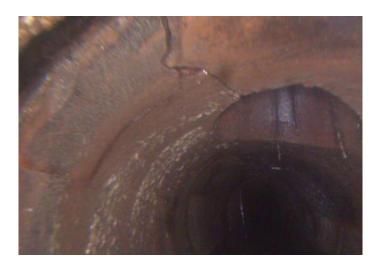
Code: FM

Description: Fracture Multiple

Distance (ft): 52.2
Structural Grade: 4

O&M Grade: 0

Clock Start/From: 10

Clock To: 12

Within 8" of Joint: YES

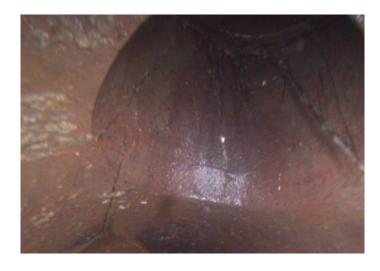
Code: **TFD**

Description: Tap Factory Defective

Distance (ft): 52.7
Structural Grade: 0

O&M Grade: 2

Clock Start/From: 12

1st Value: **6.000**

Remarks: FM; RFL

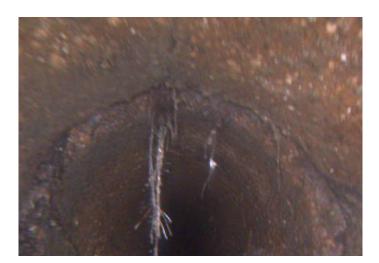
Code: RFJ

Description: Roots Fine Joint

Distance (ft): 60.4
Structural Grade: 0

O&M Grade: 1

Clock Start/From: 12

Within 8" of Joint: YES

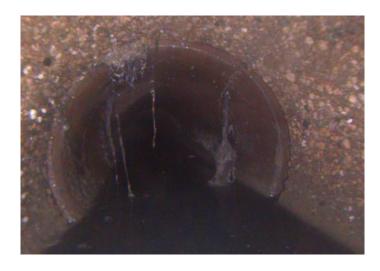
Code: RFJ

Description: Roots Fine Joint

Distance (ft): 84.3
Structural Grade: 0

O&M Grade: 1

Clock Start/From: 10

Clock To: 12

YES

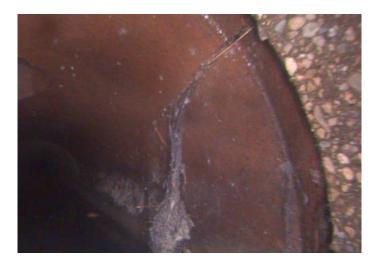
Code: FL

Description: Fracture Longitudinal

Distance (ft): 85.0
Structural Grade: 3
O&M Grade: 0
Clock Start/From: 2
Clock To:
1st Value:

Within 8" of Joint: YES

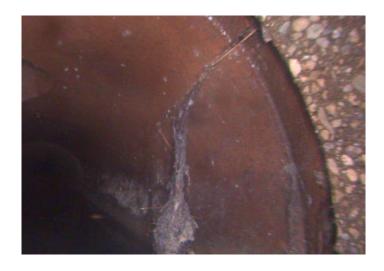
Code: RFB

Description: Roots Fine Barrel

Distance (ft): 85.0
Structural Grade: 0
O&M Grade: 2
Clock Start/From: 2

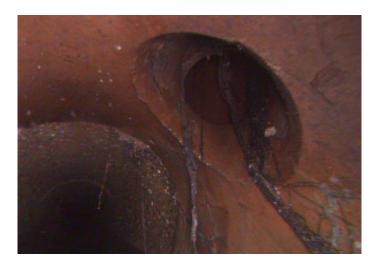
Code: RFL

Description: Roots Fine Lateral

Distance (ft): 86.4
Structural Grade: 0

O&M Grade: 1

Clock Start/From: 2

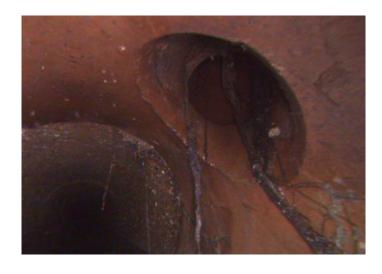
Code: **TFD**

Description: Tap Factory Defective

Distance (ft): 86.4
Structural Grade: 0

O&M Grade: 2

Clock Start/From: 2

1st Value: **6.000**

Remarks: RFL

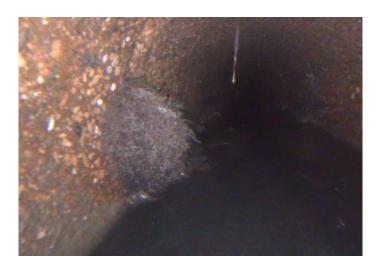
Code: RFJ

Description: Roots Fine Joint

Distance (ft): 123.7
Structural Grade: 0
O&M Grade: 1
Clock Start/From: 9

Within 8" of Joint: YES

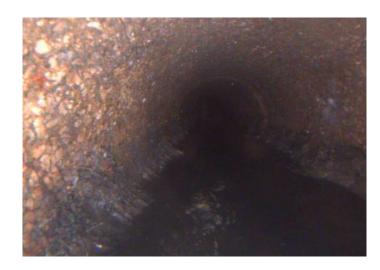
Code: MSA

Description: Abandoned Survey

Distance (ft): 124.8
Structural Grade: 0

Remarks: RFJ
