Profile/Photo Observation Report

Date:	04/18/2018	Weather:		Coding:	PACP 6.0
Pipe Length (ft):	129.7	Owner:	NA	Pre Clean:	Not Known
P.O.#:		Surveyor:	Byrd Fitzgerald	PSR:	P-504-106-105
Customer:		Clean Date:	01/01/1900	Shape:	C

Street:	OFF N VIRGINIA ST	Flow Control:	Not Controlled
City:	Hobart, IN	Year Renewed:	
Location:	Light Highway	Tape/Media #:	
Purpose:	Not Known	Dia/Height:	12"
Use:	Sanitary	Material:	PVC
Drain Area:	NA	Lining:	
Category:	NA		
Comment:

Location Details:		Direction of Survey:	Upstream
US MH:	M-504-105	DS MH:	M-504-106
		Total Length Surveyed (ft):	5.9

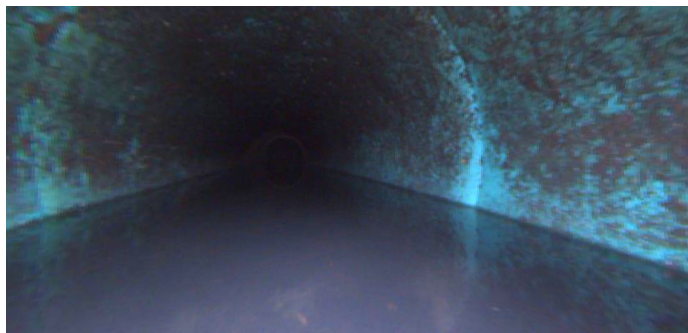
Code: **AMH**
Description: **Manhole**

Distance (ft): **.0**
Structural Grade: **0**
O&M Grade: **0**
Clock Start/From:
Clock To:
1st Value:
2nd Value:
Value Percent:
Continuous Index:
Within 8" of Joint: **NO**
Remarks: **M-504-105**

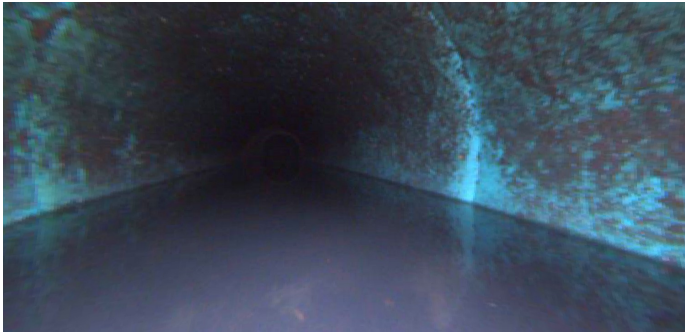
Code:	MWL
Description:	Water Level

Distance (ft):	.0
Structural Grade:	0
O&M Grade:	0
Clock Start/From:	
Clock To:	
1st Value:	
2nd Value:	
Value Percent:	10.000
Continuous Index:	
Within 8" of Joint:	NO
Remarks:

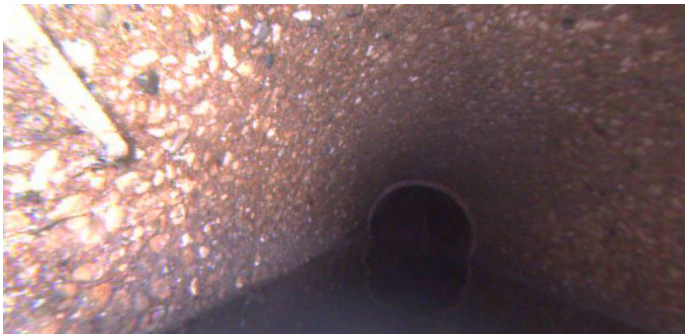
Code:	SAP
Description:	Surface Aggregate Projecting

Distance (ft):	5.9
Structural Grade:	3
O&M Grade:	0
Clock Start/From:	8
Clock To:	4
1st Value:	
2nd Value:	
Value Percent:	
Continuous Index:	
Within 8" of Joint:	
Remarks:

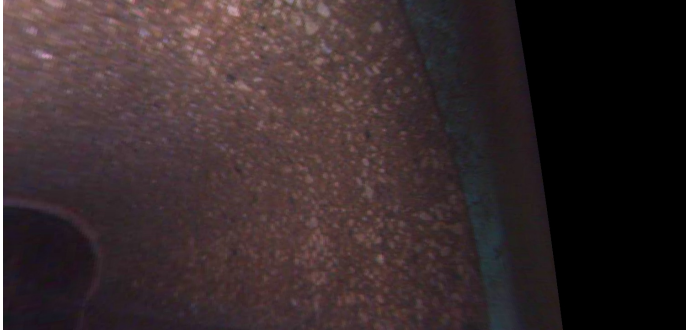
Code: **MMC**
Description: **Material Change**

Distance (ft): **5.9**
Structural Grade: **0**
O&M Grade: **0**
Clock Start/From:
Clock To:
1st Value:
2nd Value:
Value Percent:
Continuous Index:
Within 8" of Joint: **NO**
Remarks: **cp**

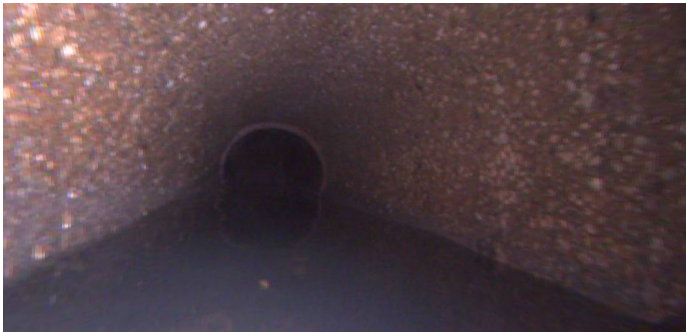
Code: **MSA**
Description: **Abandoned Survey**

Distance (ft): **5.9**
Structural Grade: **0**
O&M Grade: **0**
Clock Start/From:
Clock To:
1st Value:
2nd Value:
Value Percent:
Continuous Index:
Within 8" of Joint: **NO**
Remarks: **no blockage**
