Profile/Photo Observation Report

| Street: | Summerlin | Flow Control: | Not Controlled |
| City: | Hobart, IN | Year Renewed: | |

| US MH: | M-504-105 | DS MH: | M-504-106 |

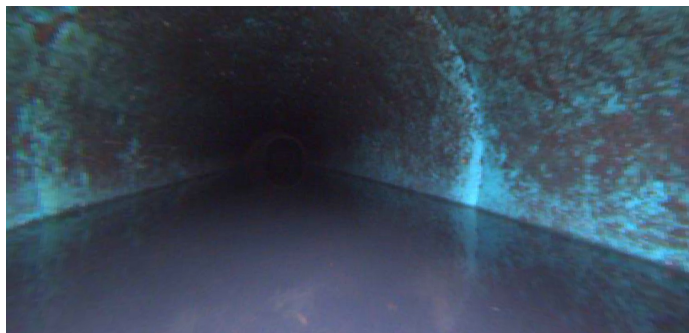
Code: **AMH**
 Description: **Manhole**

Distance (ft): **.0**
 Structural Grade: **0**
 O&M Grade: **0**
 Clock Start/From:
 Clock To:
 1st Value:
 2nd Value:
 Value Percent:
 Continuous Index:
 Within 8" of Joint: **NO**
 Remarks: **M-504-105**

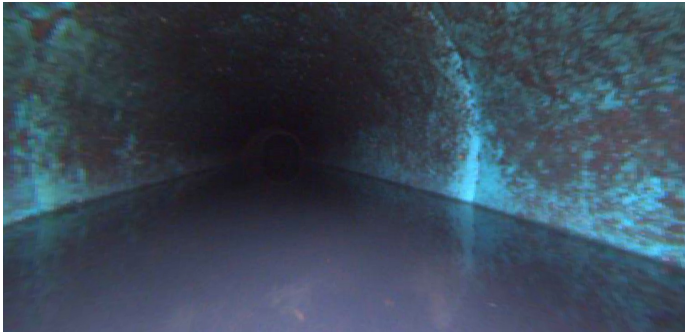
| Code: | MWL |
| Description: | Water Level |

| Value Percent: | 10.000 |

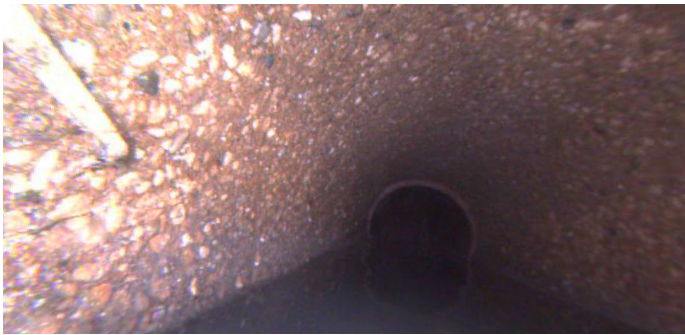
| | Position | Code | Observation | Video (sec) | Grade |
|--|---|---|---|---|---|
| | 5.9 | SAP | Surface Aggregate Projecting | 44 | S 3 |

| Code: | SAP |
| Description: | Surface Aggregate Projecting |

| Distance (ft): | 5.9 |
| Structural Grade: | 3 |
| Clock Start/From: | 8 |
| Clock To: | 4 |

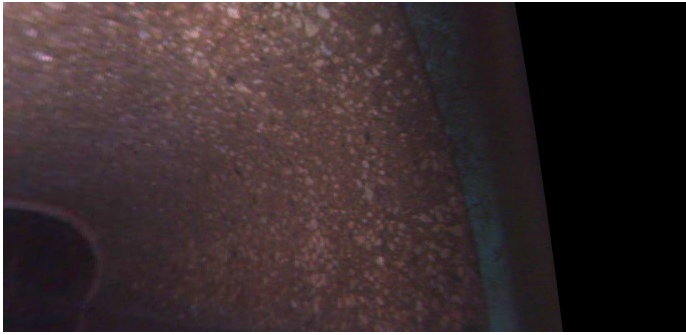
Code: **MMC**
Description: **Material Change**

Distance (ft): **5.9**
Structural Grade: **0**
O&M Grade: **0**
Clock Start/From:
Clock To:
1st Value:
2nd Value:
Value Percent:
Continuous Index:
Within 8" of Joint: **NO**
Remarks: **cp**

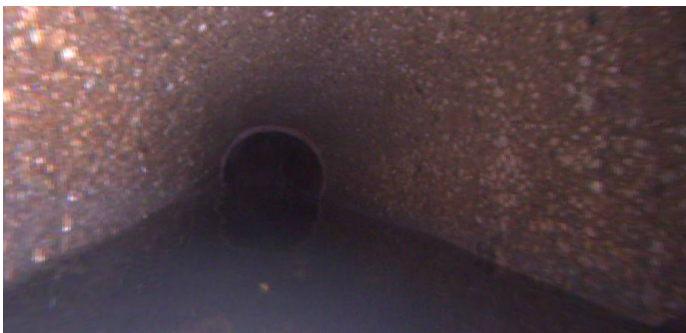
Code: **MSA**
Description: **Abandoned Survey**

Distance (ft): **5.9**
Structural Grade: **0**
O&M Grade: **0**
Clock Start/From:
Clock To:
1st Value:
2nd Value:
Value Percent:
Continuous Index:
Within 8" of Joint: **NO**
Remarks: **no blockage**
