RedZone
ROBOTICS

Street:	42nd Avenue	Flow Control:	Not Controlled
City:	Hobart, IN	Year Renewed:	
Location:	Alley	Tape/Media #:	
Purpose:	Routine Assessment	Dia/Height:	12"
Use:	Sanitary Sewage Pipe	Material:	CP
Drain Area:		Lining:	
Category:	NA		
Comment:			
Location Details:		Direction of Survey:	Downstream
US MH:	M-504-105	DS MH:	M-504-106
		Total Length Surveyed (ft):	160.3

Tuesday, April 25, 2023

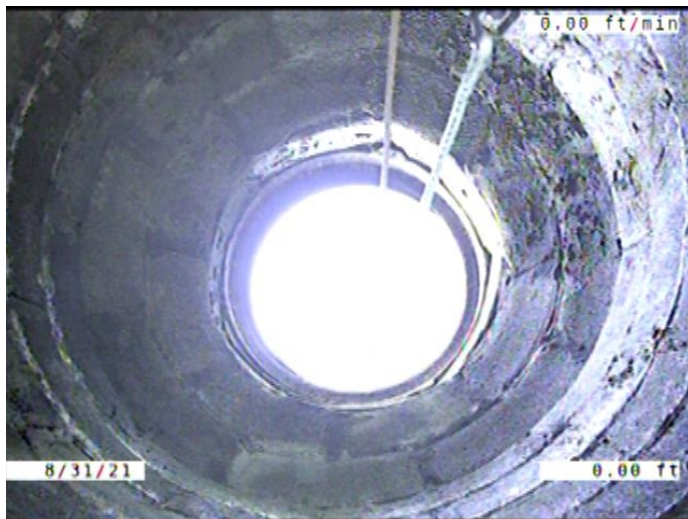
Code: **AMH**
Description: **Manhole**

Distance (ft): **.0**
Structural Grade: **0**
O&M Grade: **0**
Clock Start/From:
Clock To:
1st Value:
2nd Value:
Value Percent:
Continuous Index:
Within 8" of Joint: **NO**
Remarks: **M-504-105**

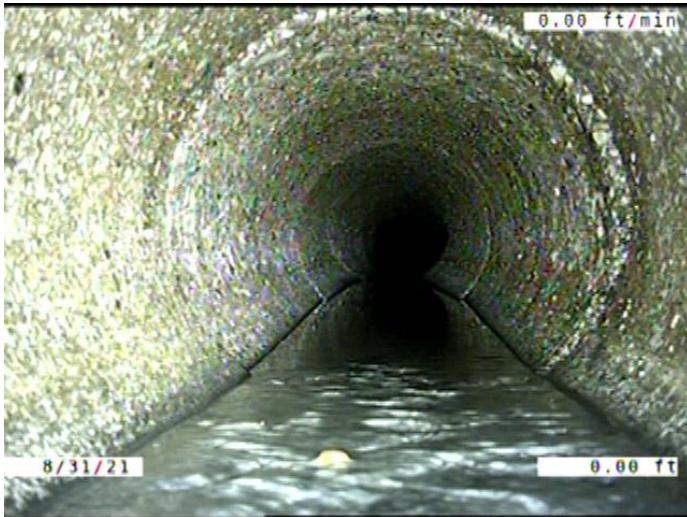
Code: **MWL**
 Description: **Miscellaneous Water Level**

Distance (ft): **.0**
 Structural Grade: **0**
 O&M Grade: **0**
 Clock Start/From:
 Clock To:
 1st Value:
 2nd Value:
 Value Percent: **5.000**
 Continuous Index:
 Within 8" of Joint: **NO**
 Remarks:

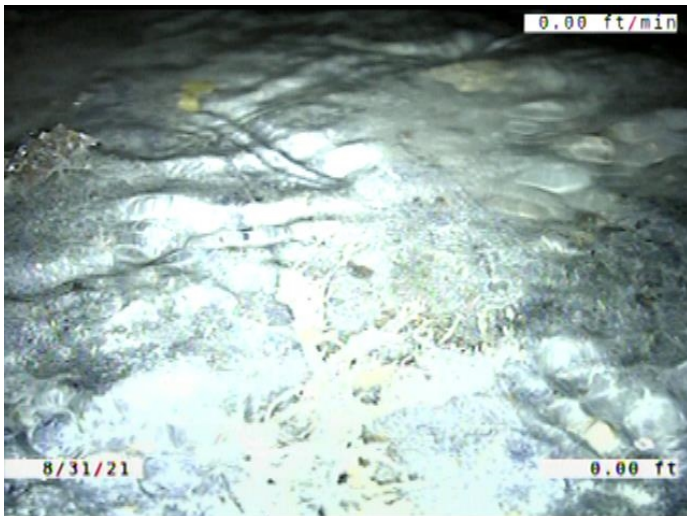
Code: **DSF**
 Description: **Deposits Settled Fine**

Distance (ft): **.0**
 Structural Grade: **0**
 O&M Grade: **2**
 Clock Start/From: **5**
 Clock To: **7**
 1st Value:
 2nd Value:
 Value Percent: **5.000**
 Continuous Index: **S01**
 Within 8" of Joint: **YES**
 Remarks:

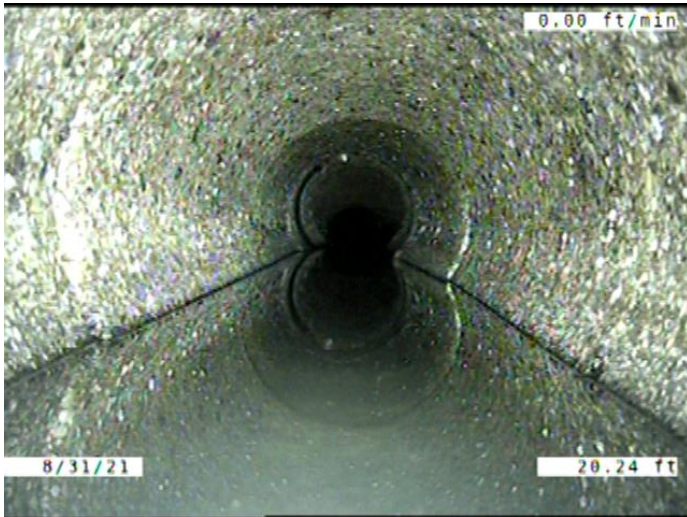
Code: **MWLS**
Description: **Miscellaneous Water Level Sag**

Distance (ft): **20.2**
Structural Grade: **2**
O&M Grade: **0**
Clock Start/From:
Clock To:
1st Value:
2nd Value:
Value Percent: **5.000**
Continuous Index: **S02**
Within 8" of Joint: **NO**
Remarks:

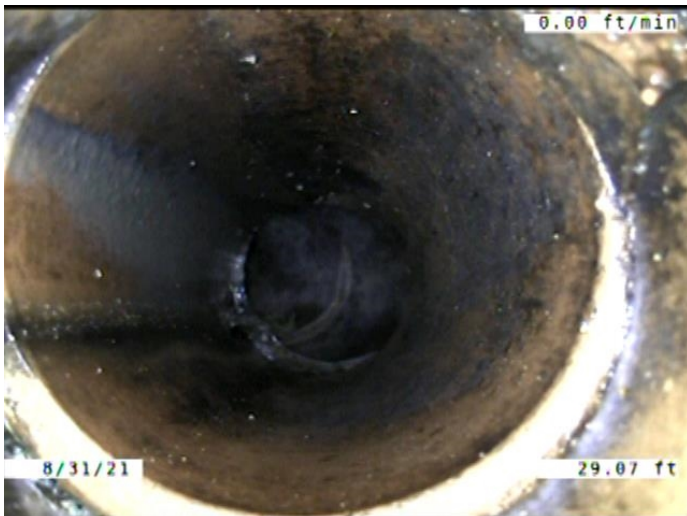
Code: **TB**
Description: **Tap Break-in/Hammer**

Distance (ft): **29.1**
Structural Grade: **0**
O&M Grade: **0**
Clock Start/From: **11**
Clock To:
1st Value: **4.000**
2nd Value:
Value Percent:
Continuous Index:
Within 8" of Joint: **NO**
Remarks:

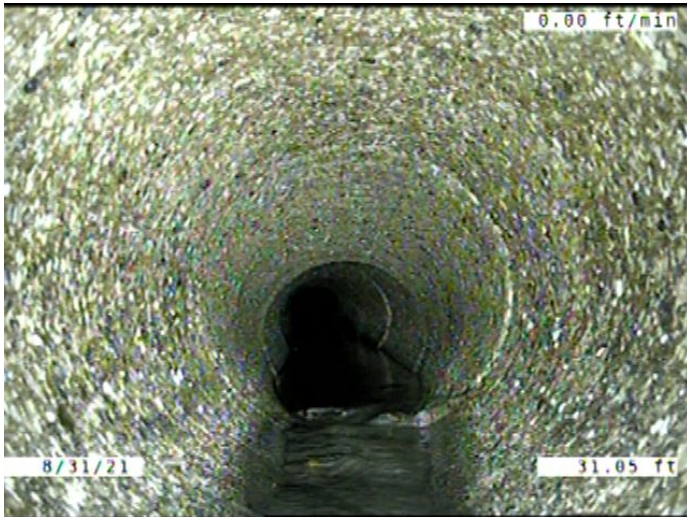
Code: **MWLS**
 Description: **Miscellaneous Water Level Sag**

Distance (ft): **31.1**
 Structural Grade: **2**
 O&M Grade: **0**
 Clock Start/From:
 Clock To:
 1st Value:
 2nd Value:
 Value Percent: **5.000**
 Continuous Index: **F02**
 Within 8" of Joint: **NO**
 Remarks:

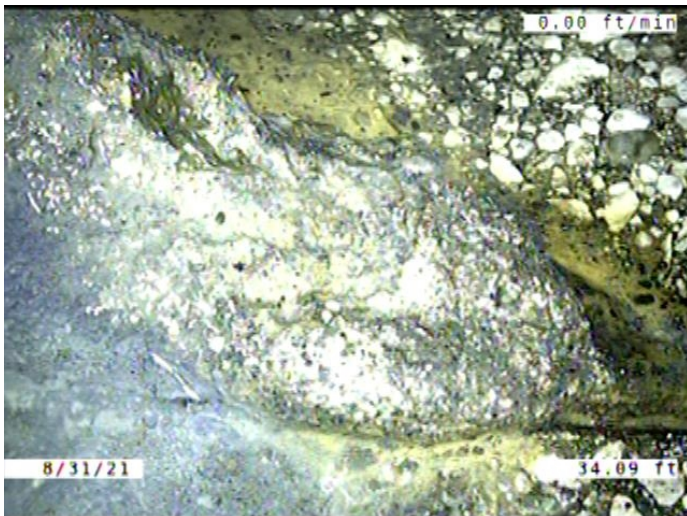
Code: **DAE**
 Description: **Deposits Attached Encrustation**

Distance (ft): **34.1**
 Structural Grade: **0**
 O&M Grade: **2**
 Clock Start/From: **4**
 Clock To: **6**
 1st Value:
 2nd Value:
 Value Percent: **5.000**
 Continuous Index:
 Within 8" of Joint: **YES**
 Remarks:

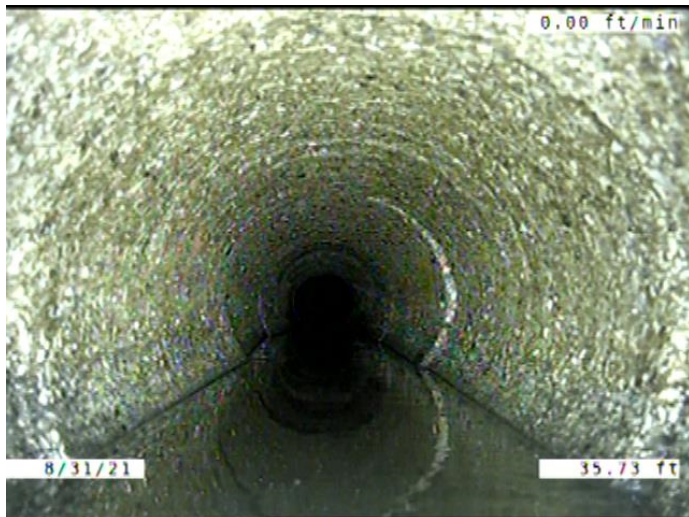
Code: **MWLS**
 Description: **Miscellaneous Water Level Sag**

Distance (ft): **35.7**
 Structural Grade: **2**
 O&M Grade: **0**
 Clock Start/From:
 Clock To:
 1st Value:
 2nd Value:
 Value Percent: **10.000**
 Continuous Index: **S03**
 Within 8" of Joint: **NO**
 Remarks:

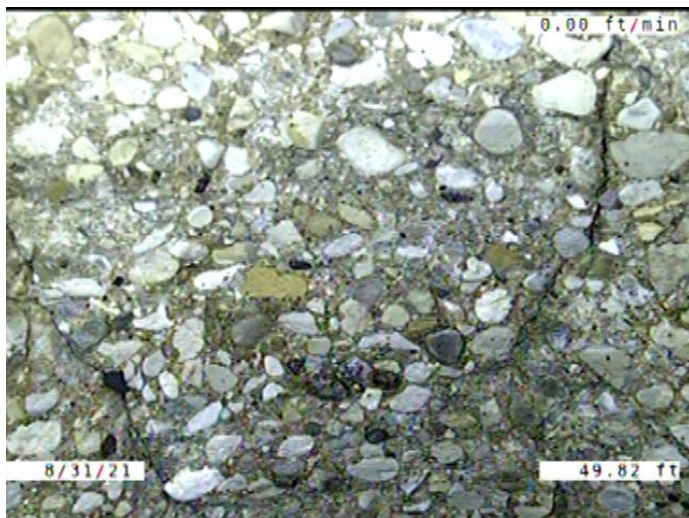
Code: **FM**
 Description: **Fracture Multiple**

Distance (ft): **49.8**
 Structural Grade: **4**
 O&M Grade: **0**
 Clock Start/From: **9**
 Clock To: **3**
 1st Value:
 2nd Value:
 Value Percent:
 Continuous Index: **S04**
 Within 8" of Joint: **YES**
 Remarks: **Wandering**

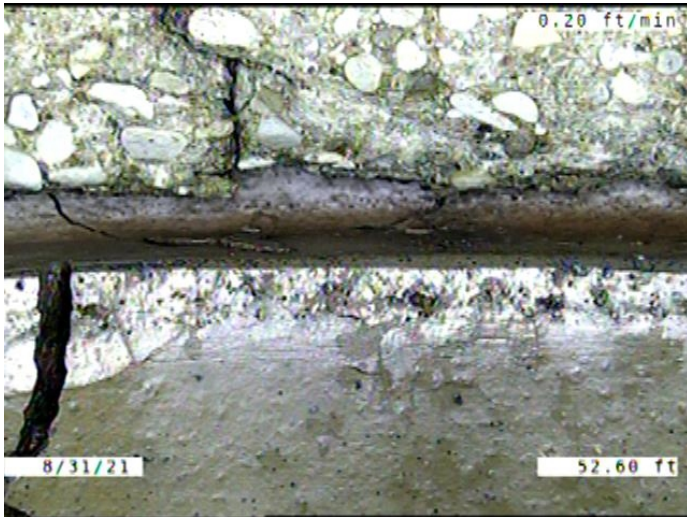
Code: **MMC**
 Description: **Miscellaneous Material Change**

Distance (ft): **52.6**
 Structural Grade: **0**
 O&M Grade: **0**
 Clock Start/From:
 Clock To:
 1st Value:
 2nd Value:
 Value Percent:
 Continuous Index:
 Within 8" of Joint: **NO**
 Remarks: **CONCRETE TO VCP**

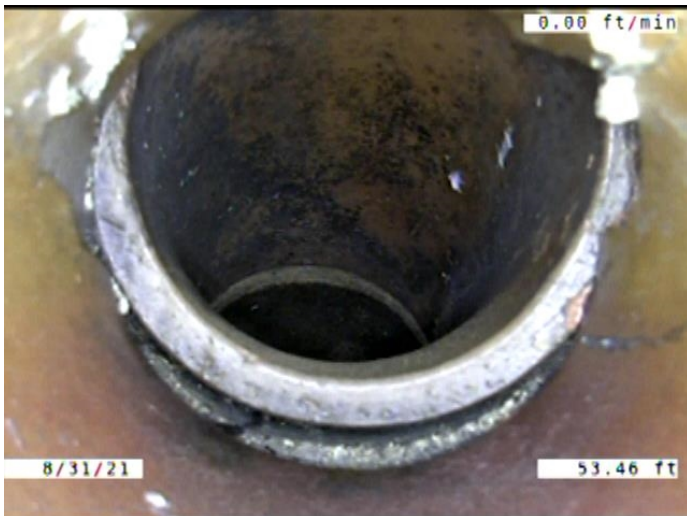
Code: **TFD**
 Description: **Tap Factory Defective**

Distance (ft): **53.5**
 Structural Grade: **0**
 O&M Grade: **3**
 Clock Start/From: **12**
 Clock To:
 1st Value: **4.000**
 2nd Value:
 Value Percent:
 Continuous Index:
 Within 8" of Joint: **YES**
 Remarks: **Debris**

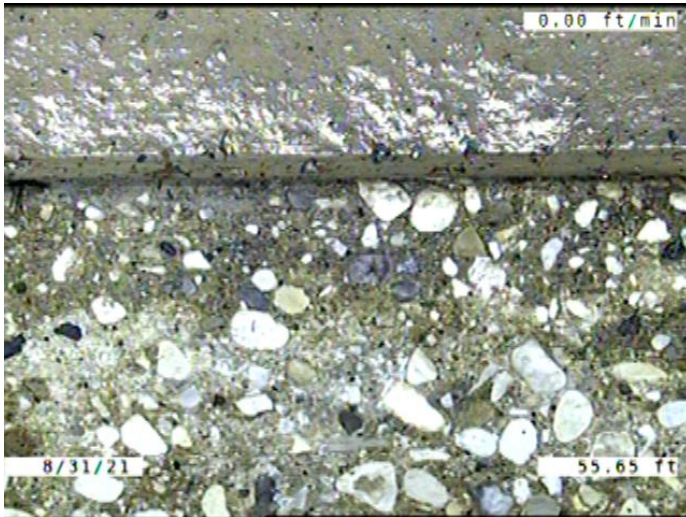
Code: **MMC**
 Description: **Miscellaneous Material Change**

Distance (ft): **55.7**
 Structural Grade: **0**
 O&M Grade: **0**
 Clock Start/From:
 Clock To:
 1st Value:
 2nd Value:
 Value Percent:
 Continuous Index:
 Within 8" of Joint: **NO**
 Remarks: **VCP TO CONCRETE**

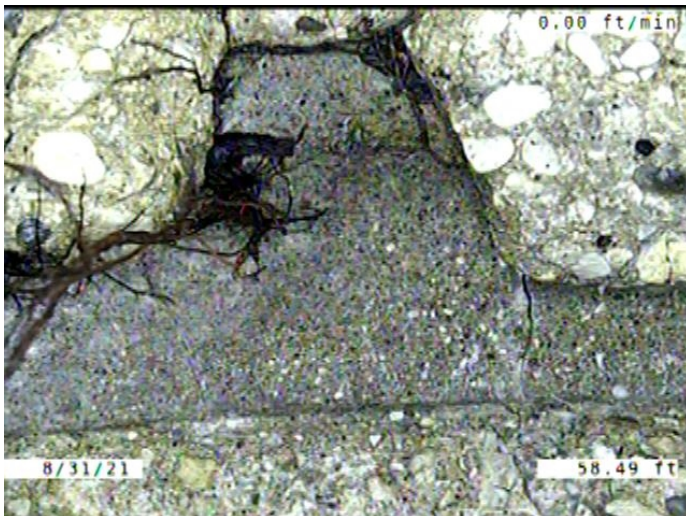
Code: **SMW**
 Description: **Surface Damage Missing Wall**

Distance (ft): **58.5**
 Structural Grade: **5**
 O&M Grade: **0**
 Clock Start/From: **8**
 Clock To: **10**
 1st Value:
 2nd Value:
 Value Percent:
 Continuous Index:
 Within 8" of Joint: **YES**
 Remarks:

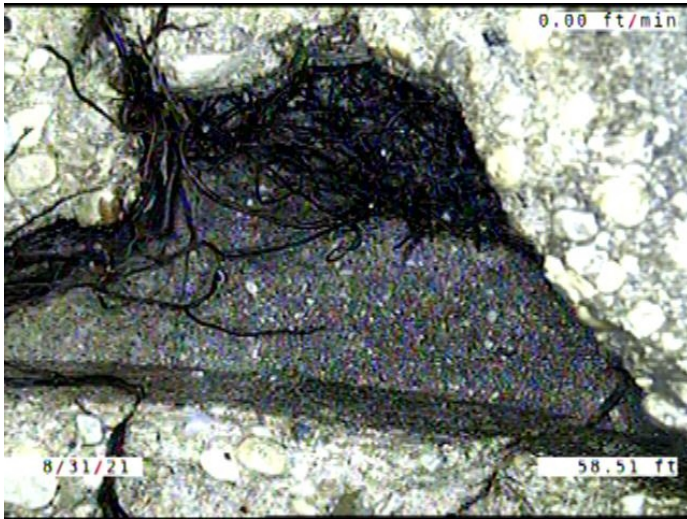
Code: **RFJ**
 Description: **Roots Fine Joint**

Distance (ft): **58.5**
 Structural Grade: **0**
 O&M Grade: **1**
 Clock Start/From: **1**
 Clock To: **3**
 1st Value:
 2nd Value:
 Value Percent:
 Continuous Index:
 Within 8" of Joint: **YES**
 Remarks:

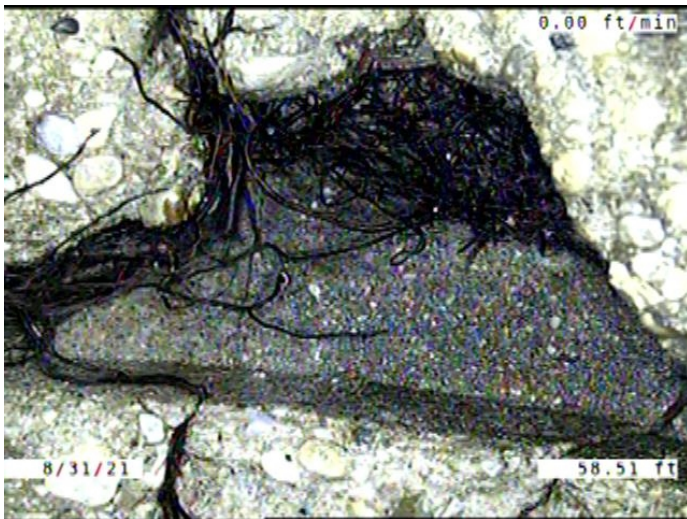
Code: **SMW**
 Description: **Surface Damage Missing Wall**

Distance (ft): **58.5**
 Structural Grade: **5**
 O&M Grade: **0**
 Clock Start/From: **12**
 Clock To: **4**
 1st Value:
 2nd Value:
 Value Percent:
 Continuous Index:
 Within 8" of Joint: **YES**
 Remarks:

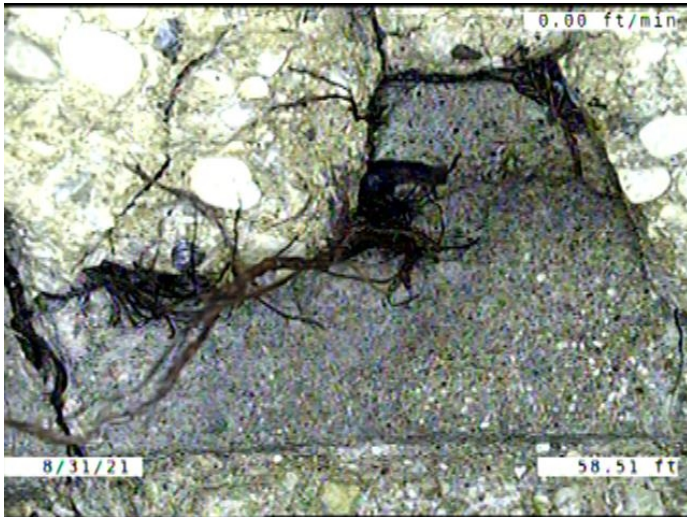
Code: **RFJ**
 Description: **Roots Fine Joint**

Distance (ft): **58.5**
 Structural Grade: **0**
 O&M Grade: **1**
 Clock Start/From: **9**
 Clock To: **10**
 1st Value:
 2nd Value:
 Value Percent:
 Continuous Index:
 Within 8" of Joint: **YES**
 Remarks:

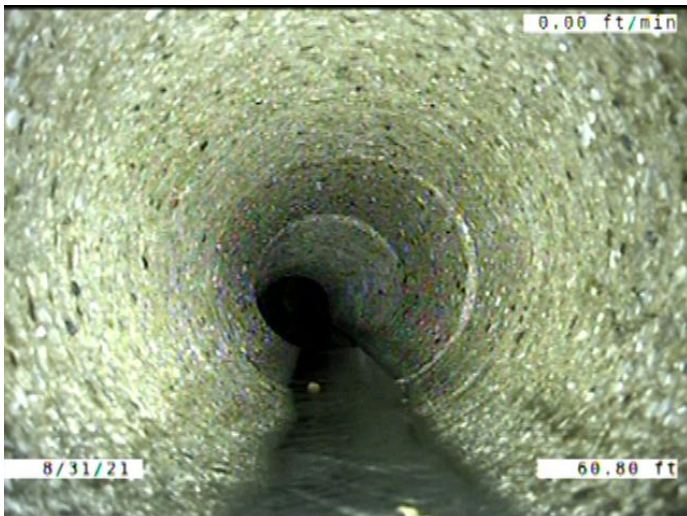
Code: **MWLS**
 Description: **Miscellaneous Water Level Sag**

Distance (ft): **60.8**
 Structural Grade: **2**
 O&M Grade: **0**
 Clock Start/From:
 Clock To:
 1st Value:
 2nd Value:
 Value Percent: **10.000**
 Continuous Index: **F03**
 Within 8" of Joint: **NO**
 Remarks:

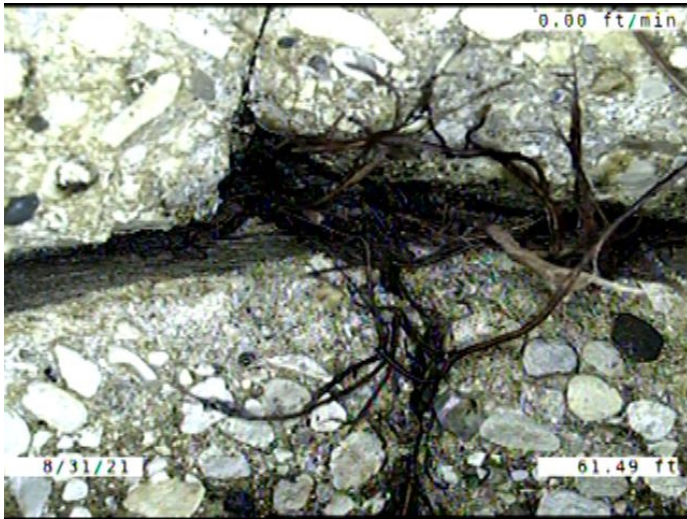
Code: **RFJ**
 Description: **Roots Fine Joint**

Distance (ft): **61.5**
 Structural Grade: **0**
 O&M Grade: **1**
 Clock Start/From: **9**
 Clock To: **3**
 1st Value:
 2nd Value:
 Value Percent:
 Continuous Index:
 Within 8" of Joint: **YES**
 Remarks:

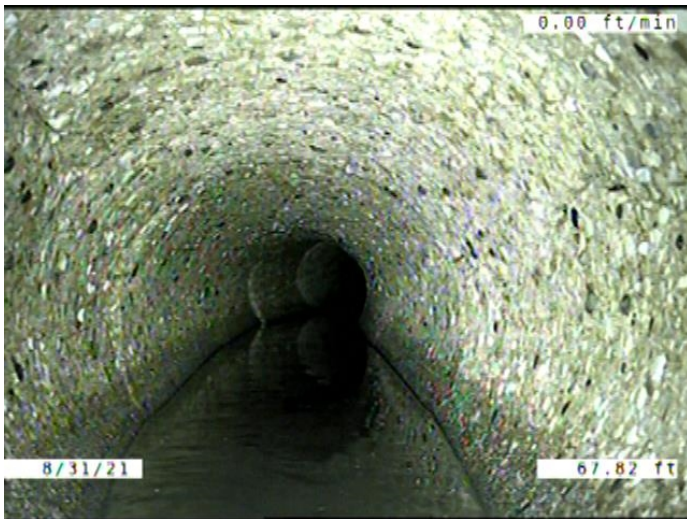
Code: **MWLS**
 Description: **Miscellaneous Water Level Sag**

Distance (ft): **67.8**
 Structural Grade: **2**
 O&M Grade: **0**
 Clock Start/From:
 Clock To:
 1st Value:
 2nd Value:
 Value Percent: **5.000**
 Continuous Index: **S05**
 Within 8" of Joint: **NO**
 Remarks:

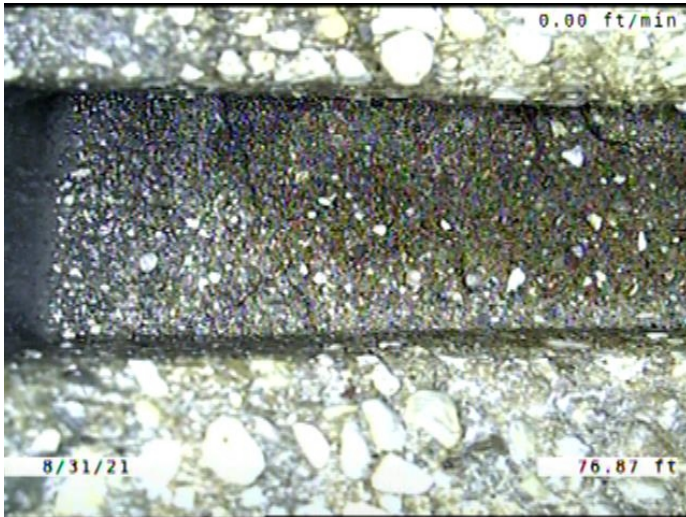
Code: **JAM**
Description: **Joint Angular Medium**

Distance (ft): **76.9**
Structural Grade: **3**
O&M Grade: **0**
Clock Start/From:
Clock To:
1st Value:
2nd Value:
Value Percent:
Continuous Index:
Within 8" of Joint: **NO**
Remarks:

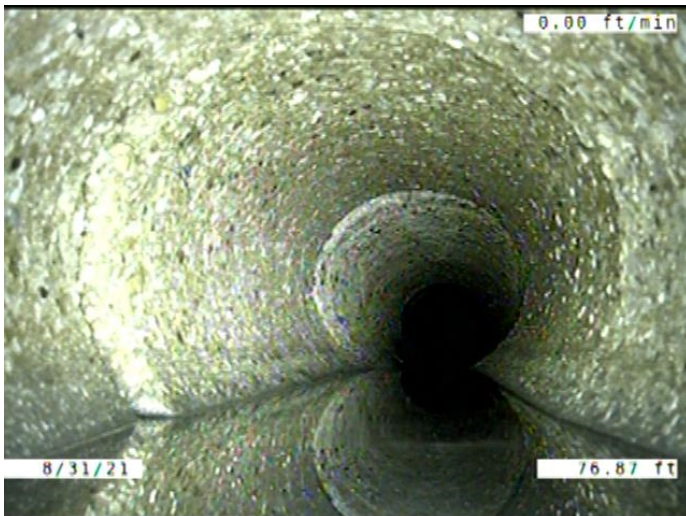
Code: **LR**
Description: **Line Right**

Distance (ft): **76.9**
Structural Grade: **0**
O&M Grade: **1**
Clock Start/From:
Clock To:
1st Value:
2nd Value:
Value Percent: **5.000**
Continuous Index:
Within 8" of Joint: **NO**
Remarks:

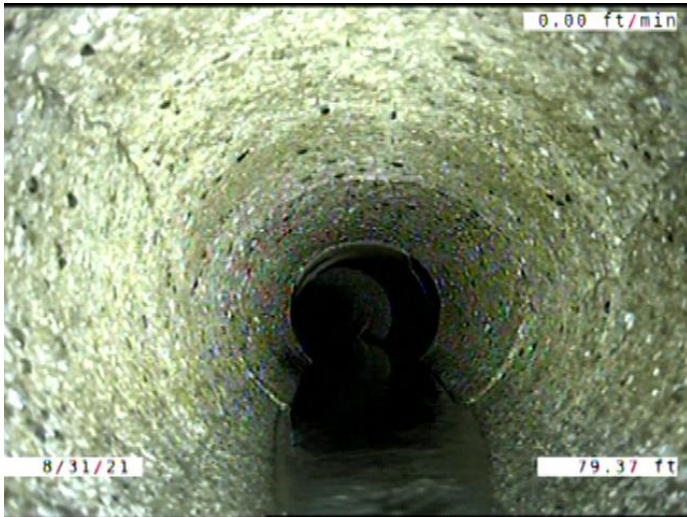
Code: **MWLS**
Description: **Miscellaneous Water Level Sag**

Distance (ft): **79.4**
Structural Grade: **2**
O&M Grade: **0**
Clock Start/From:
Clock To:
1st Value:
2nd Value:
Value Percent: **5.000**
Continuous Index: **F05**
Within 8" of Joint: **NO**
Remarks:

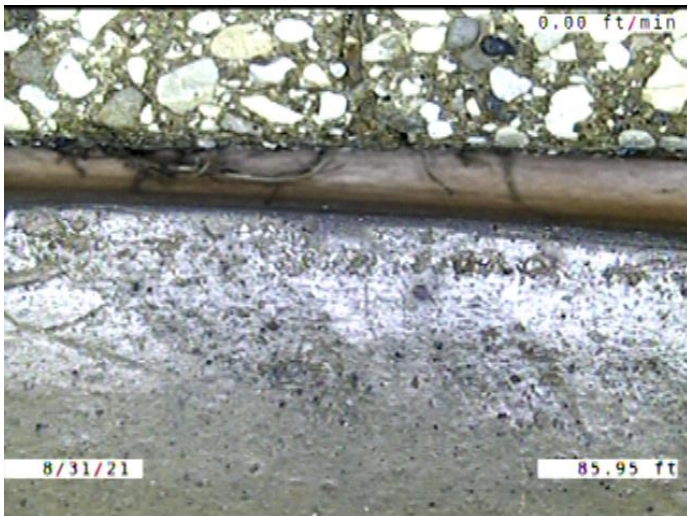
Code: **MMC**
Description: **Miscellaneous Material Change**

Distance (ft): **86.0**
Structural Grade: **0**
O&M Grade: **0**
Clock Start/From:
Clock To:
1st Value:
2nd Value:
Value Percent:
Continuous Index:
Within 8" of Joint: **NO**
Remarks: **CONCRETE TO VCP**

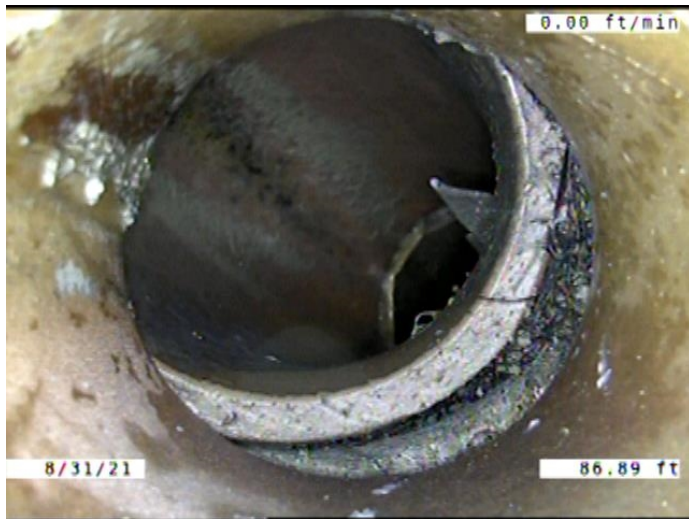
Code: **TFD**
 Description: **Tap Factory Defective**

Distance (ft): **86.9**
 Structural Grade: **0**
 O&M Grade: **3**
 Clock Start/From: **11**
 Clock To:
 1st Value: **4.000**
 2nd Value:
 Value Percent:
 Continuous Index:
 Within 8" of Joint: **YES**
 Remarks: **Debris**

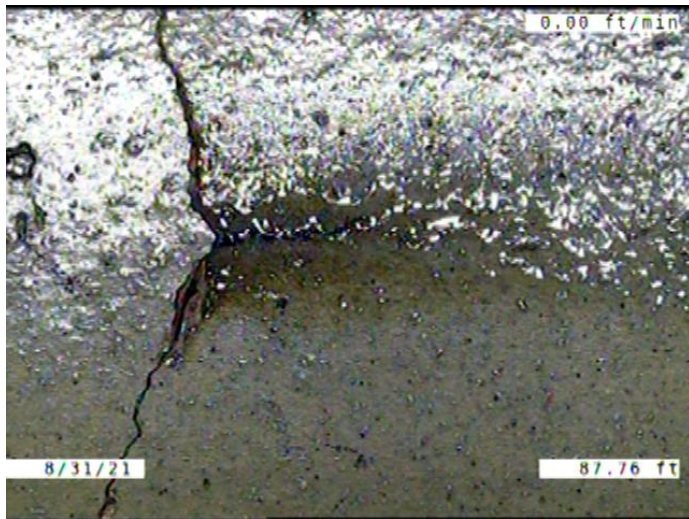
Code: **IWB**
 Description: **Infiltration Weeper Barrel**

Distance (ft): **87.7**
 Structural Grade: **0**
 O&M Grade: **2**
 Clock Start/From: **1**
 Clock To:
 1st Value:
 2nd Value:
 Value Percent:
 Continuous Index:
 Within 8" of Joint: **NO**
 Remarks:

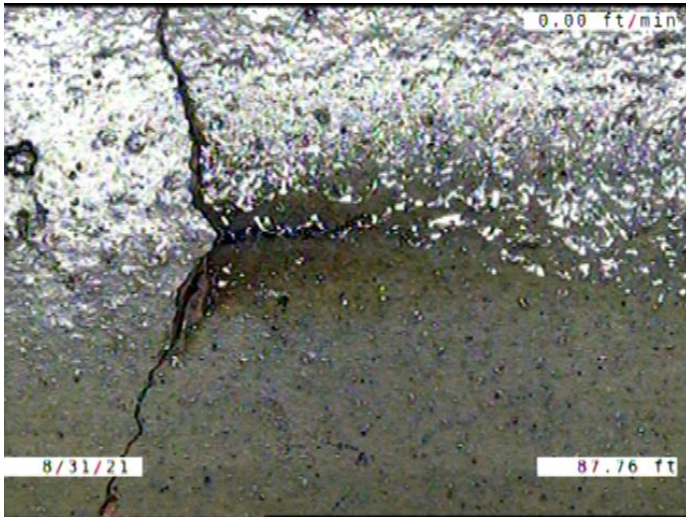
Code: **ISB**
Description: **Infiltration Stain Barrel**

Distance (ft): **87.8**
Structural Grade: **0**
O&M Grade: **1**
Clock Start/From: **1**
Clock To: **2**
1st Value:
2nd Value:
Value Percent:
Continuous Index:
Within 8" of Joint: **NO**
Remarks:

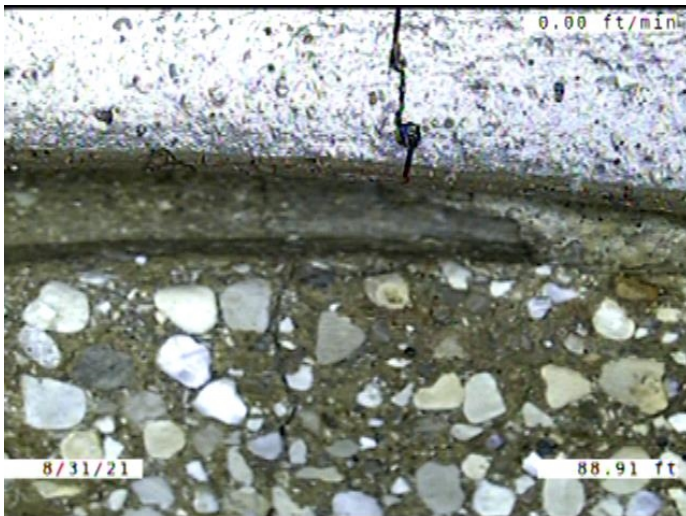
Code: **MMC**
Description: **Miscellaneous Material Change**

Distance (ft): **88.9**
Structural Grade: **0**
O&M Grade: **0**
Clock Start/From:
Clock To:
1st Value:
2nd Value:
Value Percent:
Continuous Index:
Within 8" of Joint: **NO**
Remarks: **VCP TO CONCRETE**

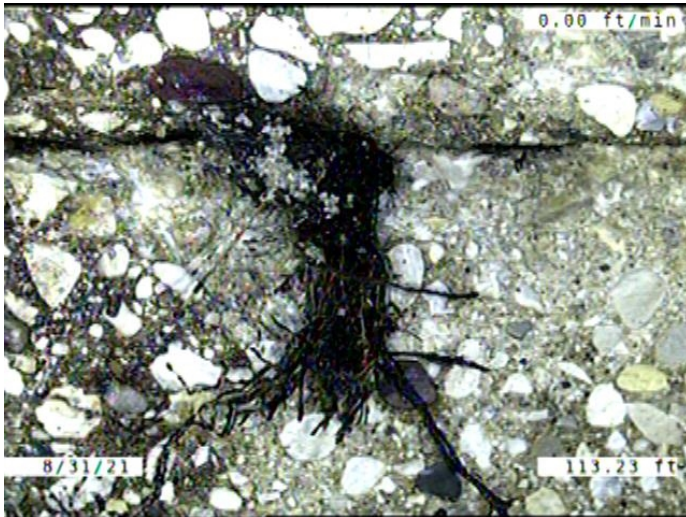
Code: **RFJ**
 Description: **Roots Fine Joint**

Distance (ft): **113.2**
 Structural Grade: **0**
 O&M Grade: **1**
 Clock Start/From: **9**
 Clock To:
 1st Value:
 2nd Value:
 Value Percent:
 Continuous Index:
 Within 8" of Joint: **YES**
 Remarks:

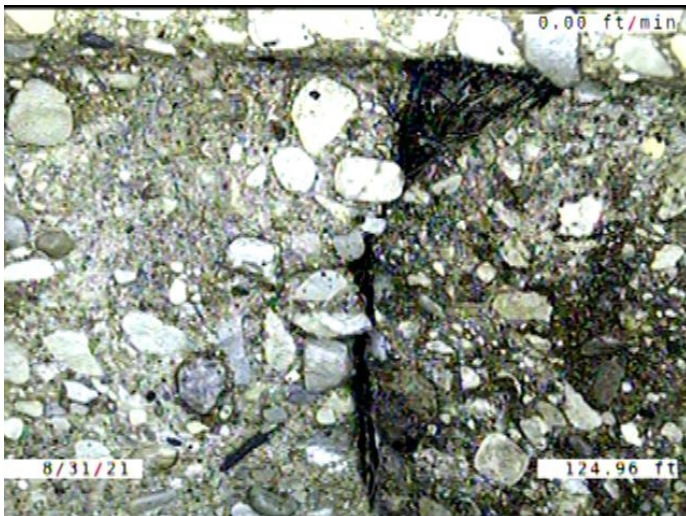
Code: **RFB**
 Description: **Roots Fine Barrel**

Distance (ft): **125.0**
 Structural Grade: **0**
 O&M Grade: **2**
 Clock Start/From: **9**
 Clock To: **3**
 1st Value:
 2nd Value:
 Value Percent:
 Continuous Index: **S06**
 Within 8" of Joint: **NO**
 Remarks:

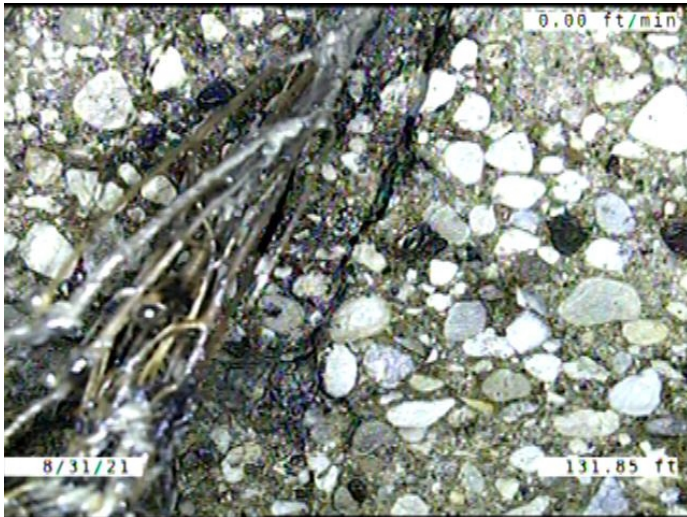
Code: **IWB**
Description: **Infiltration Weeper Barrel**

Distance (ft): **131.8**
Structural Grade: **0**
O&M Grade: **2**
Clock Start/From: **11**
Clock To:
1st Value:
2nd Value:
Value Percent:
Continuous Index:
Within 8" of Joint: **NO**
Remarks:

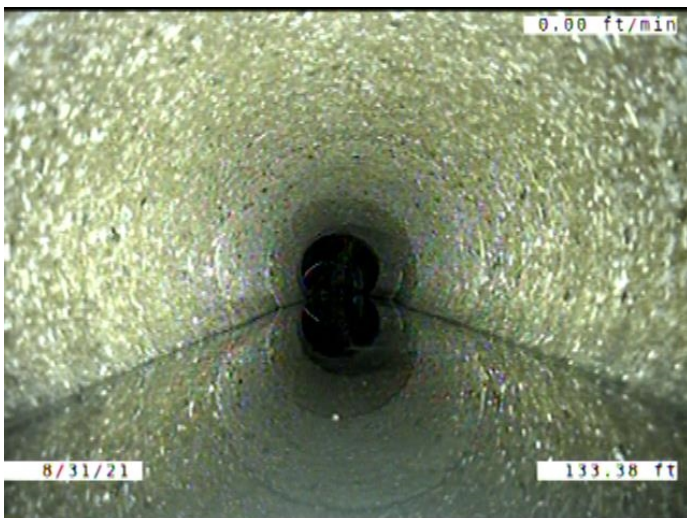
Code: **RFB**
Description: **Roots Fine Barrel**

Distance (ft): **133.4**
Structural Grade: **0**
O&M Grade: **2**
Clock Start/From: **9**
Clock To: **3**
1st Value:
2nd Value:
Value Percent:
Continuous Index: **F06**
Within 8" of Joint: **NO**
Remarks:

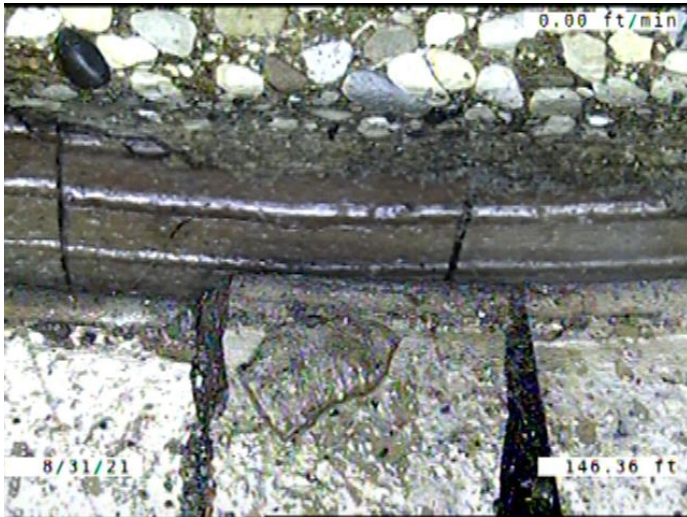
Code: **MMC**
 Description: **Miscellaneous Material Change**

Distance (ft): **146.4**
 Structural Grade: **0**
 O&M Grade: **0**
 Clock Start/From:
 Clock To:
 1st Value:
 2nd Value:
 Value Percent:
 Continuous Index:
 Within 8" of Joint: **NO**
 Remarks: **CONCRETE TO VCP**

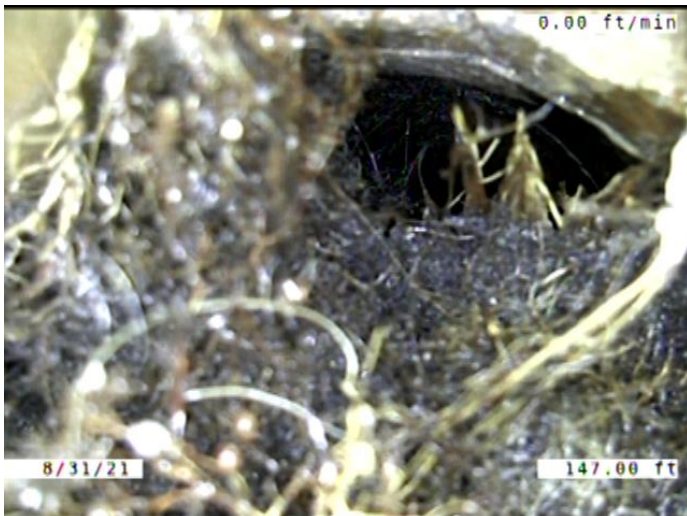
Code: **TFD**
 Description: **Tap Factory Defective**

Distance (ft): **147.0**
 Structural Grade: **0**
 O&M Grade: **3**
 Clock Start/From: **12**
 Clock To:
 1st Value: **4.000**
 2nd Value:
 Value Percent:
 Continuous Index:
 Within 8" of Joint: **YES**
 Remarks: **Debris**

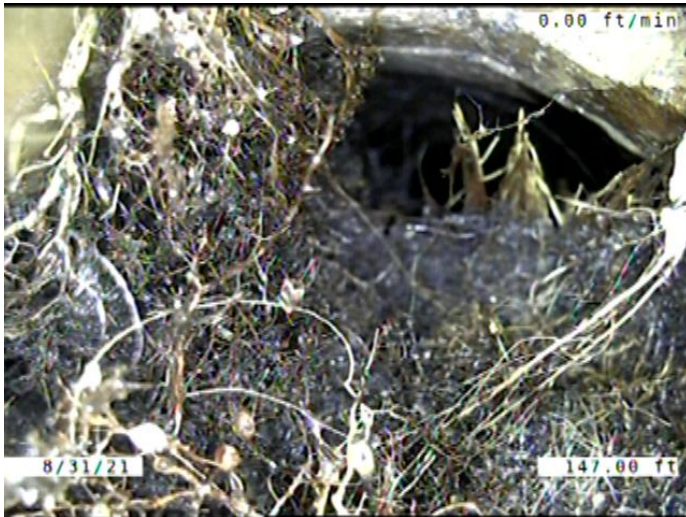
Code: **RML**
Description: **Roots Medium Lateral**

Distance (ft): **147.0**
Structural Grade: **0**
O&M Grade: **3**
Clock Start/From: **12**
Clock To:
1st Value:
2nd Value:
Value Percent: **25.000**
Continuous Index:
Within 8" of Joint: **NO**
Remarks:

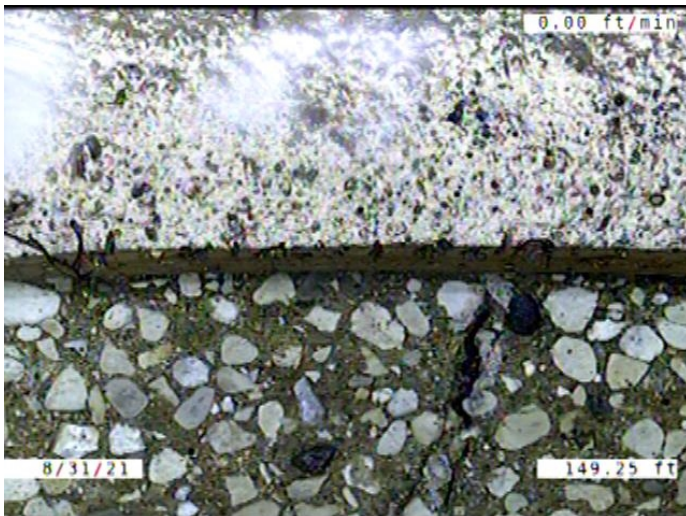
Code: **MMC**
Description: **Miscellaneous Material Change**

Distance (ft): **149.2**
Structural Grade: **0**
O&M Grade: **0**
Clock Start/From:
Clock To:
1st Value:
2nd Value:
Value Percent:
Continuous Index:
Within 8" of Joint: **NO**
Remarks: **VCP TO CONCRETE**

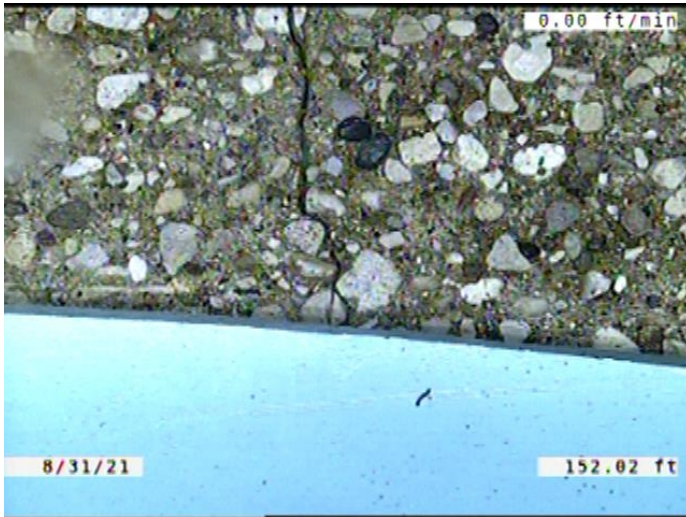
Code: **MMC**
Description: **Miscellaneous Material Change**

Distance (ft): **152.0**
Structural Grade: **0**
O&M Grade: **0**
Clock Start/From:
Clock To:
1st Value:
2nd Value:
Value Percent:
Continuous Index:
Within 8" of Joint: **NO**
Remarks: **CONCRETE TO PVC**

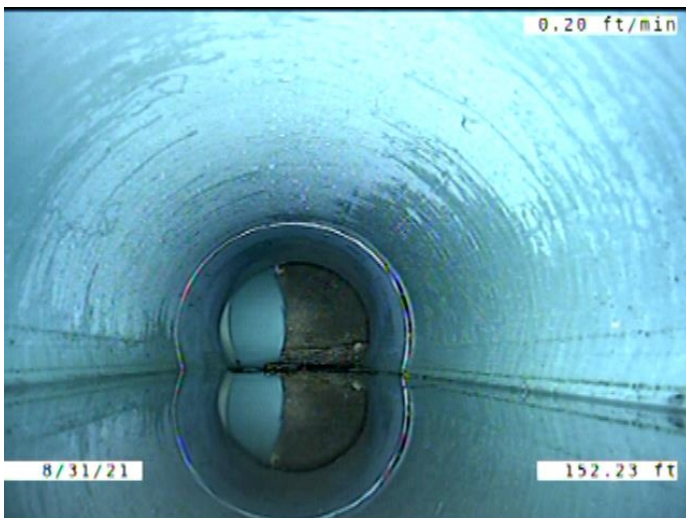
Code: **FM**
Description: **Fracture Multiple**

Distance (ft): **152.2**
Structural Grade: **4**
O&M Grade: **0**
Clock Start/From: **9**
Clock To: **3**
1st Value:
2nd Value:
Value Percent:
Continuous Index: **F04**
Within 8" of Joint: **YES**
Remarks: **Wandering**

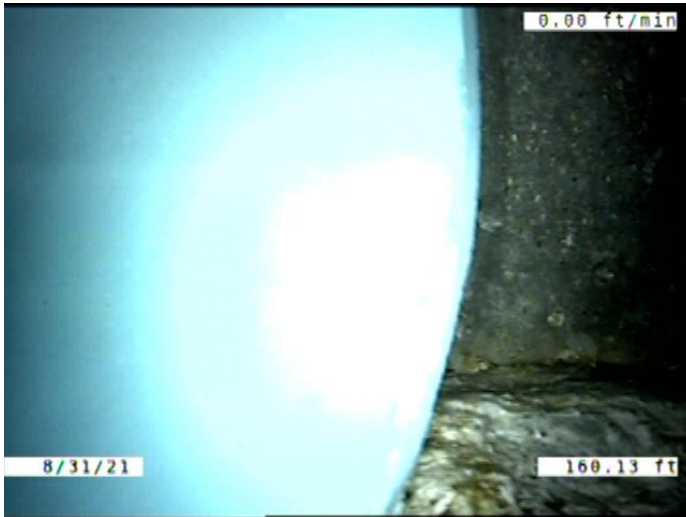
Code: **DSF**
 Description: **Deposits Settled Fine**

Distance (ft): **160.1**
 Structural Grade: **0**
 O&M Grade: **2**
 Clock Start/From: **5**
 Clock To: **7**
 1st Value:
 2nd Value:
 Value Percent: **5.000**
 Continuous Index: **F01**
 Within 8" of Joint: **YES**
 Remarks:

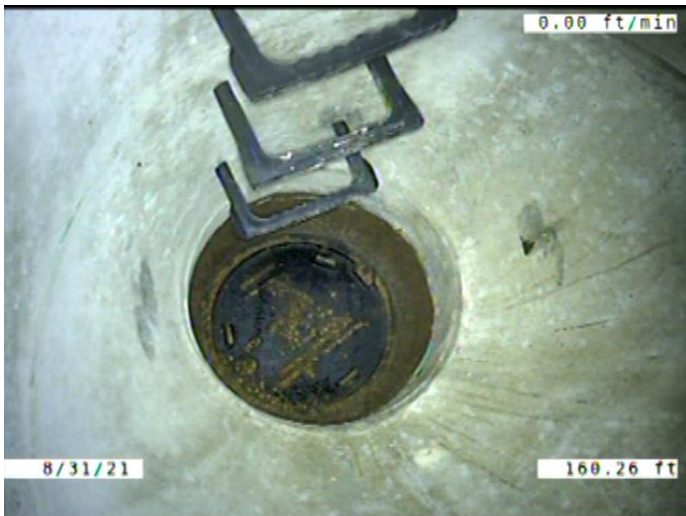
Code: **AMH**
 Description: **Manhole**

Distance (ft): **160.3**
 Structural Grade: **0**
 O&M Grade: **0**
 Clock Start/From:
 Clock To:
 1st Value:
 2nd Value:
 Value Percent:
 Continuous Index:
 Within 8" of Joint: **NO**
 Remarks: **M-504-106**
