Profile/Photo Observation Report

Date:	04/18/2018	Weather:		Coding:	PACP 6.0
Pipe Length (ft):	241.2	Owner:	NA	Pre Clean:	Not Known
P.O.#:		Surveyor:	Byrd Fitzgerald	PSR:	P-504-107-106
Customer:		Clean Date:	01/01/1900	Shape:	C

Street:	Summerlin	Flow Control:	Not Controlled
City:	Hobart, IN	Year Renewed:	
Location:	Light Highway	Tape/Media #:	
Purpose:	Not Known	Dia/Height:	8"
Use:	Sanitary	Material:	CP
Drain Area:	NA	Lining:	
Category:	NA		
Comment:

Location Details:		Direction of Survey:	Downstream
US MH:	M-504-106	DS MH:	M-504-107
		Total Length Surveyed (ft):	16.8

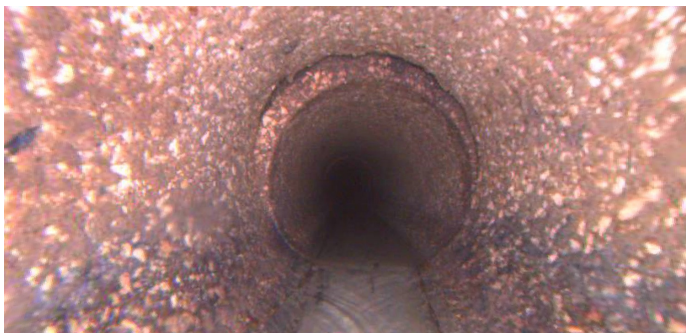
Code: **SAP**
Description: **Surface Aggregate Projecting**

Distance (ft): **.0**
Structural Grade: **3**
O&M Grade: **0**
Clock Start/From: **7**
Clock To: **5**
1st Value:
2nd Value:
Value Percent:
Continuous Index: **S01**
Within 8" of Joint:
Remarks:

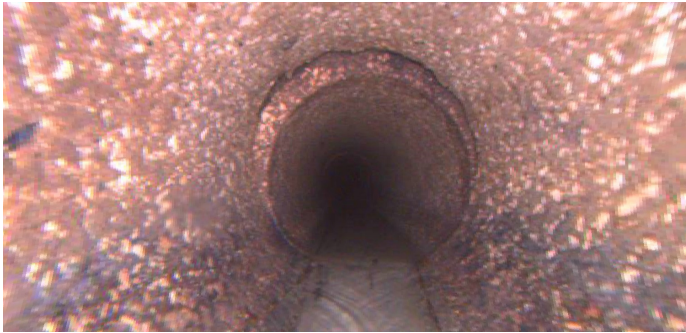
Code: **AMH**
Description: **Manhole**

Distance (ft): **.0**
Structural Grade: **0**
O&M Grade: **0**
Clock Start/From:
Clock To:
1st Value:
2nd Value:
Value Percent:
Continuous Index:
Within 8" of Joint: **NO**
Remarks: **M-504-106**

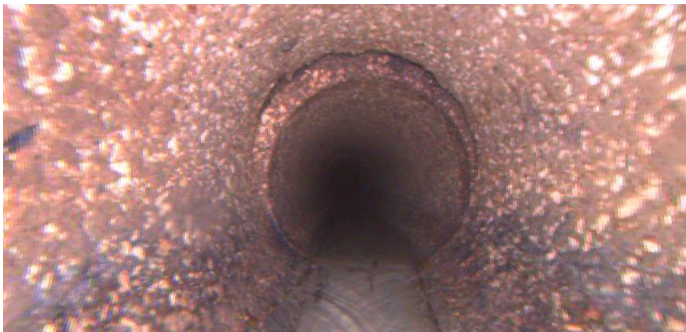
Code: **MWL**
Description: **Water Level**

Distance (ft): **.0**
Structural Grade: **0**
O&M Grade: **0**
Clock Start/From:
Clock To:
1st Value:
2nd Value:
Value Percent: **5.000**
Continuous Index:
Within 8" of Joint: **NO**
Remarks:

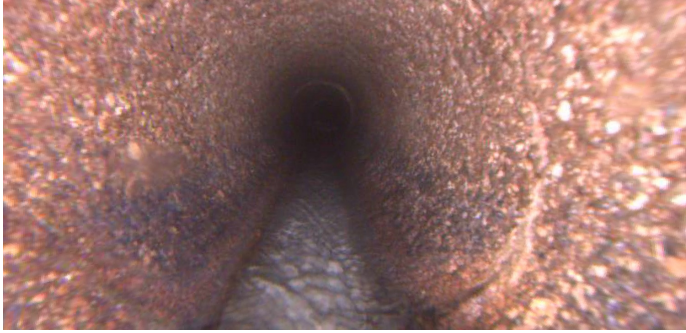
Code: **FC**
Description: **Fracture Circumferential**

Distance (ft): **10.9**
Structural Grade: **2**
O&M Grade: **0**
Clock Start/From: **12**
Clock To: **12**
1st Value:
2nd Value:
Value Percent:
Continuous Index:
Within 8" of Joint:
Remarks:

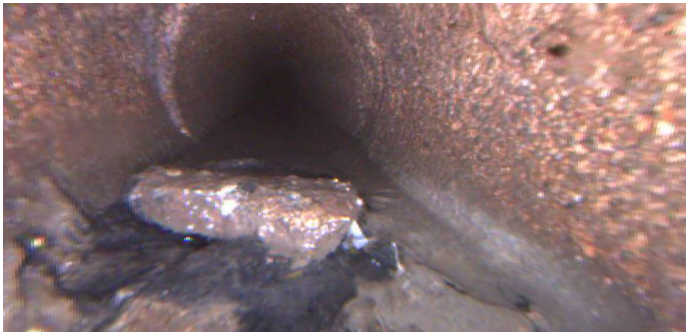
Code: **OBM**
Description: **Obstacle Pipe Material**

Distance (ft): **16.0**
Structural Grade: **0**
O&M Grade: **3**
Clock Start/From: **6**
Clock To:
1st Value:
2nd Value:
Value Percent: **15.000**
Continuous Index:
Within 8" of Joint: **NO**
Remarks: **broken pieces of pipe**

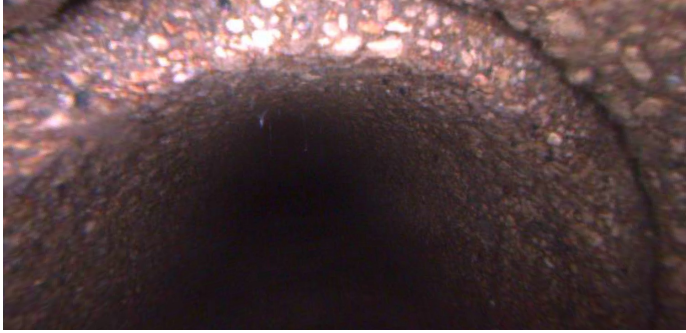
Code: **SAP**
Description: **Surface Aggregate Projecting**

Distance (ft): **16.8**
Structural Grade: **3**
O&M Grade: **0**
Clock Start/From: **7**
Clock To: **5**
1st Value:
2nd Value:
Value Percent:
Continuous Index: **F01**
Within 8" of Joint:
Remarks:

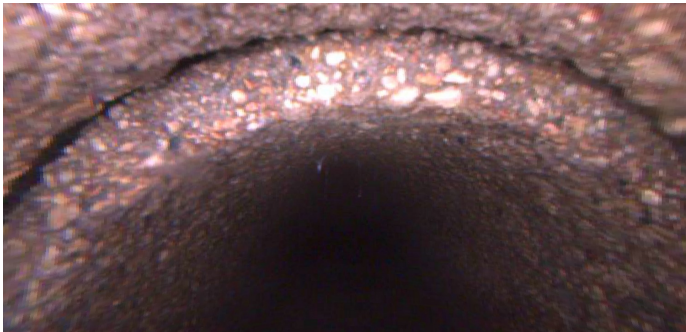
Code: **MSA**
Description: **Abandoned Survey**

Distance (ft): **16.8**
Structural Grade: **0**
O&M Grade: **0**
Clock Start/From:
Clock To:
1st Value:
2nd Value:
Value Percent:
Continuous Index:
Within 8" of Joint: **NO**
Remarks: **obn**
