## Profile/Photo Observation Report

Date:	<b>08/31/2021</b>	Weather:		Coding:	<b>PACP 7.0</b>
Pipe Length (ft):	<b>241.0</b>	Owner:	<b>City of Hobart</b>	Pre Clean:	<b>Light Cleaning</b>
P.O.#:	<b>YES502259</b>	Surveyor:	<b>S. Bucklin</b>	PSR:	<b>P-504-107-106</b>
Customer:	<b>City of Hobart</b>	Clean Date:	<b>08/30/2021</b>	Shape:	<b>C</b>

Street:	<b>42nd Avenue</b>	Flow Control:	<b>Not Controlled</b>
City:	<b>Hobart, IN</b>	Year Renewed:	
Location:	<b>Alley</b>	Tape/Media #:	
Purpose:	<b>Routine Assessment</b>	Dia/Height:	<b>8"</b>
Use:	<b>Sanitary Sewage Pipe</b>	Material:	<b>CP</b>
Drain Area:		Lining:	
Category:	<b>NA</b>		
Comment:			
Location Details:		Direction of Survey:	<b>Upstream</b>
US MH:	<b>M-504-106</b>	DS MH:	<b>M-504-107</b>
		Total Length Surveyed (ft):	<b>29.7</b>

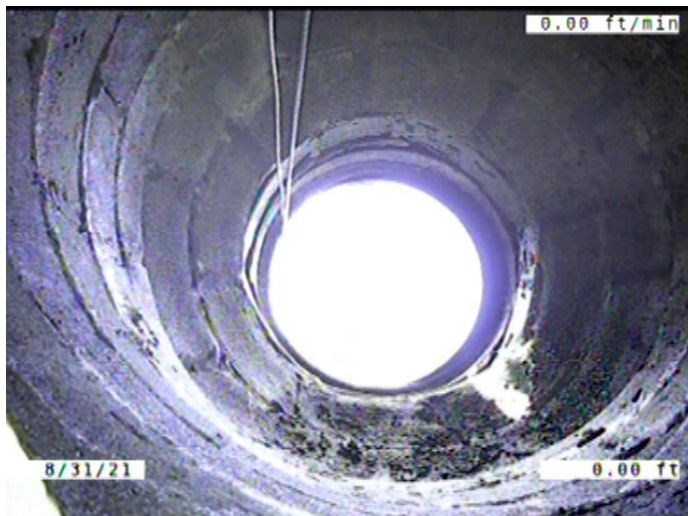
Code: **AMH**  
 Description: **Manhole**

Distance (ft): **.0**  
 Structural Grade: **0**  
 O&M Grade: **0**  
 Clock Start/From:  
 Clock To:  
 1st Value:  
 2nd Value:  
 Value Percent:  
 Continuous Index:  
 Within 8" of Joint: **NO**  
 Remarks: **M-504-107**

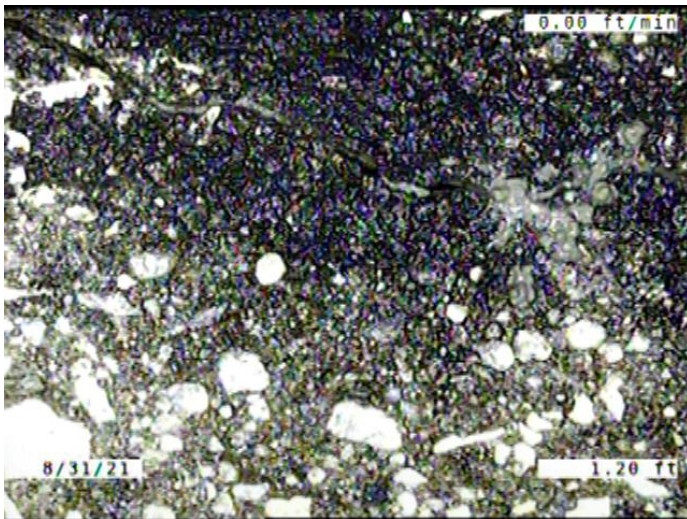
Code:	<b>FM</b>
Description:	<b>Fracture Multiple</b>
Distance (ft):	<b>1.2</b>
Structural Grade:	<b>4</b>
O&M Grade:	<b>0</b>
Clock Start/From:	<b>7</b>
Clock To:	<b>5</b>
1st Value:	
2nd Value:	
Value Percent:	
Continuous Index:	
Within 8" of Joint:	<b>NO</b>
Remarks:

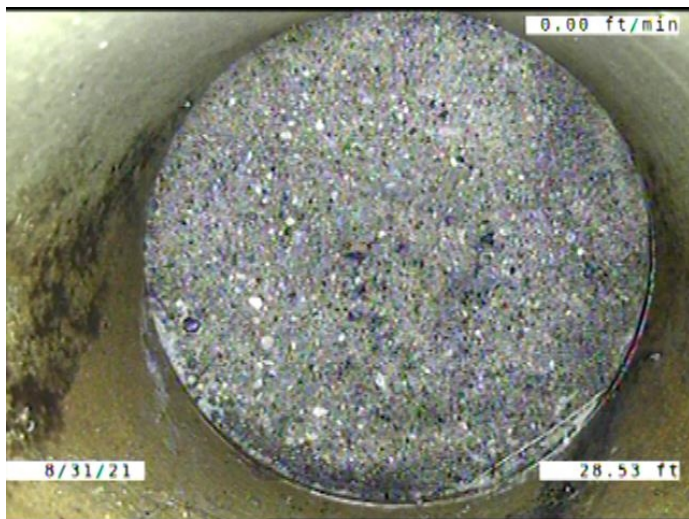
Code: **TFC**  
Description: **Tap Factory Capped**

Distance (ft): **28.5**  
Structural Grade: **0**  
O&M Grade: **0**  
Clock Start/From: **11**  
Clock To:  
1st Value: **4.000**  
2nd Value:  
Value Percent:  
Continuous Index:  
Within 8" of Joint: **YES**  
Remarks:

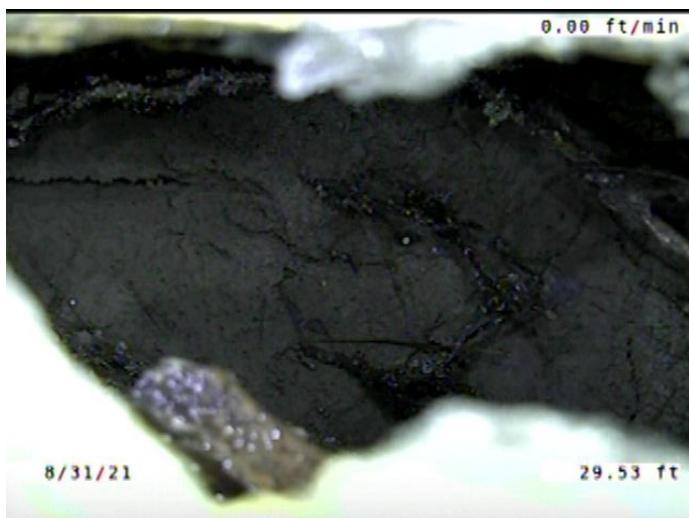
Code: **X**  
Description: **Collapse**

Distance (ft): **29.5**  
Structural Grade: **5**  
O&M Grade: **0**  
Clock Start/From:  
Clock To:  
1st Value:  
2nd Value:  
Value Percent: **100.000**  
Continuous Index:  
Within 8" of Joint: **NO**  
Remarks:
