Profile/Photo Observation Report

Date:	08/31/2021	Weather:		Coding:	PACP 7.0
Pipe Length (ft):	241.0	Owner:	City of Hobart	Pre Clean:	Light Cleaning
P.O.#:	YES502259	Surveyor:	S. Bucklin	PSR:	P-504-107-106
Customer:	City of Hobart	Clean Date:	08/30/2021	Shape:	C

Street:	42nd Avenue	Flow Control:	Not Controlled
City:	Hobart, IN	Year Renewed:	
Location:	Alley	Tape/Media #:	
Purpose:	Routine Assessment	Dia/Height:	8"
Use:	Sanitary Sewage Pipe	Material:	CP
Drain Area:		Lining:	
Category:	NA		
Comment:			
Location Details:		Direction of Survey:	Upstream
US MH:	M-504-106	DS MH:	M-504-107
		Total Length Surveyed (ft):	29.7

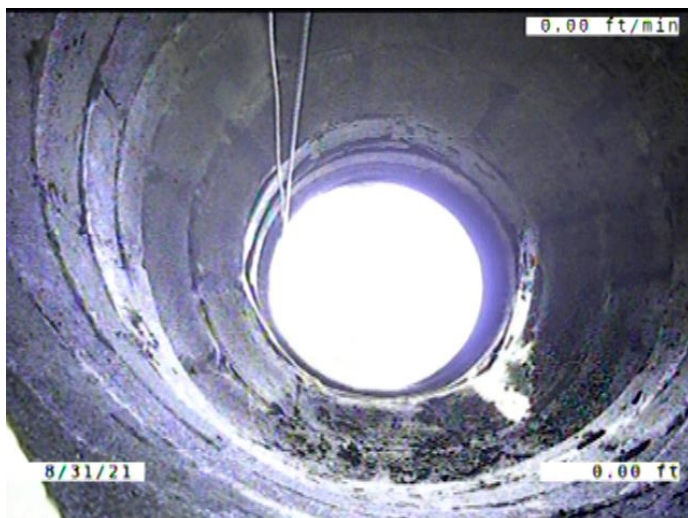
Code: **AMH**
 Description: **Manhole**

Distance (ft): **.0**
 Structural Grade: **0**
 O&M Grade: **0**
 Clock Start/From:
 Clock To:
 1st Value:
 2nd Value:
 Value Percent:
 Continuous Index:
 Within 8" of Joint: **NO**
 Remarks: **M-504-107**

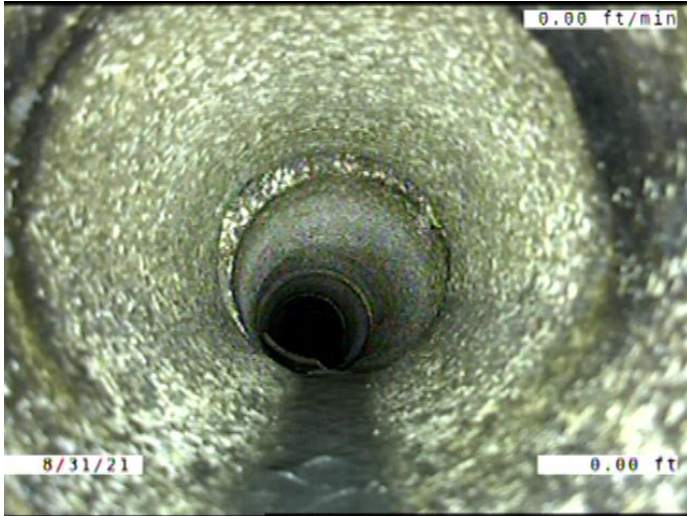
Code: **MWL**
Description: **Miscellaneous Water Level**

Distance (ft): **.0**
Structural Grade: **0**
O&M Grade: **0**
Clock Start/From:
Clock To:
1st Value:
2nd Value:
Value Percent: **5.000**
Continuous Index:
Within 8" of Joint: **NO**
Remarks:

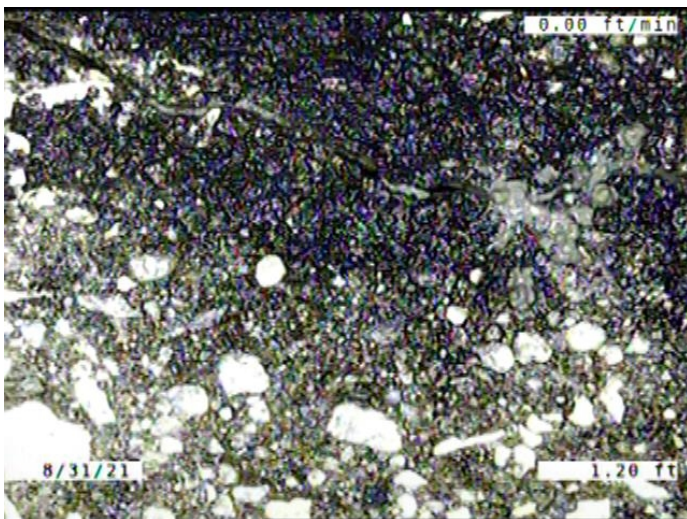
Code: **FM**
Description: **Fracture Multiple**

Distance (ft): **1.2**
Structural Grade: **4**
O&M Grade: **0**
Clock Start/From: **7**
Clock To: **5**
1st Value:
2nd Value:
Value Percent:
Continuous Index:
Within 8" of Joint: **NO**
Remarks:

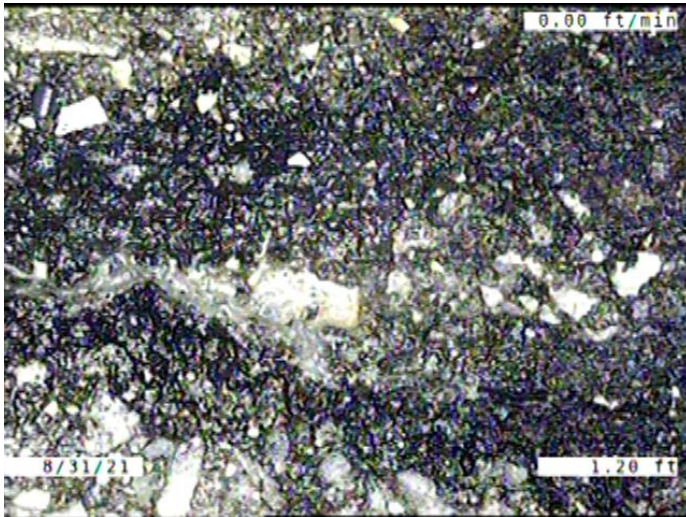
Code: **ISB**
 Description: **Infiltration Stain Barrel**

Distance (ft): **1.2**
 Structural Grade: **0**
 O&M Grade: **1**
 Clock Start/From: **7**
 Clock To: **5**
 1st Value:
 2nd Value:
 Value Percent:
 Continuous Index:
 Within 8" of Joint: **NO**
 Remarks:

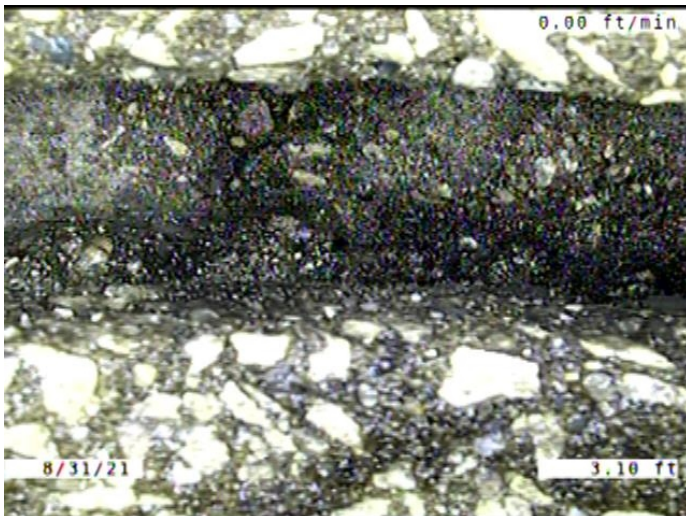
Code: **JAM**
 Description: **Joint Angular Medium**

Distance (ft): **3.1**
 Structural Grade: **3**
 O&M Grade: **0**
 Clock Start/From:
 Clock To:
 1st Value:
 2nd Value:
 Value Percent:
 Continuous Index:
 Within 8" of Joint: **NO**
 Remarks:

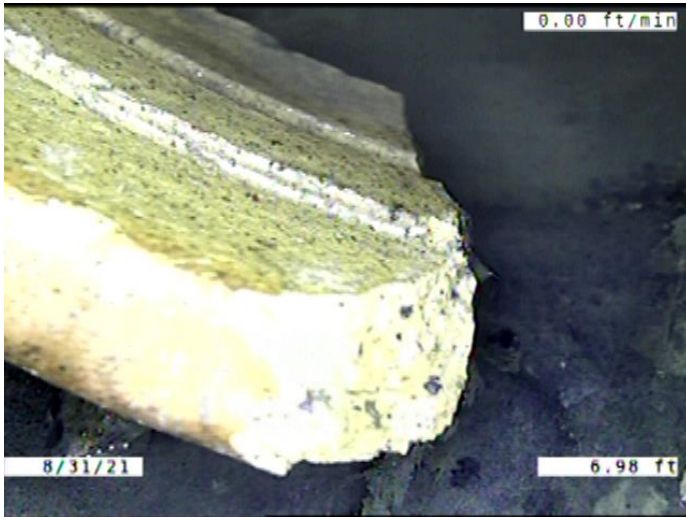
Code:	OBM
Description:	Obstruction Pipe Material in Invert
Distance (ft):	7.0
Structural Grade:	0
O&M Grade:	2
Clock Start/From:	6
Clock To:	8
1st Value:	
2nd Value:	
Value Percent:	5.000
Continuous Index:	
Within 8" of Joint:	YES
Remarks:

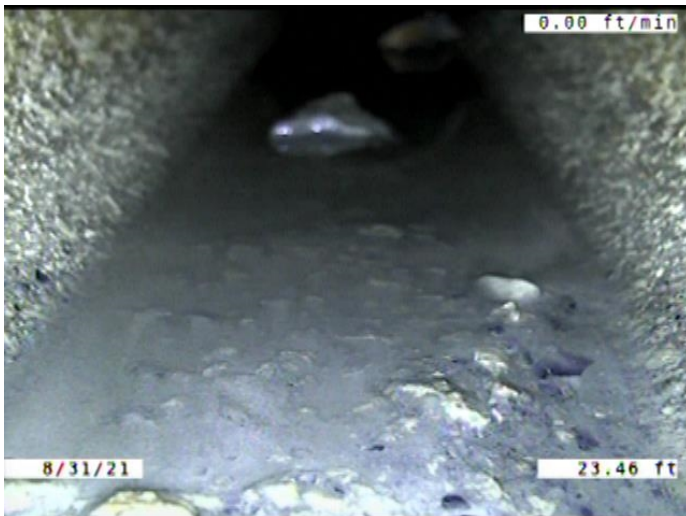
Code:	DSC
Description:	Deposits Settled Hard/Compacted
Distance (ft):	23.5
Structural Grade:	0
O&M Grade:	2
Clock Start/From:	6
Clock To:	
1st Value:	
2nd Value:	
Value Percent:	5.000
Continuous Index:	
Within 8" of Joint:	YES
Remarks:

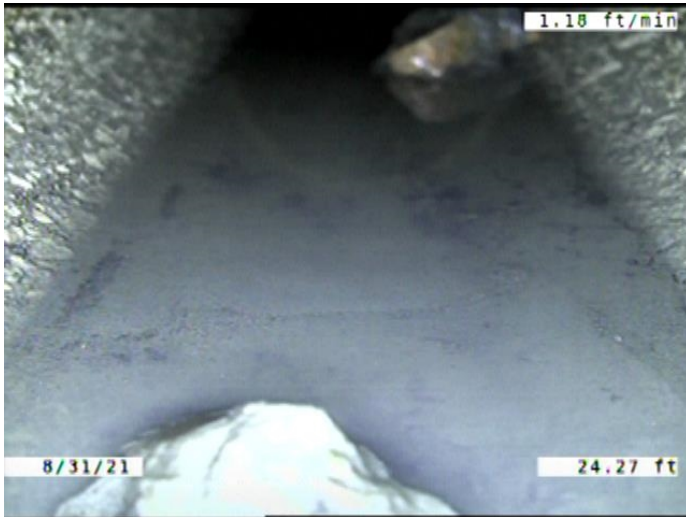
Code:	OBM
Description:	Obstruction Pipe Material in Invert
Distance (ft):	24.2
Structural Grade:	0
O&M Grade:	2
Clock Start/From:	6
Clock To:	
1st Value:	
2nd Value:	
Value Percent:	5.000
Continuous Index:	
Within 8" of Joint:	YES
Remarks:

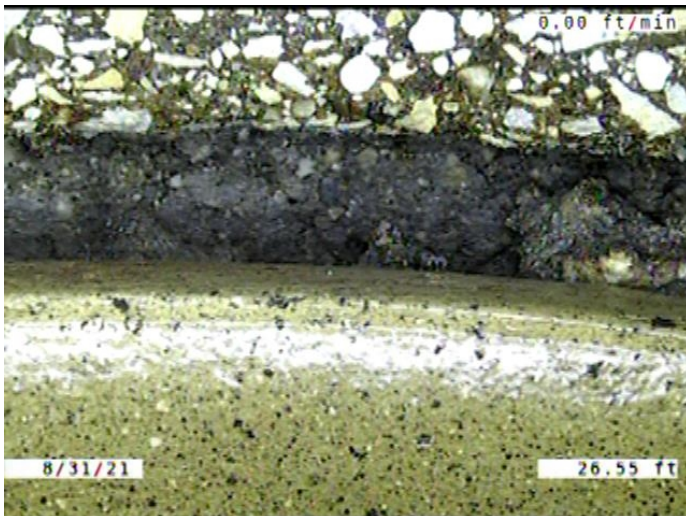
Code:	MMC
Description:	Miscellaneous Material Change
Distance (ft):	26.6
Structural Grade:	0
O&M Grade:	0
Clock Start/From:	
Clock To:	
1st Value:	
2nd Value:	
Value Percent:	
Continuous Index:	
Within 8" of Joint:	NO
Remarks:	CONCRETE TO VCP

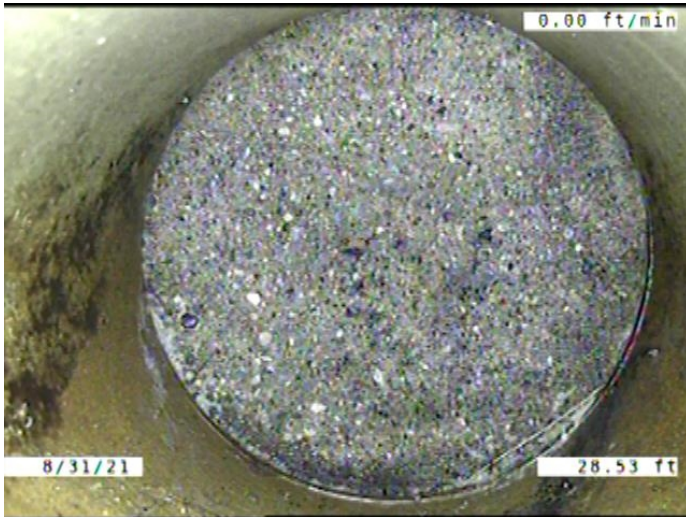
Code: **TFC**
 Description: **Tap Factory Capped**

Distance (ft): **28.5**
 Structural Grade: **0**
 O&M Grade: **0**
 Clock Start/From: **11**
 Clock To:
 1st Value: **4.000**
 2nd Value:
 Value Percent:
 Continuous Index:
 Within 8" of Joint: **YES**
 Remarks:

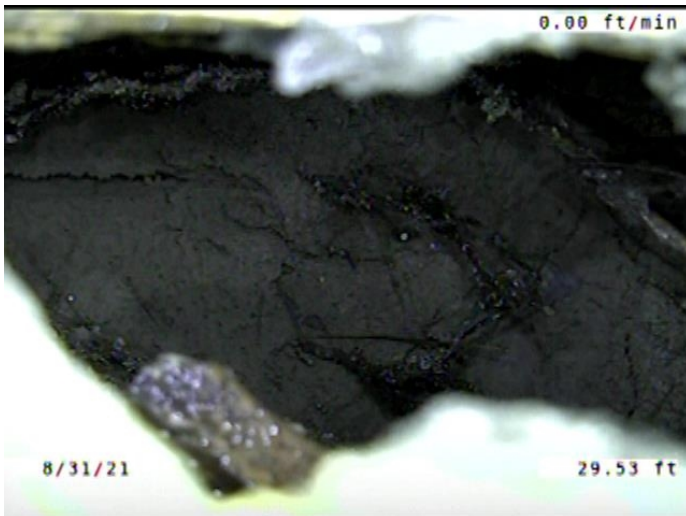
Code: **X**
 Description: **Collapse**

Distance (ft): **29.5**
 Structural Grade: **5**
 O&M Grade: **0**
 Clock Start/From:
 Clock To:
 1st Value:
 2nd Value:
 Value Percent: **100.000**
 Continuous Index:
 Within 8" of Joint: **NO**
 Remarks:

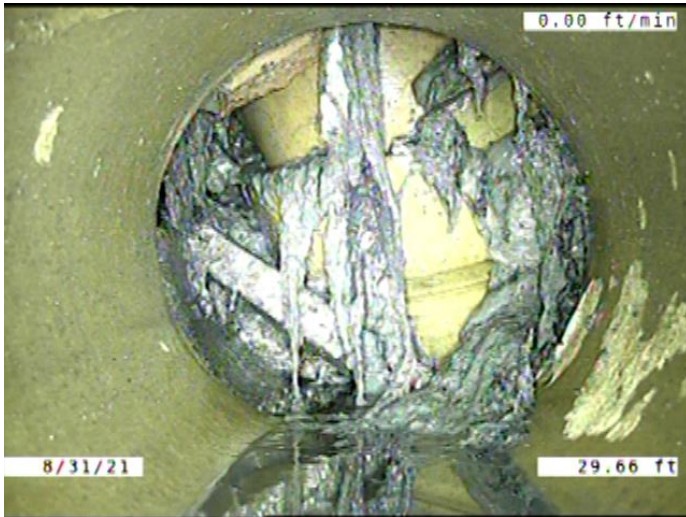
Code:	MSA
Description:	Miscellaneous Survey Abandoned
Distance (ft):	29.7
Structural Grade:	0
O&M Grade:	0
Clock Start/From:	
Clock To:	
1st Value:	
2nd Value:	
Value Percent:	
Continuous Index:	
Within 8" of Joint:	NO
Remarks:	CAMERA CANT MAKE IT PAST PROTRUDING TAP
