Profile/Photo Observation Report

Date:	10/21/2021	Weather:		Coding:	PACP 7.0
Pipe Length (ft):	241.0	Owner:	City of Hobart	Pre Clean:	Light Cleaning
P.O.#:	YES502259	Surveyor:	S. Bucklin	PSR:	P-504-107-106
Customer:	City of Hobart	Clean Date:	08/30/2021	Shape:	C

Street:	42nd Avenue	Flow Control:	Not Controlled
City:	Hobart, IN	Year Renewed:	
Location:	Alley	Tape/Media #:	
Purpose:	Routine Assessment	Dia/Height:	8"
Use:	Sanitary Sewage Pipe	Material:	CP
Drain Area:		Lining:	
Category:	NA		
Comment:			
Location Details:		Direction of Survey:	Downstream
US MH:	M-504-106	DS MH:	M-504-107
		Total Length Surveyed (ft):	97.0

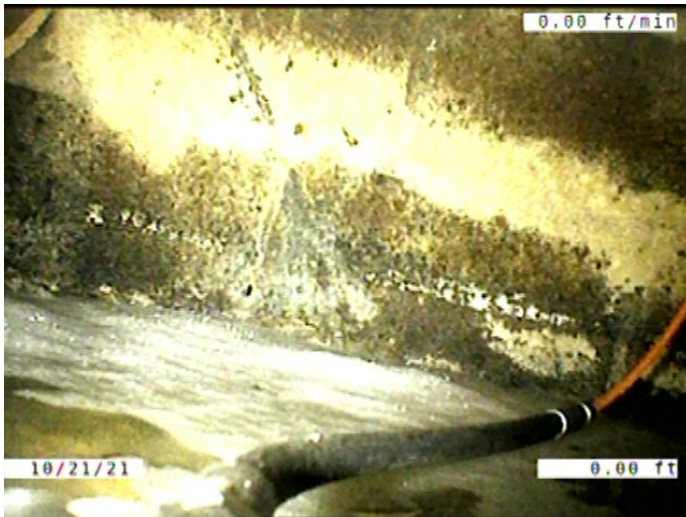
Code: **AMH**
Description: **Manhole**

Distance (ft): **.0**
Structural Grade: **0**
O&M Grade: **0**
Clock Start/From:
Clock To:
1st Value:
2nd Value:
Value Percent:
Continuous Index:
Within 8" of Joint: **NO**
Remarks: **M-504-106**

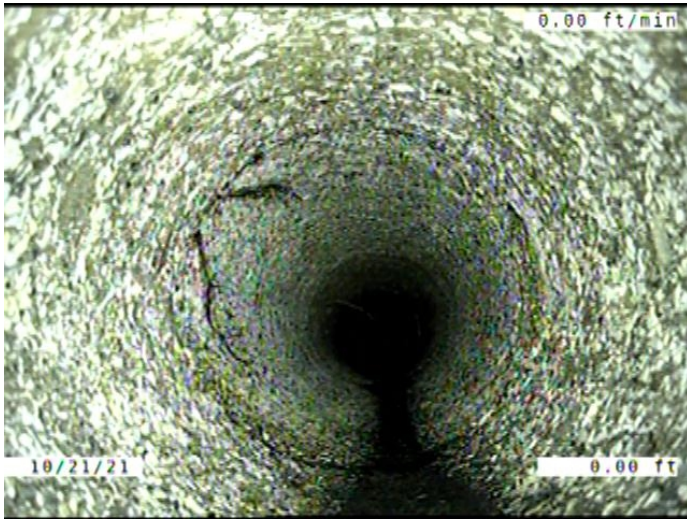
Code: **MWL**
Description: **Miscellaneous Water Level**

Distance (ft): **.0**
Structural Grade: **0**
O&M Grade: **0**
Clock Start/From:
Clock To:
1st Value:
2nd Value:
Value Percent: **5.000**
Continuous Index:
Within 8" of Joint: **NO**
Remarks:

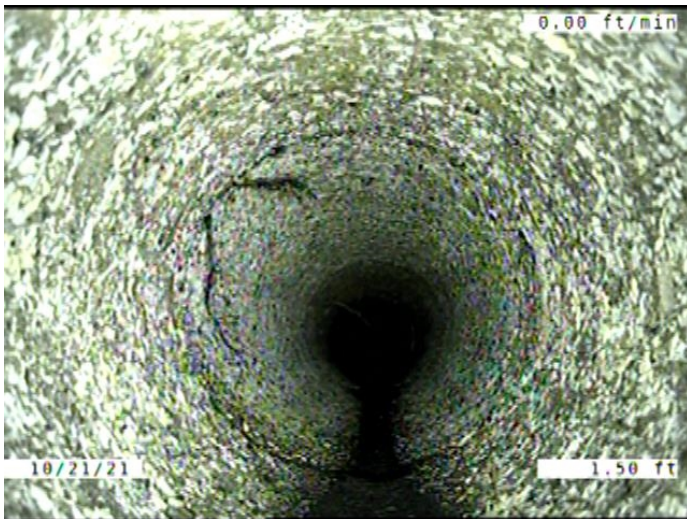
Code: **MGO**
Description: **Miscellaneous General Observation**

Distance (ft): **1.5**
Structural Grade: **0**
O&M Grade: **0**
Clock Start/From:
Clock To:
1st Value:
2nd Value:
Value Percent:
Continuous Index:
Within 8" of Joint: **NO**
Remarks: **DROP INTO THE MANHOLE. HAD TO START IN THE PIPE.**

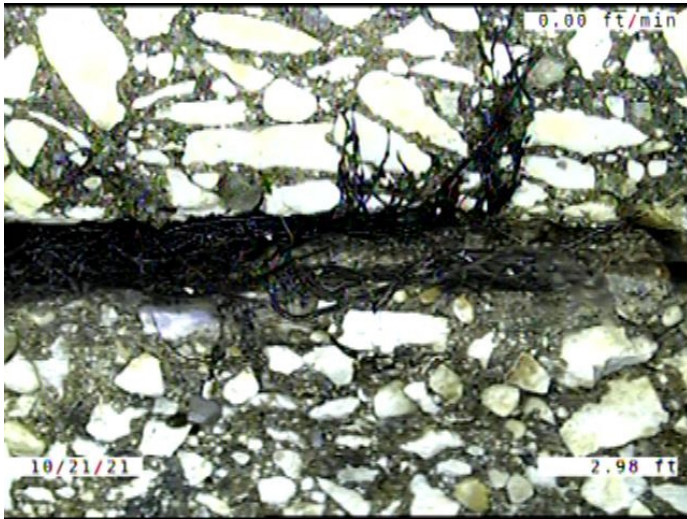
Code: **RFJ**
 Description: **Roots Fine Joint**

Distance (ft): **3.0**
 Structural Grade: **0**
 O&M Grade: **1**
 Clock Start/From: **8**
 Clock To: **2**
 1st Value:
 2nd Value:
 Value Percent:
 Continuous Index: **S01**
 Within 8" of Joint: **YES**
 Remarks:

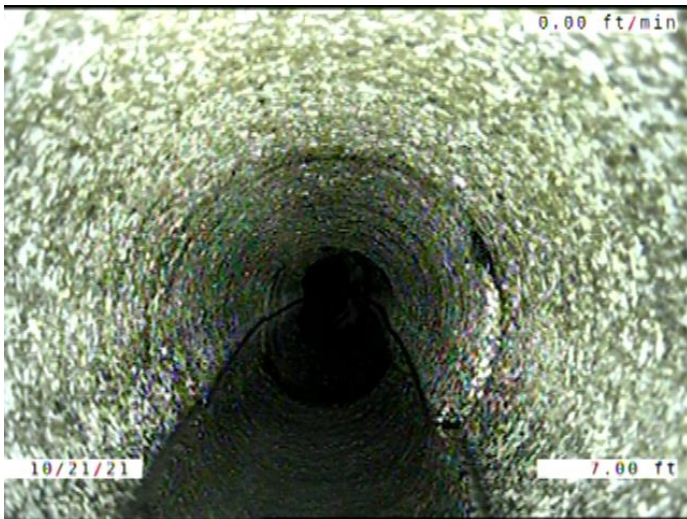
Code: **MWLS**
 Description: **Miscellaneous Water Level Sag**

Distance (ft): **7.0**
 Structural Grade: **2**
 O&M Grade: **0**
 Clock Start/From:
 Clock To:
 1st Value:
 2nd Value:
 Value Percent: **10.000**
 Continuous Index: **S02**
 Within 8" of Joint: **NO**
 Remarks:

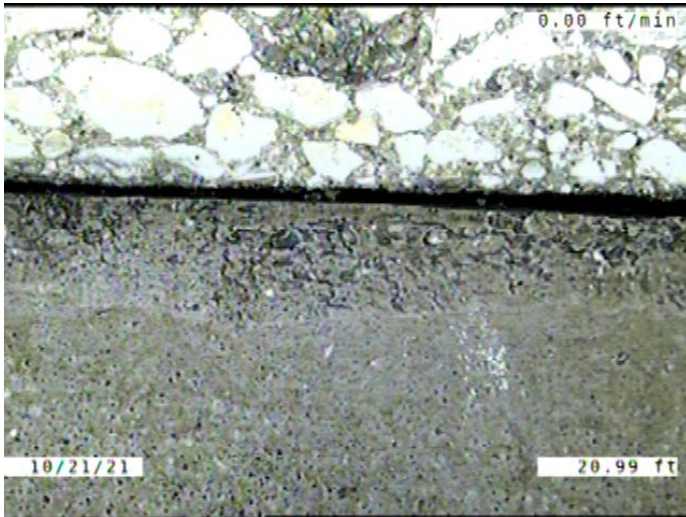
Code: **MMC**
Description: **Miscellaneous Material Change**

Distance (ft): **21.0**
Structural Grade: **0**
O&M Grade: **0**
Clock Start/From:
Clock To:
1st Value:
2nd Value:
Value Percent:
Continuous Index:
Within 8" of Joint: **NO**
Remarks: **CONCRETE TO VCP**

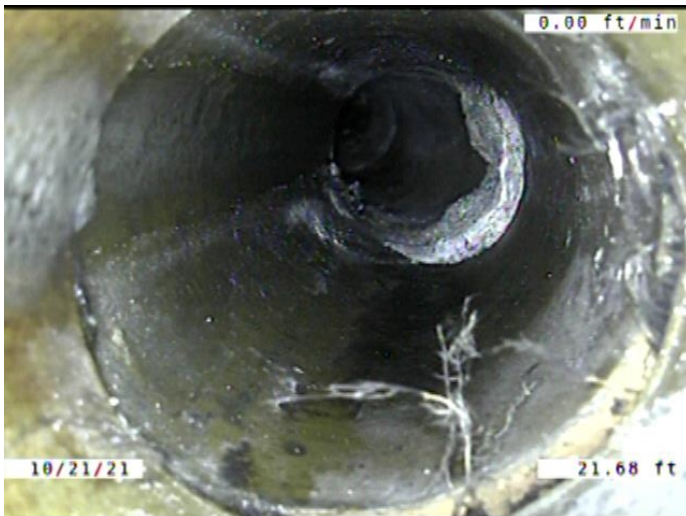
Code: **TF**
Description: **Tap Factory**

Distance (ft): **21.7**
Structural Grade: **0**
O&M Grade: **0**
Clock Start/From: **10**
Clock To:
1st Value: **4.000**
2nd Value:
Value Percent:
Continuous Index:
Within 8" of Joint: **YES**
Remarks: **CONSTANTLY RUNNING WATER**

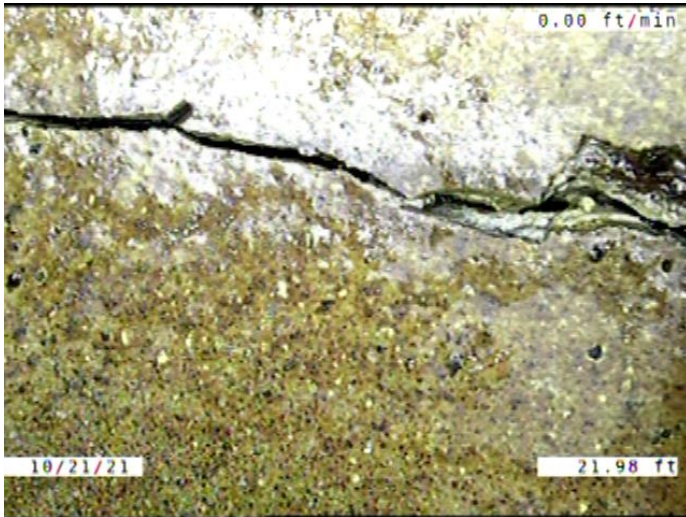
Code: **FC**
 Description: **Fracture Circumferential**

Distance (ft): **22.0**
 Structural Grade: **2**
 O&M Grade: **0**
 Clock Start/From: **8**
 Clock To: **4**
 1st Value:
 2nd Value:
 Value Percent:
 Continuous Index:
 Within 8" of Joint: **YES**
 Remarks:

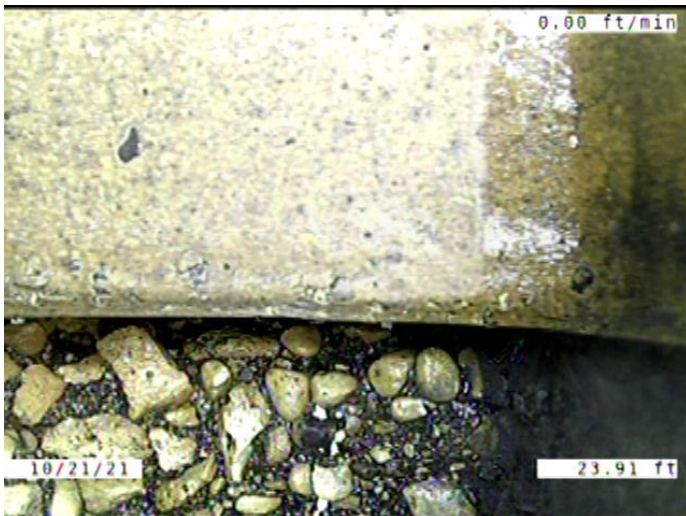
Code: **MMC**
 Description: **Miscellaneous Material Change**

Distance (ft): **23.9**
 Structural Grade: **0**
 O&M Grade: **0**
 Clock Start/From:
 Clock To:
 1st Value:
 2nd Value:
 Value Percent:
 Continuous Index:
 Within 8" of Joint: **NO**
 Remarks: **VCP TO CONCRETE**

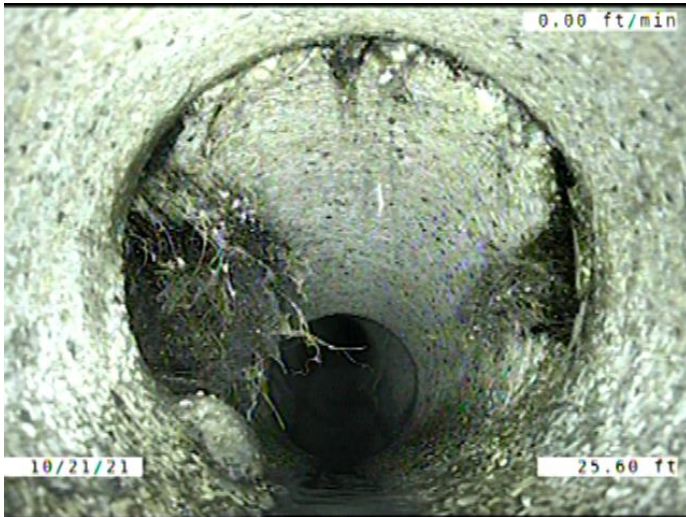
Code: **MWLS**
Description: **Miscellaneous Water Level Sag**

Distance (ft): **25.6**
Structural Grade: **2**
O&M Grade: **0**
Clock Start/From:
Clock To:
1st Value:
2nd Value:
Value Percent: **10.000**
Continuous Index: **F02**
Within 8" of Joint: **NO**
Remarks:

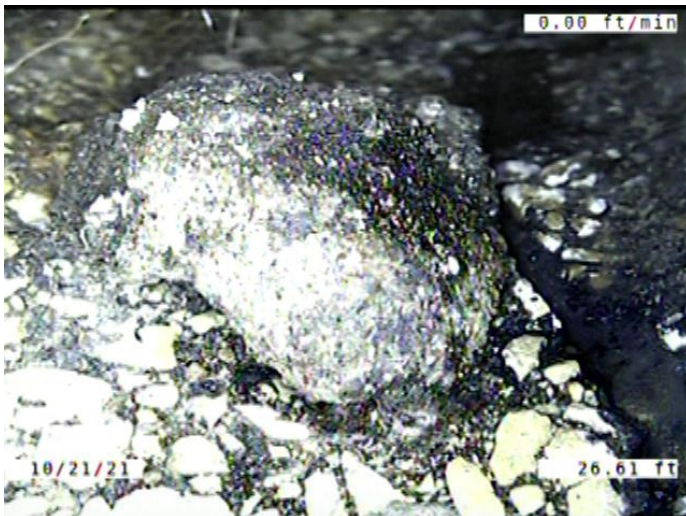
Code: **DAE**
Description: **Deposits Attached Encrustation**

Distance (ft): **26.6**
Structural Grade: **0**
O&M Grade: **2**
Clock Start/From: **7**
Clock To: **8**
1st Value:
2nd Value:
Value Percent: **5.000**
Continuous Index:
Within 8" of Joint: **YES**
Remarks:

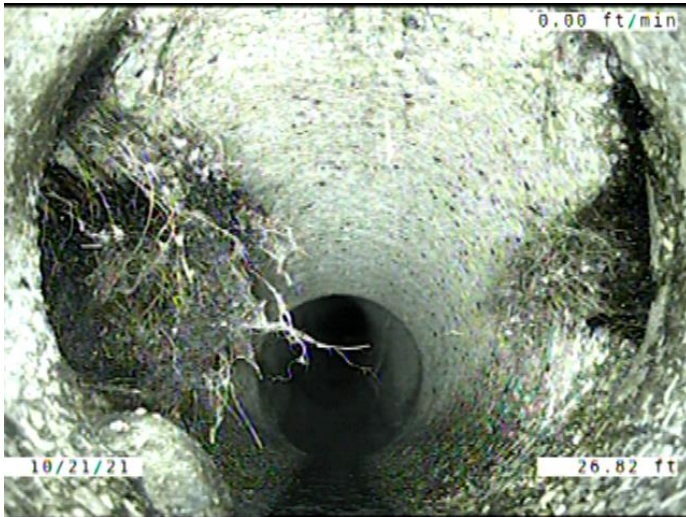
Code: **RMJ**
Description: **Roots Medium Joint**

Distance (ft): **26.8**
Structural Grade: **0**
O&M Grade: **3**
Clock Start/From: **8**
Clock To: **3**
1st Value:
2nd Value:
Value Percent: **15.000**
Continuous Index:
Within 8" of Joint: **YES**
Remarks:

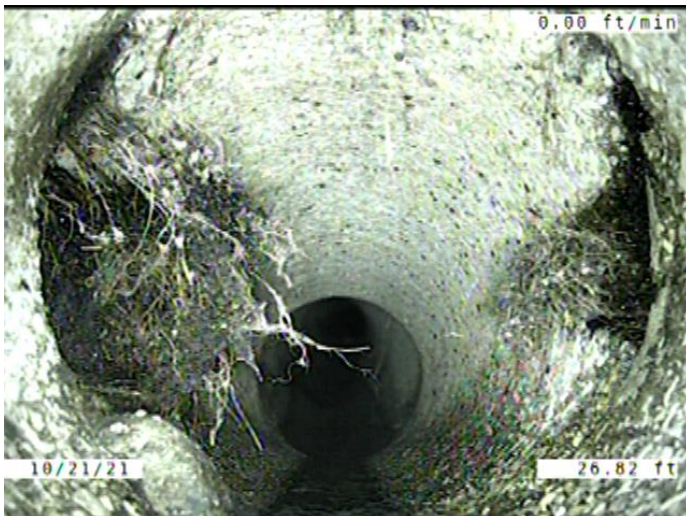
Code: **LD**
Description: **Line Down**

Distance (ft): **26.8**
Structural Grade: **0**
O&M Grade: **2**
Clock Start/From:
Clock To:
1st Value:
2nd Value:
Value Percent: **15.000**
Continuous Index:
Within 8" of Joint: **NO**
Remarks:

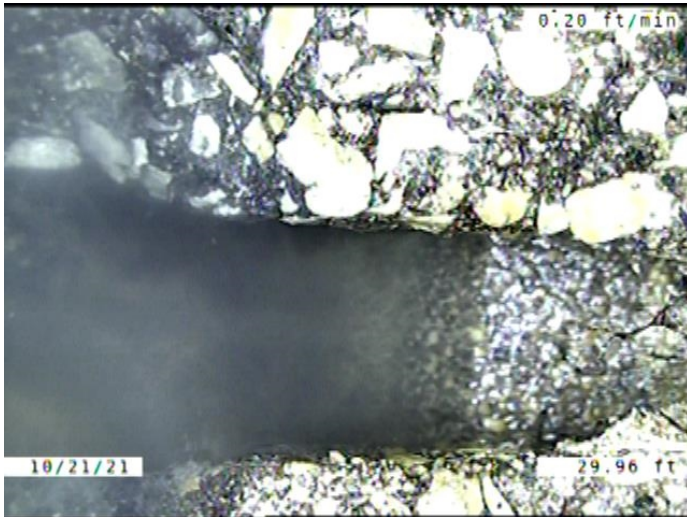
Code: **JAM**
 Description: **Joint Angular Medium**

Distance (ft): **29.9**
 Structural Grade: **3**
 O&M Grade: **0**
 Clock Start/From:
 Clock To:
 1st Value:
 2nd Value:
 Value Percent:
 Continuous Index:
 Within 8" of Joint: **NO**
 Remarks:

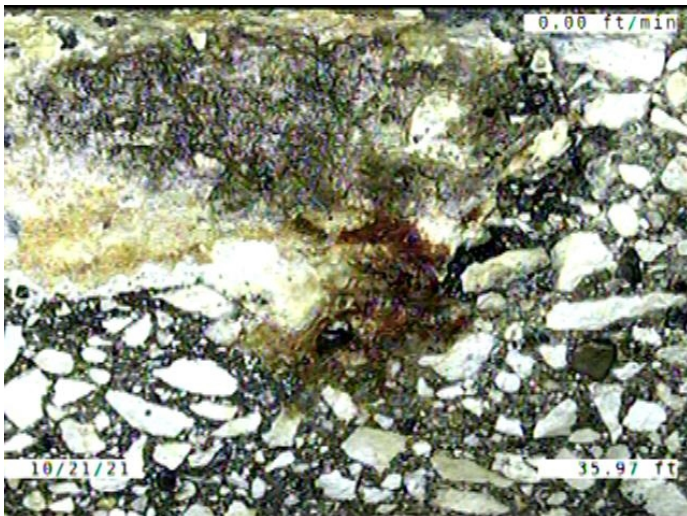
Code: **DAE**
 Description: **Deposits Attached Encrustation**

Distance (ft): **36.0**
 Structural Grade: **0**
 O&M Grade: **2**
 Clock Start/From: **7**
 Clock To: **10**
 1st Value:
 2nd Value:
 Value Percent: **5.000**
 Continuous Index:
 Within 8" of Joint: **YES**
 Remarks:

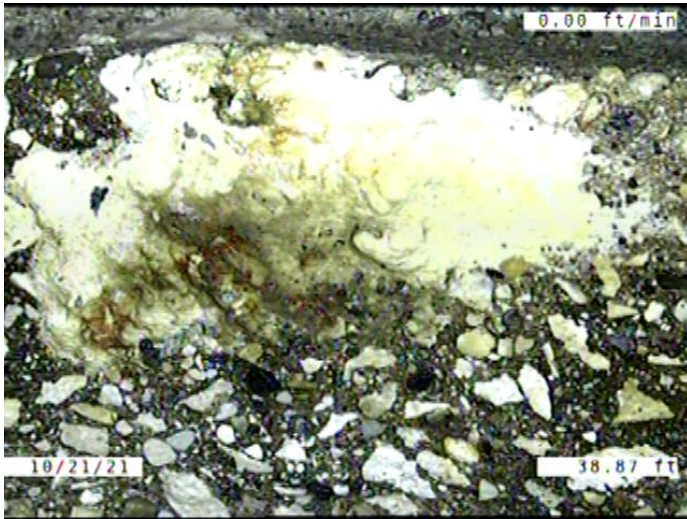
Code: **DAE**
 Description: **Deposits Attached Encrustation**

Distance (ft): **38.9**
 Structural Grade: **0**
 O&M Grade: **2**
 Clock Start/From: **1**
 Clock To: **2**
 1st Value:
 2nd Value:
 Value Percent: **5.000**
 Continuous Index:
 Within 8" of Joint: **YES**
 Remarks:

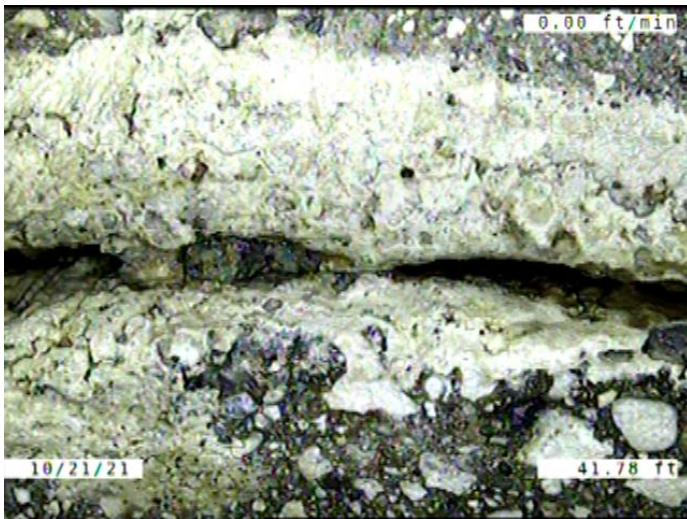
Code: **DAE**
 Description: **Deposits Attached Encrustation**

Distance (ft): **41.8**
 Structural Grade: **0**
 O&M Grade: **2**
 Clock Start/From: **2**
 Clock To: **5**
 1st Value:
 2nd Value:
 Value Percent: **5.000**
 Continuous Index:
 Within 8" of Joint: **YES**
 Remarks:

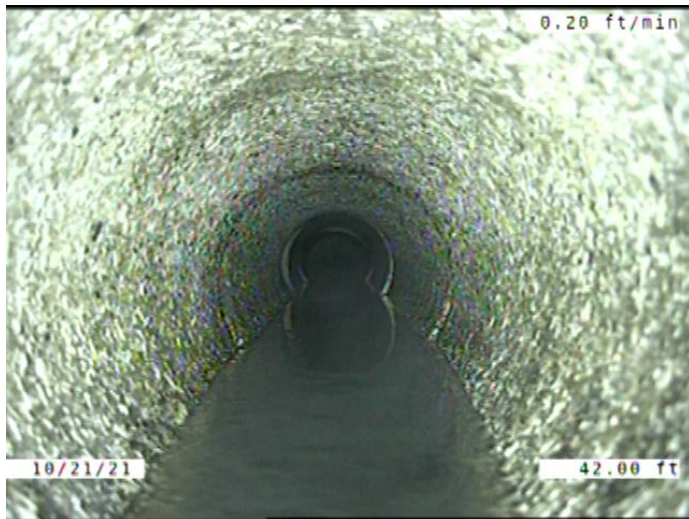
Code: **MWLS**
 Description: **Miscellaneous Water Level Sag**

Distance (ft): **42.0**
 Structural Grade: **2**
 O&M Grade: **0**
 Clock Start/From:
 Clock To:
 1st Value:
 2nd Value:
 Value Percent: **5.000**
 Continuous Index: **S03**
 Within 8" of Joint: **NO**
 Remarks:

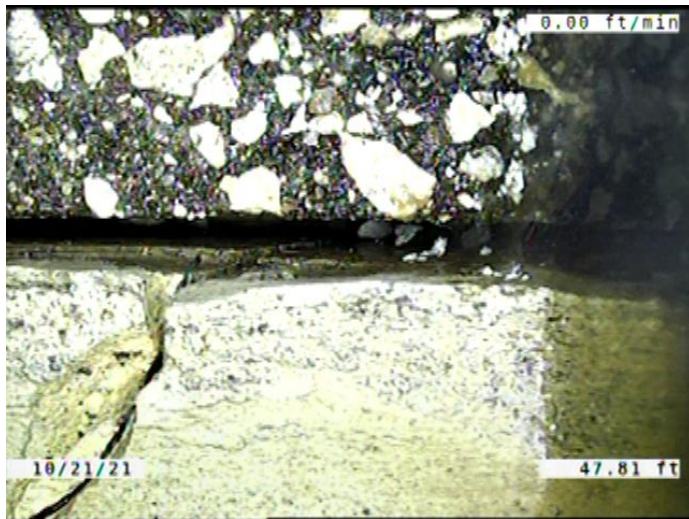
Code: **MMC**
 Description: **Miscellaneous Material Change**

Distance (ft): **47.8**
 Structural Grade: **0**
 O&M Grade: **0**
 Clock Start/From:
 Clock To:
 1st Value:
 2nd Value:
 Value Percent:
 Continuous Index:
 Within 8" of Joint: **NO**
 Remarks: **CONCRETE TO VCP**

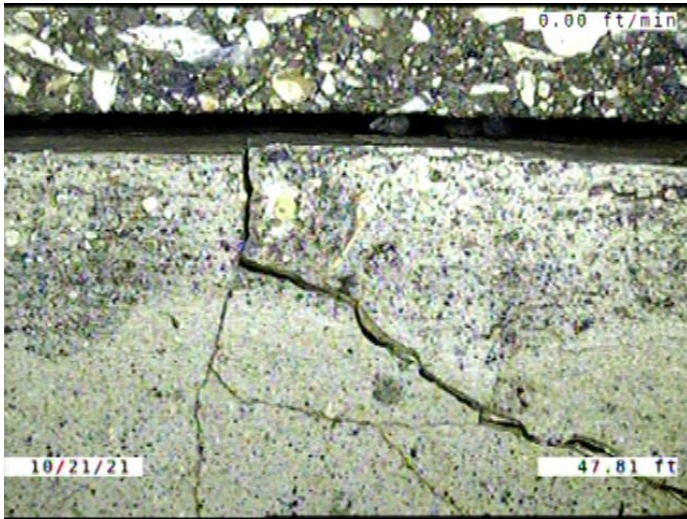
Code: **B**
Description: **Broken**

Distance (ft): **47.8**
Structural Grade: **4**
O&M Grade: **0**
Clock Start/From: **2**
Clock To: **4**
1st Value:
2nd Value:
Value Percent:
Continuous Index:
Within 8" of Joint: **YES**
Remarks:

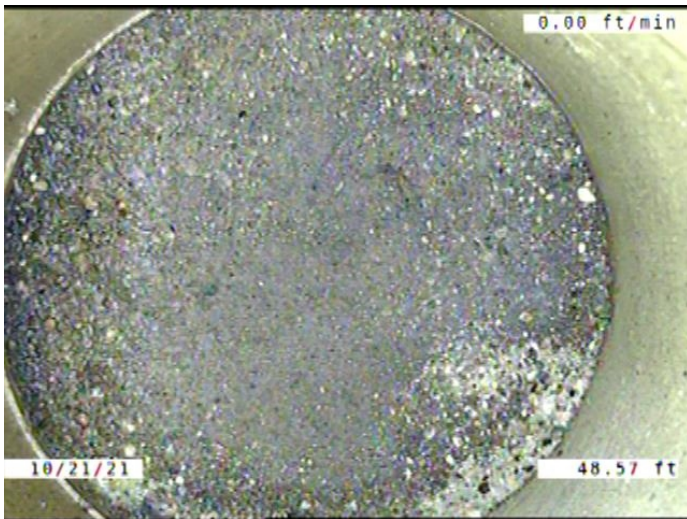
Code: **TFC**
Description: **Tap Factory Capped**

Distance (ft): **48.6**
Structural Grade: **0**
O&M Grade: **0**
Clock Start/From: **10**
Clock To:
1st Value: **4.000**
2nd Value:
Value Percent:
Continuous Index:
Within 8" of Joint: **YES**
Remarks:

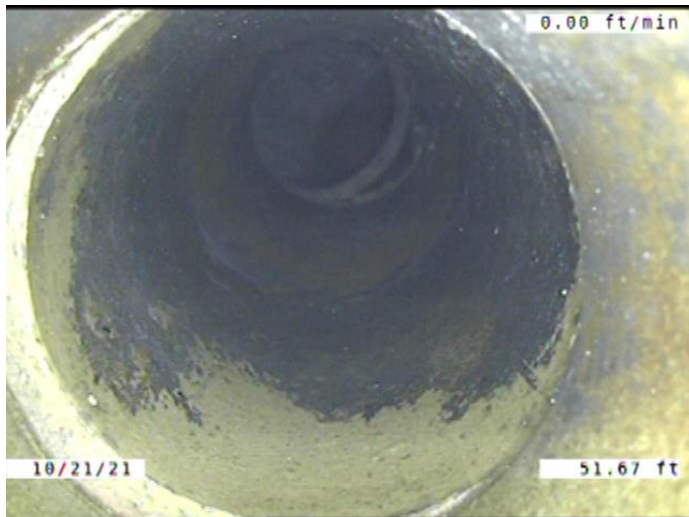
Code: **TF**
 Description: **Tap Factory**

Distance (ft): **51.7**
 Structural Grade: **0**
 O&M Grade: **0**
 Clock Start/From: **1**
 Clock To:
 1st Value: **4.000**
 2nd Value:
 Value Percent:
 Continuous Index:
 Within 8" of Joint: **YES**
 Remarks:

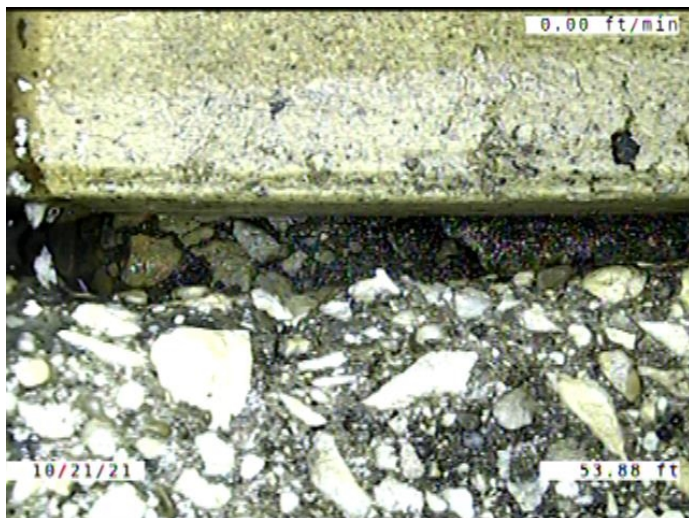
Code: **MMC**
 Description: **Miscellaneous Material Change**

Distance (ft): **53.9**
 Structural Grade: **0**
 O&M Grade: **0**
 Clock Start/From:
 Clock To:
 1st Value:
 2nd Value:
 Value Percent:
 Continuous Index:
 Within 8" of Joint: **NO**
 Remarks: **VCP TO CONCRETE**

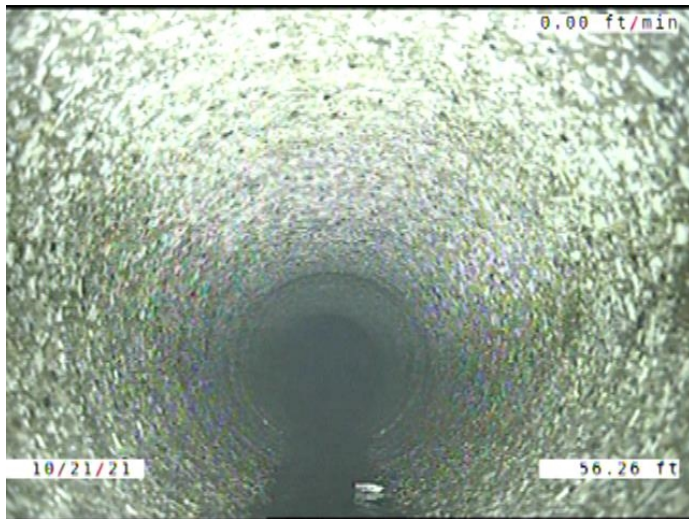
Code: **MWLS**
Description: **Miscellaneous Water Level Sag**

Distance (ft): **56.3**
Structural Grade: **2**
O&M Grade: **0**
Clock Start/From:
Clock To:
1st Value:
2nd Value:
Value Percent: **5.000**
Continuous Index: **F03**
Within 8" of Joint: **NO**
Remarks:

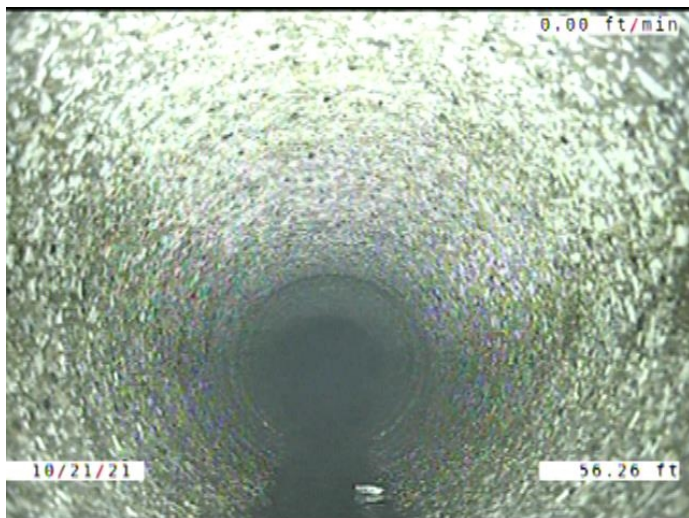
Code: **LD**
Description: **Line Down**

Distance (ft): **56.3**
Structural Grade: **0**
O&M Grade: **1**
Clock Start/From:
Clock To:
1st Value:
2nd Value:
Value Percent: **10.000**
Continuous Index:
Within 8" of Joint: **NO**
Remarks:

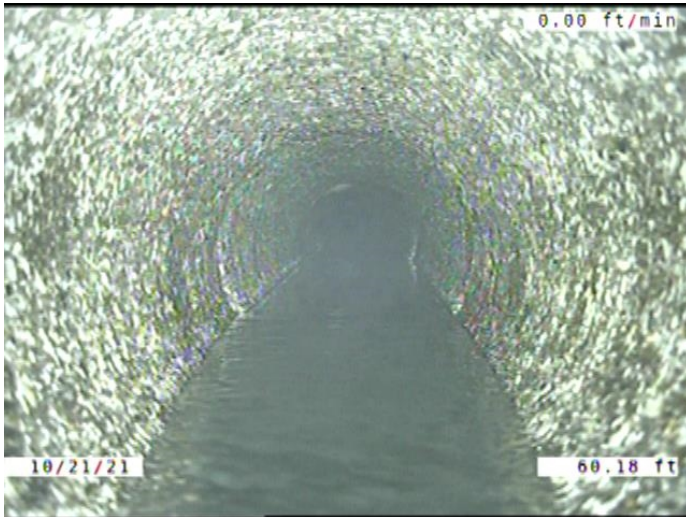
Code: **MWLS**
 Description: **Miscellaneous Water Level Sag**

Distance (ft): **60.2**
 Structural Grade: **2**
 O&M Grade: **0**
 Clock Start/From:
 Clock To:
 1st Value:
 2nd Value:
 Value Percent: **10.000**
 Continuous Index: **S04**
 Within 8" of Joint: **NO**
 Remarks:

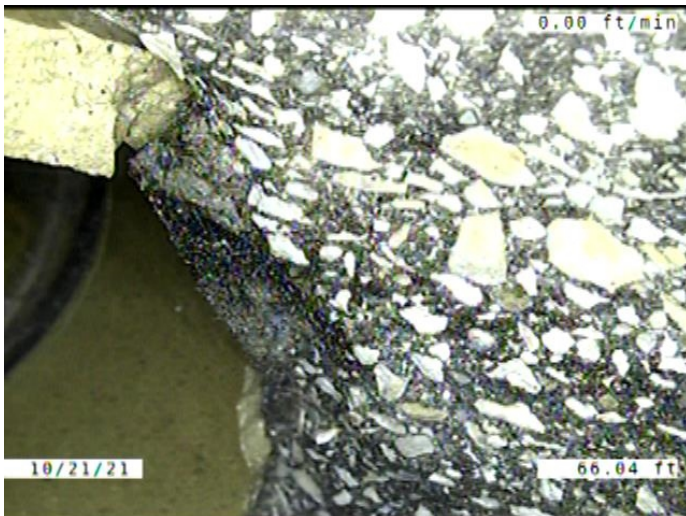
Code: **SSS**
 Description: **Surface Damage Surface Spalling**

Distance (ft): **66.0**
 Structural Grade: **2**
 O&M Grade: **0**
 Clock Start/From: **10**
 Clock To: **1**
 1st Value:
 2nd Value:
 Value Percent:
 Continuous Index:
 Within 8" of Joint: **YES**
 Remarks:

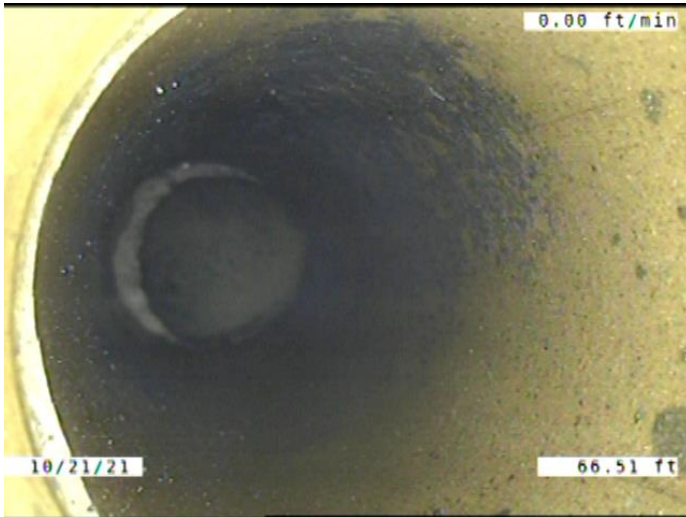
Code: **TBI**
 Description: **Tap Break-in Intruding**

Distance (ft): **66.5**
 Structural Grade: **0**
 O&M Grade: **2**
 Clock Start/From: **11**
 Clock To:
 1st Value: **4.000**
 2nd Value: **1.000**
 Value Percent:
 Continuous Index:
 Within 8" of Joint: **YES**
 Remarks:

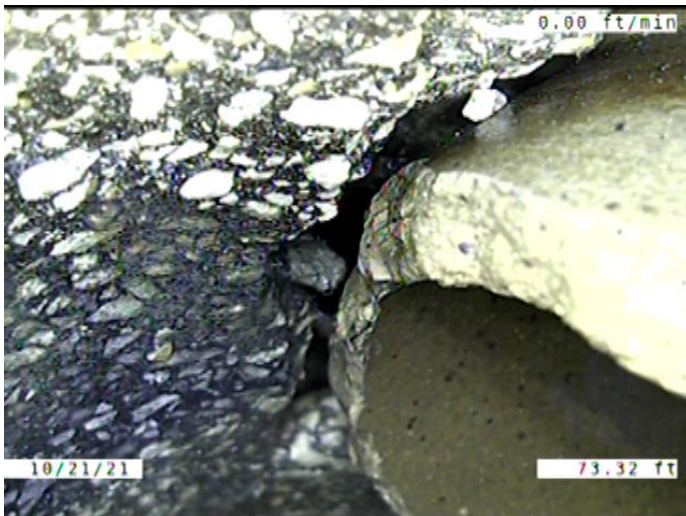
Code: **SSS**
 Description: **Surface Damage Surface Spalling**

Distance (ft): **73.3**
 Structural Grade: **2**
 O&M Grade: **0**
 Clock Start/From: **9**
 Clock To: **5**
 1st Value:
 2nd Value:
 Value Percent:
 Continuous Index:
 Within 8" of Joint: **YES**
 Remarks:

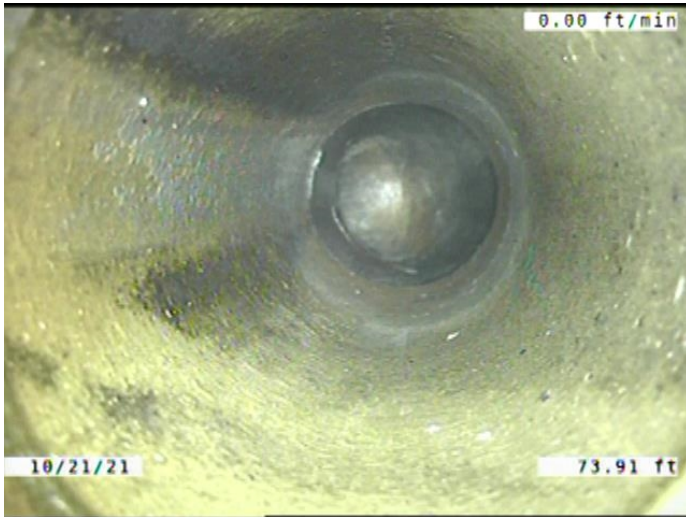
Code: **TBI**
 Description: **Tap Break-in Intruding**

Distance (ft): **73.9**
 Structural Grade: **0**
 O&M Grade: **2**
 Clock Start/From: **11**
 Clock To:
 1st Value: **4.000**
 2nd Value: **3.000**
 Value Percent:
 Continuous Index:
 Within 8" of Joint: **YES**
 Remarks:

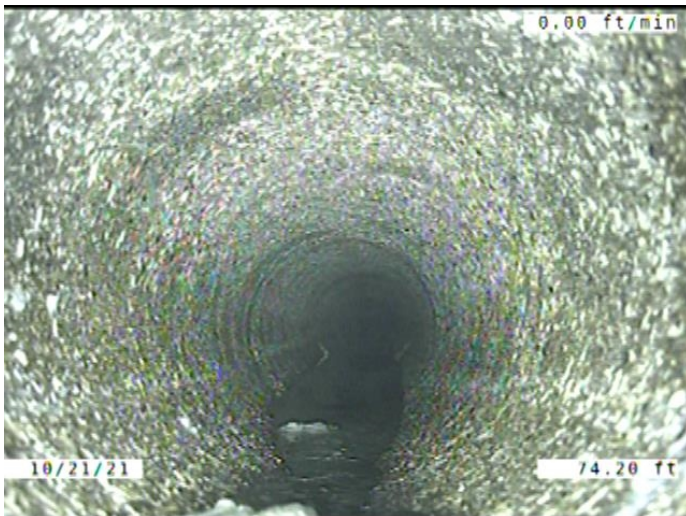
Code: **MWLS**
 Description: **Miscellaneous Water Level Sag**

Distance (ft): **74.2**
 Structural Grade: **2**
 O&M Grade: **0**
 Clock Start/From:
 Clock To:
 1st Value:
 2nd Value:
 Value Percent: **10.000**
 Continuous Index: **F04**
 Within 8" of Joint: **NO**
 Remarks:

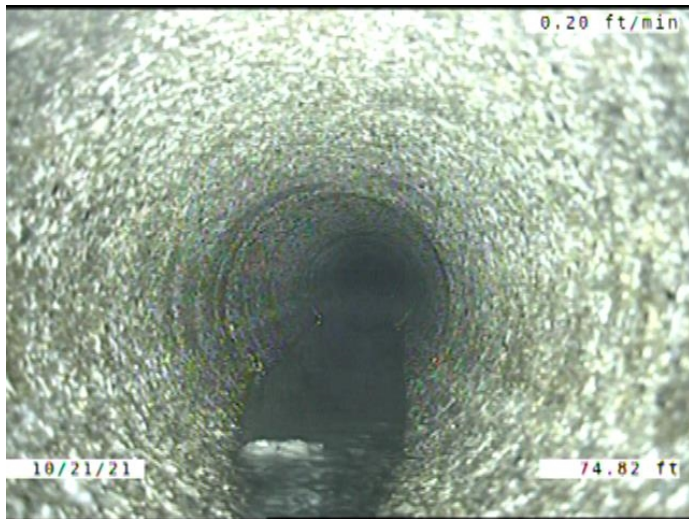
Code: **RFJ**
 Description: **Roots Fine Joint**

Distance (ft): **74.8**
 Structural Grade: **0**
 O&M Grade: **1**
 Clock Start/From: **8**
 Clock To: **2**
 1st Value:
 2nd Value:
 Value Percent:
 Continuous Index: **F01**
 Within 8" of Joint: **YES**
 Remarks:

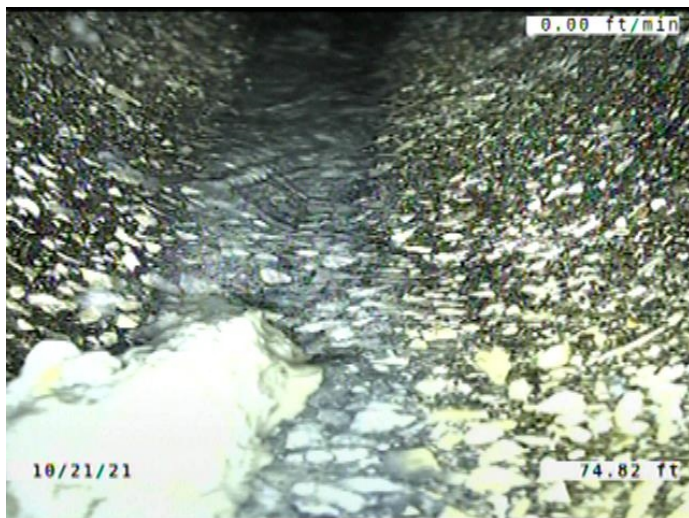
Code: **DSF**
 Description: **Deposits Settled Fine**

Distance (ft): **74.8**
 Structural Grade: **0**
 O&M Grade: **2**
 Clock Start/From: **5**
 Clock To: **7**
 1st Value:
 2nd Value:
 Value Percent: **5.000**
 Continuous Index: **S05**
 Within 8" of Joint: **YES**
 Remarks:

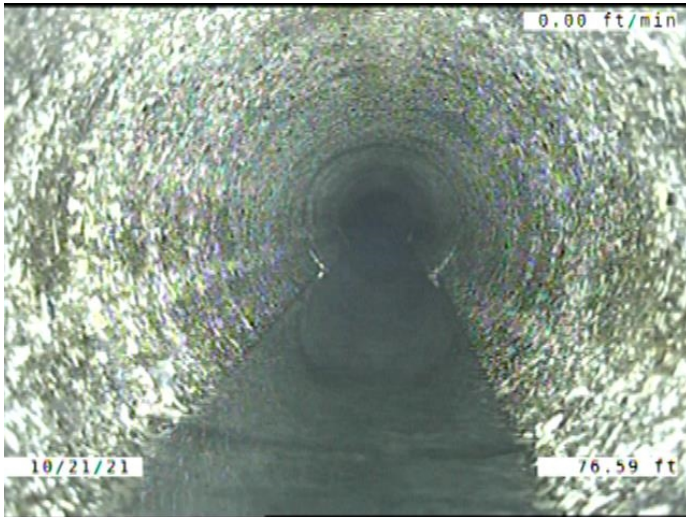
Code: **MWLS**
Description: **Miscellaneous Water Level Sag**

Distance (ft): **76.6**
Structural Grade: **2**
O&M Grade: **0**
Clock Start/From:
Clock To:
1st Value:
2nd Value:
Value Percent: **5.000**
Continuous Index: **S06**
Within 8" of Joint: **NO**
Remarks:

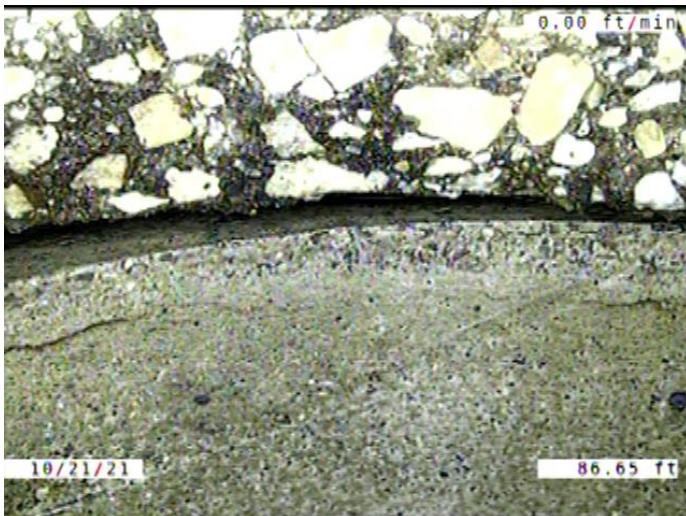
Code: **MMC**
Description: **Miscellaneous Material Change**

Distance (ft): **86.7**
Structural Grade: **0**
O&M Grade: **0**
Clock Start/From:
Clock To:
1st Value:
2nd Value:
Value Percent:
Continuous Index:
Within 8" of Joint: **NO**
Remarks: **CONCRETE TO VCP**

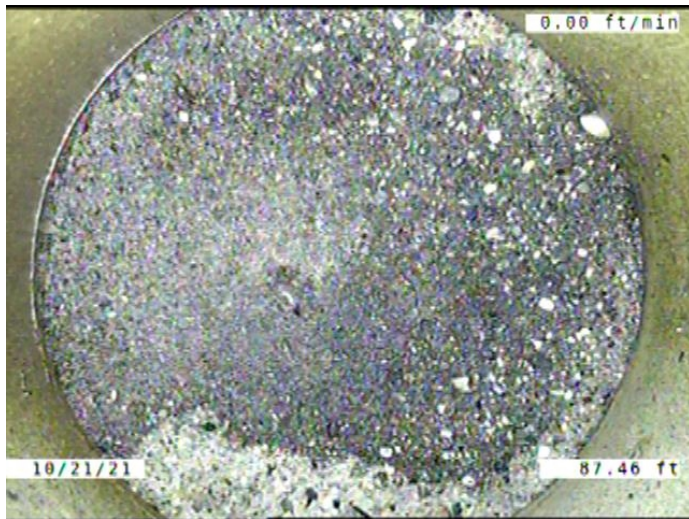
Code: **TFC**
Description: **Tap Factory Capped**

Distance (ft): **87.5**
Structural Grade: **0**
O&M Grade: **0**
Clock Start/From: **10**
Clock To:
1st Value: **4.000**
2nd Value:
Value Percent:
Continuous Index:
Within 8" of Joint: **YES**
Remarks:

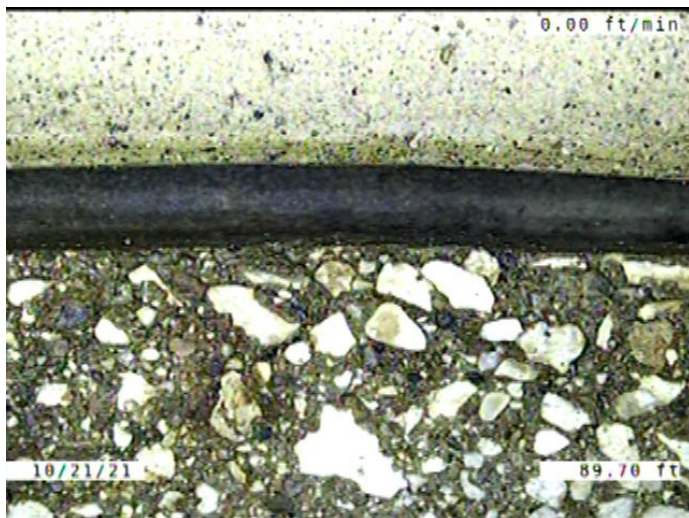
Code: **MMC**
Description: **Miscellaneous Material Change**

Distance (ft): **89.7**
Structural Grade: **0**
O&M Grade: **0**
Clock Start/From:
Clock To:
1st Value:
2nd Value:
Value Percent:
Continuous Index:
Within 8" of Joint: **NO**
Remarks: **VCP TO CONCRETE**

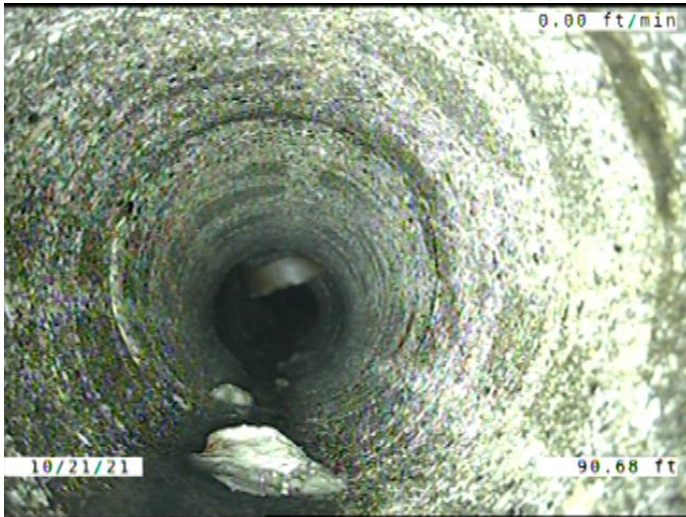
Code: **MWLS**
 Description: **Miscellaneous Water Level Sag**

Distance (ft): **90.7**
 Structural Grade: **2**
 O&M Grade: **0**
 Clock Start/From:
 Clock To:
 1st Value:
 2nd Value:
 Value Percent: **5.000**
 Continuous Index: **F06**
 Within 8" of Joint: **NO**
 Remarks:

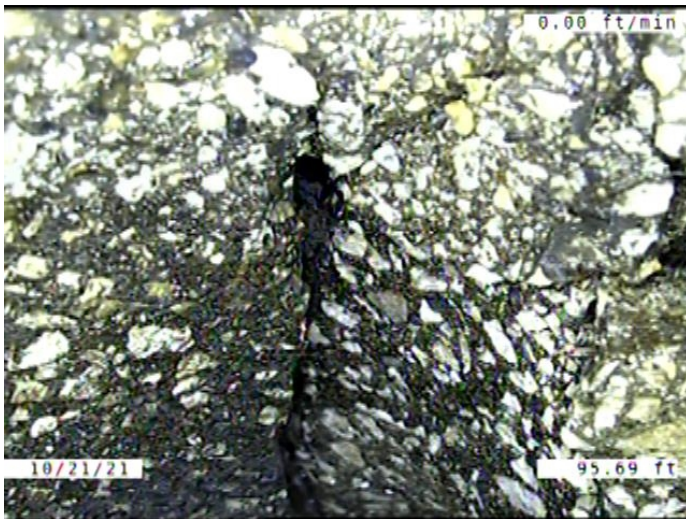
Code: **B**
 Description: **Broken**

Distance (ft): **95.7**
 Structural Grade: **4**
 O&M Grade: **0**
 Clock Start/From: **10**
 Clock To: **2**
 1st Value:
 2nd Value:
 Value Percent:
 Continuous Index:
 Within 8" of Joint: **YES**
 Remarks:

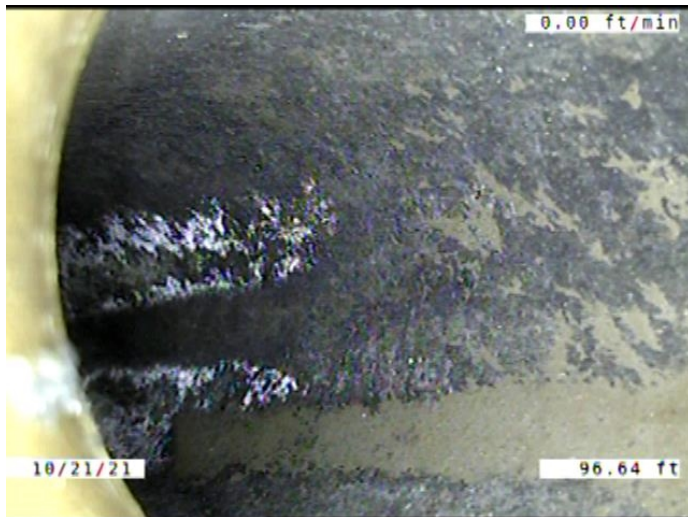
Code: **TBI**
 Description: **Tap Break-in Intruding**

Distance (ft): **96.6**
 Structural Grade: **0**
 O&M Grade: **2**
 Clock Start/From: **11**
 Clock To:
 1st Value: **4.000**
 2nd Value: **3.000**
 Value Percent:
 Continuous Index:
 Within 8" of Joint: **YES**
 Remarks:

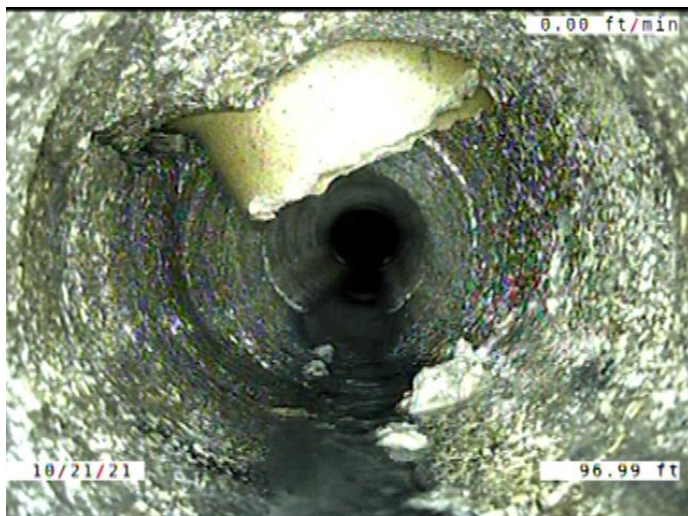
Code: **DSF**
 Description: **Deposits Settled Fine**

Distance (ft): **97.0**
 Structural Grade: **0**
 O&M Grade: **2**
 Clock Start/From: **5**
 Clock To: **7**
 1st Value:
 2nd Value:
 Value Percent: **5.000**
 Continuous Index: **F05**
 Within 8" of Joint: **YES**
 Remarks:

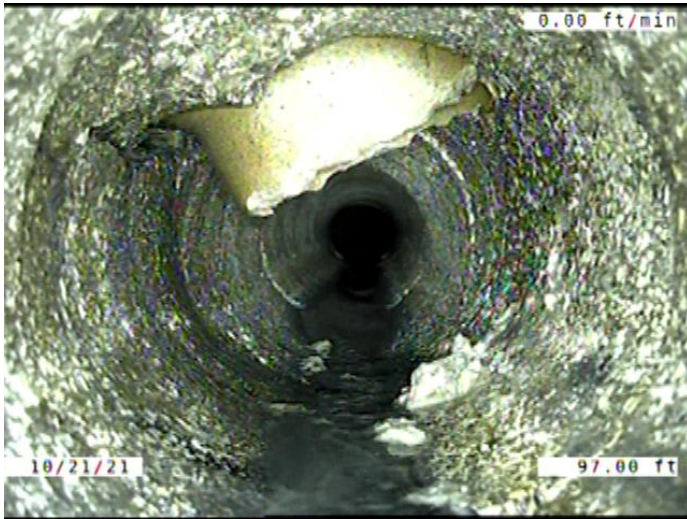
Code:	MSA
Description:	Miscellaneous Survey Abandoned
Distance (ft):	97.0
Structural Grade:	0
O&M Grade:	0
Clock Start/From:	
Clock To:	
1st Value:	
2nd Value:	
Value Percent:	
Continuous Index:	
Within 8" of Joint:	NO
Remarks:	CAMERA CANT MAKE IT PAST PROTUDING TAP
