# Profile/Photo Observation Report

Date:	<b>10/21/2021</b>	Weather:		Coding:	<b>PACP 7.0</b>
Pipe Length (ft):	<b>241.0</b>	Owner:	<b>City of Hobart</b>	Pre Clean:	<b>Light Cleaning</b>
P.O.#:	<b>YES502259</b>	Surveyor:	<b>S. Bucklin</b>	PSR:	<b>P-504-107-106</b>
Customer:	<b>City of Hobart</b>	Clean Date:	<b>08/30/2021</b>	Shape:	<b>C</b>

Street:	<b>42nd Avenue</b>	Flow Control:	<b>Not Controlled</b>
City:	<b>Hobart, IN</b>	Year Renewed:	
Location:	<b>Alley</b>	Tape/Media #:	
Purpose:	<b>Routine Assessment</b>	Dia/Height:	<b>8"</b>
Use:	<b>Sanitary Sewage Pipe</b>	Material:	<b>CP</b>
Drain Area:		Lining:	
Category:	<b>NA</b>		
Comment:			
Location Details:		Direction of Survey:	<b>Downstream</b>
US MH:	<b>M-504-106</b>	DS MH:	<b>M-504-107</b>
		Total Length Surveyed (ft):	<b>97.0</b>

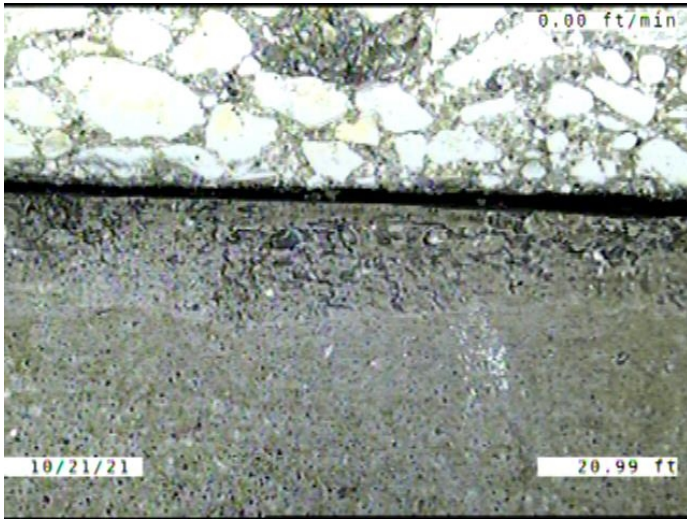
Code: **MMC**  
Description: **Miscellaneous Material Change**

Distance (ft): **21.0**  
Structural Grade: **0**  
O&M Grade: **0**  
Clock Start/From:  
Clock To:  
1st Value:  
2nd Value:  
Value Percent:  
Continuous Index:  
Within 8" of Joint: **NO**  
Remarks: **CONCRETE TO VCP**

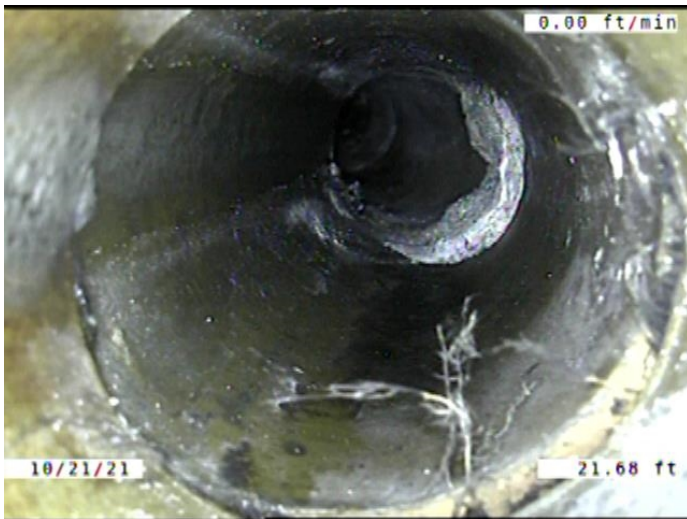
Code: **TF**  
Description: **Tap Factory**

Distance (ft): **21.7**  
Structural Grade: **0**  
O&M Grade: **0**  
Clock Start/From: **10**  
Clock To:  
1st Value: **4.000**  
2nd Value:  
Value Percent:  
Continuous Index:  
Within 8" of Joint: **YES**  
Remarks: **CONSTANTLY RUNNING WATER**

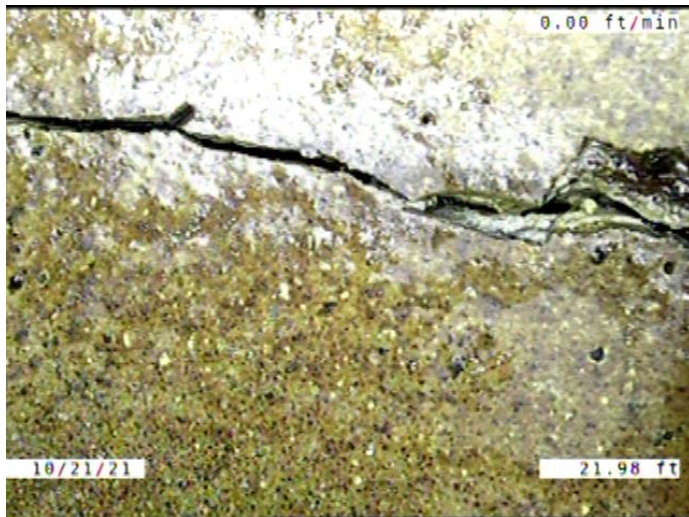
Code: **FC**  
 Description: **Fracture Circumferential**

Distance (ft): **22.0**  
 Structural Grade: **2**  
 O&M Grade: **0**  
 Clock Start/From: **8**  
 Clock To: **4**  
 1st Value:  
 2nd Value:  
 Value Percent:  
 Continuous Index:  
 Within 8" of Joint: **YES**  
 Remarks:

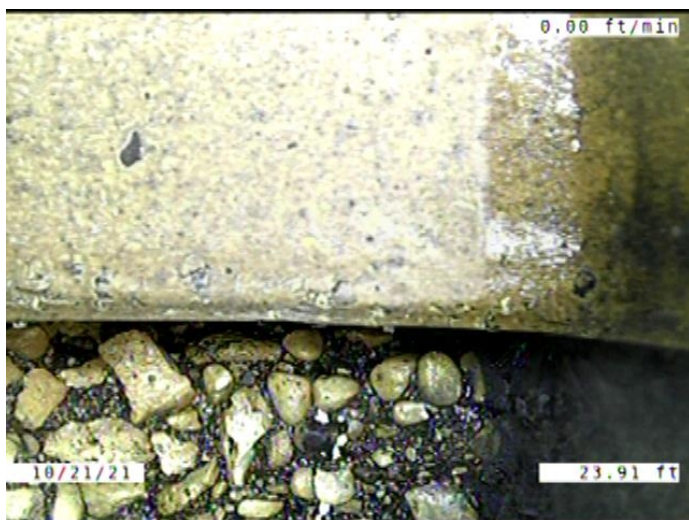
Code: **MMC**  
 Description: **Miscellaneous Material Change**

Distance (ft): **23.9**  
 Structural Grade: **0**  
 O&M Grade: **0**  
 Clock Start/From:  
 Clock To:  
 1st Value:  
 2nd Value:  
 Value Percent:  
 Continuous Index:  
 Within 8" of Joint: **NO**  
 Remarks: **VCP TO CONCRETE**

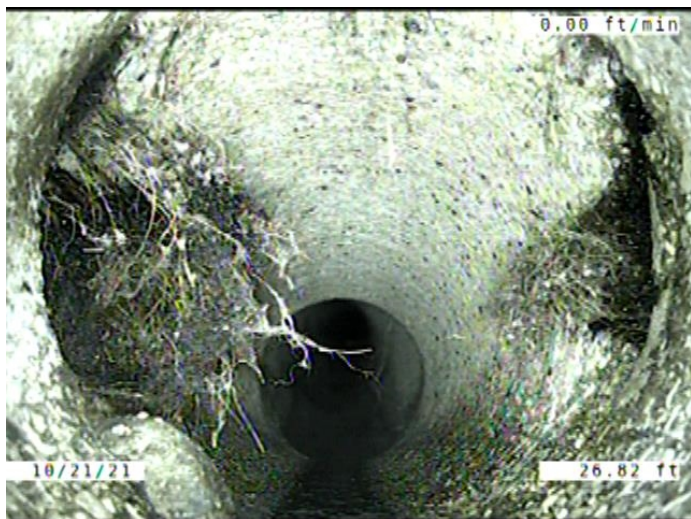
Code: **RMJ**  
 Description: **Roots Medium Joint**

Distance (ft): **26.8**  
 Structural Grade: **0**  
 O&M Grade: **3**  
 Clock Start/From: **8**  
 Clock To: **3**  
 1st Value:  
 2nd Value:  
 Value Percent: **15.000**  
 Continuous Index:  
 Within 8" of Joint: **YES**  
 Remarks:

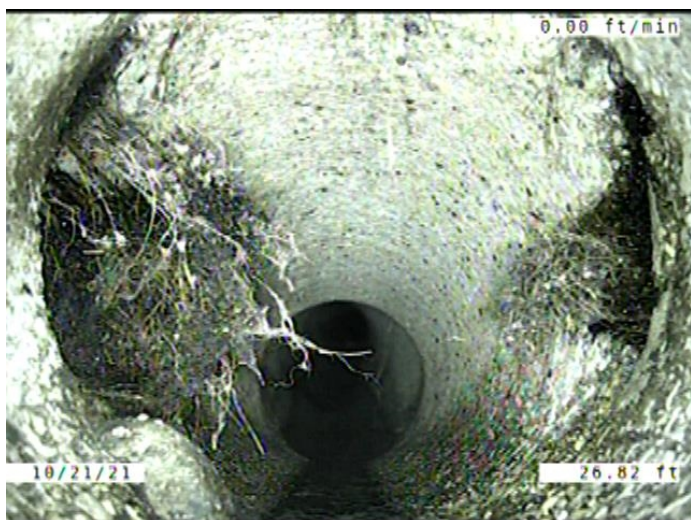
Code: **LD**  
 Description: **Line Down**

Distance (ft): **26.8**  
 Structural Grade: **0**  
 O&M Grade: **2**  
 Clock Start/From:  
 Clock To:  
 1st Value:  
 2nd Value:  
 Value Percent: **15.000**  
 Continuous Index:  
 Within 8" of Joint: **NO**  
 Remarks:

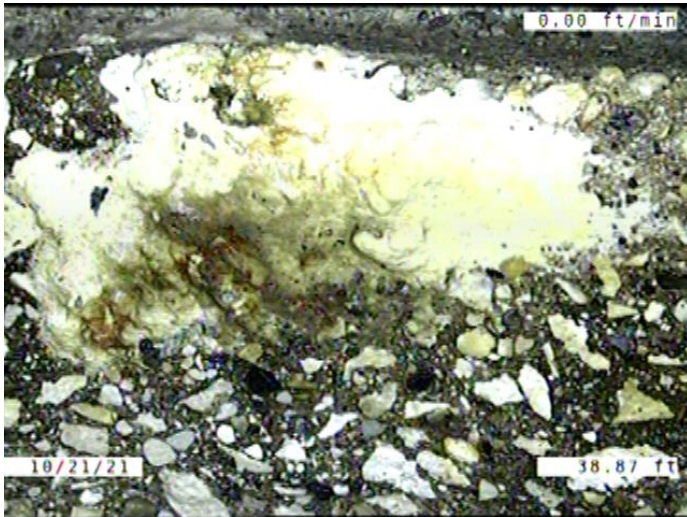
Code: **DAE**  
 Description: **Deposits Attached Encrustation**

Distance (ft): **38.9**  
 Structural Grade: **0**  
 O&M Grade: **2**  
 Clock Start/From: **1**  
 Clock To: **2**  
 1st Value:  
 2nd Value:  
 Value Percent: **5.000**  
 Continuous Index:  
 Within 8" of Joint: **YES**  
 Remarks:

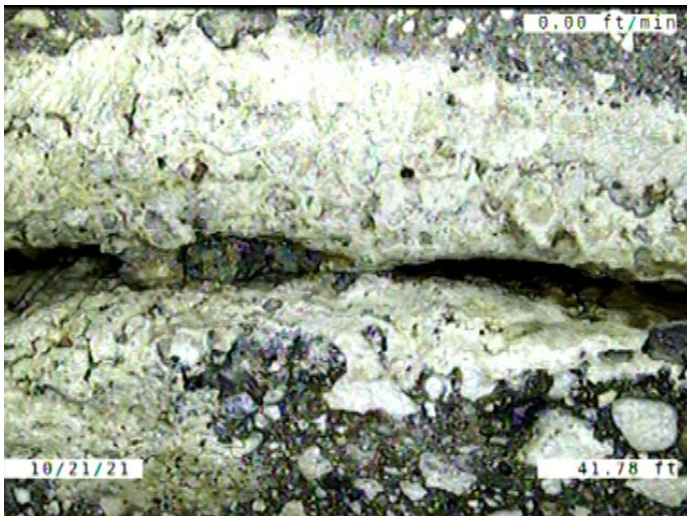
Code: **DAE**  
 Description: **Deposits Attached Encrustation**

Distance (ft): **41.8**  
 Structural Grade: **0**  
 O&M Grade: **2**  
 Clock Start/From: **2**  
 Clock To: **5**  
 1st Value:  
 2nd Value:  
 Value Percent: **5.000**  
 Continuous Index:  
 Within 8" of Joint: **YES**  
 Remarks:

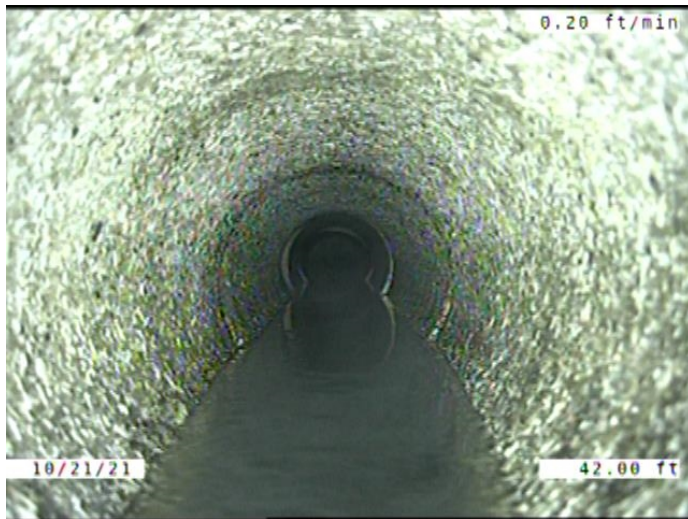
Code: **MWLS**  
 Description: **Miscellaneous Water Level Sag**

Distance (ft): **42.0**  
 Structural Grade: **2**  
 O&M Grade: **0**  
 Clock Start/From:  
 Clock To:  
 1st Value:  
 2nd Value:  
 Value Percent: **5.000**  
 Continuous Index: **S03**  
 Within 8" of Joint: **NO**  
 Remarks:

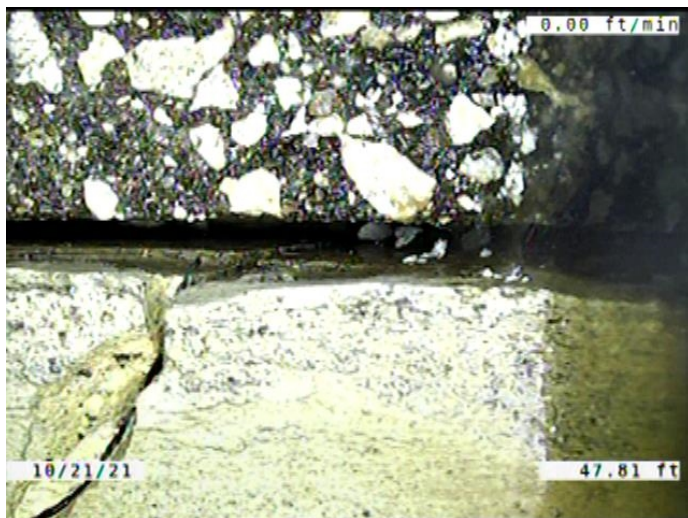
Code: **MMC**  
 Description: **Miscellaneous Material Change**

Distance (ft): **47.8**  
 Structural Grade: **0**  
 O&M Grade: **0**  
 Clock Start/From:  
 Clock To:  
 1st Value:  
 2nd Value:  
 Value Percent:  
 Continuous Index:  
 Within 8" of Joint: **NO**  
 Remarks: **CONCRETE TO VCP**

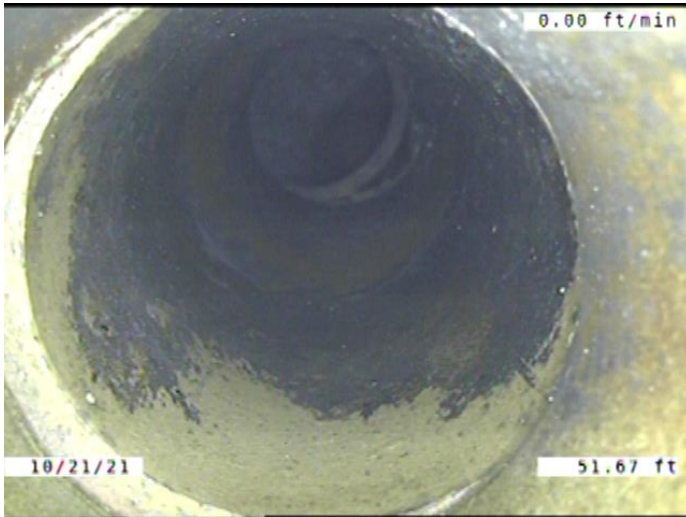
Code: **TF**  
 Description: **Tap Factory**

Distance (ft): **51.7**  
 Structural Grade: **0**  
 O&M Grade: **0**  
 Clock Start/From: **1**  
 Clock To:  
 1st Value: **4.000**  
 2nd Value:  
 Value Percent:  
 Continuous Index:  
 Within 8" of Joint: **YES**  
 Remarks:

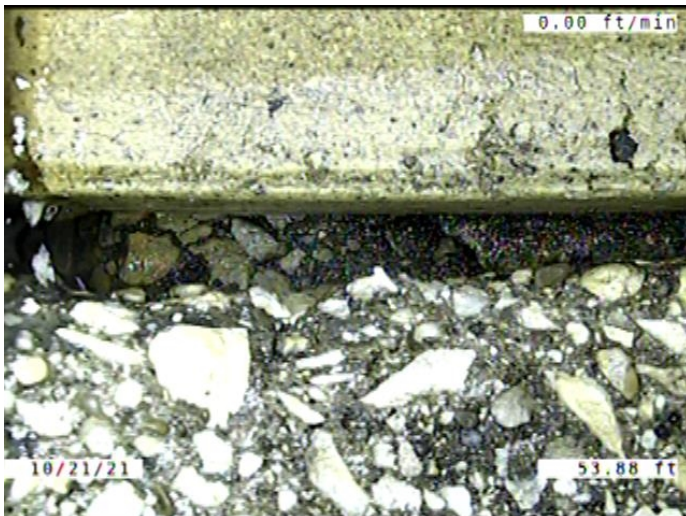
Code: **MMC**  
 Description: **Miscellaneous Material Change**

Distance (ft): **53.9**  
 Structural Grade: **0**  
 O&M Grade: **0**  
 Clock Start/From:  
 Clock To:  
 1st Value:  
 2nd Value:  
 Value Percent:  
 Continuous Index:  
 Within 8" of Joint: **NO**  
 Remarks: **VCP TO CONCRETE**

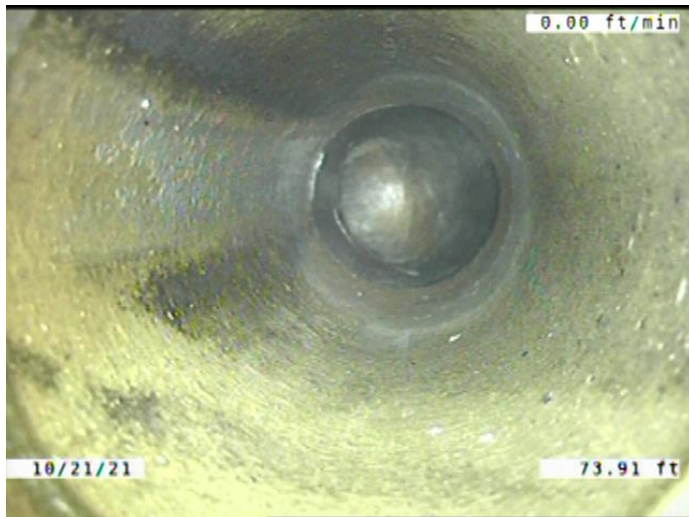
Code: **TBI**  
 Description: **Tap Break-in Intruding**

Distance (ft): **73.9**  
 Structural Grade: **0**  
 O&M Grade: **2**  
 Clock Start/From: **11**  
 Clock To:  
 1st Value: **4.000**  
 2nd Value: **3.000**  
 Value Percent:  
 Continuous Index:  
 Within 8" of Joint: **YES**  
 Remarks:

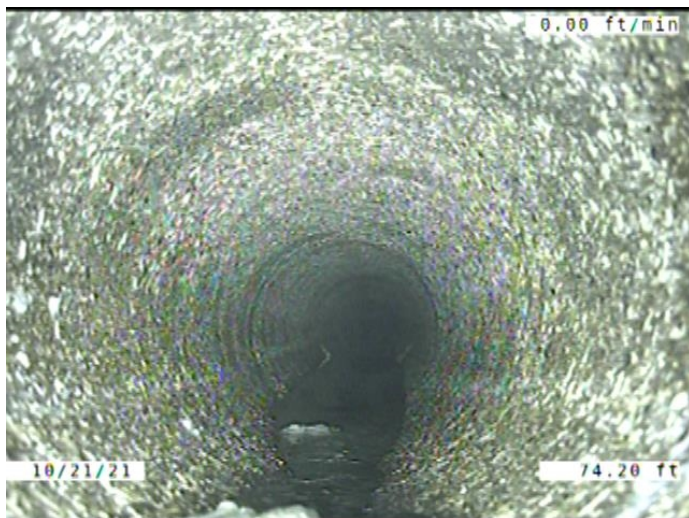
Code: **MWLS**  
 Description: **Miscellaneous Water Level Sag**

Distance (ft): **74.2**  
 Structural Grade: **2**  
 O&M Grade: **0**  
 Clock Start/From:  
 Clock To:  
 1st Value:  
 2nd Value:  
 Value Percent: **10.000**  
 Continuous Index: **F04**  
 Within 8" of Joint: **NO**  
 Remarks:

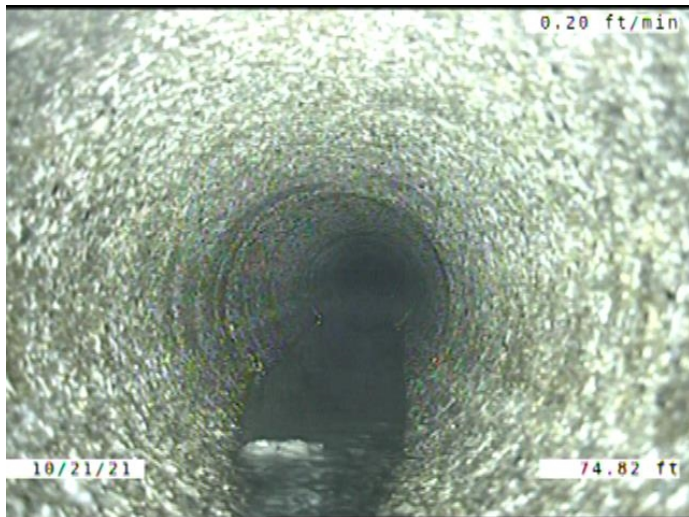
Code: **RFJ**  
 Description: **Roots Fine Joint**

Distance (ft): **74.8**  
 Structural Grade: **0**  
 O&M Grade: **1**  
 Clock Start/From: **8**  
 Clock To: **2**  
 1st Value:  
 2nd Value:  
 Value Percent:  
 Continuous Index: **F01**  
 Within 8" of Joint: **YES**  
 Remarks:

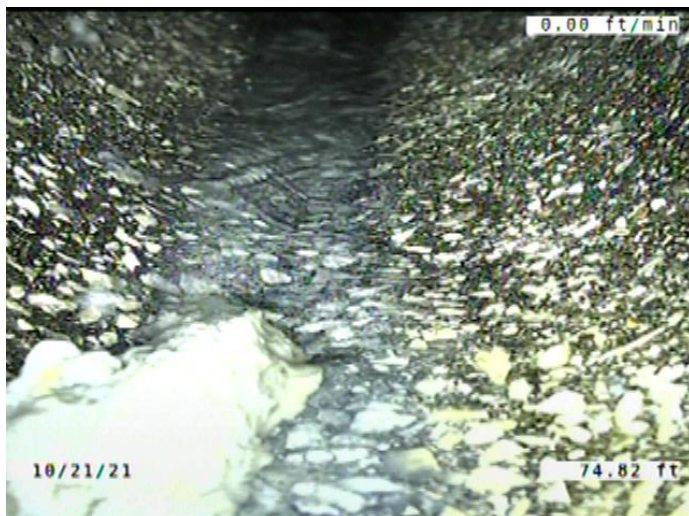
Code: **DSF**  
 Description: **Deposits Settled Fine**

Distance (ft): **74.8**  
 Structural Grade: **0**  
 O&M Grade: **2**  
 Clock Start/From: **5**  
 Clock To: **7**  
 1st Value:  
 2nd Value:  
 Value Percent: **5.000**  
 Continuous Index: **S05**  
 Within 8" of Joint: **YES**  
 Remarks:

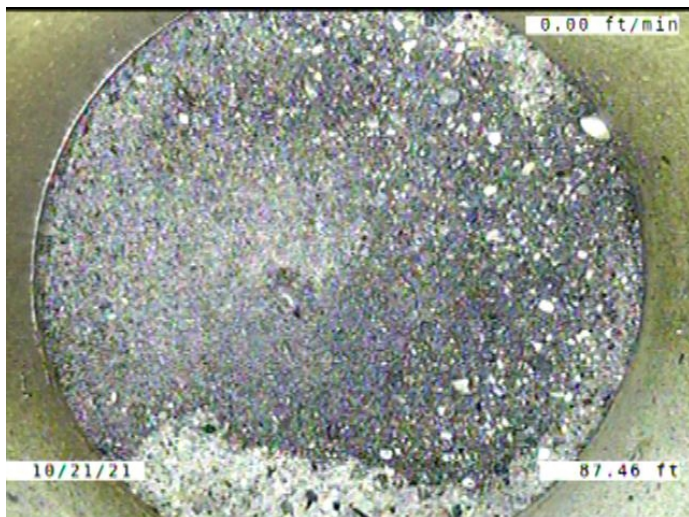
Code: **TFC**  
 Description: **Tap Factory Capped**

Distance (ft): **87.5**  
 Structural Grade: **0**  
 O&M Grade: **0**  
 Clock Start/From: **10**  
 Clock To:  
 1st Value: **4.000**  
 2nd Value:  
 Value Percent:  
 Continuous Index:  
 Within 8" of Joint: **YES**  
 Remarks:

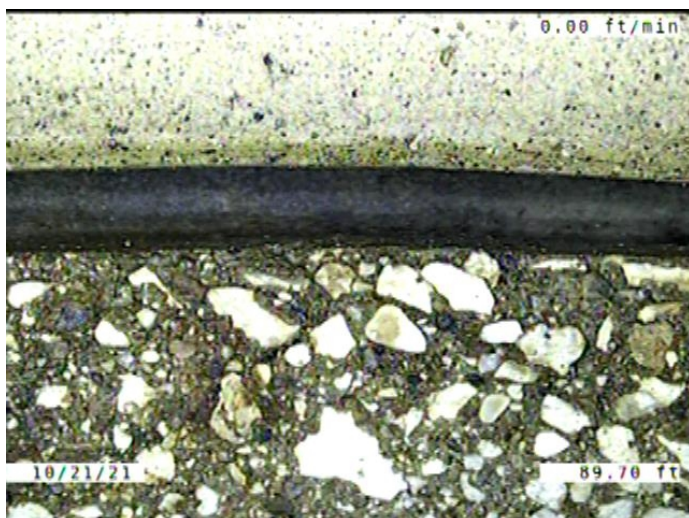
Code: **MMC**  
 Description: **Miscellaneous Material Change**

Distance (ft): **89.7**  
 Structural Grade: **0**  
 O&M Grade: **0**  
 Clock Start/From:  
 Clock To:  
 1st Value:  
 2nd Value:  
 Value Percent:  
 Continuous Index:  
 Within 8" of Joint: **NO**  
 Remarks: **VCP TO CONCRETE**

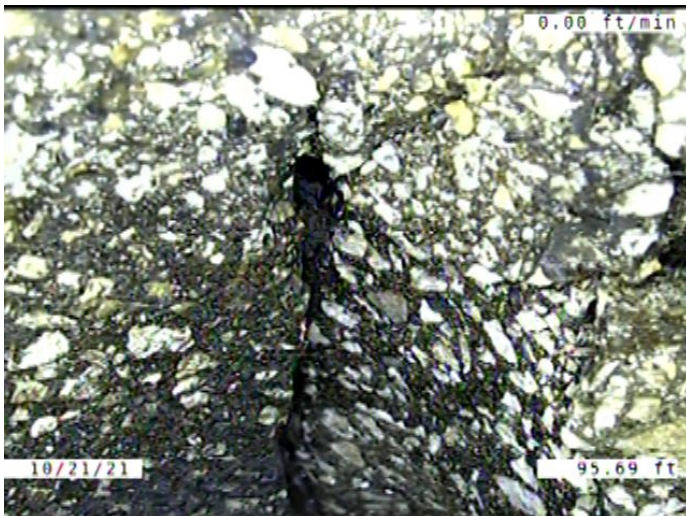
Code: **B**  
 Description: **Broken**

Distance (ft): **95.7**  
 Structural Grade: **4**  
 O&M Grade: **0**  
 Clock Start/From: **10**  
 Clock To: **2**  
 1st Value:  
 2nd Value:  
 Value Percent:  
 Continuous Index:  
 Within 8" of Joint: **YES**  
 Remarks:

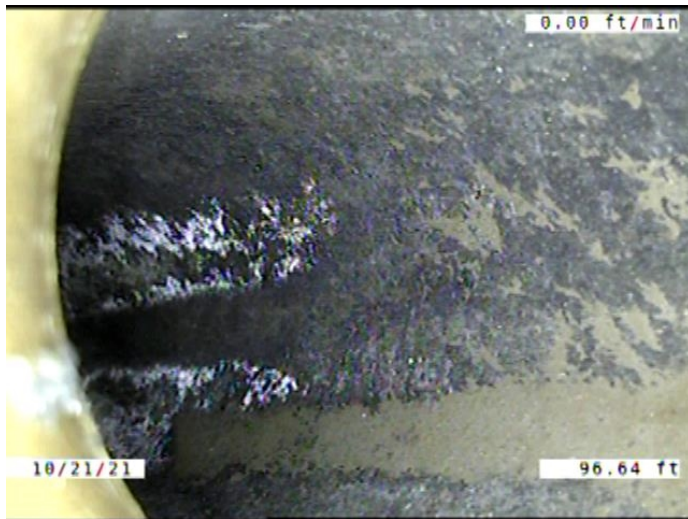
Code: **TBI**  
 Description: **Tap Break-in Intruding**

Distance (ft): **96.6**  
 Structural Grade: **0**  
 O&M Grade: **2**  
 Clock Start/From: **11**  
 Clock To:  
 1st Value: **4.000**  
 2nd Value: **3.000**  
 Value Percent:  
 Continuous Index:  
 Within 8" of Joint: **YES**  
 Remarks:

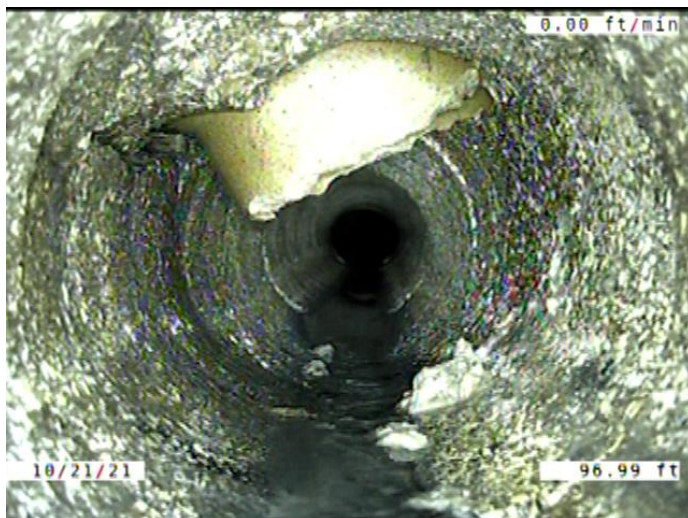
Code: **DSF**  
 Description: **Deposits Settled Fine**

Distance (ft): **97.0**  
 Structural Grade: **0**  
 O&M Grade: **2**  
 Clock Start/From: **5**  
 Clock To: **7**  
 1st Value:  
 2nd Value:  
 Value Percent: **5.000**  
 Continuous Index: **F05**  
 Within 8" of Joint: **YES**  
 Remarks:

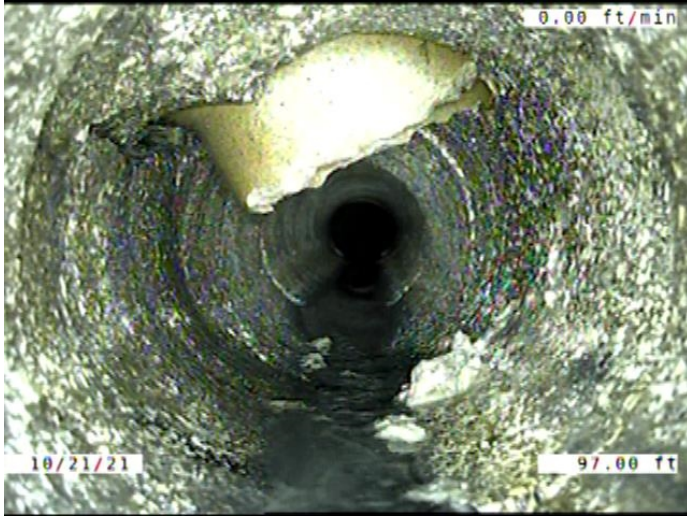
Code:	<b>MSA</b>
Description:	<b>Miscellaneous Survey Abandoned</b>
Distance (ft):	<b>97.0</b>
Structural Grade:	<b>0</b>
O&M Grade:	<b>0</b>
Clock Start/From:	
Clock To:	
1st Value:	
2nd Value:	
Value Percent:	
Continuous Index:	
Within 8" of Joint:	<b>NO</b>
Remarks:	<b>CAMERA CANT MAKE IT PAST PROTUDING TAP</b>
