Profile/Photo Observation Report

Date:	10/22/2021	Weather:		Coding:	PACP 7.0
Pipe Length (ft):	241.0	Owner:	City of Hobart	Pre Clean:	Light Cleaning
P.O.#:	YES502259	Surveyor:	S. Bucklin	PSR:	P-504-107-106
Customer:	City of Hobart	Clean Date:	08/30/2021	Shape:	C

Street:	42nd Avenue	Flow Control:	Not Controlled
City:	Hobart, IN	Year Renewed:	
Location:	Alley	Tape/Media #:	
Purpose:	Routine Assessment	Dia/Height:	8"
Use:	Sanitary Sewage Pipe	Material:	CP
Drain Area:		Lining:	
Category:	NA		
Comment:			
Location Details:		Direction of Survey:	Upstream
US MH:	M-504-106	DS MH:	M-504-107
		Total Length Surveyed (ft):	105.6

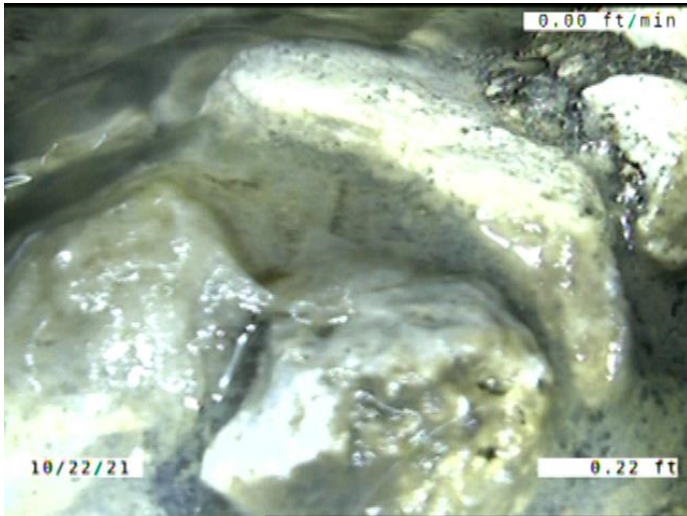
Code:	DSC
Description:	Deposits Settled Hard/Compacted
Distance (ft):	.2
Structural Grade:	0
O&M Grade:	2
Clock Start/From:	4
Clock To:	7
1st Value:	
2nd Value:	
Value Percent:	5.000
Continuous Index:	
Within 8" of Joint:	YES
Remarks:

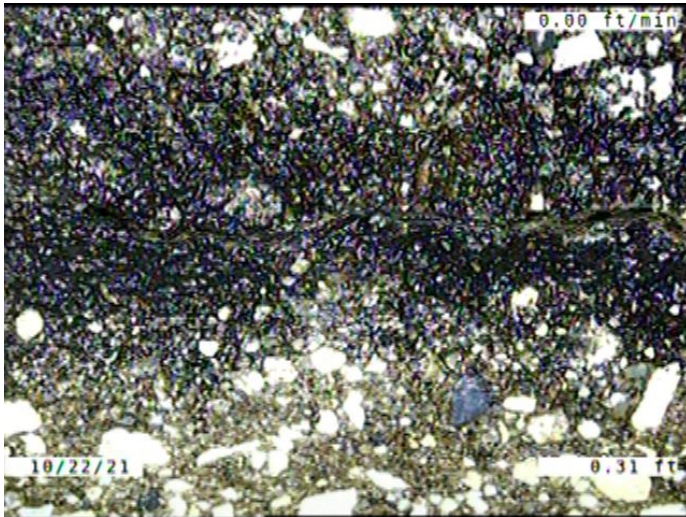
Code: **ISB**
 Description: **Infiltration Stain Barrel**

Distance (ft): **.3**
 Structural Grade: **0**
 O&M Grade: **1**
 Clock Start/From: **8**
 Clock To: **4**
 1st Value:
 2nd Value:
 Value Percent:
 Continuous Index:
 Within 8" of Joint: **YES**
 Remarks:

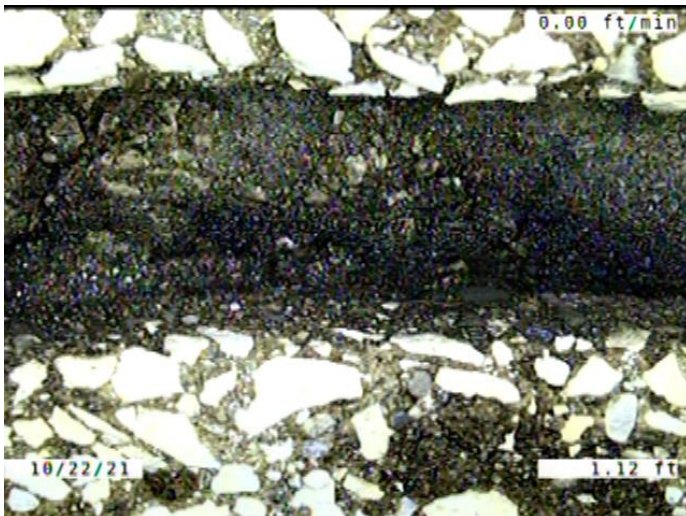
Code: **JAM**
 Description: **Joint Angular Medium**

Distance (ft): **1.1**
 Structural Grade: **3**
 O&M Grade: **0**
 Clock Start/From:
 Clock To:
 1st Value:
 2nd Value:
 Value Percent:
 Continuous Index:
 Within 8" of Joint: **NO**
 Remarks:

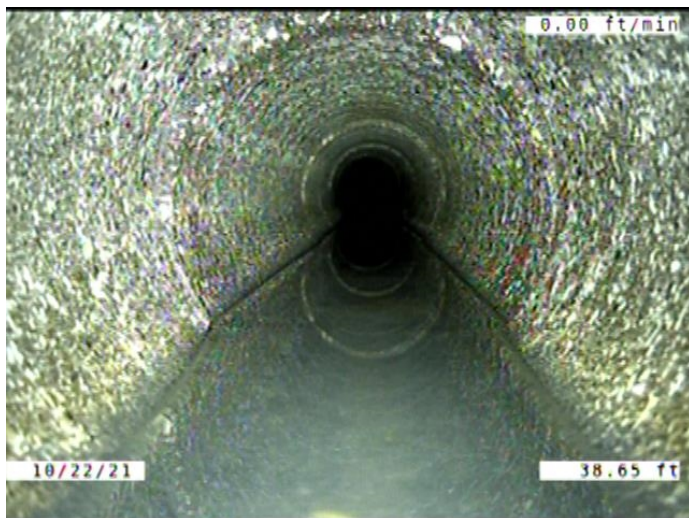
Code: **MWLS**
 Description: **Miscellaneous Water Level Sag**

Distance (ft): **38.6**
 Structural Grade: **2**
 O&M Grade: **0**
 Clock Start/From:
 Clock To:
 1st Value:
 2nd Value:
 Value Percent: **5.000**
 Continuous Index: **S02**
 Within 8" of Joint: **NO**
 Remarks:

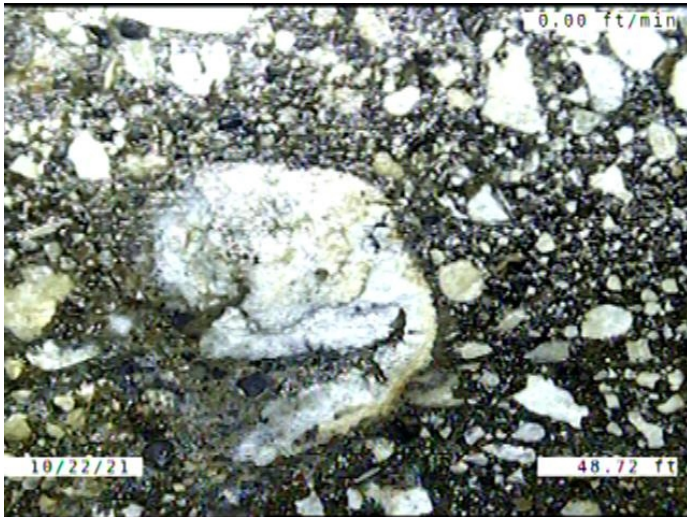
Code:	DAE
Description:	Deposits Attached Encrustation
Distance (ft):	48.7
Structural Grade:	0
O&M Grade:	2
Clock Start/From:	7
Clock To:	12
1st Value:	
2nd Value:	
Value Percent:	5.000
Continuous Index:	
Within 8" of Joint:	YES
Remarks:

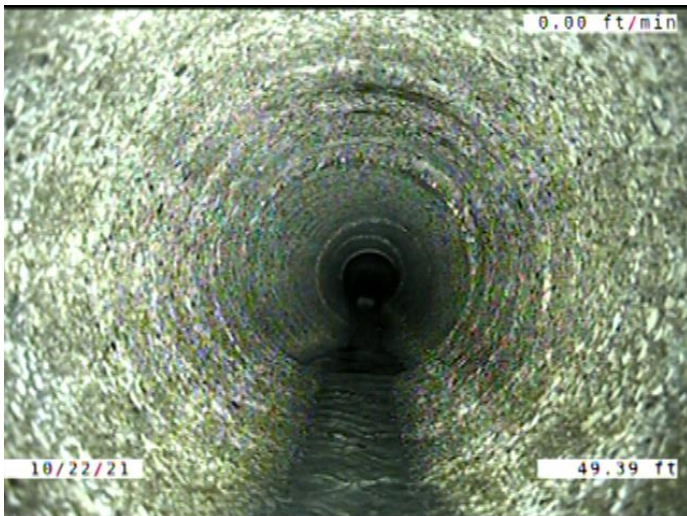
Code:	MWLS
Description:	Miscellaneous Water Level Sag
Distance (ft):	49.4
Structural Grade:	2
O&M Grade:	0
Clock Start/From:	
Clock To:	
1st Value:	
2nd Value:	
Value Percent:	5.000
Continuous Index:	F02
Within 8" of Joint:	NO
Remarks:

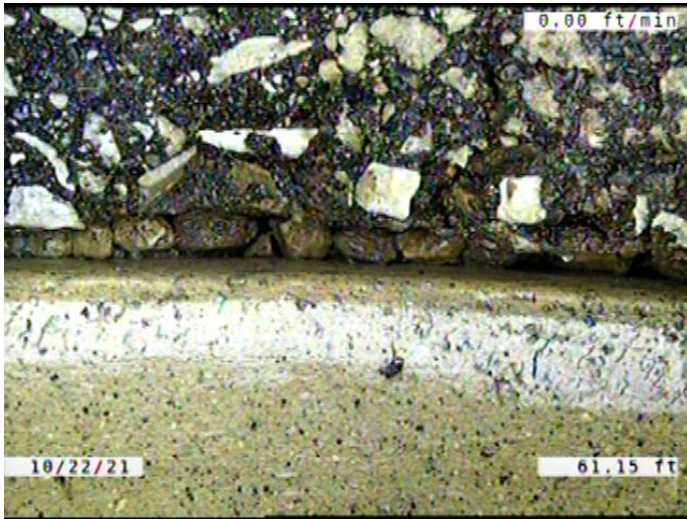
Code: **CM**
 Description: **Crack Multiple**

Distance (ft): **61.1**
 Structural Grade: **3**
 O&M Grade: **0**
 Clock Start/From: **12**
 Clock To: **12**
 1st Value:
 2nd Value:
 Value Percent:
 Continuous Index:
 Within 8" of Joint: **NO**
 Remarks:

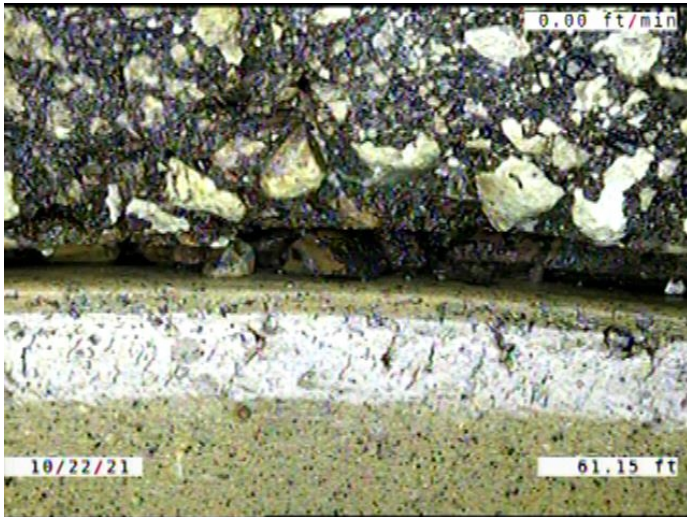
Code: **ISJ**
 Description: **Infiltration Stain Joint**

Distance (ft): **61.2**
 Structural Grade: **0**
 O&M Grade: **1**
 Clock Start/From: **7**
 Clock To: **5**
 1st Value:
 2nd Value:
 Value Percent:
 Continuous Index:
 Within 8" of Joint: **YES**
 Remarks:

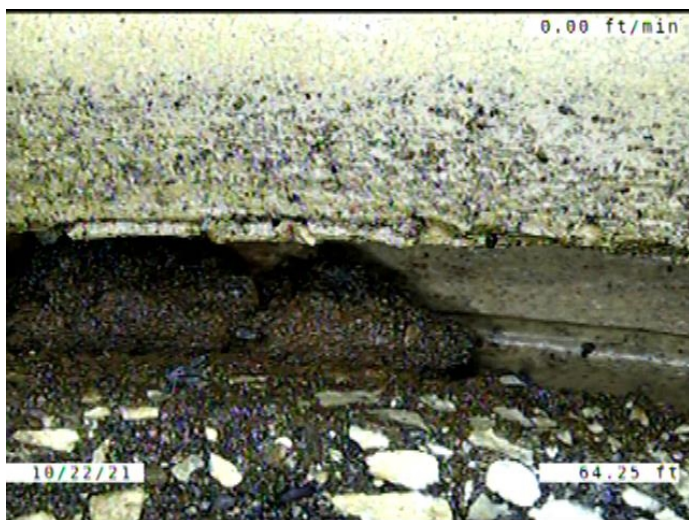
Code: **ISJ**
 Description: **Infiltration Stain Joint**

Distance (ft): **64.3**
 Structural Grade: **0**
 O&M Grade: **1**
 Clock Start/From: **1**
 Clock To: **5**
 1st Value:
 2nd Value:
 Value Percent:
 Continuous Index:
 Within 8" of Joint: **YES**
 Remarks:

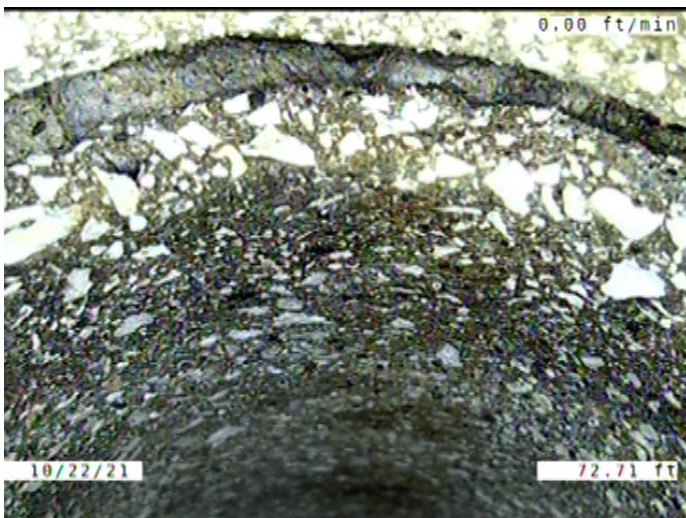
Code: **JOM**
Description: **Joint Offset Medium**

Distance (ft): **72.7**
Structural Grade: **3**
O&M Grade: **0**
Clock Start/From:
Clock To:
1st Value:
2nd Value:
Value Percent:
Continuous Index:
Within 8" of Joint: **NO**
Remarks:

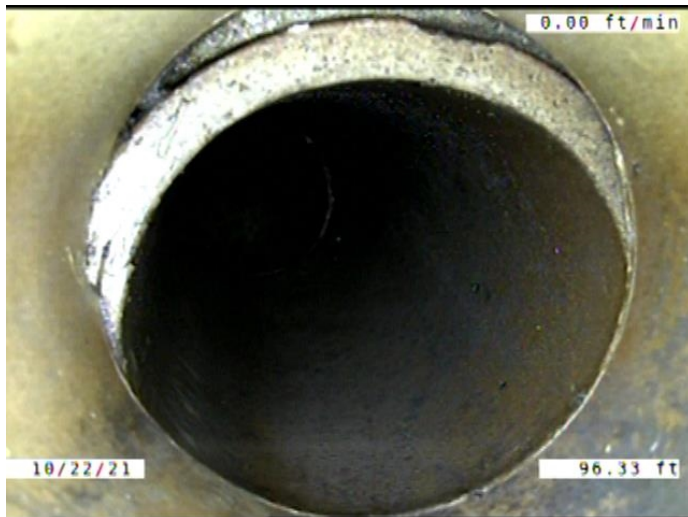
Code:	TFD
Description:	Tap Factory Defective
Distance (ft):	96.3
Structural Grade:	0
O&M Grade:	3
Clock Start/From:	11
Clock To:	
1st Value:	4.000
2nd Value:	
Value Percent:	
Continuous Index:	
Within 8" of Joint:	YES
Remarks:	LARGE OFFSET AT THE FIRST JOINT BACK. CONSTANTLY RUNNING WAT

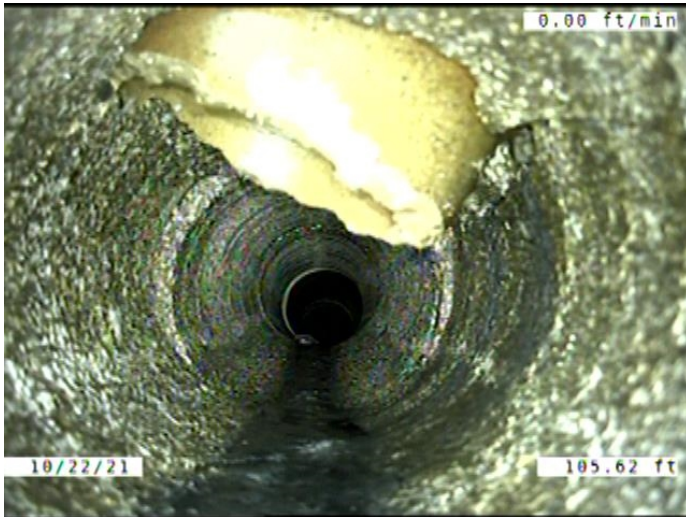
Code: **DSF**
 Description: **Deposits Settled Fine**

Distance (ft): **105.6**
 Structural Grade: **0**
 O&M Grade: **2**
 Clock Start/From: **5**
 Clock To: **7**
 1st Value:
 2nd Value:
 Value Percent: **5.000**
 Continuous Index: **F01**
 Within 8" of Joint: **YES**
 Remarks:
