Profile/Photo Observation Report

Date:	10/22/2021	Weather:		Coding:	PACP 7.0
Pipe Length (ft):	241.0	Owner:	City of Hobart	Pre Clean:	Light Cleaning
P.O.#:	YES502259	Surveyor:	S. Bucklin	PSR:	P-504-107-106
Customer:	City of Hobart	Clean Date:	08/30/2021	Shape:	C

Street:	42nd Avenue	Flow Control:	Not Controlled
City:	Hobart, IN	Year Renewed:	
Location:	Alley	Tape/Media #:	
Purpose:	Routine Assessment	Dia/Height:	8"
Use:	Sanitary Sewage Pipe	Material:	CP
Drain Area:		Lining:	
Category:	NA		
Comment:			
Location Details:		Direction of Survey:	Upstream
US MH:	M-504-106	DS MH:	M-504-107
		Total Length Surveyed (ft):	105.6

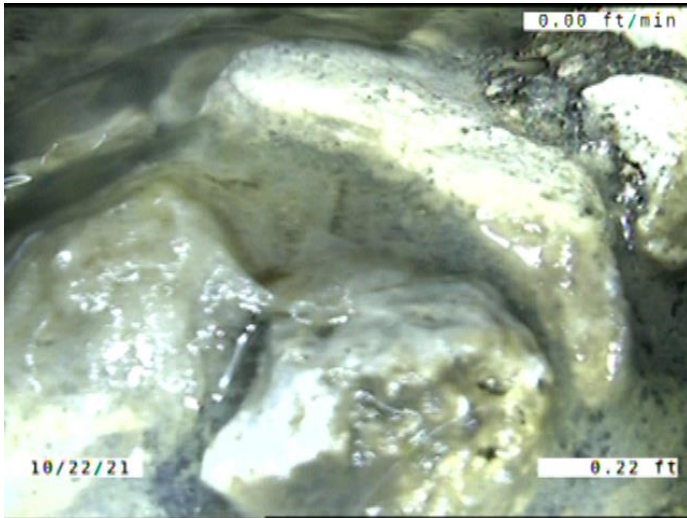
Code:	DSC
Description:	Deposits Settled Hard/Compacted
Distance (ft):	.2
Structural Grade:	0
O&M Grade:	2
Clock Start/From:	4
Clock To:	7
1st Value:	
2nd Value:	
Value Percent:	5.000
Continuous Index:	
Within 8" of Joint:	YES
Remarks:

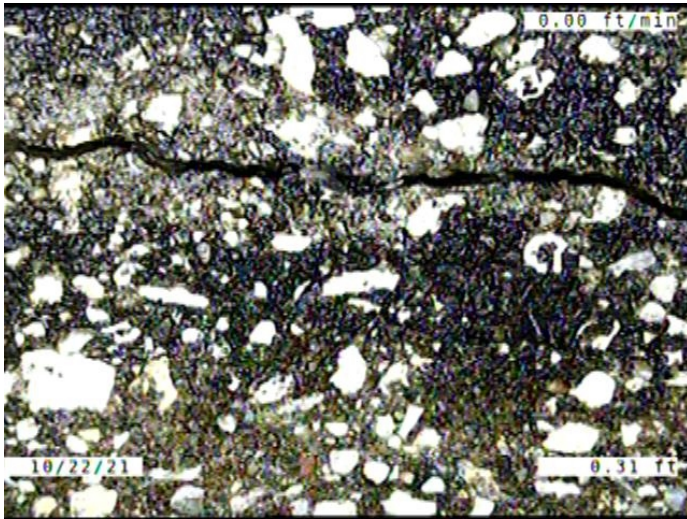
Code: **FC**
Description: **Fracture Circumferential**

Distance (ft): **.3**
Structural Grade: **2**
O&M Grade: **0**
Clock Start/From: **12**
Clock To: **12**
1st Value:
2nd Value:
Value Percent:
Continuous Index:
Within 8" of Joint: **YES**
Remarks:

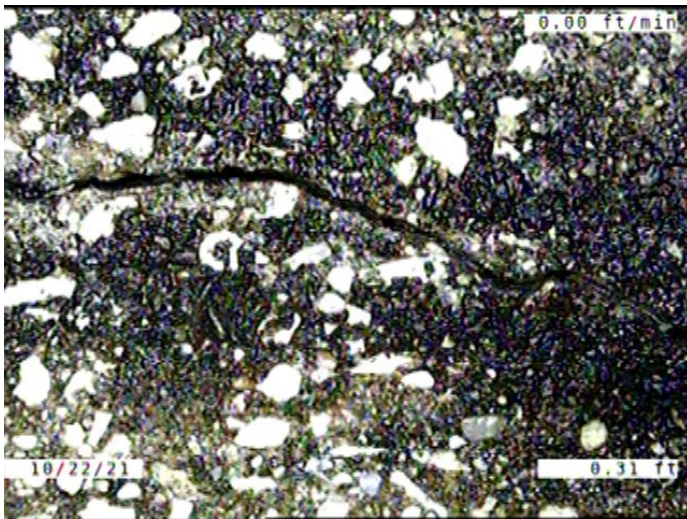
Code: **IWB**
Description: **Infiltration Weeper Barrel**

Distance (ft): **.3**
Structural Grade: **0**
O&M Grade: **2**
Clock Start/From: **11**
Clock To: **12**
1st Value:
2nd Value:
Value Percent:
Continuous Index:
Within 8" of Joint: **YES**
Remarks:

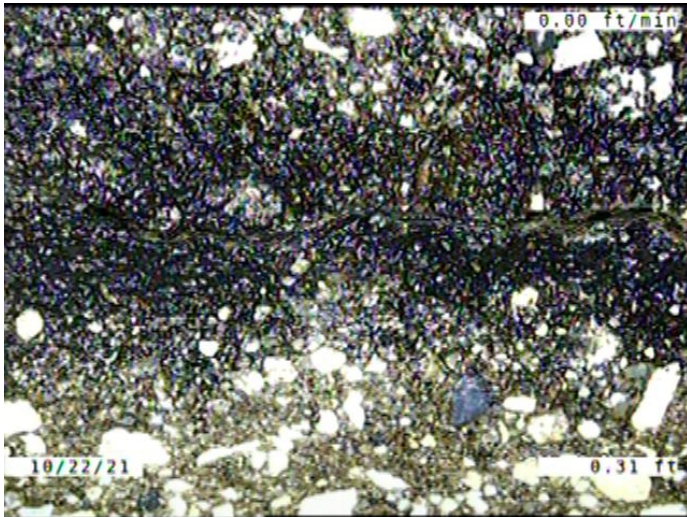
Code: **ISB**
 Description: **Infiltration Stain Barrel**

Distance (ft): **.3**
 Structural Grade: **0**
 O&M Grade: **1**
 Clock Start/From: **8**
 Clock To: **4**
 1st Value:
 2nd Value:
 Value Percent:
 Continuous Index:
 Within 8" of Joint: **YES**
 Remarks:

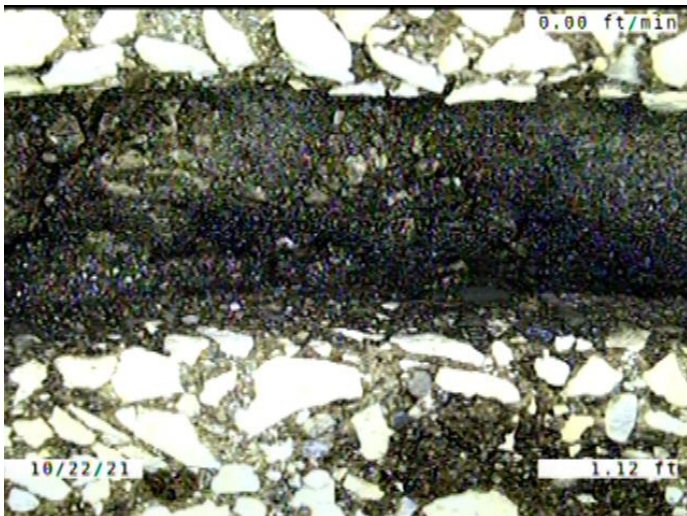
Code: **JAM**
 Description: **Joint Angular Medium**

Distance (ft): **1.1**
 Structural Grade: **3**
 O&M Grade: **0**
 Clock Start/From:
 Clock To:
 1st Value:
 2nd Value:
 Value Percent:
 Continuous Index:
 Within 8" of Joint: **NO**
 Remarks:

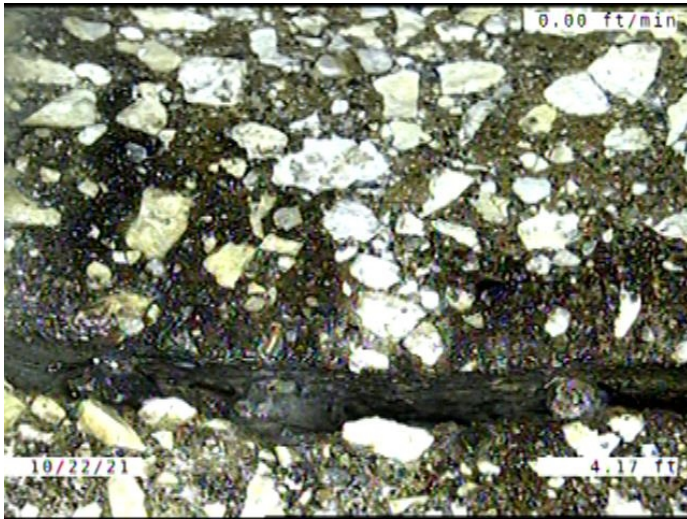
Code: **ISJ**
 Description: **Infiltration Stain Joint**

Distance (ft): **4.2**
 Structural Grade: **0**
 O&M Grade: **1**
 Clock Start/From: **4**
 Clock To: **5**
 1st Value:
 2nd Value:
 Value Percent:
 Continuous Index:
 Within 8" of Joint: **YES**
 Remarks:

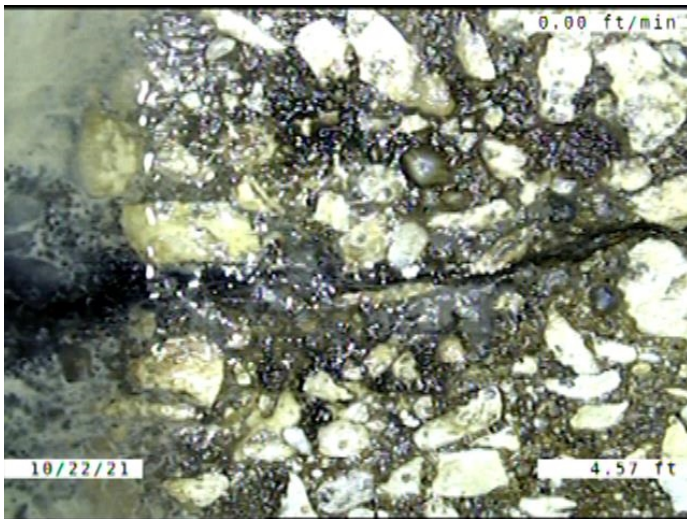
Code: **FC**
 Description: **Fracture Circumferential**

Distance (ft): **4.6**
 Structural Grade: **2**
 O&M Grade: **0**
 Clock Start/From: **1**
 Clock To: **10**
 1st Value:
 2nd Value:
 Value Percent:
 Continuous Index:
 Within 8" of Joint: **YES**
 Remarks:

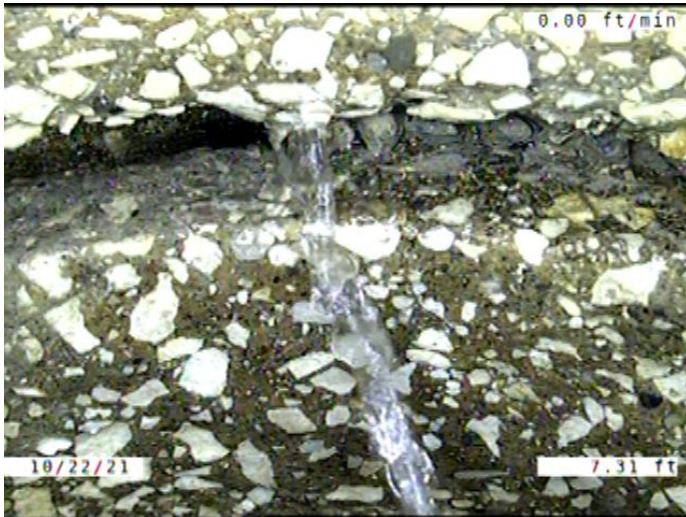
Code: **IRJ**
 Description: **Infiltration Runner Joint**

Distance (ft): **7.3**
 Structural Grade: **0**
 O&M Grade: **4**
 Clock Start/From: **12**
 Clock To: **1**
 1st Value:
 2nd Value:
 Value Percent:
 Continuous Index:
 Within 8" of Joint: **YES**
 Remarks:

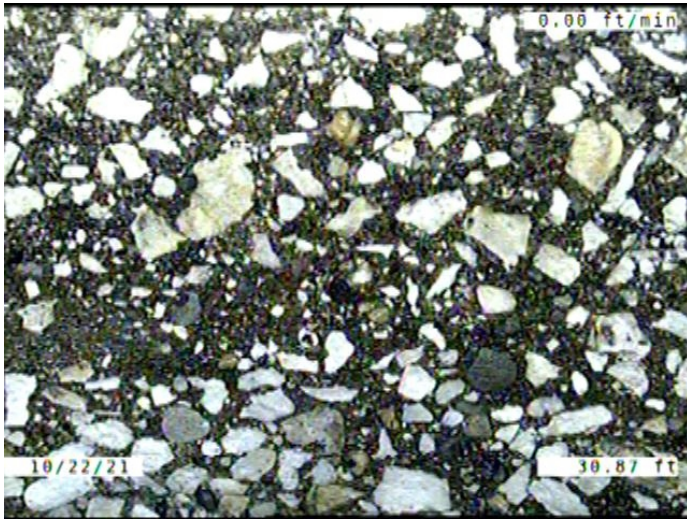
Code: **CS**
 Description: **Crack Spiral**

Distance (ft): **30.9**
 Structural Grade: **2**
 O&M Grade: **0**
 Clock Start/From: **12**
 Clock To: **12**
 1st Value:
 2nd Value:
 Value Percent:
 Continuous Index:
 Within 8" of Joint: **YES**
 Remarks:

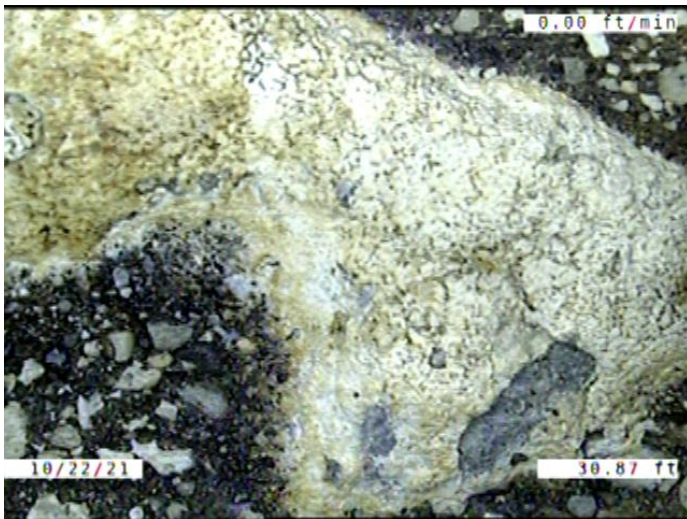
Code: **DAE**
 Description: **Deposits Attached Encrustation**

Distance (ft): **30.9**
 Structural Grade: **0**
 O&M Grade: **2**
 Clock Start/From: **7**
 Clock To: **9**
 1st Value:
 2nd Value:
 Value Percent: **5.000**
 Continuous Index:
 Within 8" of Joint: **YES**
 Remarks:

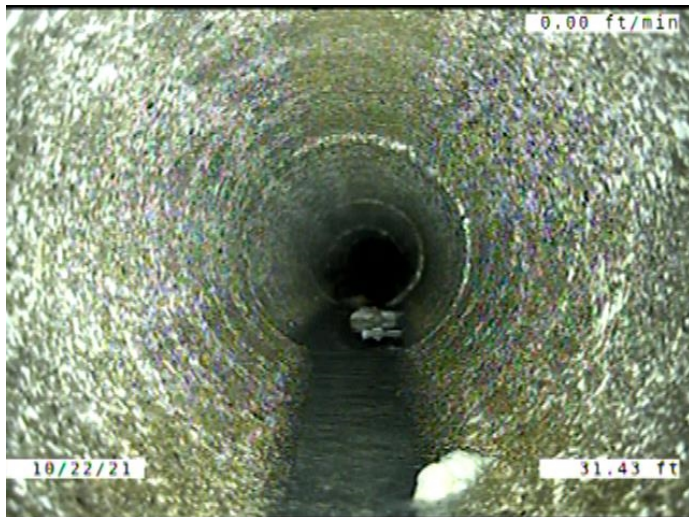
Code: **DSF**
 Description: **Deposits Settled Fine**

Distance (ft): **31.4**
 Structural Grade: **0**
 O&M Grade: **2**
 Clock Start/From: **5**
 Clock To: **7**
 1st Value:
 2nd Value:
 Value Percent: **5.000**
 Continuous Index: **S01**
 Within 8" of Joint: **YES**
 Remarks:

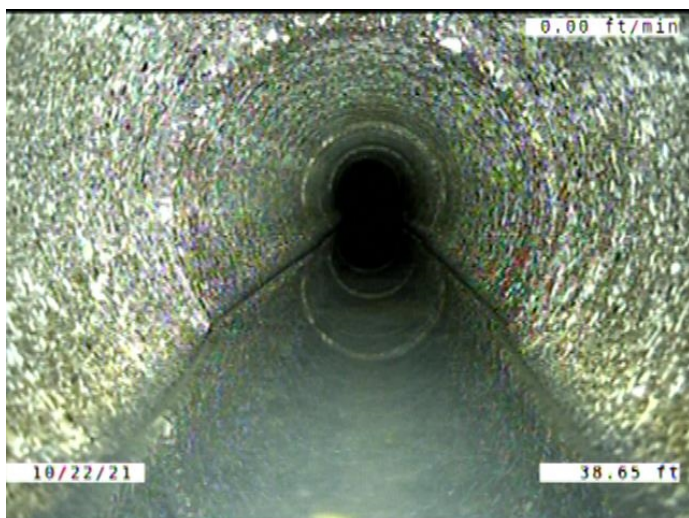
Code: **MWLS**
 Description: **Miscellaneous Water Level Sag**

Distance (ft): **38.6**
 Structural Grade: **2**
 O&M Grade: **0**
 Clock Start/From:
 Clock To:
 1st Value:
 2nd Value:
 Value Percent: **5.000**
 Continuous Index: **S02**
 Within 8" of Joint: **NO**
 Remarks:

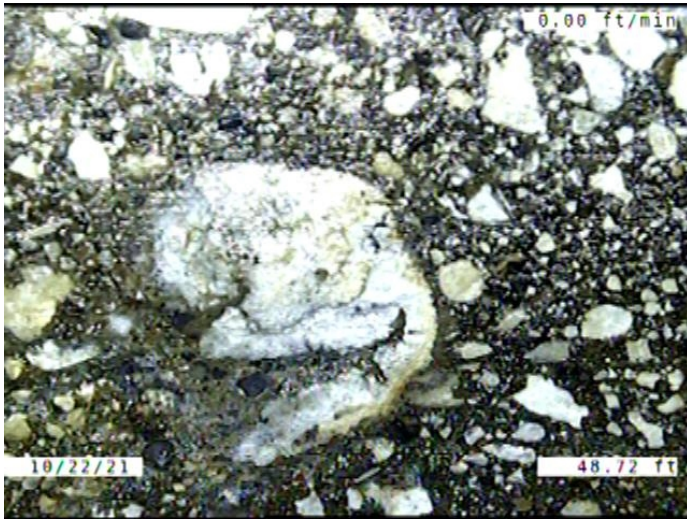
Code: **DAE**
 Description: **Deposits Attached Encrustation**

Distance (ft): **48.7**
 Structural Grade: **0**
 O&M Grade: **2**
 Clock Start/From: **7**
 Clock To: **12**
 1st Value:
 2nd Value:
 Value Percent: **5.000**
 Continuous Index:
 Within 8" of Joint: **YES**
 Remarks:

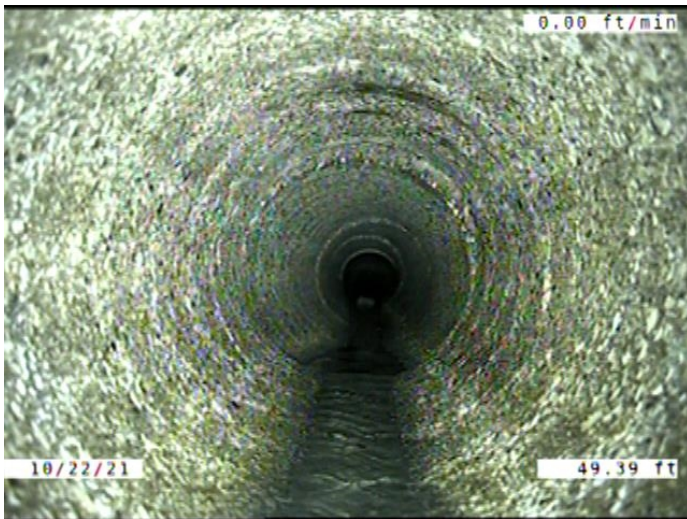
Code: **MWLS**
 Description: **Miscellaneous Water Level Sag**

Distance (ft): **49.4**
 Structural Grade: **2**
 O&M Grade: **0**
 Clock Start/From:
 Clock To:
 1st Value:
 2nd Value:
 Value Percent: **5.000**
 Continuous Index: **F02**
 Within 8" of Joint: **NO**
 Remarks:

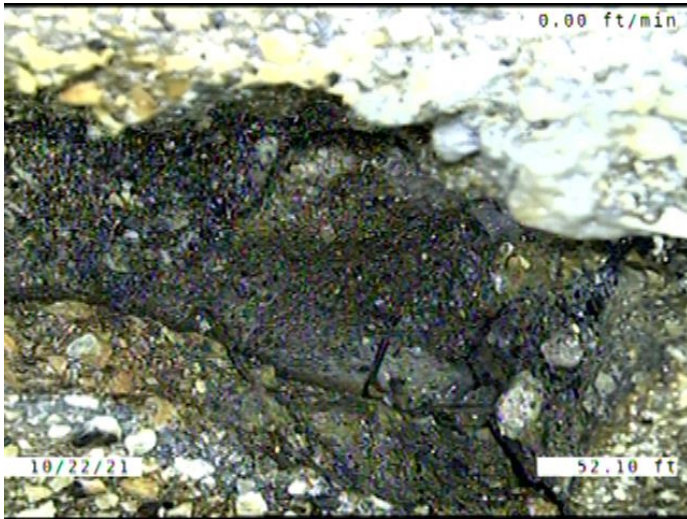
52.1	SMW	Surface Damage Missing Wall	979	S 5
52.1	FM	Fracture Multiple	1012	S 4
56.8	ISB	Infiltration Stain Barrel	1088	M 1
56.9	CM	Crack Multiple	1124	S 3

Code: **SMW**
 Description: **Surface Damage Missing Wall**

Distance (ft): **52.1**
 Structural Grade: **5**
 O&M Grade: **0**
 Clock Start/From: **9**
 Clock To: **4**
 1st Value:
 2nd Value:
 Value Percent:
 Continuous Index:
 Within 8" of Joint: **YES**
 Remarks: **INSIDE OF THE JOINT**

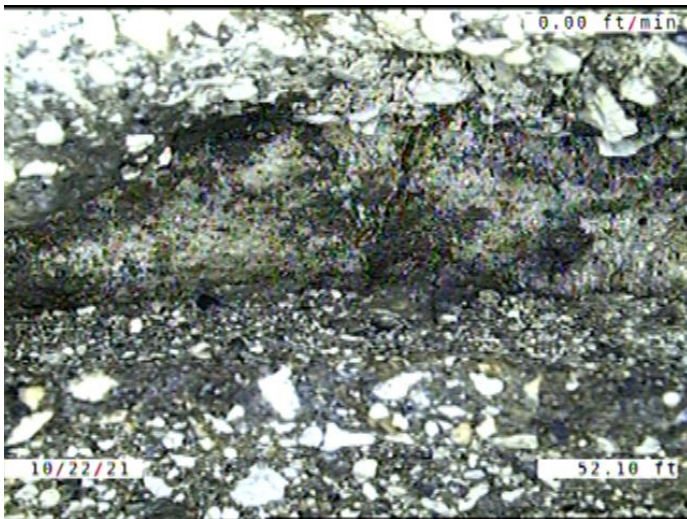
Code: **FM**
 Description: **Fracture Multiple**

Distance (ft): **52.1**
 Structural Grade: **4**
 O&M Grade: **0**
 Clock Start/From: **12**
 Clock To: **3**
 1st Value:
 2nd Value:
 Value Percent:
 Continuous Index:
 Within 8" of Joint: **YES**
 Remarks:

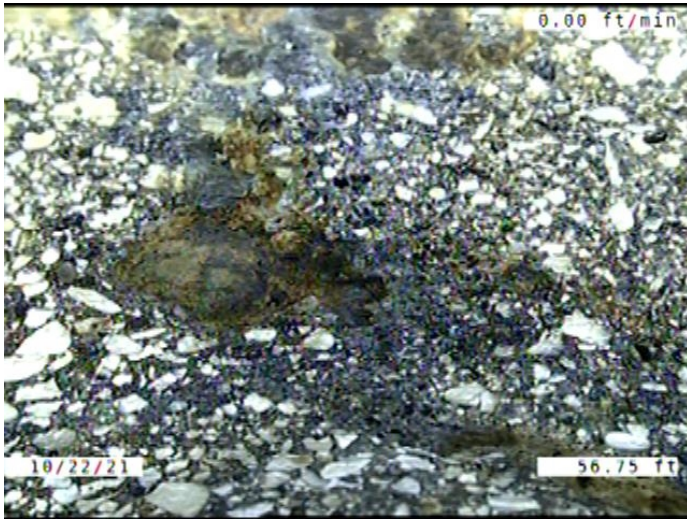
Code: **ISB**
 Description: **Infiltration Stain Barrel**

Distance (ft): **56.8**
 Structural Grade: **0**
 O&M Grade: **1**
 Clock Start/From: **8**
 Clock To: **5**
 1st Value:
 2nd Value:
 Value Percent:
 Continuous Index:
 Within 8" of Joint: **YES**
 Remarks:

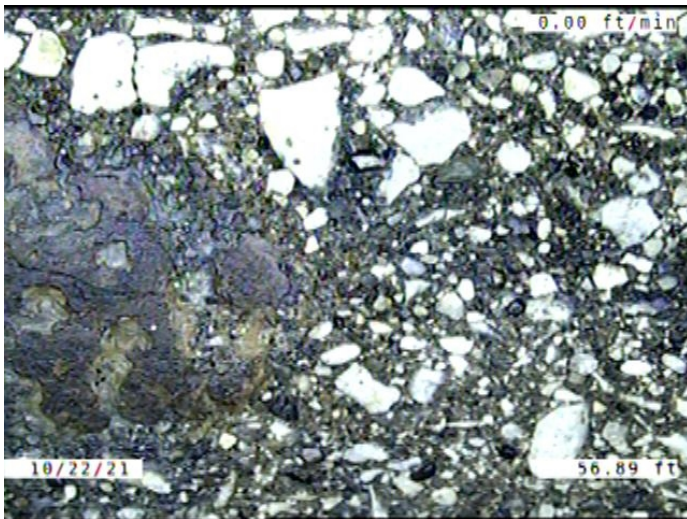
Code: **CM**
 Description: **Crack Multiple**

Distance (ft): **56.9**
 Structural Grade: **3**
 O&M Grade: **0**
 Clock Start/From: **7**
 Clock To: **5**
 1st Value:
 2nd Value:
 Value Percent:
 Continuous Index:
 Within 8" of Joint: **YES**
 Remarks:

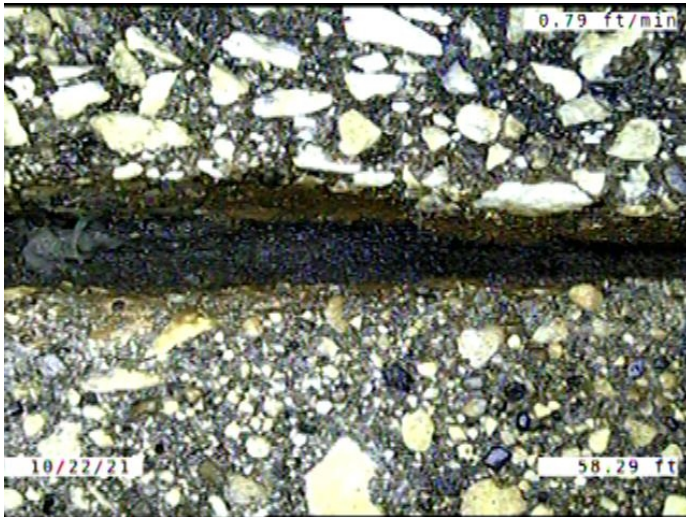
Code: **ISJ**
Description: **Infiltration Stain Joint**

Distance (ft): **58.3**
Structural Grade: **0**
O&M Grade: **1**
Clock Start/From: **7**
Clock To: **5**
1st Value:
2nd Value:
Value Percent:
Continuous Index:
Within 8" of Joint: **YES**
Remarks:

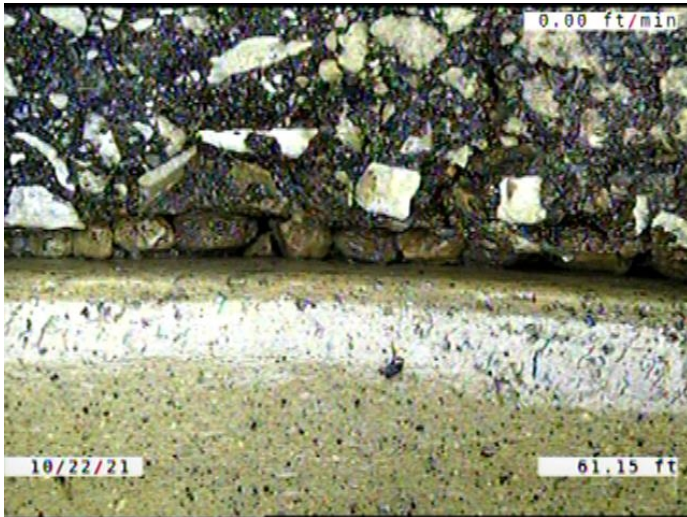
Code: **CM**
 Description: **Crack Multiple**

Distance (ft): **61.1**
 Structural Grade: **3**
 O&M Grade: **0**
 Clock Start/From: **12**
 Clock To: **12**
 1st Value:
 2nd Value:
 Value Percent:
 Continuous Index:
 Within 8" of Joint: **NO**
 Remarks:

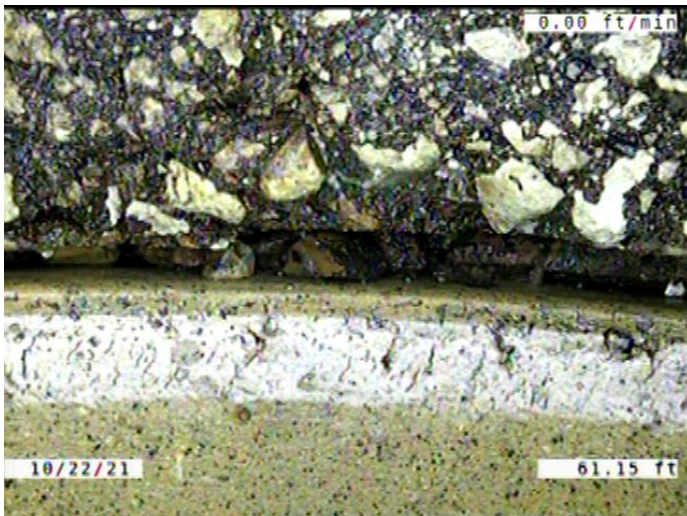
Code: **ISJ**
 Description: **Infiltration Stain Joint**

Distance (ft): **61.2**
 Structural Grade: **0**
 O&M Grade: **1**
 Clock Start/From: **7**
 Clock To: **5**
 1st Value:
 2nd Value:
 Value Percent:
 Continuous Index:
 Within 8" of Joint: **YES**
 Remarks:

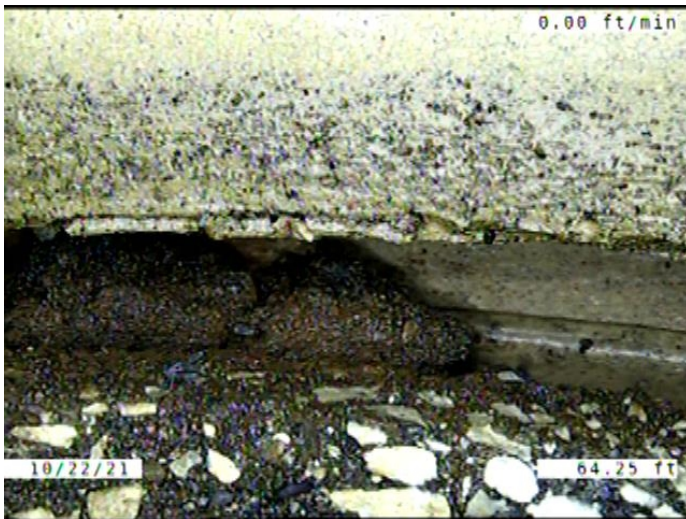
Code: **ISJ**
 Description: **Infiltration Stain Joint**

Distance (ft): **64.3**
 Structural Grade: **0**
 O&M Grade: **1**
 Clock Start/From: **1**
 Clock To: **5**
 1st Value:
 2nd Value:
 Value Percent:
 Continuous Index:
 Within 8" of Joint: **YES**
 Remarks:

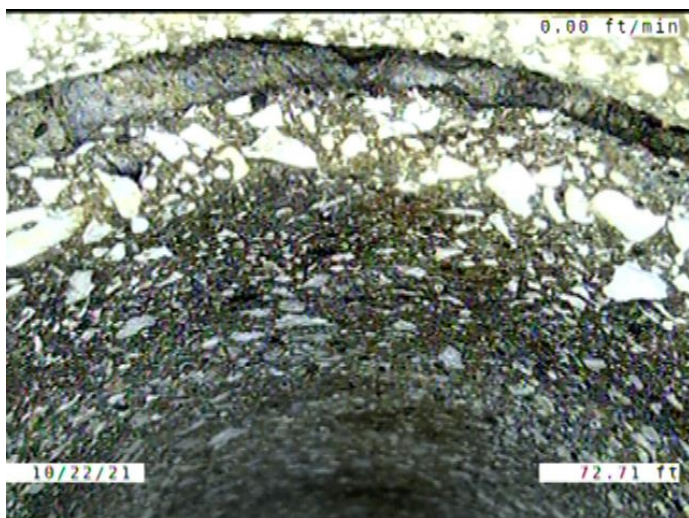
Code: **JOM**
 Description: **Joint Offset Medium**

Distance (ft): **72.7**
 Structural Grade: **3**
 O&M Grade: **0**
 Clock Start/From:
 Clock To:
 1st Value:
 2nd Value:
 Value Percent:
 Continuous Index:
 Within 8" of Joint: **NO**
 Remarks:

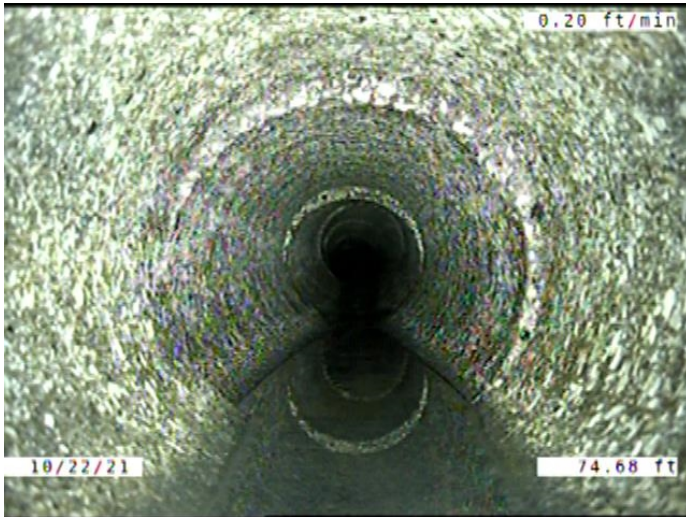
Code: **MWLS**
 Description: **Miscellaneous Water Level Sag**

Distance (ft): **74.7**
 Structural Grade: **2**
 O&M Grade: **0**
 Clock Start/From:
 Clock To:
 1st Value:
 2nd Value:
 Value Percent: **5.000**
 Continuous Index: **S03**
 Within 8" of Joint: **NO**
 Remarks:

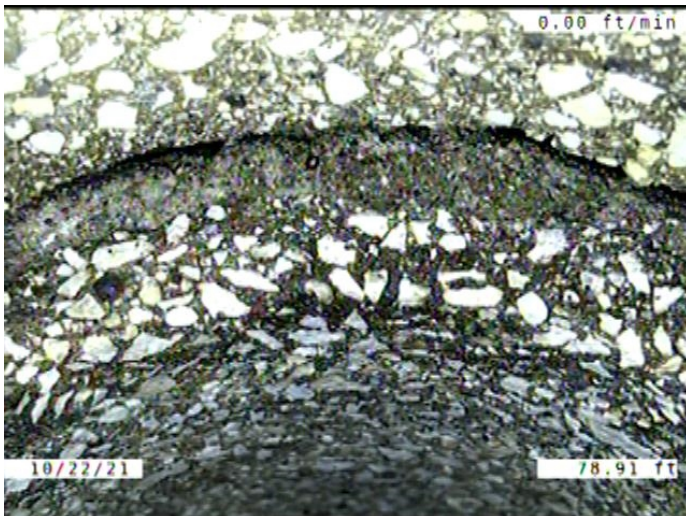
Code: **JOM**
 Description: **Joint Offset Medium**

Distance (ft): **78.9**
 Structural Grade: **3**
 O&M Grade: **0**
 Clock Start/From:
 Clock To:
 1st Value:
 2nd Value:
 Value Percent:
 Continuous Index:
 Within 8" of Joint: **NO**
 Remarks:

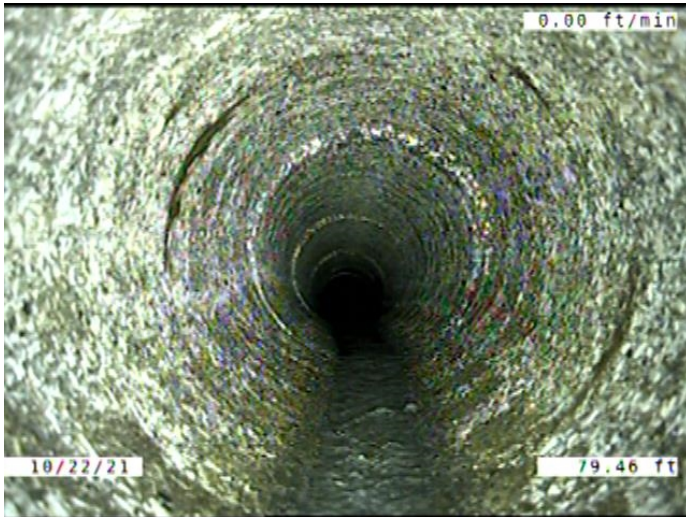
Code: **MWLS**
 Description: **Miscellaneous Water Level Sag**

Distance (ft): **79.5**
 Structural Grade: **2**
 O&M Grade: **0**
 Clock Start/From:
 Clock To:
 1st Value:
 2nd Value:
 Value Percent: **5.000**
 Continuous Index: **F03**
 Within 8" of Joint: **NO**
 Remarks:

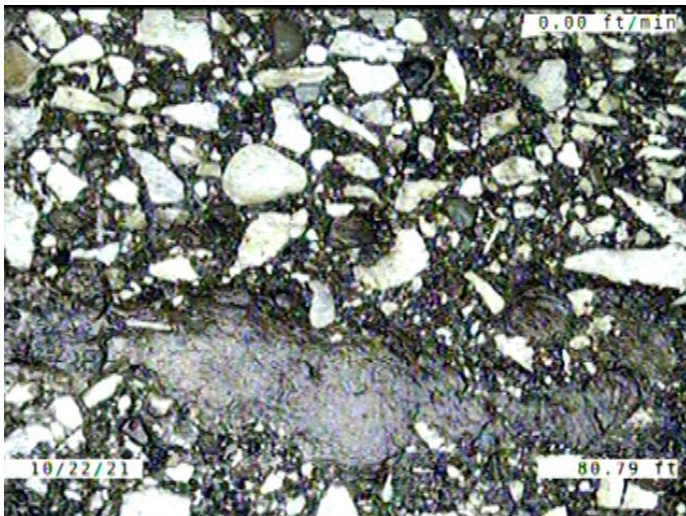
Code: **ISB**
 Description: **Infiltration Stain Barrel**

Distance (ft): **80.8**
 Structural Grade: **0**
 O&M Grade: **1**
 Clock Start/From: **8**
 Clock To: **4**
 1st Value:
 2nd Value:
 Value Percent:
 Continuous Index:
 Within 8" of Joint: **NO**
 Remarks:

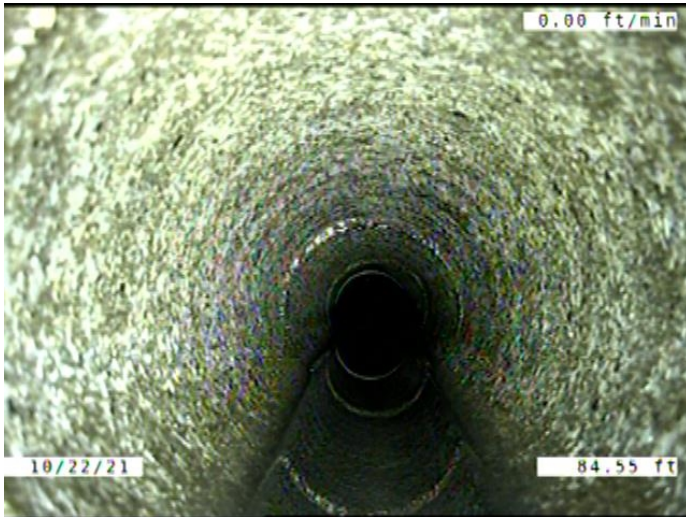
Code: **MWLS**
Description: **Miscellaneous Water Level Sag**

Distance (ft): **84.6**
Structural Grade: **2**
O&M Grade: **0**
Clock Start/From:
Clock To:
1st Value:
2nd Value:
Value Percent: **10.000**
Continuous Index: **S04**
Within 8" of Joint: **NO**
Remarks:

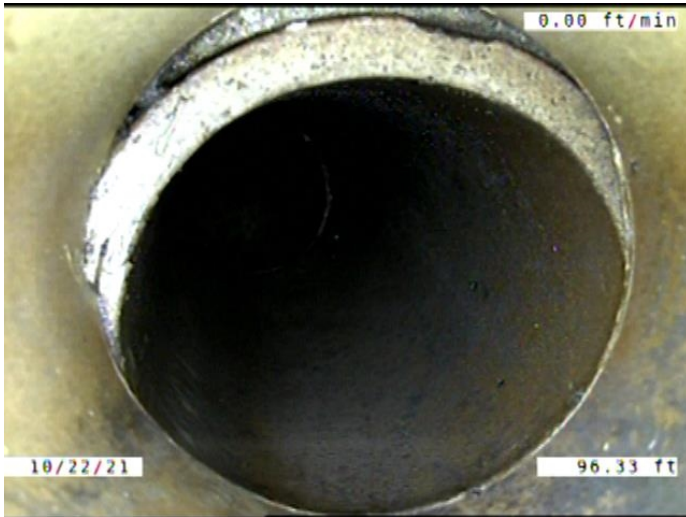
Code:	TFD
Description:	Tap Factory Defective
Distance (ft):	96.3
Structural Grade:	0
O&M Grade:	3
Clock Start/From:	11
Clock To:	
1st Value:	4.000
2nd Value:	
Value Percent:	
Continuous Index:	
Within 8" of Joint:	YES
Remarks:	LARGE OFFSET AT THE FIRST JOINT BACK. CONSTANTLY RUNNING WAT

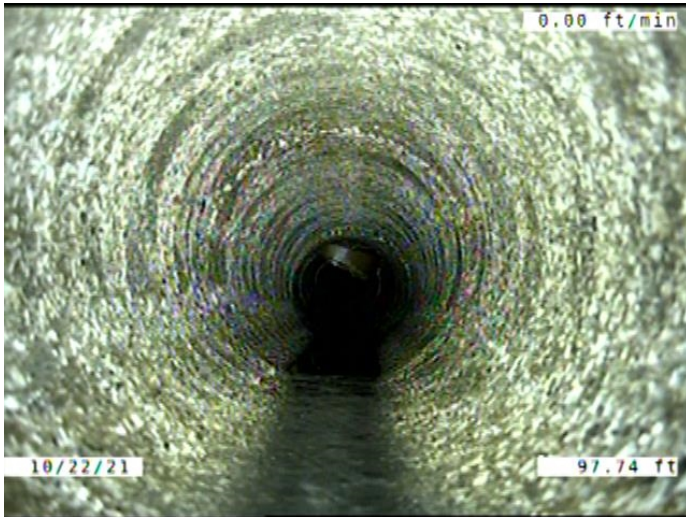
Code: **MWLS**
 Description: **Miscellaneous Water Level Sag**

Distance (ft): **97.7**
 Structural Grade: **2**
 O&M Grade: **0**
 Clock Start/From:
 Clock To:
 1st Value:
 2nd Value:
 Value Percent: **10.000**
 Continuous Index: **F04**
 Within 8" of Joint: **NO**
 Remarks:

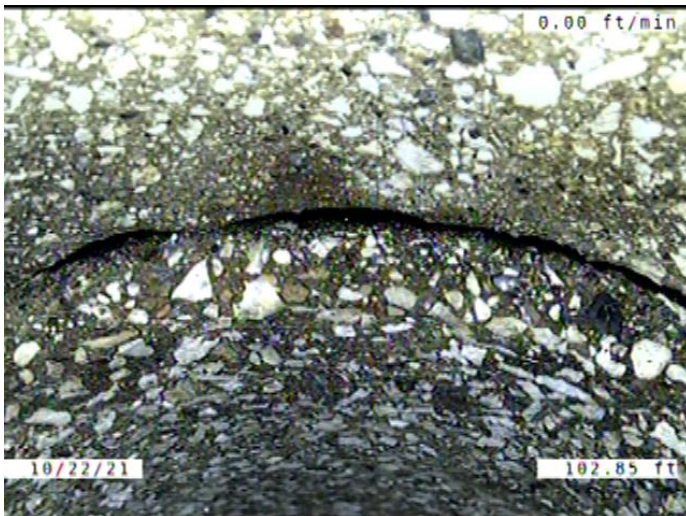
Code: **JOM**
 Description: **Joint Offset Medium**

Distance (ft): **102.8**
 Structural Grade: **3**
 O&M Grade: **0**
 Clock Start/From:
 Clock To:
 1st Value:
 2nd Value:
 Value Percent:
 Continuous Index:
 Within 8" of Joint: **NO**
 Remarks:

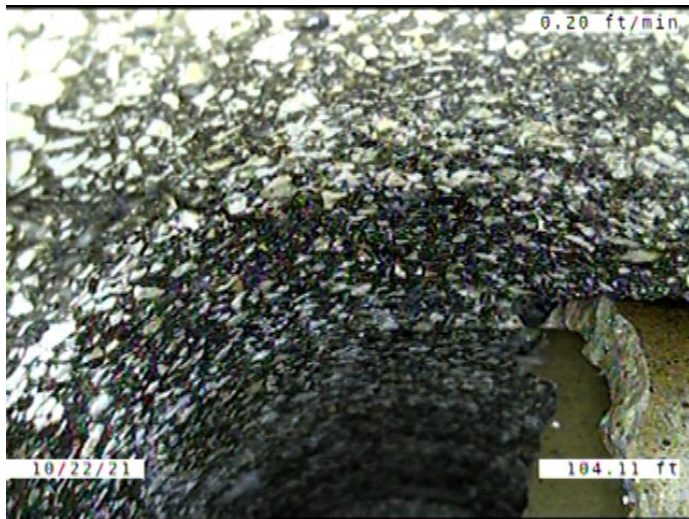
Code: **B**
 Description: **Broken**

Distance (ft): **104.1**
 Structural Grade: **4**
 O&M Grade: **0**
 Clock Start/From: **12**
 Clock To: **3**
 1st Value:
 2nd Value:
 Value Percent:
 Continuous Index:
 Within 8" of Joint: **YES**
 Remarks:

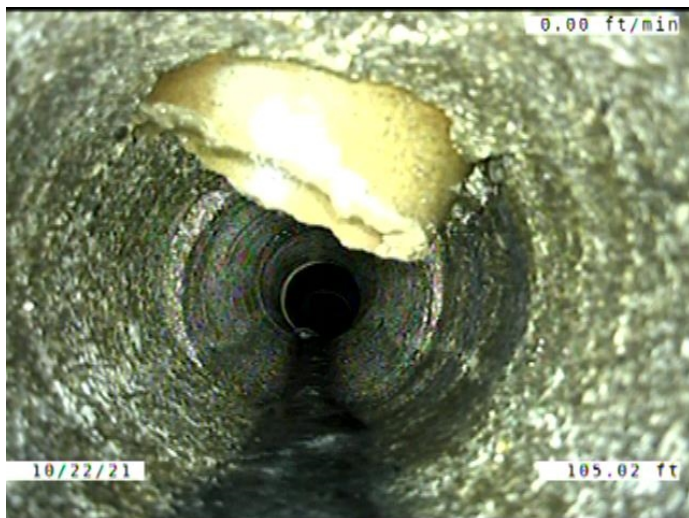
Code: **TBI**
 Description: **Tap Break-in Intruding**

Distance (ft): **105.0**
 Structural Grade: **0**
 O&M Grade: **2**
 Clock Start/From: **1**
 Clock To:
 1st Value: **4.000**
 2nd Value: **2.000**
 Value Percent:
 Continuous Index:
 Within 8" of Joint: **YES**
 Remarks:

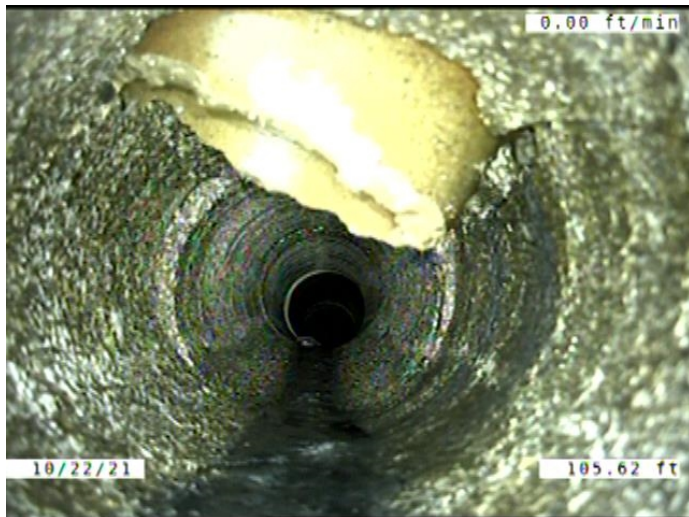
Code: **DSF**
 Description: **Deposits Settled Fine**

Distance (ft): **105.6**
 Structural Grade: **0**
 O&M Grade: **2**
 Clock Start/From: **5**
 Clock To: **7**
 1st Value:
 2nd Value:
 Value Percent: **5.000**
 Continuous Index: **F01**
 Within 8" of Joint: **YES**
 Remarks:
