## Profile/Photo Observation Report

Date:	<b>04/18/2018</b>	Weather:		Coding:	<b>PACP 6.0</b>
Pipe Length (ft):	<b>216.8</b>	Owner:	<b>NA</b>	Pre Clean:	<b>Not Known</b>
P.O.#:		Surveyor:	<b>Byrd Fitzgerald</b>	PSR:	<b>P-504-108-106</b>
Customer:		Clean Date:	<b>01/01/1900</b>	Shape:	<b>C</b>

Street:	<b>N DELAWARE ST</b>	Flow Control:	<b>Not Controlled</b>
City:	<b>Hobart, IN</b>	Year Renewed:	
Location:	<b>Light Highway</b>	Tape/Media #:	
Purpose:	<b>Not Known</b>	Dia/Height:	<b>12"</b>
Use:	<b>Sanitary</b>	Material:	<b>VCP</b>
Drain Area:	<b>NA</b>	Lining:	
Category:	<b>NA</b>		
Comment:

Location Details:		Direction of Survey:	<b>Upstream</b>
US MH:	<b>M-504-106</b>	DS MH:	<b>M-504-108</b>
		Total Length Surveyed (ft):	<b>3.1</b>

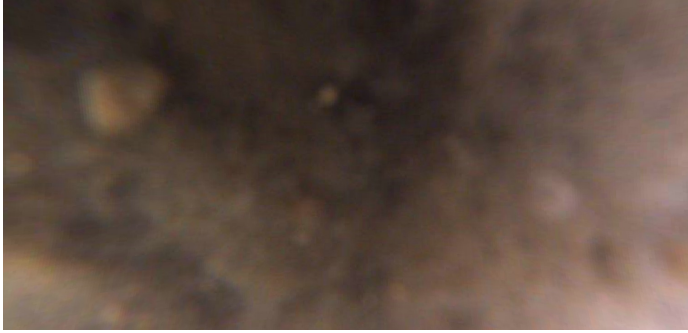
Code:	<b>MSA</b>
Description:	<b>Abandoned Survey</b>
Distance (ft):	<b>3.1</b>
Structural Grade:	<b>0</b>
O&M Grade:	<b>0</b>
Clock Start/From:	
Clock To:	
1st Value:	
2nd Value:	
Value Percent:	
Continuous Index:	
Within 8" of Joint:	<b>NO</b>
Remarks:	<b>mcu</b>
