Profile/Photo Observation Report

Street:	Summerlin	Flow Control:	Not Controlled
City:	Hobart, IN	Year Renewed:	
Location:	Light Highway	Tape/Media #:	
Purpose:	Not Known	Dia/Height:	12"
Use:	Sanitary	Material:	VCP
Drain Area:	NA	Lining:	
Category:	NA		
Comment:

Location Details:		Direction of Survey:	Upstream
US MH:	M-504-106	DS MH:	M-504-108
		Total Length Surveyed (ft):	3.1

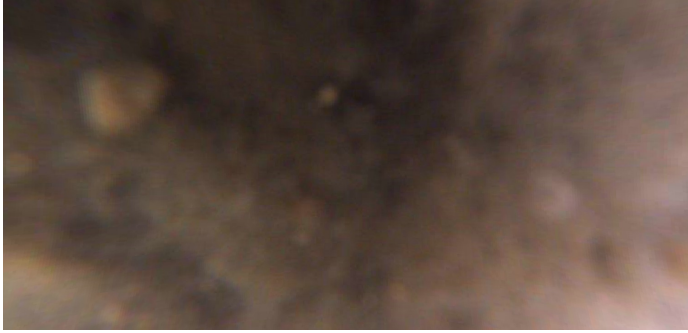
Code:	MSA
Description:	Abandoned Survey
Distance (ft):	3.1
Structural Grade:	0
O&M Grade:	0
Clock Start/From:	
Clock To:	
1st Value:	
2nd Value:	
Value Percent:	
Continuous Index:	
Within 8" of Joint:	NO
Remarks:	mcu
